US Environmental Protection Agency – Region 2  
 Caribbean Environmental Protection Division  
 Response and Remediation Branch

*Resource Conservation and Recovery Act (RCRA)*  
 Compliance Evaluation Inspection

| Facility Name: | Aluminios de Puerto Rico LLC | | |
| Date of Inspection: | April 24, 2024 | | |

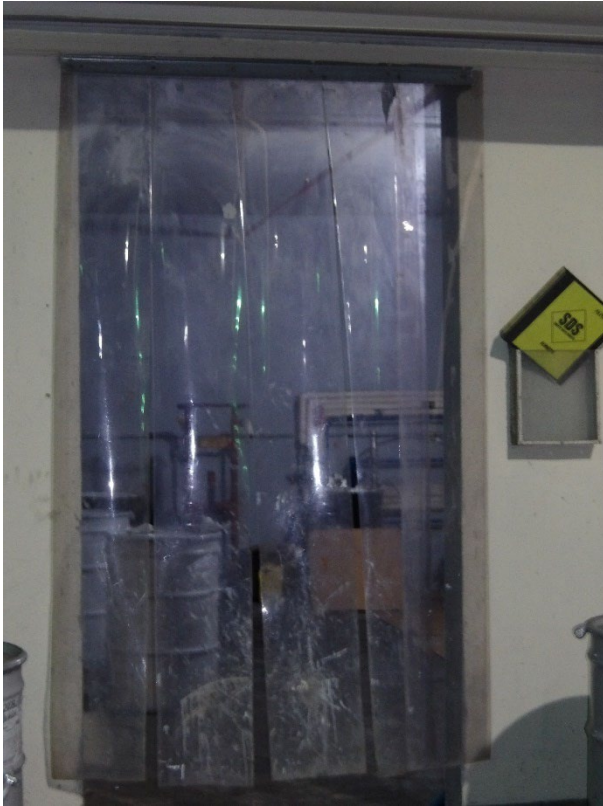
The Facility's main hazardous waste stream is in the Paint Room, See Appendix A, Photograph One (1) for an outside overview of this area. The room is divided into two work areas: a preparation area, and the paint room.

Photograph One (1): Outside Overview of the Paint Room SAA

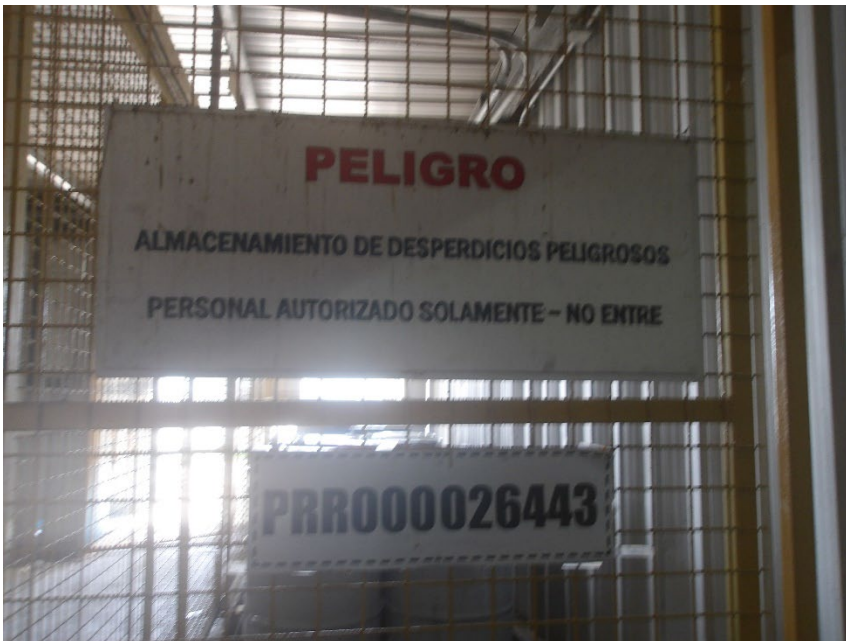
The hazardous waste is accumulated in a locked cage inside a room within the Facility. The cage had the Facility's RCRA ID number and a "hazardous waste storage area" placard posted, See Appendix A, Photograph Two (2).

Photograph Two (2): Hazardous Waste signage at the CAA

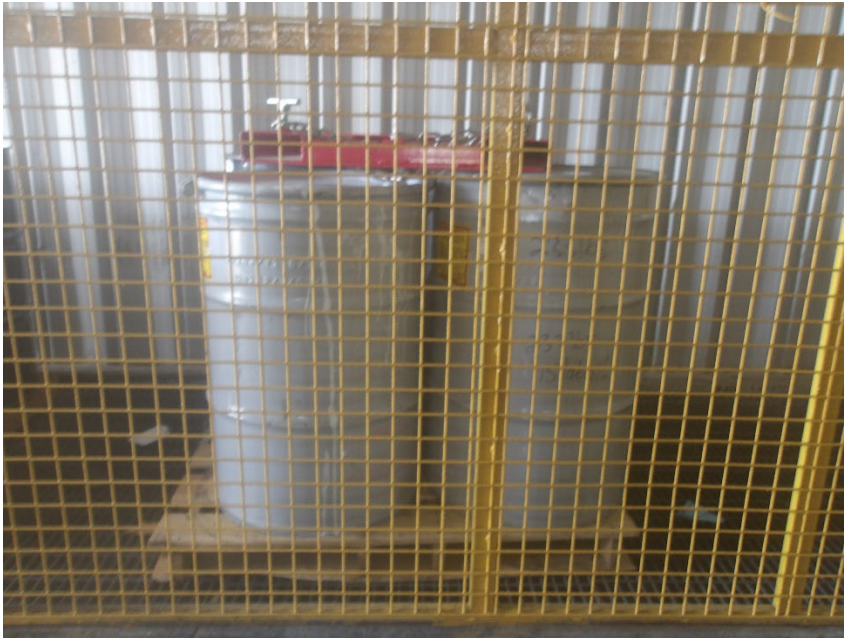
The drums were properly labeled with the words "hazardous waste", accumulation start dates and with an indication of the nature of its hazard, See Appendix A, Photographs Three (3), Four (4) and Five (5). There was a charged and inspected fire extinguisher (See Appendix A, Photograph Six [6]), and an eye washing station (See Appendix A, Photograph Seven [7]).

Photograph Three (3): 4 55-gallon drums of liquid waste paint in the CAA

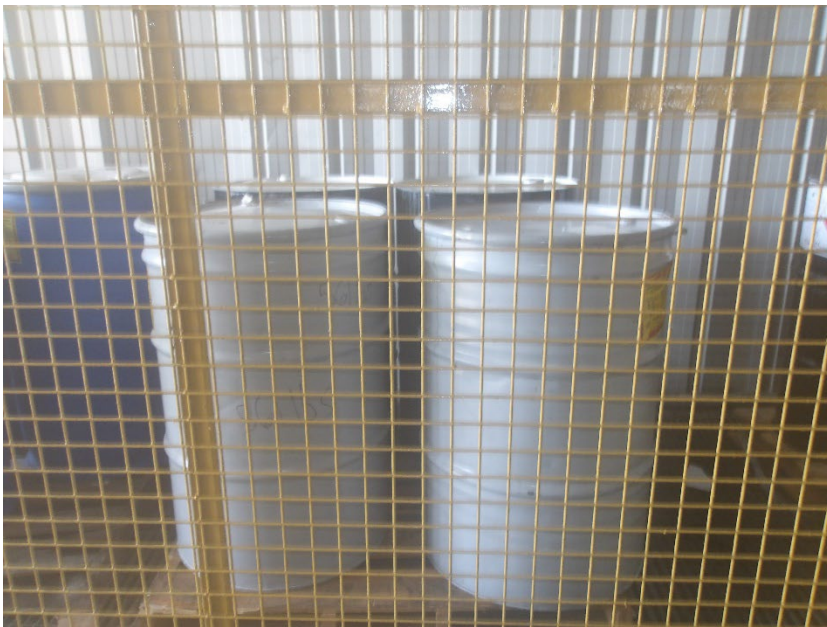
Photograph Four (4): 4 55-gallon drums of solid waste paint in the CAA

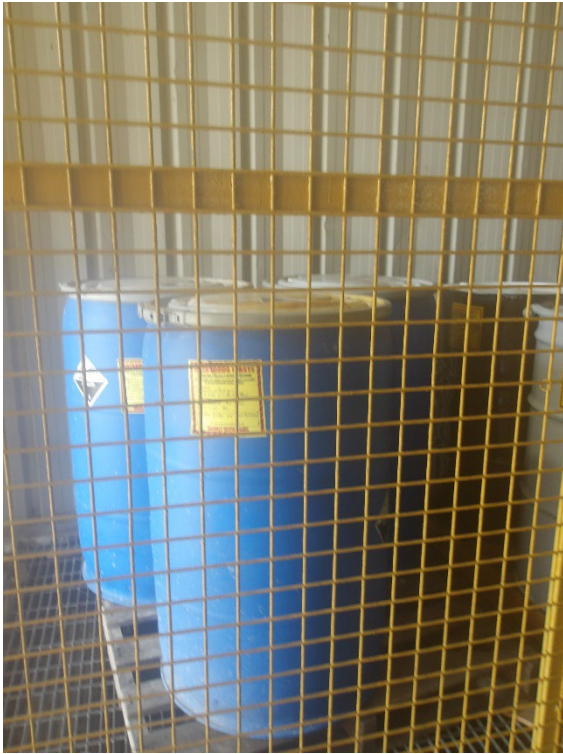
Photograph Five (5): 3 55-gallon drums of caustic sludge in the CAA

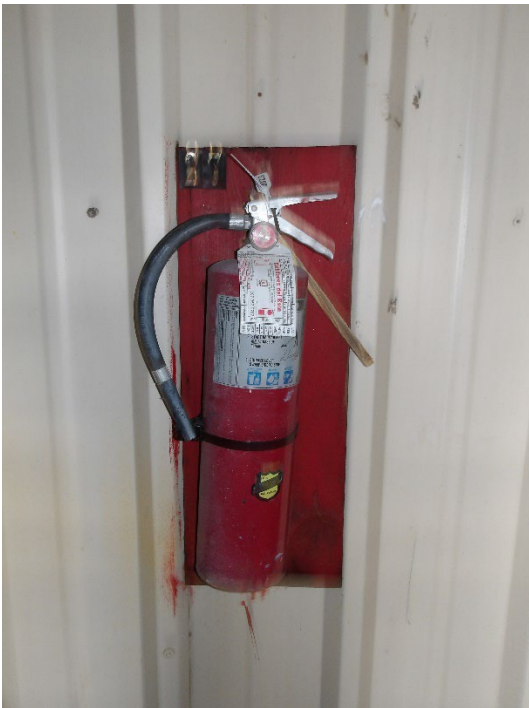
Photograph Six (6): Fire Extinguisher in the CAA

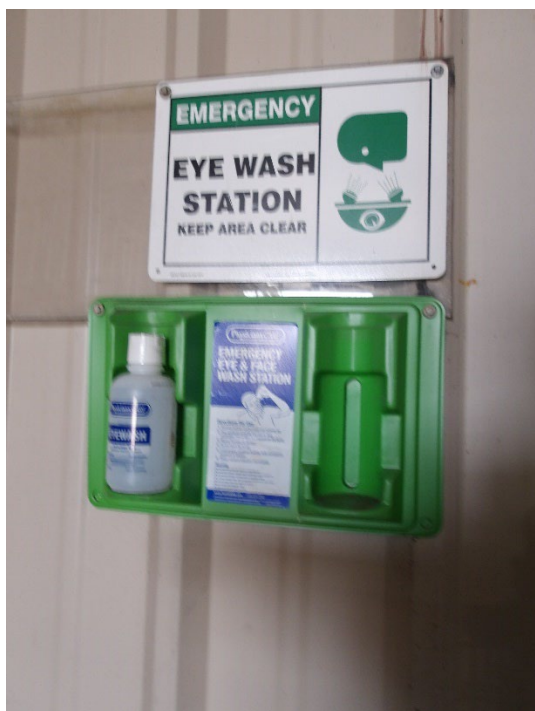
Photograph Seven (7): Eye Wash Station in the CAA

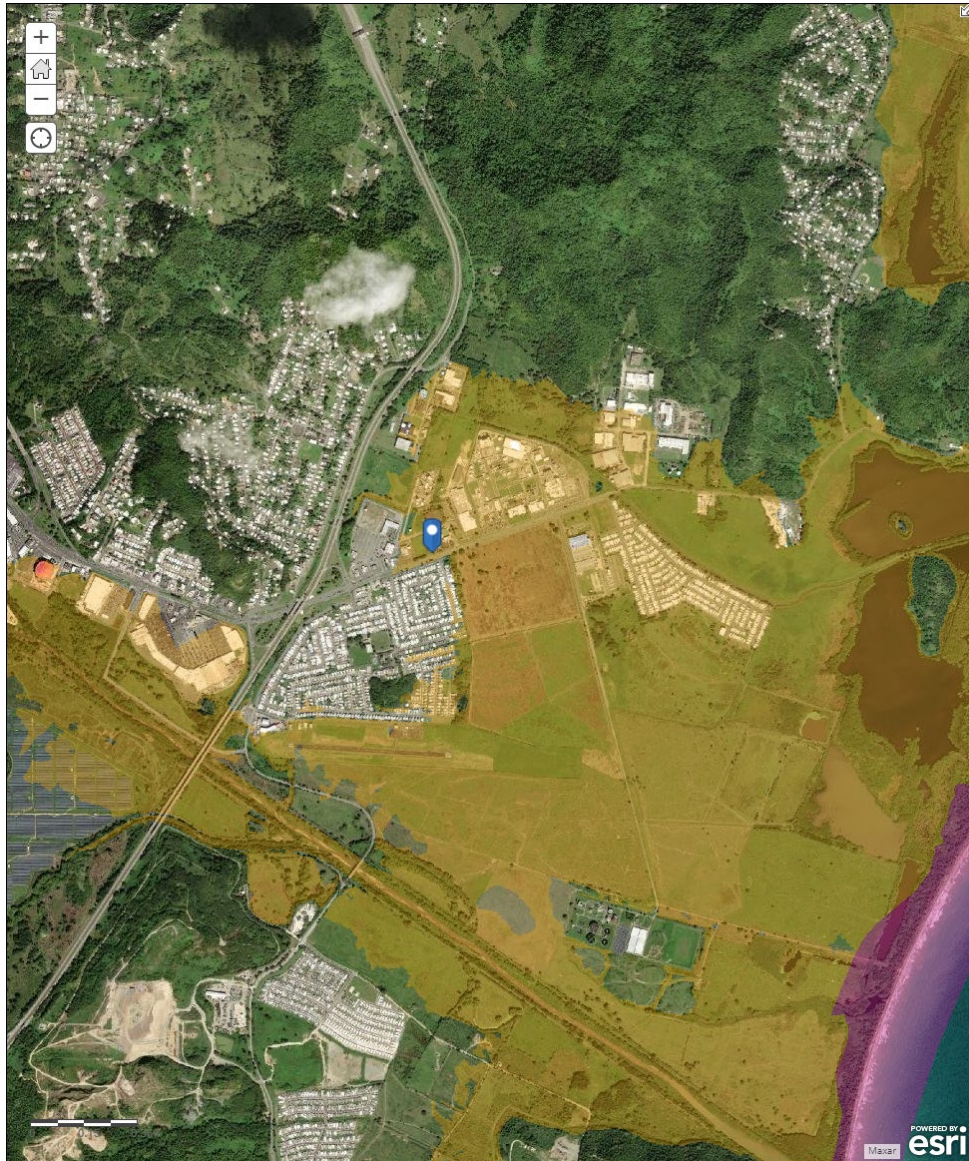
The Facility is located within the FEMA 100-Year Flood Zones layer.

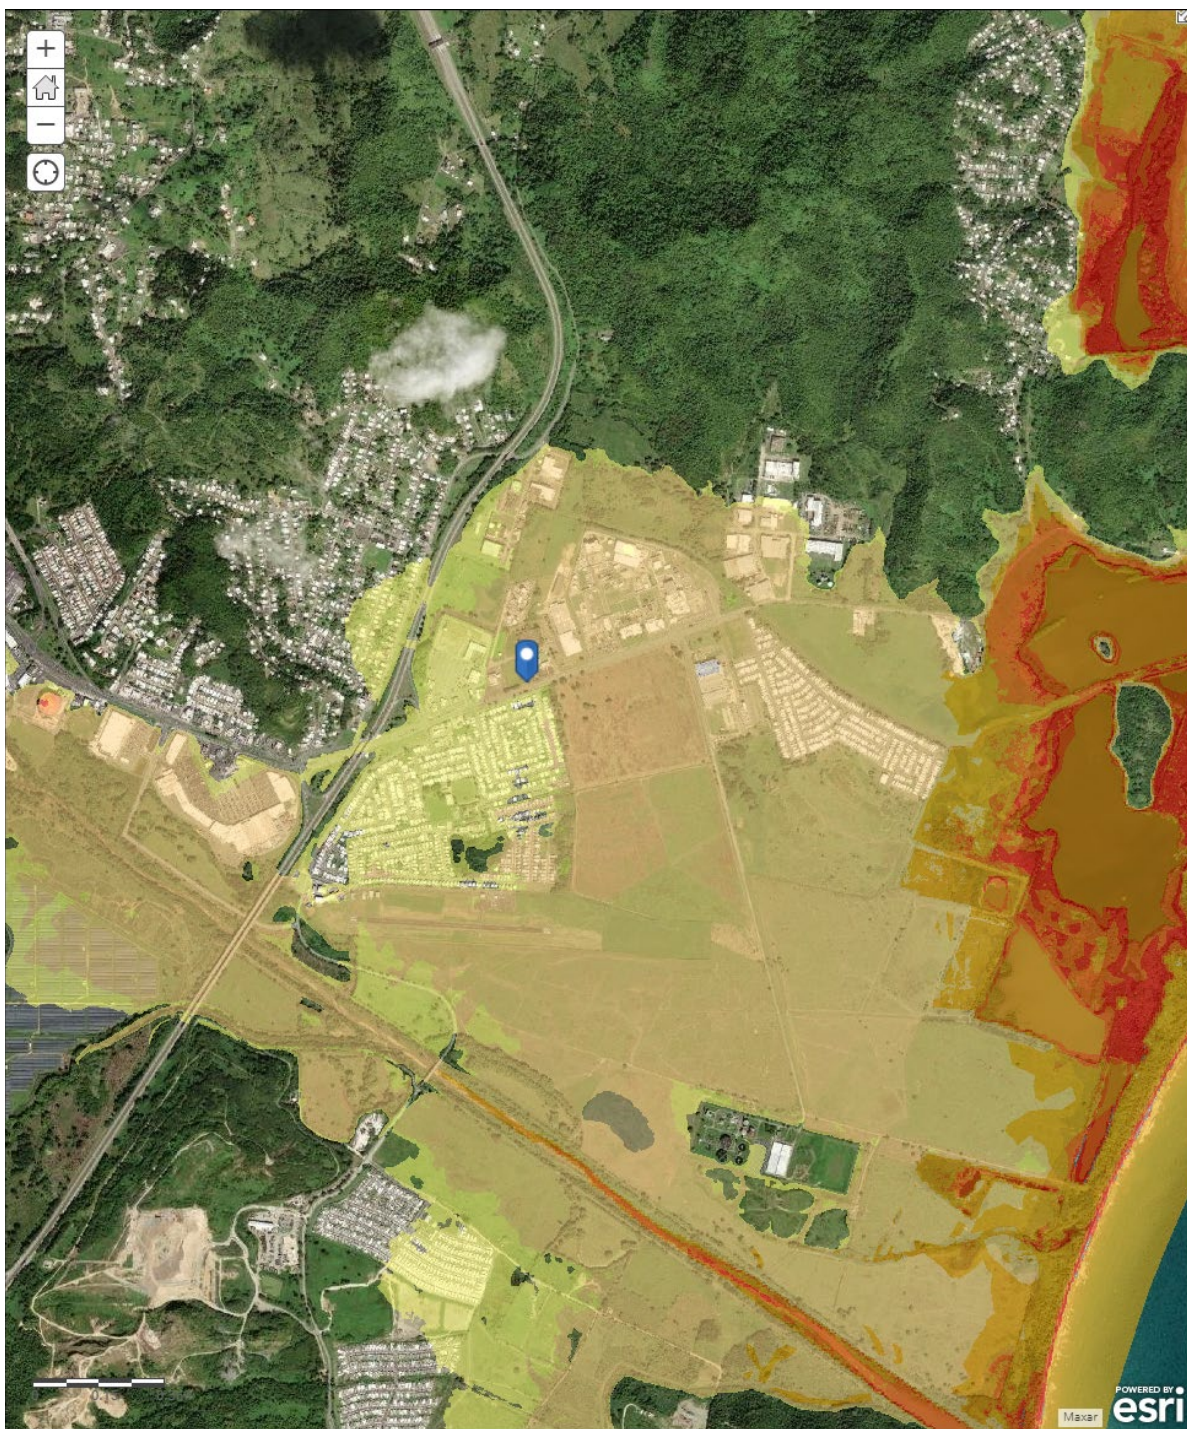
The Facility is located within a flood potential risk area based on EPA's Region 2 Composite Flood Risk layer.
