UNITED STATES ENVIRONMENTAL PROTECTION AGENCY  
REGION 8

Re: Inspection report for Salish Kootenai Housing Authority/St. Ignatius Southside Wastewater Treatment facility, NPDES permit #MT0029017

## NPDES– Municipal Wastewater

## Photographs for St. Ignatius Southside WWTF

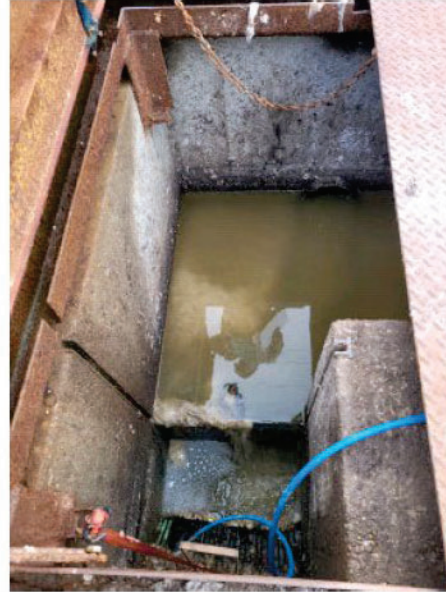
Photo number 1 taken by Evan Smith on 06/15/2022.

Influent with manual bar screen.

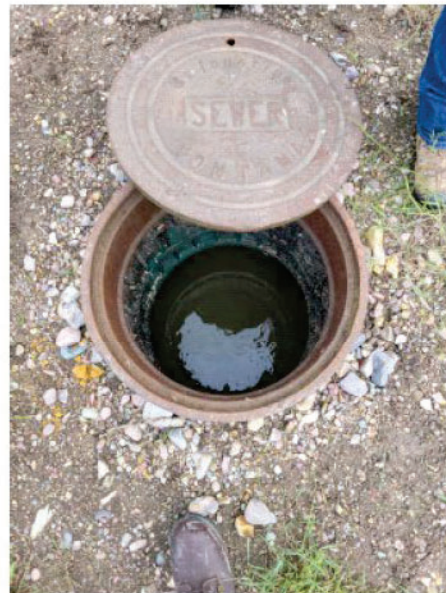
Photo number 2 taken by Evan Smith on 06/15/2022.

Manhole to access influent holding tank

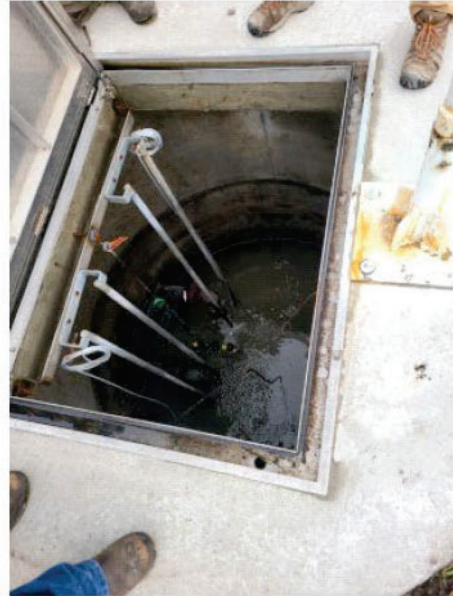
Photo number 3 taken by Evan Smith on 06/15/2022.

Lift station on-site with float system and alarms.

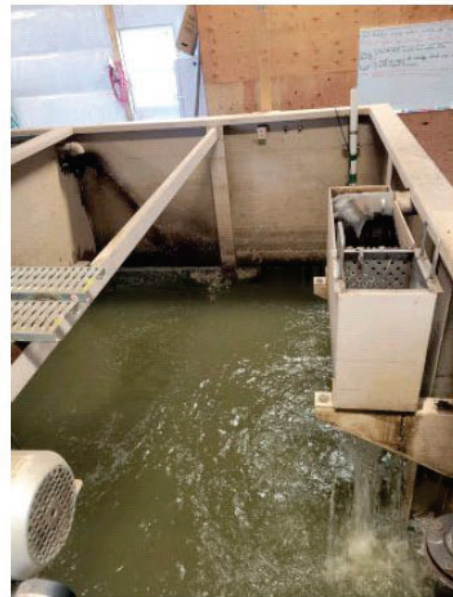
Photo number 4 taken by Evan Smith on 06/15/2022.

Aerated equalization tank

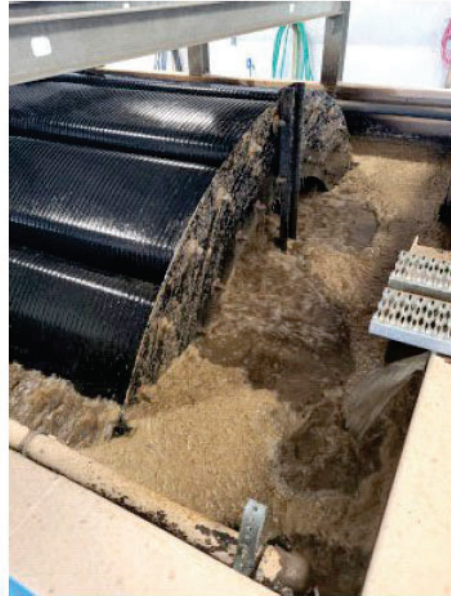
Photo number 5 taken by Evan Smith on 06/15/2022.

Bio-Rotor. Rotating wheel with biofilm for biological treatment.

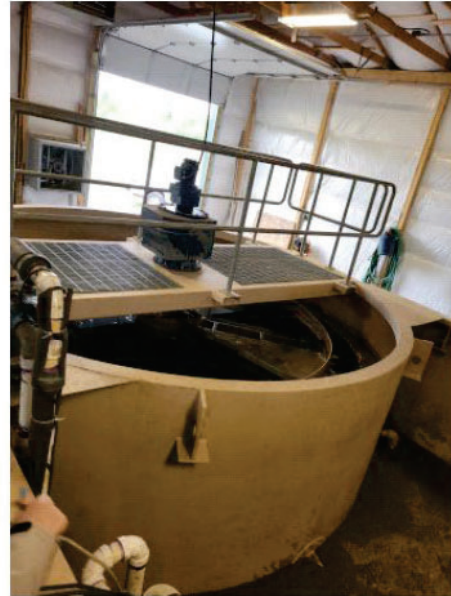
Photo number 6 taken by Evan Smith on 06/15/2022.

Secondary clarifier.

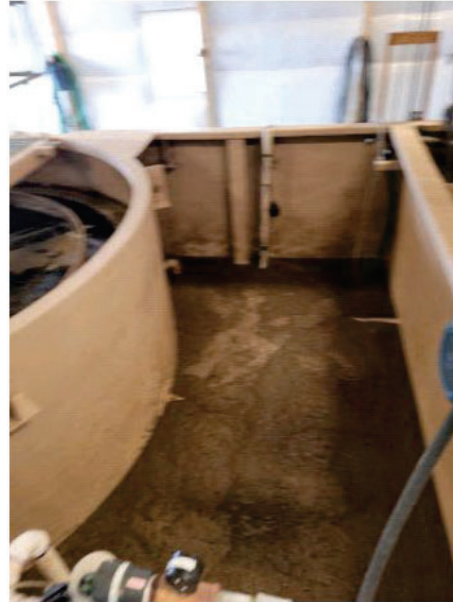
Photo number 7 taken by Evan Smith on 06/15/2022.

Digester.

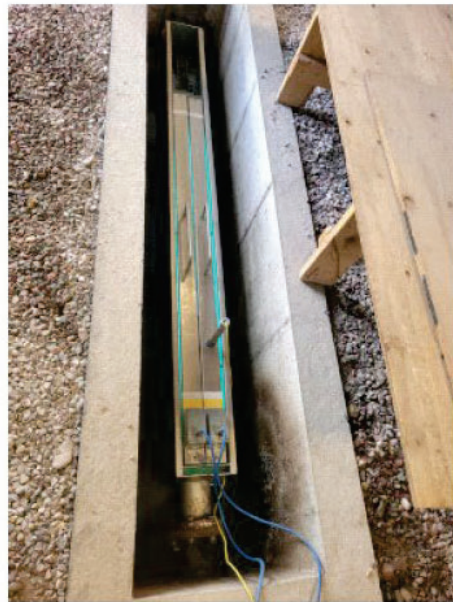
Photo number 8 taken by Evan Smith on 06/15/2022.

Ultraviolet disinfection system.

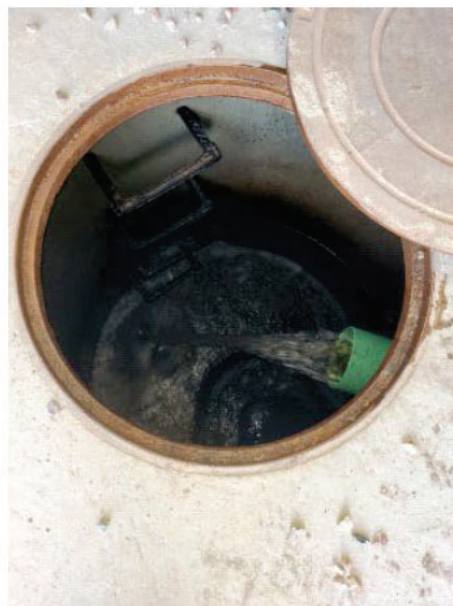
Photo number 9 taken by Evan Smith on 06/15/2022.

Manhole with outfall pipe. This is the location of sample collection.

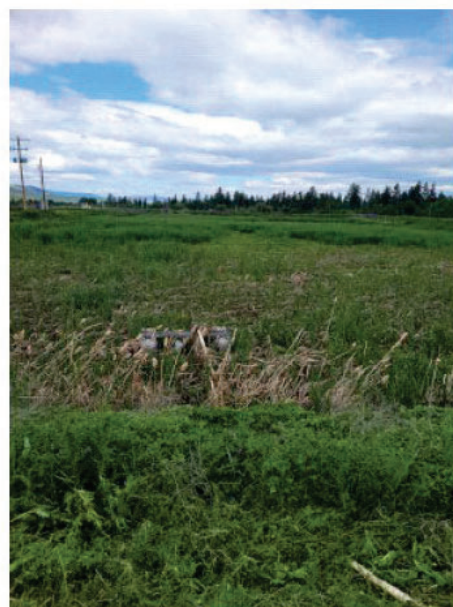
Photo number 10 taken by Evan Smith on 06/15/2022.

Lagoon cell 1. This was part of the old treatment system, no longer used except for an emergency use.

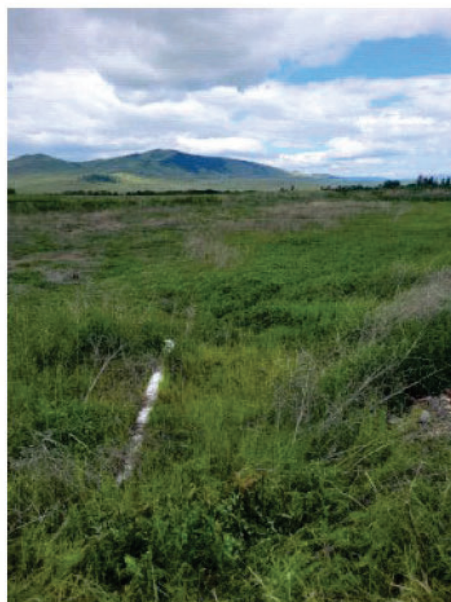
Photo number 11 taken by Evan Smith on 06/15/2022.

Lagoon cell 2. This was part of the old treatment system, no longer used except for an emergency use. Pipe is the old inlet pipe.
