Purpose: NPDES SSO Inspection Report

Facility: City of Chicago Heights, Illinois

Date of Inspection: October 25, 2022

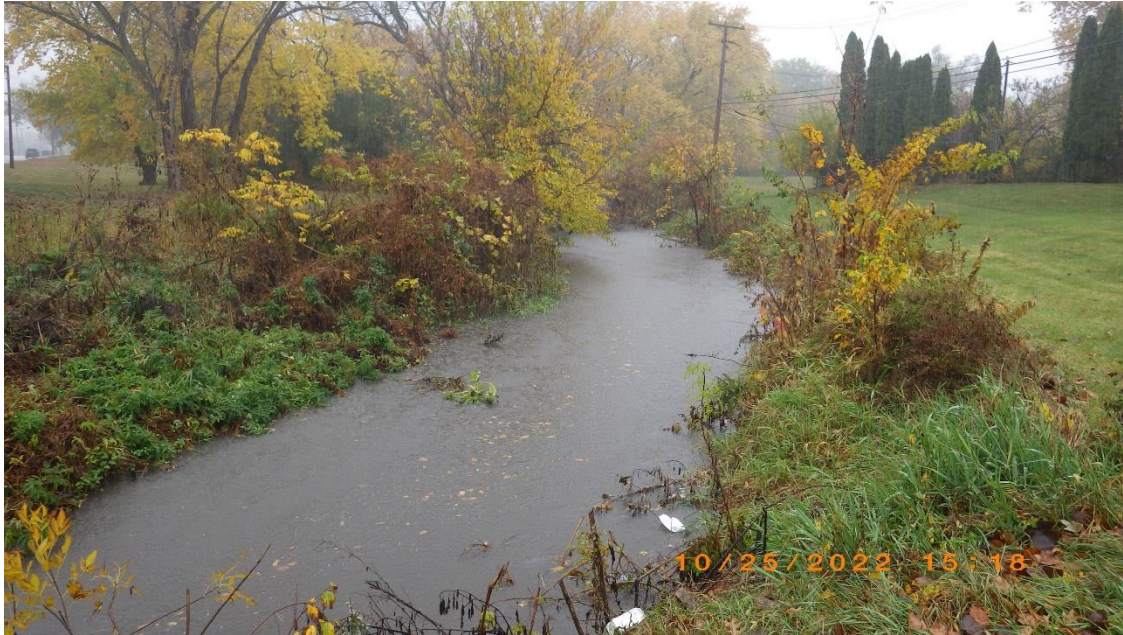
1: RIMG0095

EPA inspectors arrived at an unnamed tributary to Thorn Creek near the intersection of Parkside Avenue and Peoria Street at 3:18 PM. Inspectors noted vegetation along the banks of the tributary. See Photos 1 and 2.

Description: Overview of unnamed tributary to Thorn Creek. Note vegetation along banks.

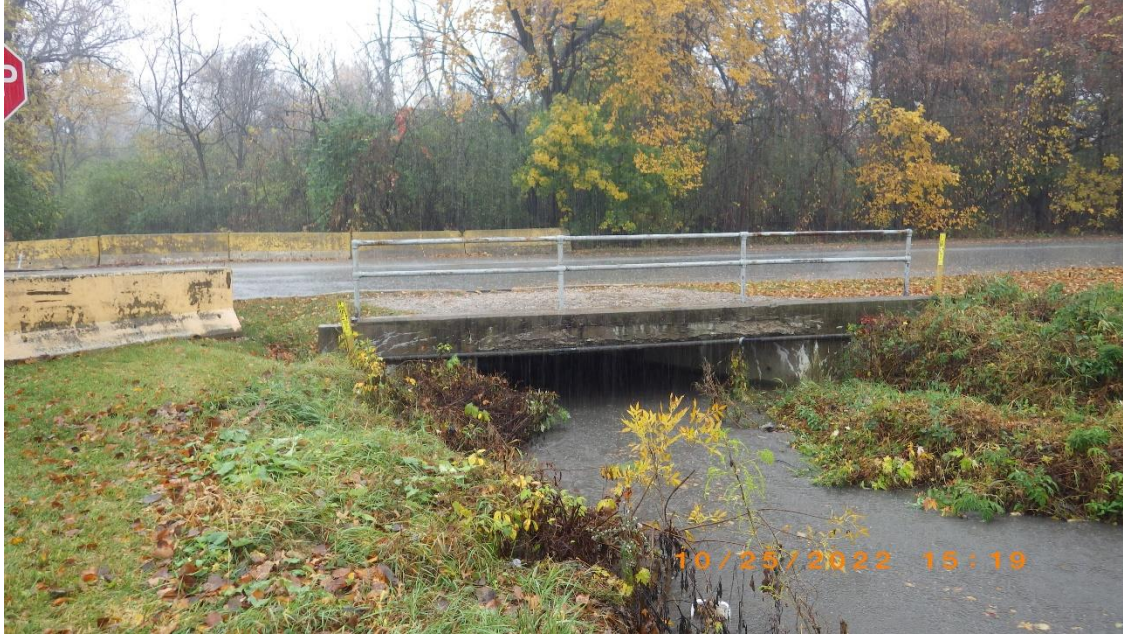
2: RIMG0096

Description: Overview of unnamed tributary to Thorn Creek.

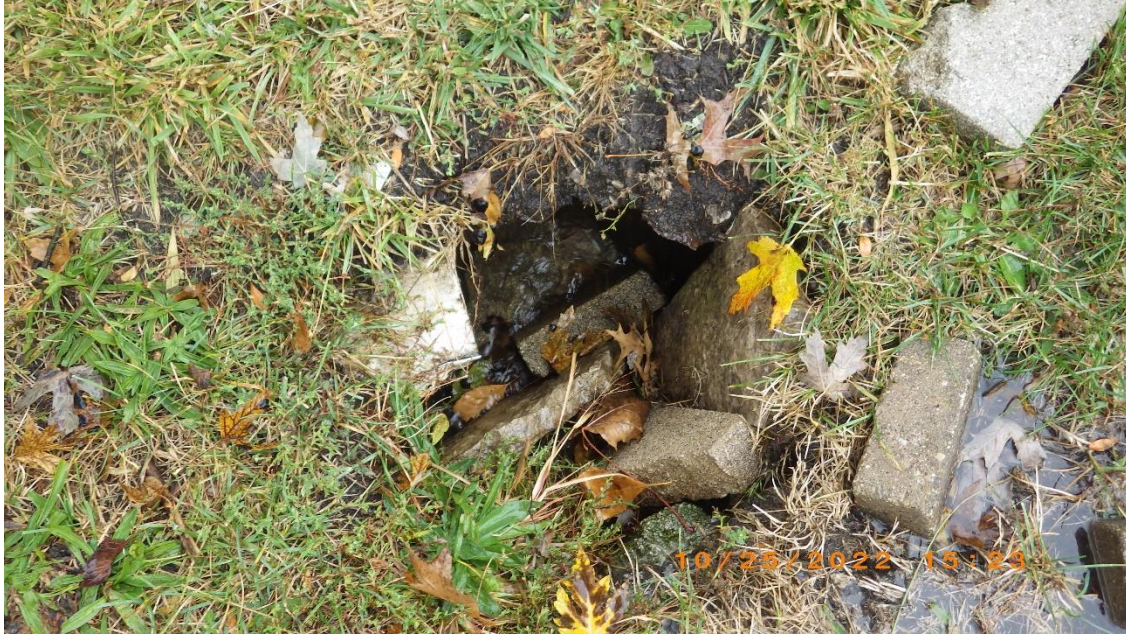
4: RIMG0098

EPA inspectors arrived at 71 Broadway at 3:22 PM. Inspectors noted an approximately 10-inch hole in a culvert in front of this address. See Photos 3 and 4.

- A culvert used to convey stormwater on Broadway was damaged;
- The storm water inlet at the intersection of West Memorial Avenue and Willow Drive was not set at a grade that allowed for effective drainage of storm water; and
- There was a large volume of standing stormwater at the intersection of West 16th Street and Division Street.

Description: Hole in stormwater culvert.

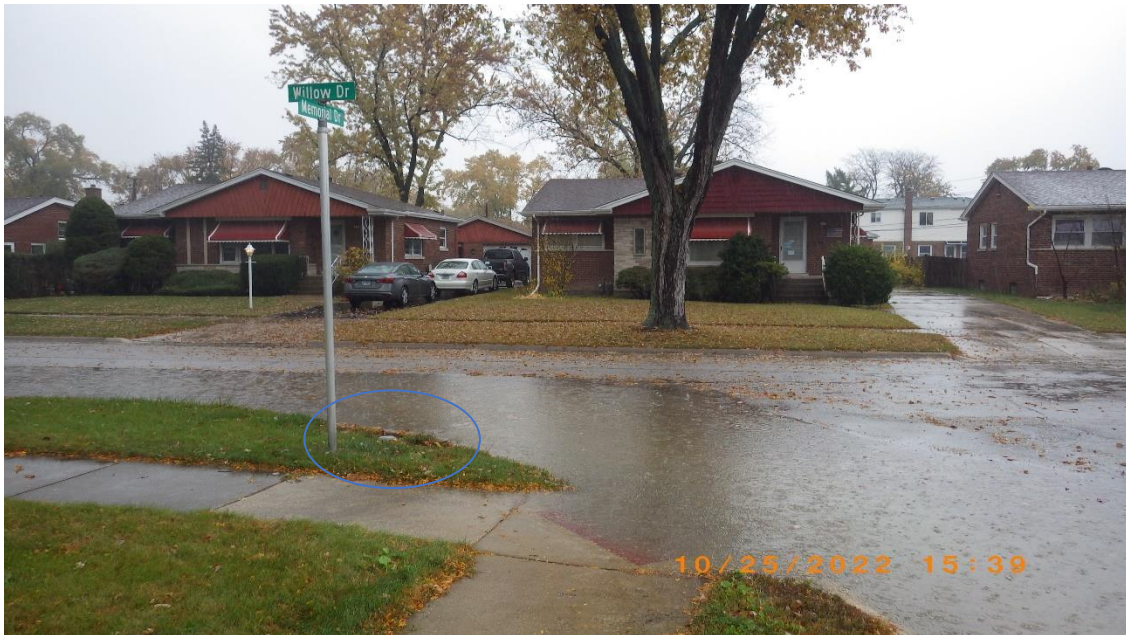
5: RIMG0099

EPA inspectors arrived at the intersection of West Memorial Avenue and Willow Drive at 3:39 PM. Inspectors noted a large amount of standing water at this intersection. The pool of water was slowly draining into a stormwater inlet. The inlet appeared to be set at a grade that did not allow effective drainage of stormwater. See Photos 5 and 6.

Description: Overview of localized flooding. Note there is a stormwater inlet at base of street sign (blue circle).

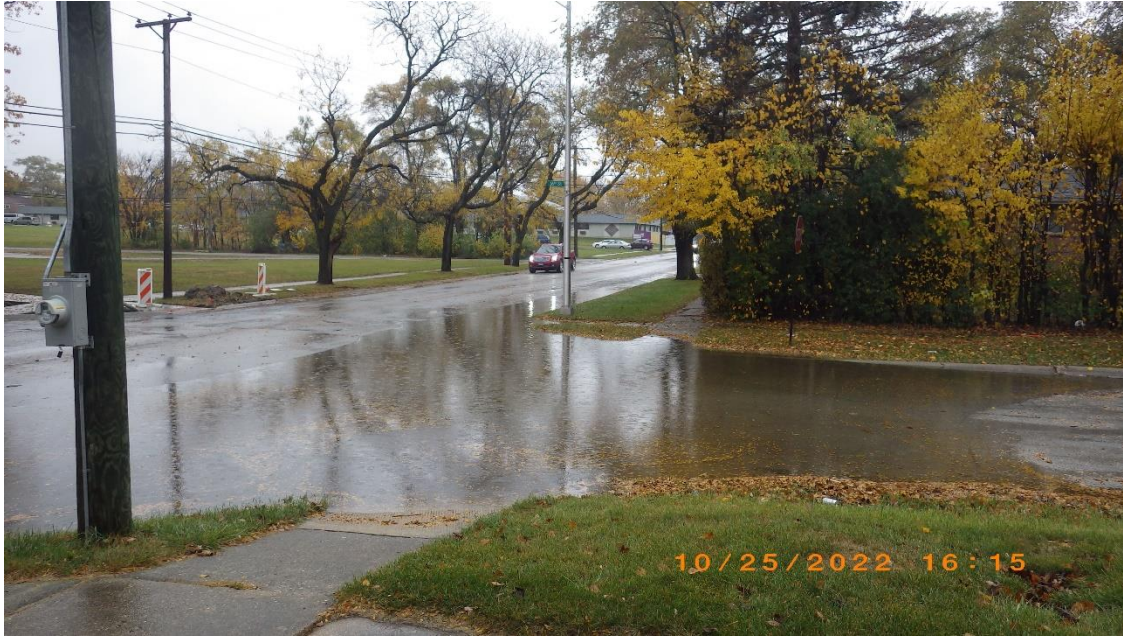
7: RIMG0101

EPA inspectors arrived at the intersection of West 16th Street and Division Street at 4:15 PM. Inspectors noted a large amount of standing water at this intersection. See Photo 7.

Description: Overview of localized flooding.
