COMPLIANCE EVALUATION INSPECTION REPORT  
U.S. ENVIRONMENTAL PROTECTION AGENCY, REGION 5

**Purpose:** NPDES Compliance Evaluation Inspection

**Facility:** Leesville Land LLC  
86900 Sinfield Road  
Hopedale, Ohio 43976

**NPDES Permit:** OH0011827

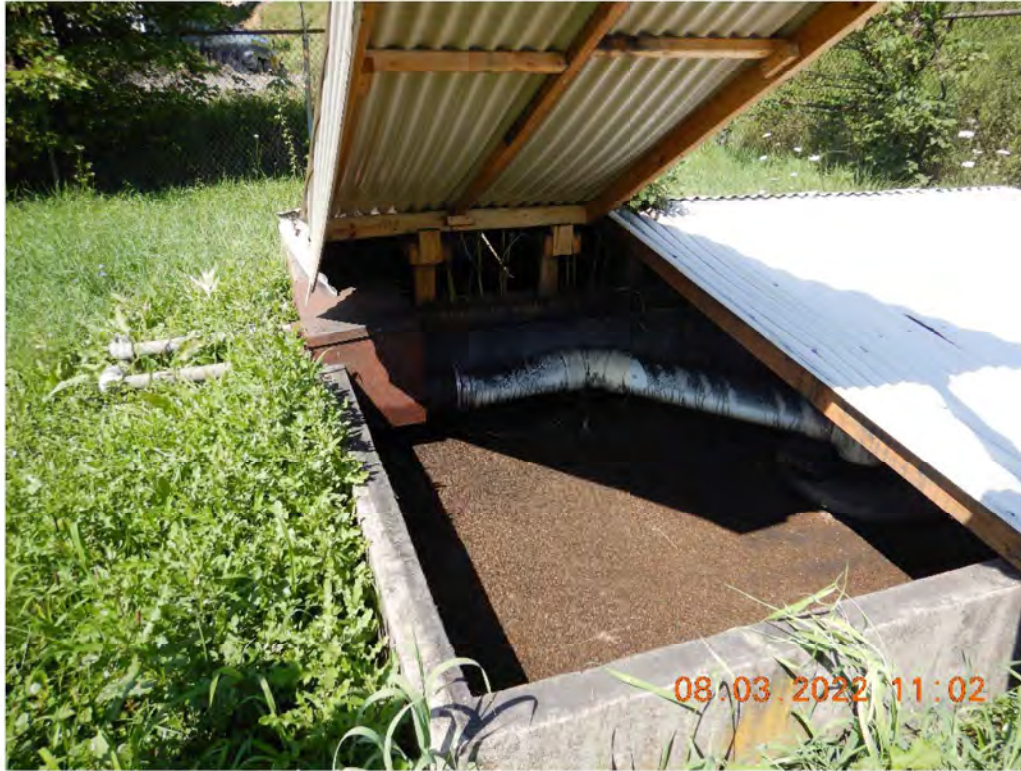
2: DSCN3866

Description: Covered sand filtration beds. Covers installed to keep coal dust from settling within the filtration beds.

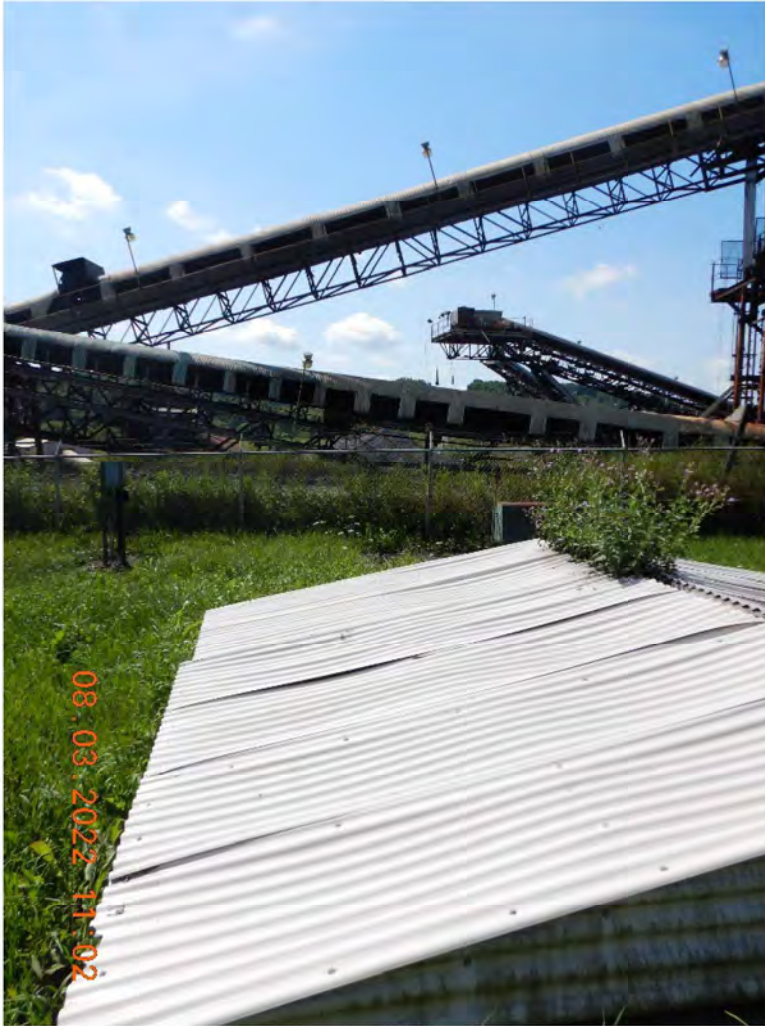
3: DSCN3867

Description: View of the location of the covered sand filtration beds relative to the coal yard conveyors.

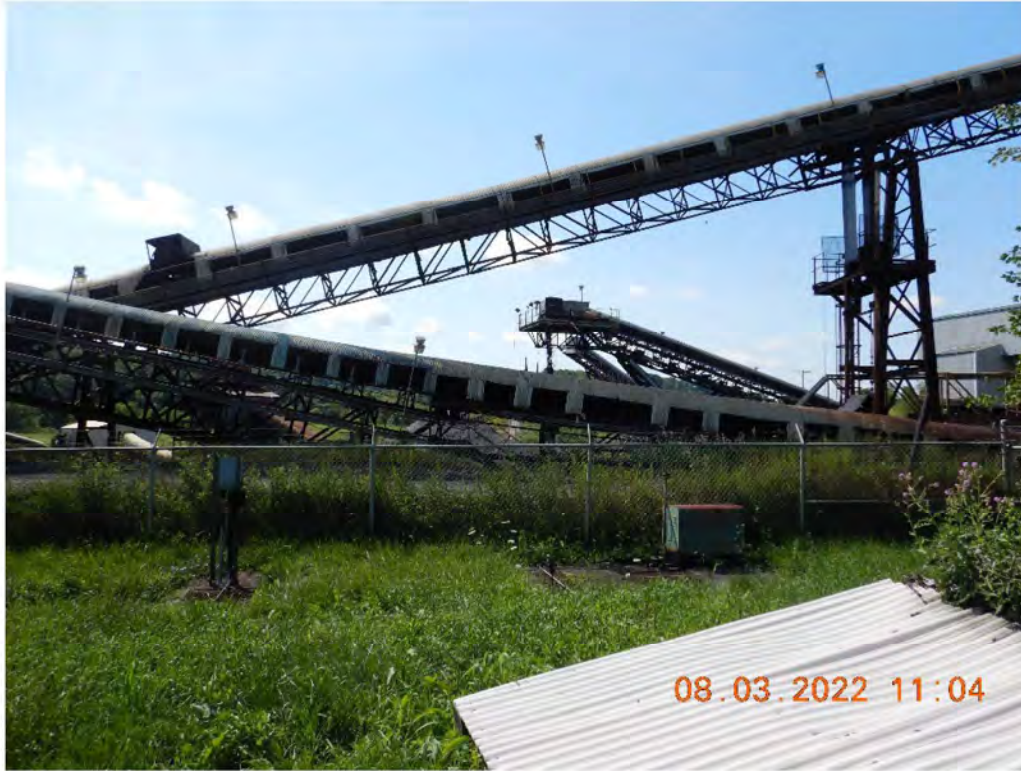
4: DSCN3868

Description: View of the location of the covered sand filtration beds relative to the coal yard conveyors, with coal falling from the end of the conveyor in center of photograph.

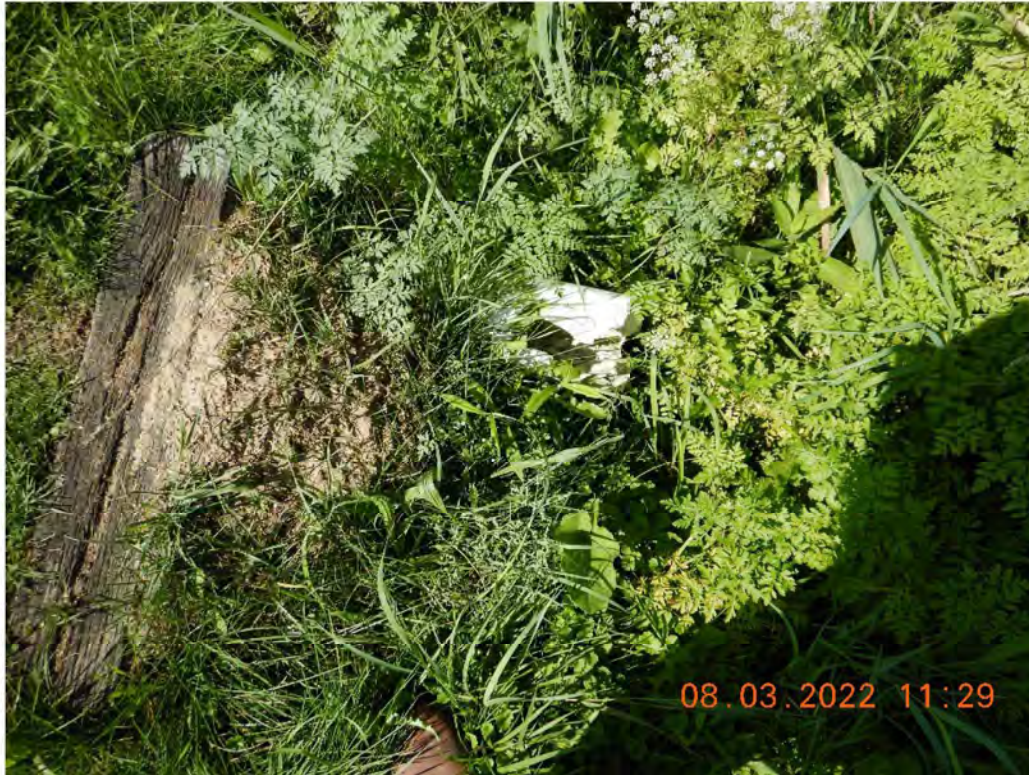
8: DSCN3872

Description: Close-up view of the preparation plant sewage treatment plant Outfall 10 (white plastic pipe). No flow occurring at the time of inspection.

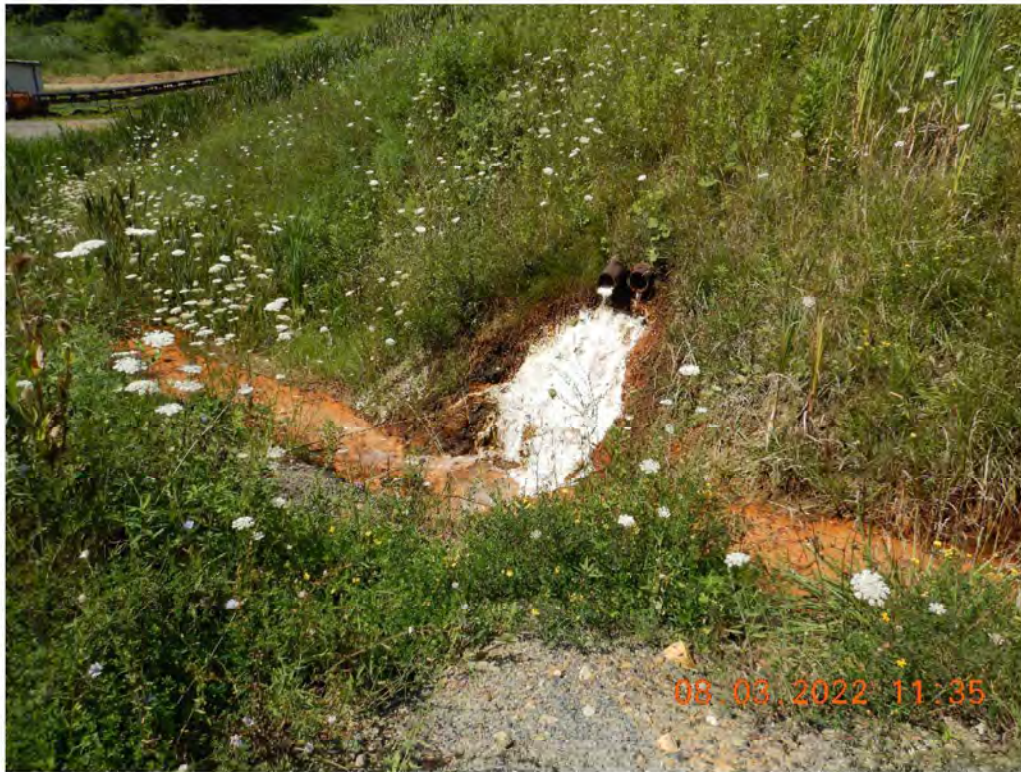
11: DSCN3875

Description: White colored precipitate at one of the outlet pipes for the mine refuse impoundment underdrains located just northeast of the Preparation Plant.

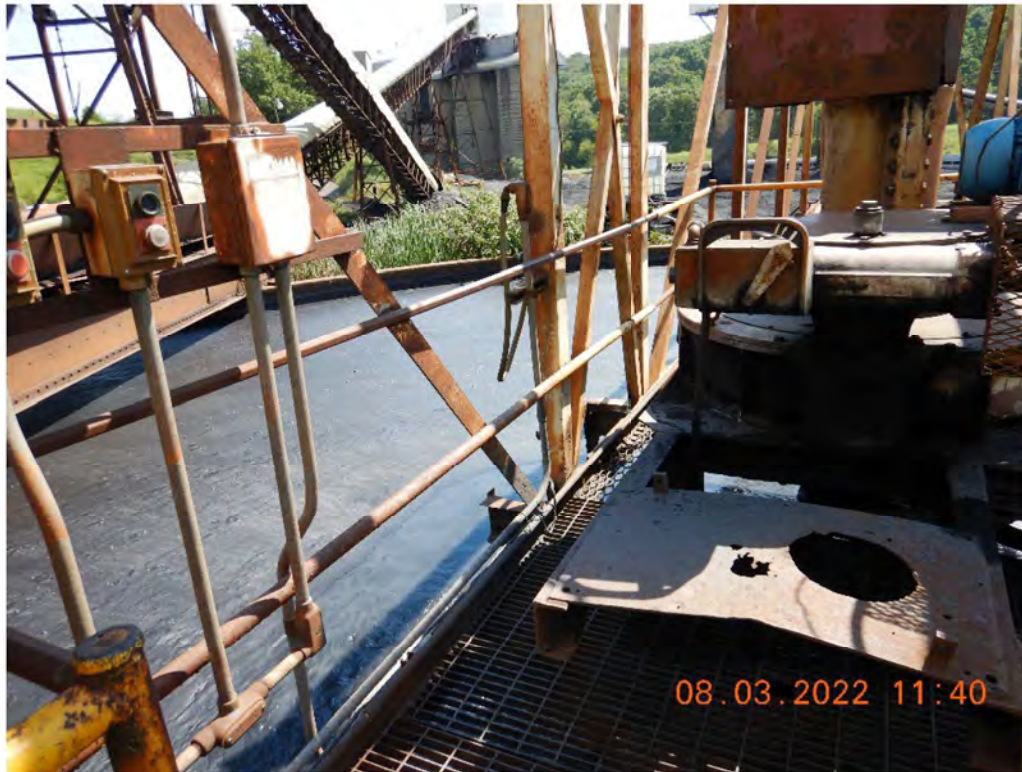
14: DSCN3878

Description: View looking over the north side of the preparation plant thickener unit. Layer of solids visible on surface of thickener.

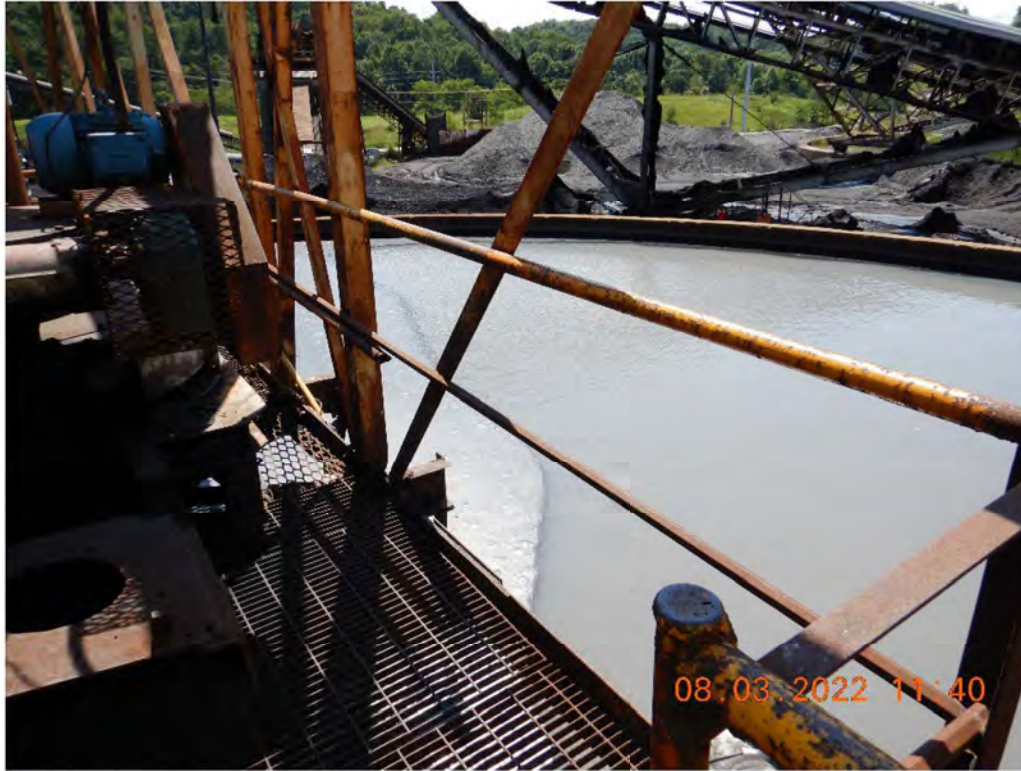
15: DSCN3879

Description: View looking over the south side of the preparation plant thickener unit. Layer of solids on surface of thickener unit visible in the center of the photograph.

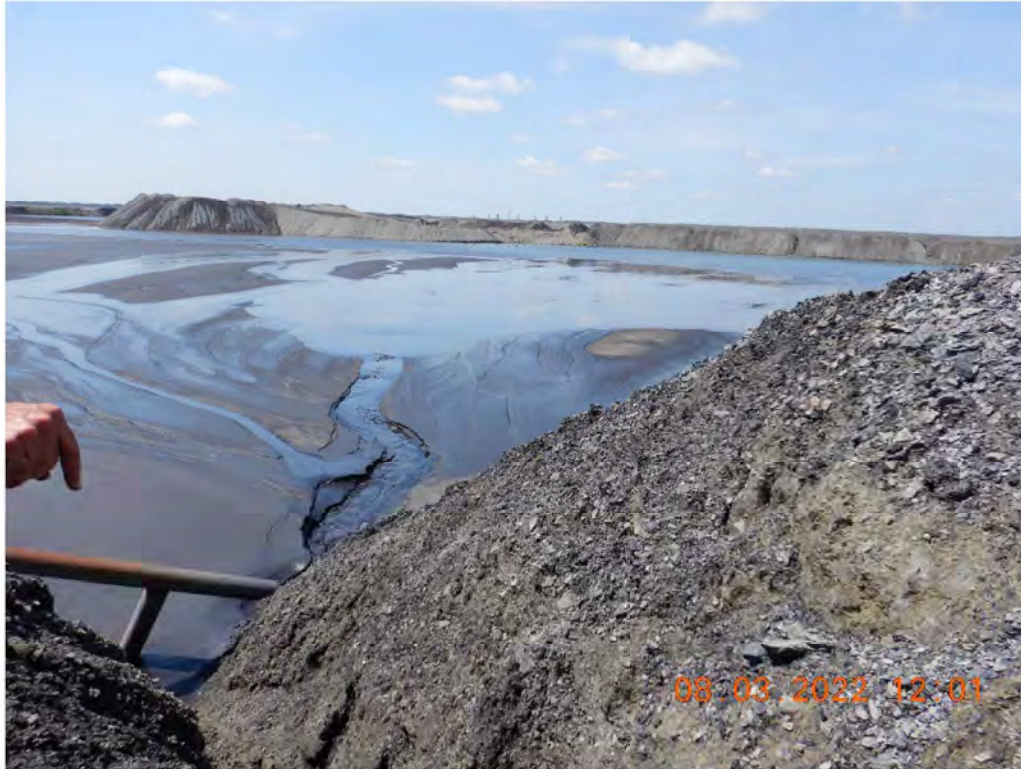
20: DSCN3884

At 12:00 pm, EPA and Mr. Henderson drove to the top of the wet impoundment. A delta has formed under the discharge from the pipe which pumps sludge slurry from the sludge thickener. (Photo 19-20). Mr. Henderson stated that the pipe must be moved when the buildup gets too high to maintain head. EPA noted waterfowl residing on the top of the impoundment. EPA noted pipes periodically built into the side of the impoundment and Mr Henderson stated that they are used to check the water table in the impoundment.

Description: Discharge pipe where the preparation plant thickener slurry is pumped into the impoundment. Pipe was observed discharging the slurry into the impoundment.

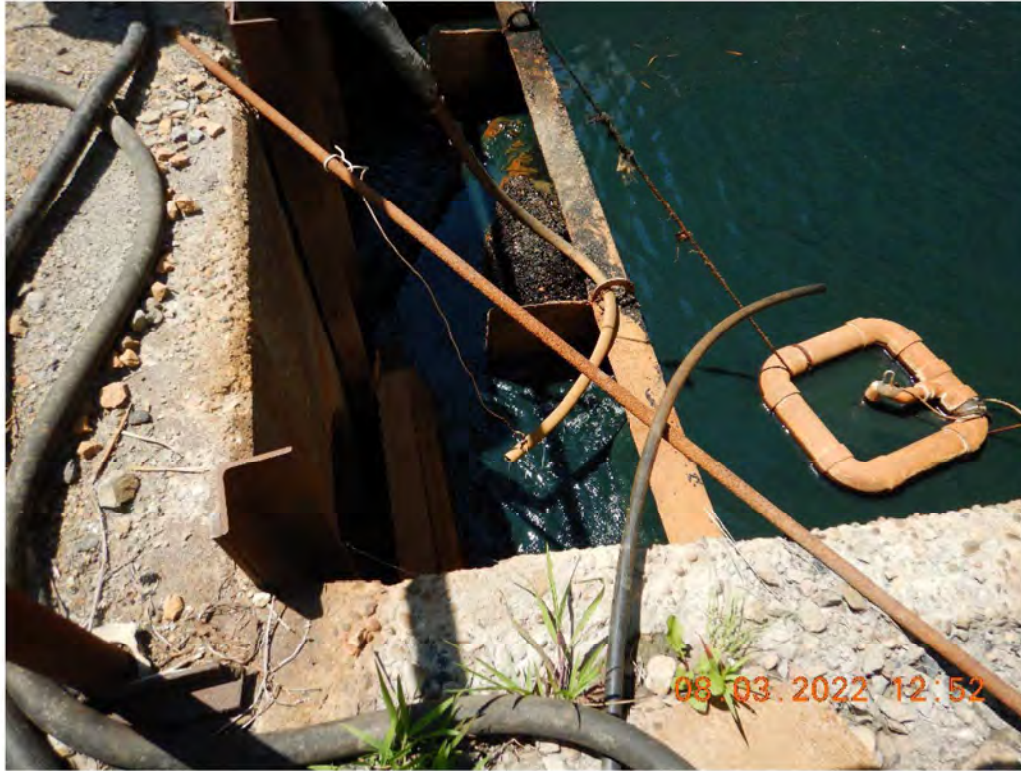
24: DSCN3888

Description: There is a square float supporting the in situ pH meter. EPA observed the tubing that dispenses flocculant into the northeast corner of the treatment basin. The pH meter is connected to a WebMaster control panel which sends alerts to operators and operates the pump for adding caustic.

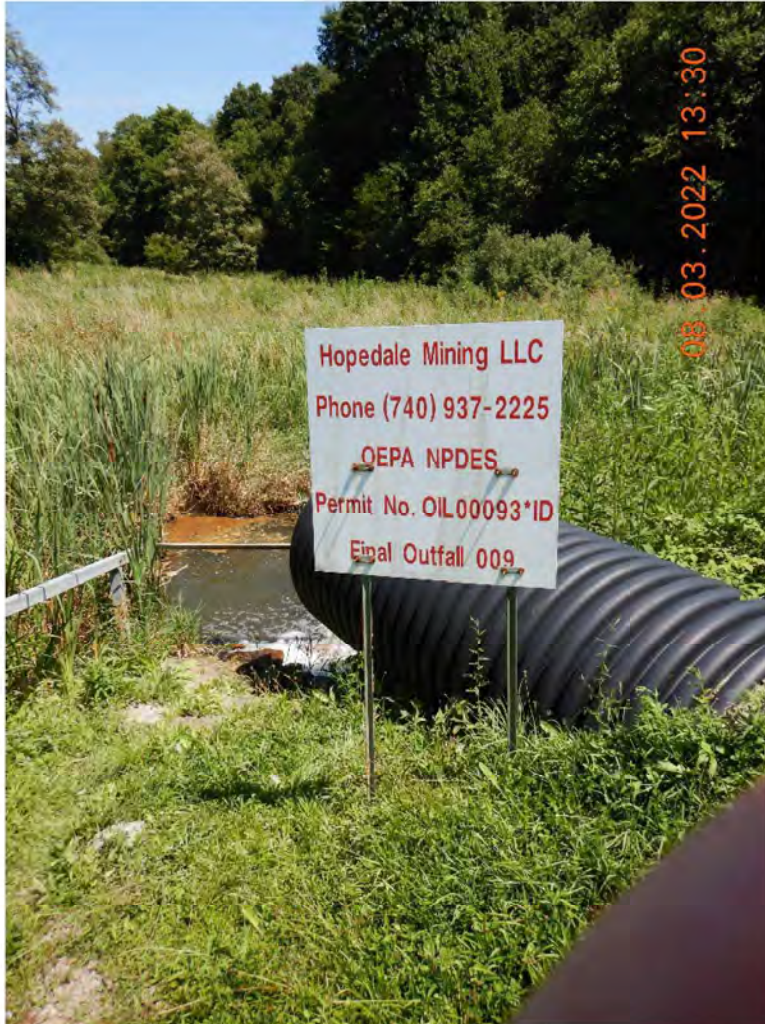
35: DSCN3899

Description: Outfall identification sign for Outfall 009. Note floating orange discoloration on surface of the water after discharge from Facility.

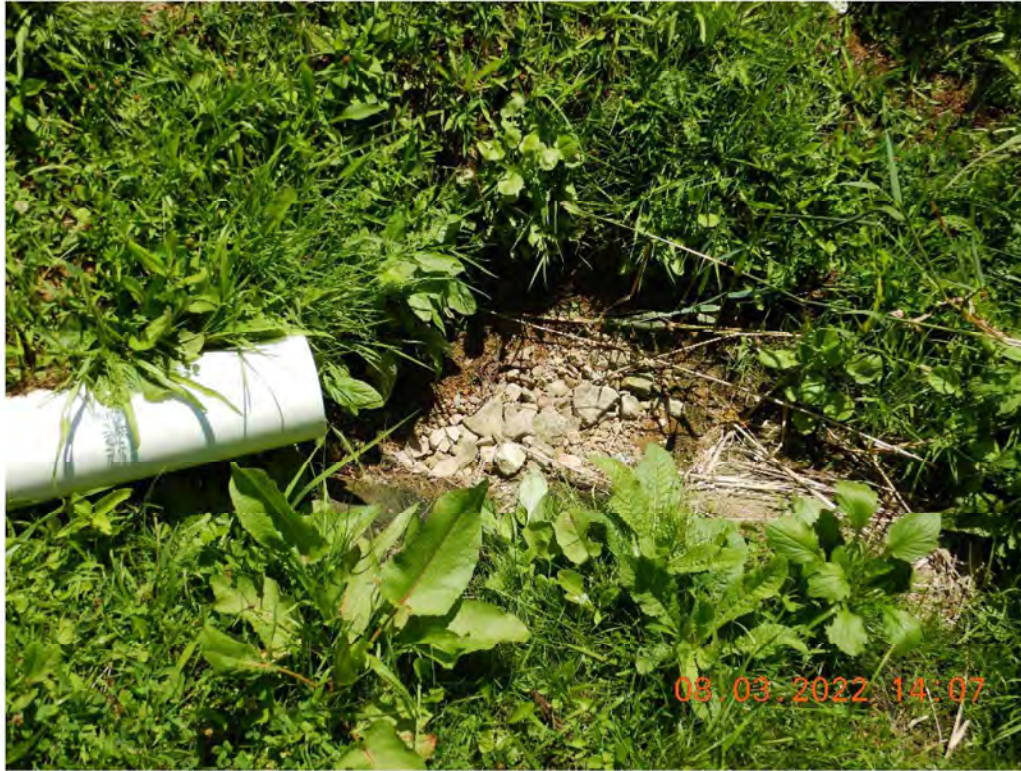
43: DSCN3907

Description: WWTP discharge point designed to flow into pond upstream of Outfall 012. No flow at time of inspection.

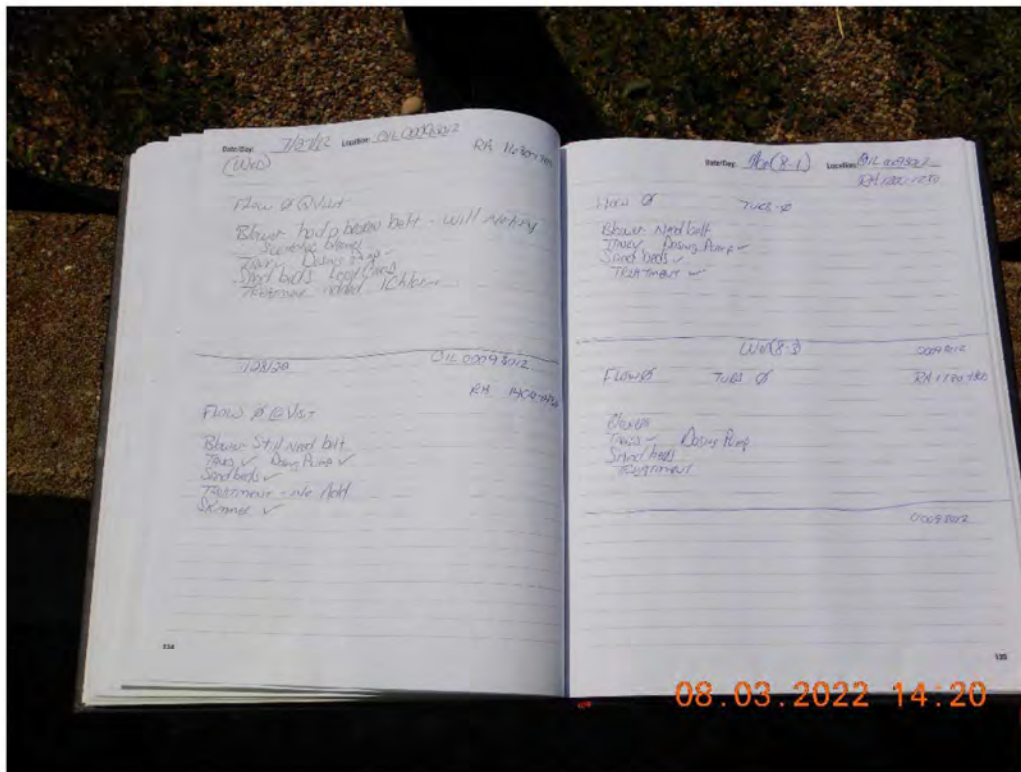
47: DSCN3911

EPA and Mr. Henderson viewed the deep mine bathhouse and office wastewater treatment plant at 2:10pm. The processes include a trash trap, equalization tank, aeration basin, clarifier, two sludge returns, skimmer, dosing tank, sand beds chlorination, dechlorination and a separate sludge holding tank, according to Mr. Clift during the August 19<sup>th</sup> discussion. The effluent flows into a pond first, before discharging at Outfall 012 (Appendix B, Image 4). EPA noted duckweed on the pond and that the pipe from the WWTP was not discharging at the time of the inspection. Mr. Barcalow guessed that the last time sludge was removed was in 2015 and Mr. Clift stated that he does not expect sludge will need to be removed soon. EPA reviewed a logbook which was located at the bathhouse and office WWTP (Photos 45 - 47) and noted operator visits twice a week lasting for 30 minutes each. The last entry was dated August 3 for 17:30-18:00. When EPA questioned QES about their operator visits, Mr. Blackman stated that operators routinely do not pre-date logbook entries and that both WWTP's should have operator visits at the same times and dates so that the Preparation Plant WWTP logbook can be compared with this one in case there was a recording error for the time on the August 3<sup>rd</sup> entry for 17:30-18:00. EPA viewed the logbook at 14:20.

Description: Operator logbook pages for the Deep Mine Bathhouse and Office Sewage Treatment Plant for July 27, 2022 through August 3, 2022. Note entry time for August 3, 2022 is noted as "1730 -1800" and the photograph was taken at 14:20.

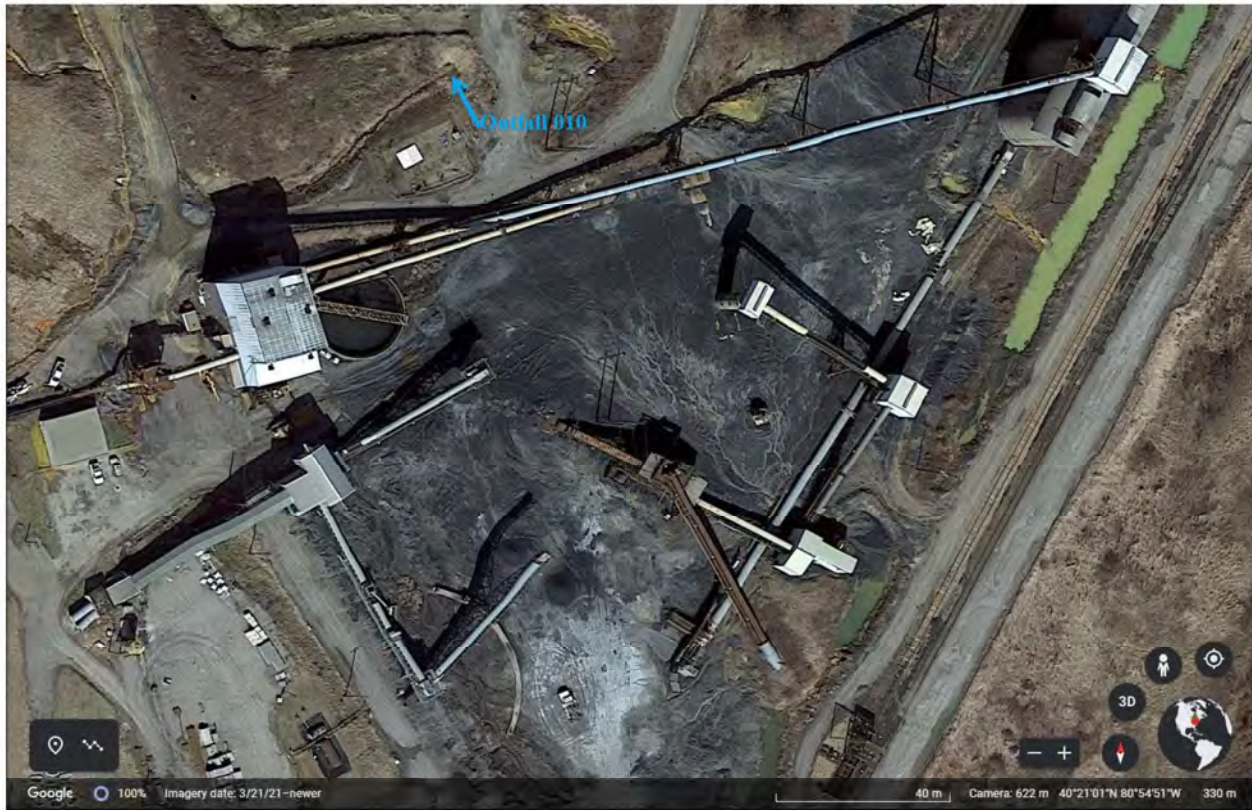
Image 3. Aerial image of Outfall 010 near the conveyor belt. White square indicative of the cover built to prevent dust from conveyor belt from blowing into the sand filters.
