# NPDES Compliance Inspection Report

## Nisqually Clear Creek Fish Hatchery

**NPDES Permit Tracking Number  
# WAG130015**

**Inspection Date: August 8, 2023**

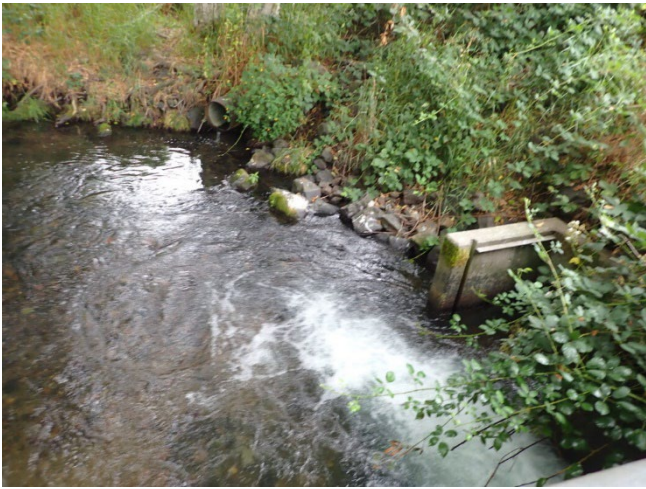
Photo #:01 (P8080001)

Description: Facing North, photo of the Facility's Outfall 001 with active discharge into Clear Creek from both upper and lower hatchery complexes except pond #16 (inactive).

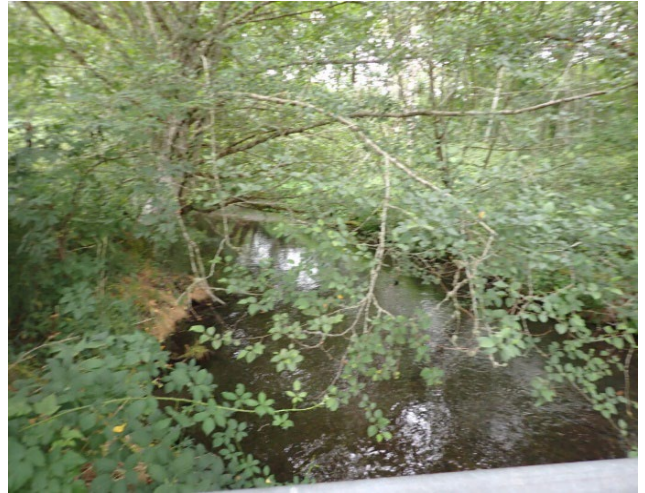
Photo #:02 (P8080006)

Description: Facing West, photo of Clear Creek just downstream of Outfall 001. Clear Creek flows into the Nisqually River.

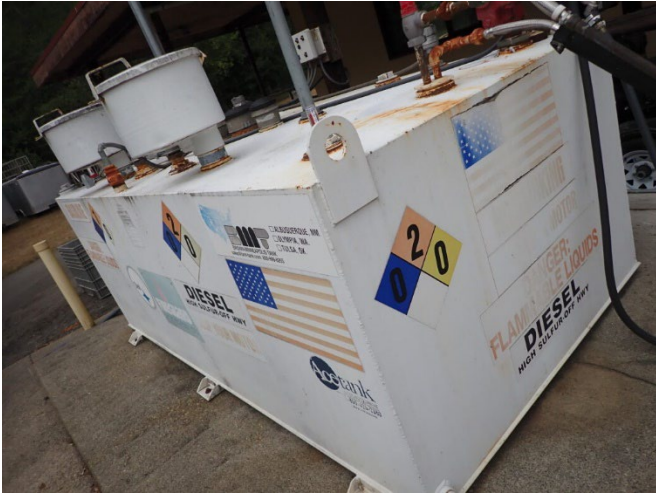
Photo #:13 (P8080040)

Description: Photo of the Facility's upper hatchery complex diesel station used to fuel equipment, tractors, generators, and pumps.

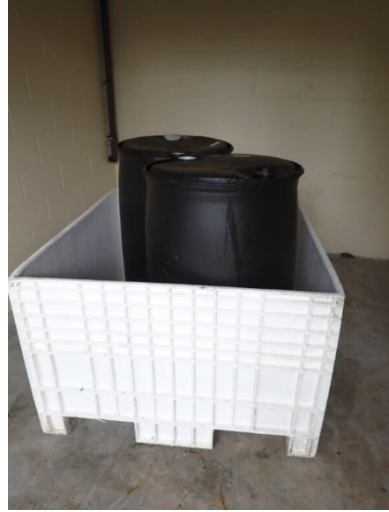
Photo #:14 (P8080045)

Description: Photo of the Facility's formaldehyde drum storage with secondary containment. One of the drums was empty.

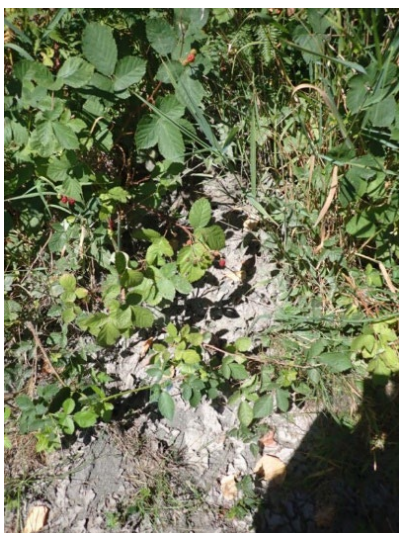
Photo #:19 (P8080068)

Description: Photo of solids discharge in the woods next to the Facility's upper hatchery complex offline settling basin.

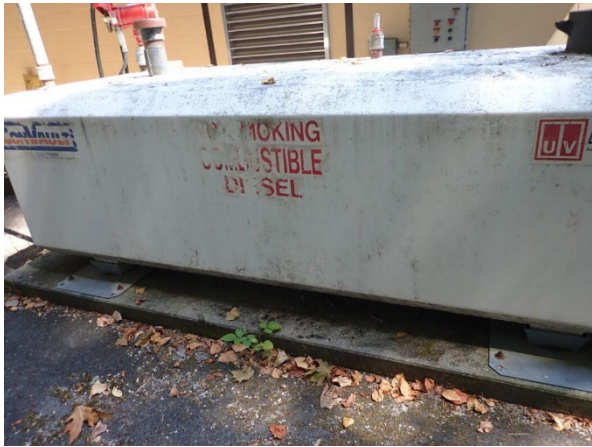
Photo #:21 (P8080077)

The lower hatchery complex diesel station did not have an NFPA label on it, and an unlabeled glass jar with no lid containing an unknown white substance was observed during the inspection. Both of these observations suggest a need for the Facility’s BMP Plan material storage section to be updated to ensure the Facility follows proper material storage procedures.

Description: Photo of the Facility's lower hatchery complex diesel station not bearing the National Fire Protection Agency label.

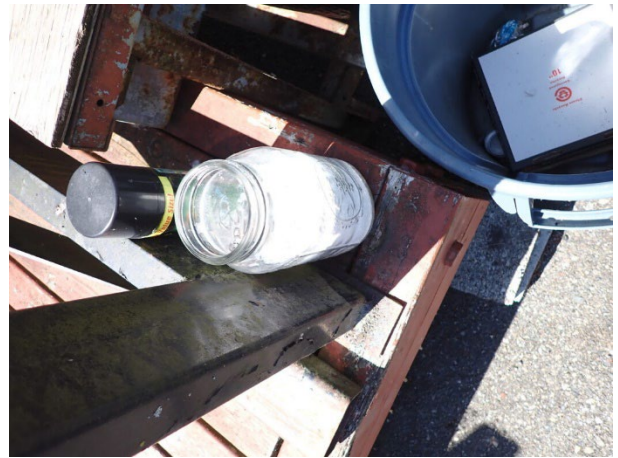
Photo #:22 (P8080079)

On August 10, 2023, I received an email from Mr. St. Jean stating that the unknown white substance in the glass jar observed during the inspection was baking soda paste used on the battery terminal of a tote tipper.

Description: Photo of an unknown white substance inside an unlabeled glass jar with no lid observed in the Facility's lower hatchery complex.

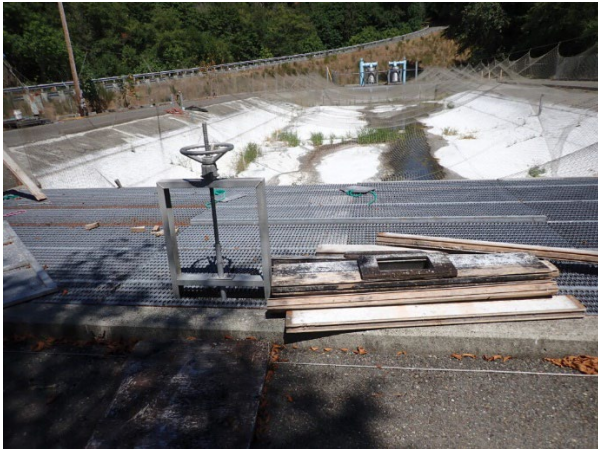
Photo #:25 (P8080088)

Description: Facing Northeast, photo of the Facility's pond #16 not in active use. This pond has been inactive for a couple of years.
