**CLEAN WATER ACT COMPLIANCE EVALUATION INSPECTION REPORT
U.S. ENVIRONMENTAL PROTECTION AGENCY
REGION 5**

Purpose: Stormwater Inspection

Facility: Midstates Rail LLC (Midstates Rail)
13830 Brainard Avenue
Burnham, Illinois 60633

Date of Inspection: April 13, 2022

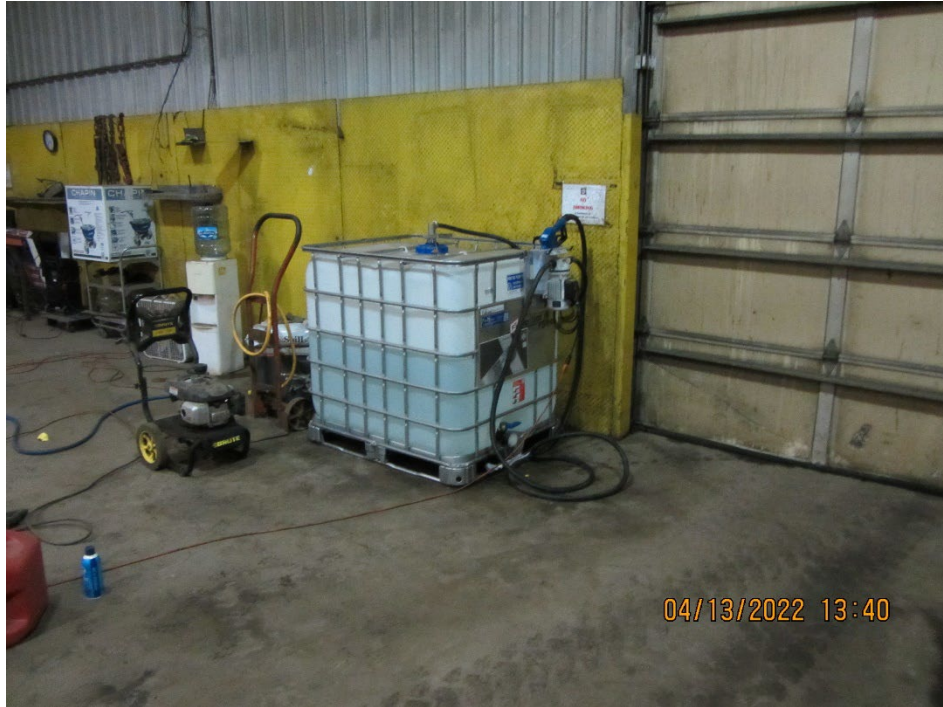
1: IMG_0226

Description: Tote containing diesel exhaust fluid
Location: Building on southeast corner of the site
Camera Direction: Southwest
Date/Time: 4/13/22, 1:40 p.m.

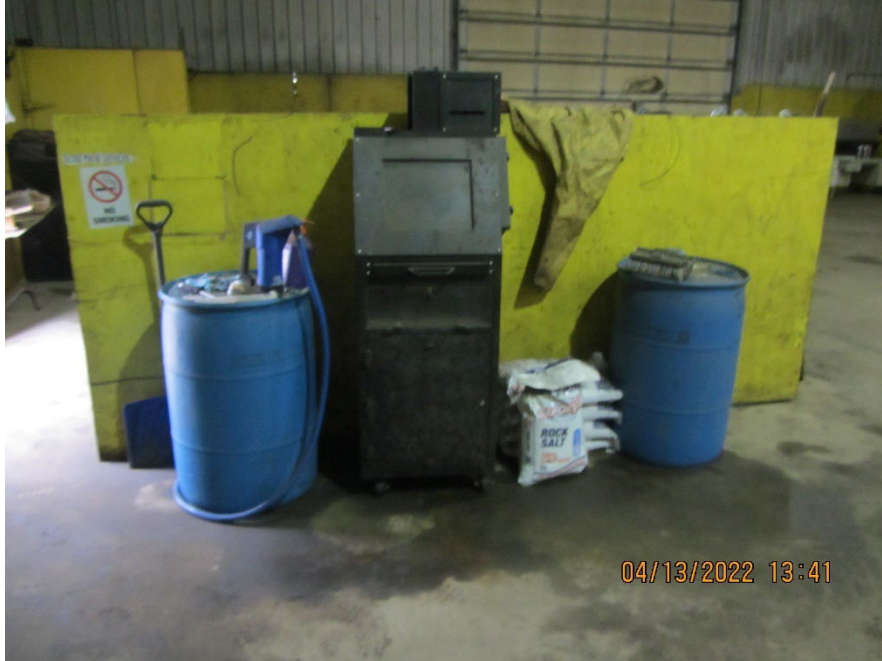
2: IMG_0227

Description: Drums containing diesel exhaust fluid

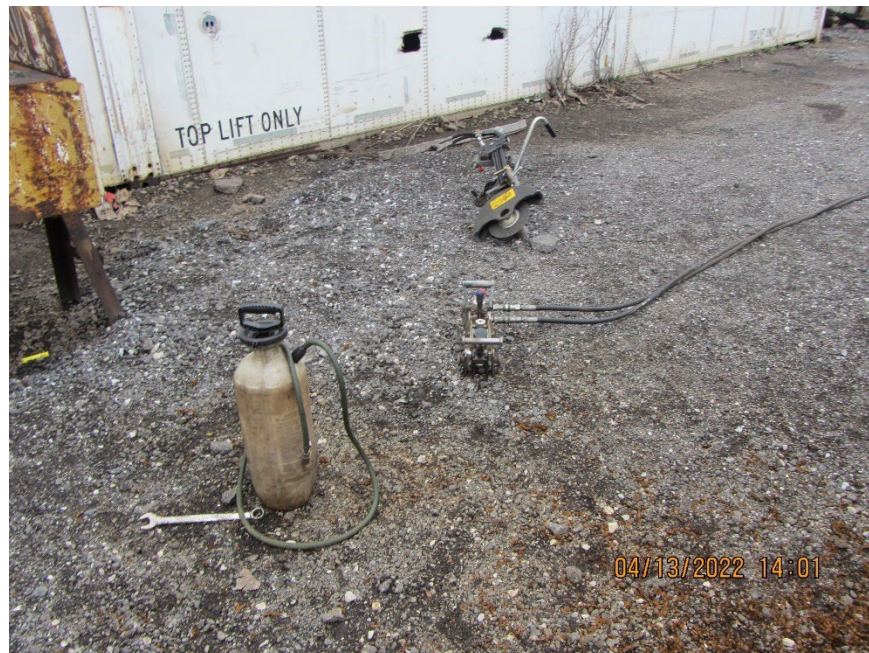
3: IMG_0228

Description: Drill with tank of water used for cooling

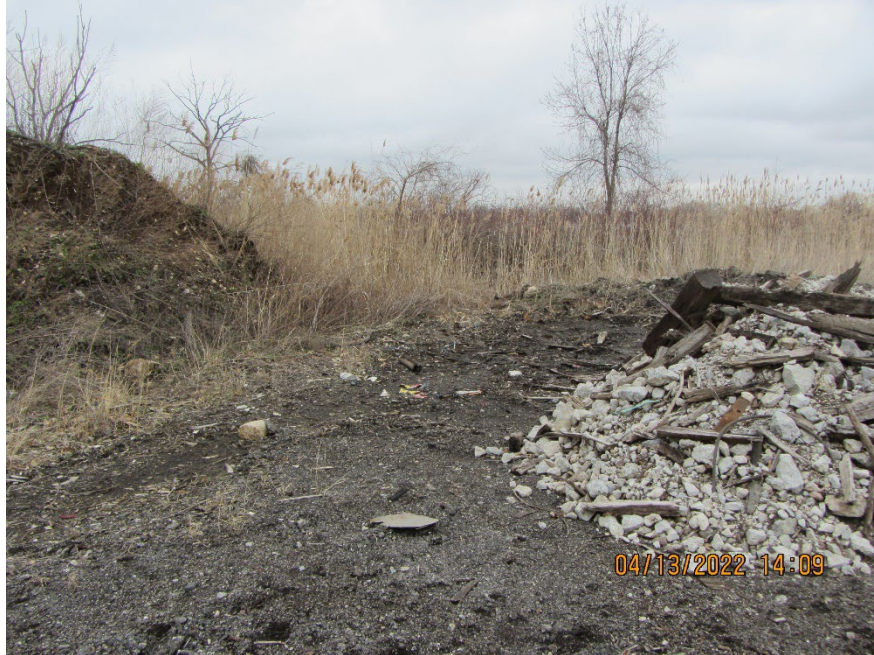
4: IMG_0229

Description: Damp ground around scrap with Powder Horn Lake just beyond the tall grass

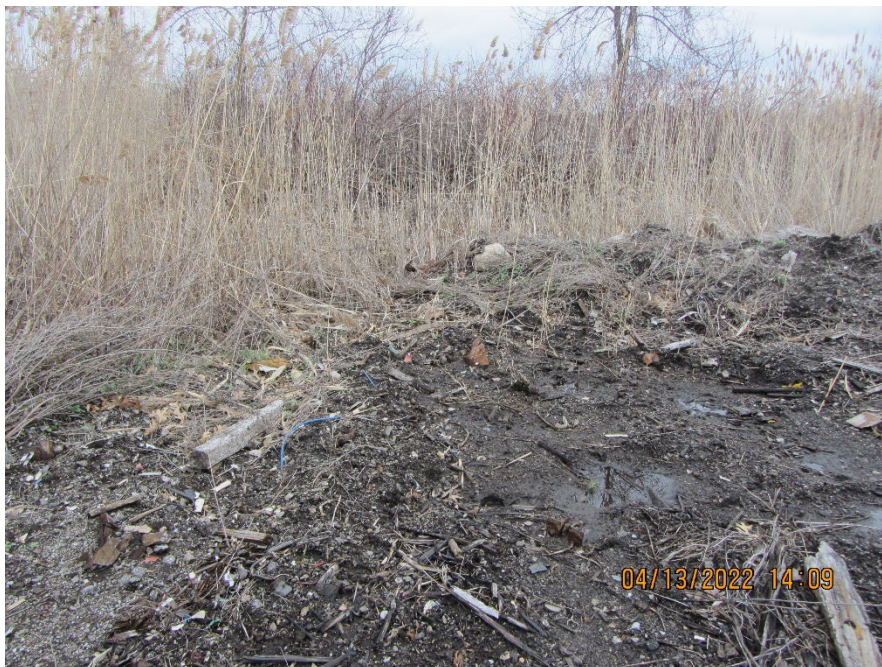
5: IMG_0230

Description: Same as Photo 4 but zoomed in

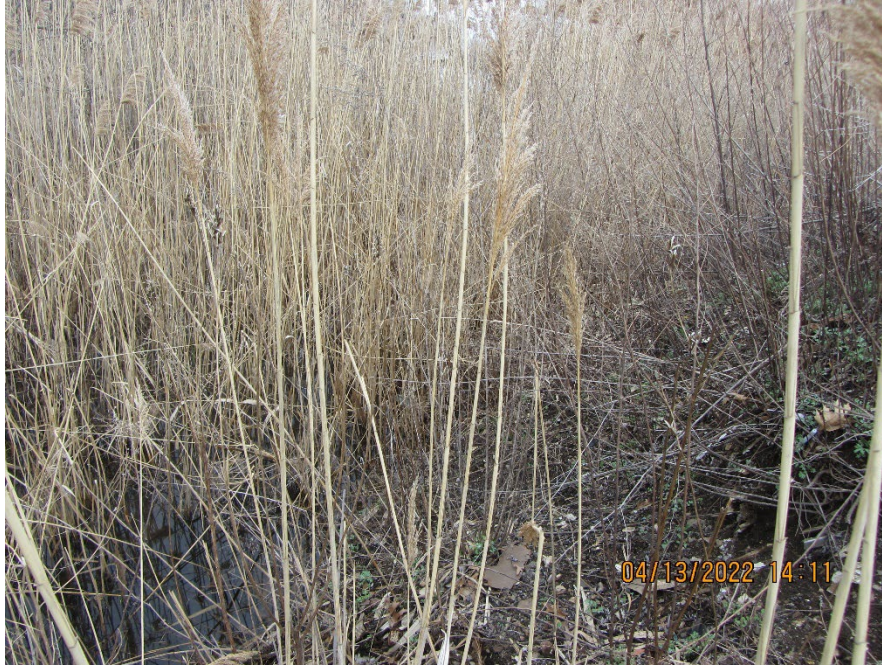
6: IMG_0231

Description: Closer view of the wet ground at the foot of the grass shown in Photos 4 and 5

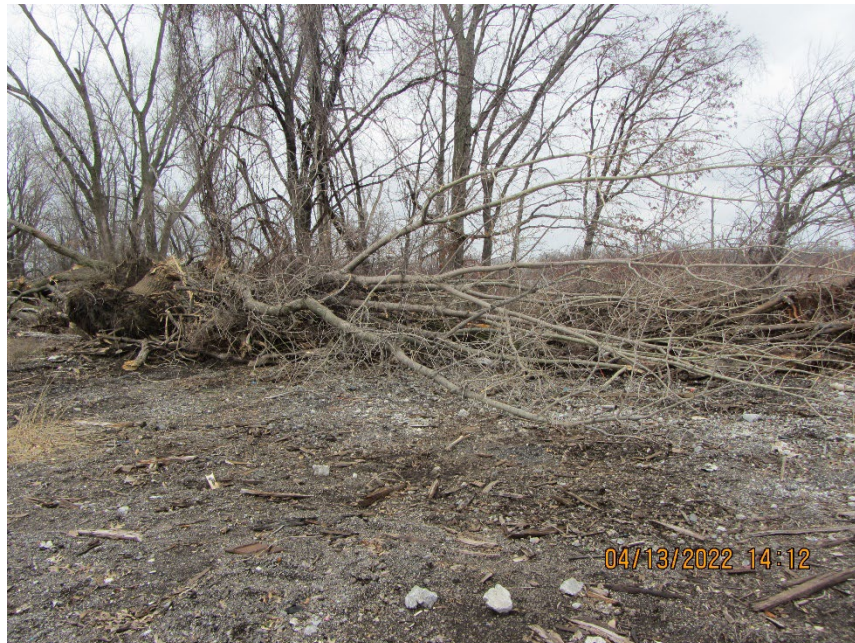
7: IMG_0232

Description: Felled tree acting as a barrier to Powder Horn Lake

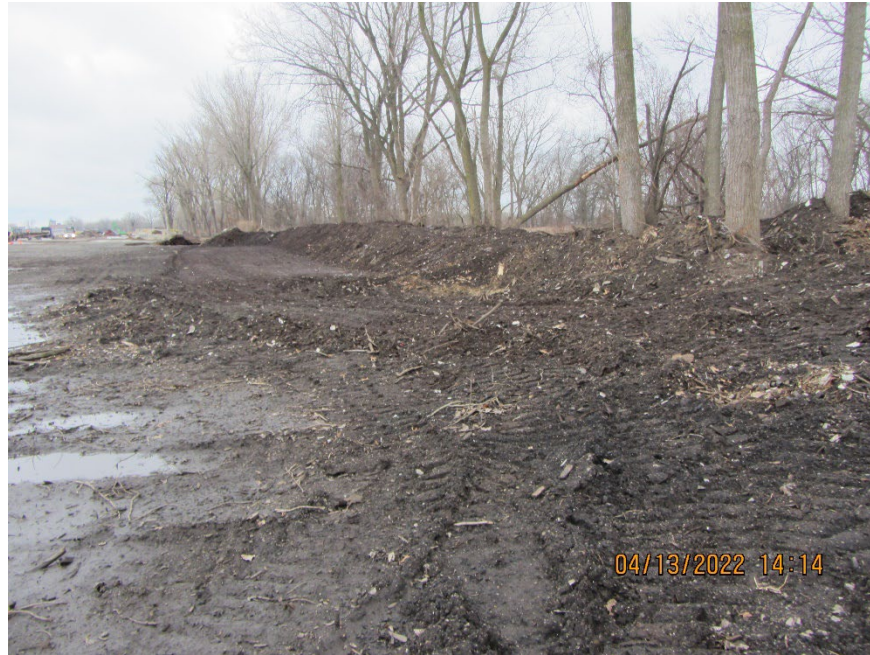
8: IMG_0233

Description: Soil berm along west border of the site

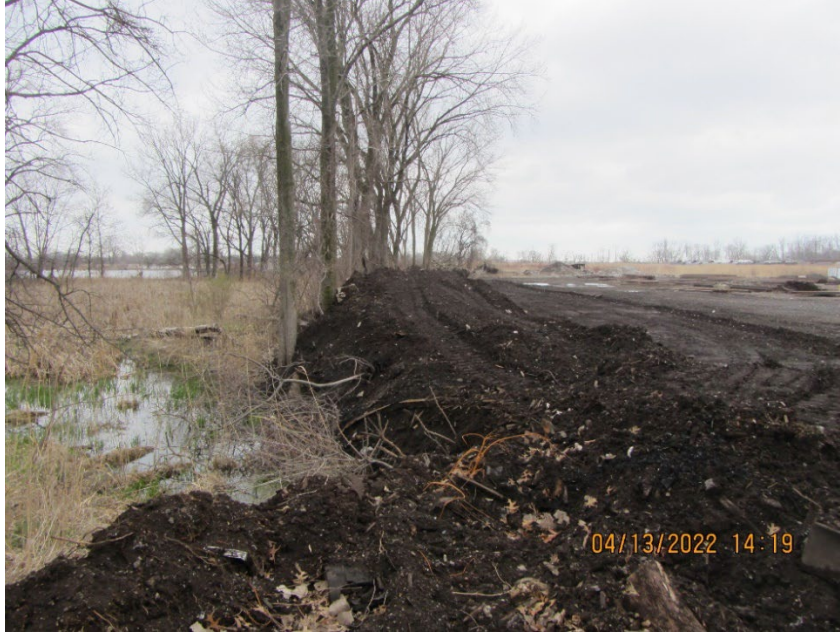
10: IMG_0235

Description: Tire tracks on soil berm with pooled water to the west

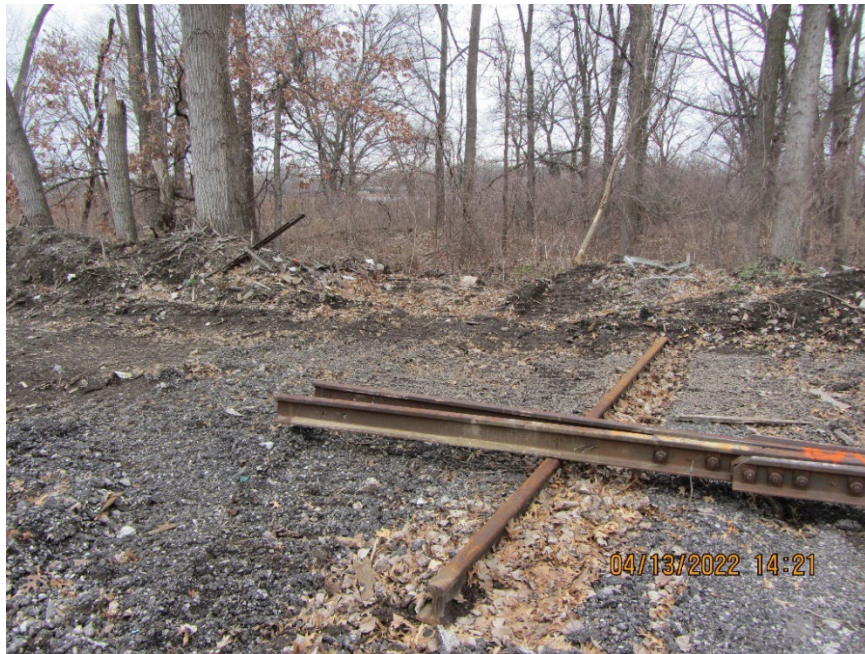
11: IMG_0236

Description: Open section of soil berm that appeared to have slight downward sloping toward Powder Horn Lake

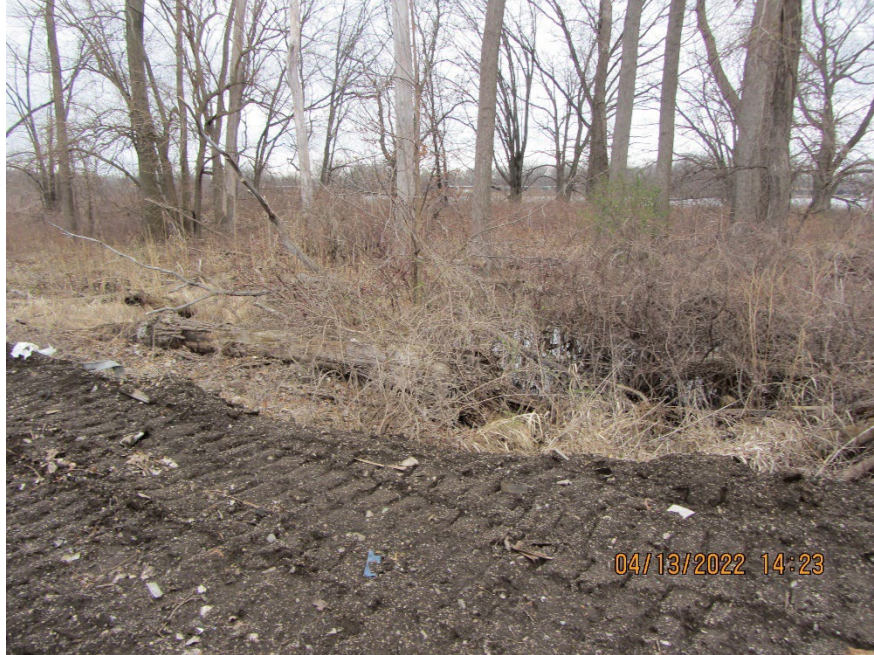
12: IMG_0237

Description: Tire tracks on soil berm with pooled water to the west

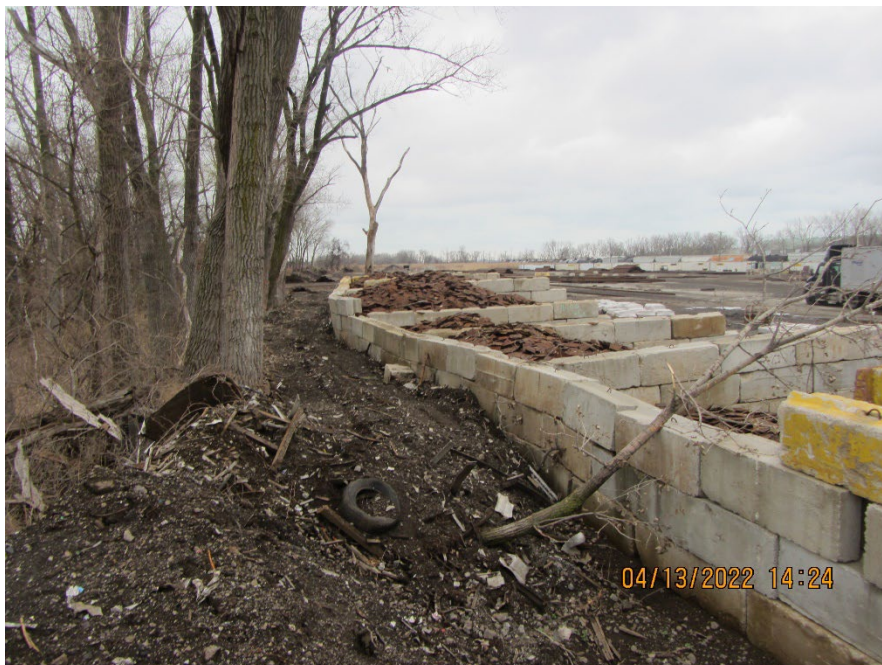
13: IMG_0238

Description: Tie plates piled over the top of stone-walled, separated storage areas

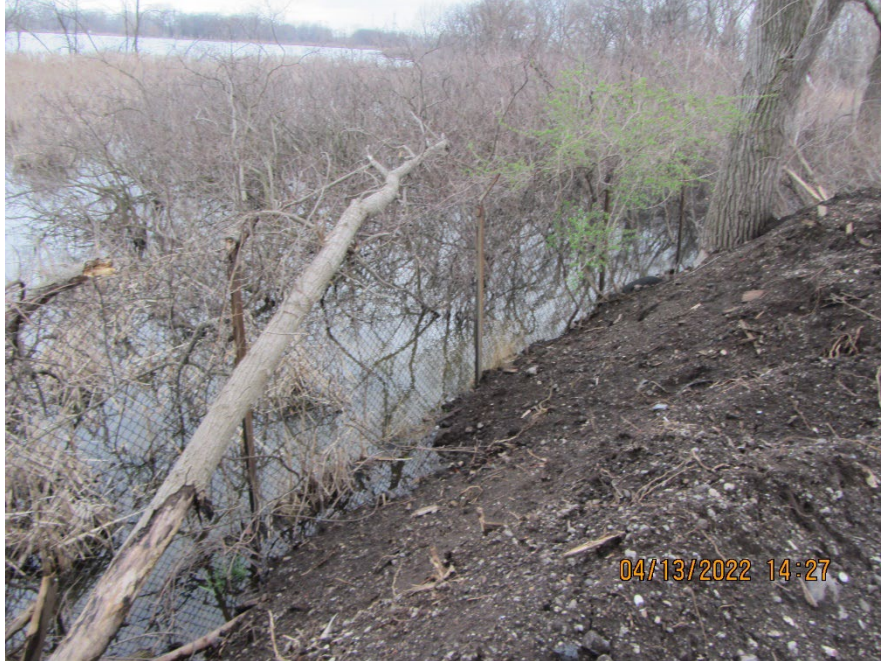
14: IMG_0239

Shortly after arriving at the back of the site, Mr. Sotelo left to handle some business and allowed Mr. Atkinson and I to continue touring the site on our own. We began walking south along the western edge of the property before heading over to the east side. On the northwest side, Midstates Rail had placed trees and large branches to function as a barrier to the lake, but there were gaps between some of the branches along the ground. (Photo 7). South of these felled trees is a soil berm along the western border of the site, with water on the ground at several spots along the outside of it (Photos 8, 10, and 12-14). At least one spot of the berm was open with what appeared to be a slight sloping gradient toward Powder Horn Lake (Photo 11). Along the berm at some spots were tire tracks from vehicles traveling along the top of it, and there was evidence of erosion to the west of the berm (Photo 14).

Description: Powder Horn Lake marsh/wetland against west side of site

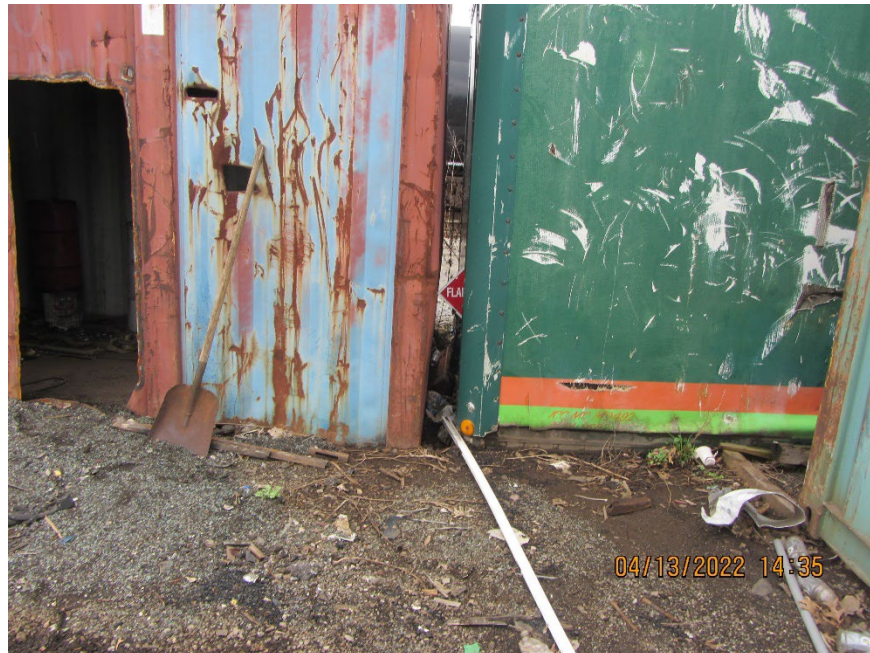
17: IMG_0242

On the northeast side of the site, about 25 railcars line the perimeter. There is an opening, near a pile of railroad ties, between two of these cars (Photos 16-18). To the south, next to piles of railroad ties, is a chain link fence (Photos 20-23). In this area, in the southeast corner of the site is a large pool of water next to the fence that appears to have oil staining on the ground.

Description: Opening between railcars (shown in Photo 16) bordering east side of site

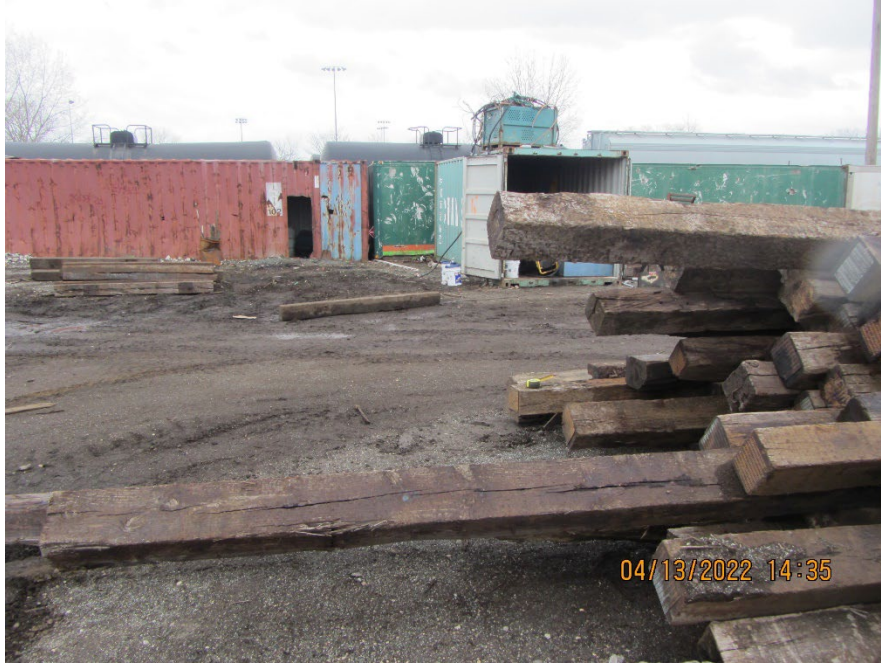
18: IMG_0243

Description: Zoomed out view of Photo 17, with railroad tie scrap in foreground

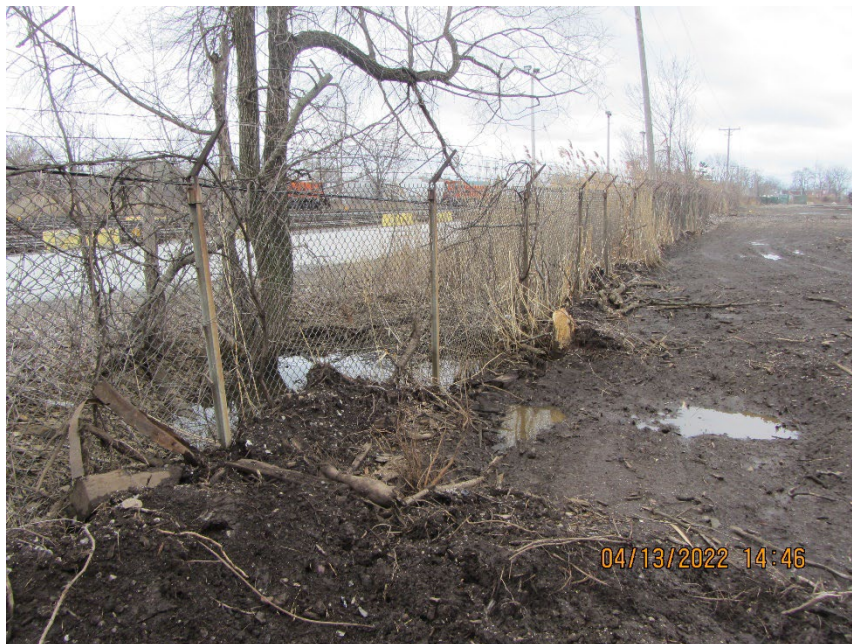
21: IMG_0246

Description: Low section of ground that appeared to slope downward toward chain link fence
Location: Near middle of eastern border of site, south of Photo 17
Camera Direction: Southeast
Date/Time: 4/13/22, 2:46 p.m.

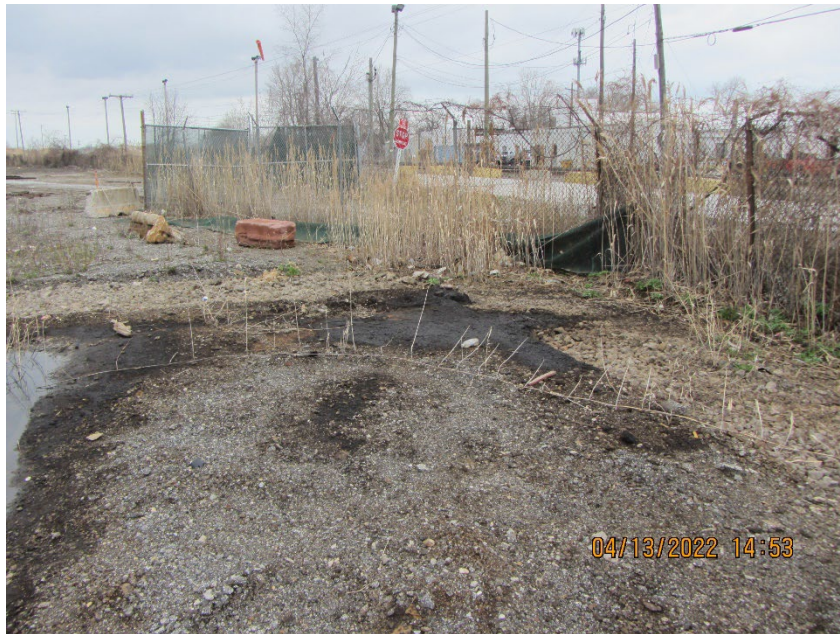
23: IMG_0248

Description: What appears to be oil staining by the small pond shown in Photo 22
