**Region 6 - Enforcement & Compliance Assurance Division**  
**INSPECTION REPORT**

| Inspection Date(s): | 3/4/2025 | |
| Company Name: | <b>Betsy Production Company, Inc.</b> | |
| Facility Name: | <b>Southern Corley SWD</b> | |

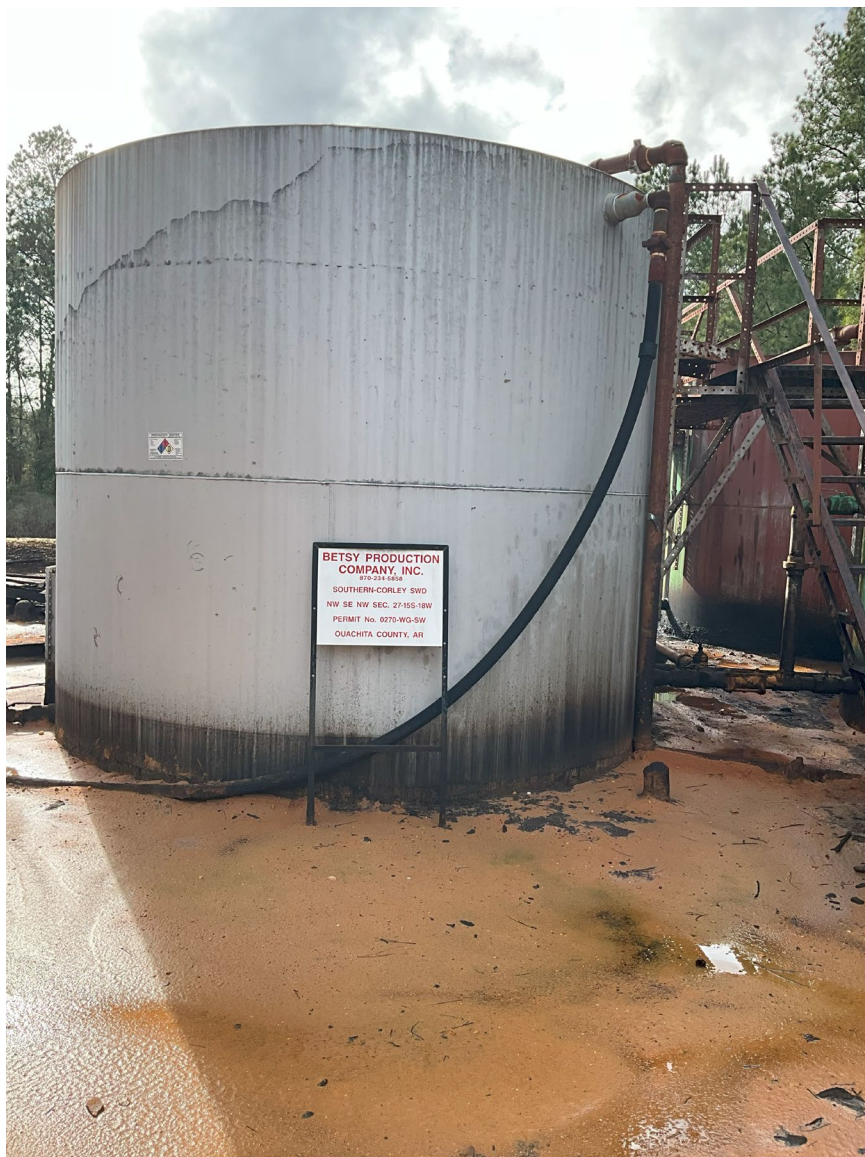
Photo No. 1

I observed the facility sign, secondary containment, pipes, valves, and storage tanks located at the facility; see Appendix 1 (photo log), photo No. 1 and No. 2. For additional GPS location and photo metadata, see Appendix 1.

**Description:** This photo was taken looking northwest and shows the facility sign.

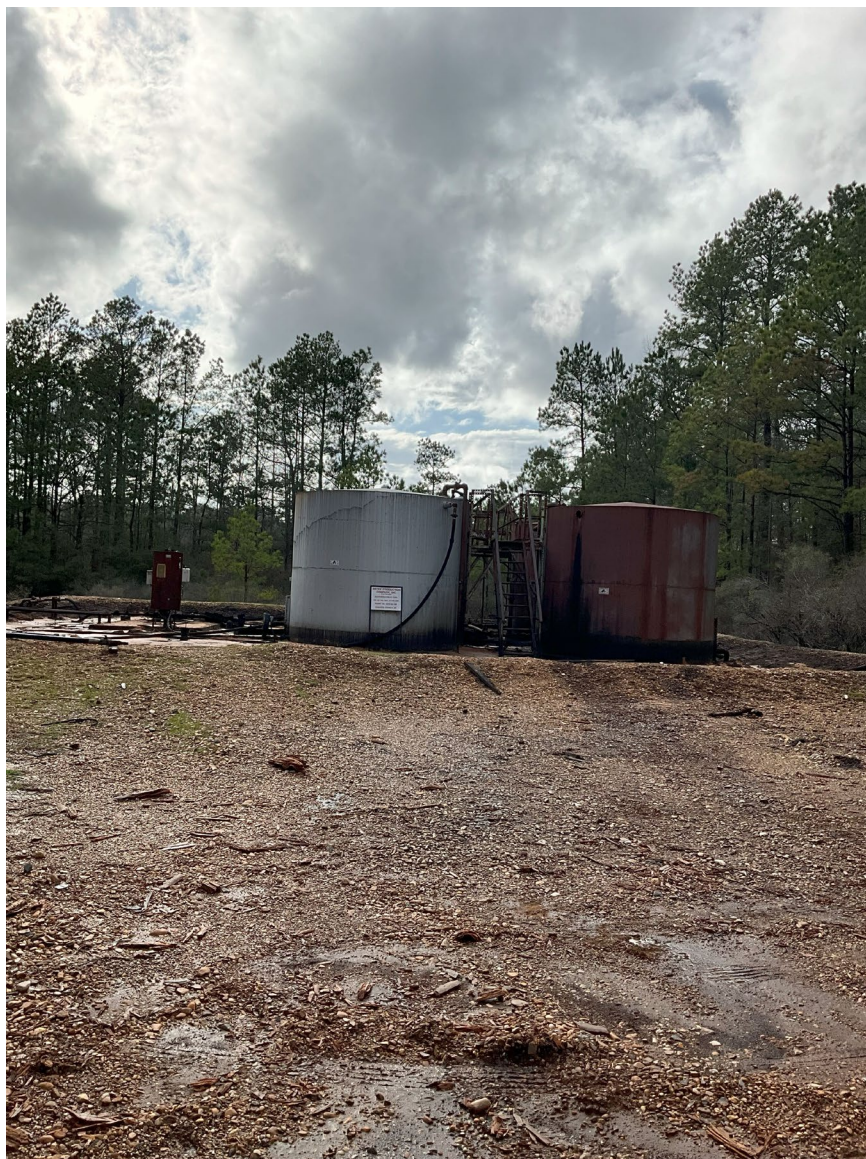
Photo No. 2

**Description:** This photo was taken looking west and shows an overview of the facility.

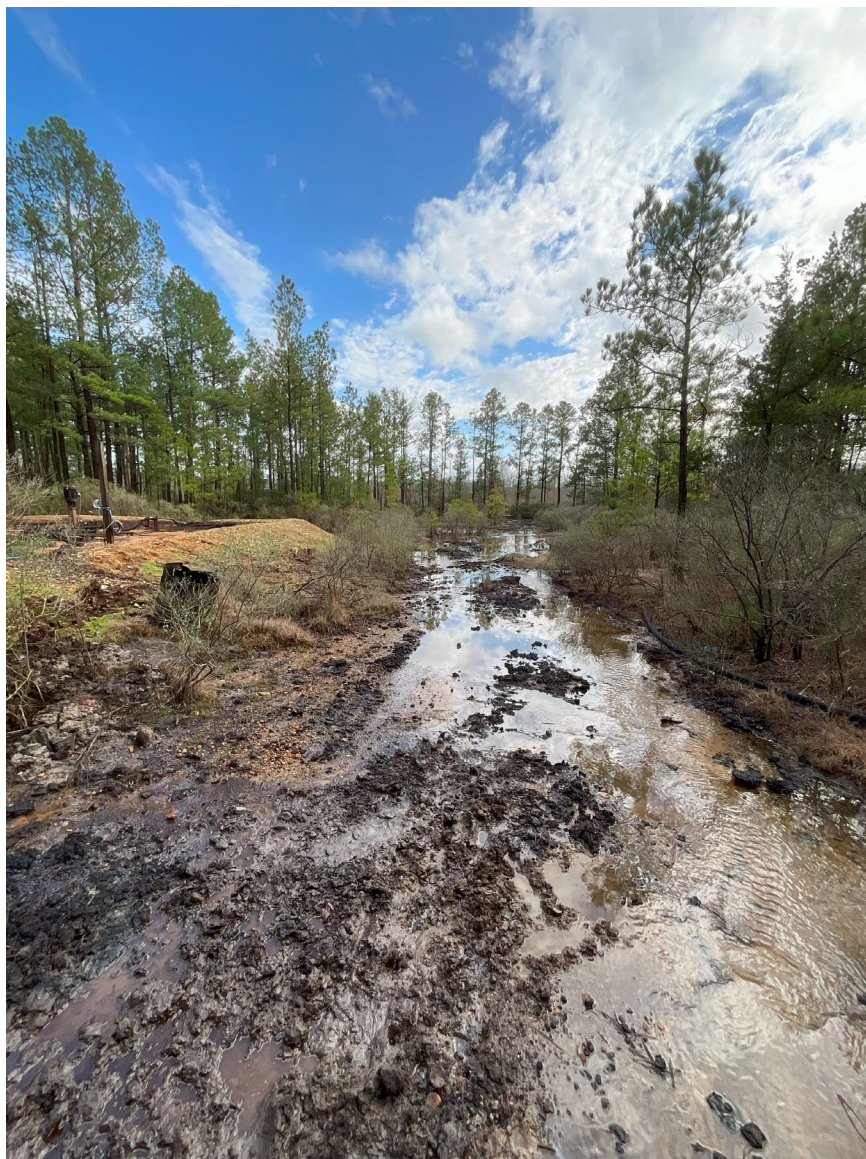
Photo No. 3

I observed a historical impacted flow path from the facility, see photo No. 3.

No closing conference was held due to no Betsy Production Company, Inc. staff being present during the inspection. An area of concern at the time of the inspection is the historical impacted flow path from the facility.

**Description:** This photo was taken looking west showing a historical impacted flow path.

Inspector will conduct follow-up phone calls with the company representatives over the coming weeks and months to ensure areas of concern are properly addressed.
