## Region 6 - Enforcement & Compliance Assurance Division

### INSPECTION REPORT

| Inspection Date(s): | 05/07/2025 | |
| Company Name: | <b>City of Monroe</b> | |

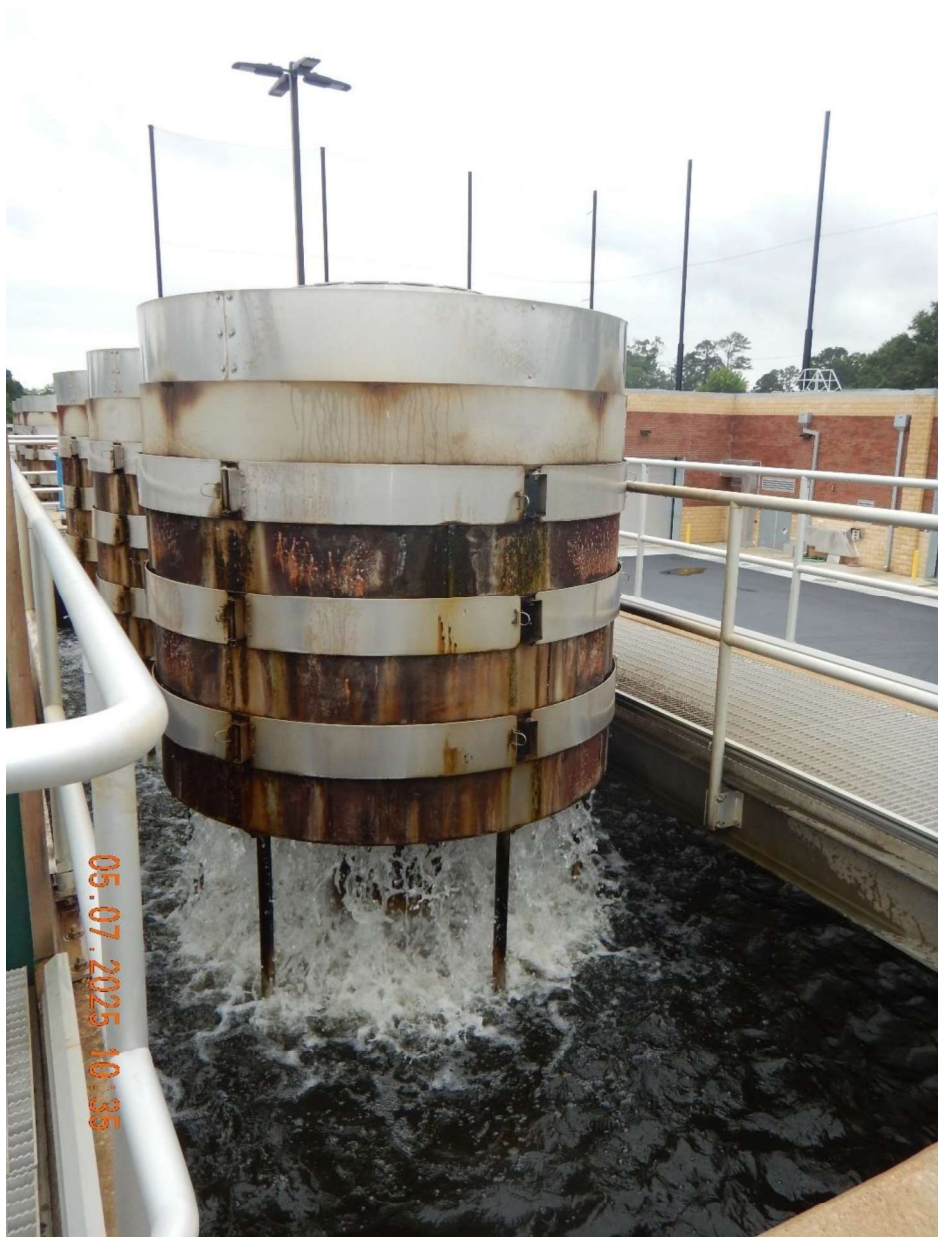
**Observation 1.** There was visible corrosion on the aerators. (Appendix 2, Photo No. 3).

**Aerators** View of aerators.

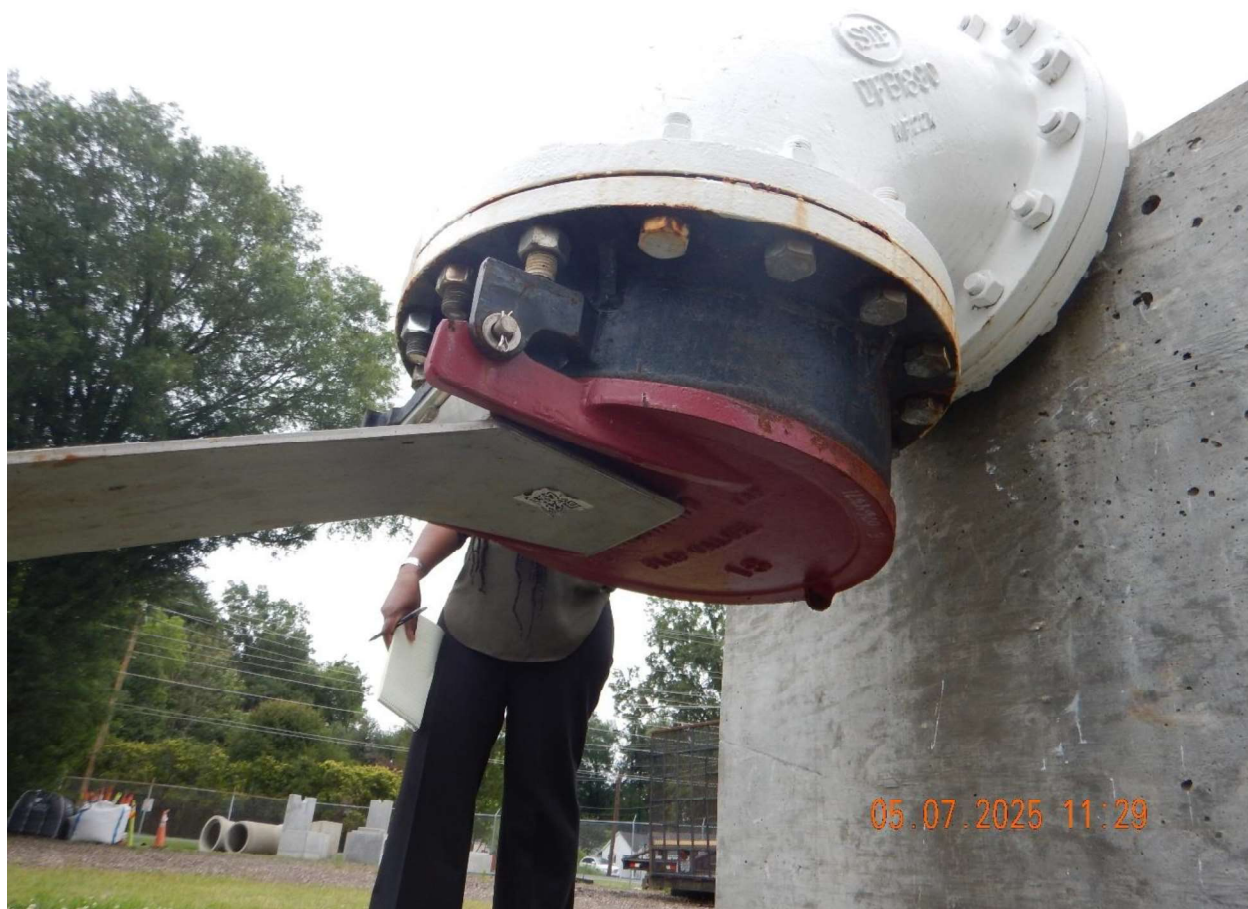
**Overflow** View of overflow at GST #2

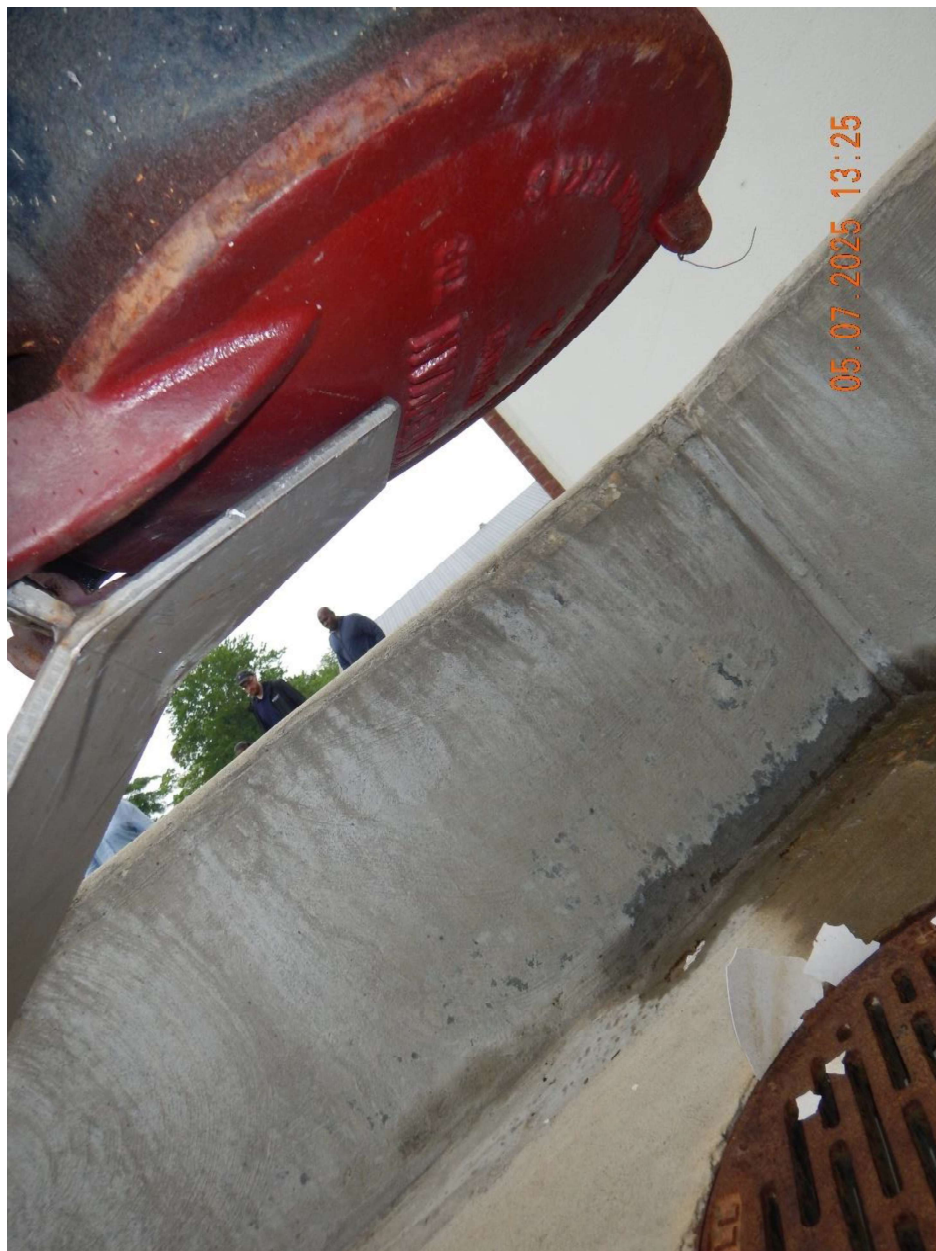
**Overflow** View of Chauvin tank overflow pipe with flap closed.

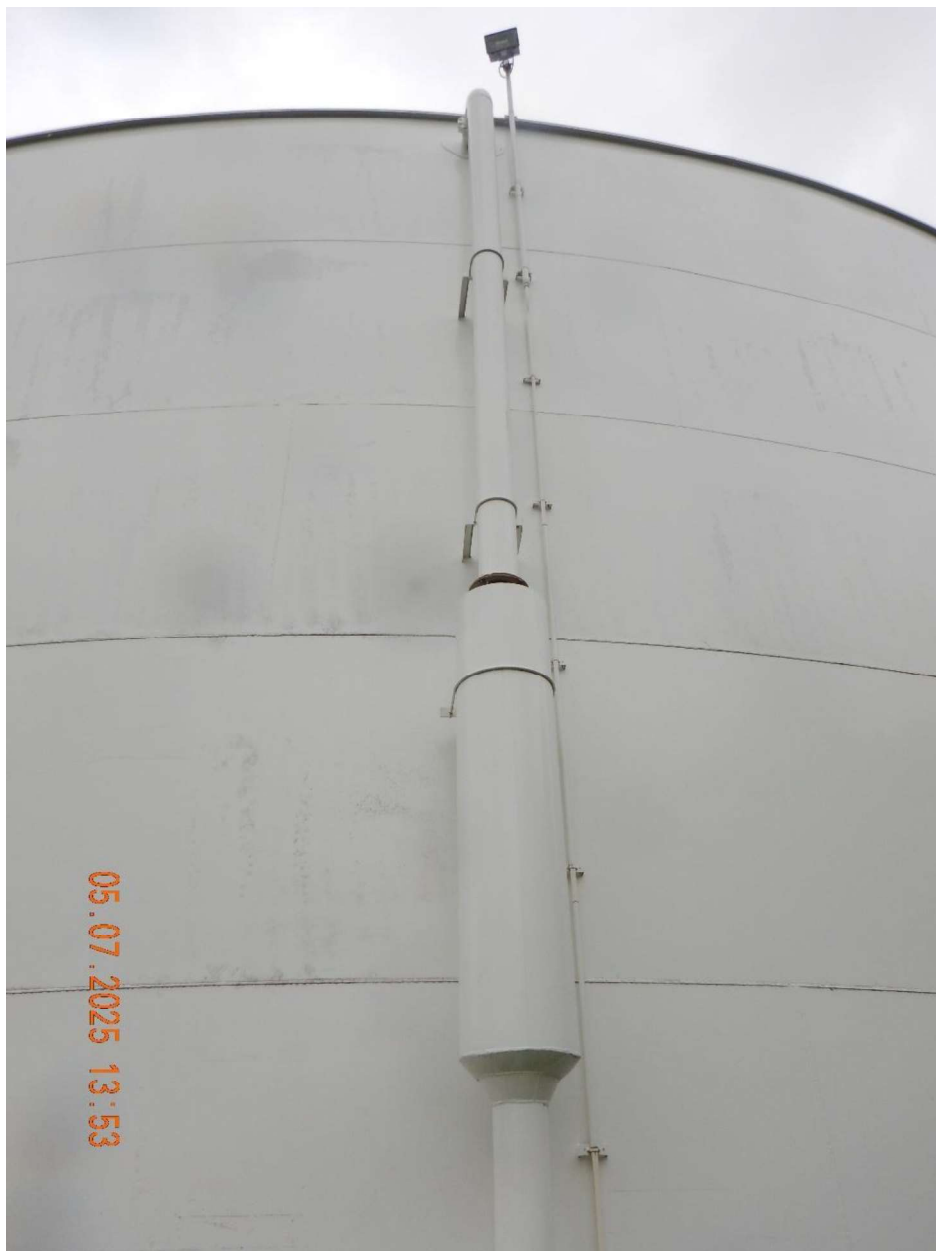
**Overflow Pipe** View of Ruffin overflow pipe with gap screened.

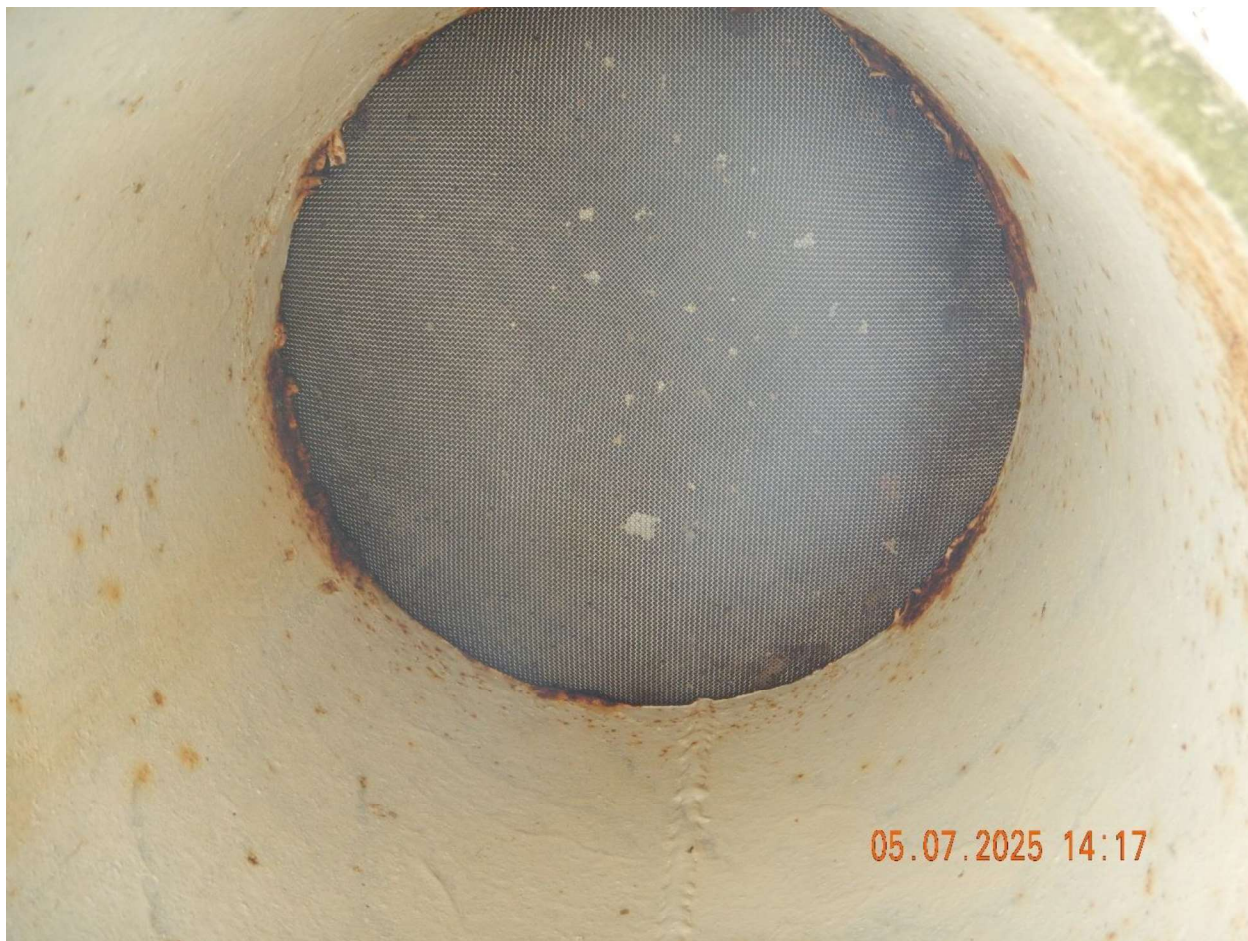
**Overflow** View of screened overflow pipe at Thomas Tank.

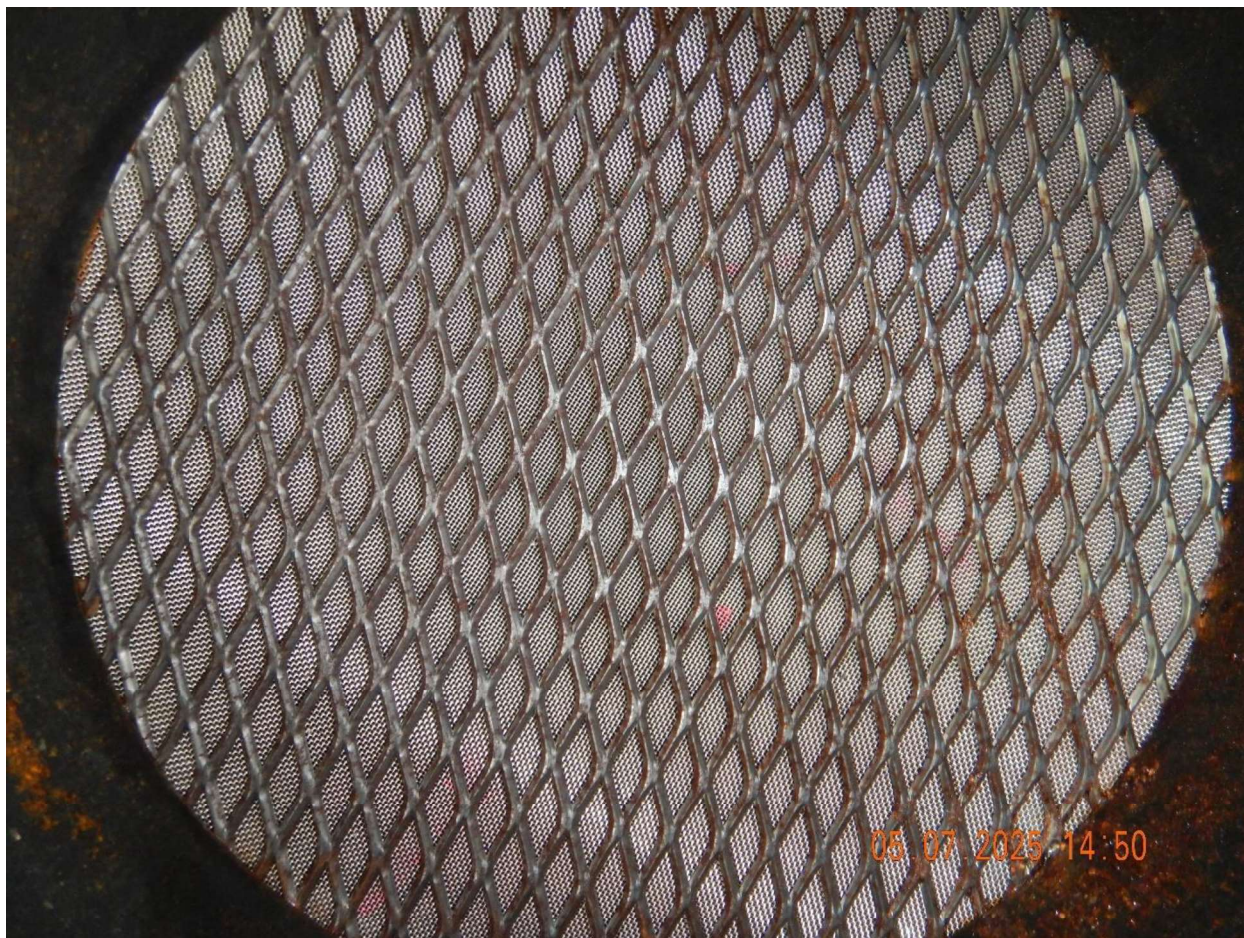
**Overflow** View of screened overflow at Selman pump station.

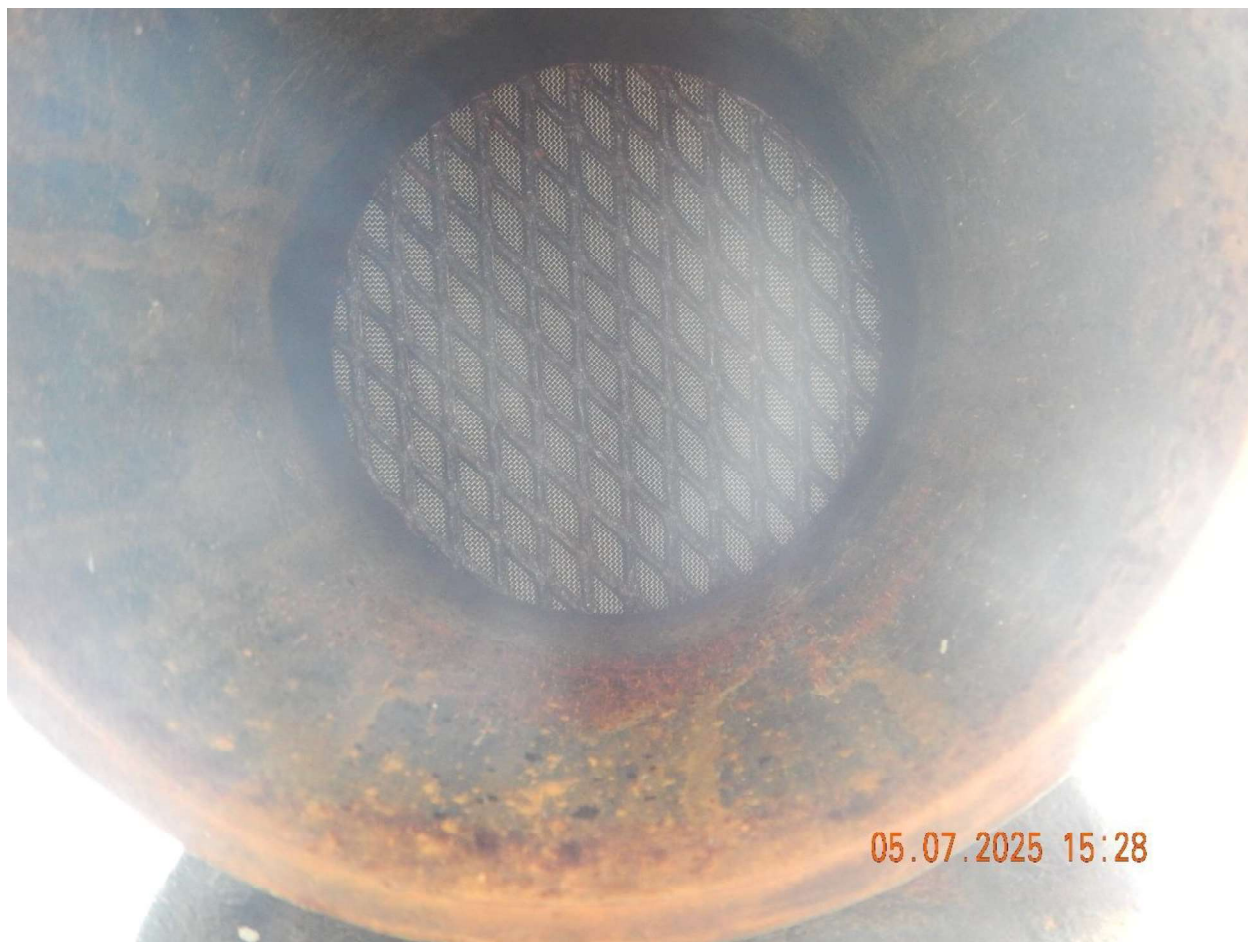
**Overflow** View of screened overflow at Grammont tower.

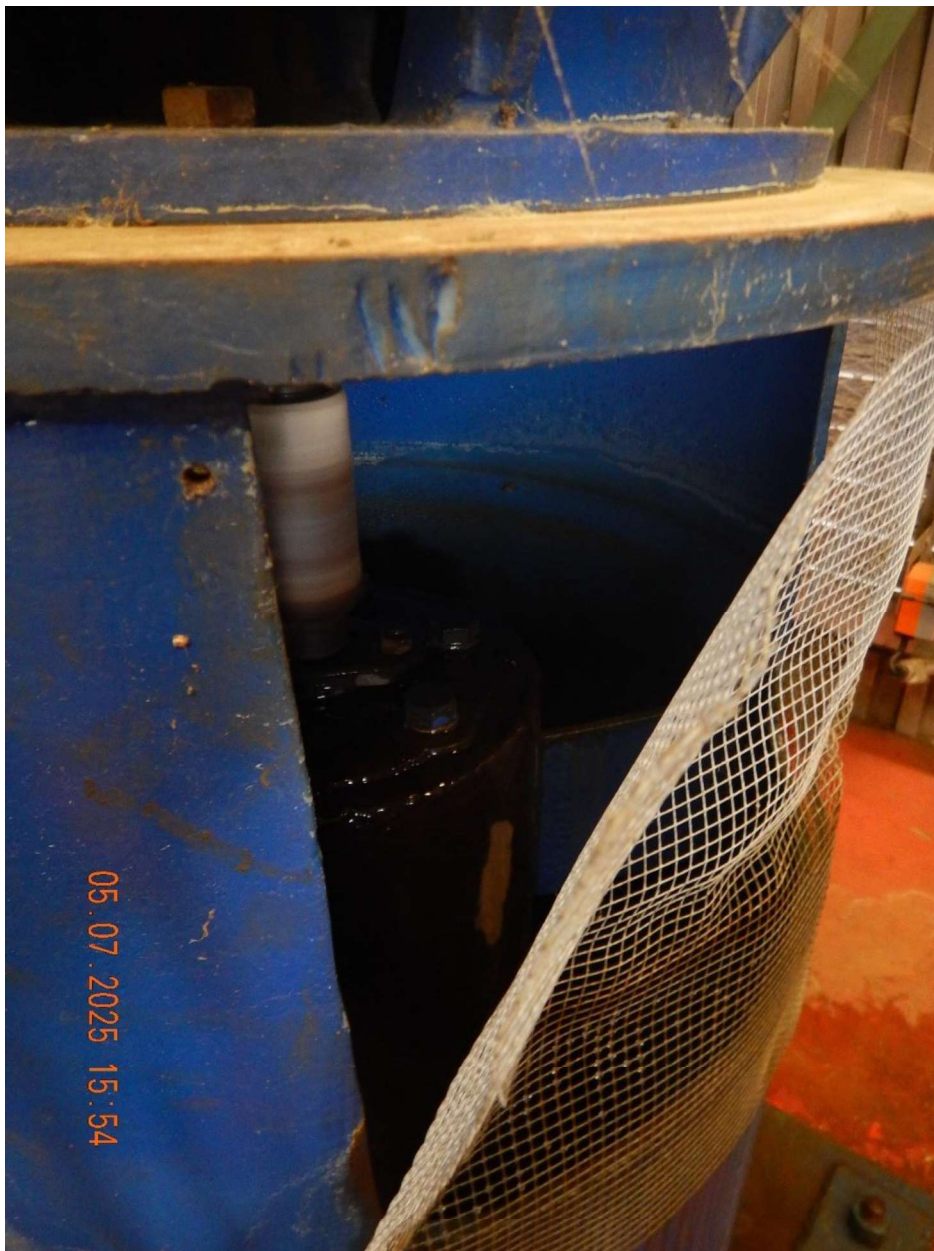
**Observation 3.** Pump 3 was leaking at the Bayou intake (Appendix 2, Photo No. 51).

**Pump 3** View of leak at pump 3.
