**Region 6 - Enforcement & Compliance Assurance Division**  
**INSPECTION REPORT**

| Media Program: | RCRA Compliance Evaluation Inspection | |
| Company Name: | <b>Printpack, Inc.</b> | |
| Facility Name: | <b>Printpack Converting Plant</b> | |

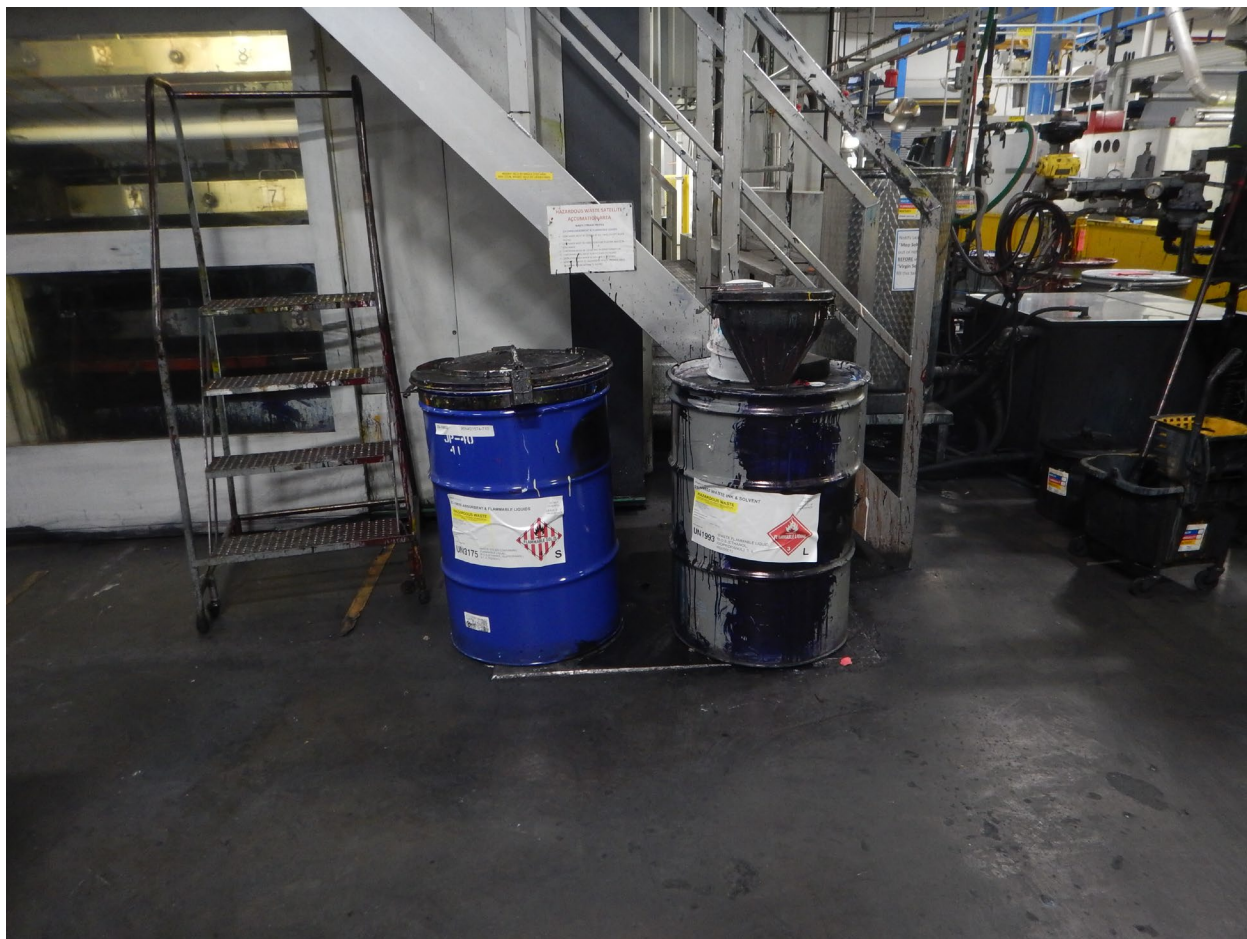
Photo No. 1

Each of the three printing presses had two 55-gallon drums staged for the satellite accumulation of hazardous waste (Photo 1). One drum of each pair is dedicated to liquid phase ink/solvent waste from the printers, and the other is dedicated to ink- and solvent-contaminated solid media.

| Description:<br>View of two satellite accumulation containers next to one of the printing presses. | | |

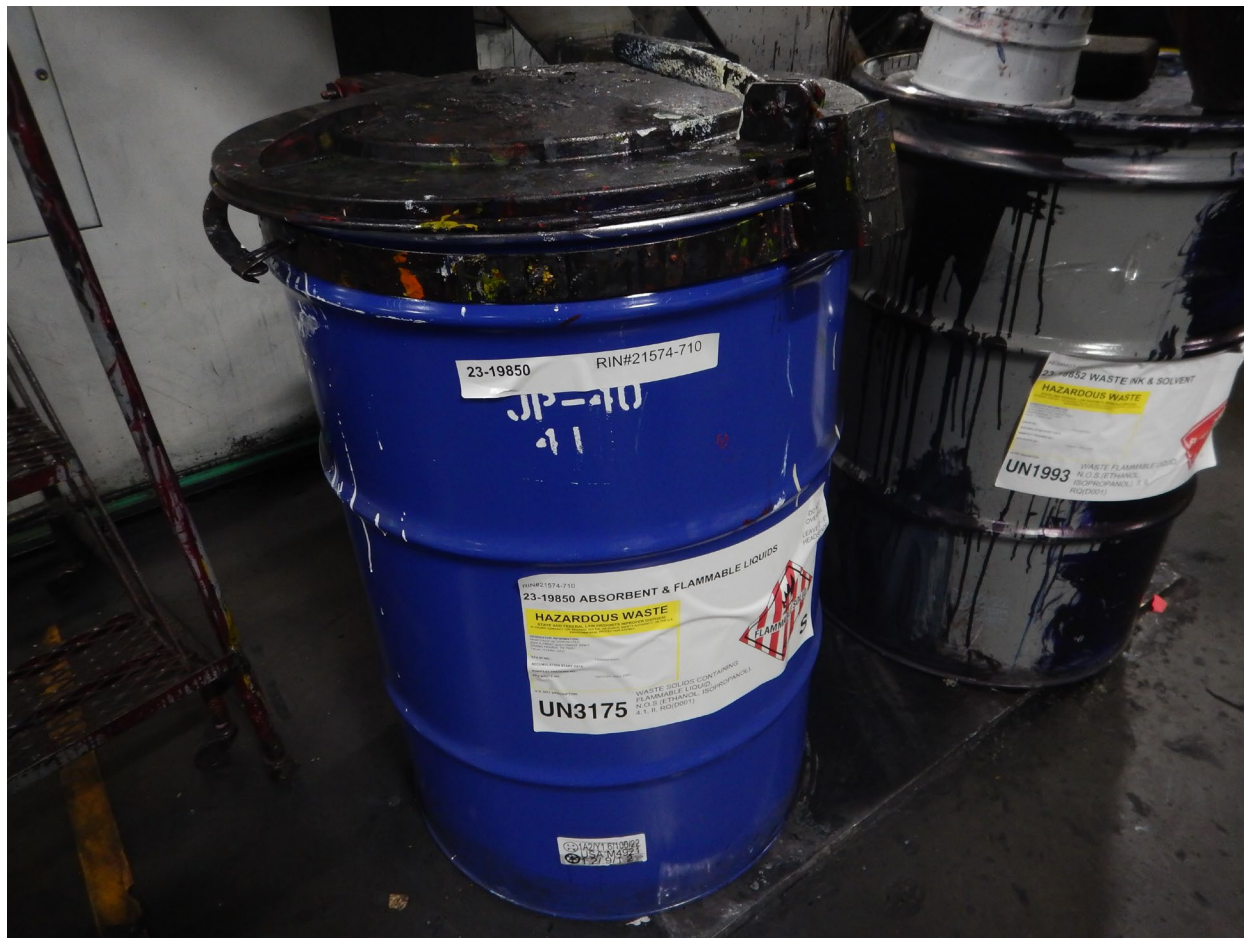
Photo No. 2

During the inspection, I observed one funnel with its lid not secured in the closed position, one drum with its lid not secured in the closed position, and one drum with a lid that was incorrectly attached and did not provide a vapor-tight seal (Photos 2 & 3). We observed the satellite accumulation drums were correctly labeled as hazardous waste, though each satellite accumulation area appears designed to exceed the 55-gallon limit for hazardous waste accumulation in a satellite accumulation area.

| Description:<br>Closeup of a satellite accumulation drum with an unsecured lid. | | |

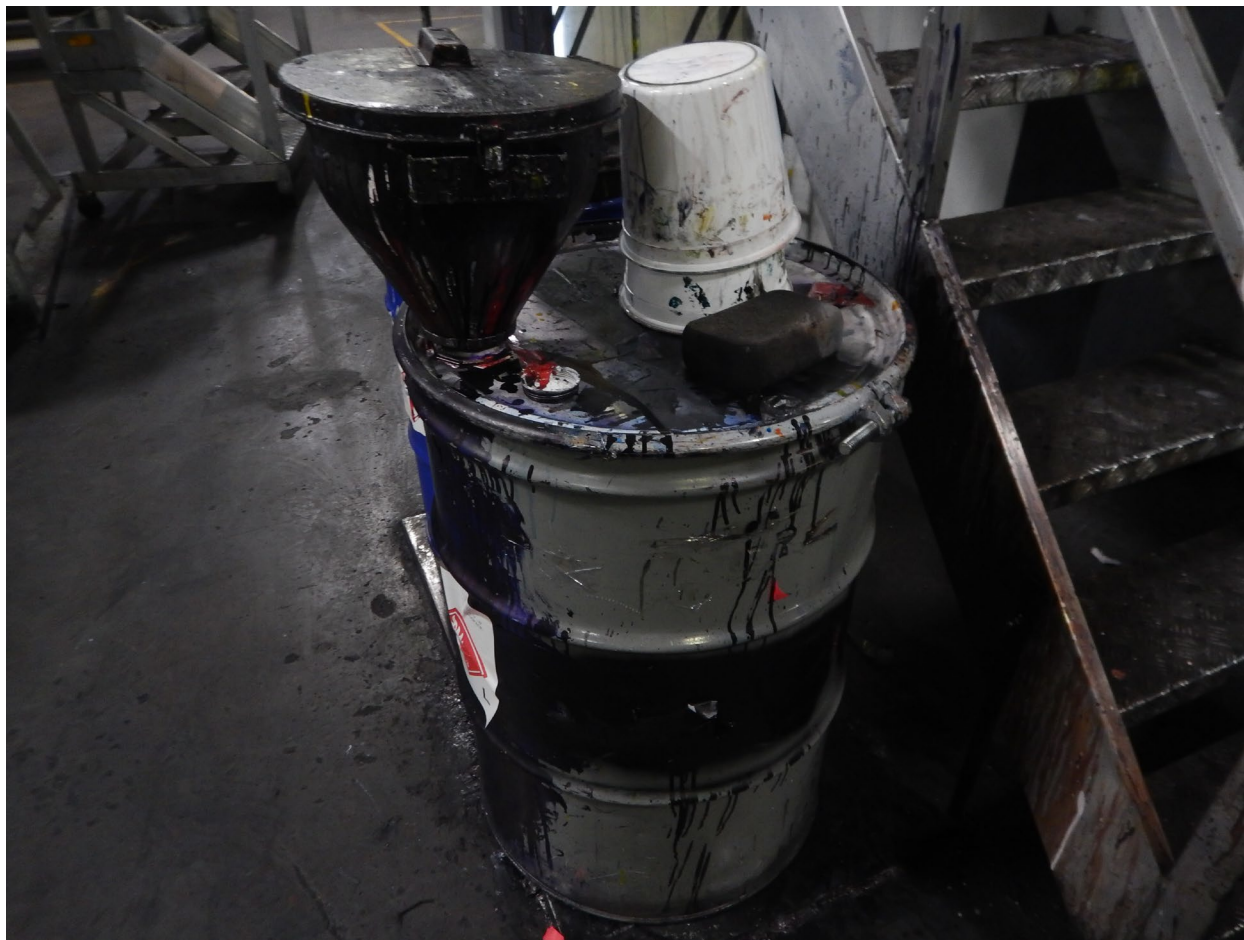
Photo No. 3

| Description:<br>Closeup of a satellite accumulation drum with an unsecured funnel. | | |

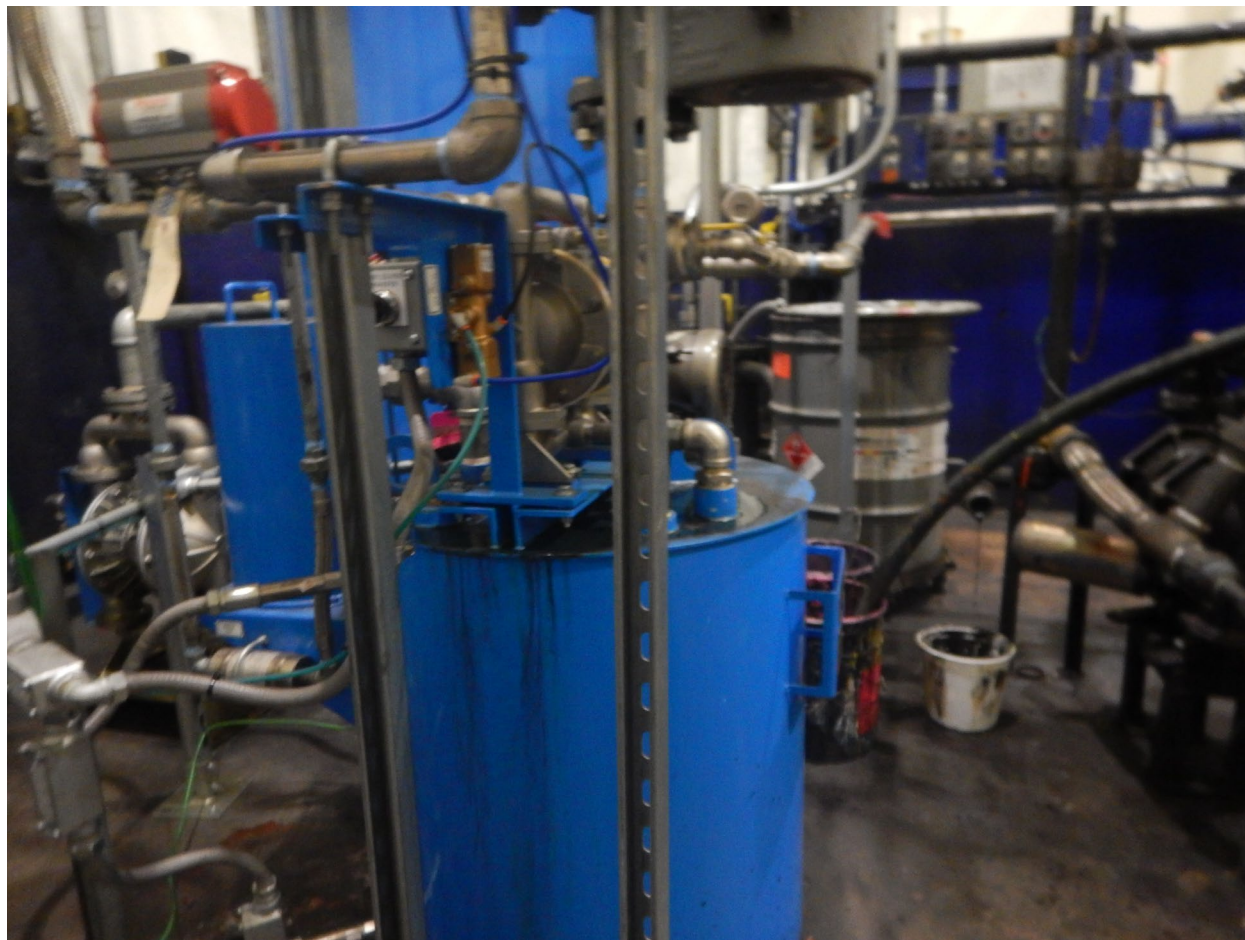
Photo No. 4

| Description:<br>View of equipment leak from piping carrying clean solvent. | | |

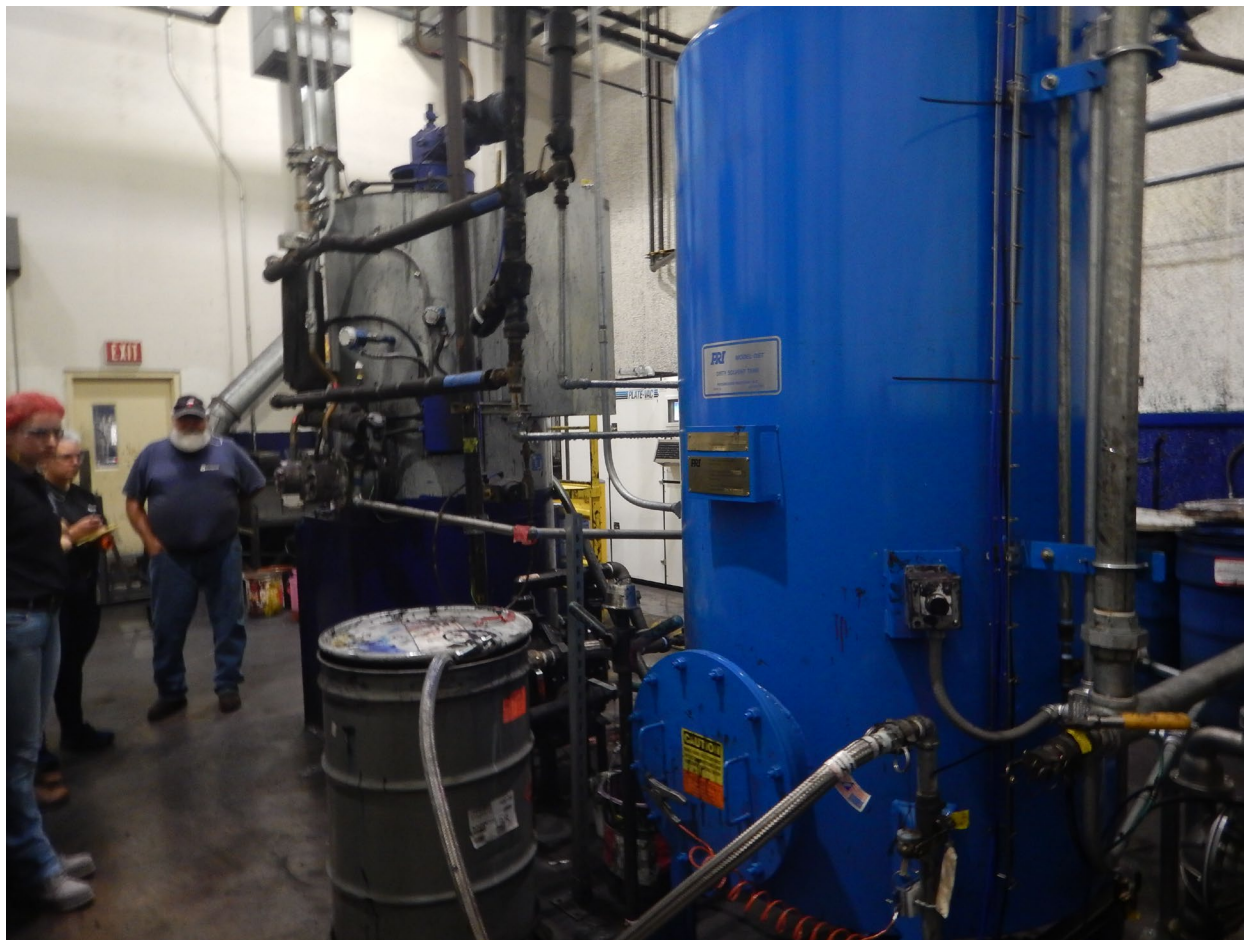
Photo No. 5

The distillation room is located within the ink room, near the entrance from the printing press area, and contains a spent solvent distillation unit. The distillation unit is equipped with a dedicated feed tank. At the time of the inspection, the feed tank was not marked as a hazardous waste tank. I observed an open 55-gallon drum of spent solvent next to the tank with one end of a flex hose inserted (Photos 5 & 6). The

| Description:<br>Overview of solvent reclamation area. Note open dirty solvent drum. | | |

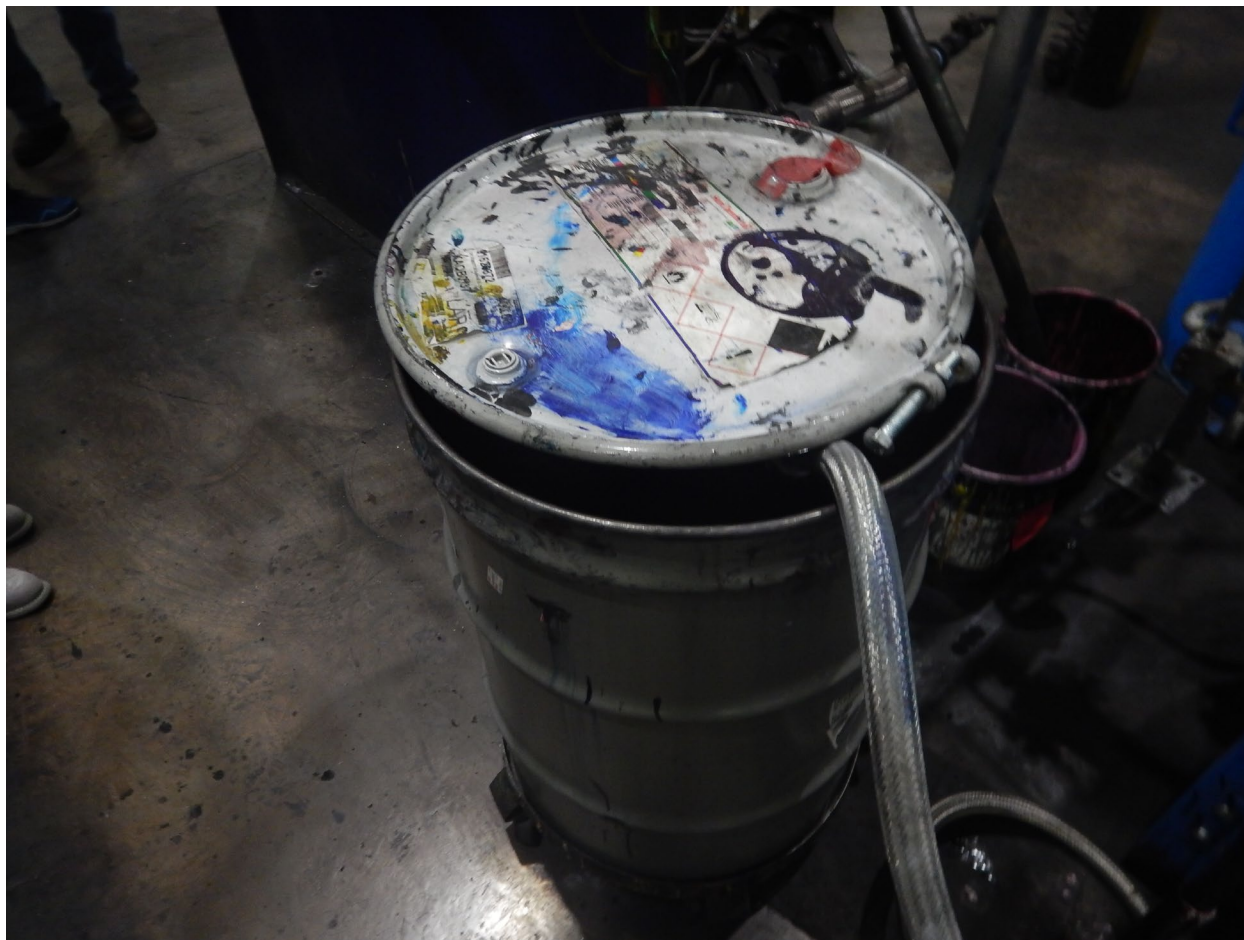
Photo No. 6

other end of the flex hose connected to the distillation tank. The open spent solvent container was also unlabeled, and no operators were present (Photo 7). I also identified three open-ended lines on the distillation bottoms waste lines, plus one active leak from a line associated with the reclaimed solvent tank (Photo 8). Solvent odors were present in the area. The facility stated line caps are on order. Printpack made a claim of secondary hazardous materials for spent solvent being reclaimed in the distillation area.

| <b>Description:</b><br>Closeup of open, unlabeled container that holds dirty solvent. Hose inserted into the drum feeds to the dirty solvent tank for reclamation. | | |

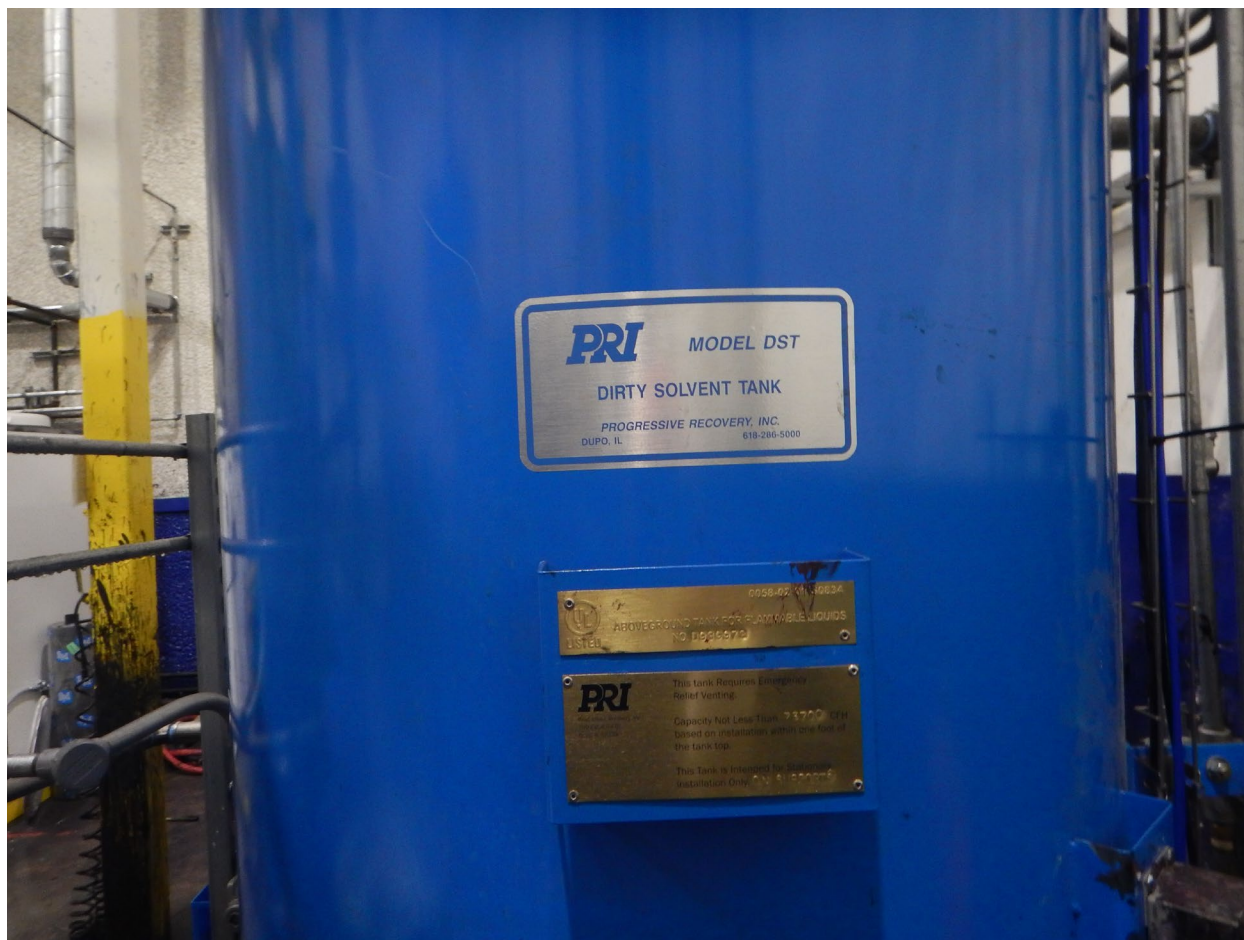
Photo No. 7

| Description:<br>Closeup of dirty solvent tank in the solvent reclamation area. The tank is missing a "Hazardous Waste" marking. | | |

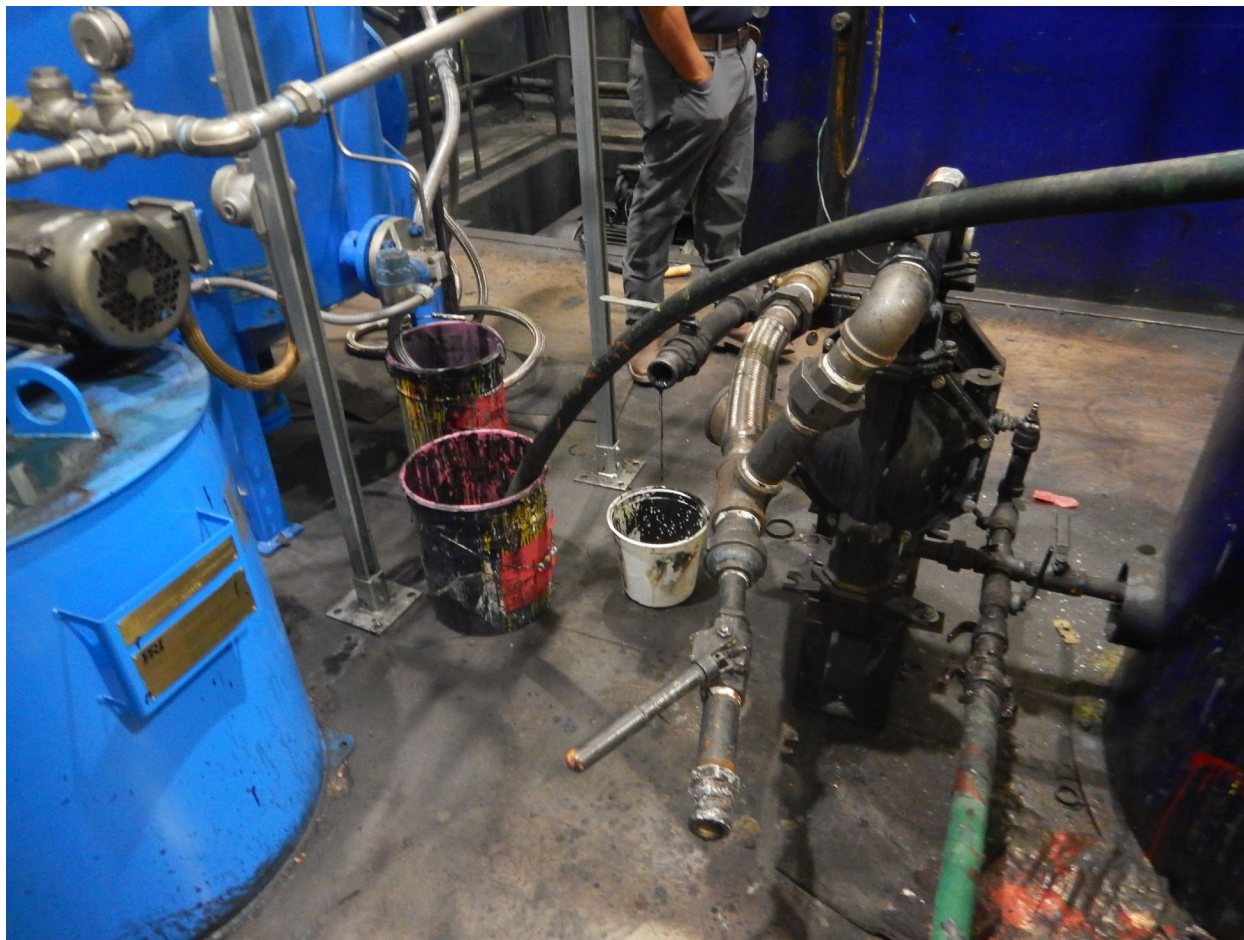
Photo No. 8

| Description:<br>Open-ended lines in the solvent reclamation area. | | |

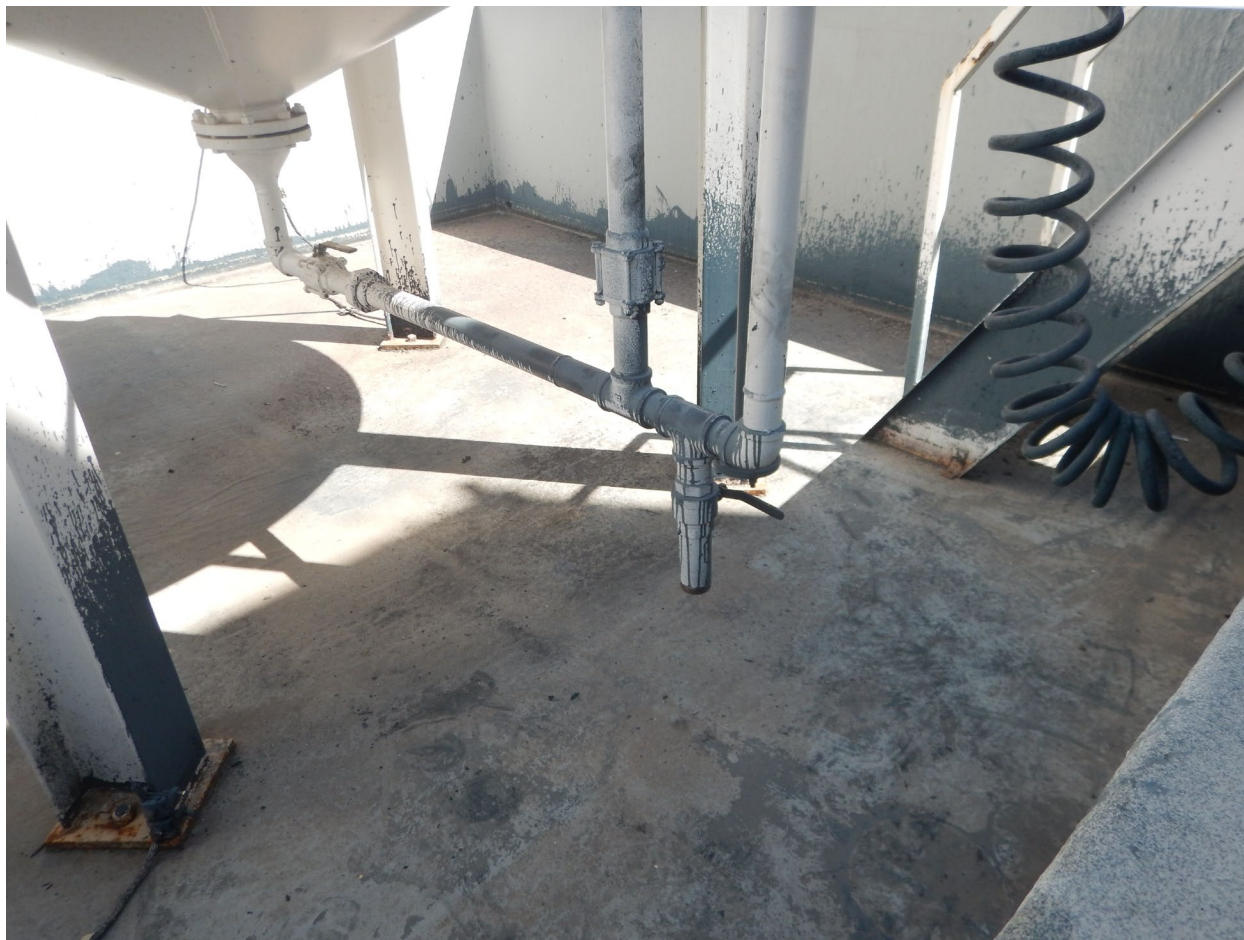
Photo No. 9

Tank 5 receives spent solvent from the printing presses and accumulates it prior to solvent reclamation in the solvent recovery unit. Printpack claims the spent solvent accumulated in Tank 5 is a hazardous secondary material. I identified one open-ended line associated with this tank and noticed the tank was not marked as a hazardous waste tank (Photo 9).

| Description:<br>Open-ended line in piping under Tank 5. | | |

Tank 5 had recently experienced a pump failure. While staining was still present, no other indications of the spill remained. After we ended the inspection for the day, Printpack labeled the tank and capped the open-ended line.

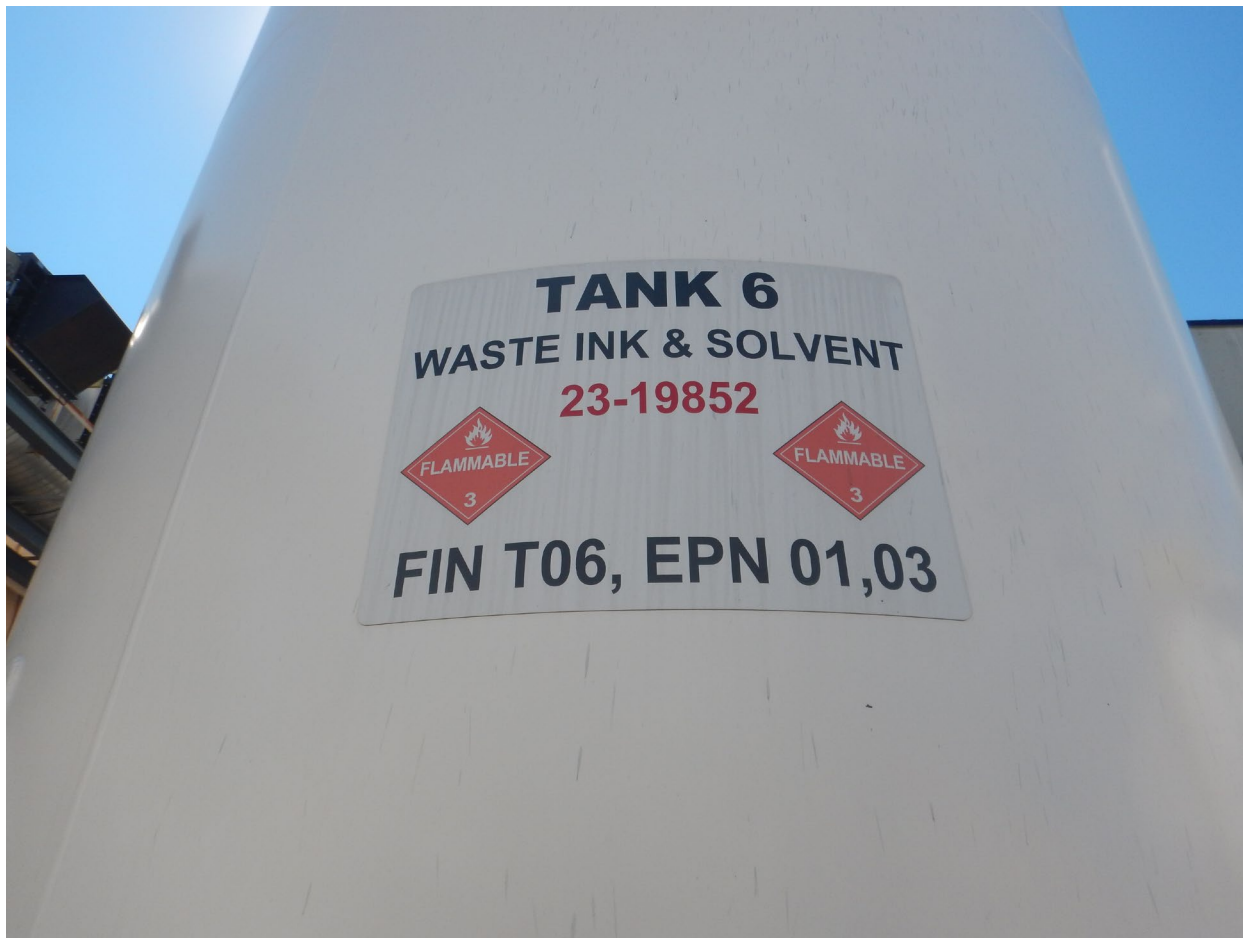
Photo No. 10

Tank 6 receives distillation column bottoms from the solvent reclamation still. It was marked as a solvent waste tank but is not marked with the words "Hazardous Waste" (Photo 10). I identified one open-ended line associated with this tank. As I inspected the top of the tank, I noticed solvent odors present. After we ended the inspection for the day, Printpack labeled the tank and capped the open-ended line. I confirmed this the following day.

| Description:<br>View of Tank 6 label. There are no "Hazardous Waste" markings on the tank. | | |

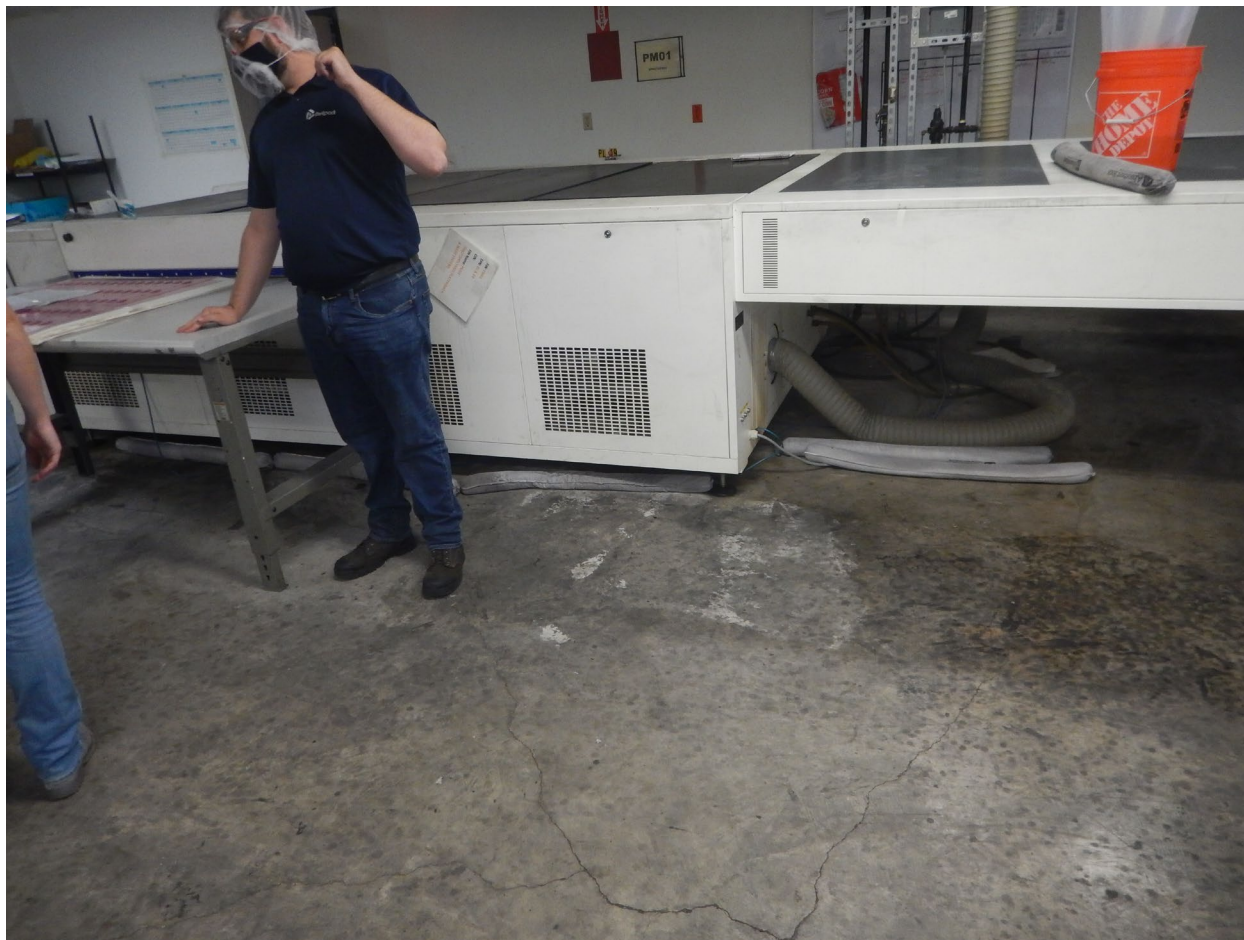
Photo No. 11

The facility has two mask removal units which use solvent to remove the mask agent from printing plates. Each is piped to a single solvent reclamation unit located in the distillation area. At the time of the inspection, I noticed a sorbent boom located underneath one of the two mask removal units that had been placed there in advance of a maintenance activity (Photo 11).

| Description:<br>Boom in photolithography area under a mask removal unit. | | |
