INSPECTION REPORT

| Type of Inspection | Industrial Stormwater Inspection (ISI) | |
| Permittee Name | Northeast Asphalt, Inc. (Pearl Quarry) | |
| Permit Number | WIR051IA0B | |

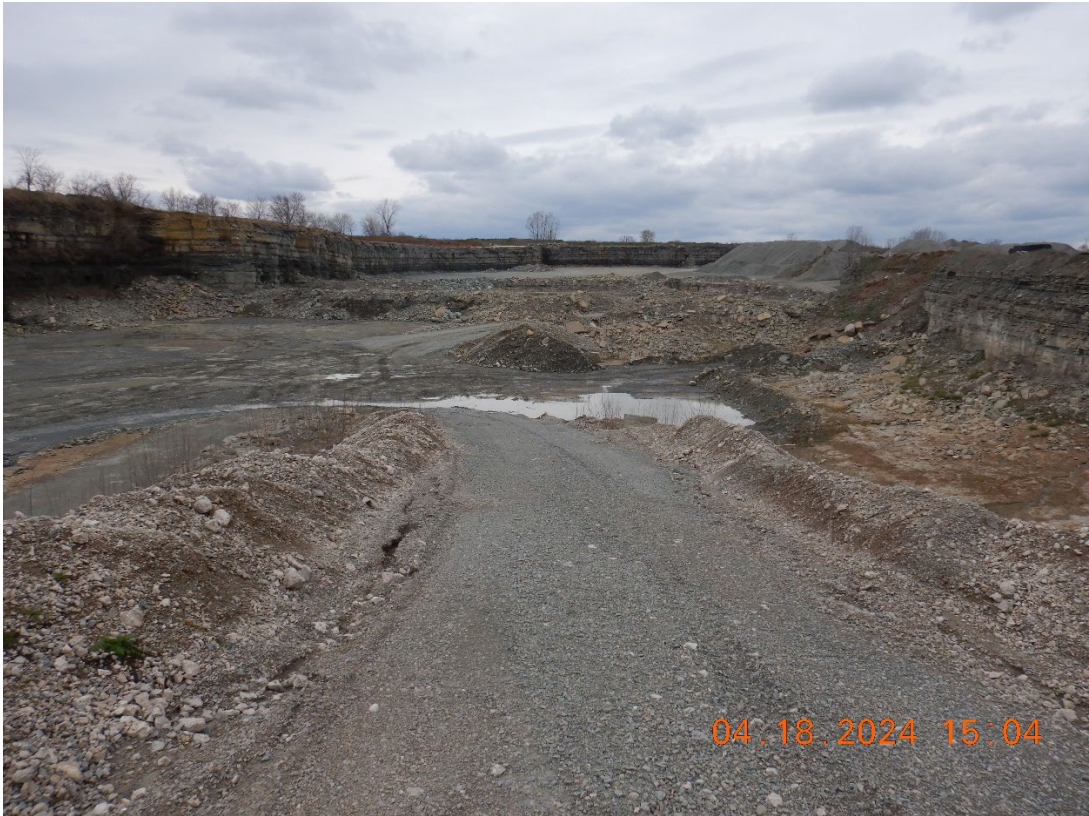
| Road Into Quarry | | | DSCN0700.JPG |

| Overview of Pearl Quarry | | | |

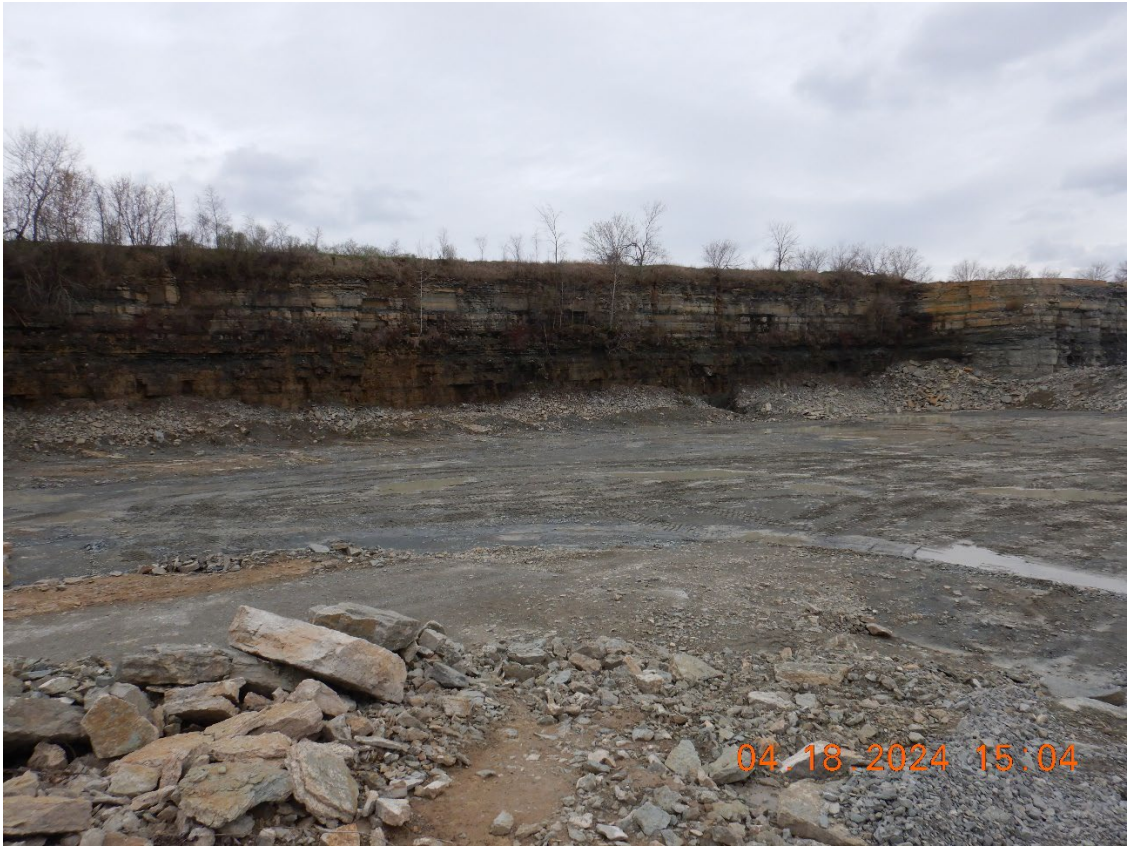
| Inside of Quarry | | | DSCN0701.JPG |

| Southeast side in Quarry | | | |

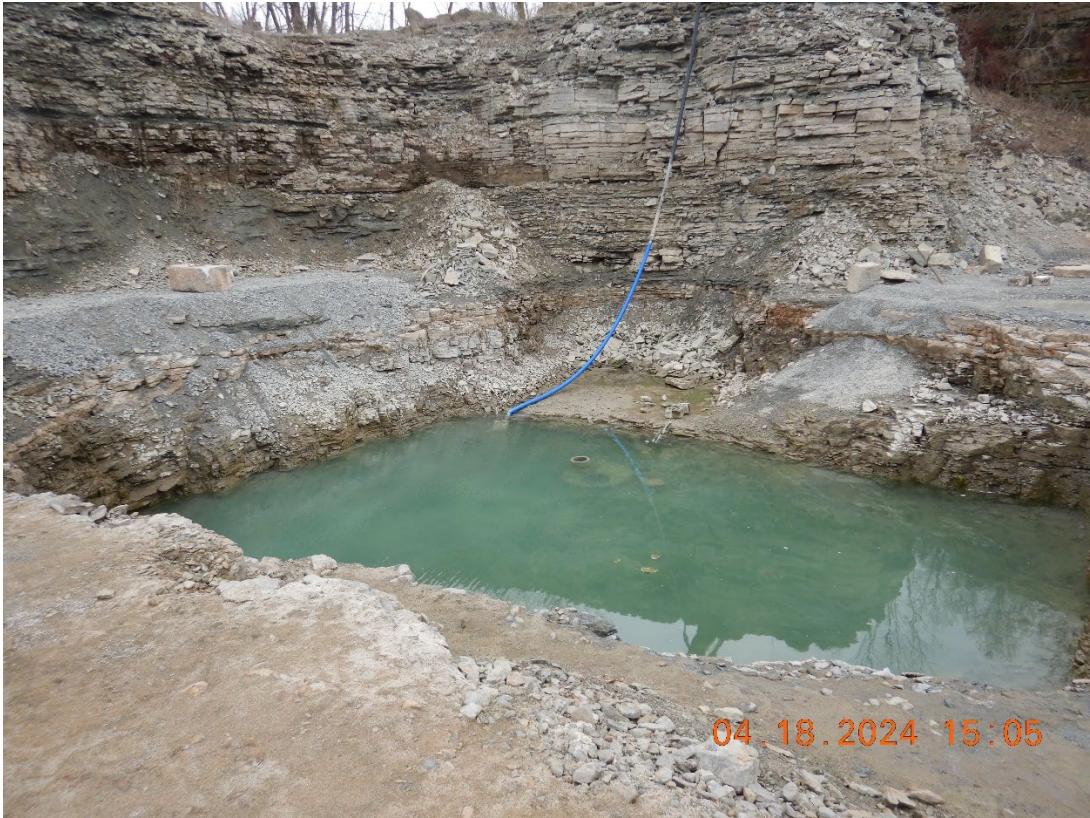
| Stormwater Sump Hole | | | DSCN0702.JPG |

| Stormwater collection area on southeast corner in quarry | | | |

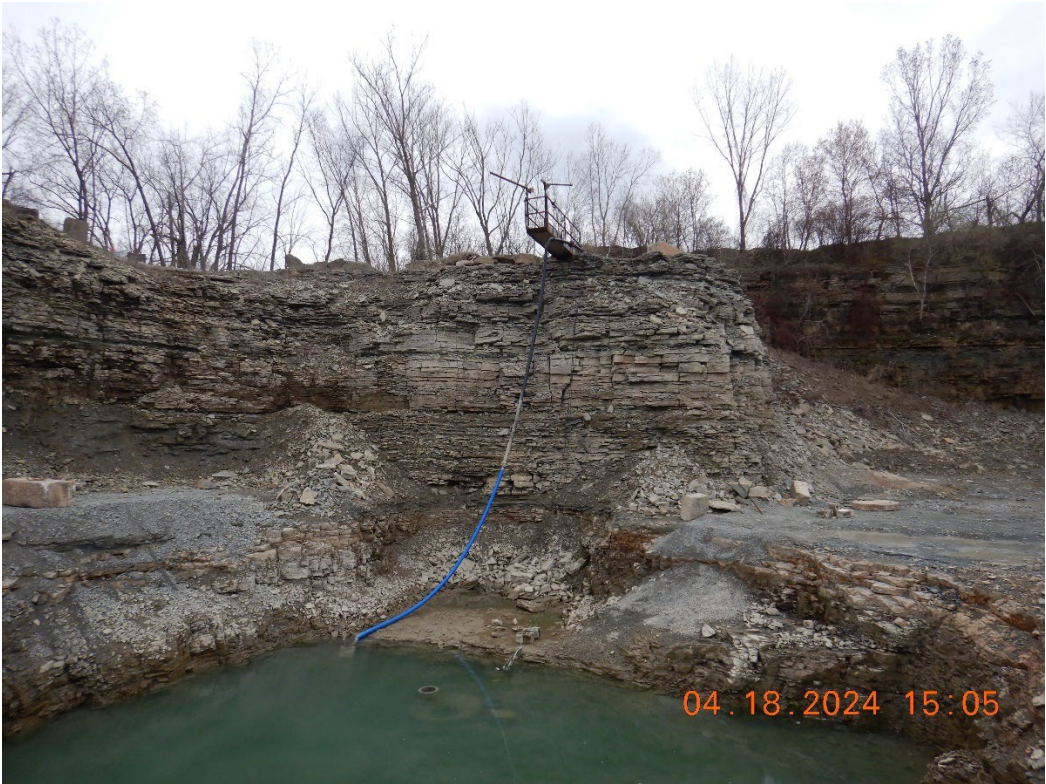
| Stormwater Sump Hole | | | DSCN0703.JPG |

| Hose from stormwater sump hole in quarry to discharge area | | | |

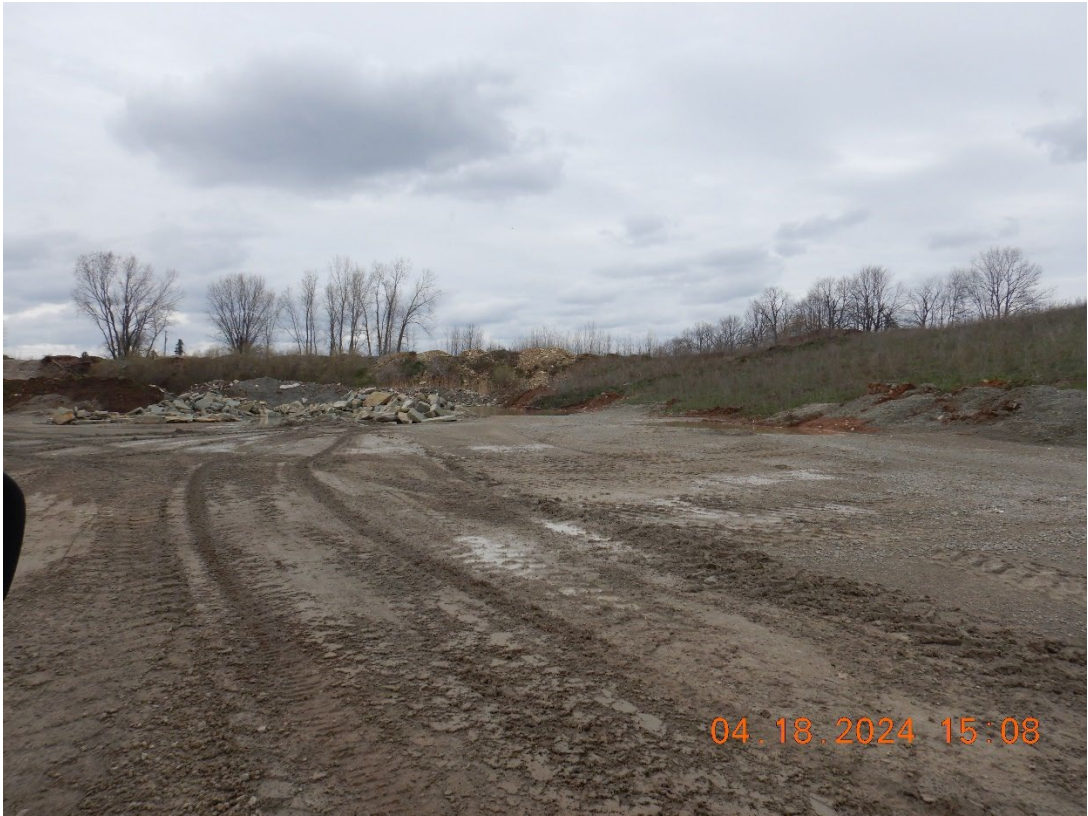
| Inside of Quarry | | | DSCN0704.JPG |

| Overview inside of Quarry (northwest side) | | | |

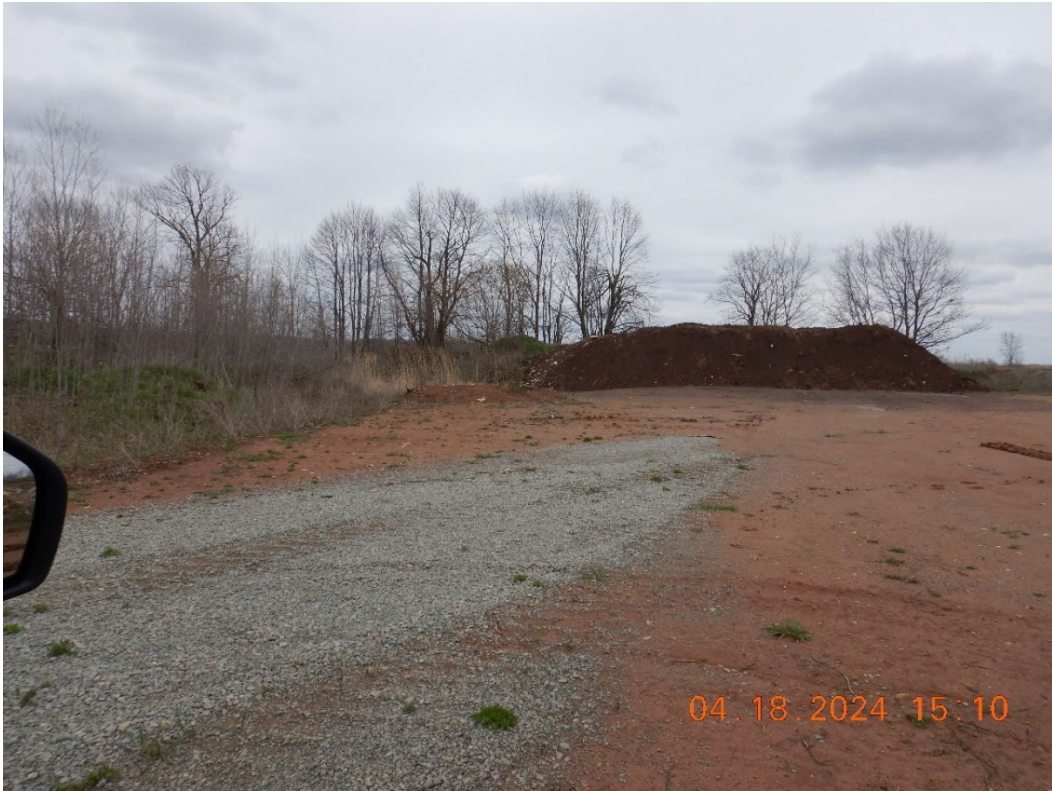
| Northside of Quarry | | | DSCN0705.JPG |

| Dirt pile on north side of quarry | | | |

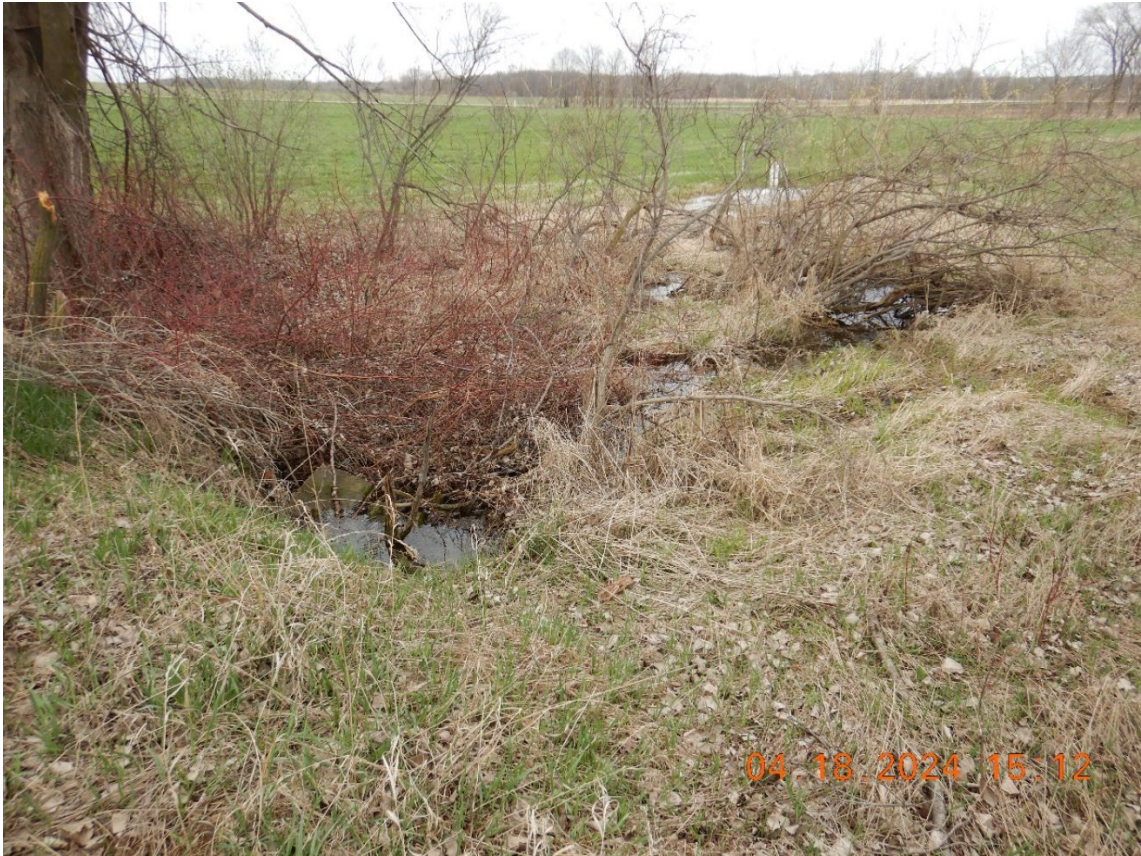
| Stormwater Drainage Ditch | | | DSCN0706.JPG |

| Stormwater drainage ditch on north side outside of quarry | | | |

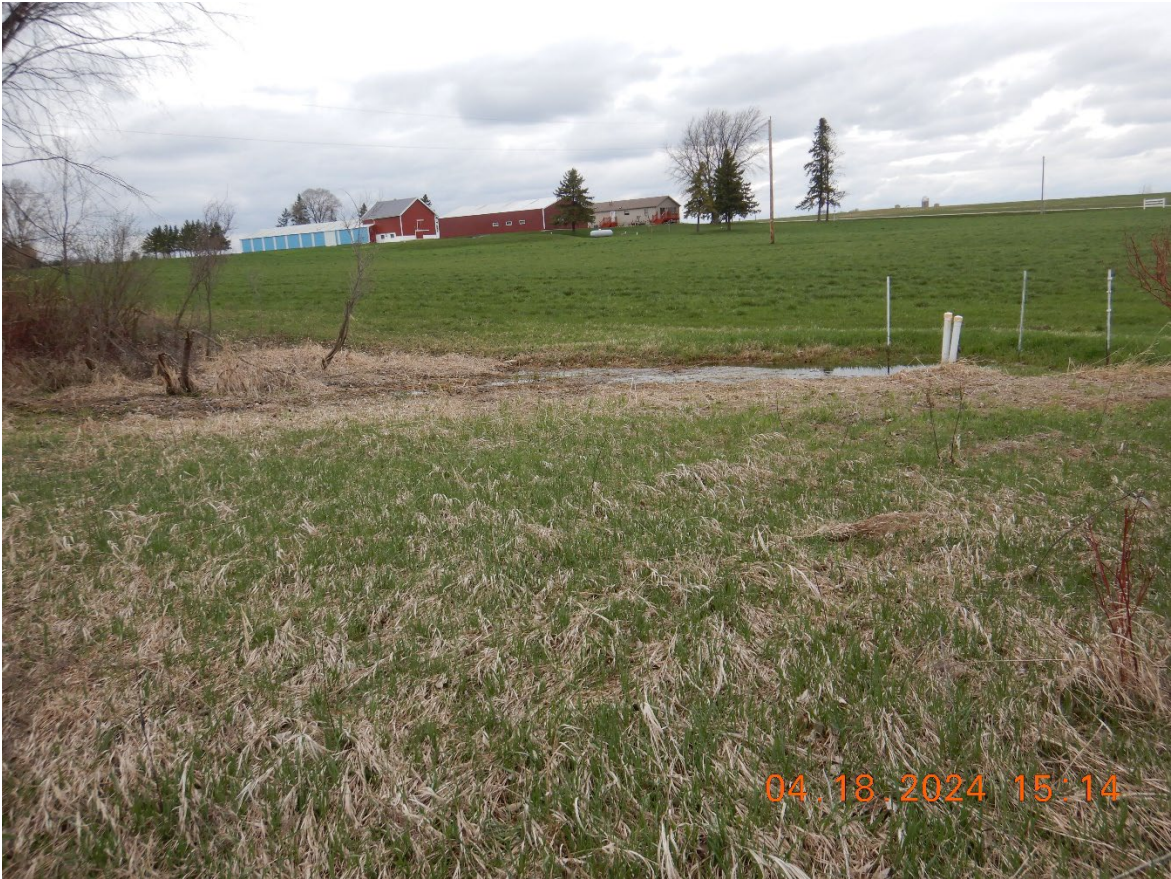
| Stormwater Drainage Collection Area | | | DSCN0707.JPG |

| Stormwater drainage ditch to collection area north side of quarry | | | |

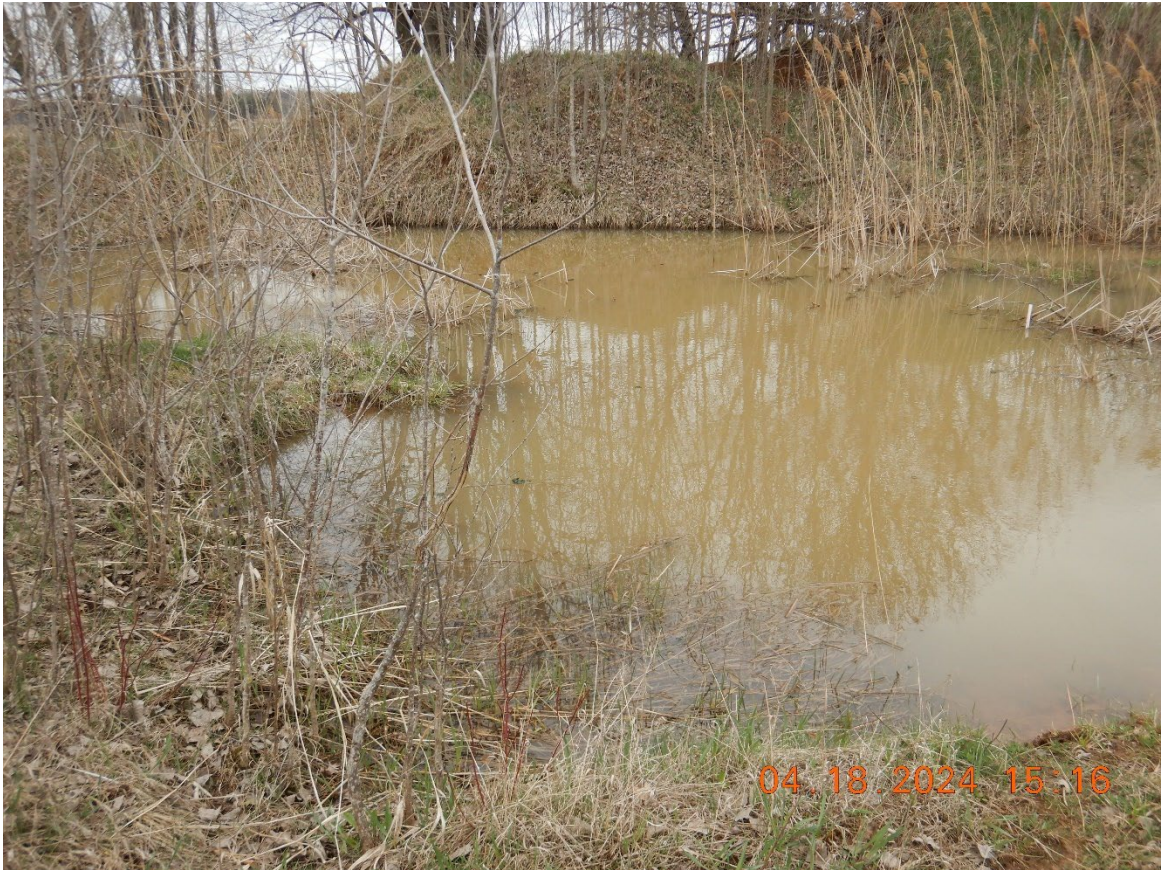
| Stormwater Depression | | | DSCN0708.JPG |

| <b>AOC:</b><br><br>The most current SWPPP reviewed did not include site description meeting requirements in Section 6.2.2. | |

| Stormwater collected in depression on north side of quarry (not described in the SWPPP). | | | |

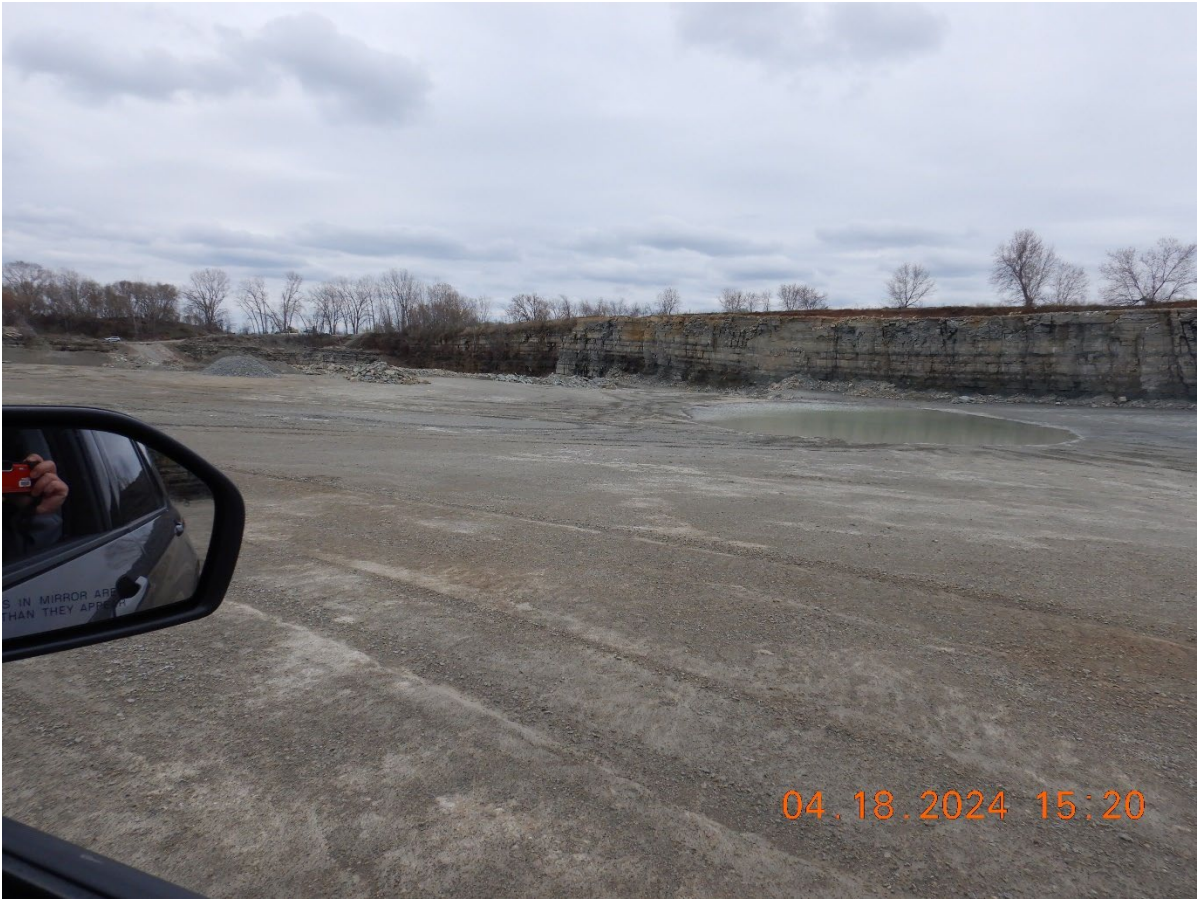
| Westside of Quarry | | | DSCN0709.JPG |

| Overview of northwest side of quarry | | | |

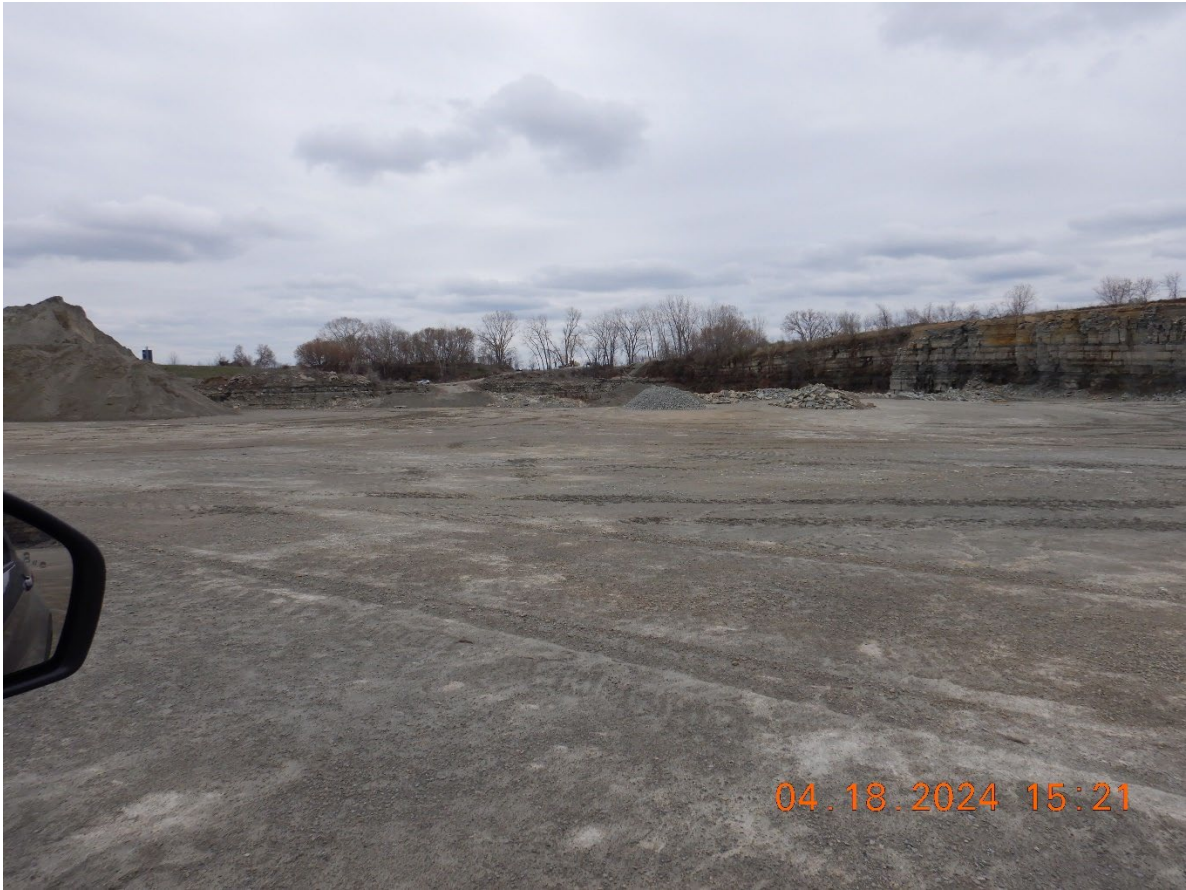
| Westside of Quarry | | | DSCN0710.JPG |

| Overview of southwest side of quarry | | | |

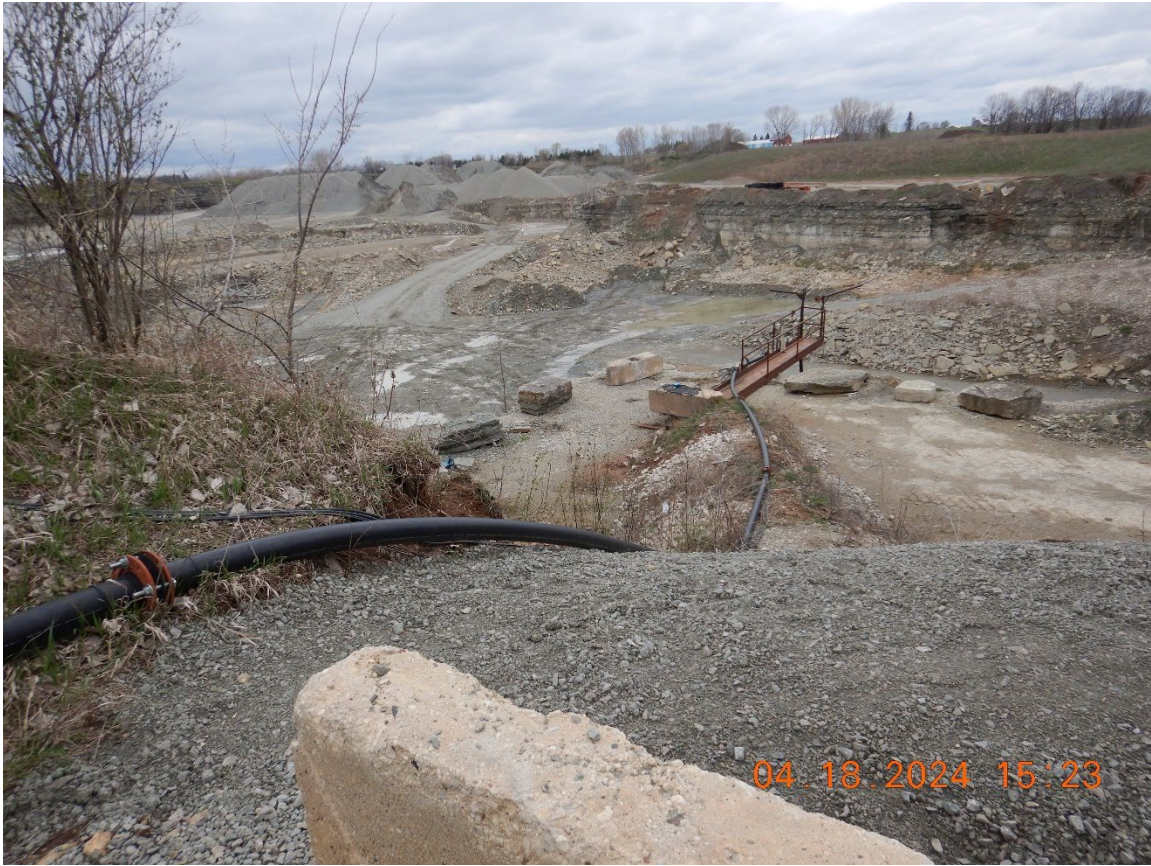
| Stormwater Hose on Top of Quarry | | | DSCN0711.JPG |

| Stormwater hose from collection area in quarry up to stormwater ditch | | | |

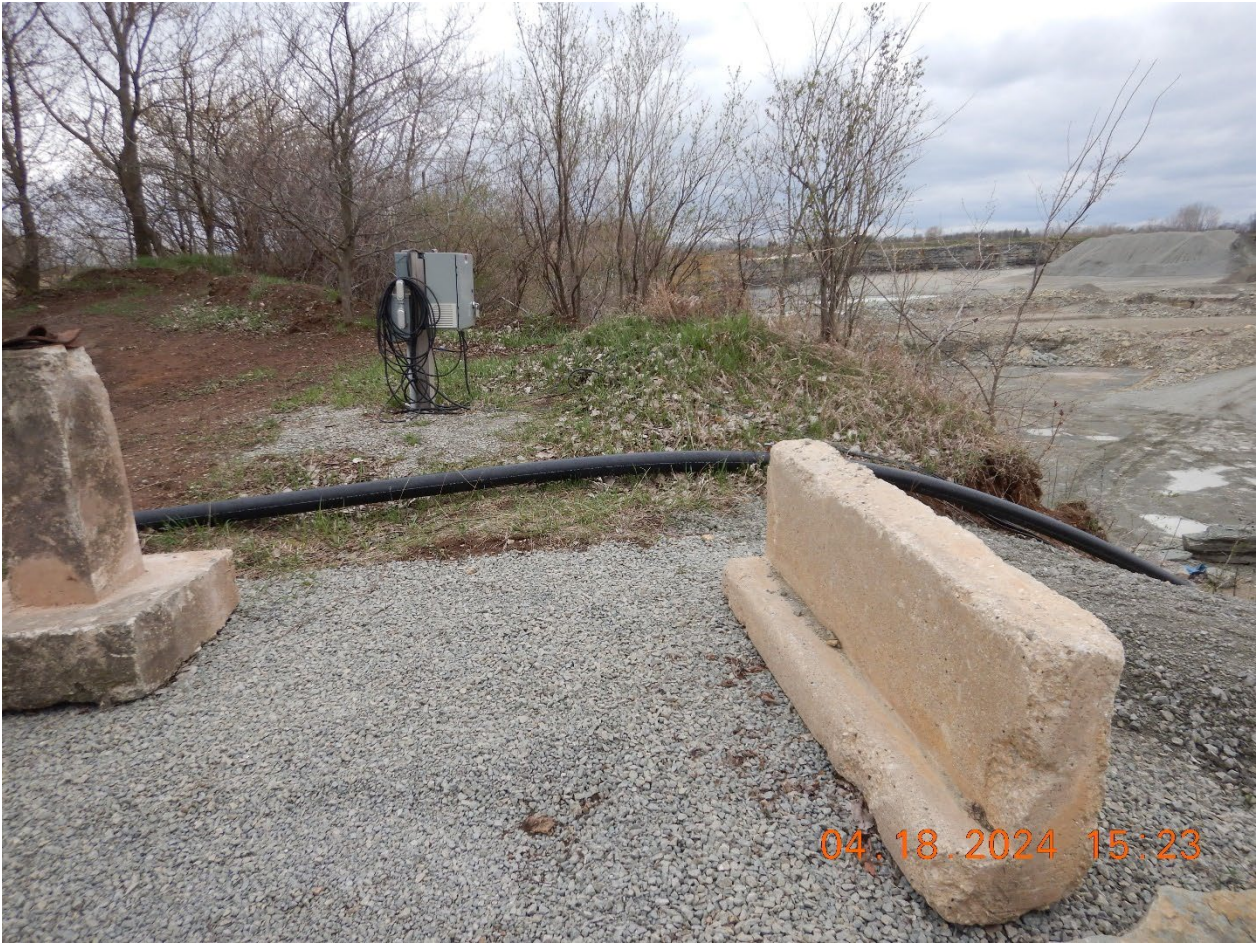
| Stormwater Pump Power Station | | | DSCN0712.JPG |

| Stormwater pump power station on top of quarry | | | |

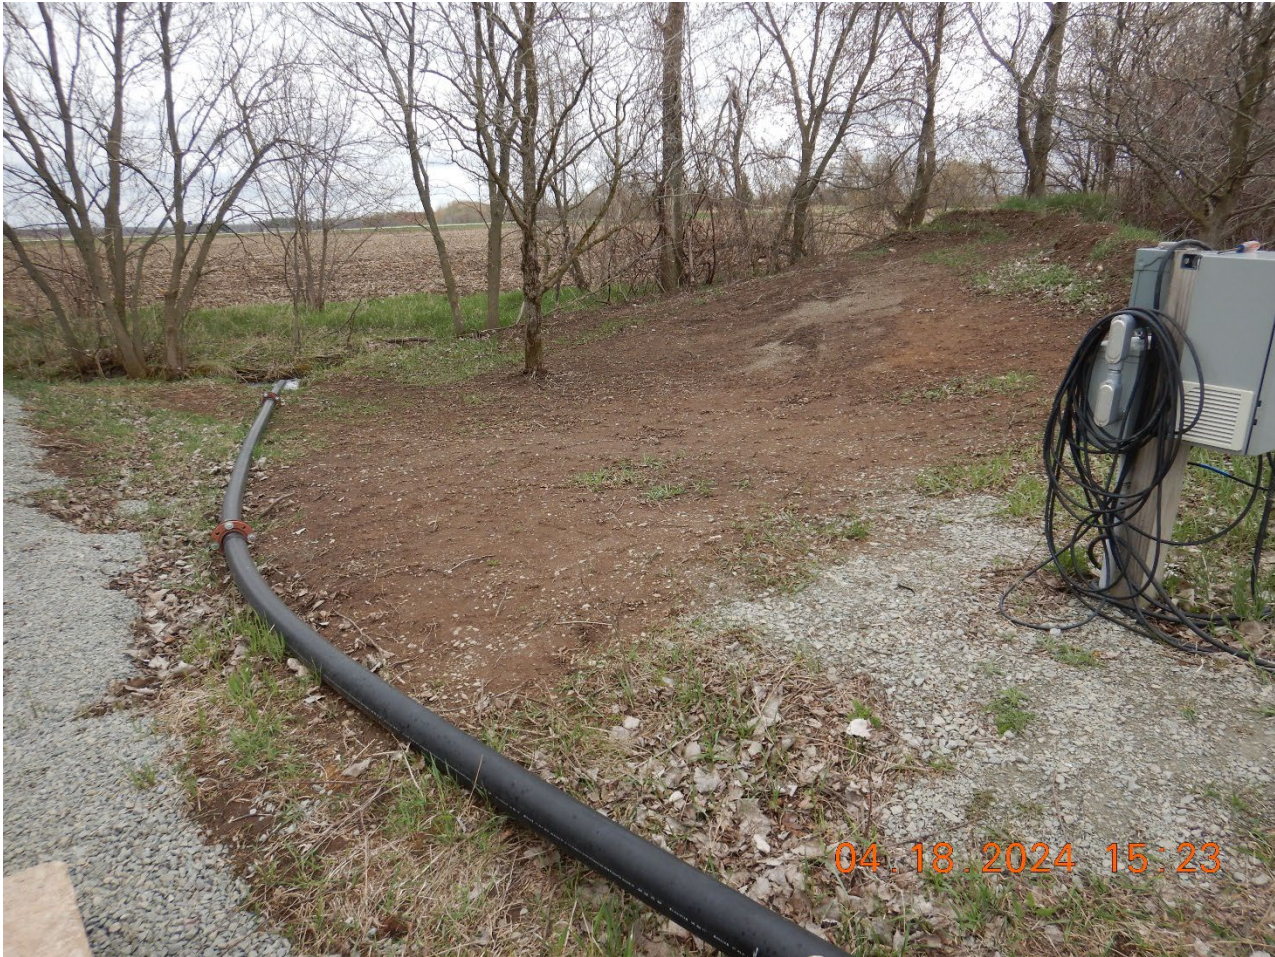
| Hose to Stormwater Ditch | | | DSCN0713.JPG |

| Stormwater hose from collection area in quarry up to stormwater ditch | | | |

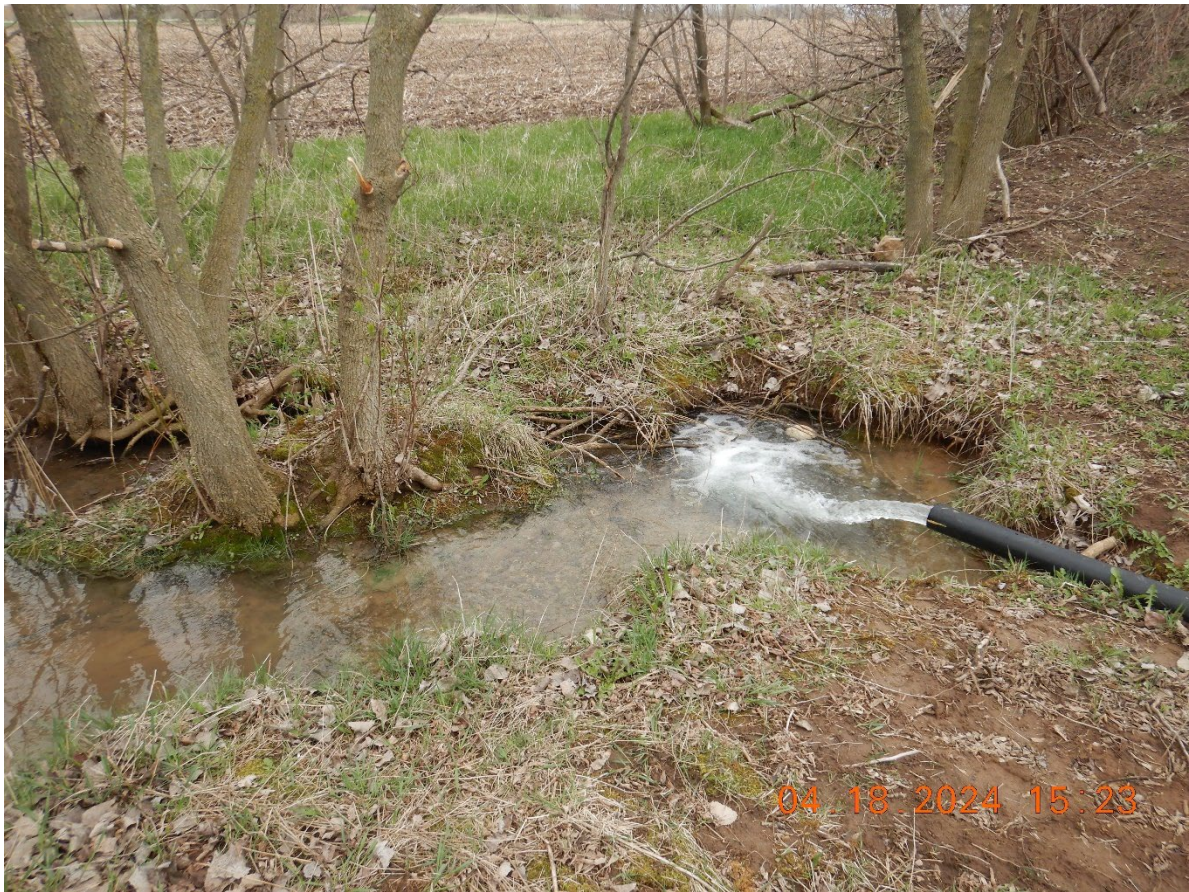
| Stormwater Discharge to Ditch | | | DSCN0714.JPG |

| Stormwater hose from collection area in quarry discharging to stormwater ditch | | | |

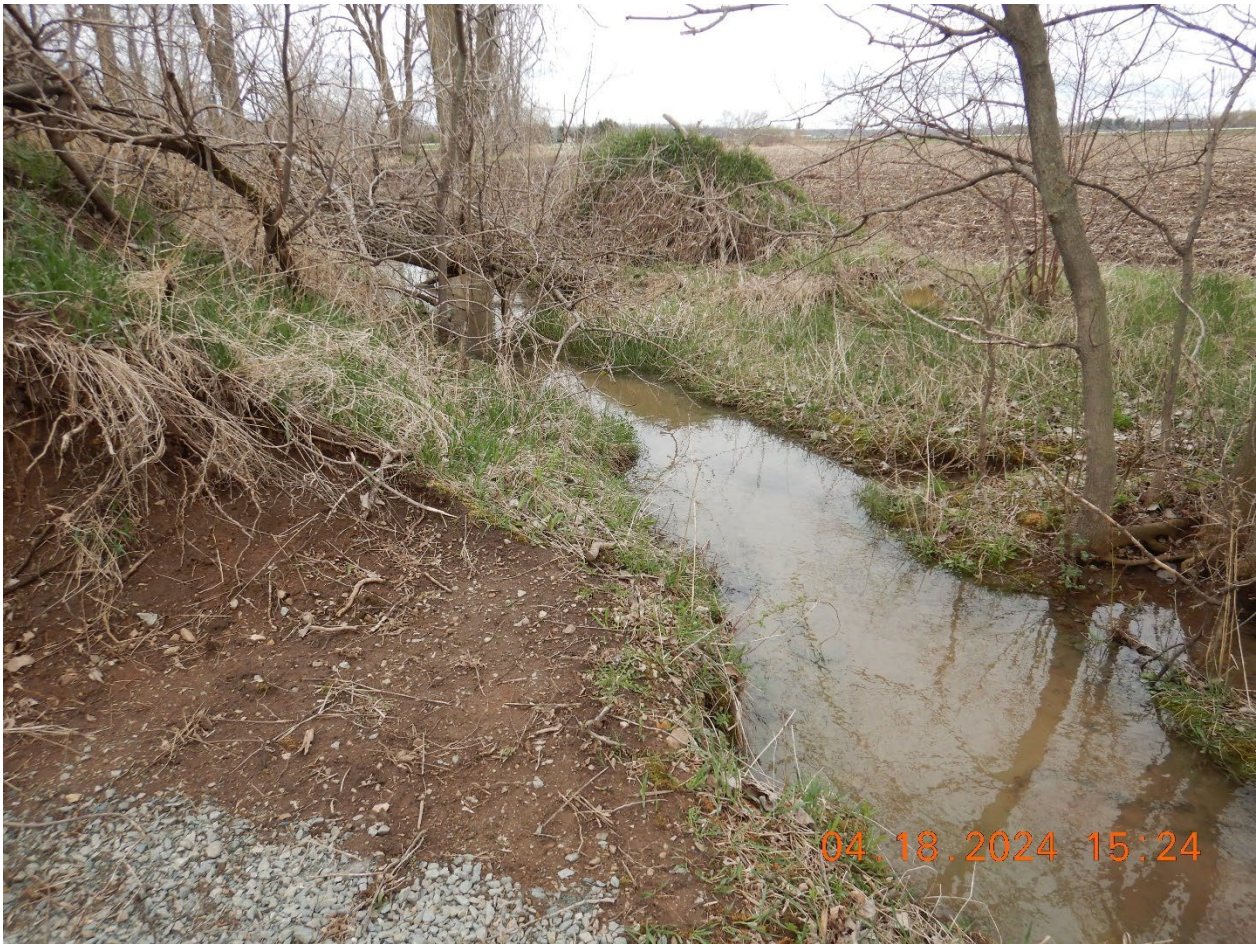
| Stormwater Ditch Flowing South | | | DSCN0715.JPG |

| Stormwater ditch flowing south parallel to site entrance road | | | |

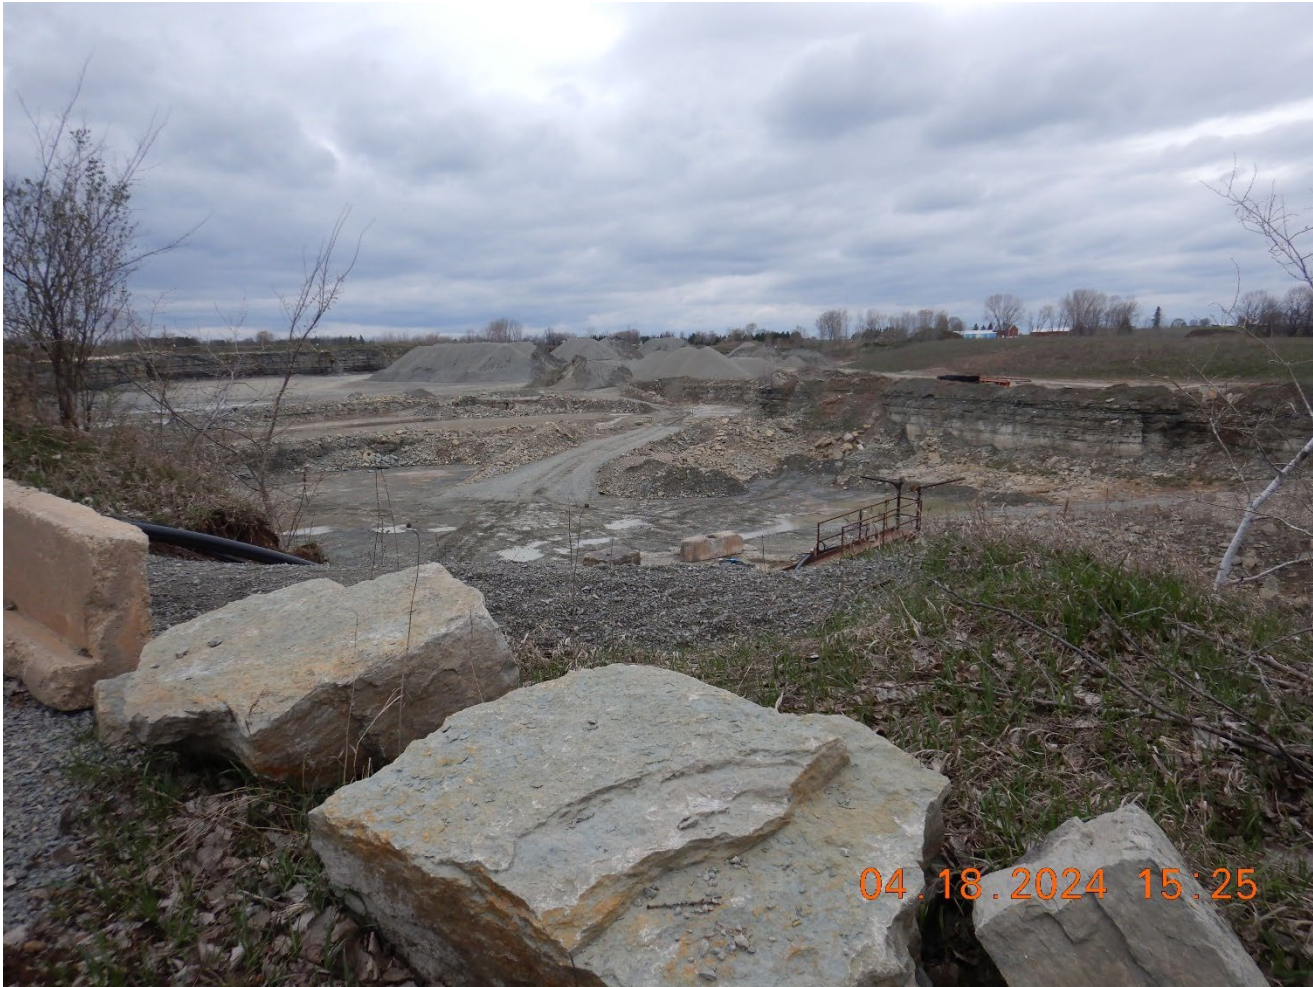
| Quarry Overview from Top | | | DSCN0716.JPG |

| Overview of Pearl Quarry from top | | | |

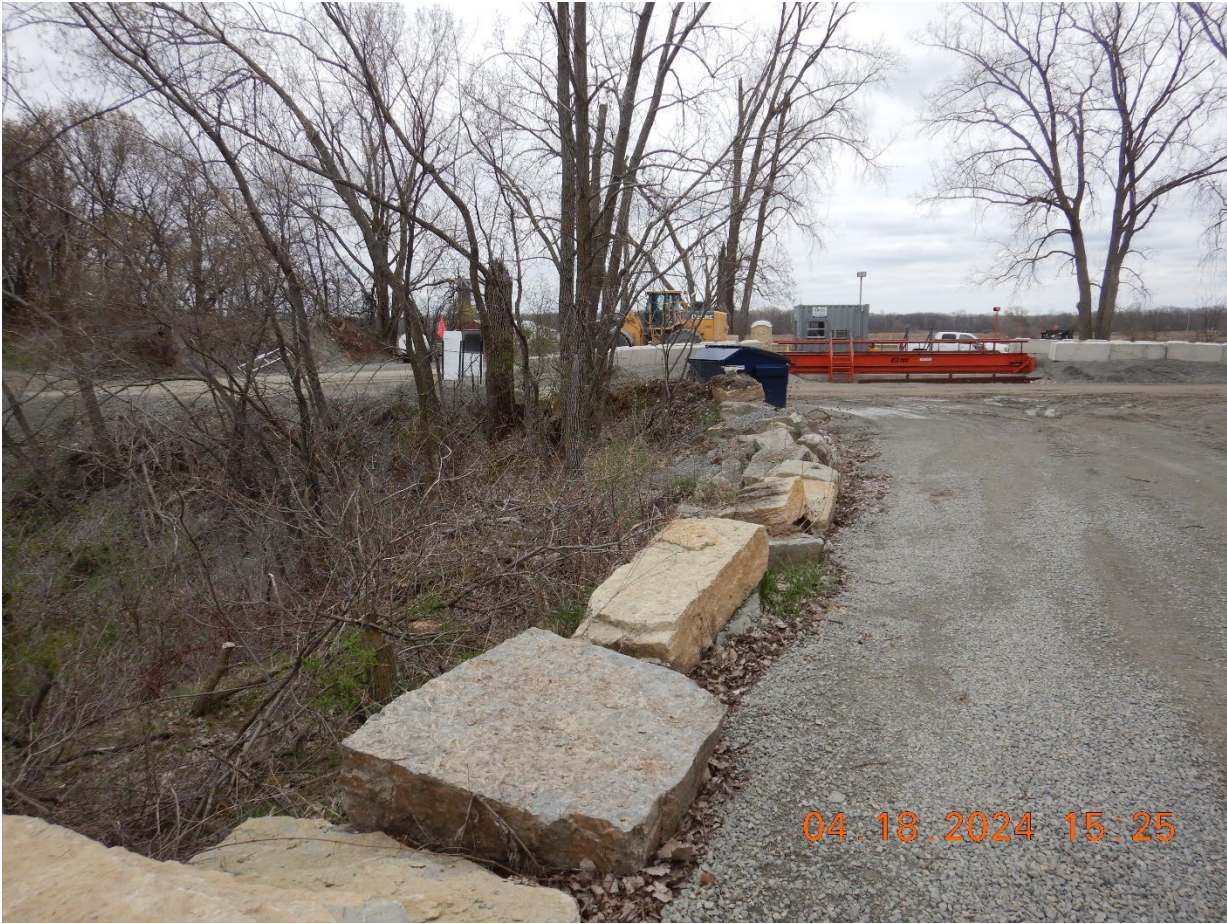
| Pearl Quarry Entrance | | | DSCN0717.JPG |

| Entrance to Pearl Quarry next to stormwater discharge to ditch at top of quarry | | | |

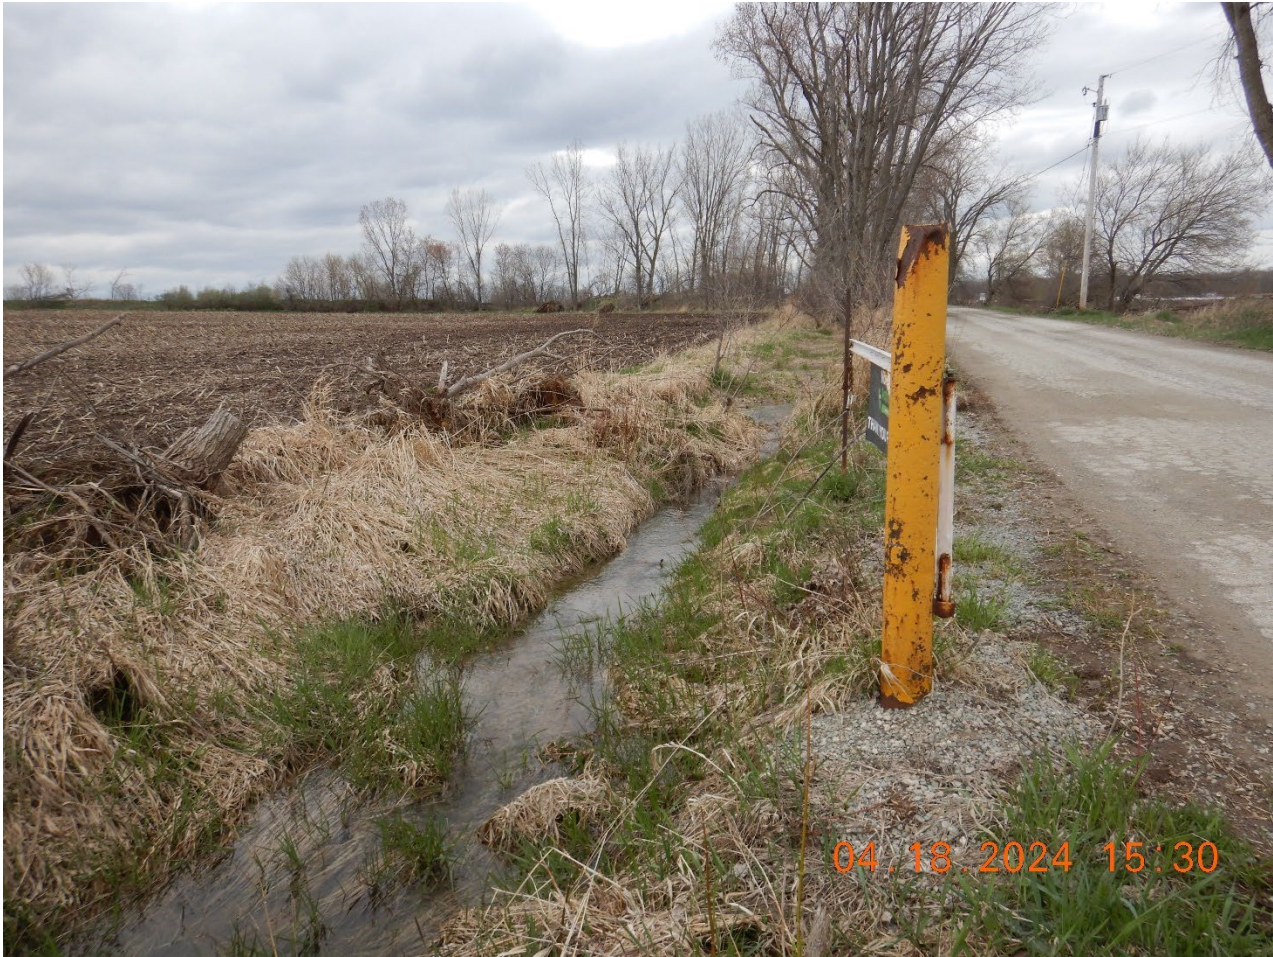
| Stormwater Ditch | | | DSCN0718.JPG |

| Stormwater flow along ditch out of quarry entrance and parallel to road entrance (on leased property). | | | |

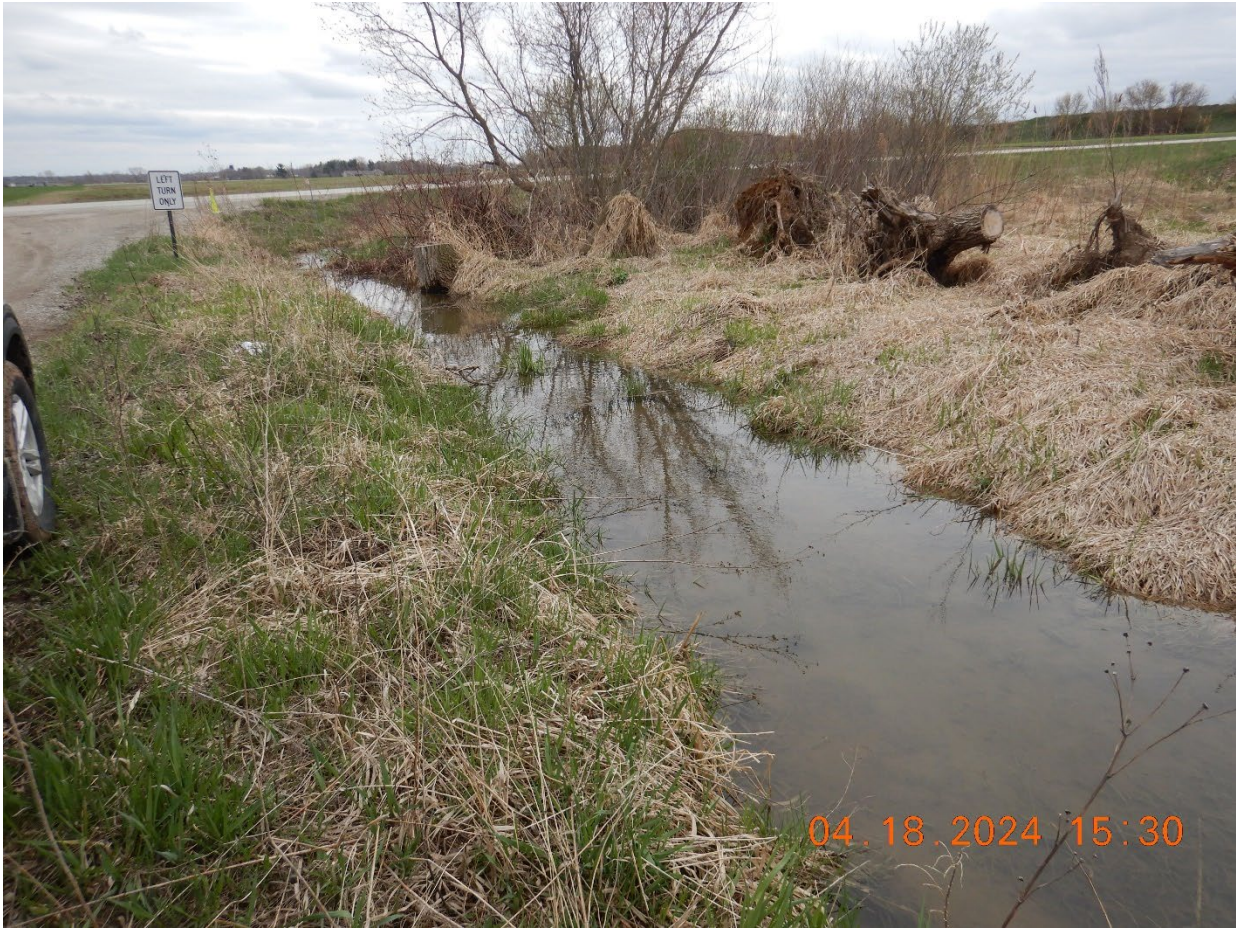
| Stormwater Ditch | | | DSCN0719.JPG |

| Stormwater flowing along ditch south towards merge with Pearl Street west-east stormwater ditch (on leased property up to Pearl Road and east west ditch) | | | |

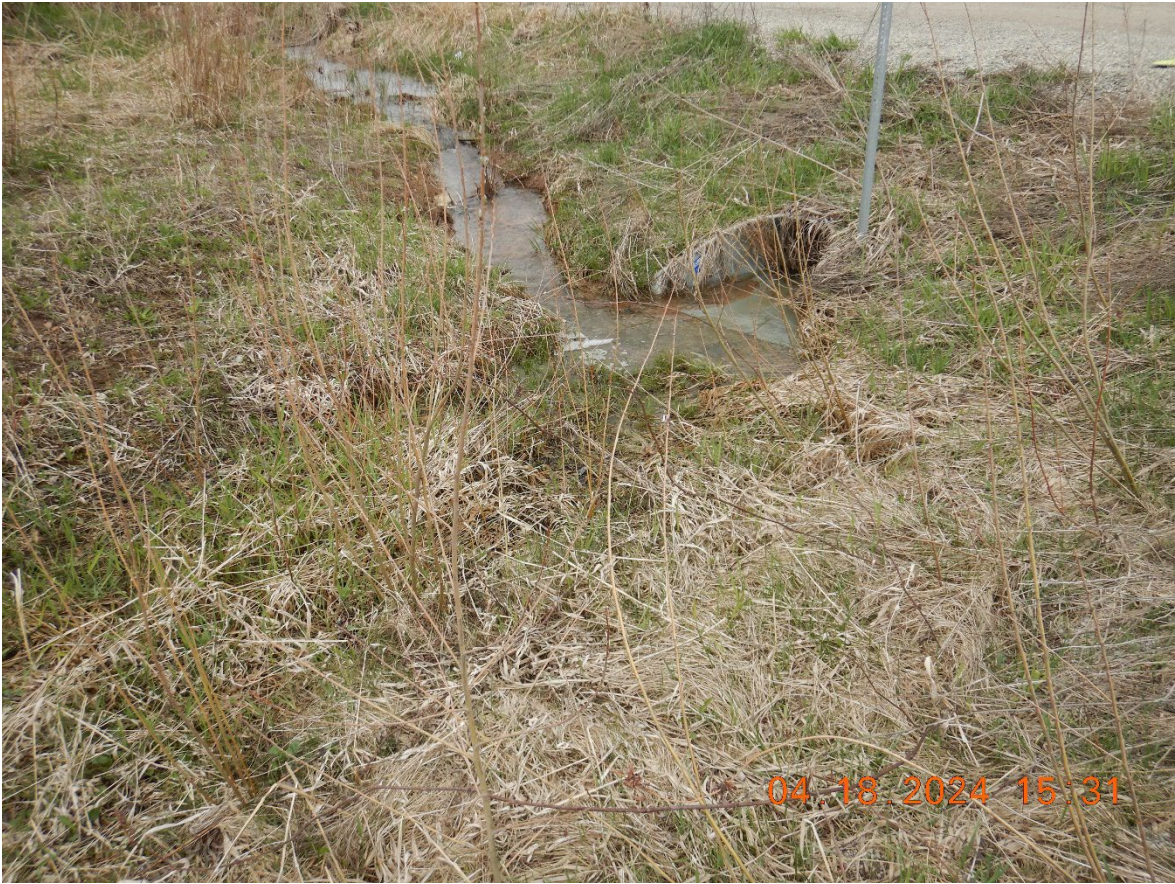
| Stormwater Ditch to Pearl Street Culver | | | DSCN0720.JPG |

| Stormwater flow from Pearl Quarry merging with Pearl Street west-east stormwater ditch/culvert | | | |
