INSPECTION REPORT

| Type of Inspection | Industrial Stormwater Inspection (ISI) | |
| Permittee Name | Northeast Asphalt, Inc. (Pearl Quarry) | |
| Permit Number | WIR051IA0B | |

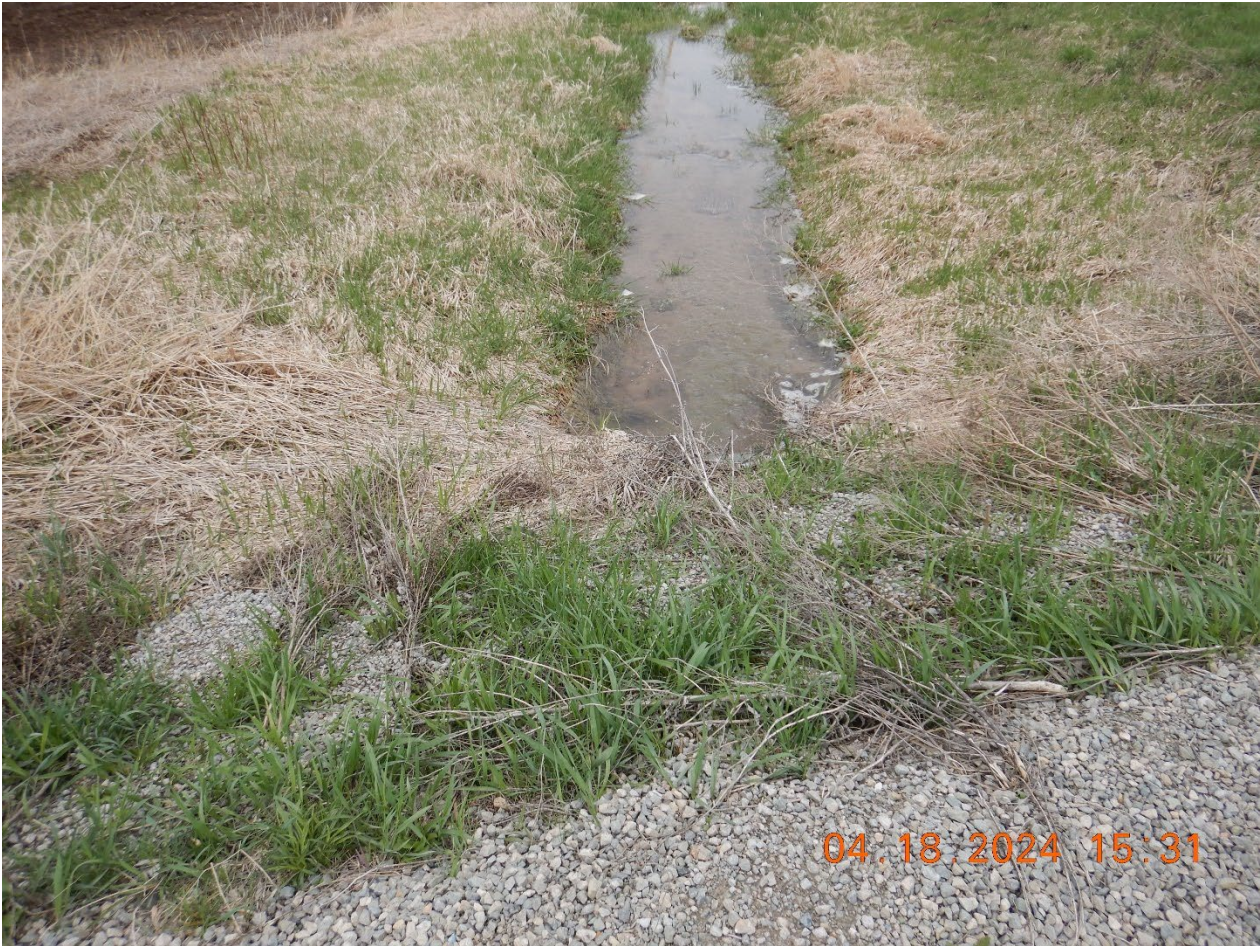
| Pearl Street Stormwater Ditch | | | DSCN0721.JPG |

| Stormwater flow under Pearl Quarry Entrance Road culvert flowing east merging with stormwater from other properties. Ultimately flows to Duck Creek approximately 1 mile away (not on leased property). | | | |
