RCRA COMPLIANCE EVALUATION INSPECTION

Alstom Transportation
71 Wall Street
Plattsburgh, New York

NY0001007236

February 29, 2024

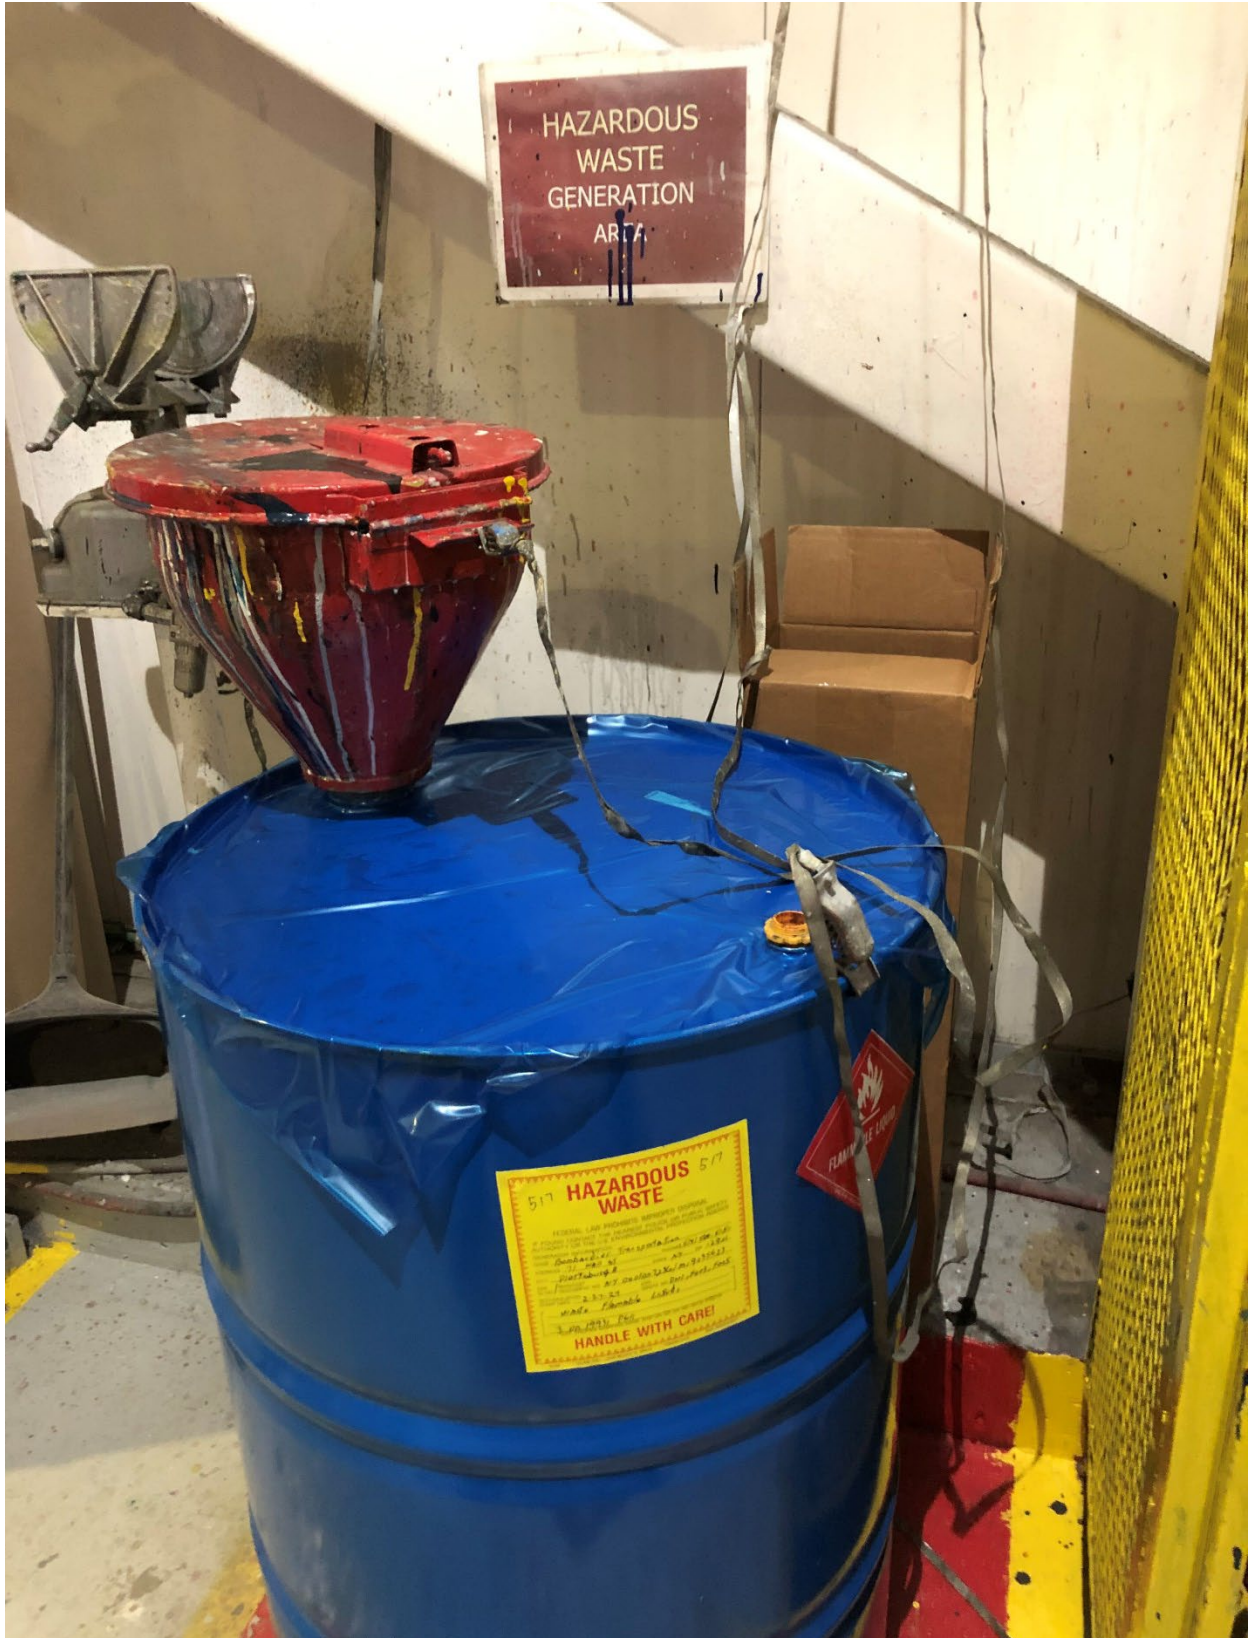
On the day of the inspection, there were two 55-gallon drums of hazardous waste being stored in the Hazardous Materials Storage Room. One drum was almost empty with a hazardous waste label and a flammable liquid label attached to the container. The hazardous waste label was marked with an accumulation start date of 2/27/24, waste flammable liquids, and EPA waste codes D001, F003, and F005. The second drum was one-fourth full, with a hazardous waste label and a flammable solid label attached to the container. The hazardous waste label was marked with an

Photo #1: View of the drum of waste flammable liquids.

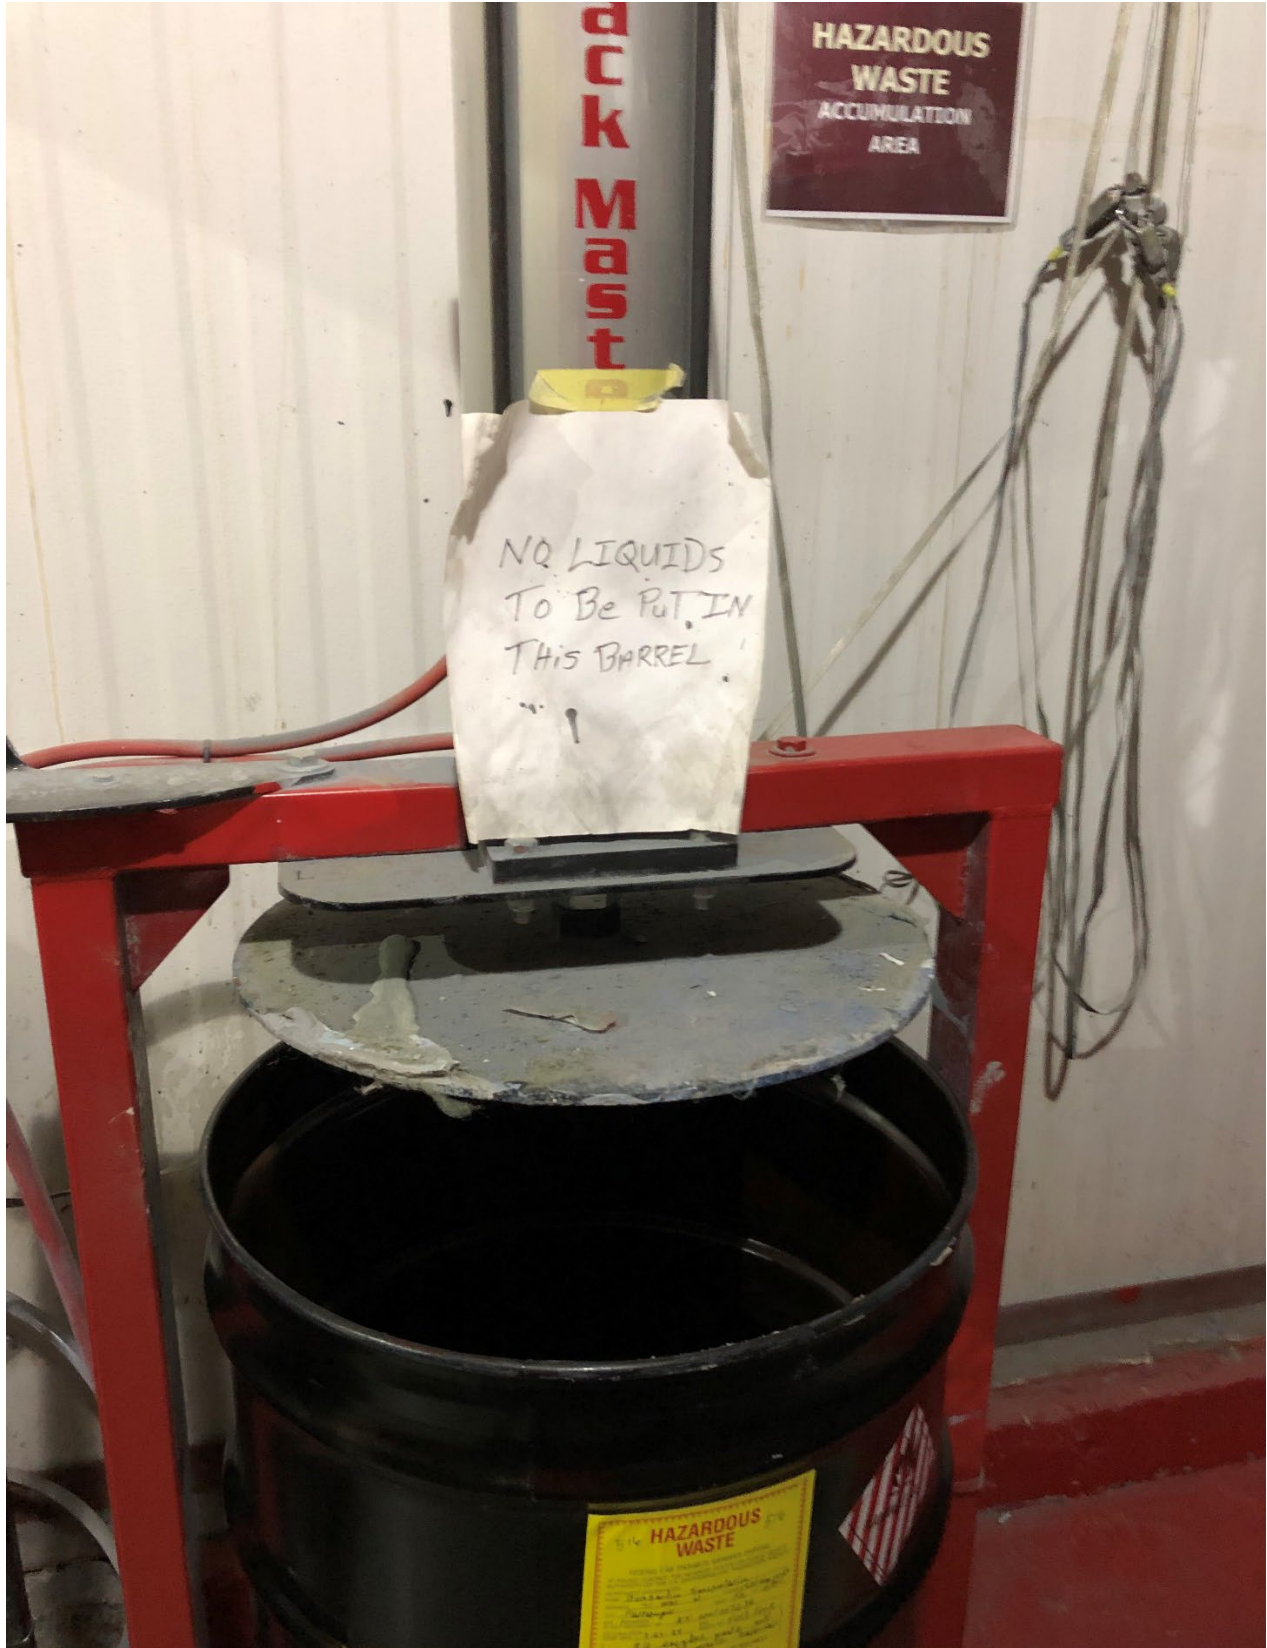
accumulation start date of 2/27/24, hazardous waste solids, and EPA waste codes F003 and F005. The lid was not on the container.

The 55-gallon drum of hazardous waste solids was open with the lid off the container. Containers holding hazardous waste must be kept closed during storage, except when adding or removing waste, as specified in 40 CFR Section 265.173(a). The facility representative was informed of this requirement and the lid was placed on the drum immediately.

Photo #2: View of the drum of hazardous waste solids with the lid off.

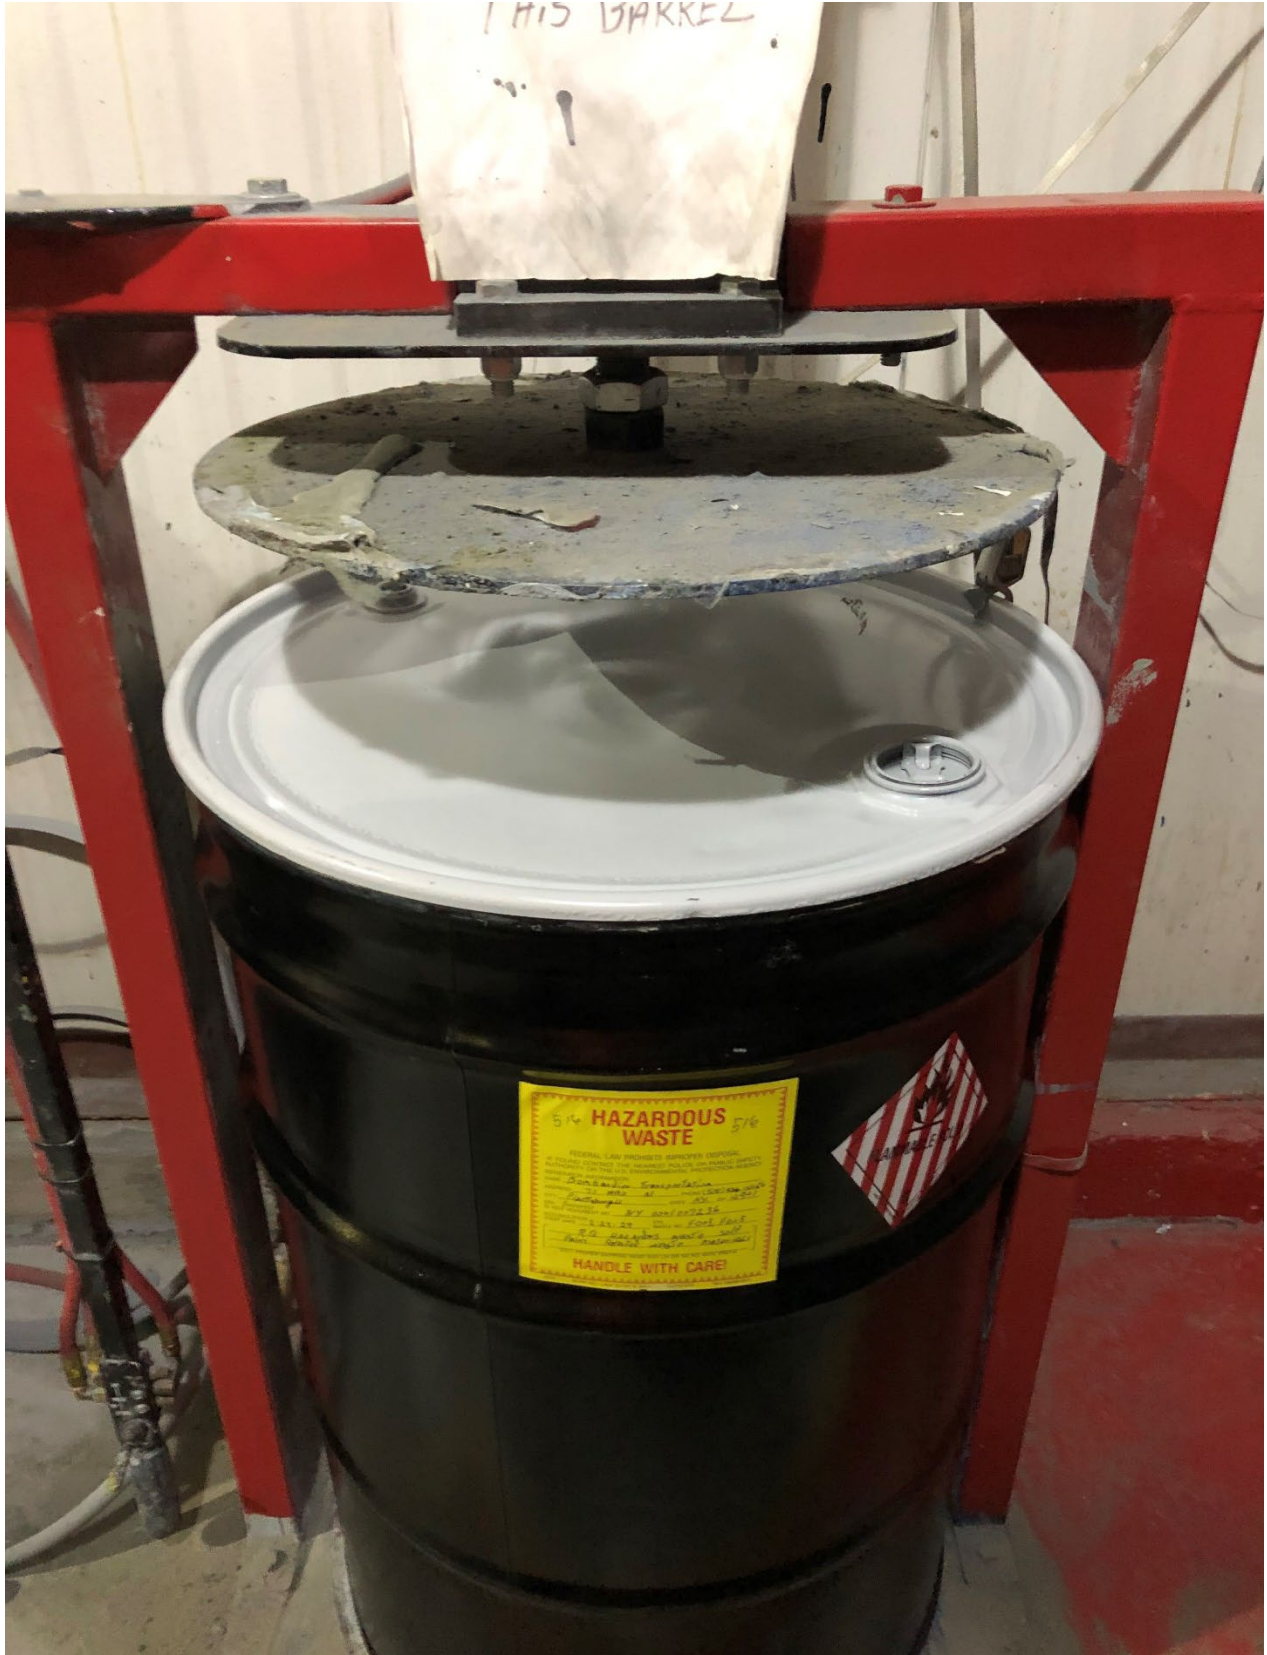
Photo #3: View of the drum of hazardous waste solids after the lid was placed on the container.

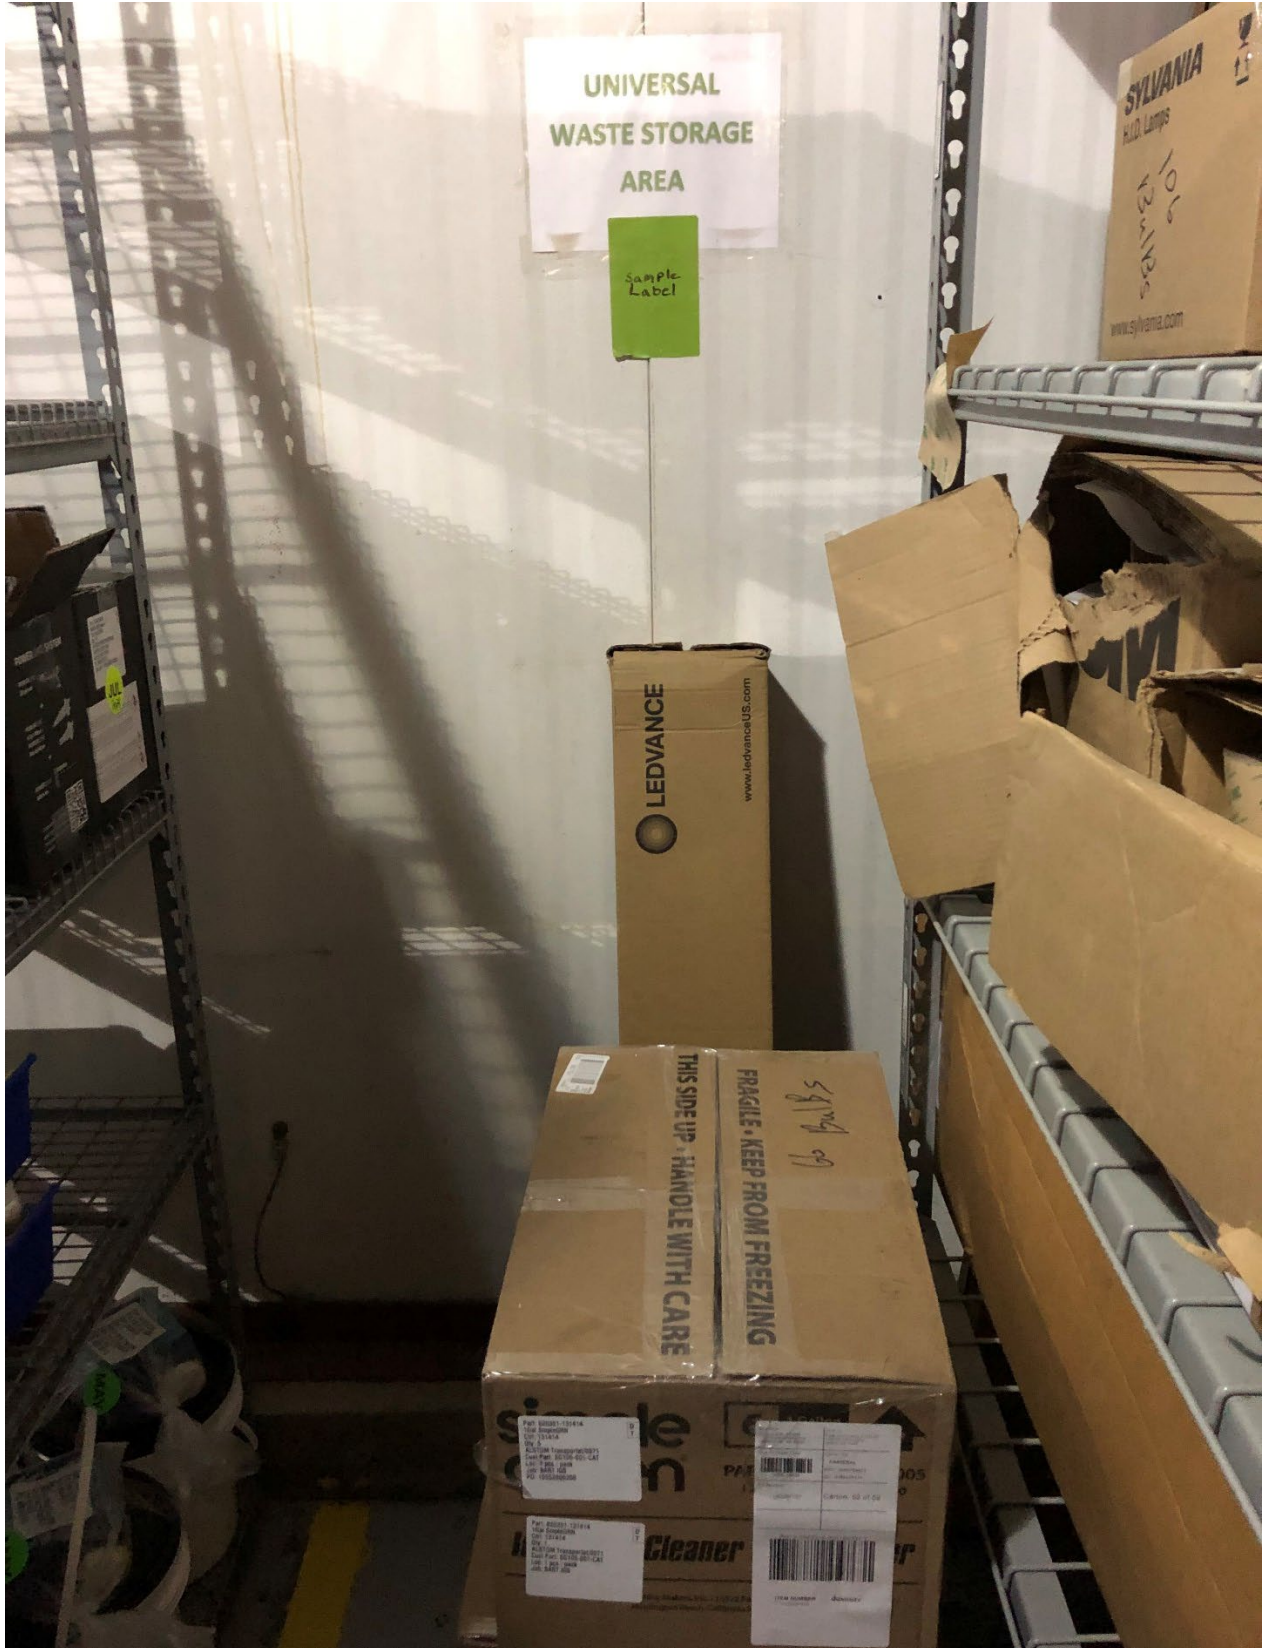
Used fluorescent lamps containing mercury are collected in bulb boxes and stored in the Hazardous Materials Storage Room as universal waste.

Photo #4: View of the containers of universal waste.

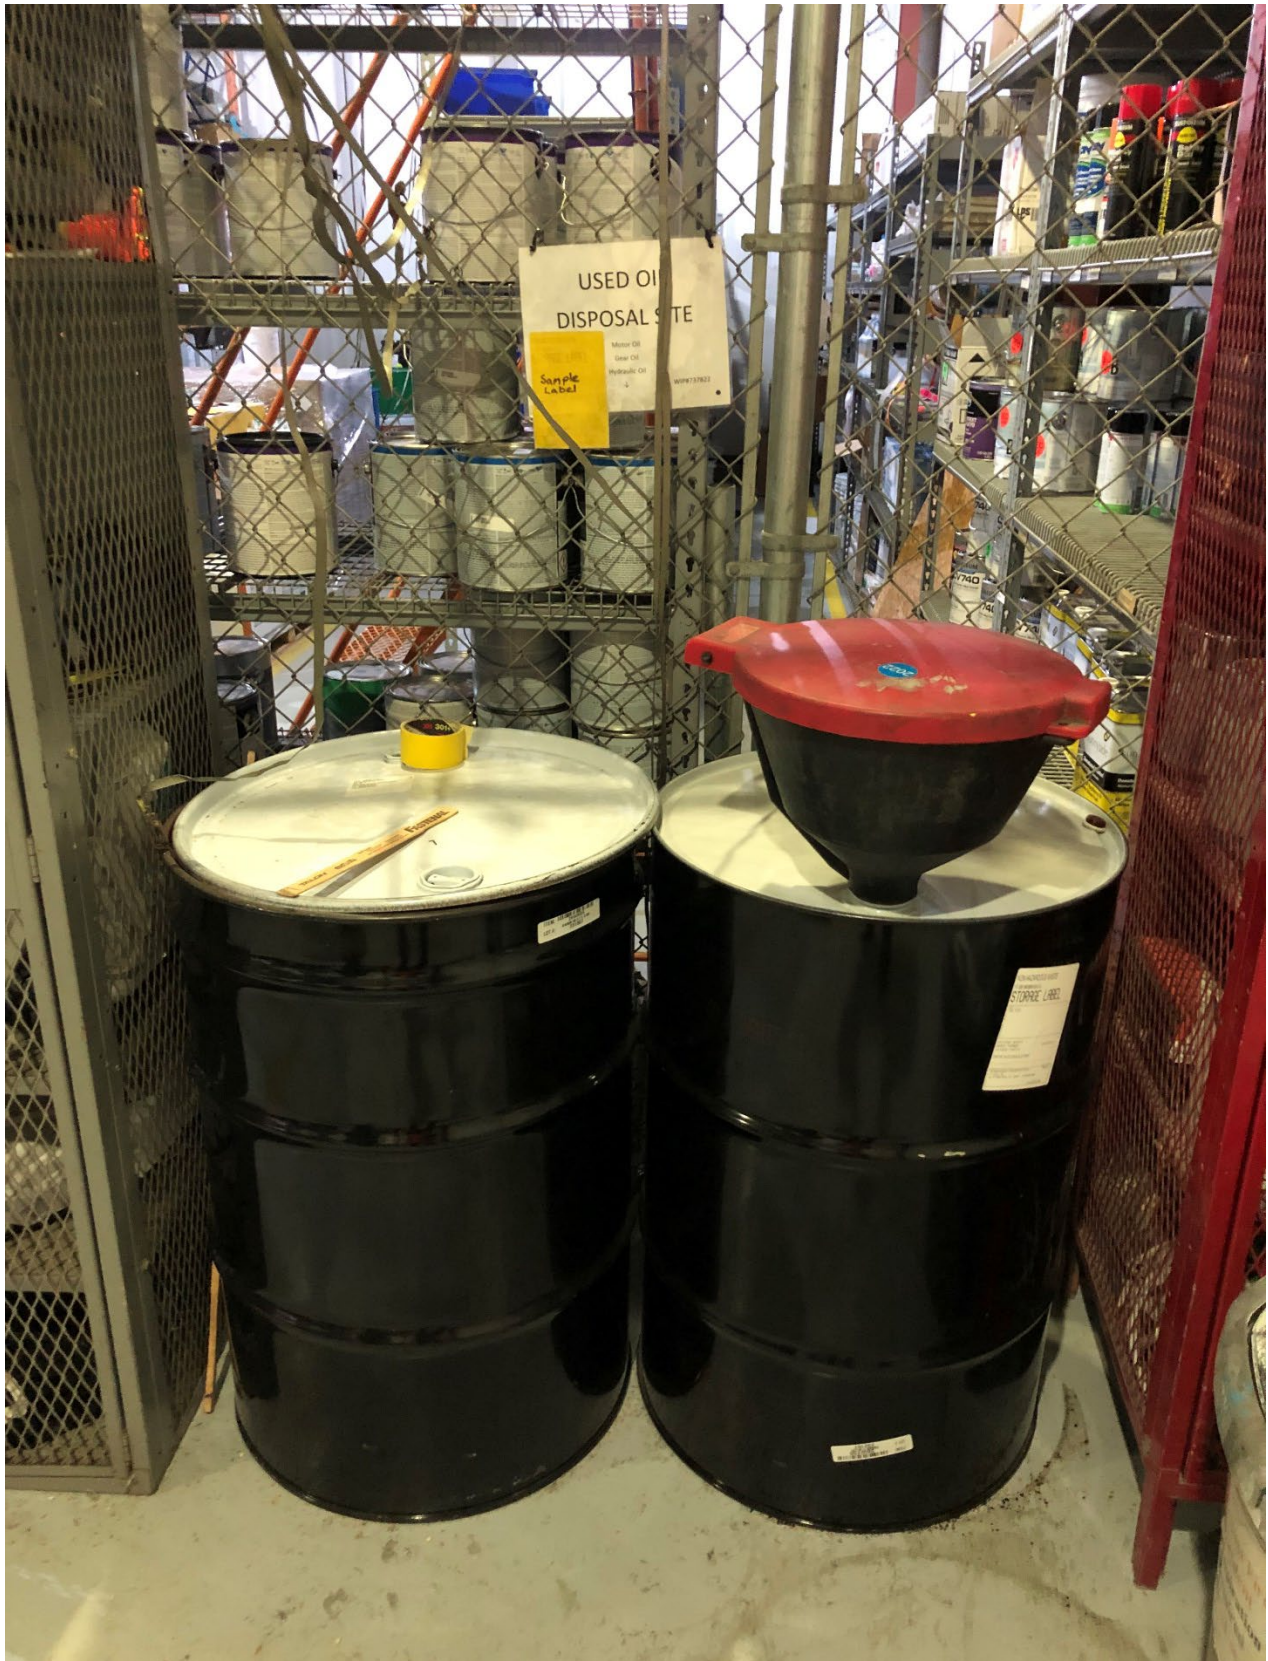
Used oil from machinery is collected in 55-gallon drums and stored in the Hazardous Materials Storage Room as non-hazardous used oil.

Photo #5: View of the containers of used oil.
