**REPORT ON AN INCIDENT AT THE EDC-CRACKING UNIT /  
VCSA-MEETING IN BOSTON ON SEPTEMBER 28, 1989**

## EXPLOSION IN VCM PLANT IN 1988

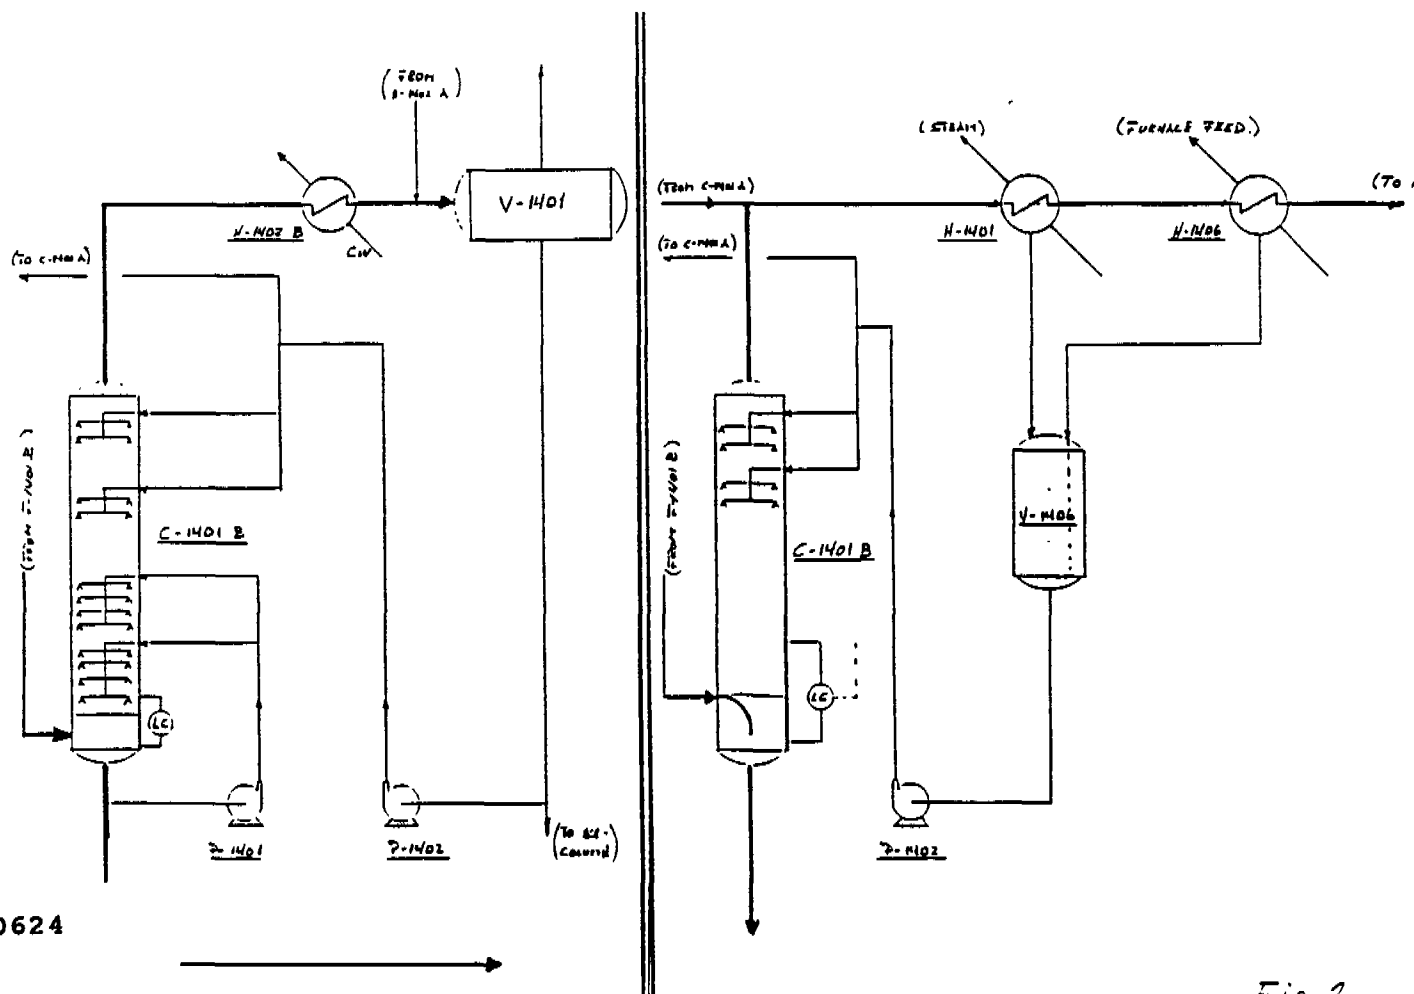
Two important modifications in the cracking quench system are shown in figure 2. Originally the quench tower had a bottom circulation system. EDC/VCM/HCl at a ratio of about 87/9/4 and a temperature around 175 °C was circulated by a pump. The liquid contained some coke and there were constant troubles with the pump's mechanical seal. We also had indications of stress corrosion cracking in pipes and valves. In 1981 we therefor replaced this system with a submerged inlet into the quench tower.

The second important modification was carried out in 1984. To conserve energy, a steam boiler and a feed preheater were installed in the quench overhead.

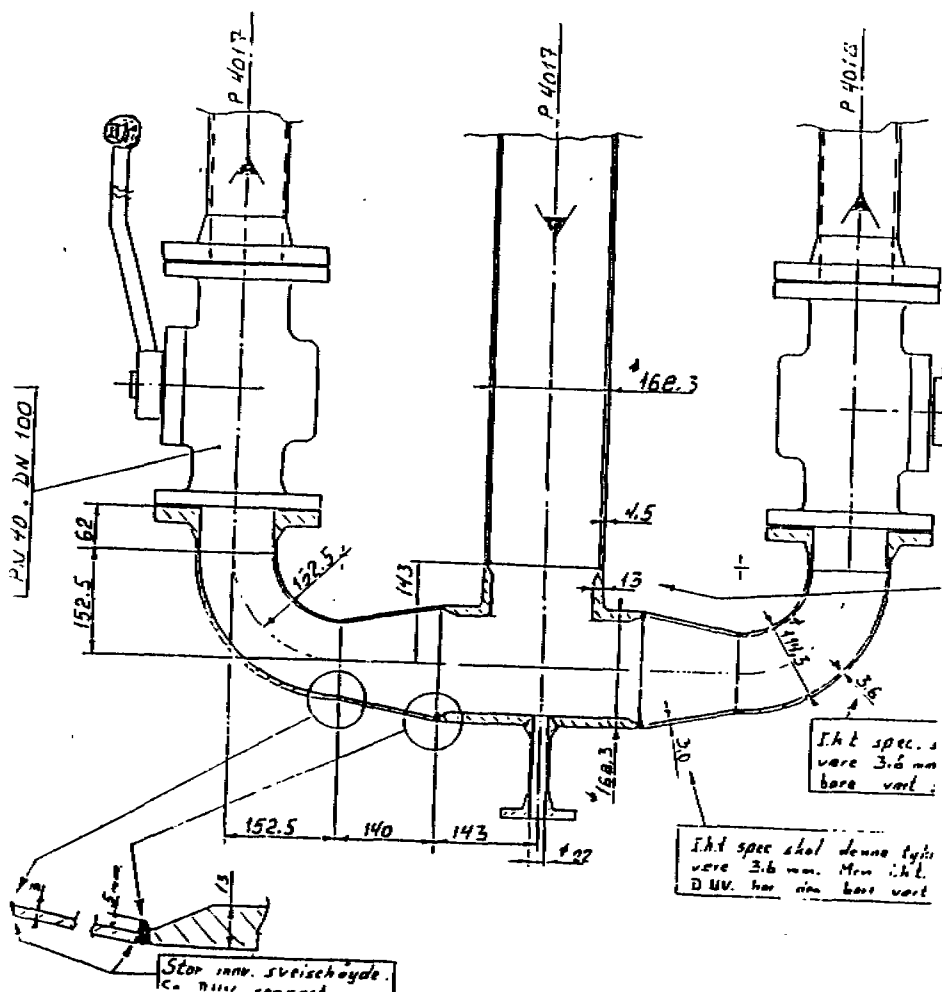
Fig 3.

A detailed drawing of the pipe fitting where the rupture occurred is shown in figure 3. The design of this fitting was unfavourable in several respects:

- The liquid flow was turned 180 degrees.
- The T-piece had a much greater wall thickness than the rest of the construction.
- Some internal welding seams had a protrusion of about 5 mm.
- There are indications that the bend that ruptured, initially had a wall thickness of only 3 mm instead of 3,6 mm.

The flow characteristics of the return bend was investigated using a fluid dynamics program (FLUENT). The investigation showed that high local velocities occurred, especially in the inner curve of the bend. This is just where the rupture took place.

- Bigger pipe diameter
- Pipes with greater wall thickness
- Zig-zag baffles in the top of the quench tower to hold back coke particles and liquid droplets.
- Redesign of return bend
- Thickness measurement program to include also bends.
