**Region 6 - Enforcement & Compliance Assurance Division**  
**INSPECTION REPORT**

| Inspection Date(s): | 09/22/22 | |
| Company Name: | Morales Feedlots, Inc. | |
| Facility Name: | Morales Cattle Feedlot | |

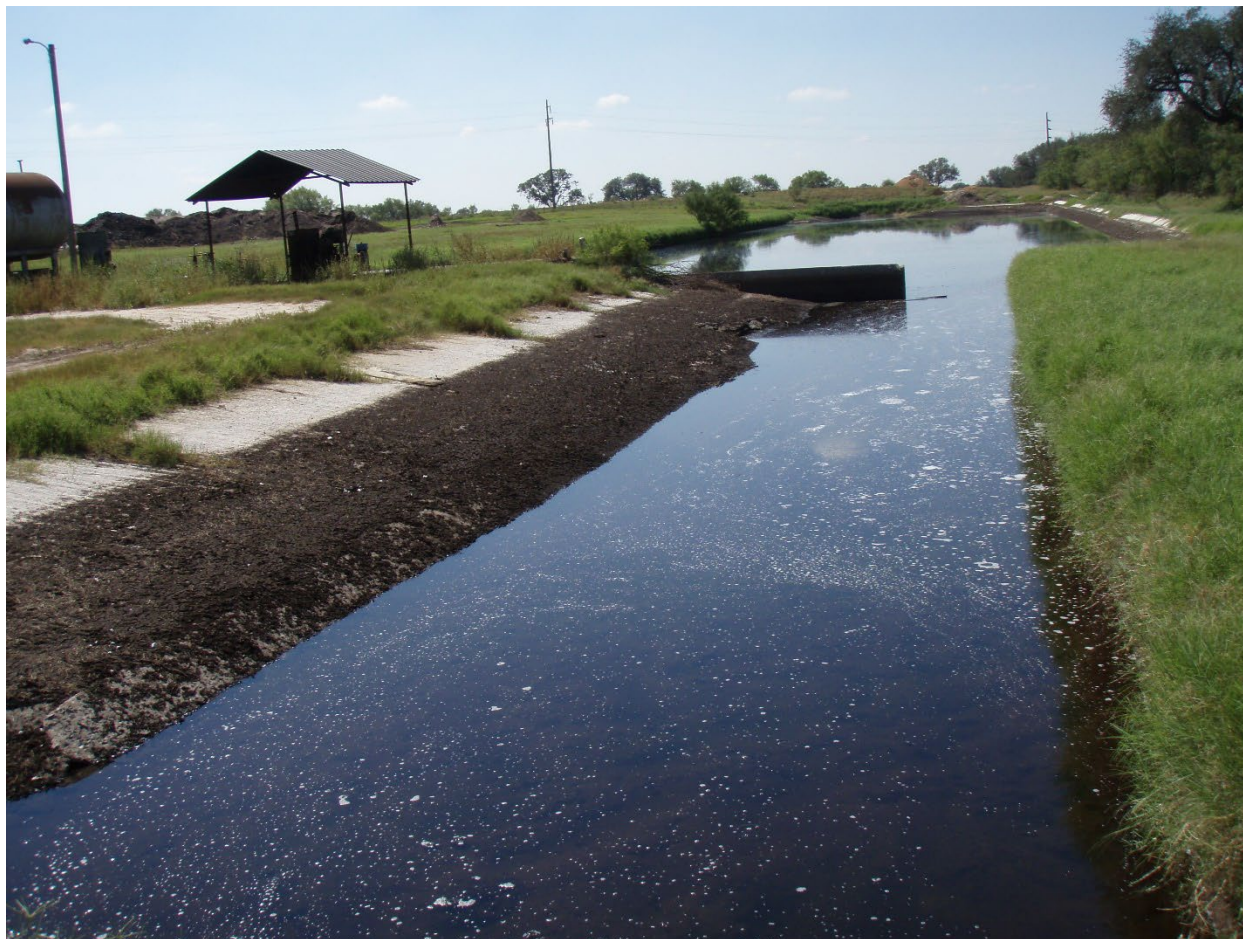
Photo No. 1

Description: This photo shows the concrete settling pit that receives runoff from the pens to the north and the manure composting area to the south. The manure composting area is shown in the background. RCS 1 is directly south. View is to the south.

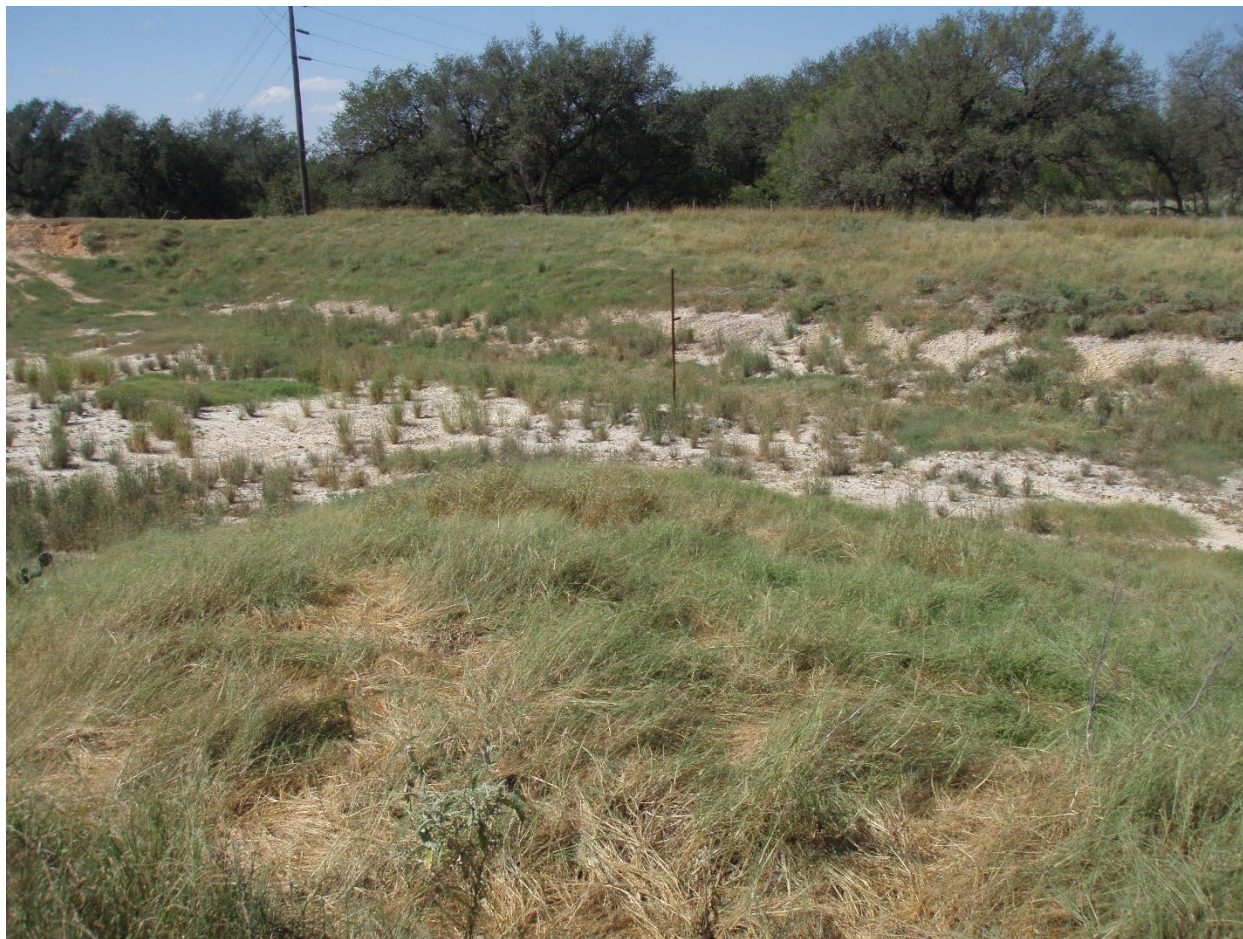
*Photo No. 2*

*Description: This photo shows RCS 1 with the pole marker visible in the center. This RCS has been cleared out in preparation for closure and contained no visible waste at the time of the inspection. View is to the southwest.*

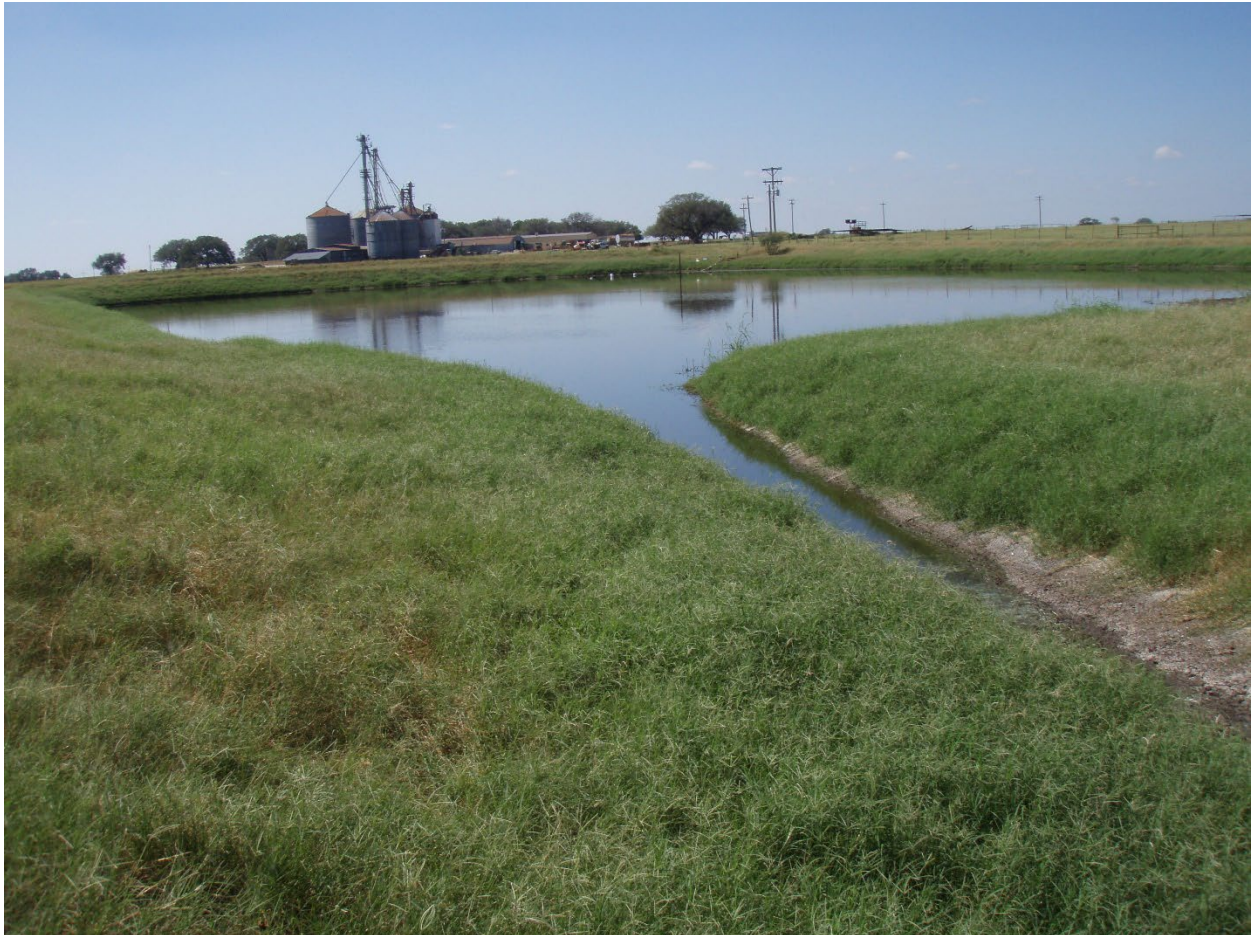
*Photo No. 3*

*Description: This picture shows RCS 2 with pole marker visible and the feed mill, commodity storage, and office in the background. Drainage channels are coming from the production areas directing flow to the RCS. View is to the southwest.*
