Re: EPA Inspection Report – Michigan Sugar Company Piling Grounds

**CLEAN WATER ACT COMPLIANCE EVALUATION INSPECTION REPORT  
U.S. ENVIRONMENTAL PROTECTION AGENCY, REGION 5**

**Purpose:** Compliance Evaluation Sampling Inspection

**Facilities:** Michigan Sugar Company – Piling Grounds of Albee,  
Blumfield, Breckenridge, Au Gres and Hope/Midland

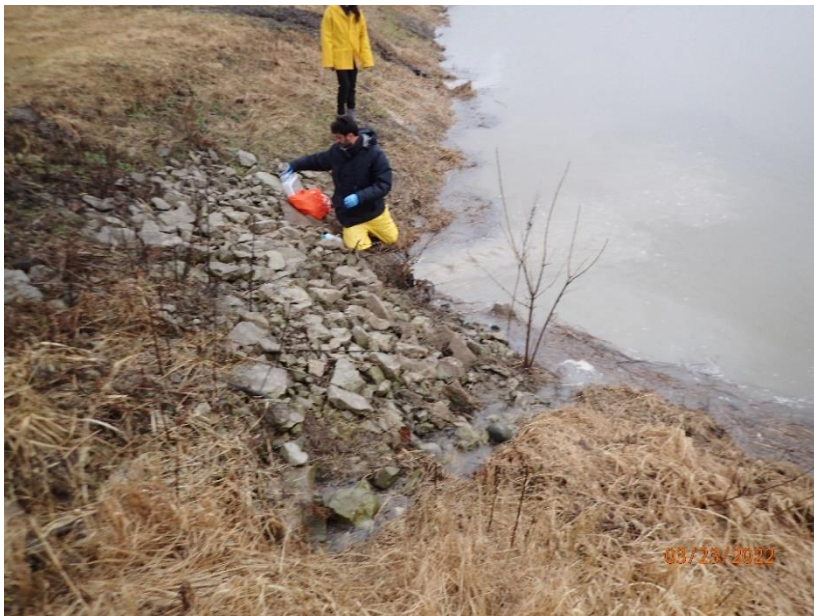
6: P3230083

Description: EPA took sample named “Albee” from the pipe that discharges stormwater from the piling ground into the pond at 8:29 A.M. EPA noted that it took six seconds to fill a one liter bottle.

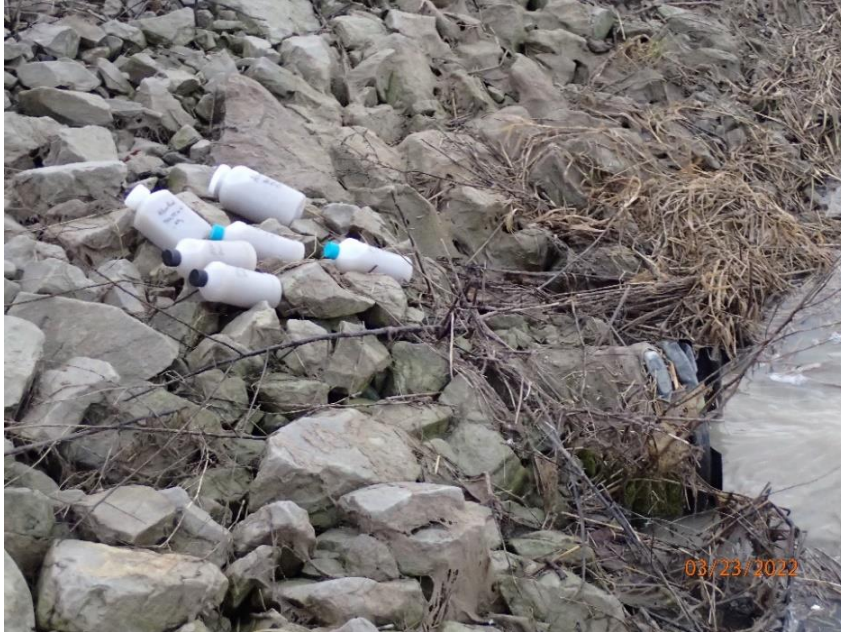
7: P3230084

Description: EPA split the samples with Michigan Sugar Company.

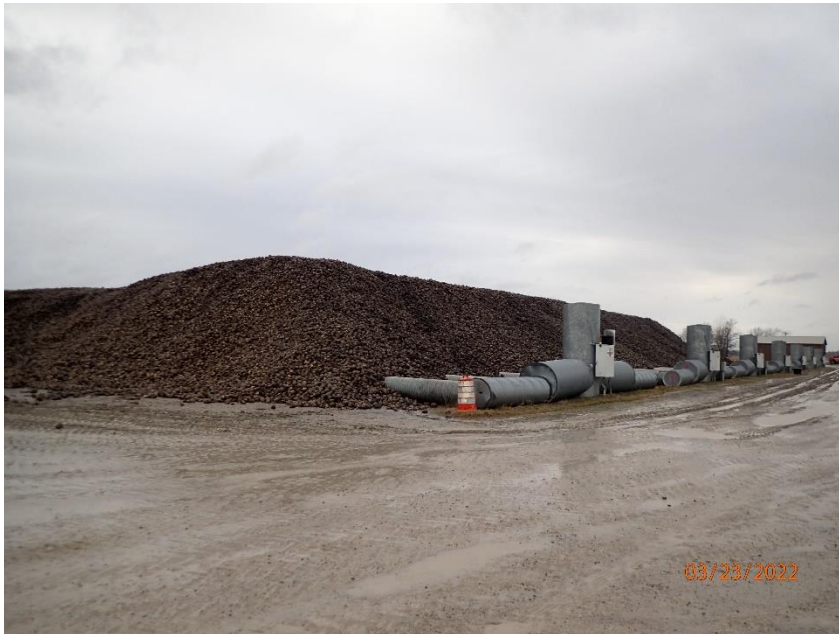
18: P3230095

Description: Sugar beets were still present at the Albee Piling Ground on the day of the inspection.

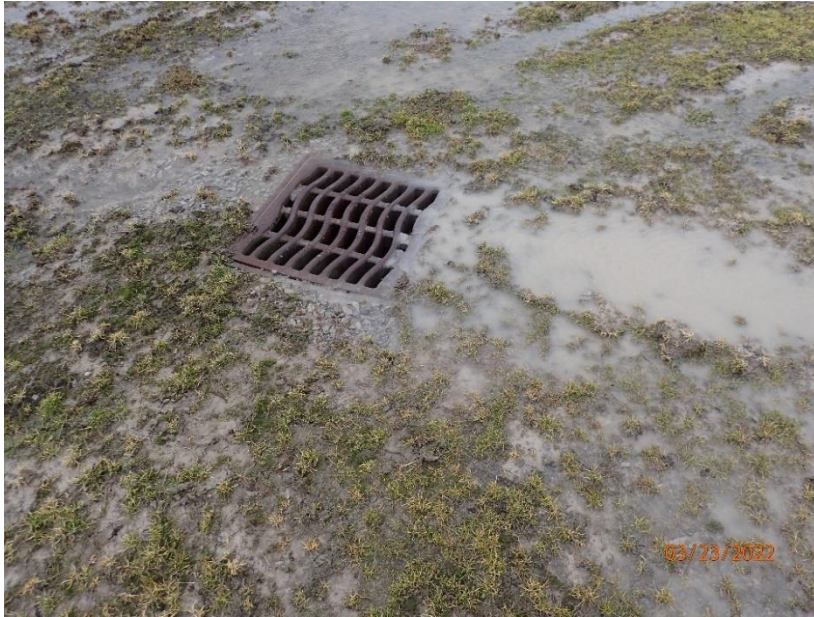
15: P3230101

Description: EPA observed the surface flow to the catch basin. This catch basin is the last one before the flow goes to the pond.

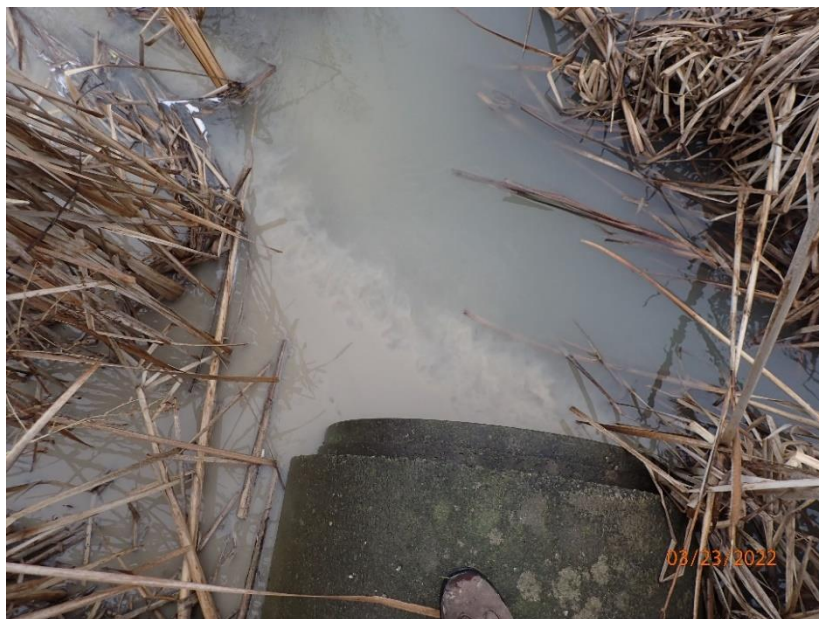
29: P3230104

Description: EPA observed a plume from the pipe from the Blumfield East Piling Ground to the pond northwest of the site.

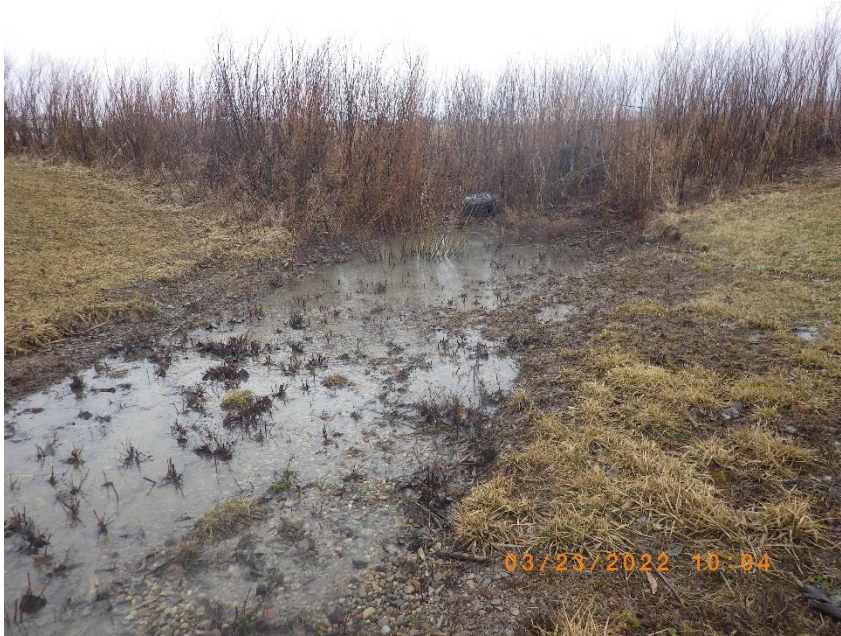
38: RIMG2491

Description: Runoff flowing west and entering a catch basin at Blumfield West piling ground.

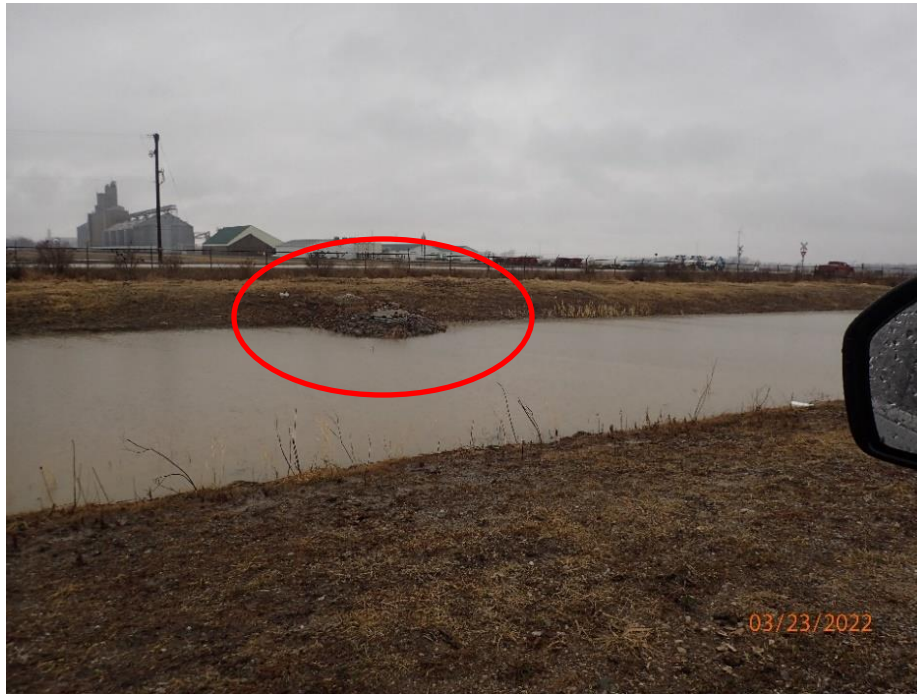
47: P3230116

Description: The outlet from the pond is beneath the first inlet pipe in the rock structure (circled with a red circle).

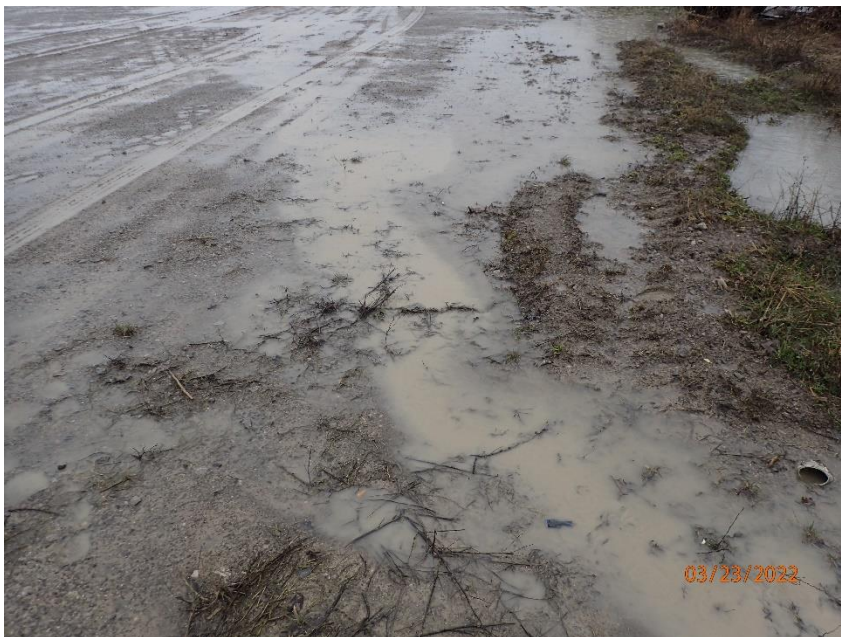
51: P3230120

Description: EPA observed the surface flow from the piling ground to the storm water structure.

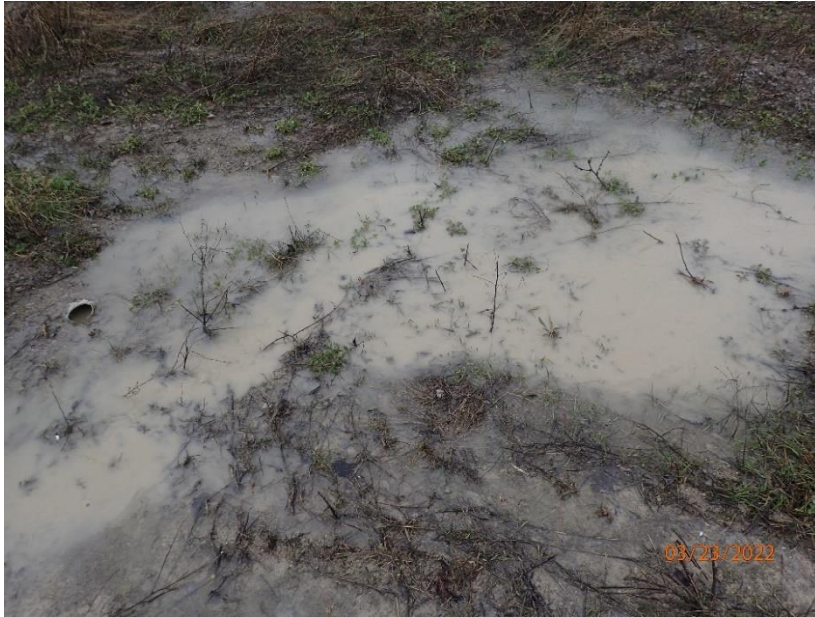
53: P3230121

Description: EPA observed the surface flow was milky and there was a plume from the piling ground.

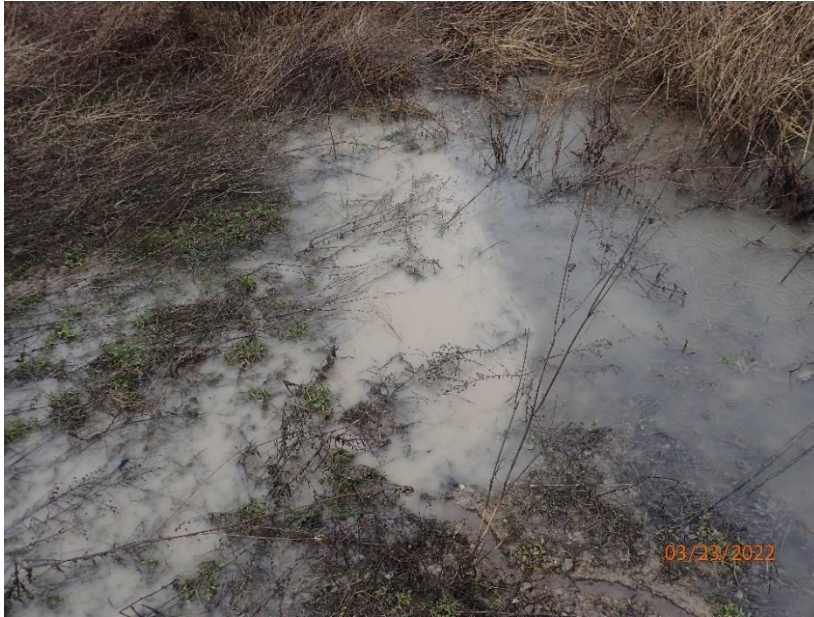
55: P3230123

Description: EPA observed the surface flow was milky and there was a plume from the piling ground.

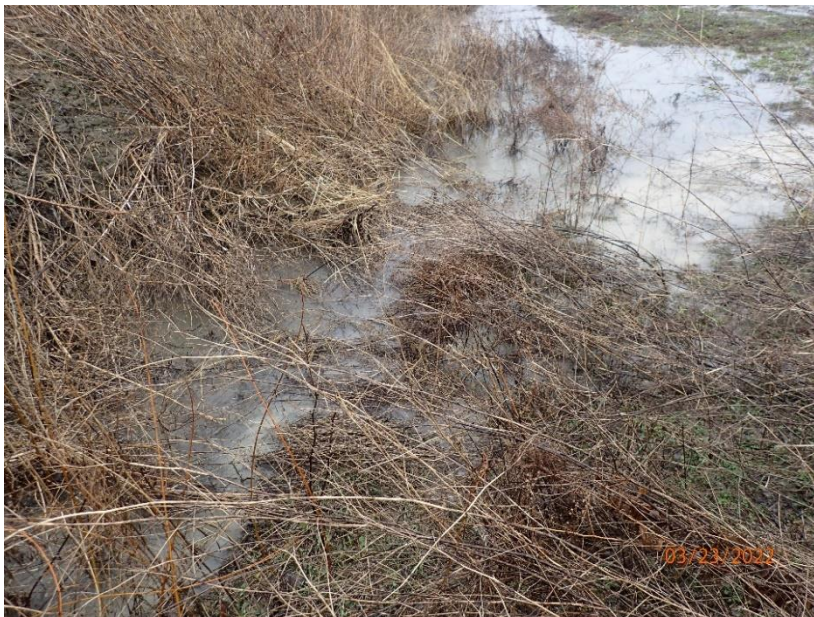
56: P3230124

Description: EPA observed the surface flow was milky and there was a plume from the piling ground.

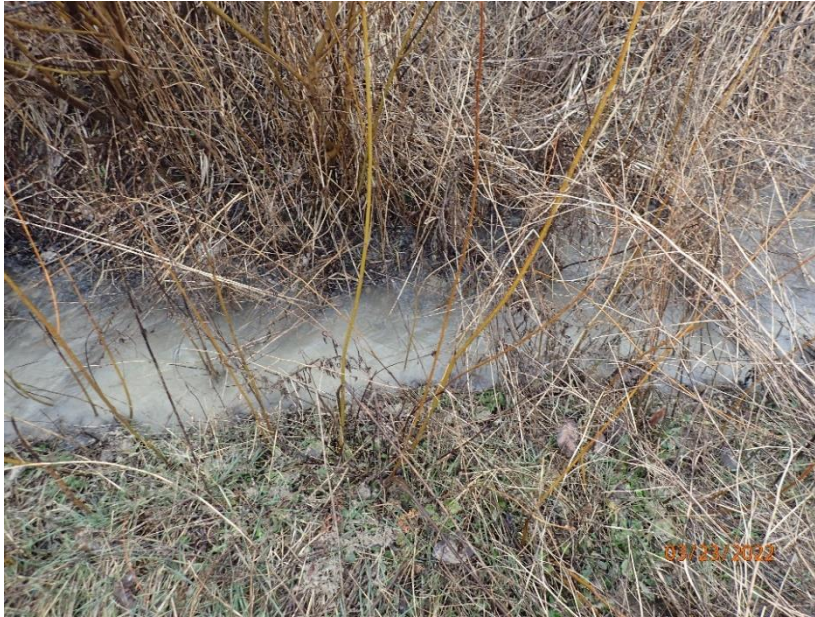
57: P3230125

Description: EPA observed the surface flow was milky and there was a plume from the piling ground.

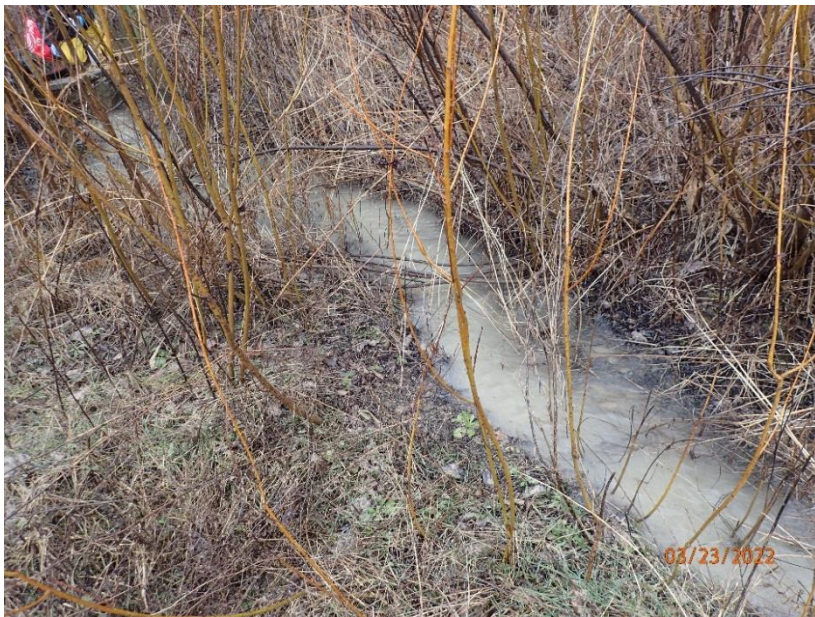
58: P3230126

Description: EPA observed the surface flow was milky and there was a plume from the piling ground.

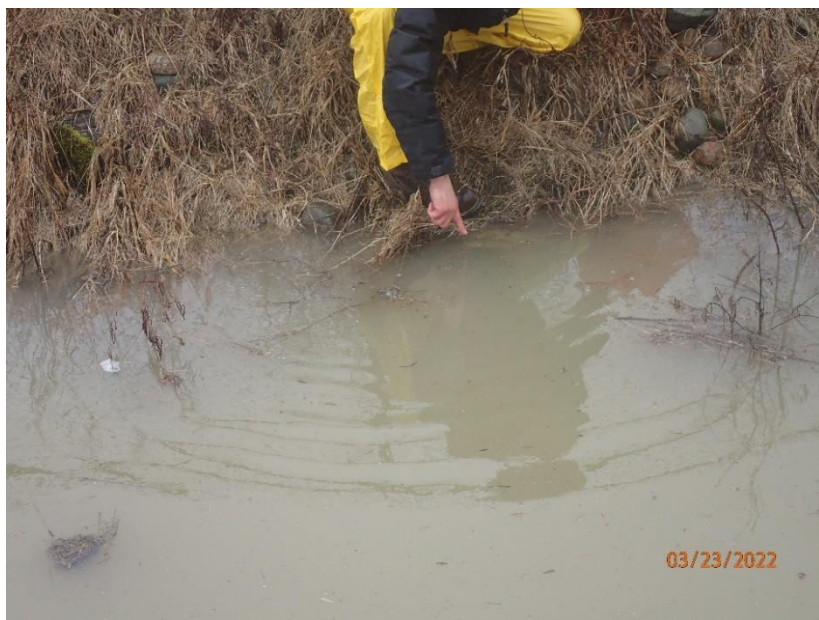
67: P3230135

Description: EPA noted where the outlet pipe to the ditch along Ransom Road was located. It was under water on the day of the inspection.

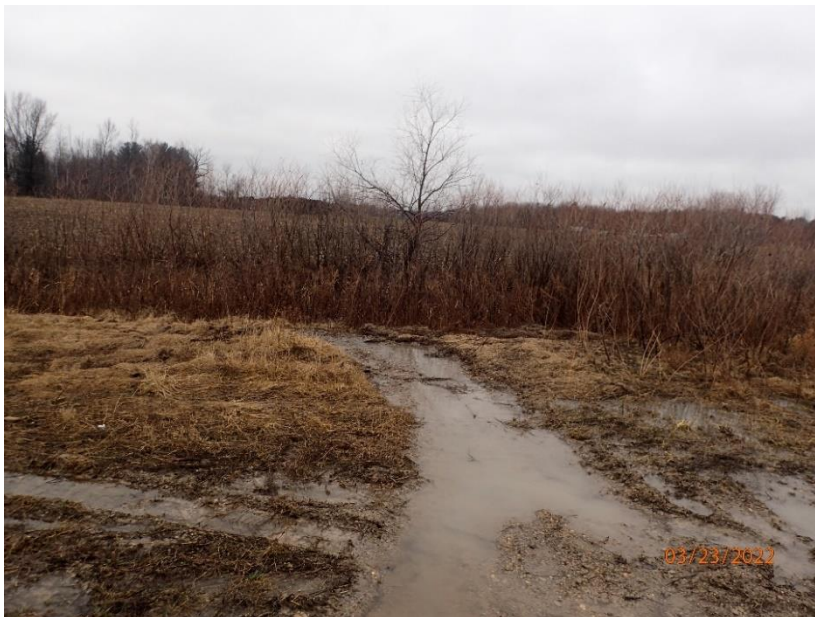
96: P3230161

Description: EPA also observed surface runoff to a ditch on the south side of the Hope/Midland Piling Ground.

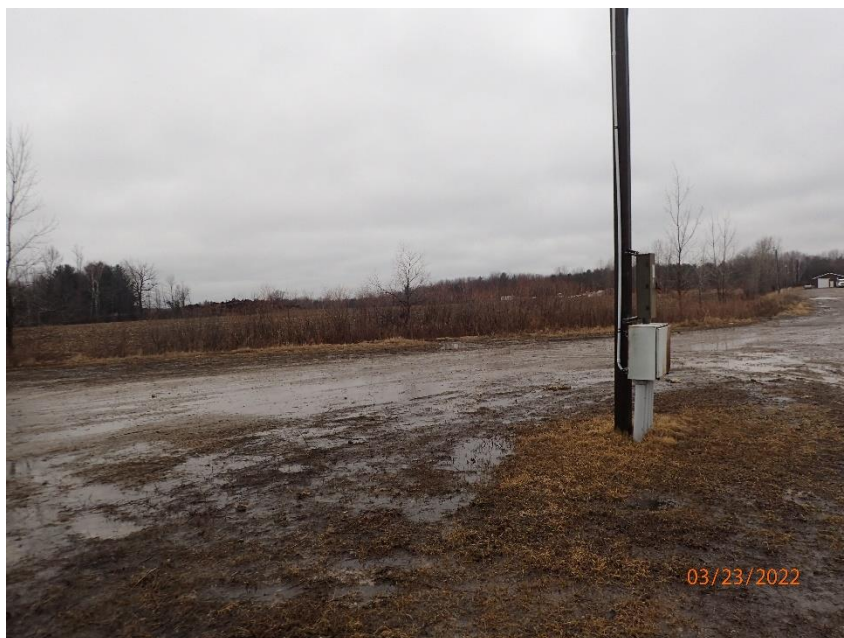
97: P3230162

Description: EPA also observed surface runoff to a ditch on the south side of the Hope/Midland Piling Ground.
