## MISSISSIPPI DEPARTMENT OF ENVIRONMENTAL QUALITY

Re: Notice of Violation  
Hazlehurst POTW, Lagoon  
Hazlehurst, Mississippi  
Copolah County  
Water - NPDES Permit No. MS0023884

**Mississippi Department of Environmental Quality  
Office of Pollution Control  
Water Compliance Inspection Report**

**Site Name:** Hazlehurst POTW, Lagoon

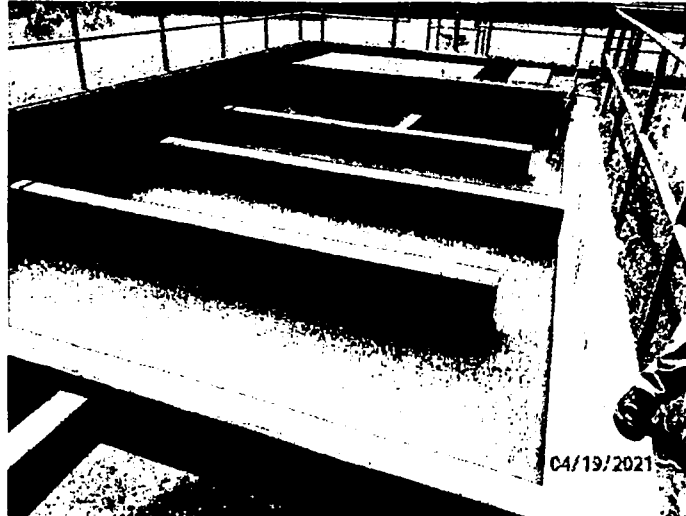
Chlorine gas is normally used for disinfection, but the feed system was inoperable. It was not known how long the gas feed system had been inoperable, not how long it would be before repairs could be made. Mr. Hayden stated that he places calcium hypochlorite tablets in the cascade aeration area for disinfection. There were no tablets observed. The water in the chlorine contact chamber was light green in appearance with some floating duckweed (see Photo 8).

Photo 8: Chlorine contact basin
