REPORT OF COMPLIANCE EVALUATION INSPECTION  
(INDUSTRIAL STORMWATER)

**Advantage Metals Recycling LLC. – Cheyenne Facility**

Authorization Number: **KSR000551**

ON  
June 22, 2023

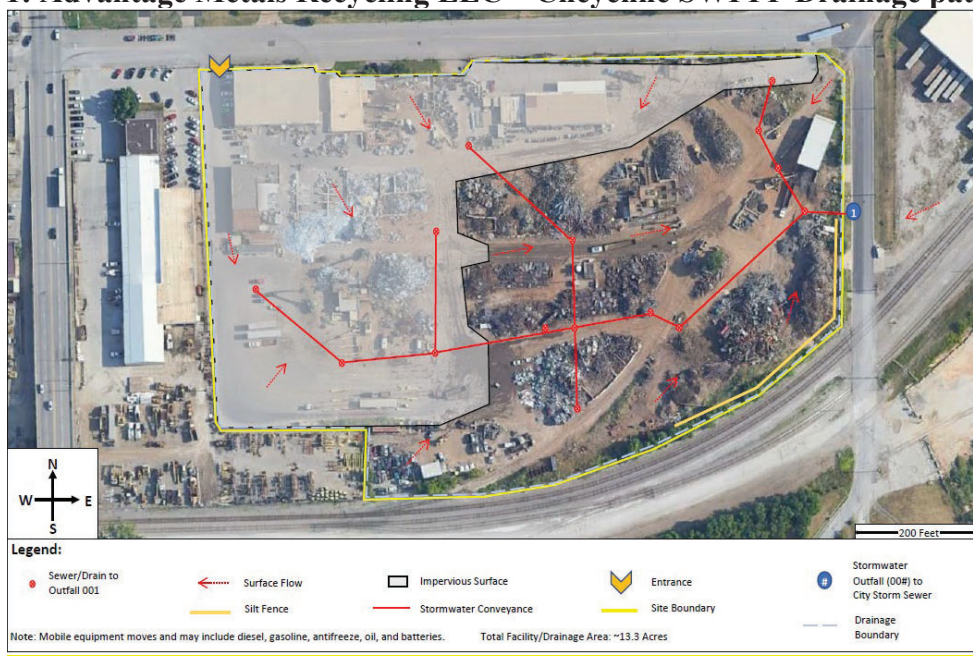
**Figure 1: Advantage Metals Recycling LLC – Cheyenne SWPPP Drainage patterns map.**

Based on the local topography of the site and drainage description provided and indicated on the site plan included in the SWPPP, overall, the Facility is sloped allowing stormwater to sheet flow into stormwater inlets that lead to Outfall 001. However, while onsite during the inspection, dust prevention water was seen discharging from two locations on the North/Northeast side of the facility. Figure 1 is the drainage pattern map located in the facility's SWPPP.

4. During my visual inspection of the site, I observed two unidentified outfalls on the north side of the facility (Photos 6-10). There was no stored material in the area surrounding these outfalls, however, dust suppression water was seen draining from the facility out of these outfalls. Since these outfalls were not listed in the SWPPP, I issued NOPF #1 for unidentified outfalls.
5. I observed an unknown substance presumed to be creosote seeping from railroad ties in the northeast section of the facility (Photos 11 and 12). This substance is exposed to stormwater and has a potential to run offsite. Therefore, I issued NOPF #2.
6. While reviewing the SWPPP after the inspection it was observed that the site map showing the drainage patterns of the facility it not accurate for the northeastern section of the facility as shown in Figure 2.

Overall, structural controls appeared to be installed correctly, and records indicated that non-structural controls appeared adequate as well. However, the site needs to update their SWPPP site map to show proper drainage patterns and look into the substance seeping from the railroad ties.

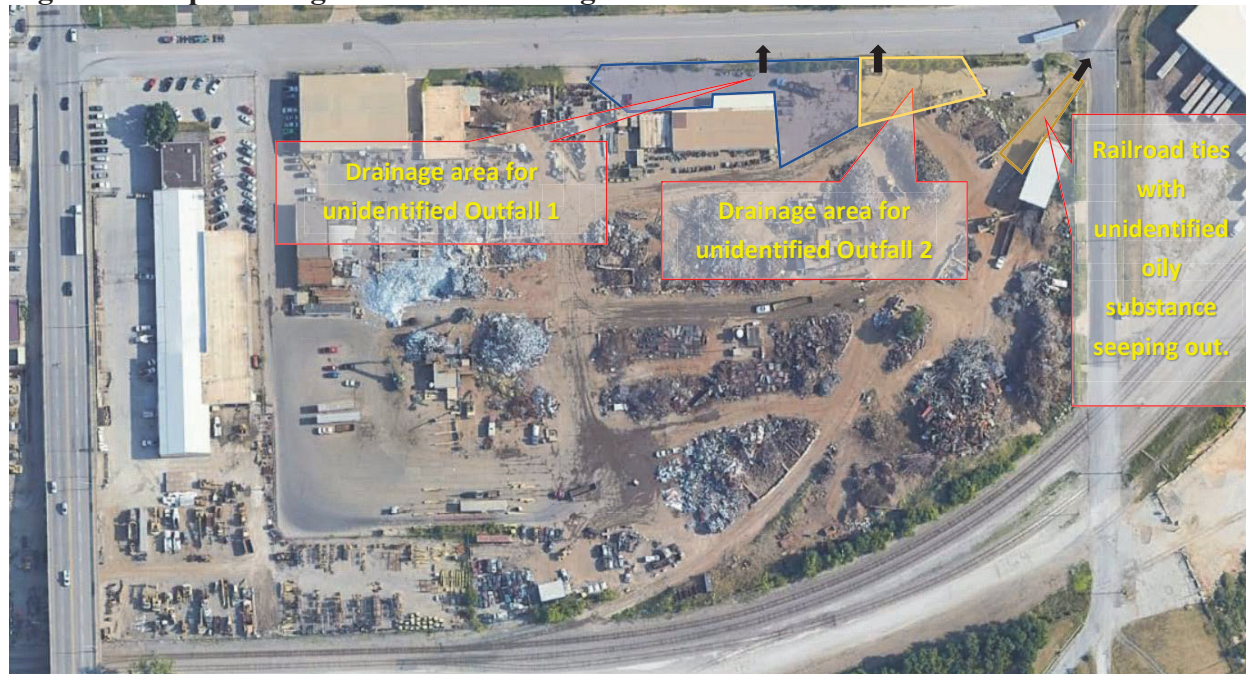
**Figure 2: Map showing locations of findings on NOPF.**

Figure 2 shows the drainage areas observed discharging to the two unidentified outfalls. This area was free from stored materials but was watered with dust prevention water from the facility.

This water was then observed leaving the site from the two unidentified outfalls. Figure 2 also shows the area where an unknown substance was seeping out of the railroad ties, along with the potential drainage path.
