DATE: JANUARY 12, 1990

SUBJECT: SPILLS AND RELEASES,  
1989

## SPILLS AND RELEASES AT LAKE CHARLES

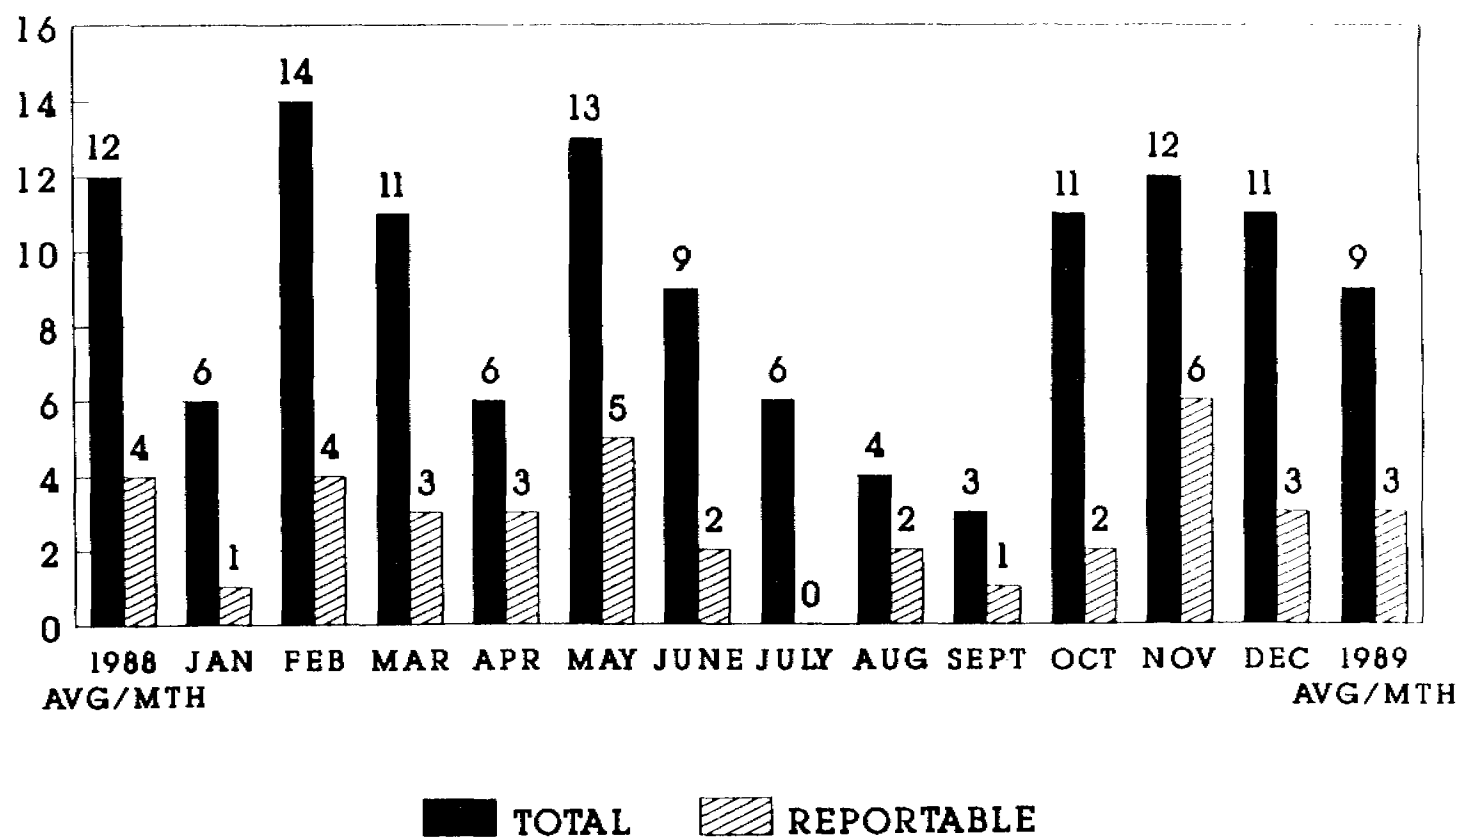
FIGURE 1

Figure 1 represents the 1989 total/reportable spill record for the complex on a month by month basis. The average number of total releases per month in 1989 was 9 compared to 12 in 1988. This represents a 26% decrease in total releases. The average number of reportable releases per month in 1989 was 3 compared to 4 in 1988. This represents a 29% decrease in reportable releases which is a significant achievement. A goal for 20% reduction in releases has been set for 1990.

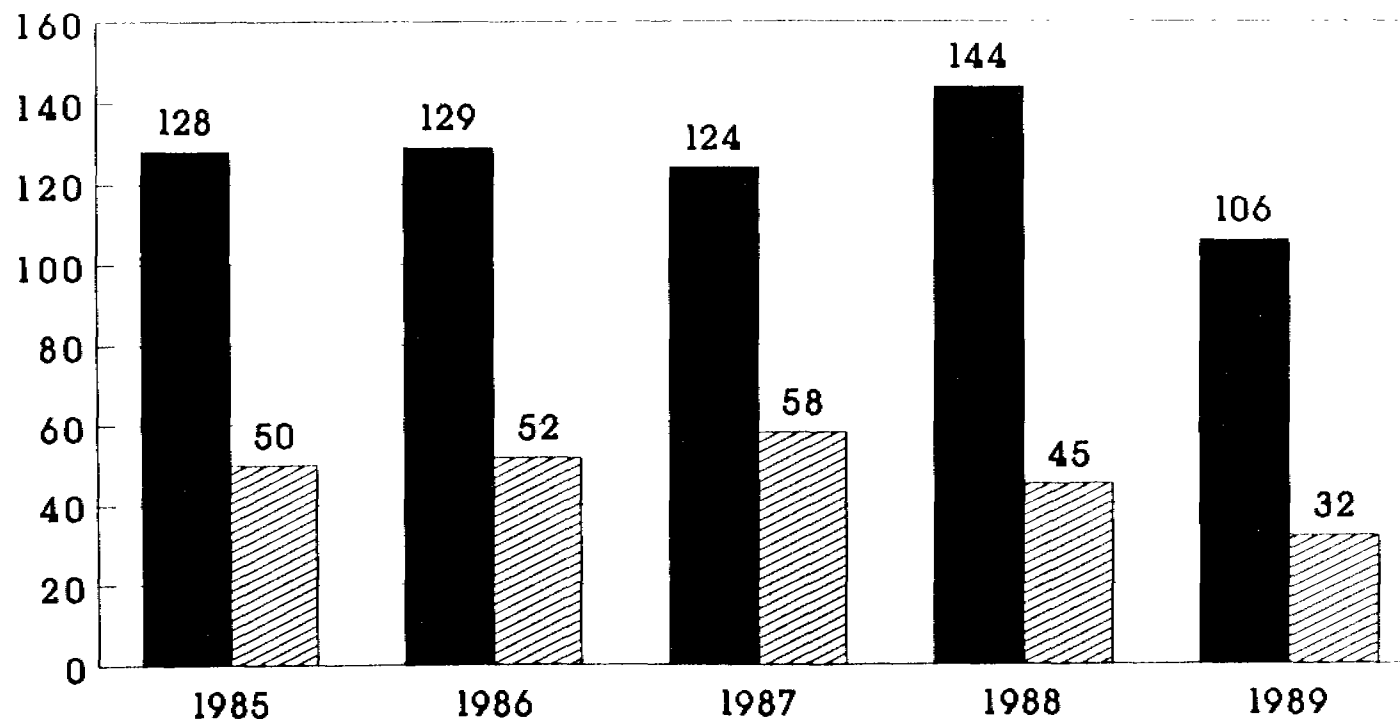
FIGURE 2

Figure 2 illustrates the complex spill/release record since 1985. This graph further demonstrates the reduction made in release incidents in 1989 (both total and reportable).

Total Releases - 27% Reduction (from 1988)  
Reportable Releases - 29% Reduction (from 1988)

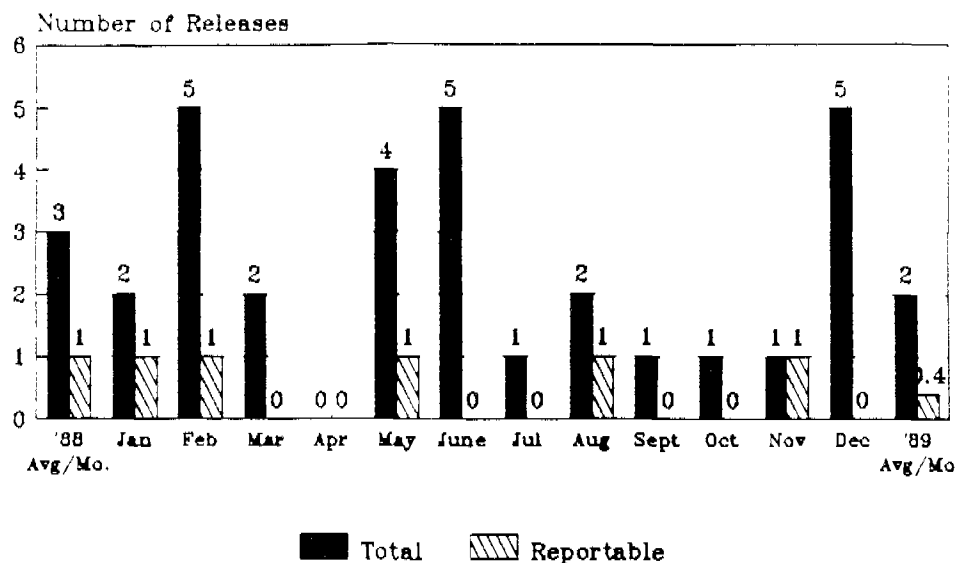
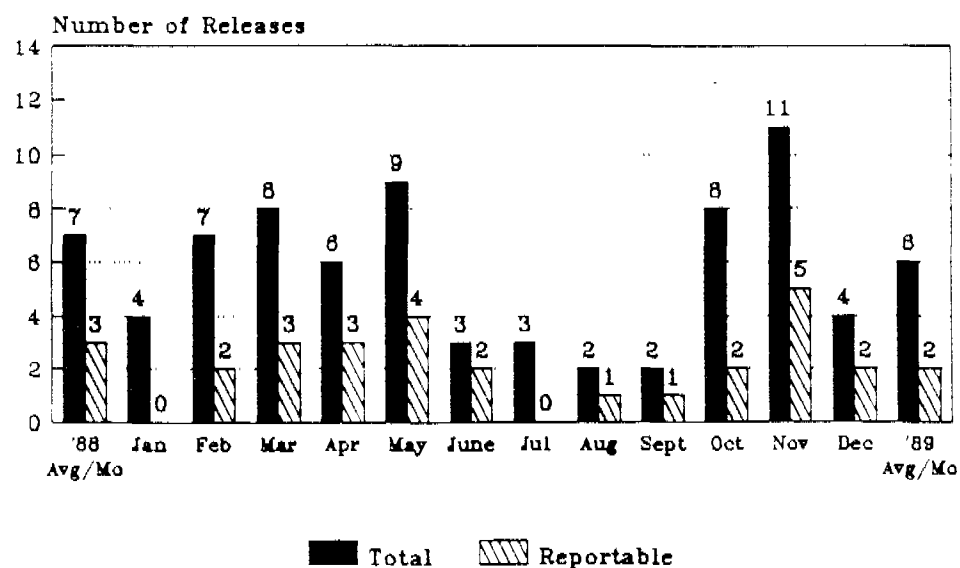
FIGURE 3

Figure 3 depicts the releases by month from the Chlor/Alkali and Derivatives areas in 1989. The remainder of the releases not shown occurred in the Complex and Shipping areas.

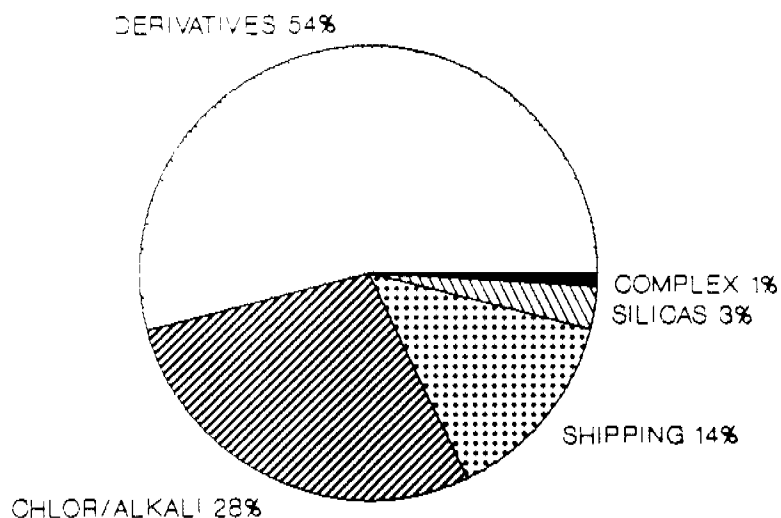
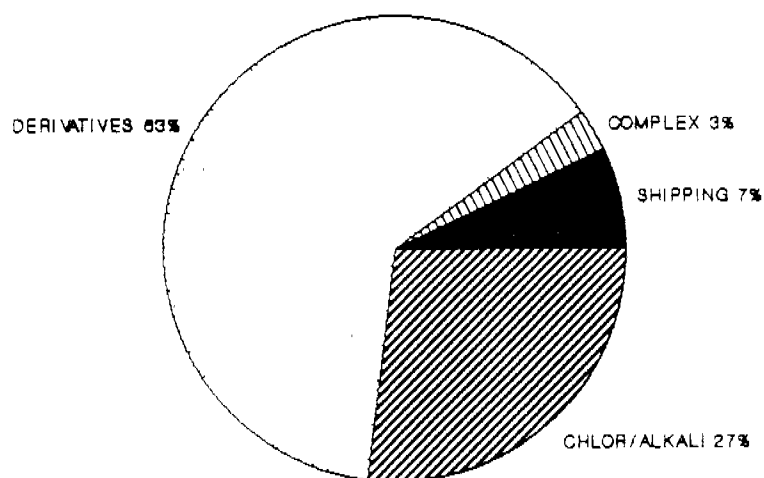
FIGURE 4

The pie charts in Figure 4 compare the percentage of total releases attributable to each area of the complex in 1989 vs. 1988.

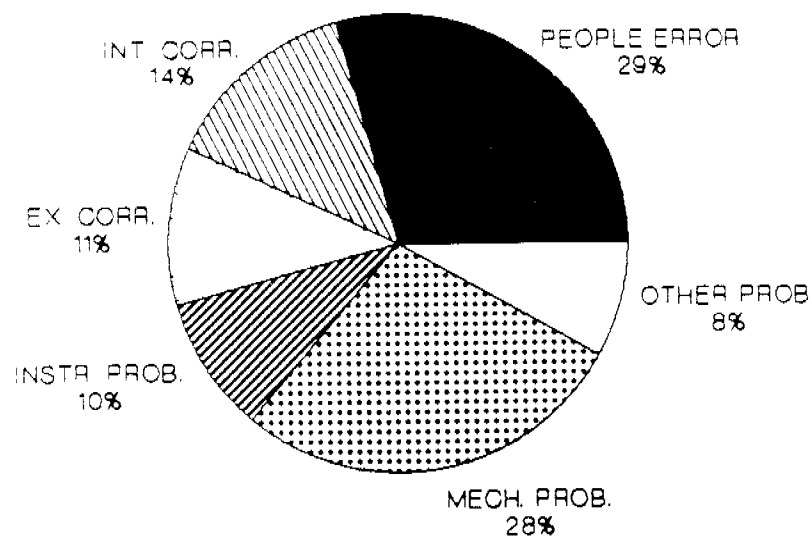
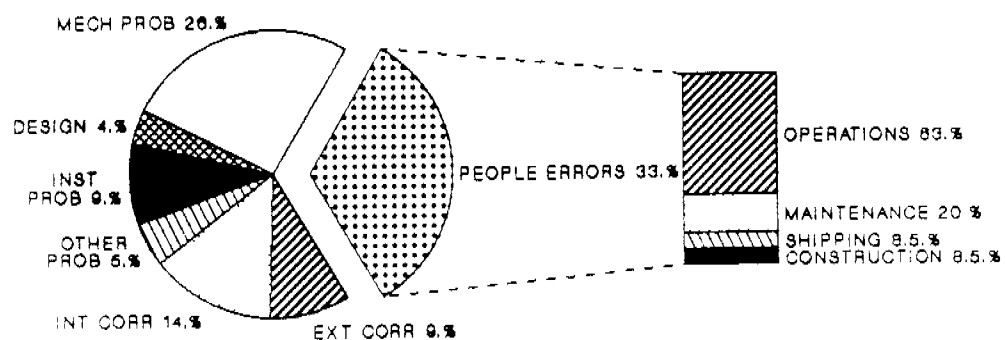
FIGURE 5

Figure 5 compares the breakdown of release incidents by causes in 1989 vs. 1988. A new category of "design problem" was added in 1989. This is one reason for the reduction seen in the releases

caused by "Other Problems". Releases caused by "People Errors" rose in 1989 from 29% to 33%. Because of the large number of people errors experienced, this category is now broken down into the areas of Operations, Maintenance, Construction, and Shipping personnel.
