## **Appendix A**

### **Photograph Log**

**U.S. ENVIRONMENTAL PROTECTION AGENCY  
REGION 4  
ENFORCEMENT AND COMPLIANCE ASSURANCE DIVISION  
CLEAN WATER ACT COMPLIANCE INSPECTION REPORT  
for**

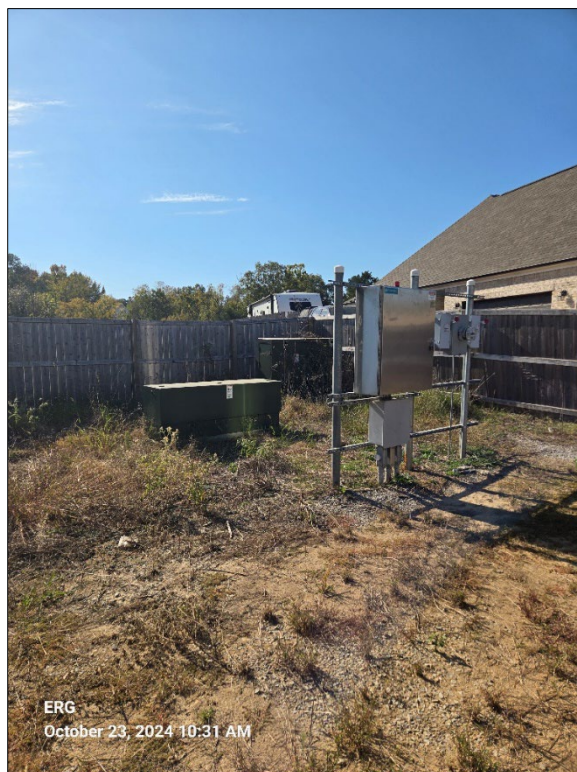
**Photograph 1.** McElroy Farms lift station. Note the excessive vegetation around the lift station.

**Observation 2.** The inspectors observed some solids and grease accumulation at the McElroy Farms Lift Station (refer to [Appendix A, Photograph 3](#)). Additionally, the inspectors observed excessive vegetation around the lift station and that the valve pit access was not raised to prevent infiltration (refer to [Appendix A, Photographs 1 and 4](#), respectively).

Foliage/Grass within McElroy Farms lift station has been cut.

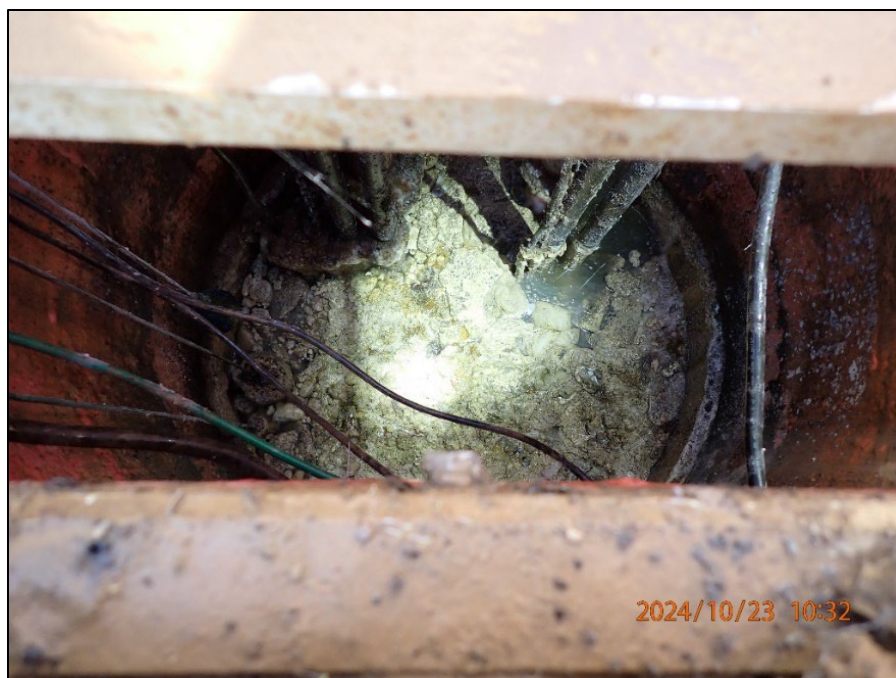
**Photograph 3.** McElroy Farms lift station wet well. Note the grease accumulation.

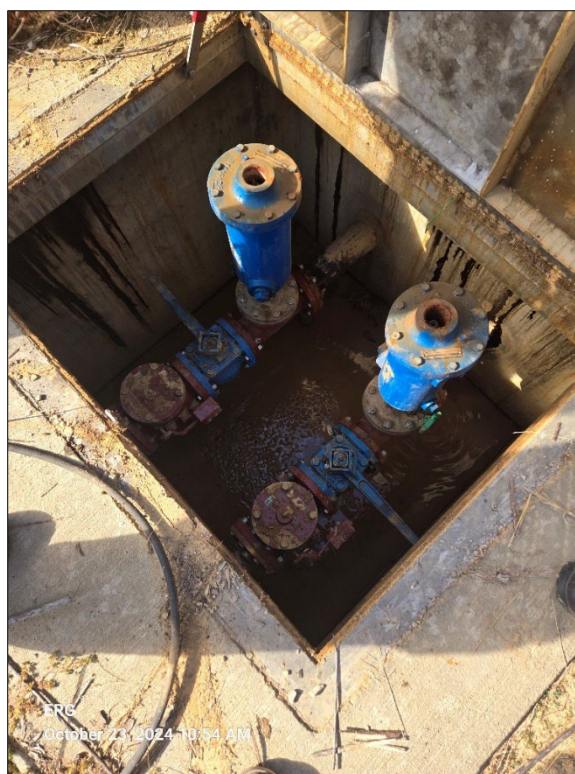
**Photograph 4.** McElroy Farms lift station valve pit. Note that the valve pit access is not raised.

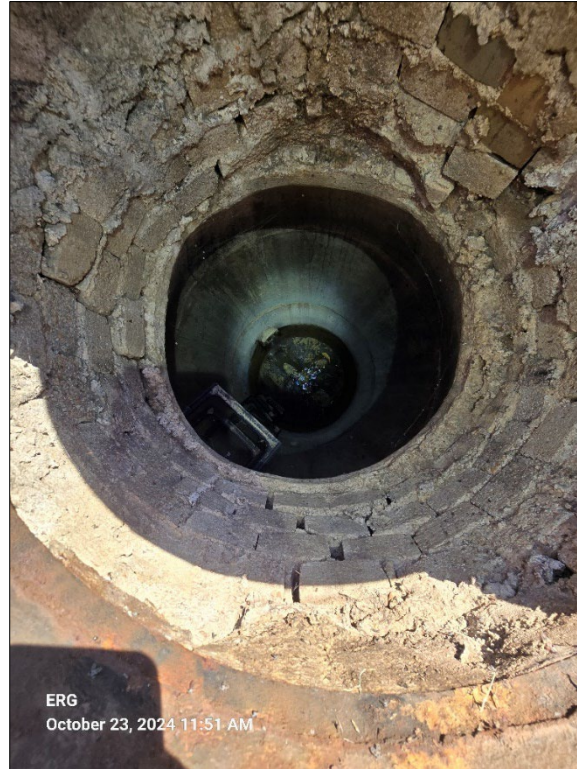
**Photograph 13.** Interior of the manhole at Braybourne & Sandbourne. Note the small solids and grease accumulation in the manhole.

- Observation 6.** The inspectors observed some solids and grease accumulation at the Braybourne & Sandbourne manhole (refer to [Appendix A, Photograph 13](#)).

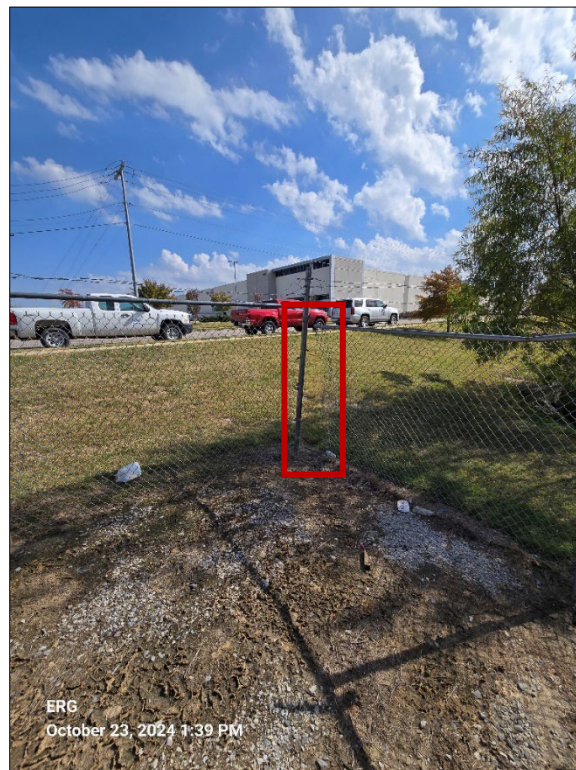
**Photograph 18.** Legacy Park North lift station perimeter fencing. Note the gap in the fence, outlined in red.

**Observation 3.** The inspectors observed a gap in the perimeter fencing at the Legacy Park North Lift Station (refer to [Appendix A, Photograph 18](#)). Additionally, the inspectors observed one of the check valve counterweights was disconnected (refer to [Appendix A, Photograph 19](#)).

The counterweight at the North Legacy Park Lift station has been reinstalled on the check valve arm. Fencing quote obtained and PO issued for perimeter fence installation. (see above attachments).

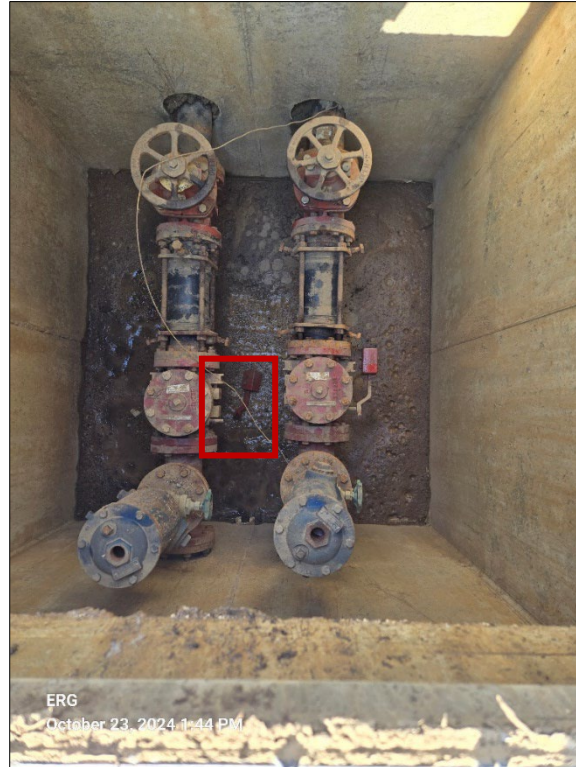
**Photograph 19.** Legacy Park North lift station valve pit. Note the counterweight (outlined in red) is disconnected for the left check valve.

*Following the inspection, the system representatives provided photographs of the reinstalled check valve counterweight and a quote for repairs to the perimeter fencing (refer to [Appendix B, Exhibit 6](#)).*

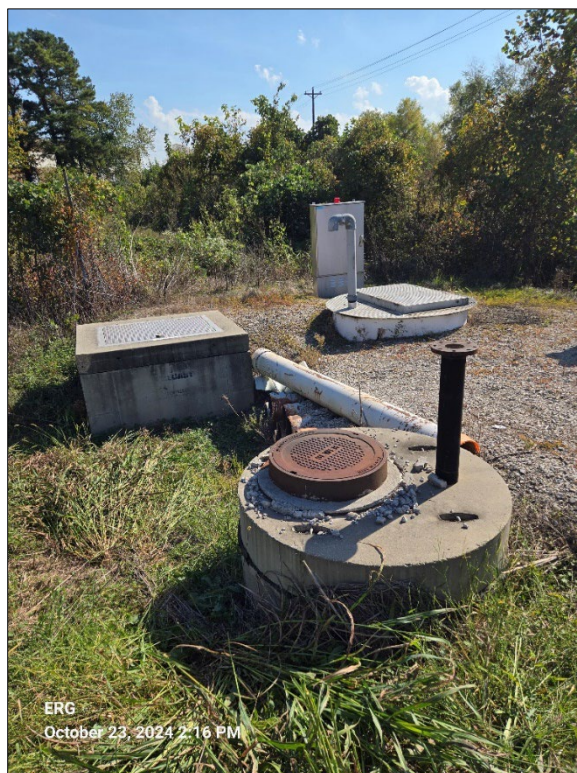
**Photograph 22.** High Point lift station. Note the valve pit and wet well were not locked.

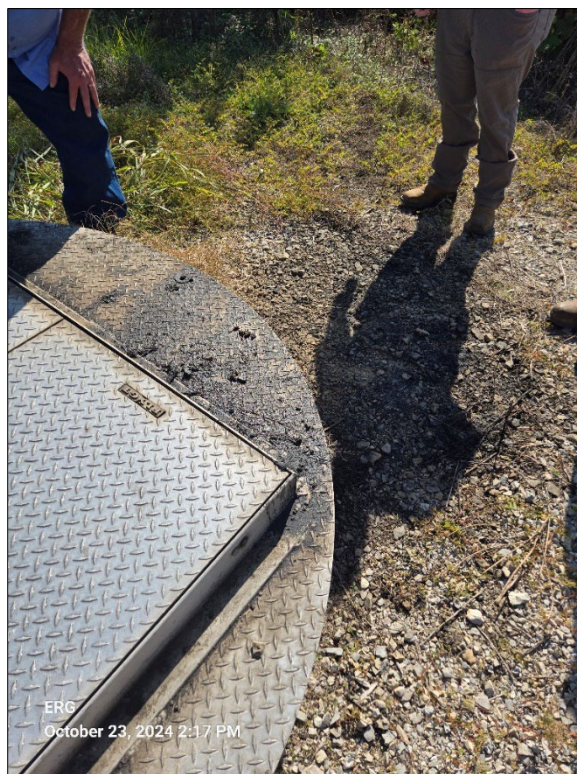
**Photograph 23.** Oil residual and/or evidence of overflow by the wet well at High Point lift station.

- Observation 4.** The inspectors observed oil and/or evidence of overflow at the High Point Lift Station (refer to [Appendix A, Photograph 23](#)). The inspectors observed black fluid and large amounts of floating solids in the wet well (refer to [Appendix A, Photograph 24](#)). The system representatives stated that this lift station receives wastewater from an airplane parts manufacturer, and that DCRUA has previously inspected and sampled at this location due to pretreatment concerns.

The High Point Lift Station was cleaned 10-25-24. As requested, cleaning frequency is being increased scheduled at least 3 times annually.

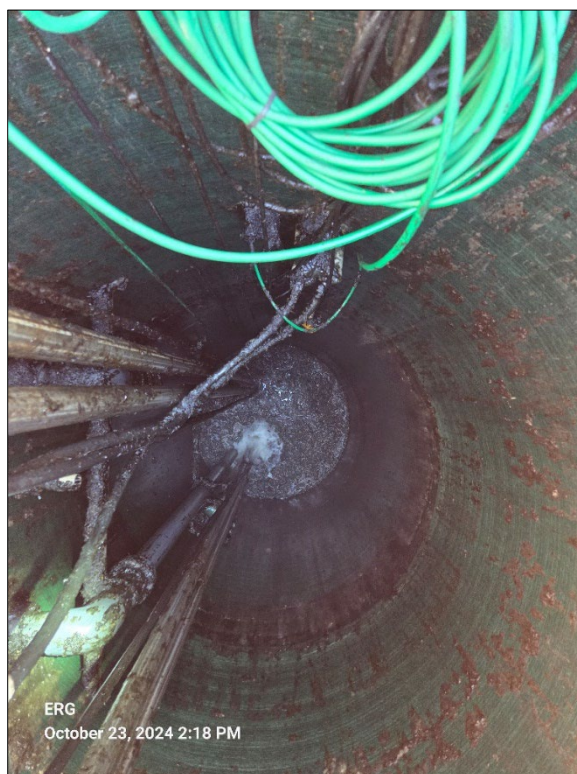
**Photograph 24.** High Point lift station wet well. Note the black fluid and black solids in the wet well.

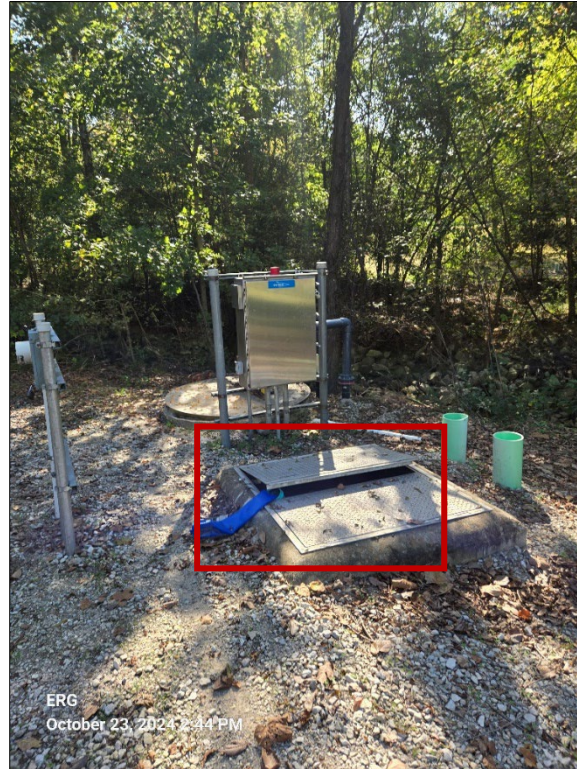
**Photograph 25.** East State Line lift station. Note one of the doors to the old valve pit (outlined in red) was open and not locked.

- Observation 5.** The inspectors observed that the old valve pit at the East State Line Lift Station was not locked (refer to [Appendix A, Photograph 25](#)) to prevent entry and vandalism.

East Stateline Road lift station old valve pit and wet well are secured.
