**Region 2 Caribbean Environmental Protection Division  
Multimedia Permits and Compliance Branch**

**CAA Inspection Report**

**Inspection Date:** 2/12/2024

**Facility Name:** Safetech Corporation

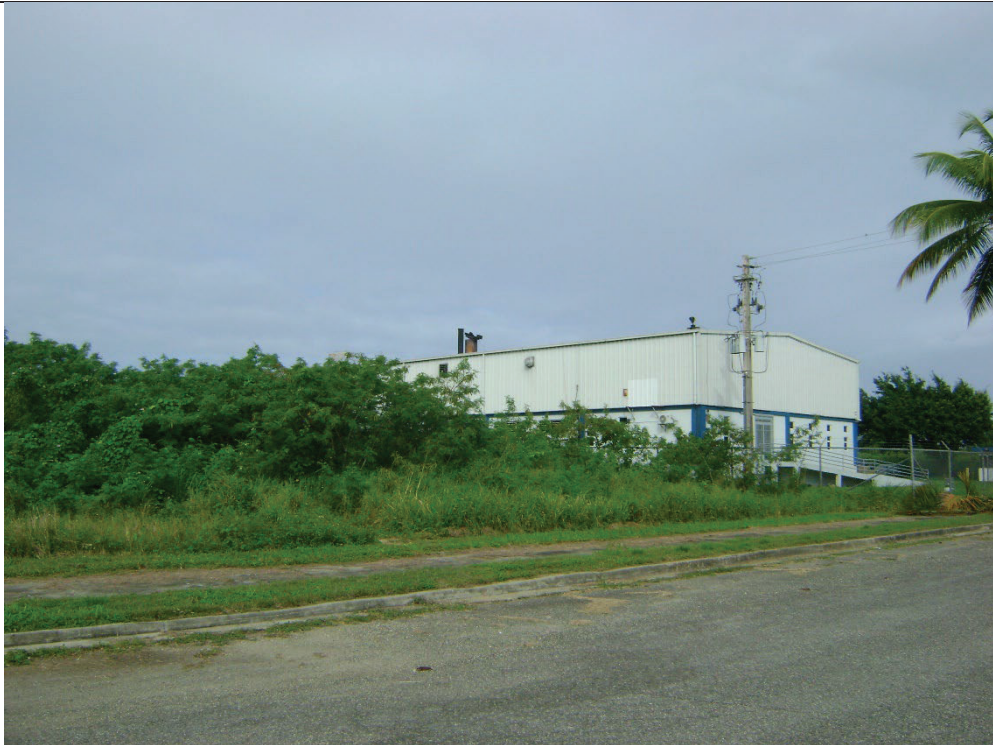
- The inspectors noted that there was another stack next to the scrubber stack that they observed to be open that morning and told Mr. Saldaña they had seen visible emissions coming from the stack. They asked Mr. Saldaña what this stack was. Mr. Saldaña told the inspectors that this is the incinerator bypass stack, which is opened during incinerator startup when it is running on propane to get up to temperature. He told the inspectors that the stack is closed when the incinerator is burning waste.
- The inspectors asked Mr. Saldaña if the facility often observes black smoke coming from the incinerator stack. Mr. Saldaña responded that there is usually a brief puff of black smoke when they start up the incinerator.

| Appendix A: Digital Image Log for Safetech Corporation, Arecibo, PR | | | | |
|---|---|---|---|---|
| 1 | DSC01225.JPG | <div></div> <div>View of open incinerator bypass stack from street outside of facility.</div> | 2/12/2024 | 9:30 am |

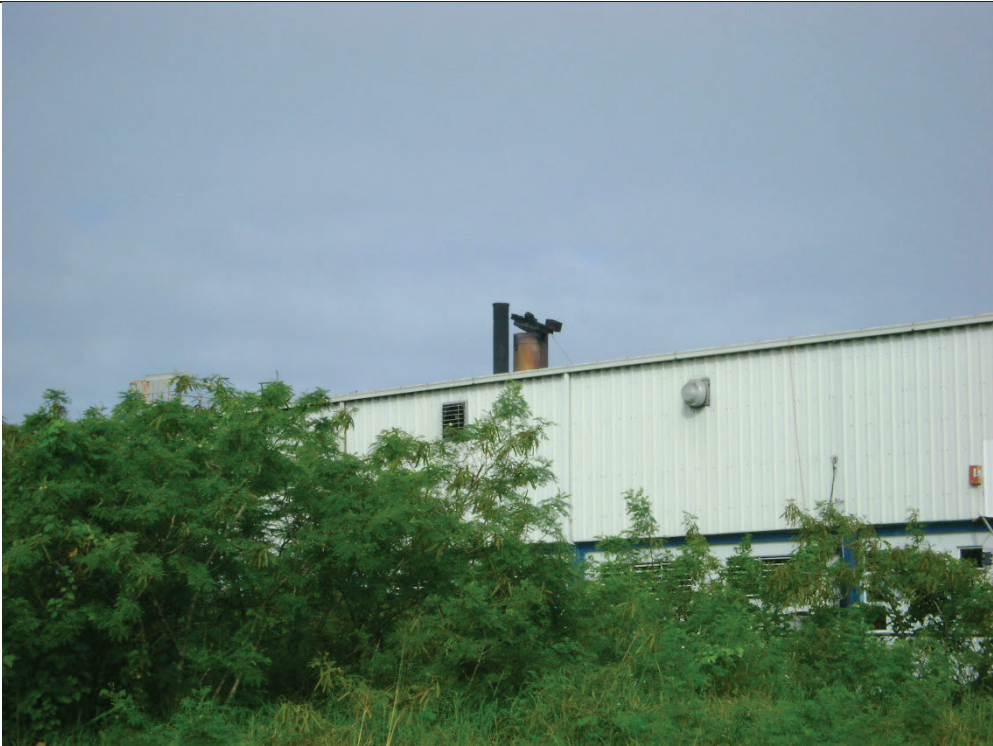
| | | View of open incinerator bypass stack from street outside of facility. | | |

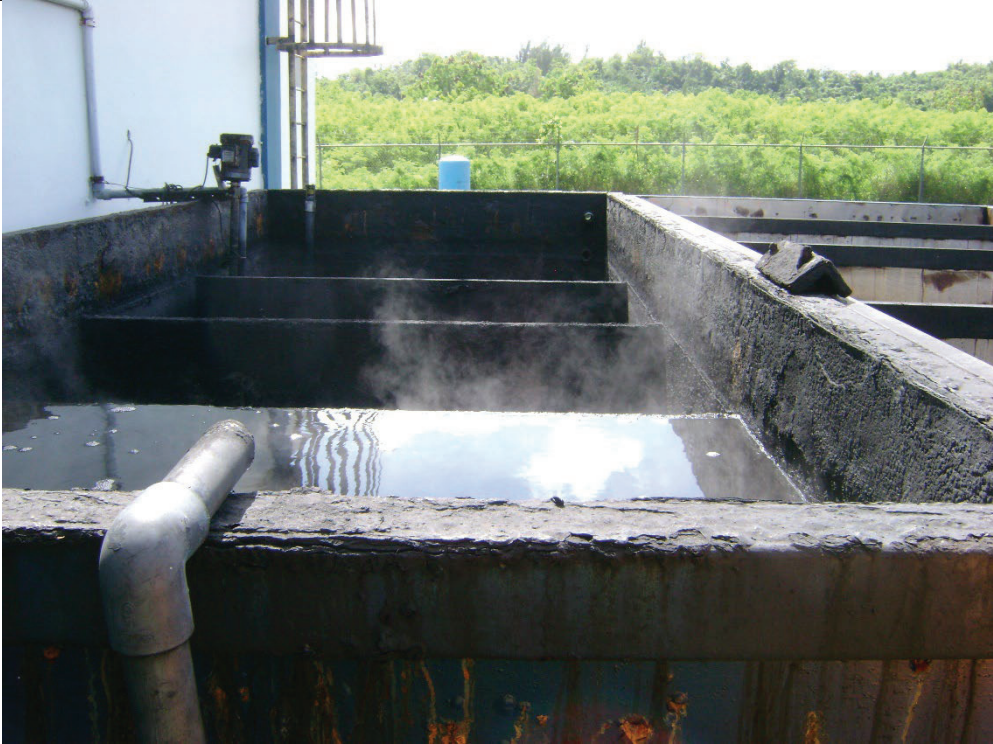
| | | Scrubber wastewater sediment tank. | | |

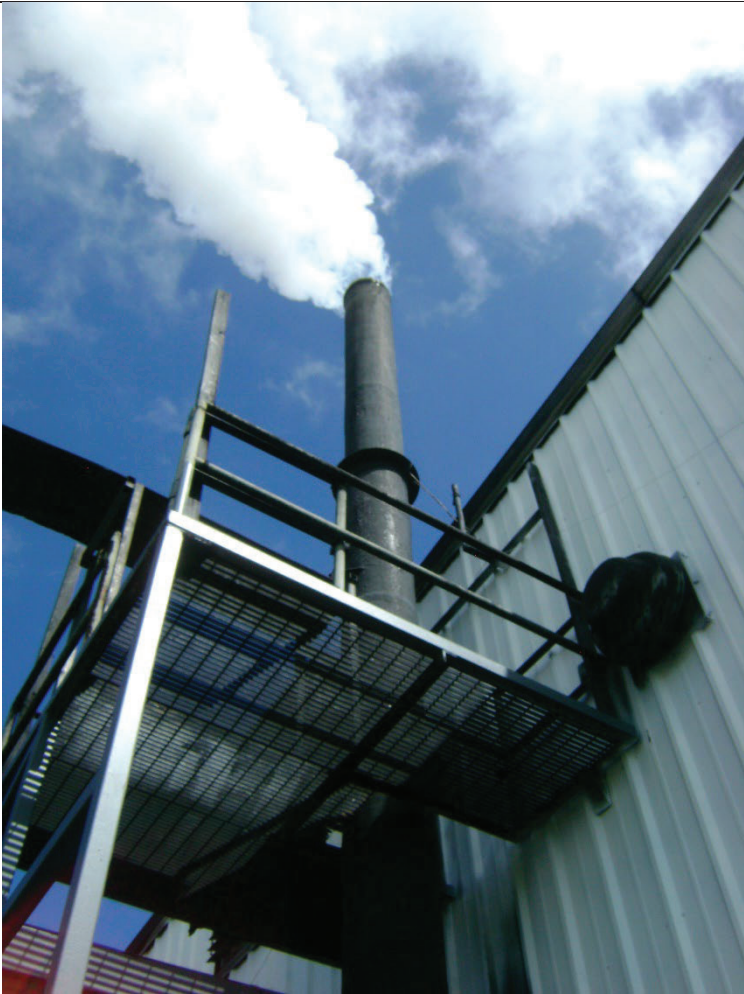
The group then stepped outside of the building to observe the scrubber stack (see images 4-5) and scrubber wastewater sediment tank (see image 3). The inspectors observed a white vapor cloud coming from the wet scrubber stack, which Mr. Saldaña informed them was mostly water vapor. The inspectors noticed black droplets of water landing on their skin while walking close to the scrubber stack.

White vapor cloud from scrubber stack.

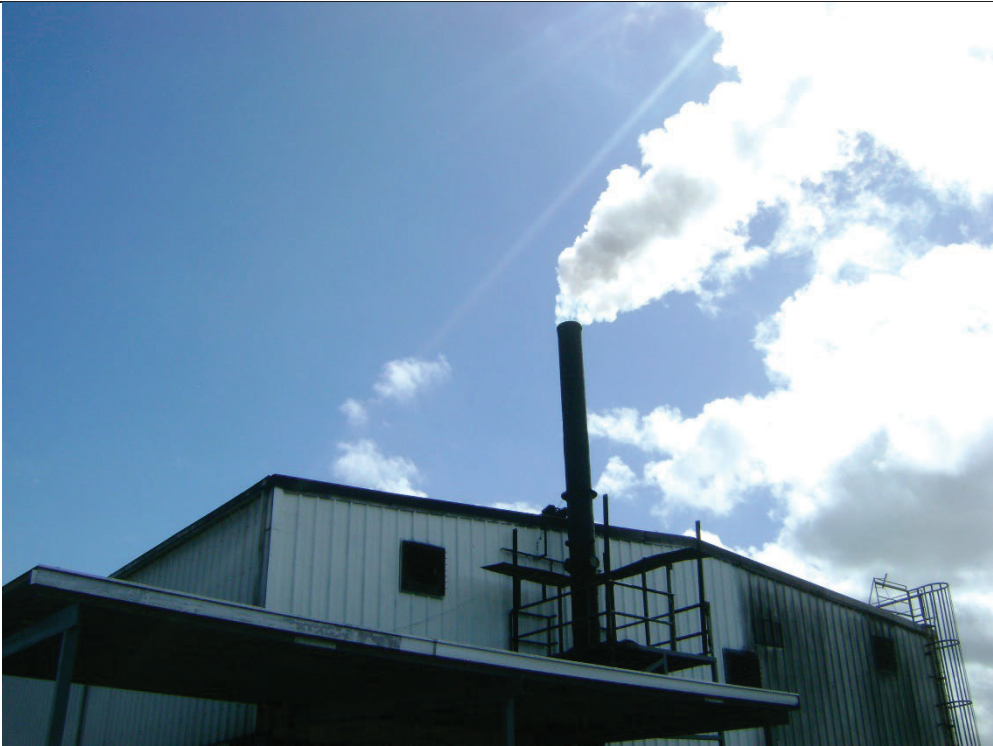
| 5 | DSC01230.JPG | <p>White vapor cloud from scrubber stack.</p> | 2/12/2024 | 11:17 am |

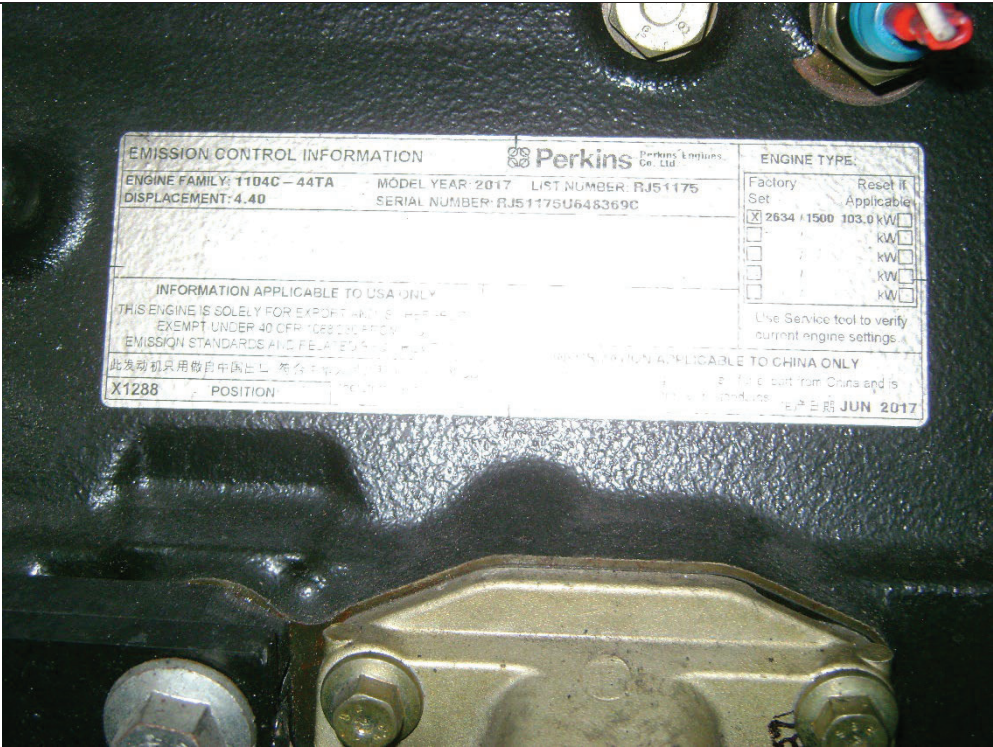
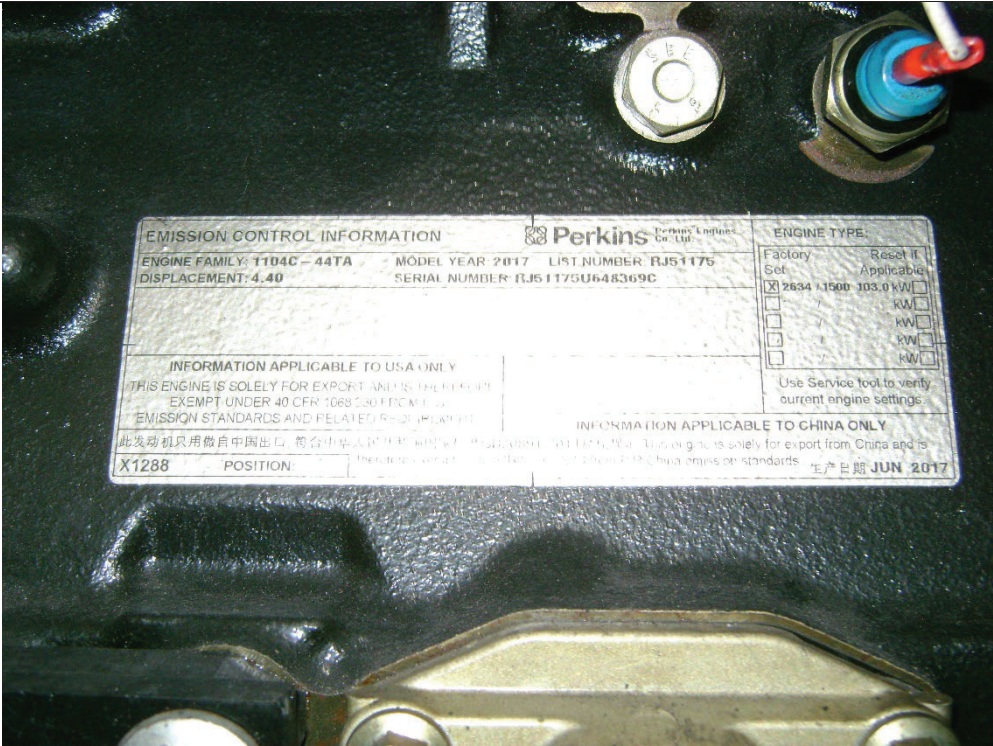
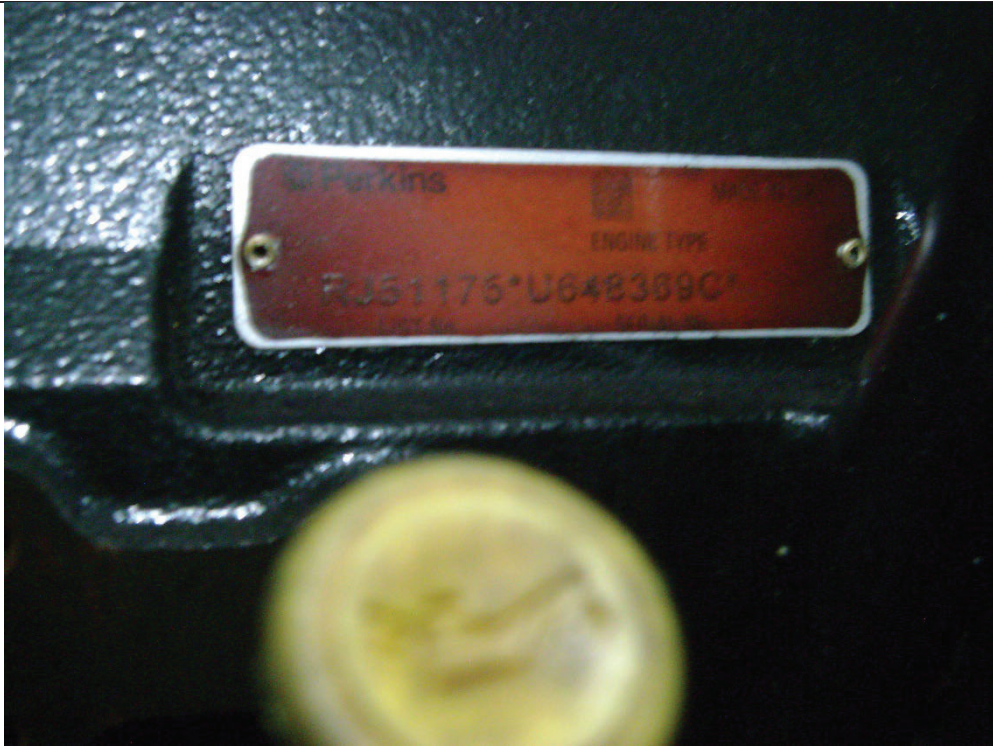
| 6 | DSC01233.JPG | <p>Plate on emergency generator engine.</p> | 2/12/2024 | 11:25 am |

| 7 | DSC01234.JPG | <p>Plate on emergency generator engine.</p> | 2/12/2024 | 11:25 am |

| 8 | DSC01236.JPG | <p>Plate on emergency generator engine.</p> | 2/12/2024 | 11:26 am |

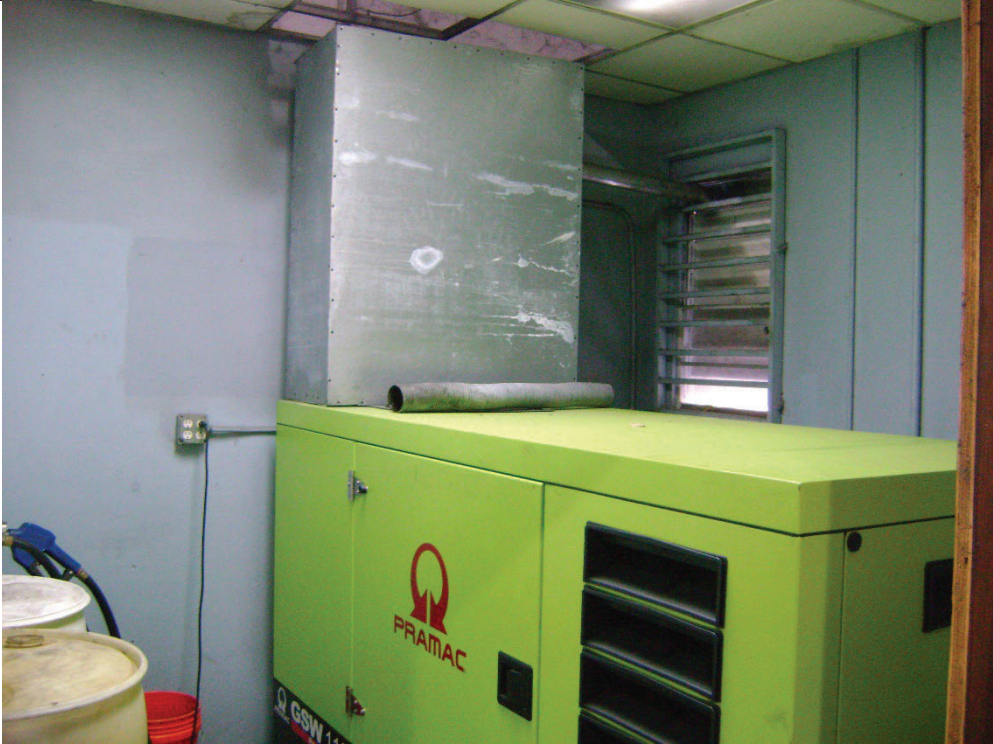
When the group went back inside, they visited the facility's emergency generator. Mr. Saldaña told the inspectors that maintenance on the emergency generator is performed twice per year. The inspectors noted that the emergency generator appeared to have an exhaust pipe that was routed toward the window, but the pipe seemed to dead-end prior to passing to the other side of the window (see image 9). Mr. Saldaña explained that the generator is rarely operated, but when it is, they open the window and add a corrugated tube to the fixed pipe to extend it out the window as a means of venting emissions from the generator. The inspectors captured additional photos of the plates on the emergency generator (see image 6-8).

| 9 | DSC01237.JPG | <p>Emergency generator with vent routed through window on right side of photo.</p> | 2/12/2024 | 11:28 am |

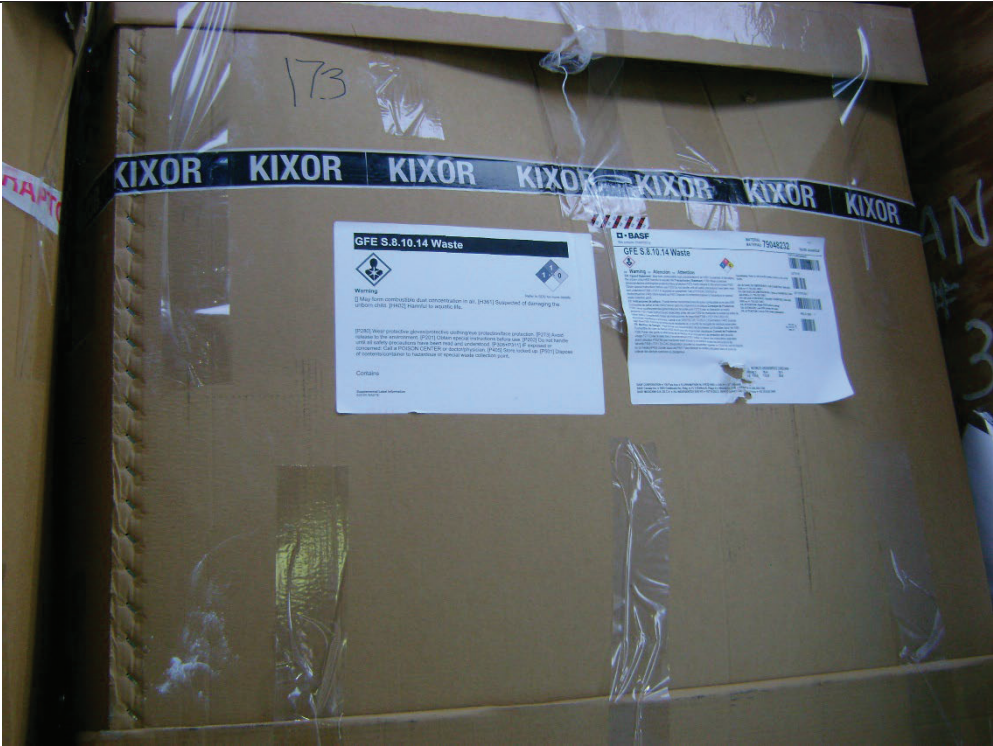
The group started at the facility's materials receiving and storage area. Mr. Saldaña informed the inspectors that materials are received on pallets via truck. The inspectors observed a truck that was in the process of being unloaded. Mr. Saldaña told the inspectors that the facility also stores spare parts in case they need to perform maintenance on any of the equipment. The inspectors noted that some of the boxes of waste material appeared to have hazard labels and took a photo of one of these boxes (see image 10). The inspectors asked Mr. Saldaña about the hazard labels, and he explained that the facility does not have control over the boxes in which their clients place the product to be incinerated. He said that the product within the boxes is certified by the client as non-hazardous.

| 10 | DSC01238.JPG | <p data-bbox="537 938 1444 993">Box of waste received from supplier to be incinerated. Hazard labels indicate “Suspected of damaging the unborn child” and “Harmful to aquatic life.”</p> | 2/12/2024 | 11:29 am |

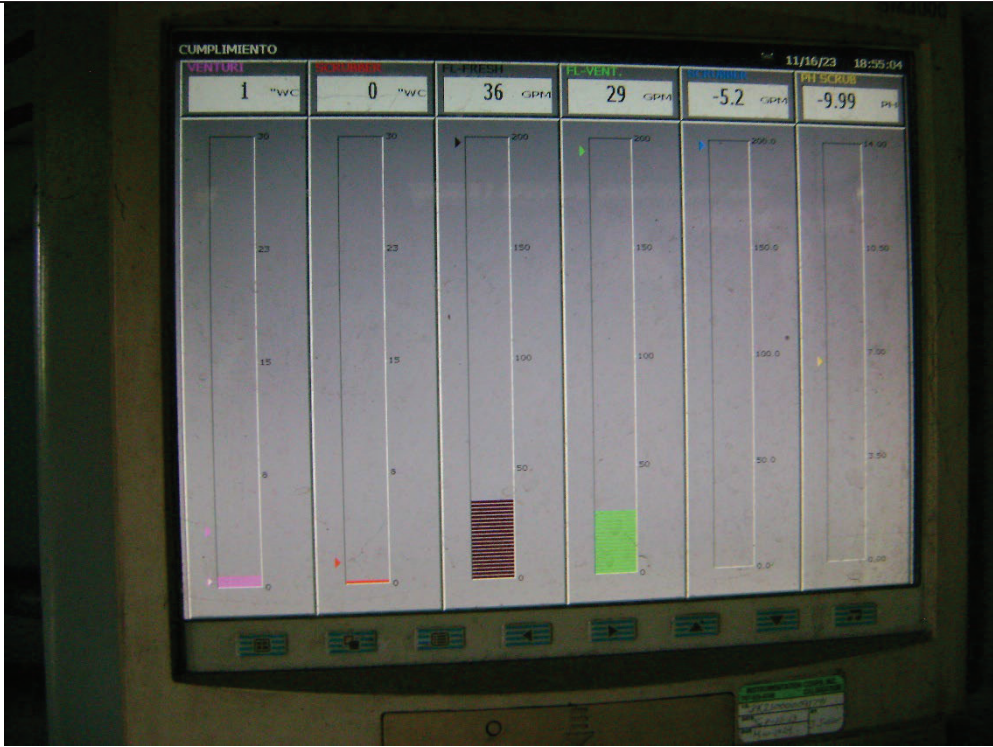
The group then returned to the incinerator area where the inspectors observed the monitoring devices for the incinerator and wet scrubber. The inspectors observed that the digital scrubber monitoring screen and pressure drop meters for both the venturi and the scrubber all indicated pressure drops of 0 inches of water column (see images 11 and 12). When they pointed this out to Mr. Saldaña, he informed the inspectors that the scrubber was not operating because incinerator had not been burning any waste since the inspectors arrived earlier that morning. The incinerator was on standby, meaning it was running only on propane. Ms. Hubbard recorded the following temperatures shown on the incinerator control while the incinerator was on standby:

| 11 | DSC01239.JPG | <p>Monitoring screen indicating pressure drop across the venturi and the scrubber, flow rates through the incinerator and scrubber, and scrubber water pH. Photo taken when incinerator was on standby. Date and time shown on screen are inaccurate.</p> | 2/12/2024 | 11:46 am |

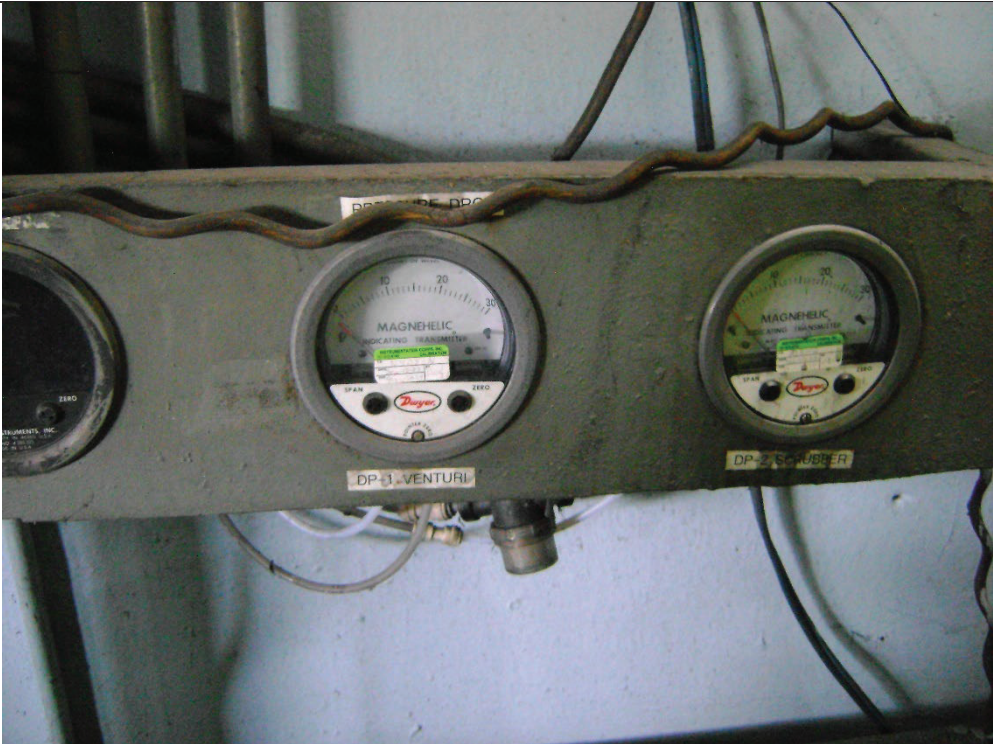
| 12 | DSC01240.JPG | <p data-bbox="537 930 1524 993">Differential pressure gauges for venturi and scrubber. Both gauges read 0 inches of water. Photo taken when incinerator was on standby.</p> | 2/12/2024 | 11:47 am |

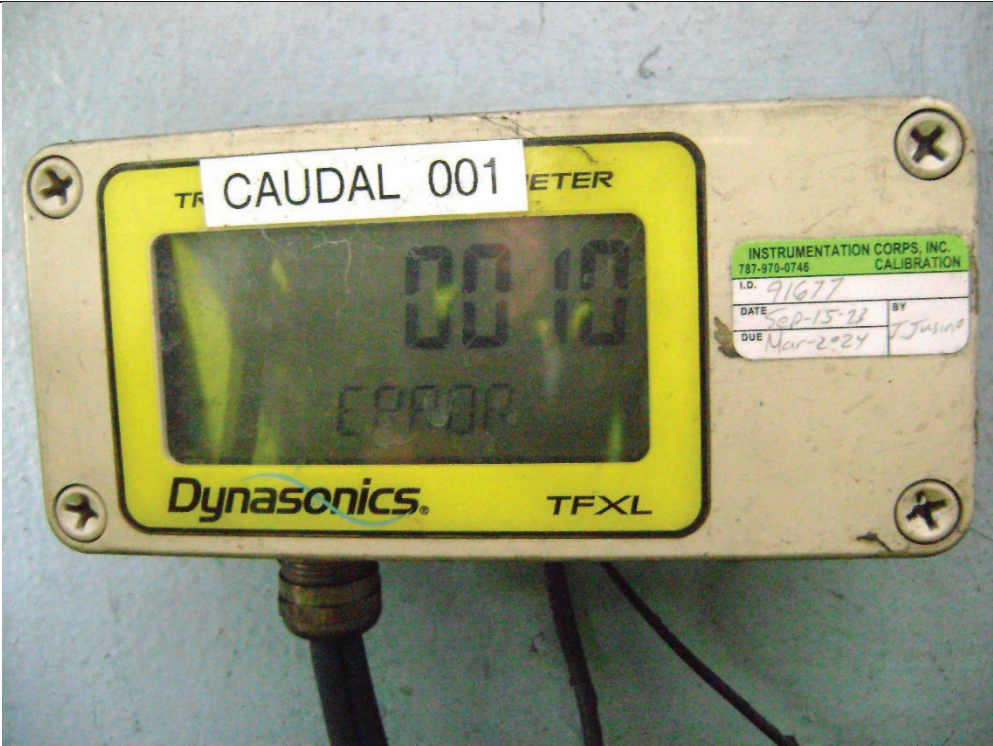
| 13 | DSC01241.JPG | <p>Wet scrubber flow meter.</p> | 2/12/2024 | 11:49 am |

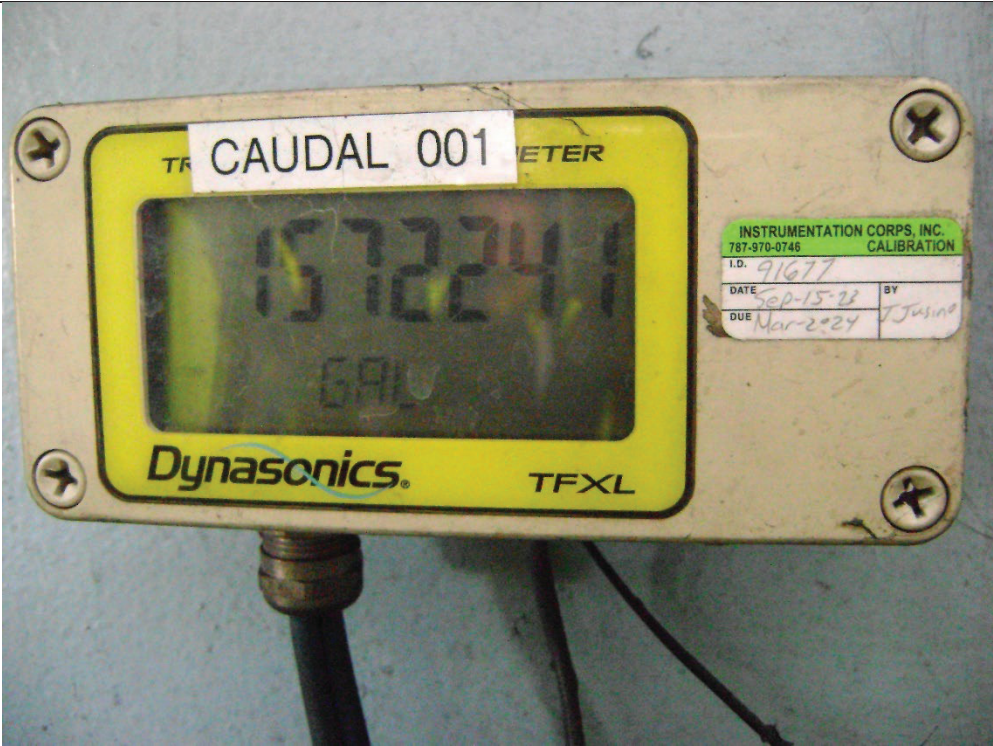
| | | Wet scrubber flow meter. | | |

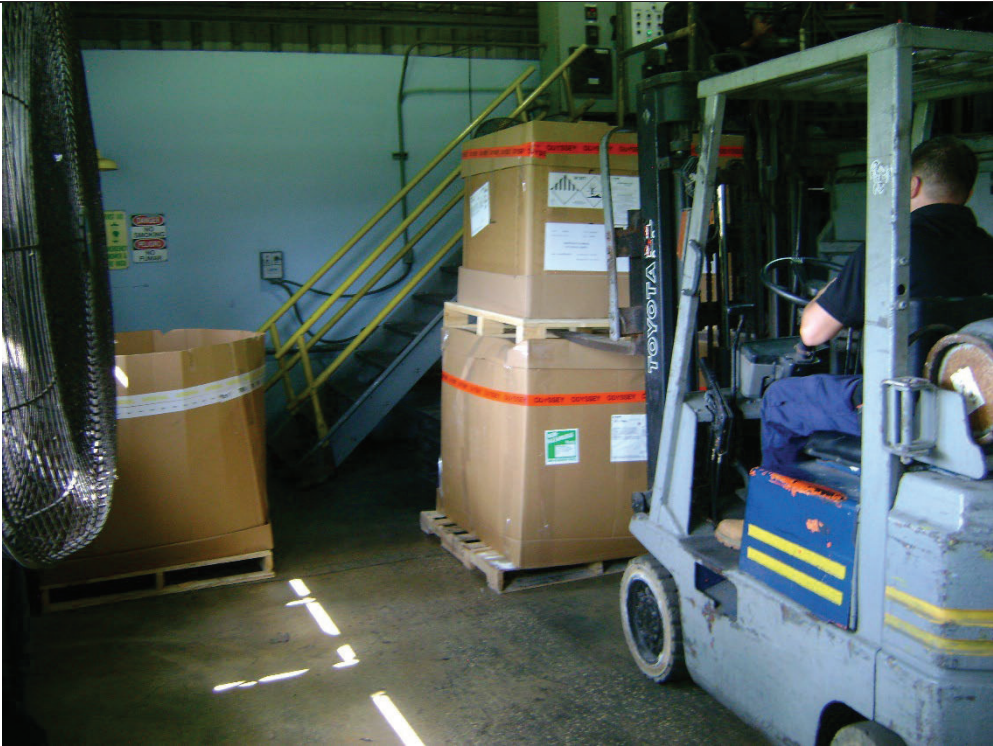
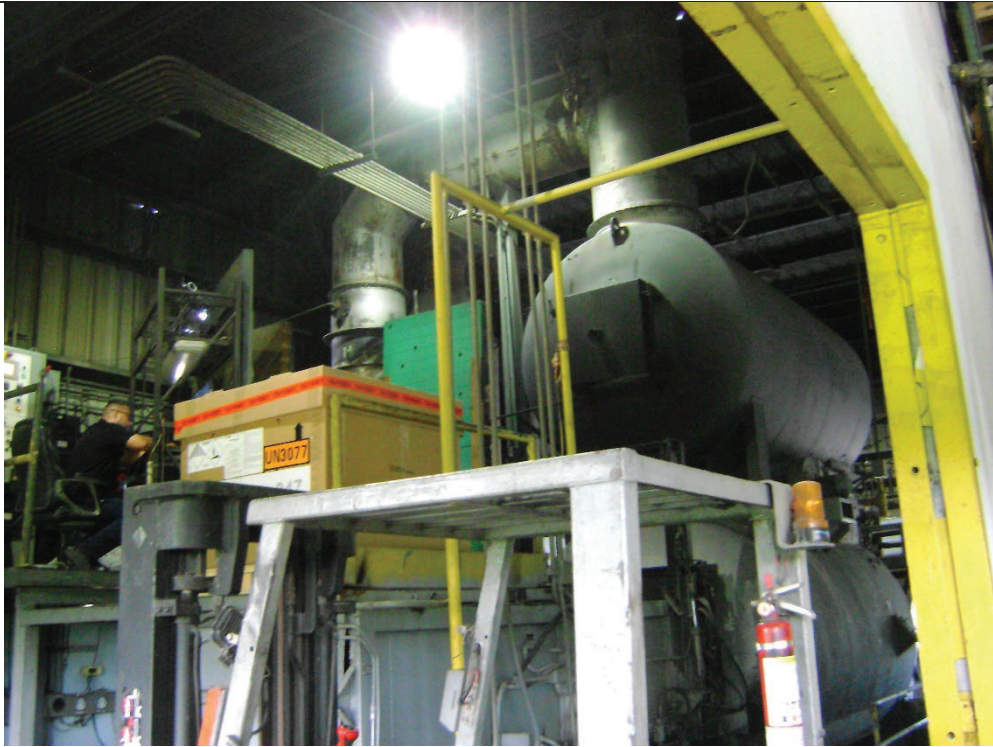
ordered one of the operators to operate the incinerator. The operators placed cardboard boxes that appeared to be empty into the incinerator chamber to burn.

| 15 | DSC01243.JPG | <p data-bbox="537 932 968 959">Waste being loaded into incinerator.</p> | 2/12/2024 | 11:54 am |

| 16 | DSC01244.JPG | <p>Waste being loaded into incinerator.</p> | 2/12/2024 | 11:54 am |

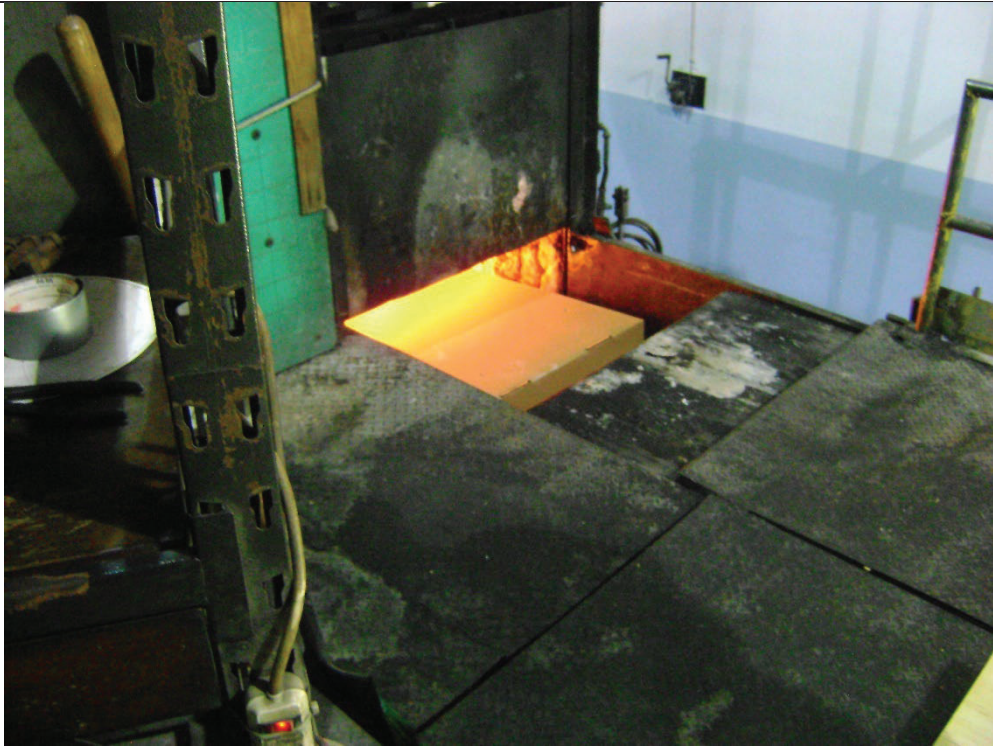
| | | Waste being loaded into incinerator. | | |

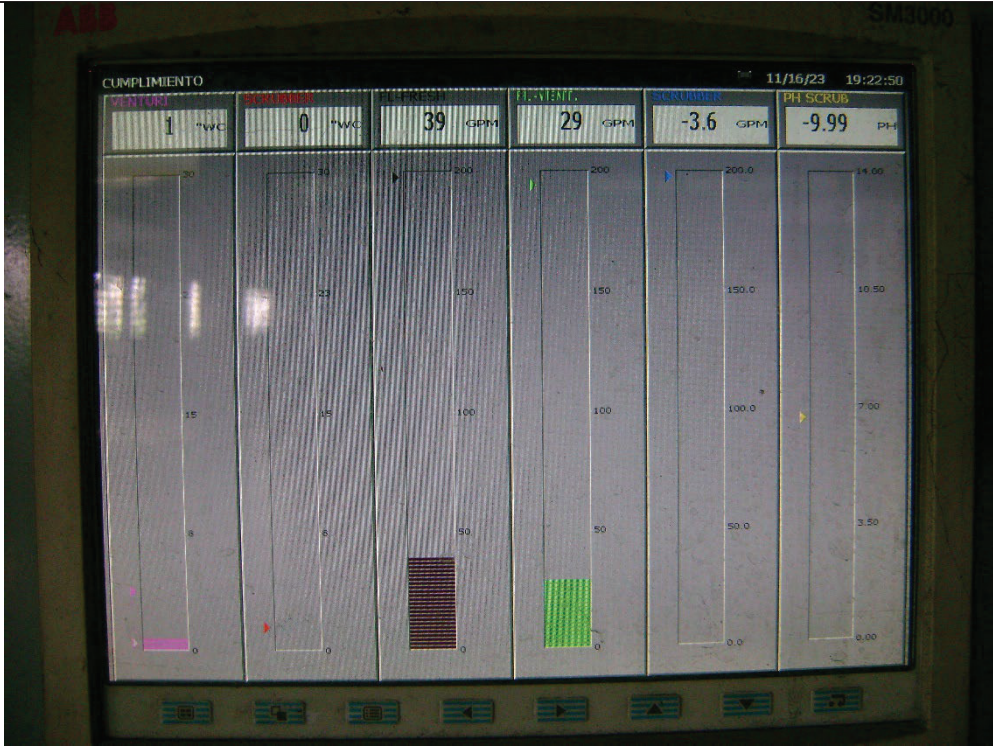
| 18 | DSC01246.JPG | <p>Monitoring screen indicating pressure drop across the venturi and the scrubber, flow rates through the incinerator and scrubber, and scrubber water pH. Photo taken after waste was added to the incinerator. Date and time shown on screen are inaccurate.</p> | 2/12/2024 | 12:15 pm |

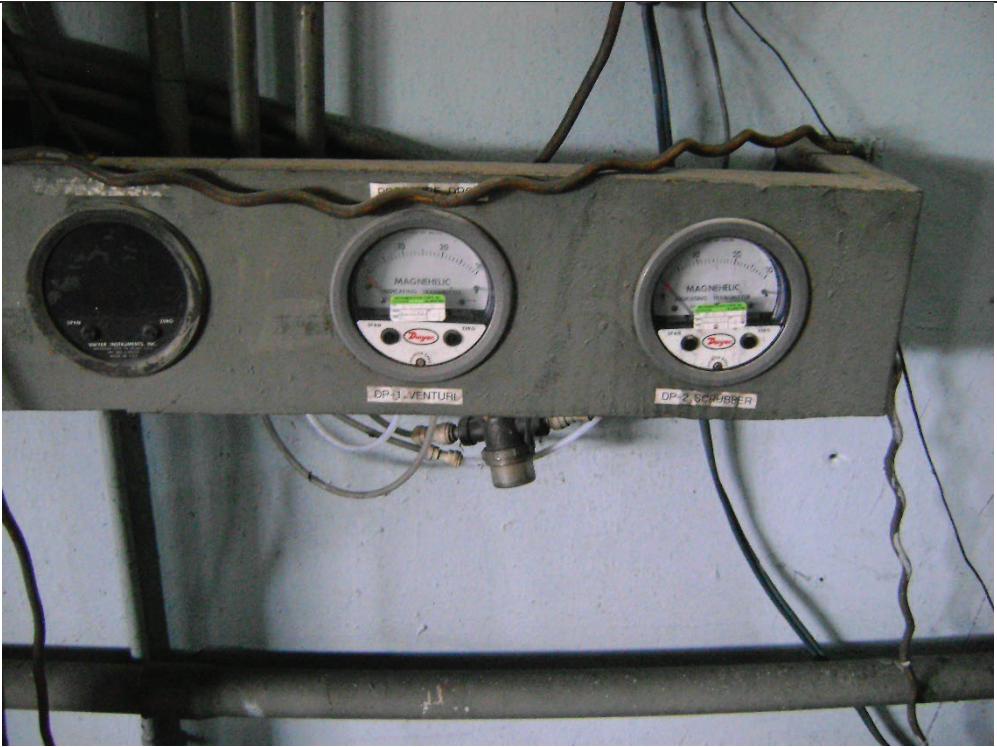
| 19 | DSC01247.JPG | <p data-bbox="537 933 1528 993">Differential pressure gauges for venturi and scrubber. Both gauges read 0 inches of water. Photo taken after waste was added to the incinerator.</p> | 2/12/2024 | 12:15 pm |
