**Region 6 - Enforcement & Compliance Assurance Division**  
**INSPECTION REPORT**

| Regulatory Program(s) | Clean Water Act-National Pollution Discharge Elimination System (Brine) | |
| Company Name: | <b>Calgary Energy, LLC</b> | |
| Facility Name: | <b>Tidal Osage</b> | |

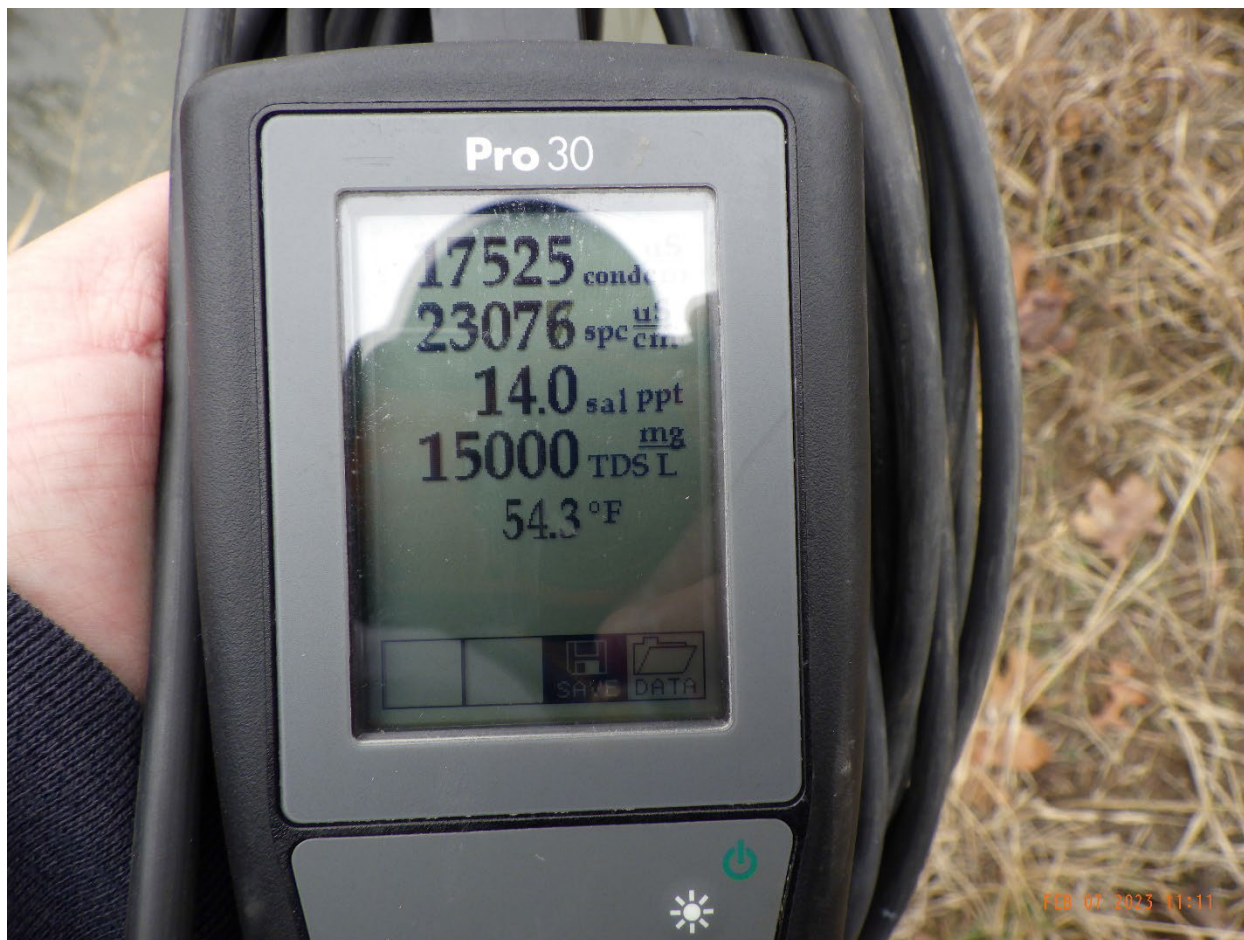
I observed and elevated TDS field reading of 15,000 mg/L (GPS 36.5384, -96.4157) in the main channel of the impacted tributary of Little Hominy Creek, this field reading is documented in Photo No. 1 of Appendix 1 (Photo Log). This was the highest observed TDS field reading of the inspection.

**Description:** This was an elevated TDS field reading of 15,000 mg/L taken in the main channel of the impacted unnamed tributary of Little Homing Creek.

At the time of the inspection, there were no cleanup activities underway. Calgary Energy, LLC should ensure an appropriate amount of manpower is maintained daily along the impacted area. Calgary Energy, LLC should continue removing elevated TDS waters from the impacted tributary. The flowpath from the release point to the point of entry should be cleaned. Cleanup activities should continue until background TDS readings are observed along the impacted tributary.

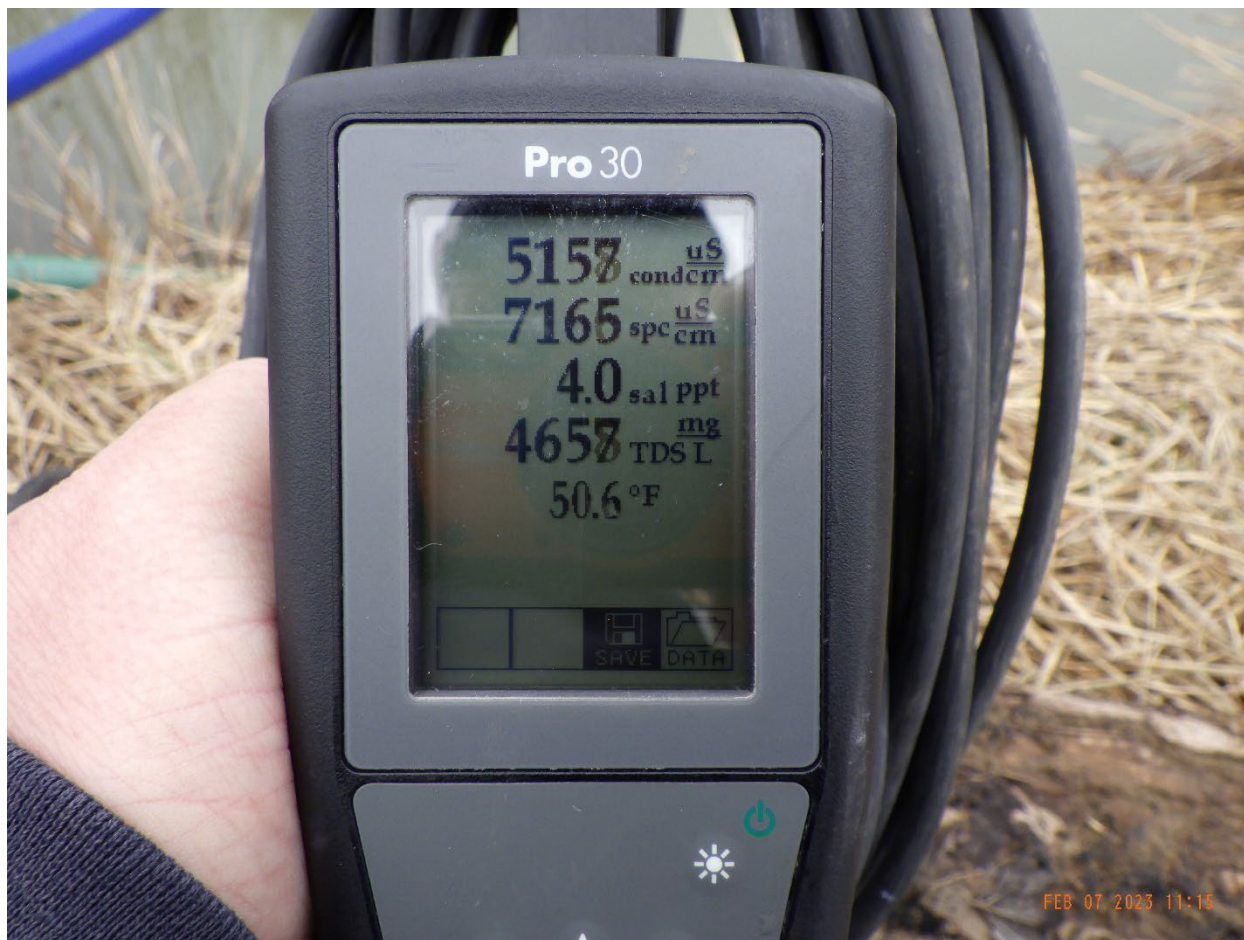
Photo No. 2

Continuing downstream, I observed an elevated TDS field reading of 4,657 mg/L (GPS 36.53833, -96.41504) in the main channel of the impacted tributary.

**Description:** This was an elevated TDS field reading of 4,657 mg/L taken in the main channel of the impacted tributary.

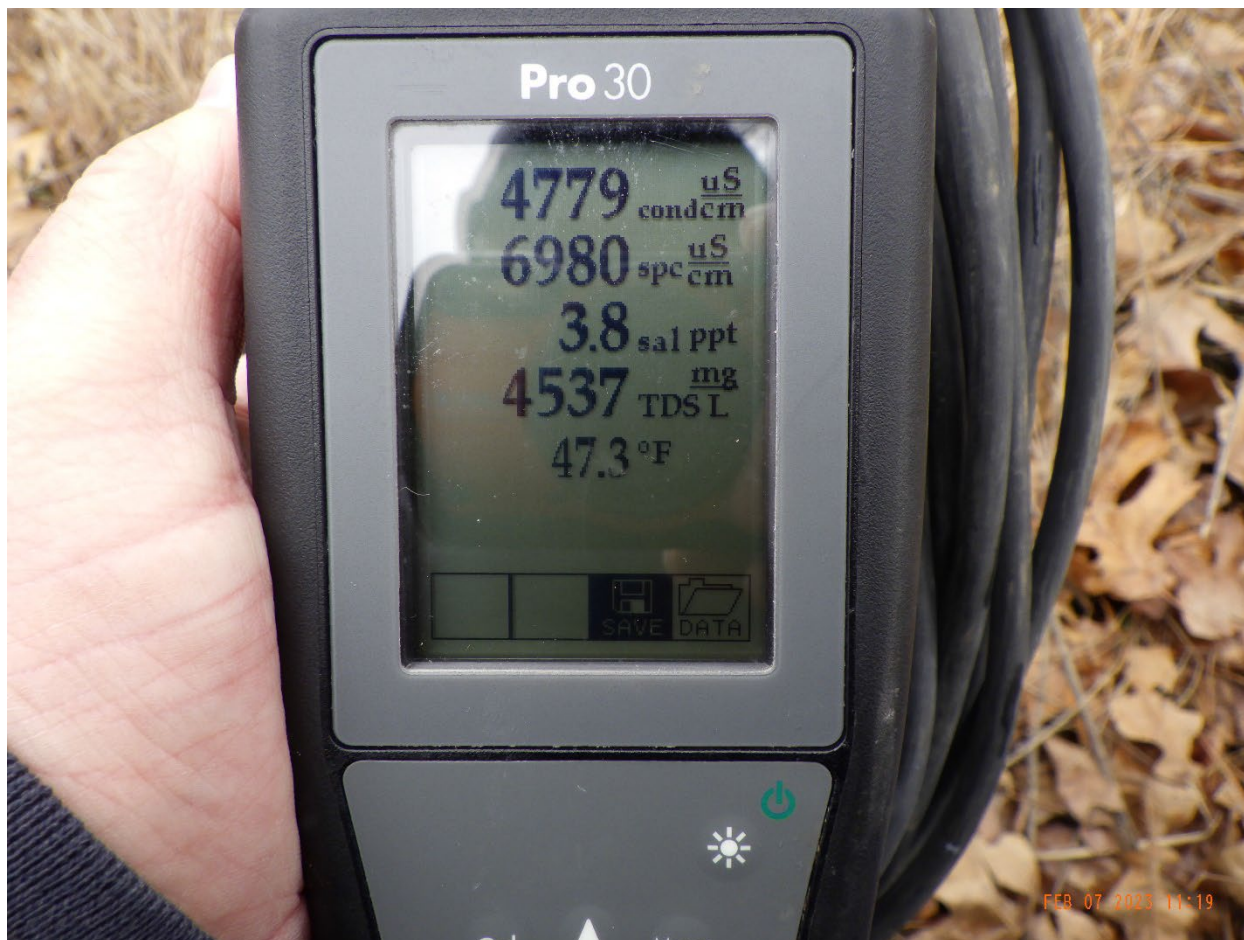
Photo No. 3

I observed and elevated TDS field reading of 4,537 mg/L (GPS 36.53749, -96.41419) along the impacted tributary.

**Description:** This was an elevated TDS field reading of 4,537 mg/L taken in the main channel of the impacted tributary.

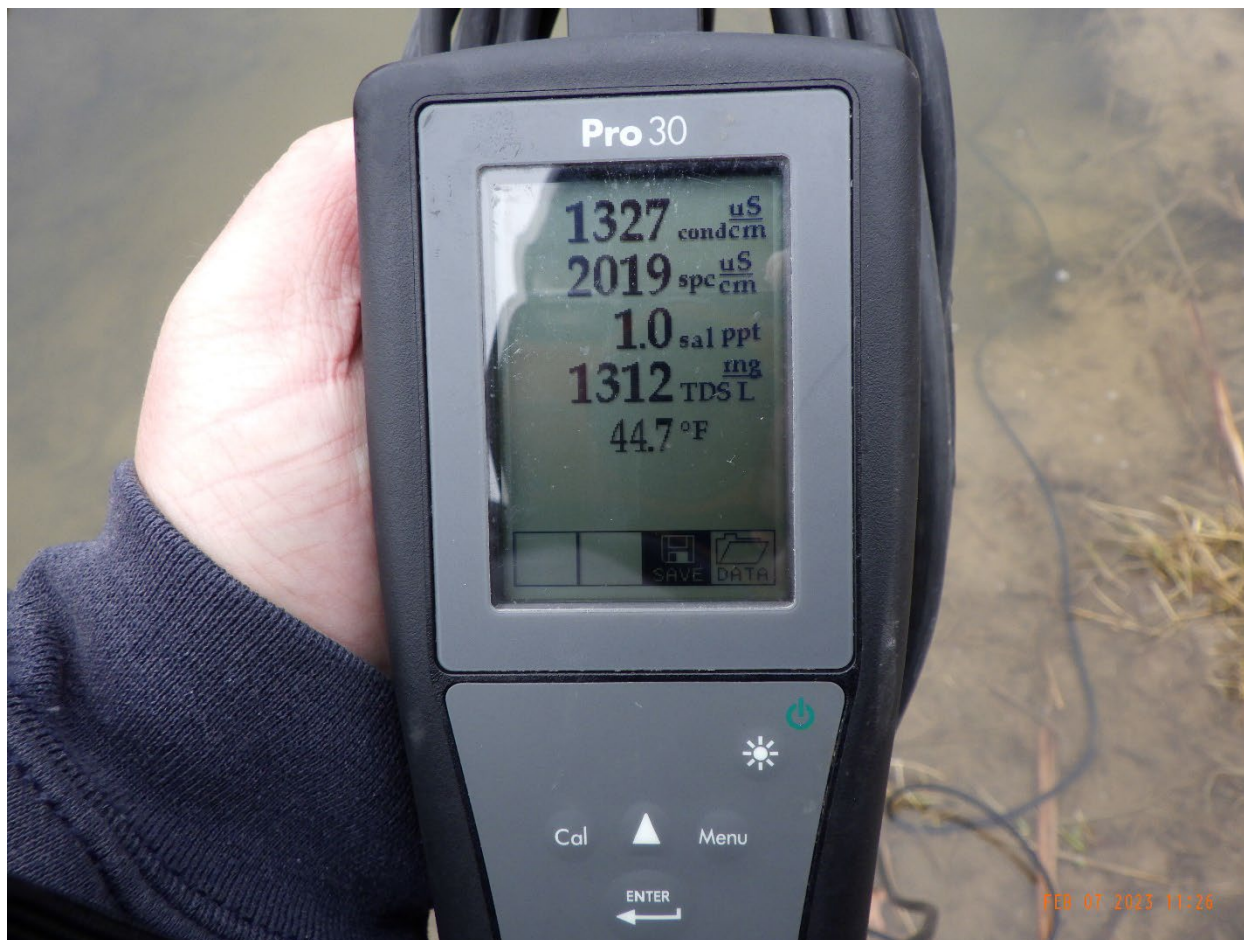
Photo No. 4

At the lowermost temporary containment dam, I observed a TDS field reading of 1,312 mg/L (GPS 36.53725, -96.4131) in the unnamed tributary. This represented the lowest observed TDS field reading of the inspection.

**Description:** This was a TDS field reading of 1,312 mg/L taken at the lower containment dam which had been place by the operator to prevent further downstream migration of impacted waters.
