**UNITED STATES ENVIRONMENTAL PROTECTION AGENCY, REGION 2
CARIBBEAN ENVIRONMENTAL PROTECTION DIVISION
MULTIMEDIA PERMITS AND COMPLIANCE BRANCH**

**NPDES Stormwater Inspection
Industrial Site**

CHITOLIE TRUCKING SERVICE, LLC

Inspection Date: March 30, 2023

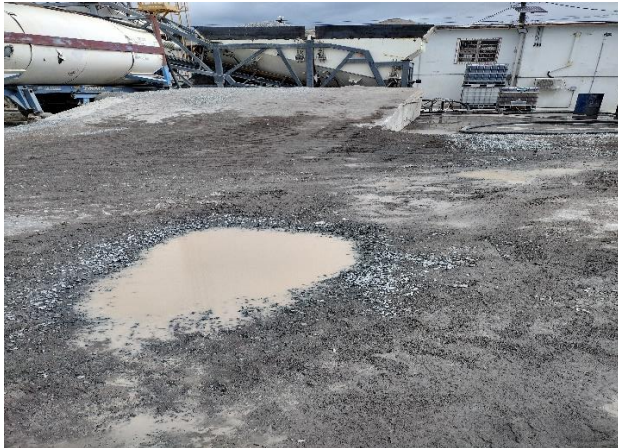
1. ***Potential for Transport of Sediment from Accumulated Residues on Materials Loading Ramp of the Ready-mixed Concrete Plant*** – Observed an accumulation of raw materials (sand, gravel, and cement) on the loading ramp, which is situated where the accumulated material residues on and off the loading ramp are in the flow path of storm water draining resulting in wash-off the residual materials off-site. See **IMGs 1571 and 6838 of CHITOLIE’S March 30, 2023 NPDES SWI Photo Album, ATTACHMENT 3**, of the 2023 Inspection Report.

IMG 1571-Materials build-up on and off-loading ramp of the RMCP and in path of stormwater flow.

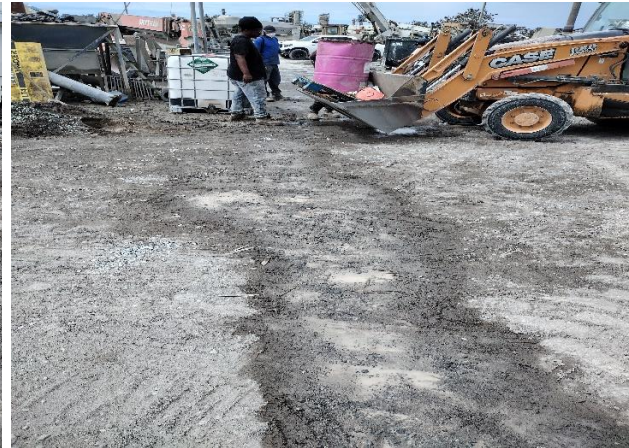
IMG 6838-Dry-weather flow from area of RMCP towards central area of Facility carrying pollutants.

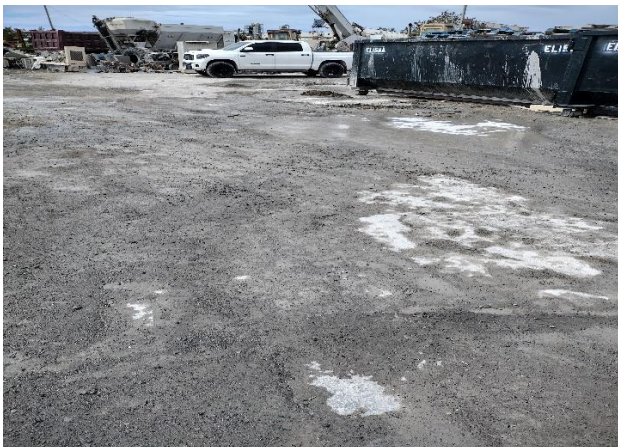
IMG 6352-Dry-weather flow through central area of Facility.

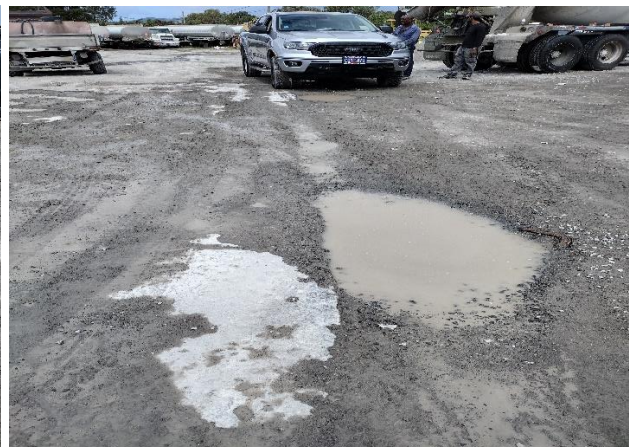
IMG 9313-Continuation of dry-weather flow going into central section of the Facility, before draining to towards the lower entrance and into the road.

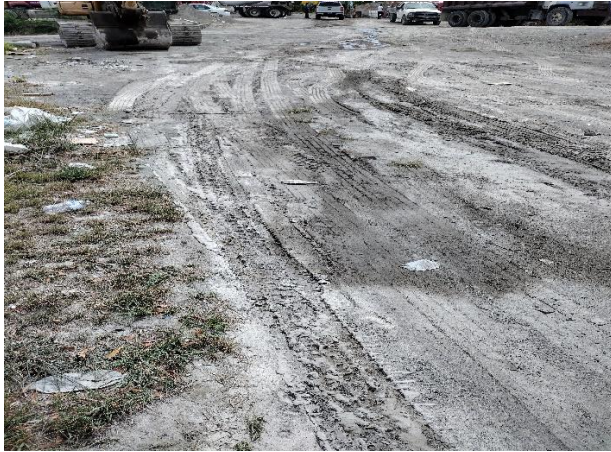
IMG 5839-Continuation of stormwater flow path through the central section of the Facility.

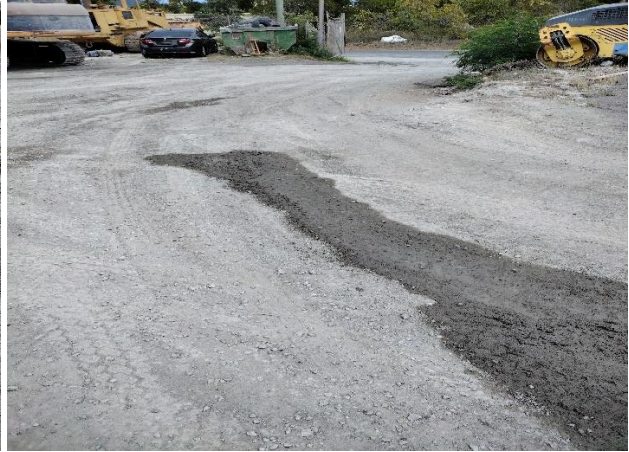
IMG 9755-Evidence of dry-weather flow draining to the lower entrance (Outfall 2) captured during the 2023 Inspection.

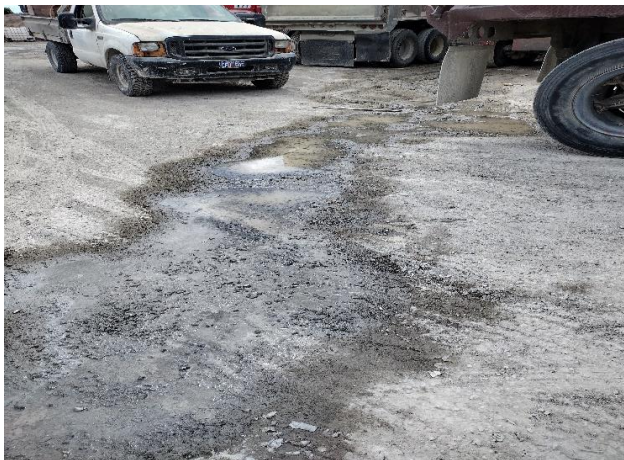
IMG 6346-Dry-weather flow draining from central Section and towards northwest corner of Facility.

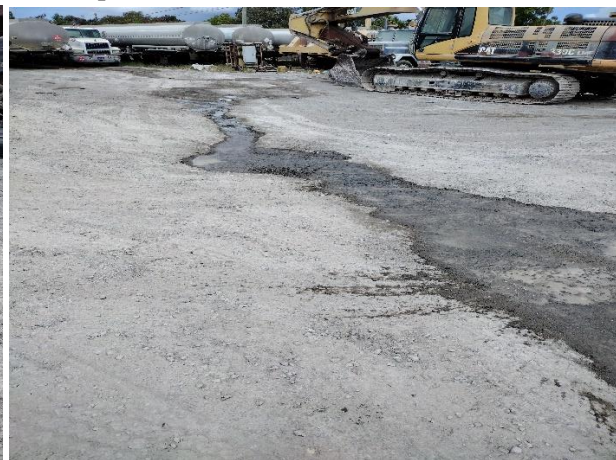
IMG 6639-Dry-weather flow draining along the ground towards the northwestern corner of the Facility.

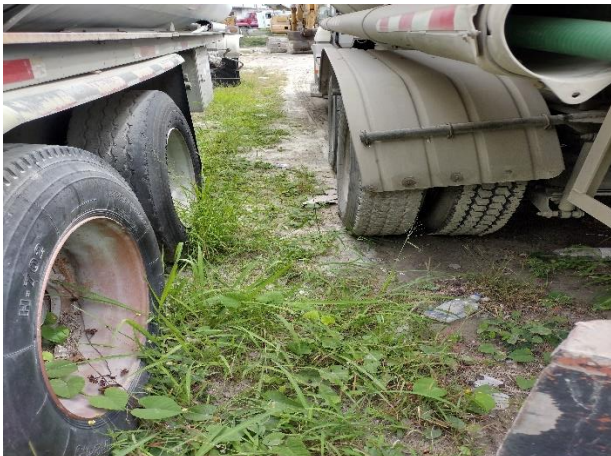
IMG 6958-Evidence that process wastewater flows from mid-section of Facility reaches the northwest corner.

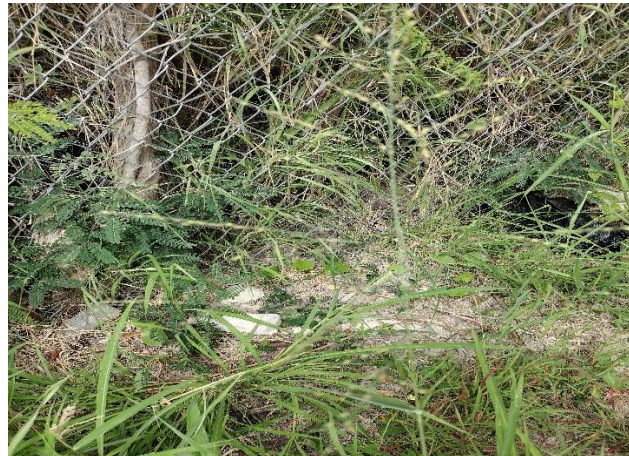
IMG 8205-Point at the fence line in the northwest of Facility where wastewater stream is discharged off-site.

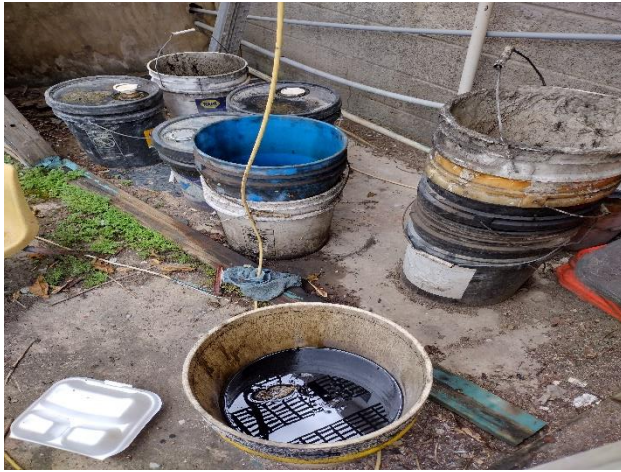
Failure to situate the containers of wastes described in sub-paragraphs c.ii. 1 and 2, immediately above within an appropriate containment, increases the potential for releases of the pollutants in the event of accidental spills caused by traffic in and out of the shed. This concern is supported by **IMGs 0229, 5353, 0136, 1437 and 5926 of CHITOLIE’S March 30, 2023 NPDES SWI Photo**

IMG 0229-Containers with engine fluids from auto and equipment maintenance on-site. Containers were exposed to all environmental conditions.

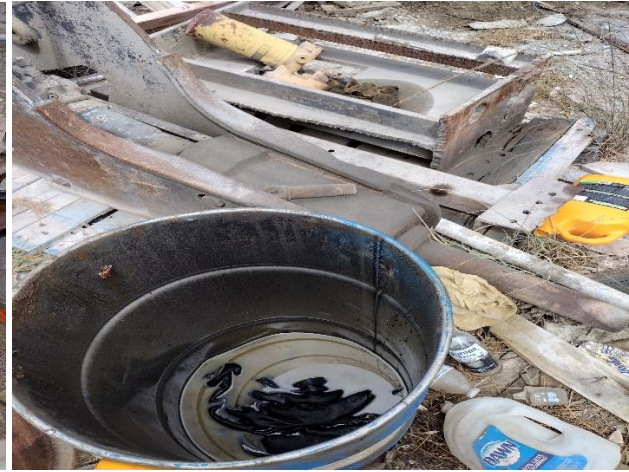
IMG 5353-Close-up of container with wastes and exposed to all environmental conditions.

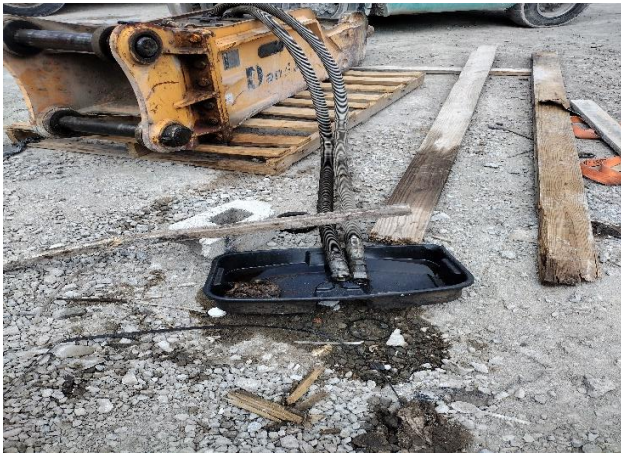
IMG 0136-Close-up view of equipment repair occurring in the open. Spilled oil-based fluid onto ground.

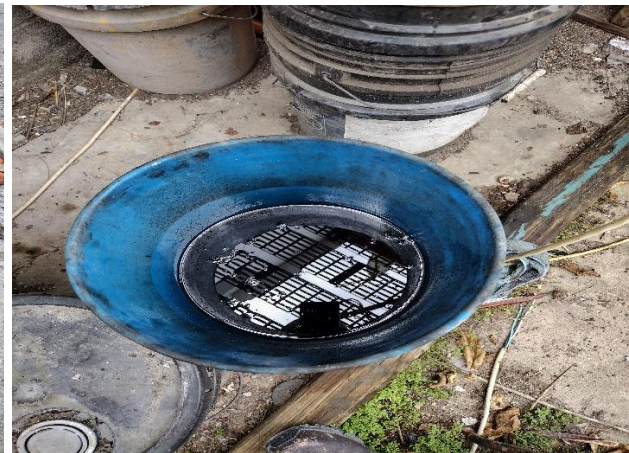
IMG 1437-View of oil-based fluid removed from engines and equipments under maintenance on-site.

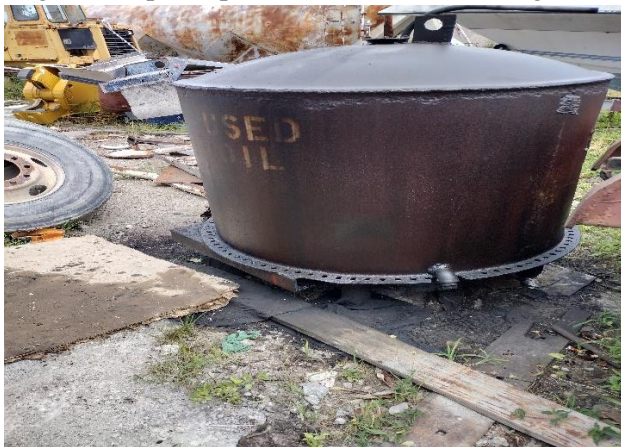
1. ***Failure to Minimize the Potential for Release of Spilled Used-oil*** – As was observed at the time of the 2022 Inspection, similar concerns were observed on this occasion regarding a large metal tank in which Chitolie stores used oil generated from maintenance servicing of its fleet of trucks, other vehicles, and heavy equipments. The used oil storage tank was still not within a containment. In addition, the EPA Inspector observed that the tank was situated in different location on this occasion of the Facility, and that, the ground area around the tank appeared heavily saturated from spilled oil residues.

IMG 5926-View of Facility's used-oil storage tank. The ground beneath the tank appeared very saturated from used oil spilled.

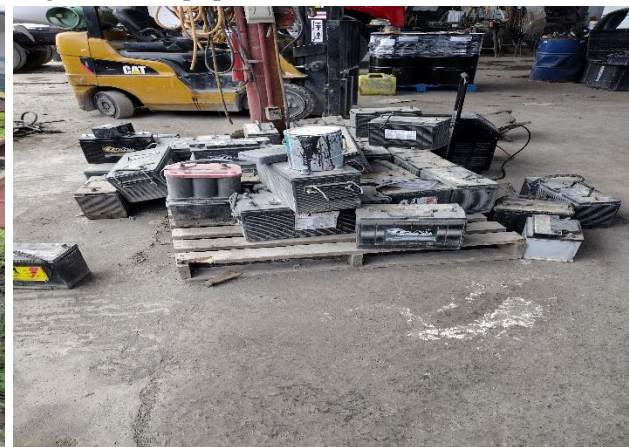
3. ***Improper management of regulated hazardous wastes*** – As was observed during the 2022 Inspection, similarly, on this occasion of the 2023 Inspection, the EPA Inspector observed an accumulation of spent automobile batteries staged on the floor of the maintenance shed where the Facility's vehicle fleet and heavy equipments are serviced. Some of the spent batteries were situated in a manner that could be impacted by traffic in and out of the maintenance stalls, leading to accidently releases of waste from impacted battery units. See **IMG 3264 of CHITOLIE'S March 30, 2023 NPDES SWI Photo Album, ATTACHMENT 3**, of the 2023 Inspection Report.

IMG 3264-Collection of spent batteries staged at front of the maintenance shed.

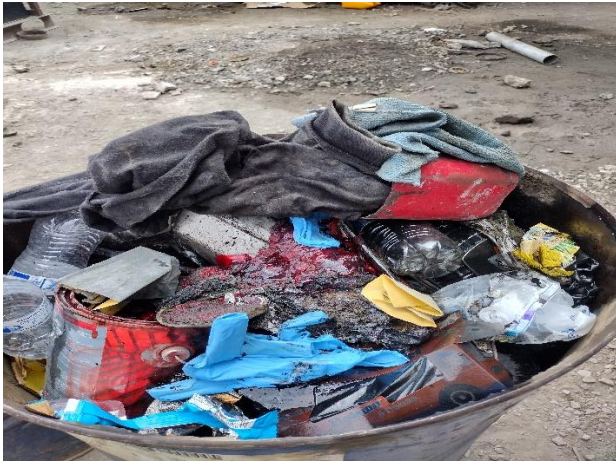
4. ***Improper disposal of potentially regulated wastes*** – Observed oily-soaked rags, gloves, and paint residues mixed with generated refuse and discarded into a 55-gallon metal drums staged just outside of the maintenance shed. According to Mr. Chitolie, wastes collected in the metal drums in question are disposal as regular garbage. See **IMG 8603 of CHITOLIE'S March 30, 2023 NPDES SWI Photo Album, ATTACHMENT 3**, of the 2023 Inspection Report.

IMG 8603-Close-up view of oil-soaked rags. Paint residues discarded among regular garbage.

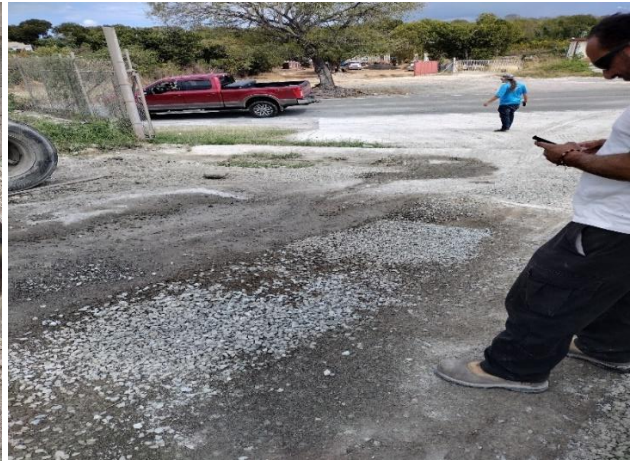
2. ***Discharge of Pollutants from Ready-Mixed Concrete Residues Spills in the Product Loading Bay*** – Observed residue of ready-mixed concrete and wastewater that flow through the product loading bay and that drains-off beyond a concrete berm, and eventually into the nearby road. See **IMGs 6690, 2419 and 6311 of CHITOLIE’S March 30, 2023 NPDES SWI Photo Album, ATTACHMENT 3**, of the 2023 Inspection Report.

IMG 6690-Product loading bay and flow path into Outfall 1. Ready-mixed concrete residues, exposed to storm water runoff.

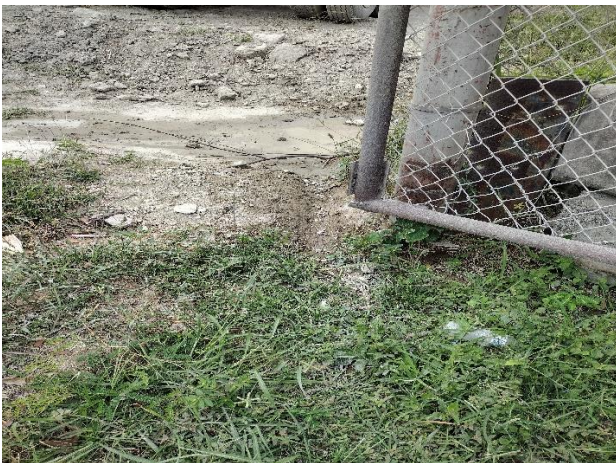
IMG 2968-Close-up view of drainage point where ready-mixed concrete, wash water and stormwater runoff flow drains-off at end of installed berm.

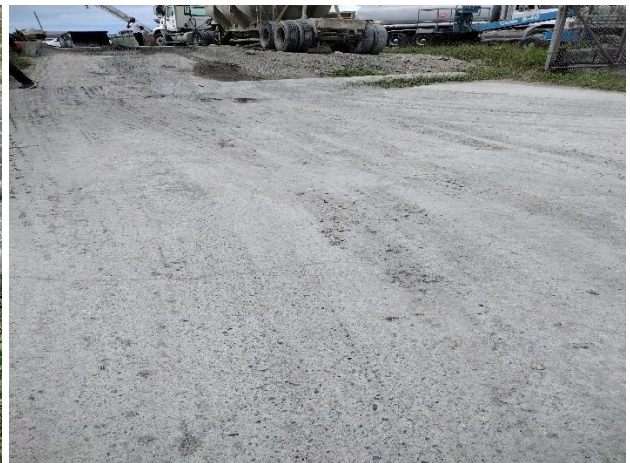
IMG 2419-Entrance/exit into product loading bay. Ready-mixed concrete residues cover the pavement, and exposed to all environmental conditions.

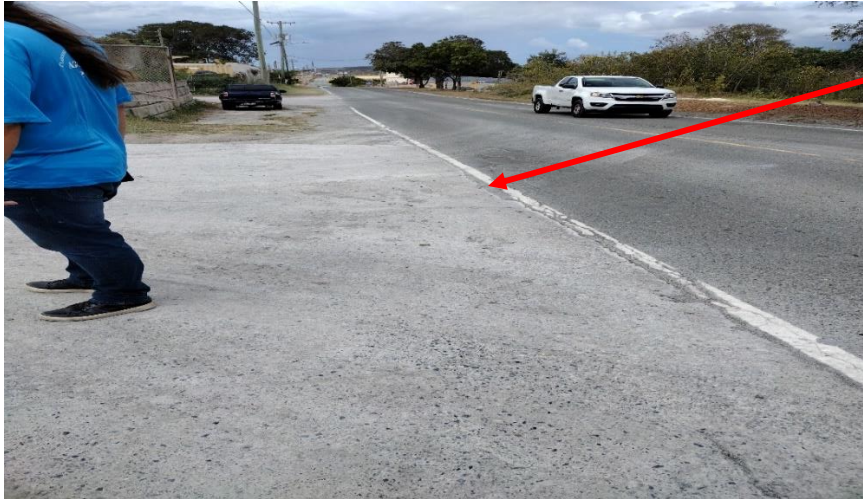
- **Outfall 1** – Storm water runoff flow from areas around the administrative office building and the RMCP through the upper entrance/exit used to access the RMCP product loading bay. Outfall 1 is featured in **IMG 6607 in Part B of CHITOLIE’S March 30, 2023 NPDES SWI Photo Album, ATTACHMENT 3**, of the 2023 Inspection Report.
- **Outfall 2** – Storm water runoff flow through the central section of Facility and through the lower entrance/exit. Also observed that a dry-weather discharge was occurring and draining towards the entrance/exit. Outfall 2 is featured in **IMG 3694 in Part B of CHITOLIE’S March 30, 2023 NPDES SWI Photo Album, ATTACHMENT 3**, of the 2023 Inspection Report.

Outfall 1 – Discharge of stormwater flow from the upper driveway into area storm water drainage system, then into Cane Garden Bay.

IMG 6607-Upper exit from Facility. Location where trucks loaded with Ready-mixed concrete leave Facility to deliver product to field sites. Point where dry-weather flows observed occurring and evidence of industrial storm water discharges.

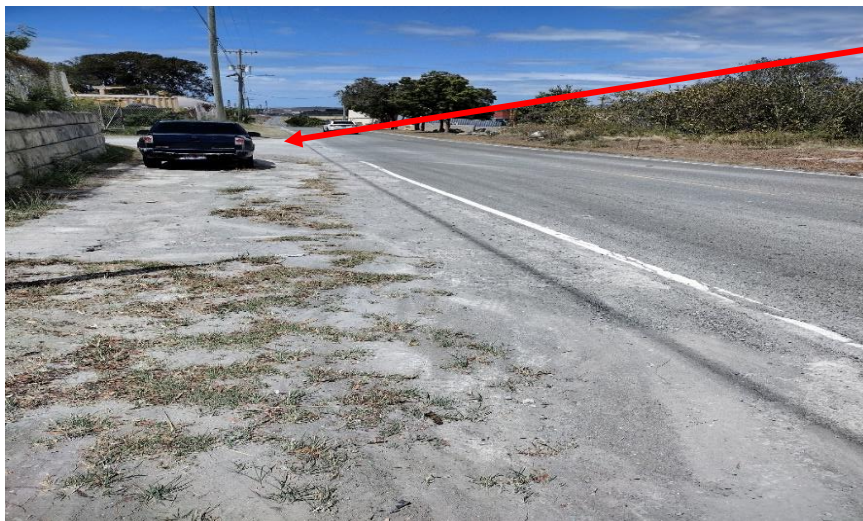
Outfall 2 – Discharge of storm water flow from the upper driveway into area stormwater drainage system, then into Cane Garden Bay.

IMG 3694-Lower entrance/exit of the Facility. Location where most of traffic into and out of the Facility occur. Point where dry-weather flows observed occurring and evidence of industrial storm water discharges.

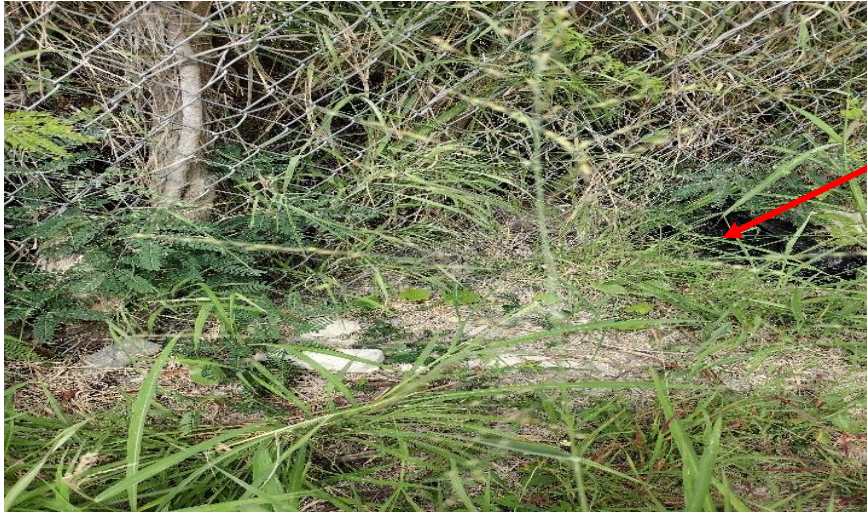
- **Outfall 3** – Stormwater runoff flow from the central section of the through the chain-link fence along the northwestern corner boundary of the Facility. Outfall 3 is featured in **IMG 8205 in Part B of CHITOLIE’S March 30, 2023 NPDES SWI Photo Album, ATTACHMENT 3**, of the 2023 Inspection Report.

Outfall 3 – Discharge of storm water flow at a point along the northwestern corner into an adjacent lot. Stormwater runoff drains towards Cane Garden Bay.
