*Resource Conservation and Recovery Act (RCRA) Compliance Evaluation Inspection (CEI)*  
*Quality Electroplating Corp.*  
 PRD090592544

*Resource Conservation and Recovery Act (RCRA)*  
 Compliance Evaluation Inspection (CEI)

<b>Facility Name:</b>		<b>Quality Electroplating Corp.</b>					
<b>EPA ID Number:</b>		<b>PRD090592544</b>					
<b>Completion Date:</b>		<b>March 30, 2023</b>					
Generator Status in Record:		Large Quantity Generator					
RCRA Permitted:		No					
Corrective Action:		No					
Project ID		CEPD-RCRA-08-0090					
Basis for Inspection:		Core Program (Conducted during the COVID-19 pandemic timeframe.)					
<b>Facility Personnel:</b>							
Name:	Title:	Email:	Phone:	Attend to:			
				OM <sup>1</sup>	FW <sup>2</sup>	DR <sup>3</sup>	CM <sup>4</sup>
Ms. Jeannette Miranda	ES <sup>5</sup> Manager	<a href="mailto:jeannettemirandapr@hotmail.com">jeannettemirandapr@hotmail.com</a>	787-743-0825	√	√	√	√
<b>EPA Personnel:</b>							
Inspector's Name		EPA Region 2-CEPD	Enforcement Officer	phone/email			
Ms. Rosana Caballer-Cruz		EPA Region 2-CEPD	Enforcement Officer	787-977-5880/ <a href="mailto:caballer.rosana@epa.gov">caballer.rosana@epa.gov</a>

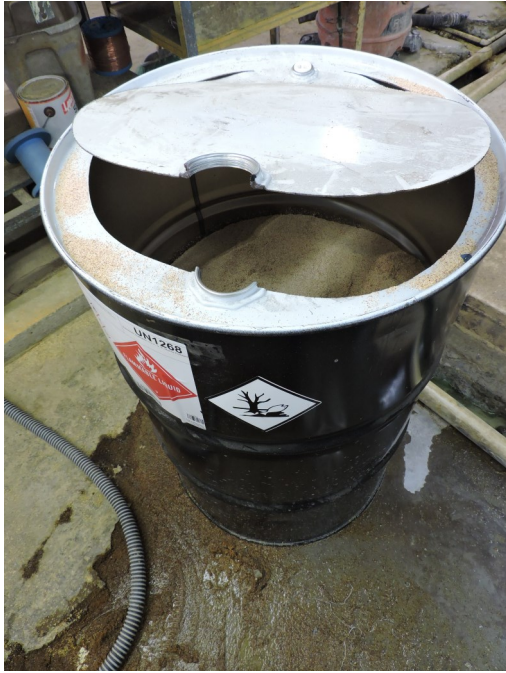
Here, one (1) 55-gallon steel container was observed with a flammable liquid label (Picture #1). I asked Ms. Miranda about this container since, at the time of the inspection, it was being used to store sand in order to dry the pieces already manufactured. As a result, I asked her how this sand is handled and disposed of and if any hazardous waste determination has been made. She replied that, by knowledge, they have determined that the content in this container was not hazardous waste, and they dispose of the latter as regular waste. Also, she told me that this was not the correct container to store the sand and requested one of her employees to change the container.

Picture 1 — Tin Subarea— Here, one (1) 55-gallon steel container was observed with a flammable liquid label. This container was being used to stored sand in order to dry the pieces already manufactured.

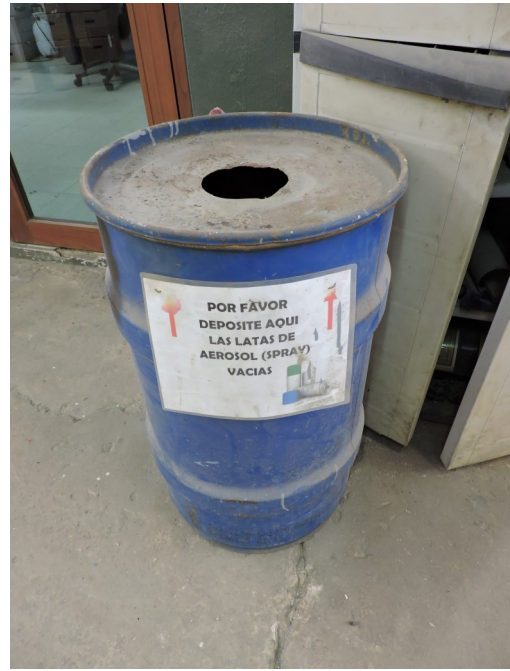
Also identified as a maintenance area, here, a 30-gallon container was observed. The latter was labeled as Empty Aerosol cans and was observed open, with mixed regular waste<sup>16</sup> and aerosol cans (Picture #2), A pictographic label and/or indication of the hazard was not observed. The container was observed dirty, as well. I asked the facility representative about the hauler company that provides the pickup services. She replied that Stericycle is the hauler company that collects this container. She also mentioned that this container would be collected by the hauler company as universal waste. Nevertheless, at the time of the inspection, the container was not observed labeled as universal waste. In addition, according to information gathered at this subarea, it seems that the facility personnel are treating this subarea as a Satellite Accumulation Area (SAA). As a result, I shared with her information related to the SAA requirement during the CEI and, in addition, told her that additional information would be sent to her for future reference<sup>17</sup>.

At the time of the inspection, the facility failed to comply with this requirement in the Mechanical shop subarea and at the 90-day HWAA. At the Mechanical shop subarea, a 30-gallon container was observed labeled as Empty Aerosol cans, but without the pictographic label nor the indication of the hazard. At the 90-day HWAA, several containers were without the pictographic label nor the indication of the hazard, such as the ones observed at the SAA HW-2 subarea, at the Characterization in progress subarea, and the Silver sludge subarea.

Picture 2 — Mechanical Shop Subarea— Here, a 30-gallon container was observed. The latter was labeled as Empty Aerosol cans and was observed open, with regular waste mixed with aerosol cans.

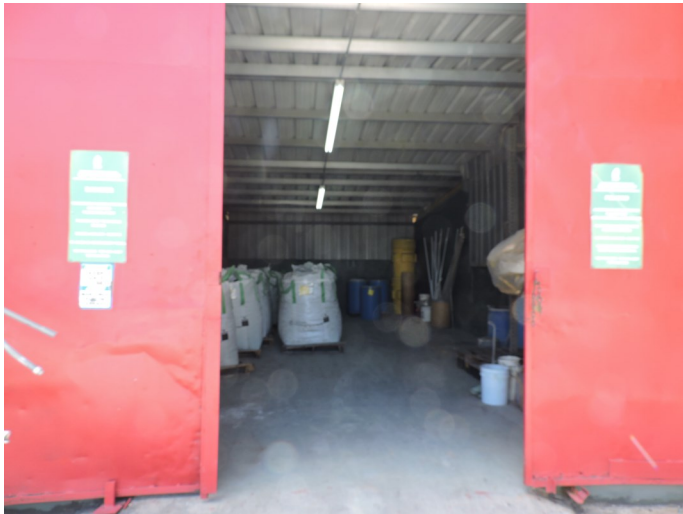
The area consists of a concrete floor and half concrete walls (lower)/half galvalume wall (upper) and ceiling. The area was labeled as hazardous waste and the phone number and schedule are available (Picture #3). Emergency equipment, such as an eyewash station, fire extinguisher<sup>19</sup>, and mainline phone<sup>20</sup>, were also observed. The area was observed without aisle space<sup>21</sup>, I asked Mr. Lopez about an alarm. He showed me the alarm and, according to him, it is operational and functional. Also, I asked about the log and the number of employees that are authorized to work in this area. According to them, this area's log is available at the WWTP area, and currently two (2) additional employees are granted to access this area.

Picture 3 — 90-day Hazardous Waste Accumulation Area (HWAA) - Zoom-out of the area that is used to store the hazardous waste generated at the facility.

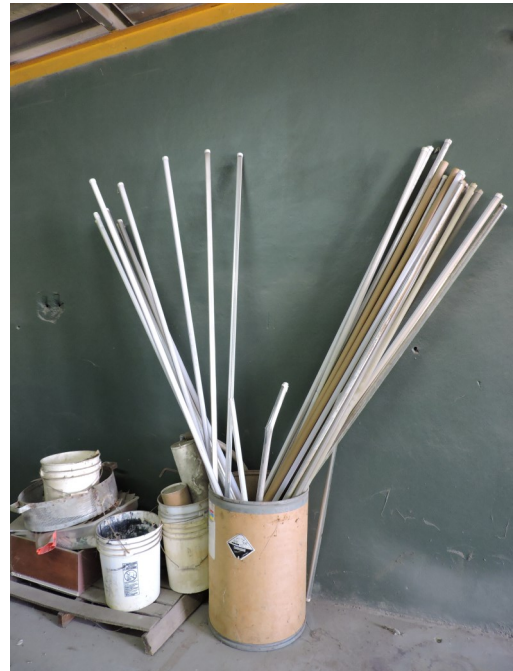
Here, one (1) cardboard container was observed with approximately 30 lamps (Picture #4). The container was observed open and with a corrosive pictographic label. Nevertheless, a hazardous waste label or hazardous waste or universal waste markings were not observed. The container was not observed dated, as well, and both containers and lamps were observed dirty and with spider webs. I asked them about the lamps, and they told me that these were not fluorescent lamps, that they were LED lamps. According to the facility representatives, they told me that although their hauler company is Stericycle, the hauler company have told them that they do not pick up this type of waste. I told them that additional information on the latter would be requested.

Picture 4 — SAA HW-1 subarea— Here, one (1) cardboard container was observed with approximately 30 lamps. The container was observed open, and with a corrosive pictographic label.

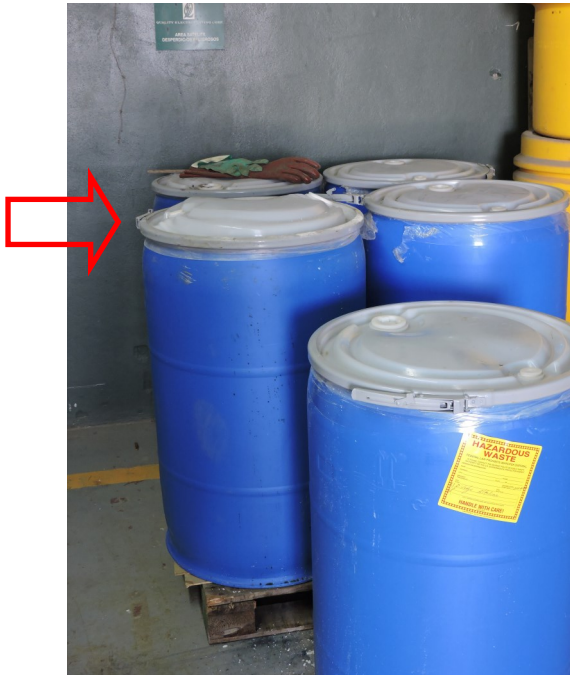
Here, five (5) 55-gallon blue plastic containers were observed. Four (4) of them were placed above a wood panel and one was observed above the concrete floor. The one on the concrete floor was observed labeled as hazardous waste, nevertheless, a pictographic label or indication of the hazard were not observed. It was closed and dated 3/12/2023.

The other four (4) 55-gallon containers above the wood panel were observed without labels, with no pictographic label or indications of the hazard, and no information related to the date. In addition, although four (4) of them were closed, one of them was observed swollen (Picture #5). I asked the facility representatives about the four containers in order to obtain additional information about them. When I asked why these four containers did not have a hazardous waste label, pictographic label and/or indication of the hazard, and no information related to the date available, Mr. Lopez told me that he uses the information available in the container observed above the concrete floor to then fill out the information of the other four (4) at a later date. When I asked about the swollen container and why it was in such condition, they replied that they did not know. Then, Mr. López attempted to open the swollen container to release pressure from one of the small holes available in the container's lid. By the time of this action, we were very close to it, and I told Mr. Lopez that this was not a safe action to do. Nevertheless, he continued to open the container. Just after, I started to hear what appeared to be the release of the gas<sup>22</sup> that had been accumulating in this container. This action was taken in front of me and front of Ms. Miranda, the facility's Environmental & Safety Manager.

9. Maintenance and operation of facility- At the time of the inspection, Mr. Lopez, without any previous notice or any safety protocol, took an unplanned and unwarranted action with a swollen 55-plastic container, that was not labeled, without a pictographic label or indication of the hazard and with no information whatsoever of why this container was

Picture 5 — SAA HW-2 subarea— Here, five (5) 55-gallon blue plastic containers were observed. Just one of them was labeled as hazardous waste, nevertheless, a pictographic label nor indication of the hazard was not observed. One of them was observed swollen.

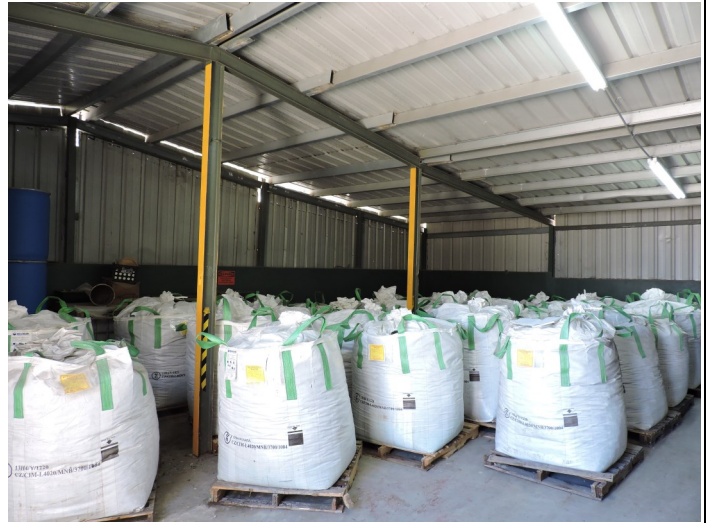
Here, a lack of aisle space between the approximately thirty-two (32)<sup>23</sup> 2,000-lb bags was observed. By the time I gained access to the facility's 90-day HWAA, as a result of the lack of space, Ms. Miranda and I observed Mr. Lopez walking above the mentioned bags. Then, when I was inspecting this subarea, I asked the facility representatives about these bags, and Ms. Miranda told me that all the bags observed contained F006 (Picture #6). Due to a lack of aisle space, I was able to access only one of the bag's labels. It was labeled as hazardous waste, with the facility's EPA ID No., and also the F006 code and the hazardous waste solids, with a date of 2/15/2023. I asked the facility representatives if this information is accurate for the other bags. Ms. Miranda told me that the bags have different dates. I was not able to access nor confirm this information as a result of the lack of aisle space in this subarea.

7. Lack of aisle space – This condition was observed especially in the bags subarea, where approximately 32-2,000 lbs bags were observed without any aisle space. Inspection and information of each bag were not able to be conducted as a result of lack of space.

At the time of the inspection, the facility failed to comply with this requirement at the 90-day HWAA. Here, approximately thirty-two (32) 2,000-lb bags were observed without any aisle space. As a result, an inspection was not able to be conducted thru all the available bags and the information on each bag was not able to be gathered, as well. In addition, as a result of lack of space, I observed Mr. Lopez walking above some of the 2,000 lbs bags while he was working at the 90-day HWAA.

Picture 6— Bags subarea— Zoom-out of the subarea. Here, lack of space between the approximately 32 2,000-lbs bags were observed.

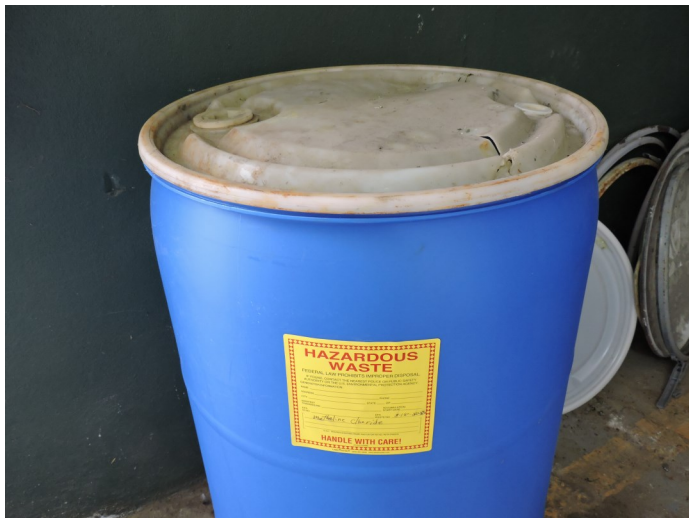
Here, a 55-gallon blue plastic container was observed. The latter had the hazardous waste label on it and the following information was available, as well: methylene chlorine, date on 3/18/2023. Nevertheless, a pictographic label and/or hazard information was not available. Also, the container was observed open and with its lid broken (Picture #7). I told them that additional information on the latter would be requested.

Picture 7 — Characterization in progress subarea—Here, a 55-gallon blue plastic container was observed. The container was observed open and with its lid broken.

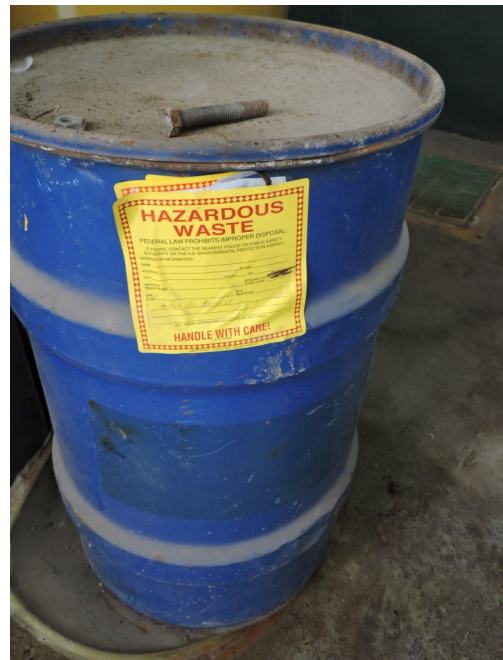
Here, a 20-gallon<sup>24</sup> blue steel container was observed. At the time of the inspection, the latter was labeled as hazardous waste and was observed empty and with dust (Picture #8).

Picture 8 — Aerosol can container subarea—Here, a 20-gallon blue steel container was observed. At the time of the inspection, the later was labeled as hazardous waste and was observed empty and with dust.

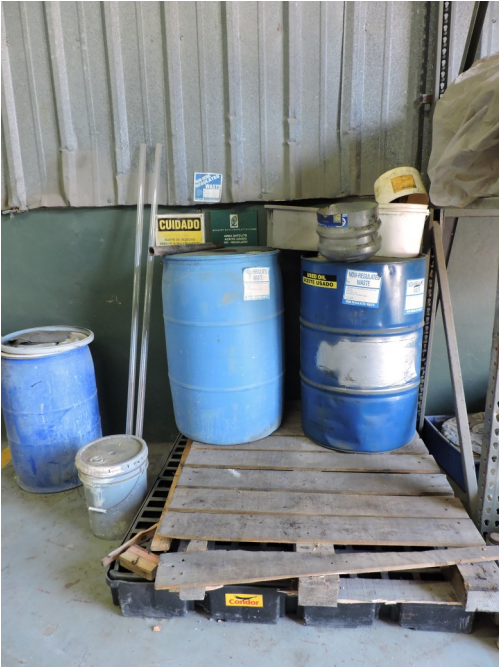
Here, one (1) 55-gallon plastic container and one (1) 55-gallon blue steel container were observed. At the time of the inspection, the 55-gallon plastic container was empty, while the 55-gallon blue steel container was observed labeled as used oil, and was labeled as non-regulated waste, as well (Picture #9).

Picture 9 — Used oil subarea—Here, the 55-gallon plastic container was empty, while the 55-gallon blue steel container was observed labeled as used oil, and was labeled as non-regulated waste, as well.

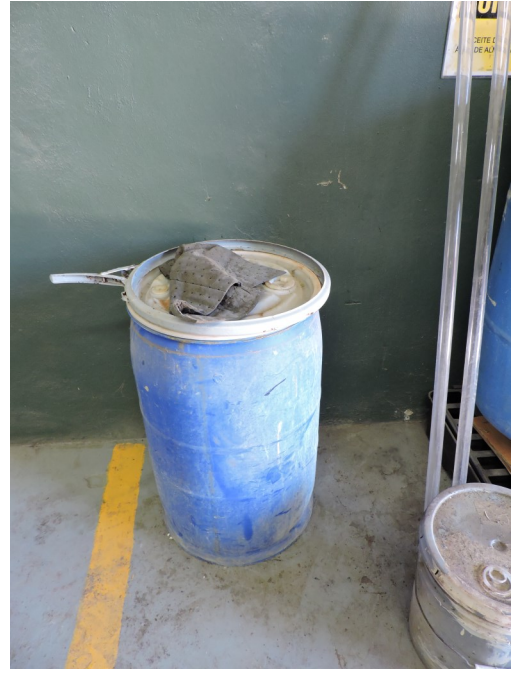
Here, according to Mr. Lopez, the container<sup>25</sup> observed in this area contains silver sludge. Nevertheless, at the time of the inspection, the latter was not labeled, no pictographic label and/or indication of the hazard was available, and the date was not available, as well (Picture #10). In addition, the container was observed open and dirty. When I asked about this container, they told me that it was misplaced in this area and that it was for silver recycling<sup>26</sup>. I asked if a hazardous waste determination was conducted, and they replied that such a determination had not been conducted. I told them that additional information on the latter would be requested.

Picture 10— Silver sludge subarea— This container was not labeled, a pictographic label nor indication of the hazard was not available, and the date was not available, as well. Nevertheless, it was informed by the facility representatives that the latter contains silver sludge.

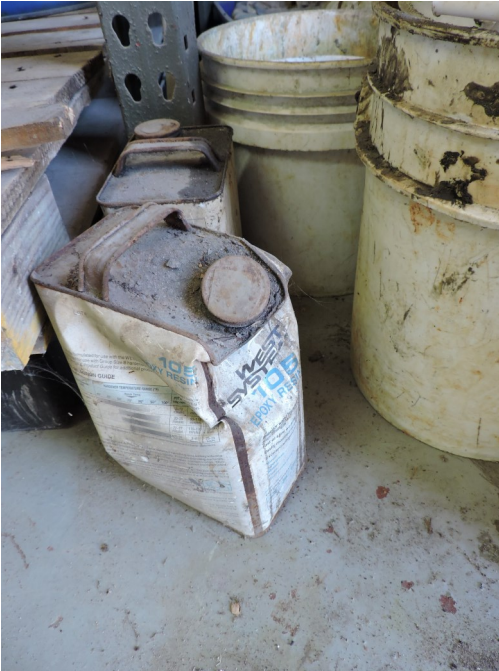
This was the last subarea identified. Here, two (2) containers<sup>27</sup> with epoxy resin were observed. At the time of the inspection, one of them was observed in bad condition, corroded and with dust (Picture #11). At the time of the inspection, it was not clear if these containers were in use or to be discarded.

Picture 11 — Epoxy subarea—Here, two (2) containers with epoxy resin were observed. At the time of the inspection, one of them was observed in bad condition, corroded and with dust.

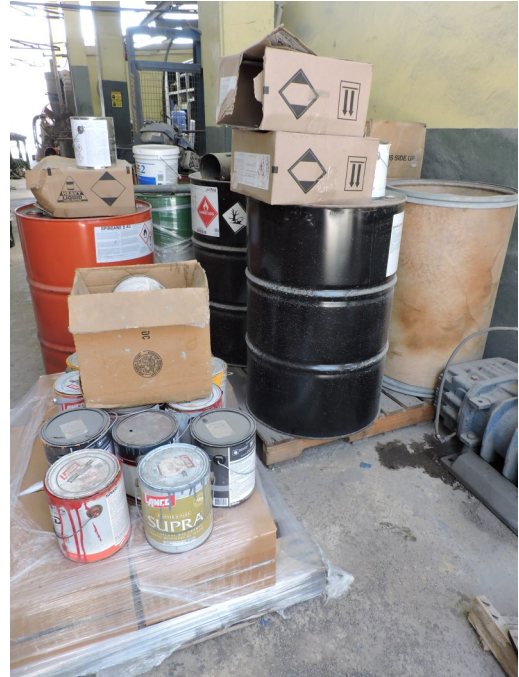
While walking from the 90-day HWAA to the WWTP Area, I observed an area with concrete floor and ceiling with approximately thirteen (13) 1-gallon paint containers. These containers were observed corroded and with dust (Picture #12). This observation was made in front of a cage-like area, which has a fence as a physical barrier, identified as “Inflamable”<sup>30</sup>. According to Ms. Miranda, all the containers observed were in use. In addition, a piece of mechanical equipment was observed within this area. At the time of the inspection, it appears that a leak<sup>31</sup> was observed on the area’s concrete floor. Spill equipment, such as absorbent material, was not observed nearby this equipment (Picture #13).

Picture 12 — In-front of flammable (cage-like) Area—While walking from the 90-day HWAA to the WWTP Area, I observed an area with concrete floor and ceiling with approximately thirteen (13) 1-gallon paint containers. These containers were observed corroded and with dust.

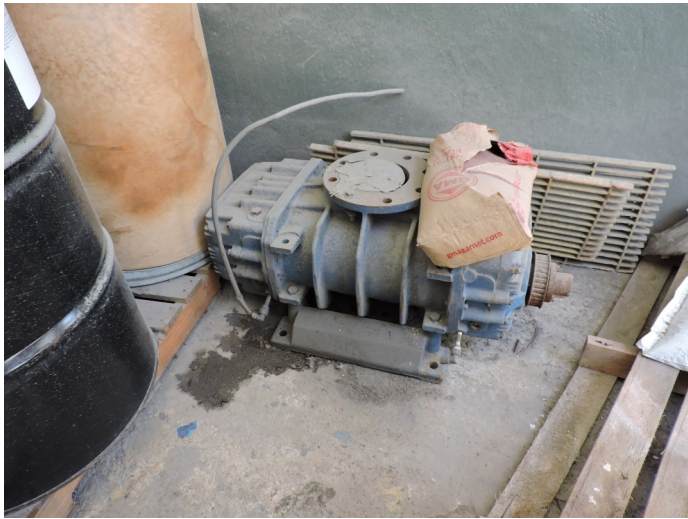
Picture 13 — In-front of flammable (cage-like) Area— At the time of the inspection, it appears that a leak was observed at the area’s concrete floor. Spill equipment, such as absorbent material, was not observed nearby this equipment.

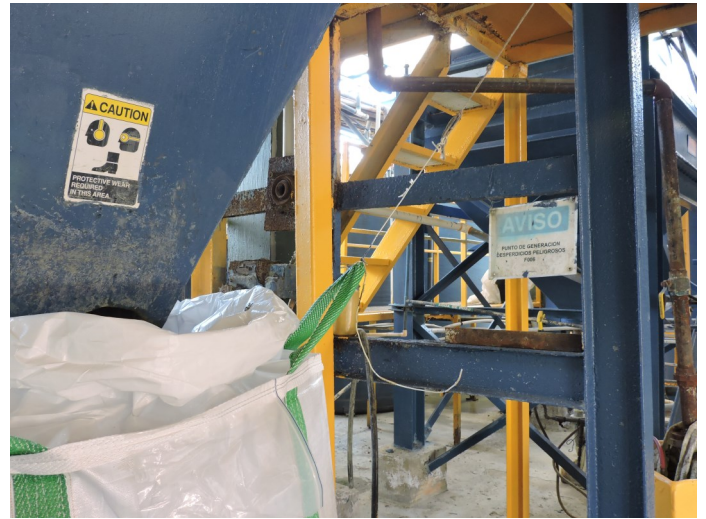
The facility representative told me that one (1) F006 hazardous waste point of generation is available in this area (Picture #14). Here, is where the sludge (F006) is generated and collected to then be transferred to the facility sludge dryer (Picture #15). After drying it, the outcome is collected into the 2,000 lb bags<sup>34</sup> to finally be transferred to the facility's 90-day HWAA for storing and disposal activities. At the time of the inspection, I observed one (1) open bag connected to the facility's equipment<sup>35</sup>. Near the latter, I observed an additional bag with sludge content and one (1) metal container<sup>36</sup> with sludge content, as well (Picture #16). At the time of the inspection, it was not clear if this metal container and the additional bag with sludge content was part of the facility's F006 hazardous waste point of generation previously identified by the facility representative. Just after, we moved from the point of generation to the sludge dryer area<sup>37</sup>. Here, the facility representative told me that the dryer equipment was not operational and functional. Nevertheless, sludge content was observed in the dryer equipment (Picture #15).

Picture 14 — WWTP Area— Picture of the facility’s F006 hazardous waste point of generation.

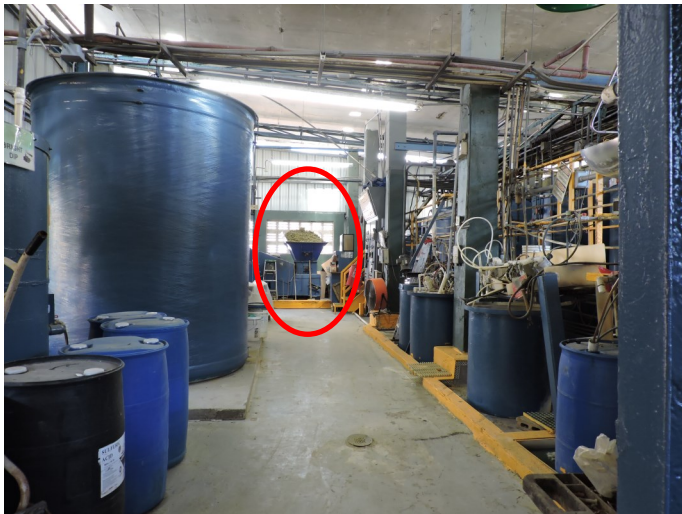
Picture 15 — WWTP Area—Here, is where the sludge (F006) is generated and collected to then be transferred to the facility dryer. The latter has been highlighted with a red circle.

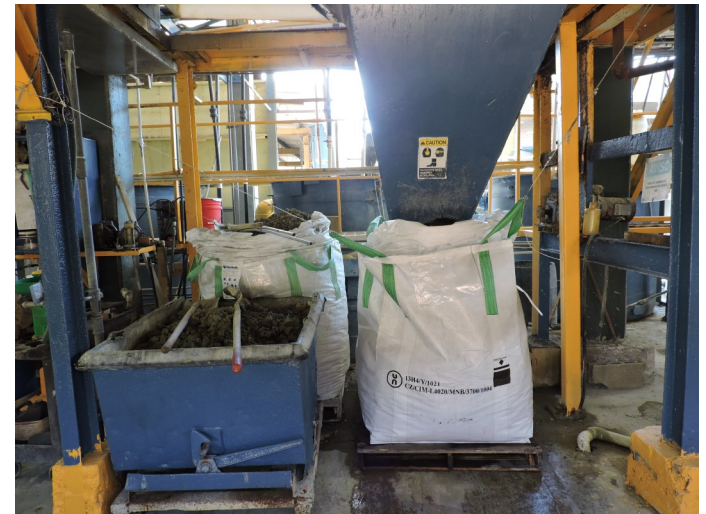
Picture 16 — WWTP Area—Near the point of generation, I observed an additional bag with sludge content and one (1) metal container with sludge content, as well. At the time of the inspection, it was not clear if this metal container and the additional bag with sludge content is part of the facility’s F006 hazardous waste point of generation.
