**CWA COMPLIANCE EVALUATION INSPECTION REPORT  
U.S. ENVIRONMENTAL PROTECTION AGENCY, REGION 5**

Compliance Evaluation Inspection

Shady Lane Farms, Inc.  
4791 West Valley Road  
Shannon, Illinois 61078  
Stephenson County  
42.20388948442224, -89.70346842591846

09/13/2023

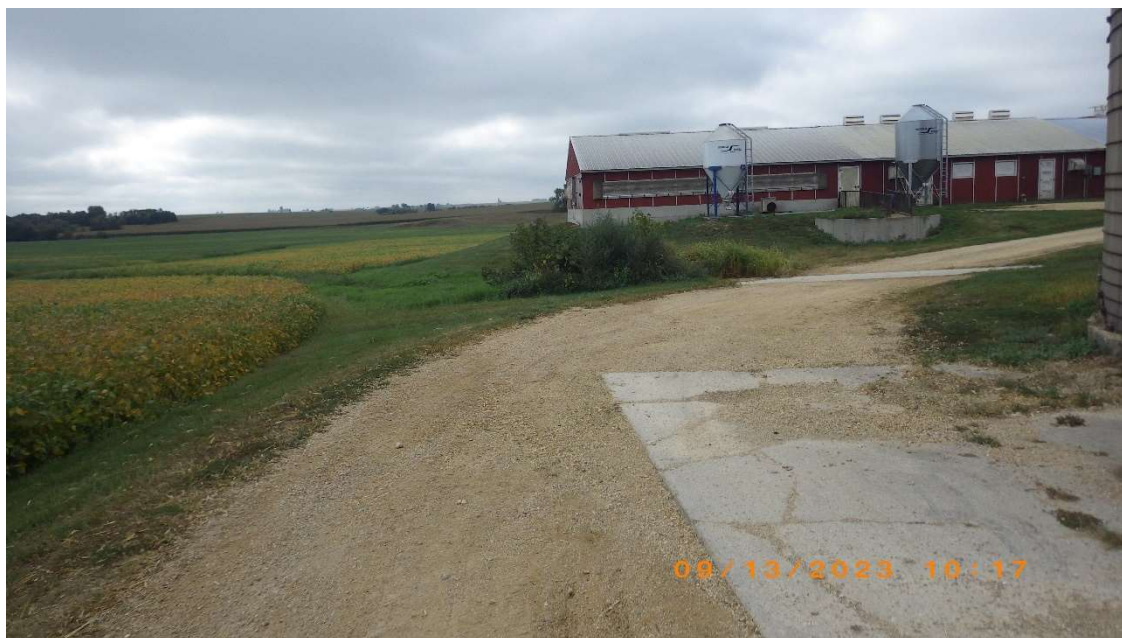
1: RIMG0002

Description: Looking south on the east side of the Facility toward the east end of the Finishing Barn 2.

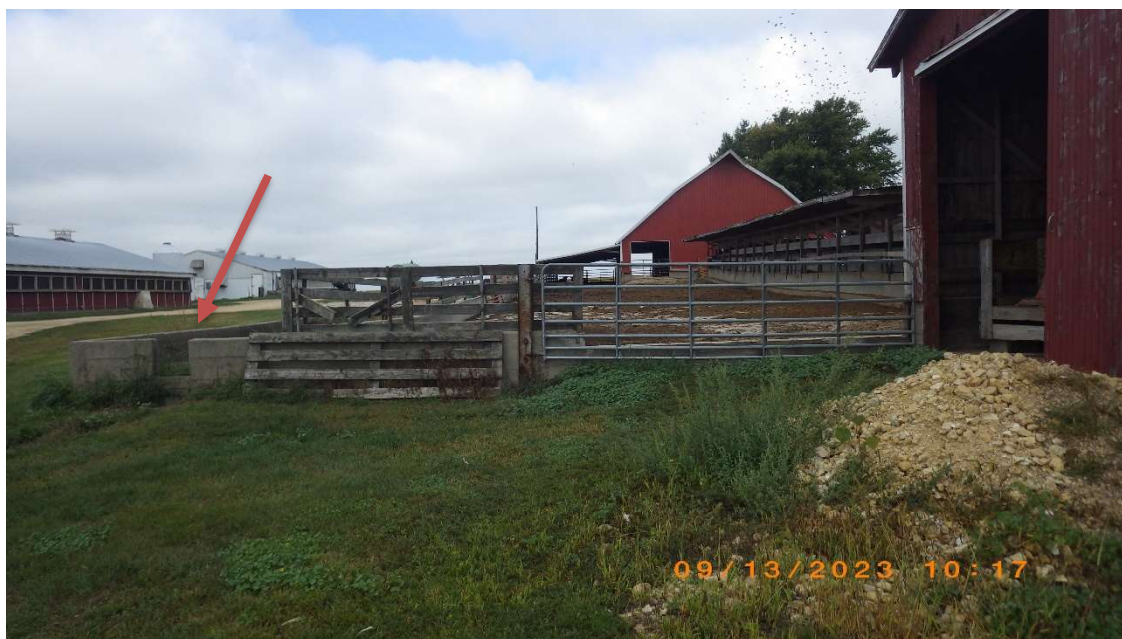
2: RIMG0003

1. The sedimentation tank had a designed overflow point to overflow southeast to a grassed waterway approximately 1,725 feet to perennial Lost Creek.

Description: Looking west across the cattle feedlot toward the Cattle Barn. Note the sedimentation tank and designed overflow point (red arrow).

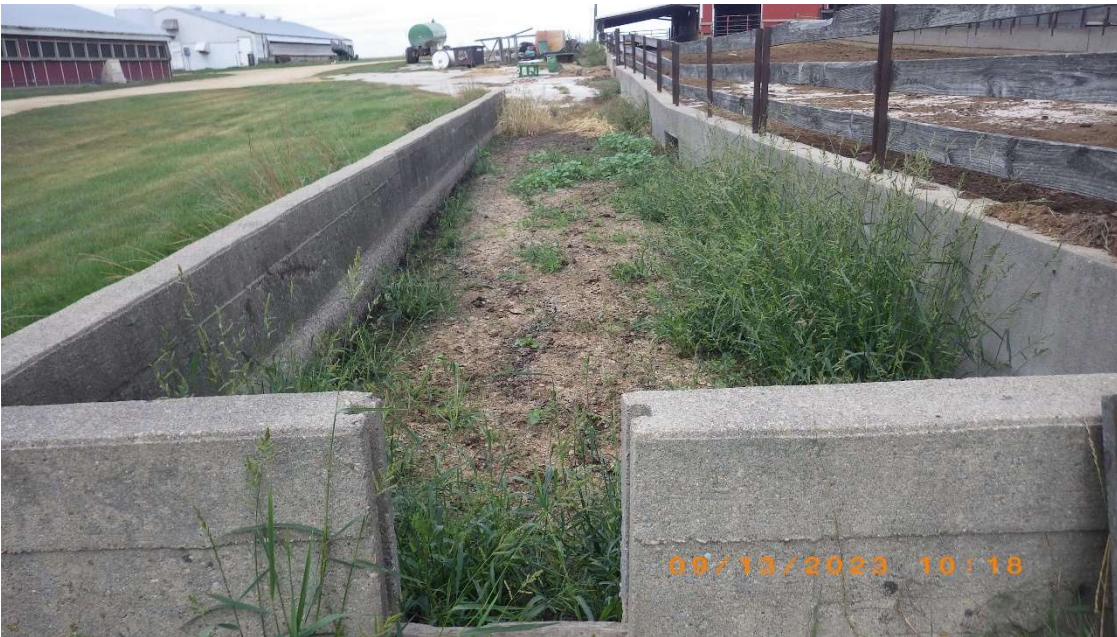
3: RIMG0004

Description: Looking west across the sedimentation tank. This structure receives runoff from the cattle feedlot.

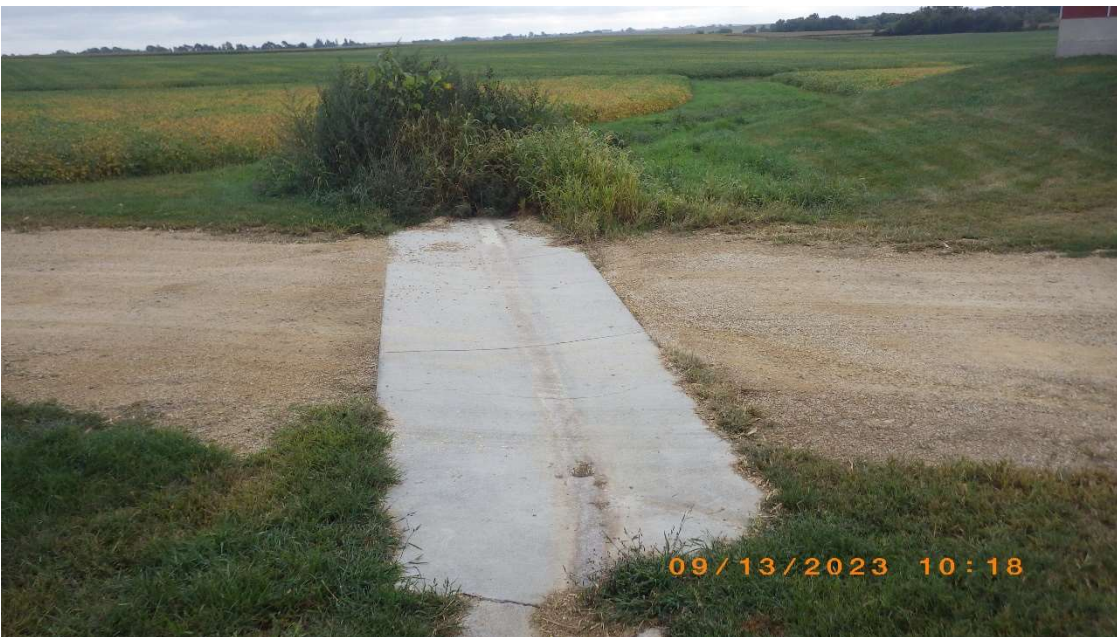
4: RIMG0005

Description: Concrete structure east of the sedimentation tank which conveys flow from the sedimentation tank overflow, across the driveway, to the grassed waterway. Note that there was no flow at the time of the inspection. The marks on the concrete structure are staining and not liquid.

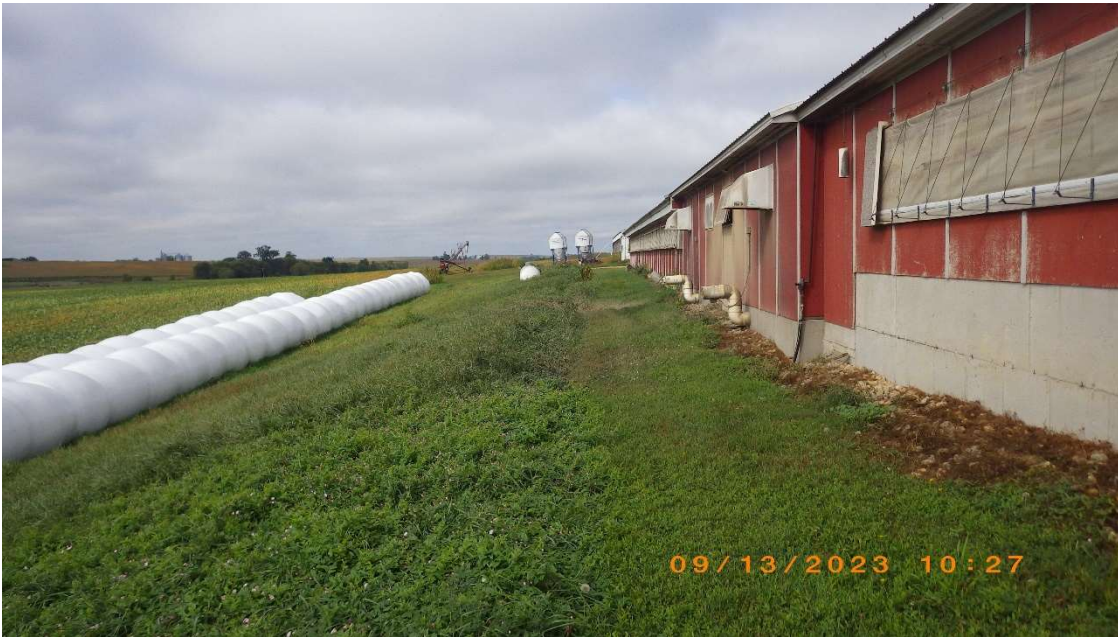
5: RIMG0006

Description: Looking west along the south side of the finishing barns.

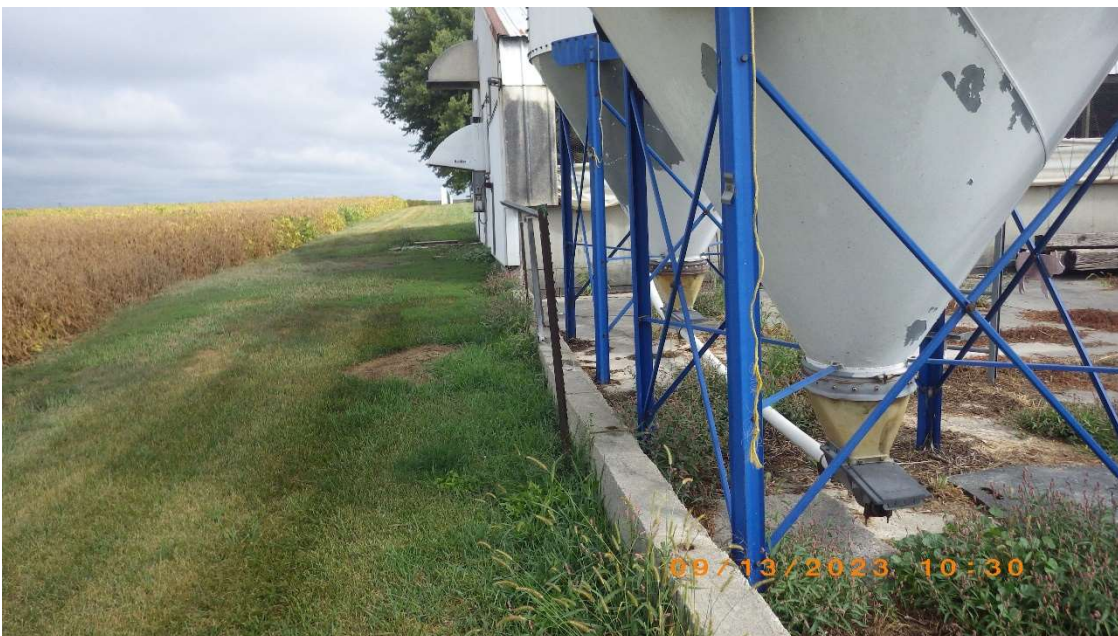
6: RIMG0007

Description: Looking north from the southwest corner of the Facility.

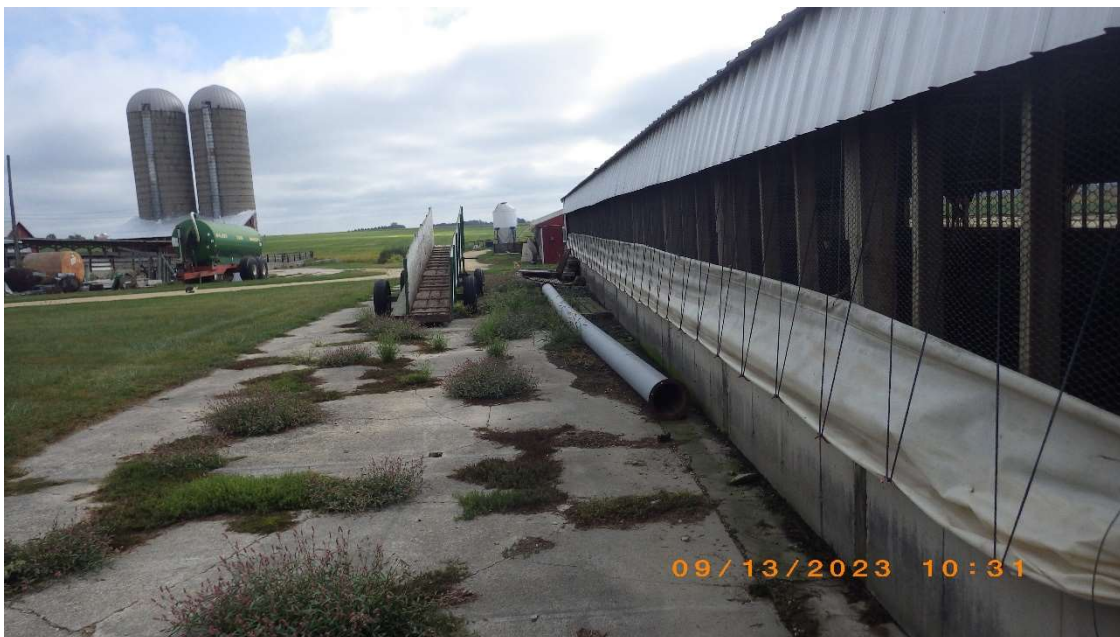
7: RIMG0008

Description: Looking east along the north side of Finishing Barn 1.

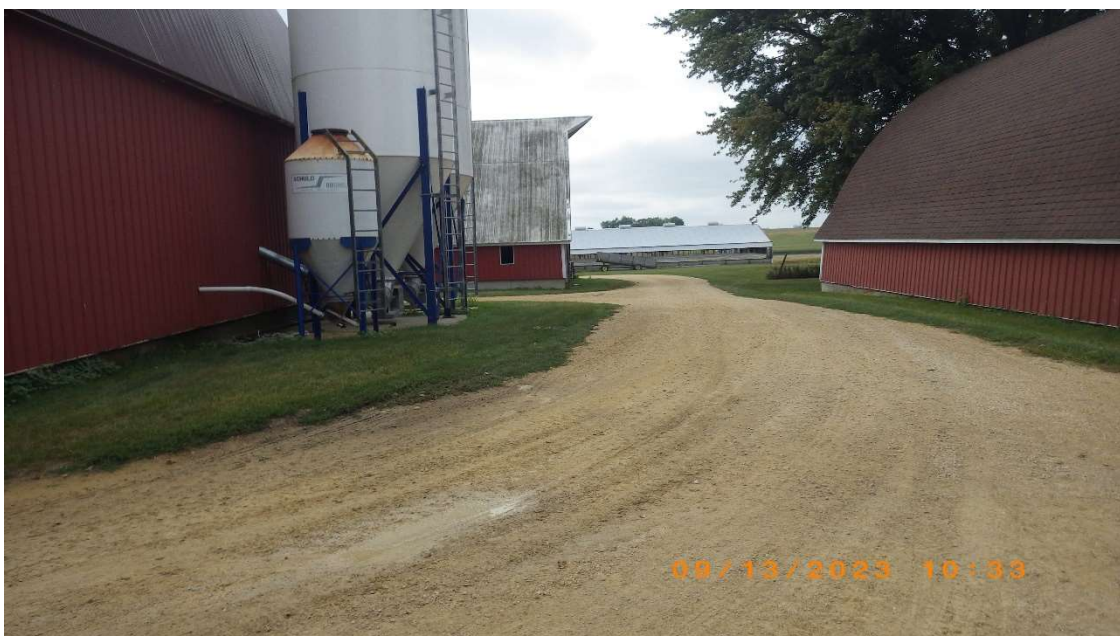
8: RIMG0009

Description: Looking south along the west side of the Facility.

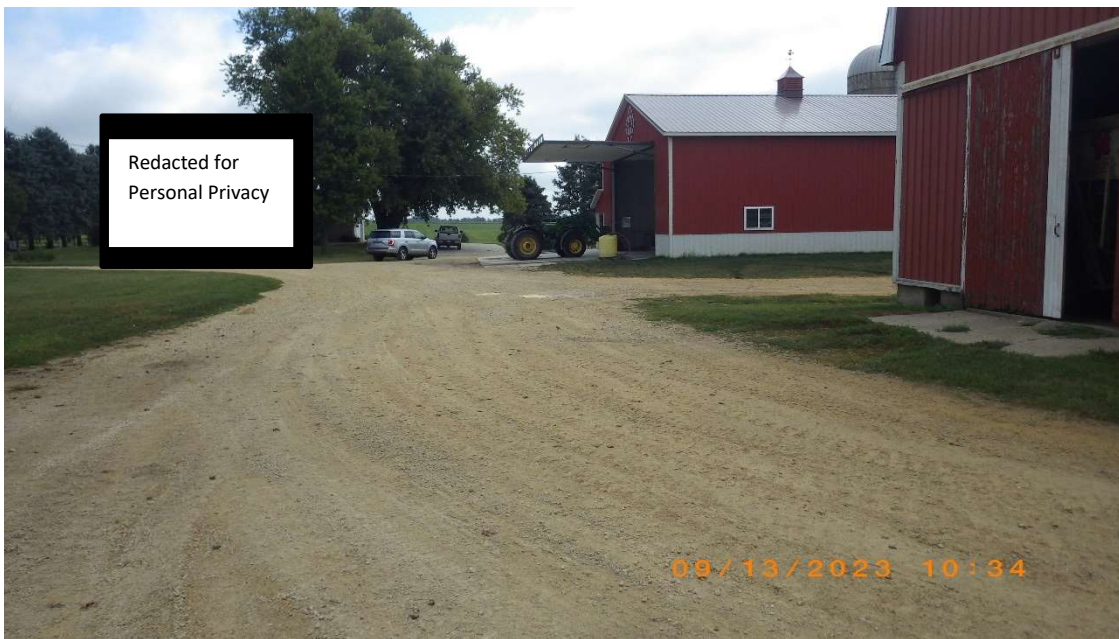
9: RIMG0010

Description: Looking East along the north side of the Facility.

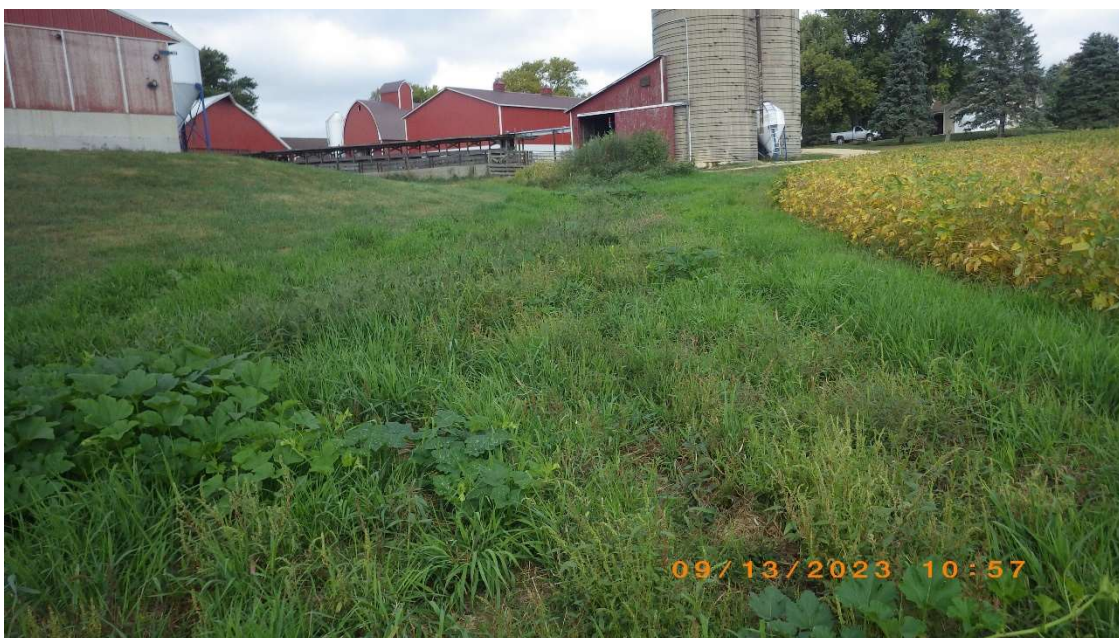
10: RIMG0011

Description: Looking Northwest along the grassed waterway to which the sedimentation tank overflow would flow.

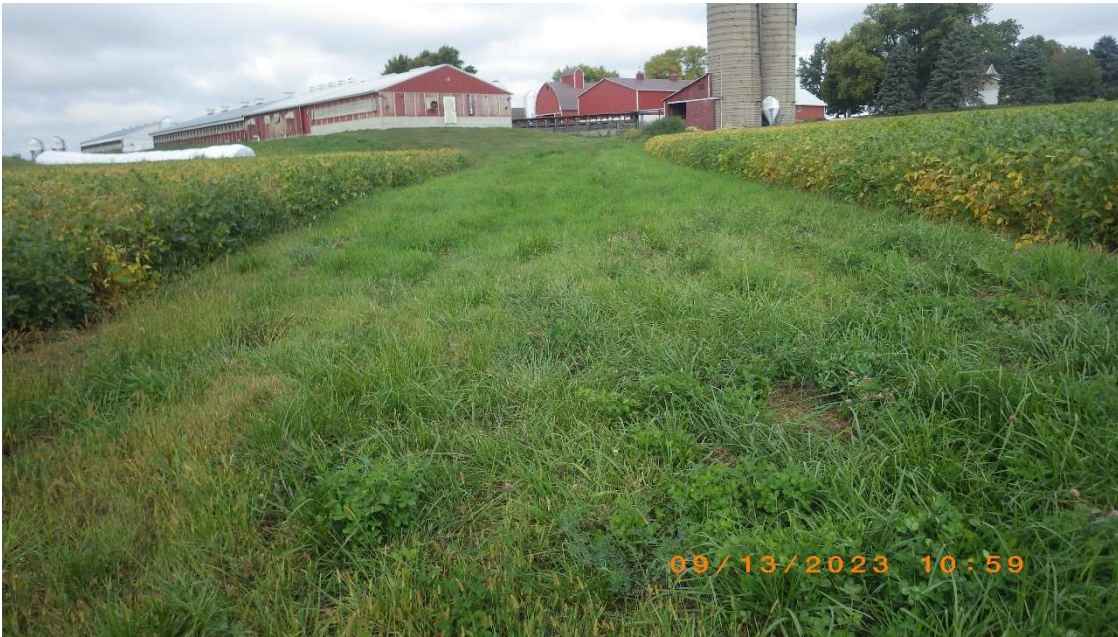
11: RIMG0012

Description: Looking northwest along the grassed waterway.

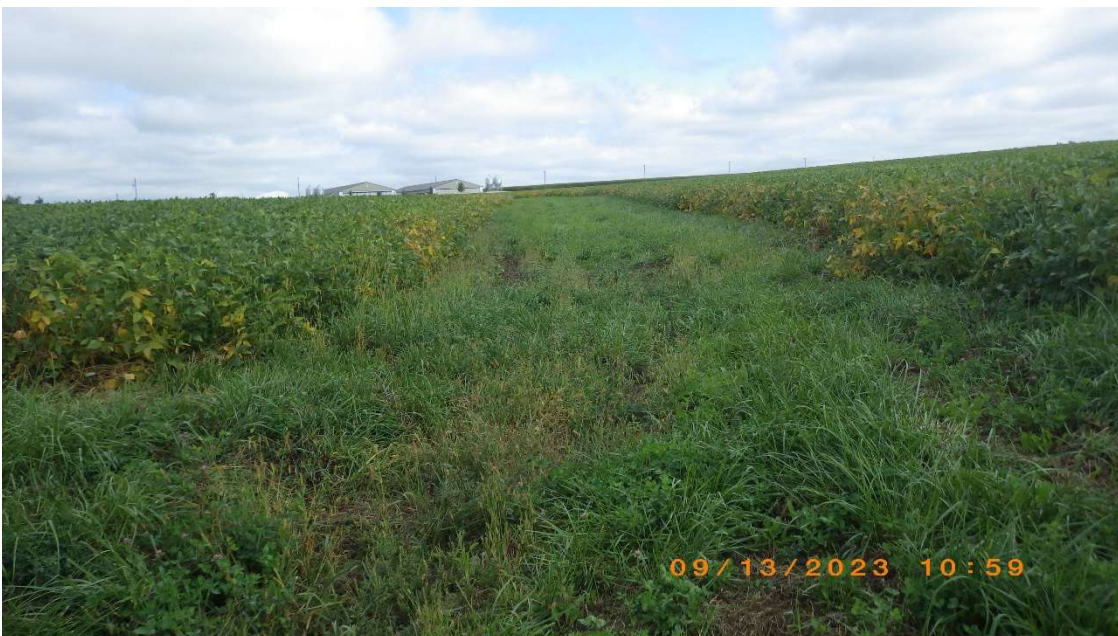
12: RIMG0013

Description: Looking north along the grassed waterway.

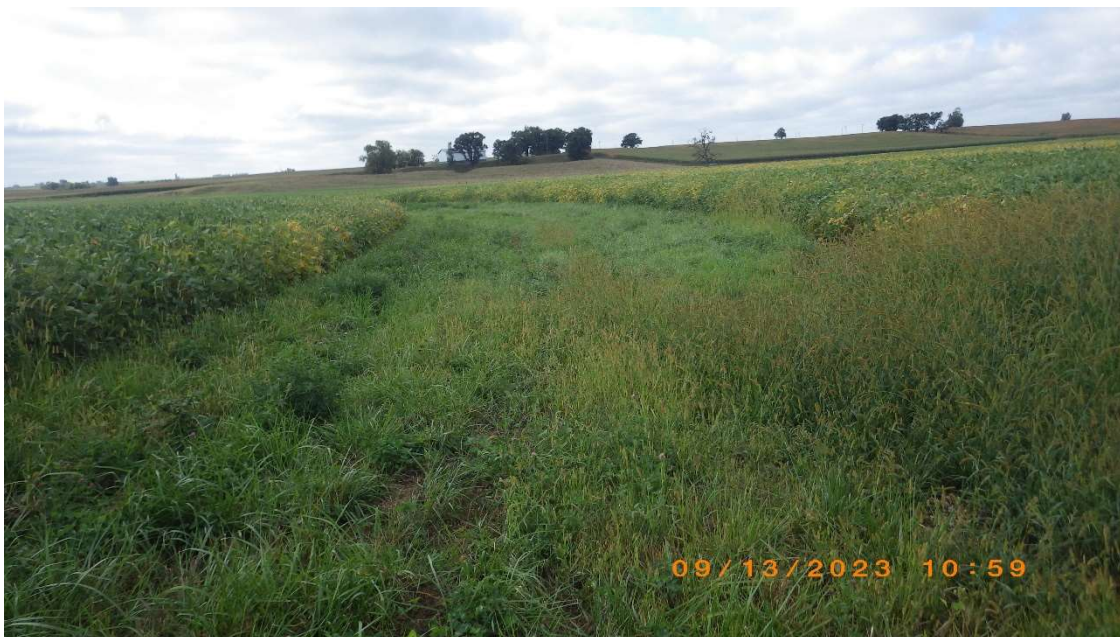
13: RIMG0014

Description: Looking south along the grassed waterway

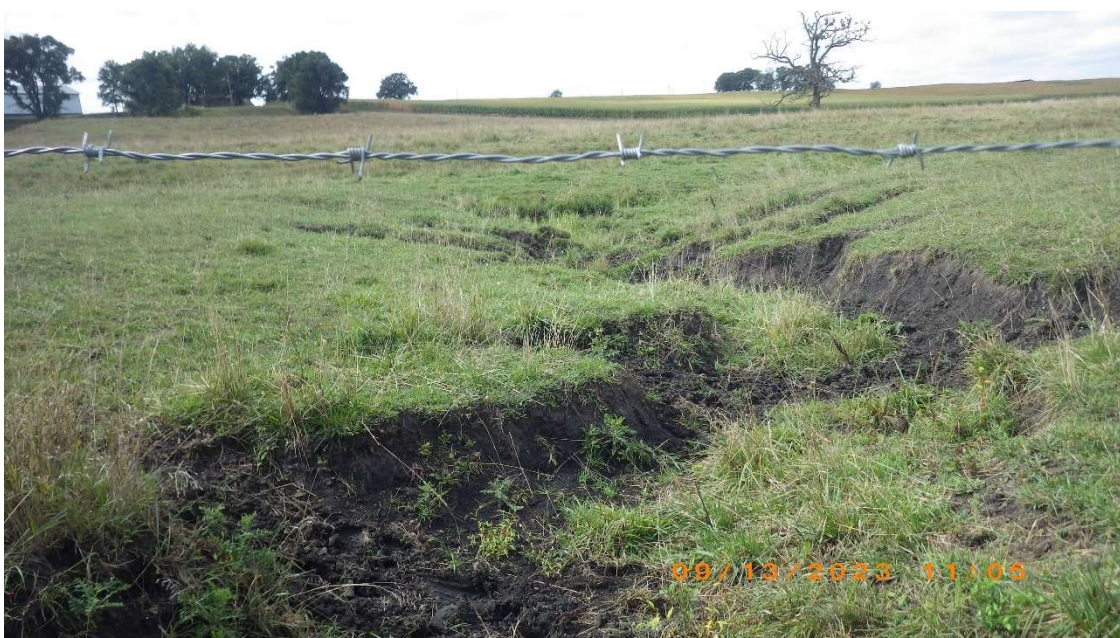
14: RIMG0015

Description: Looking southwest from the south end of the grassed waterway.

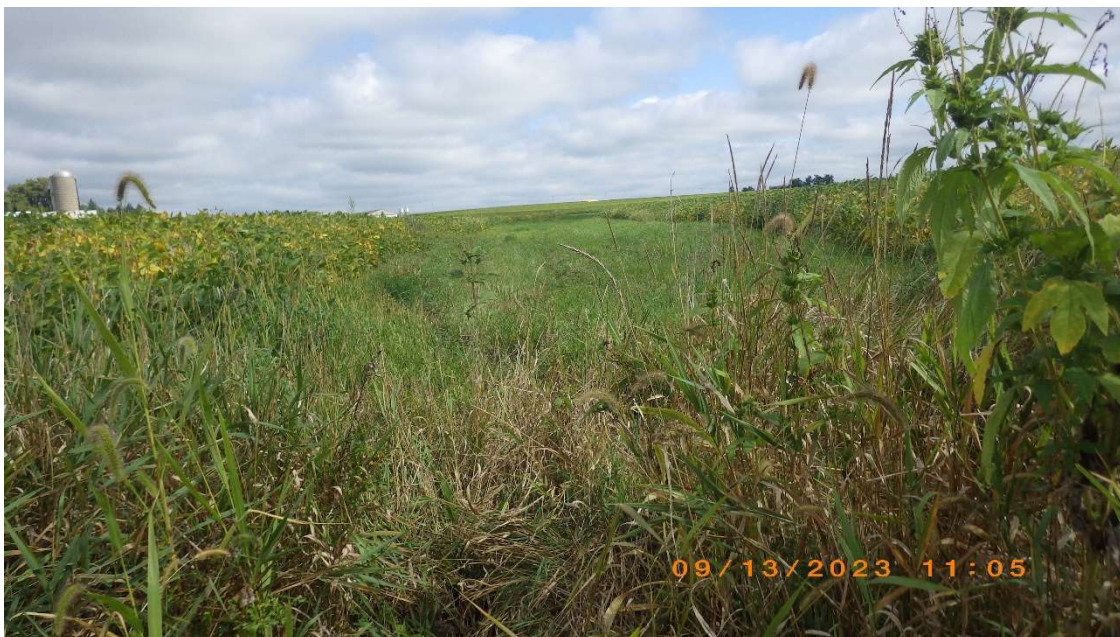
15: RIMG0016

Description: Looking northeast along the grassed waterway from the south end.

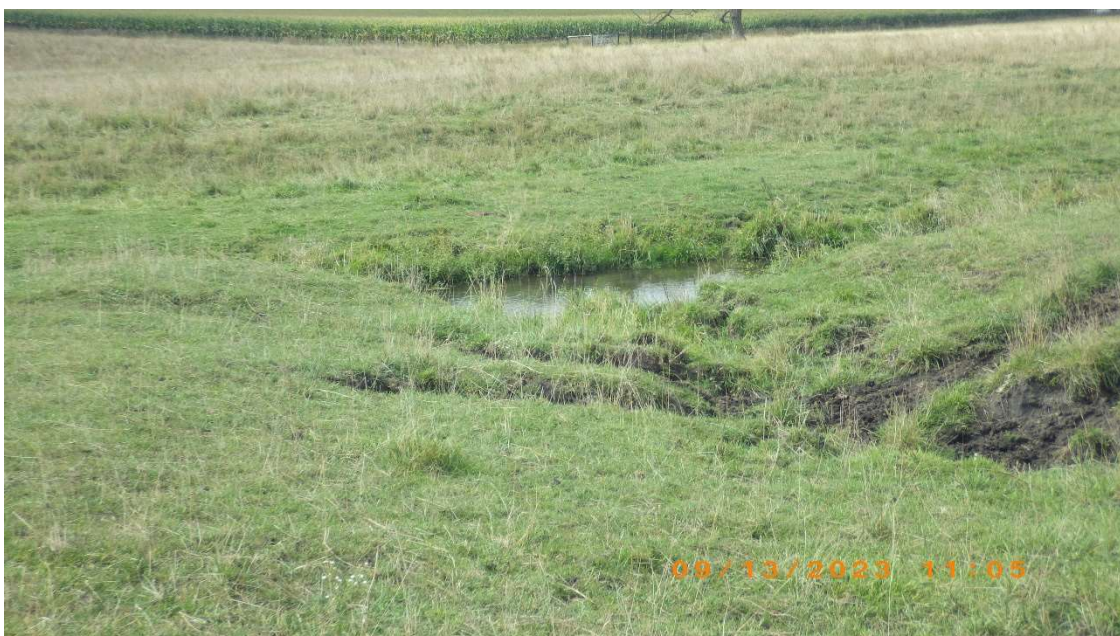
16: RIMG0017

Description: Close up of water flowing in Lost Creek.
