Region 2 Caribbean Environmental Protection Division
Multimedia Permits and Compliance Branch

CAA Inspection Report

Inspection Date: 12/4/2024
Facility Name: Steri-Tech Inc.
Facility Address: Road, 701, Km 0.7, Salinas Industrial Park, Salinas, Puerto Rico 00751
ICIS-Air ID #: PR0000007212300022
EPA Lead Inspector: Alex Rivera, Enforcement Officer, rivera.alex@epa.gov, 787-977-5845
EPA other attendees: Carlos Huertas-Hernández, On-Scene Coordinator, 787-977-5861
Eduardo A. Ortiz, On-Scene Coordinator, 787-977-5879
Facility Contact(s): Andrés Vivoni, VP & General Manager, 787-824-4040, avivoni@steri-tech.com

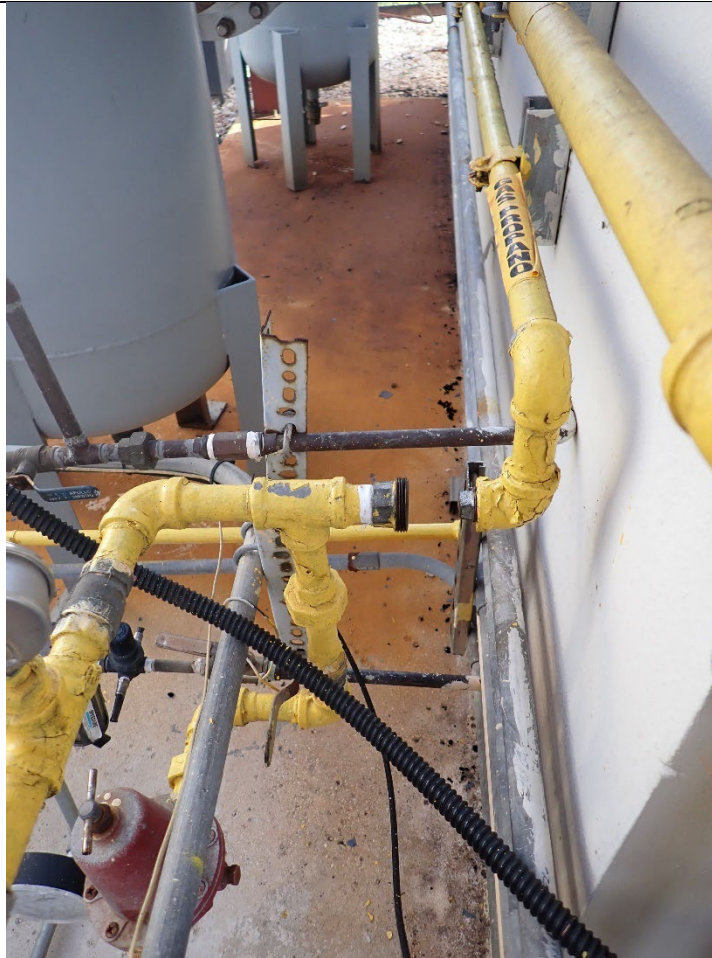
5. The TO was off at the time of the inspection and Mr. Sánchez informed that a mechanic recently disconnected the TO from its propane supply piping. Mr. Sánchez showed Inspector Rivera where the disconnection was done and that the piping was blinded. See Appendix A image PC040004 and further details.

Partial view of the TO propane supply piping. The piping was cut and blinded at the time of the inspection to disconnect the TO from its propane supply.

7. Mr. Vivoni informed that he instructed his staff to physically disconnect the TO from its propane supply piping connection.
8. Mr. Vivoni indicated that both DNER and EPA will be receiving a written notification providing further details about the incident and STI's corrective actions.

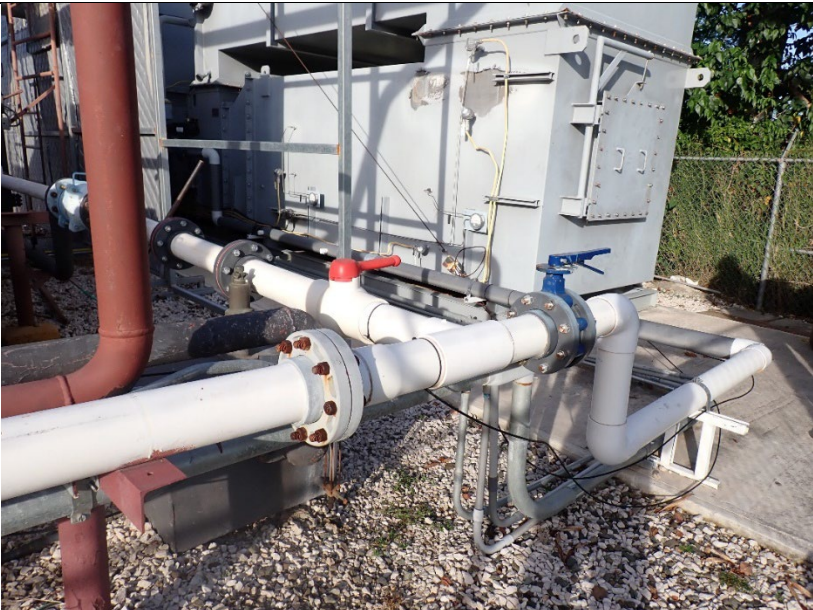
<p data-bbox="573 1354 1499 1382">Partial view of the facility aeration rooms and sterilization chambers process gas piping.</p>	12-4-24	16:23 PM

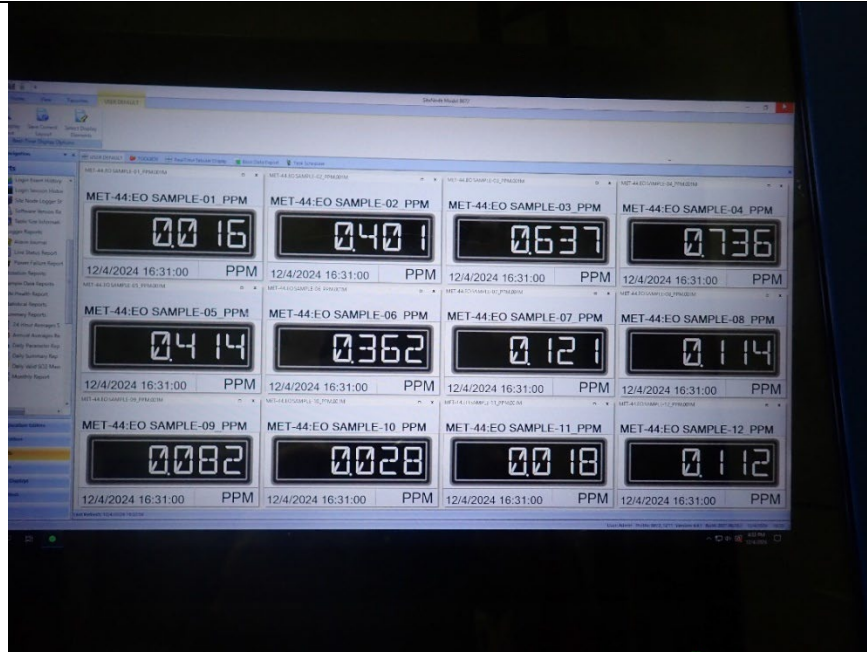
10. Inspector Rivera asked Mr. Sánchez to provide access to the EtO indoor monitoring system control room. Mr. Sánchez provided access to the EtO indoor monitoring system control room and Inspector Rivera took a photo of the system monitor screen. See Appendix A image PC040015 for further details.

6. Inspector Rivera asked Mr. Sánchez to explain how the alarm of the EtO indoor monitoring system works. Mr. Sánchez explained that the system has visual alarms and that when EtO concentrations at any of its 12 monitoring points exceed 5 ppm it will trigger a yellow-colored alarm and a red-colored alarmed when concentrations exceed 10 ppm. Mr. Sánchez added that occasional concentration spikes are showed in the system data and those are caused when operators open the sterilization chambers to remove the sterilized product and transfer it to the aeration rooms. Mr. Sánchez added, that prior to transferring the product to the aeration room, the operators remove the biological indicators that are placed at each batch, which is analyzed in a laboratory for confirming its subsequent release. Mr. Sánchez informed that operators are required to wear self-contained breathing apparatus while conducting the activity.

View of the facility EtO indoor monitoring system control panel screen.
