**Region 6 - Enforcement & Compliance Assurance Division**  
**INSPECTION REPORT**

| Inspection Date(s): | 12/8/2022 | |
| Media Program: | RCRA Compliance Evaluation Inspection | |
| Facility Name: | Galveston Dry Dock and Rig Repair | |

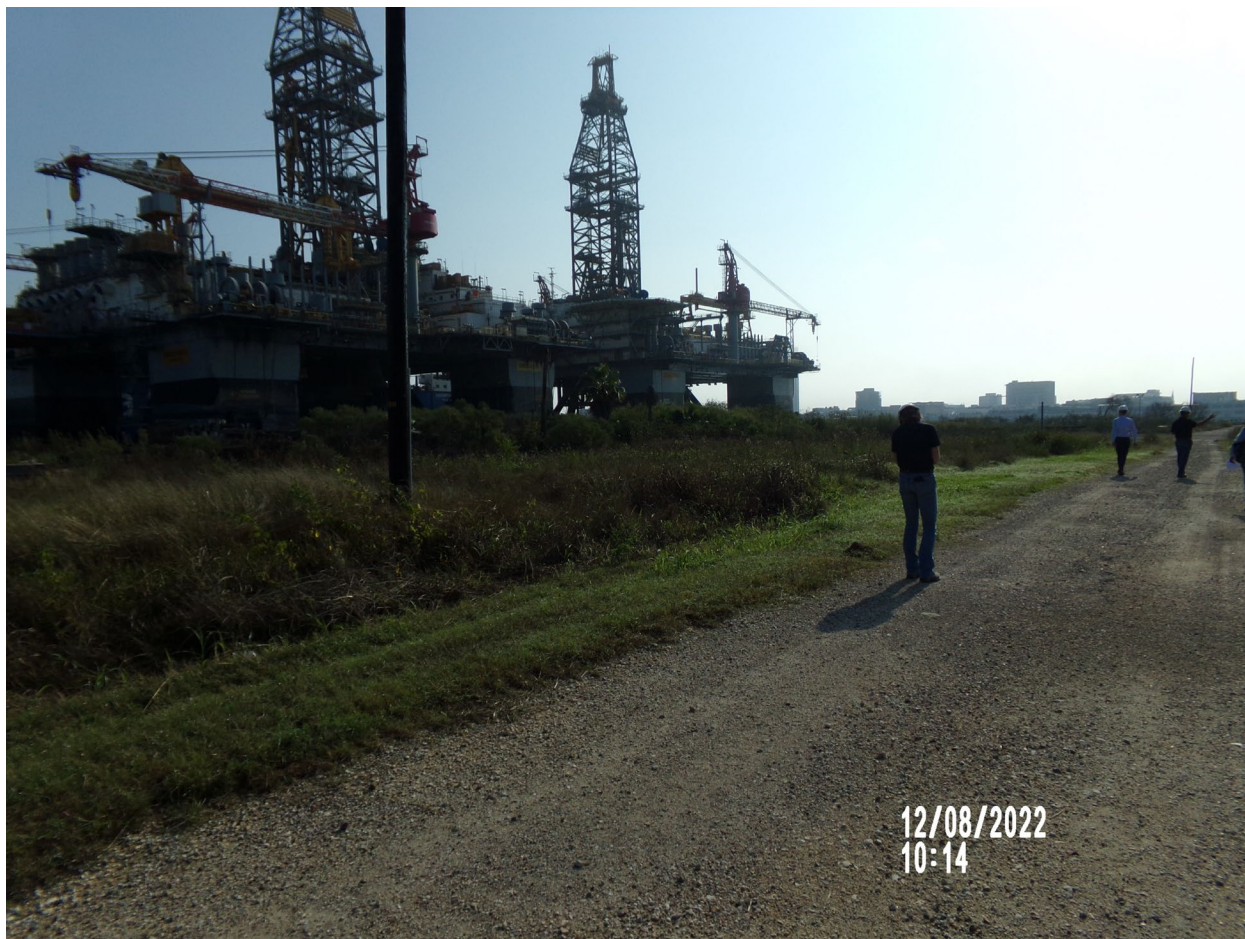
Photo No. 1

| Description:<br>View of vegetated dredge material along the gravel path to Pier A. Looking southeast. | | |

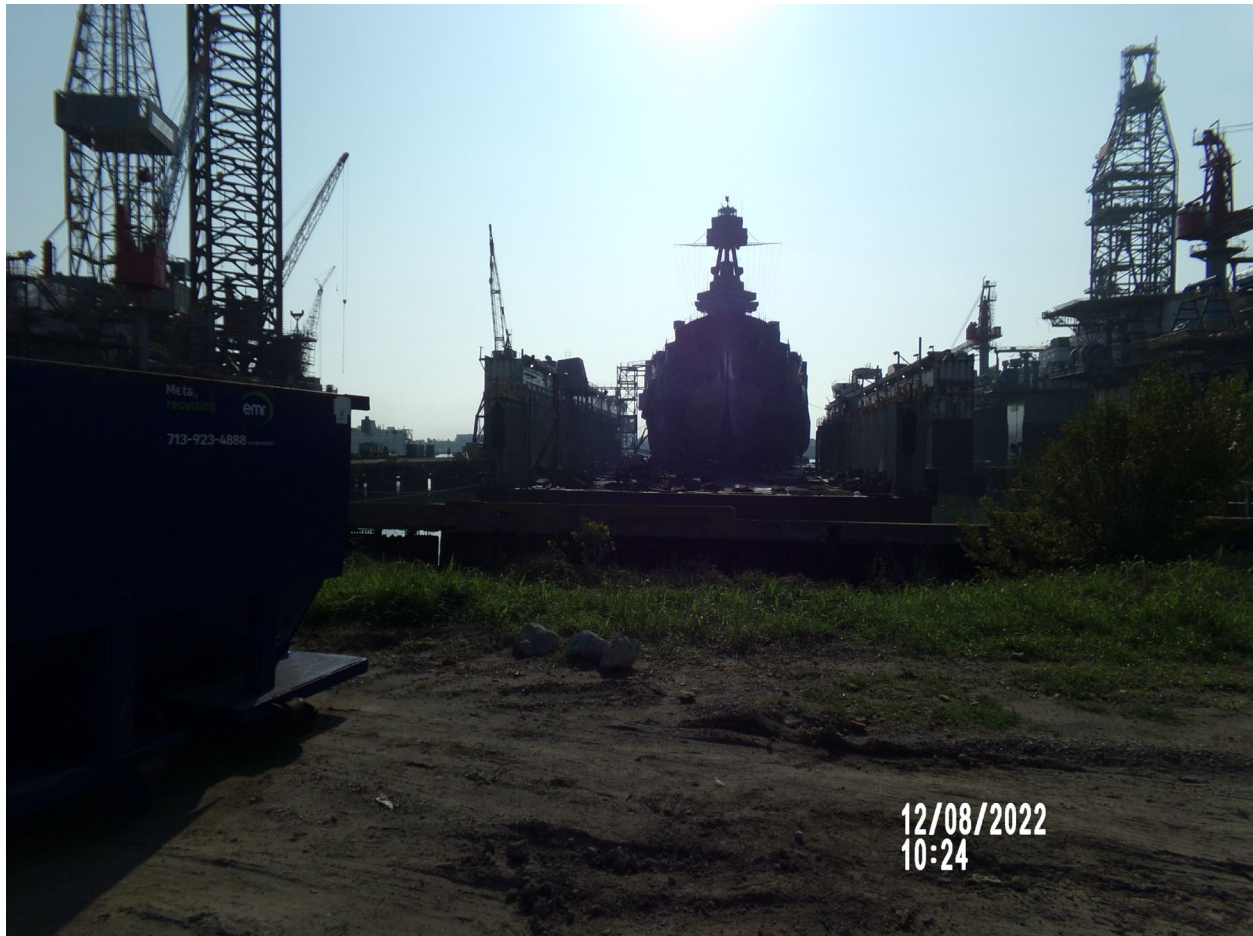
Photo No. 2

| <b>Description:</b><br>View of Battleship Texas in dry dock. Looking south to Pier C from Main Street. | | |

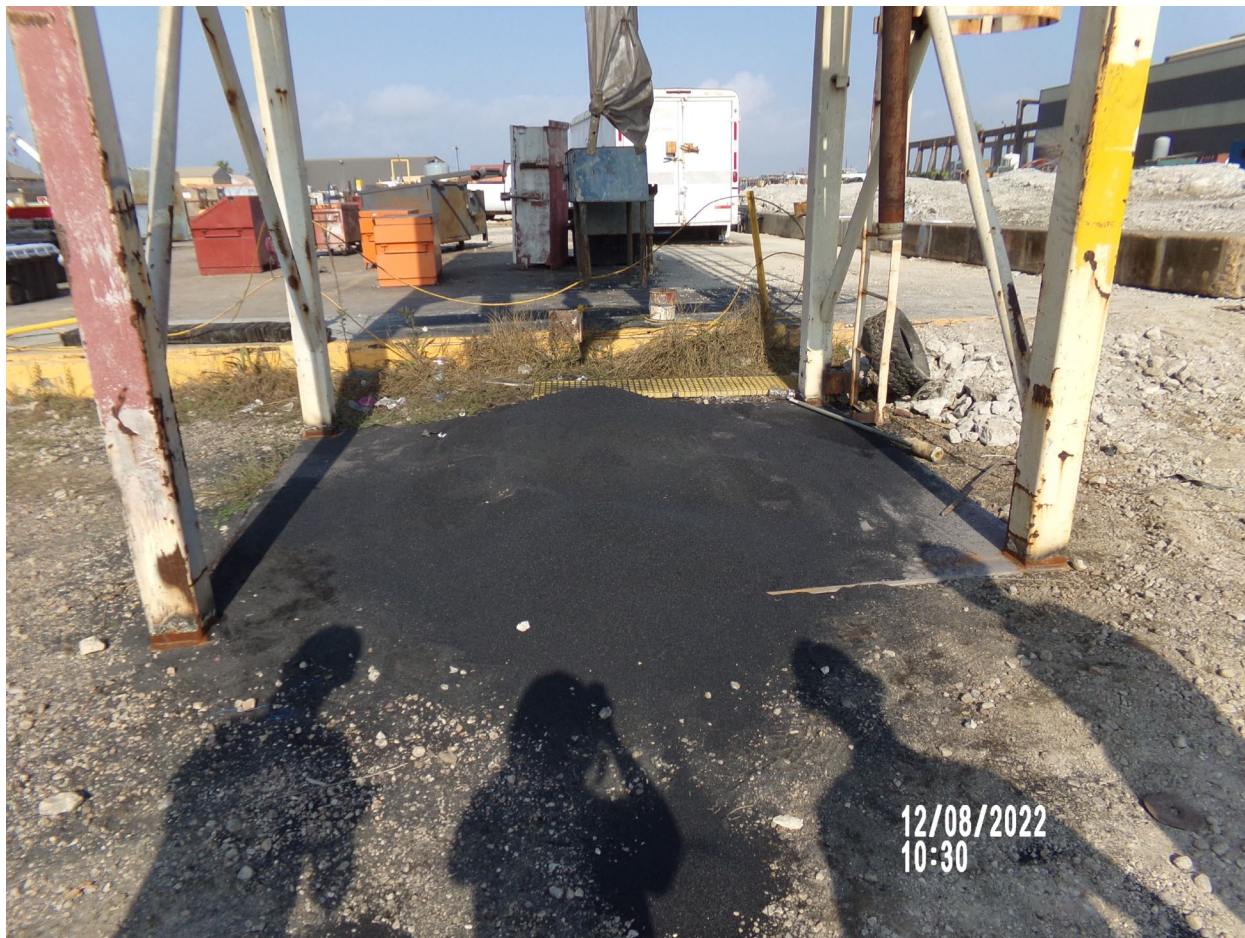
Photo No. 3

On the north side of Main Street, we observed a sand hopper with coal slag blast material on the ground beneath the hopper (Appendix 1, Photo 3). Mr. Haughton told us that coal slag is used instead of sand for blasting and surface preparation. We were also told that the used blast material is recycled and reprocessed offsite as road base. We also observed a drum in this area labeled as non-hazardous oily waste (Appendix 1, Photos 5 & 6). Mr. Haughton explained that once the drum was full, it would be moved to the waste storage area.

| Description:<br>Sand hopper with coal slag blast material. Looking north from Main Street. | | |

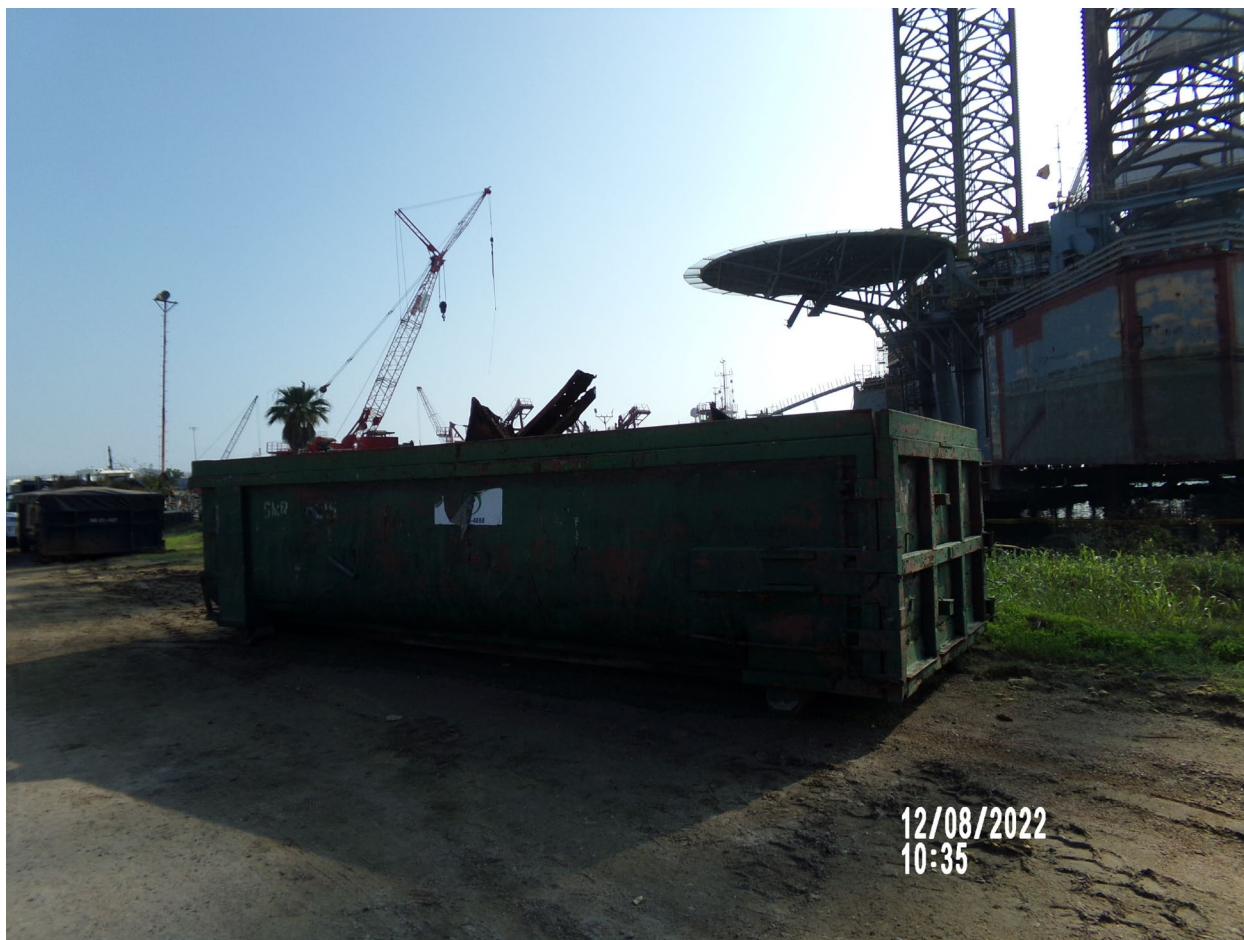
Photo No. 4

| Description:<br>Metal dumpster containing corroded steel from the Battleship Texas. Looking south-southeast from Main Street. | | |

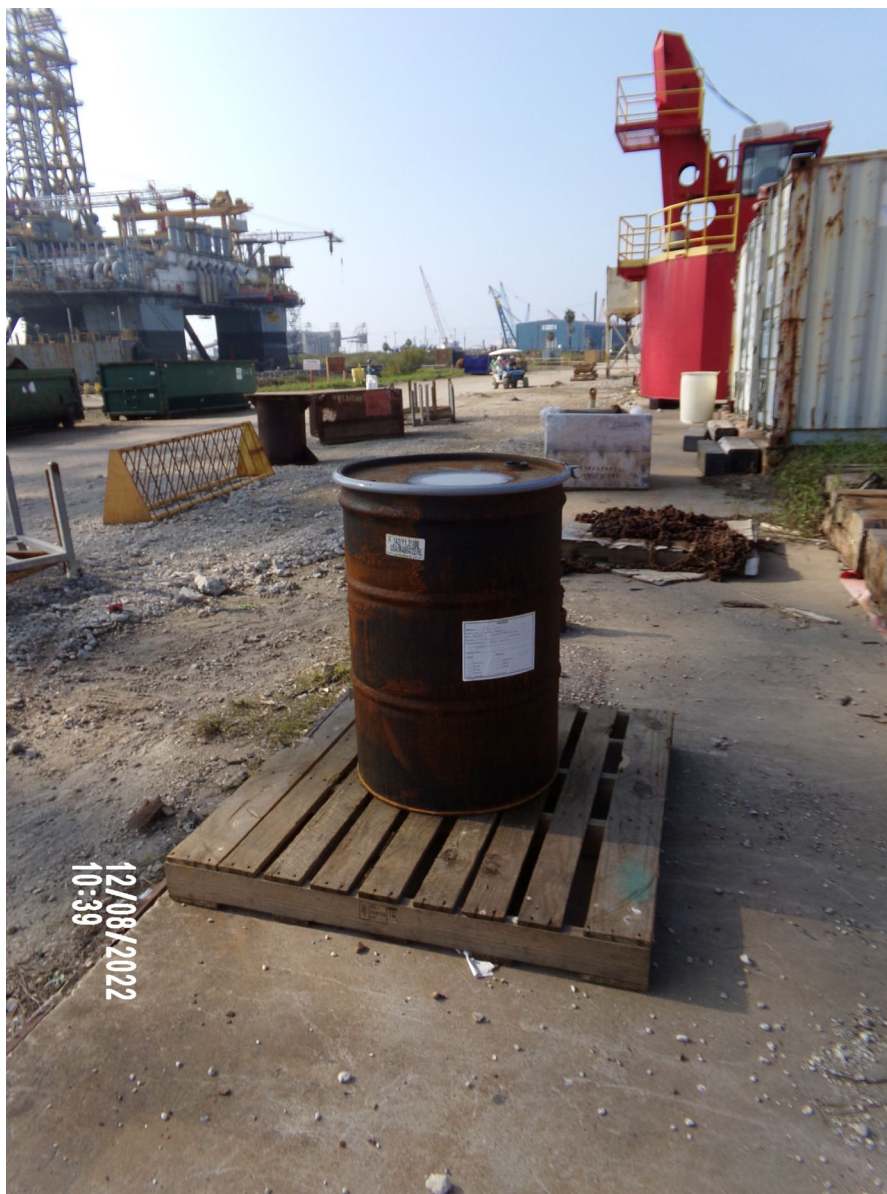
Photo No. 5

| <b>Description:</b><br>55-gallon drum labeled as non-hazardous "Oily Waste." View looking west from the north side of Main Street. | | |

Close-up view of waste label on oily waste drum along Main Street. Drum has an issued date of 11-21-2022 and no accumulation date on the label.

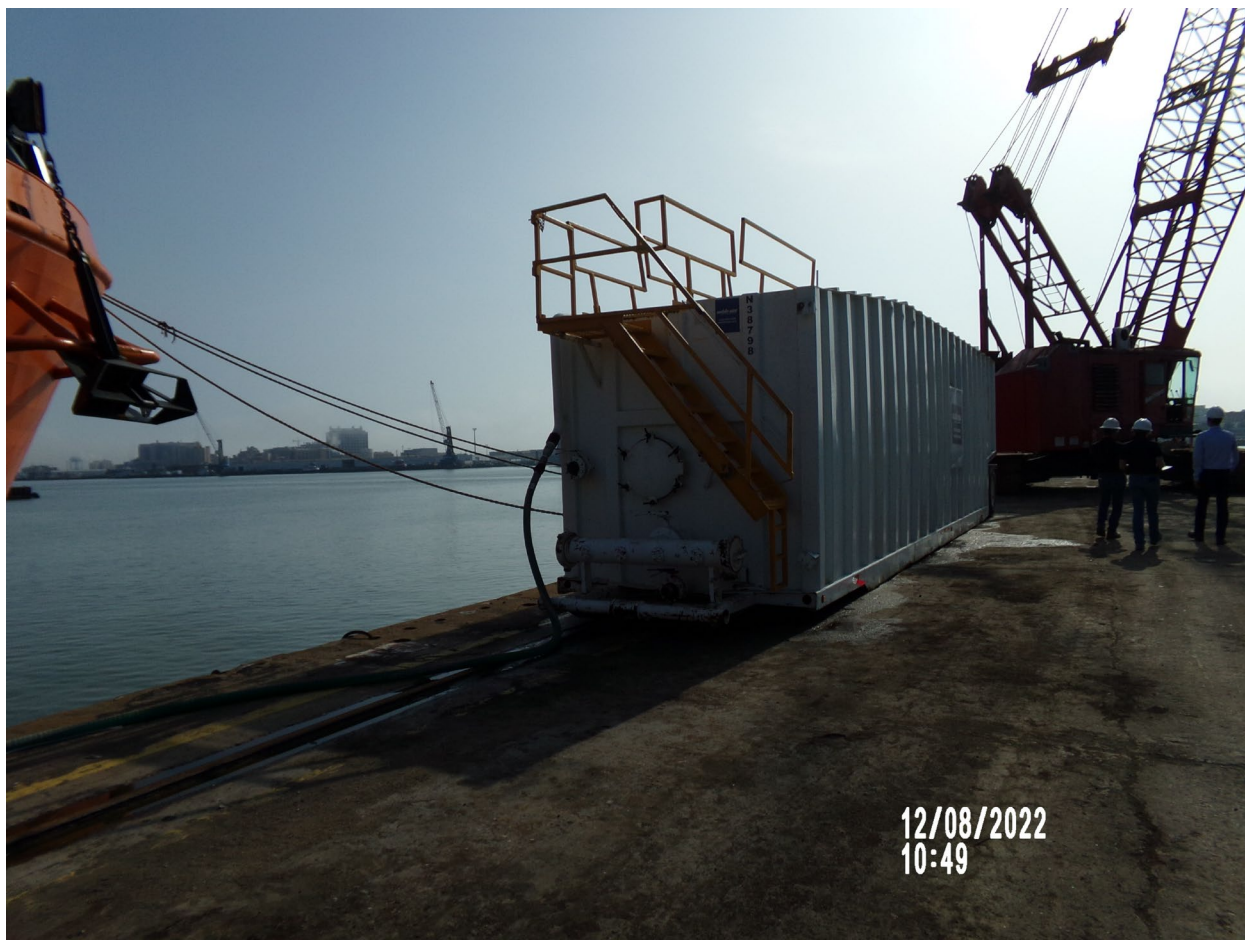
Photo No. 7

The inspection team observed operations on Pier D, where workers were performing maintenance on a Jackup rig and a ship in dry dock (Appendix 1, Photo 8). We also noticed a frack tank on the dock that was actively taking up waste (Appendix 1, Photo 7). We asked about the tank's contents, and though Mr. Haughton did not know what specifically was in the tank, he said that sewage is the most common waste placed into these tanks. He also said that the ship offloading the waste does not carry any hazardous waste.

| Description:<br>Frac tank actively managing waste on Pier D. View looking south-southeast. | | |

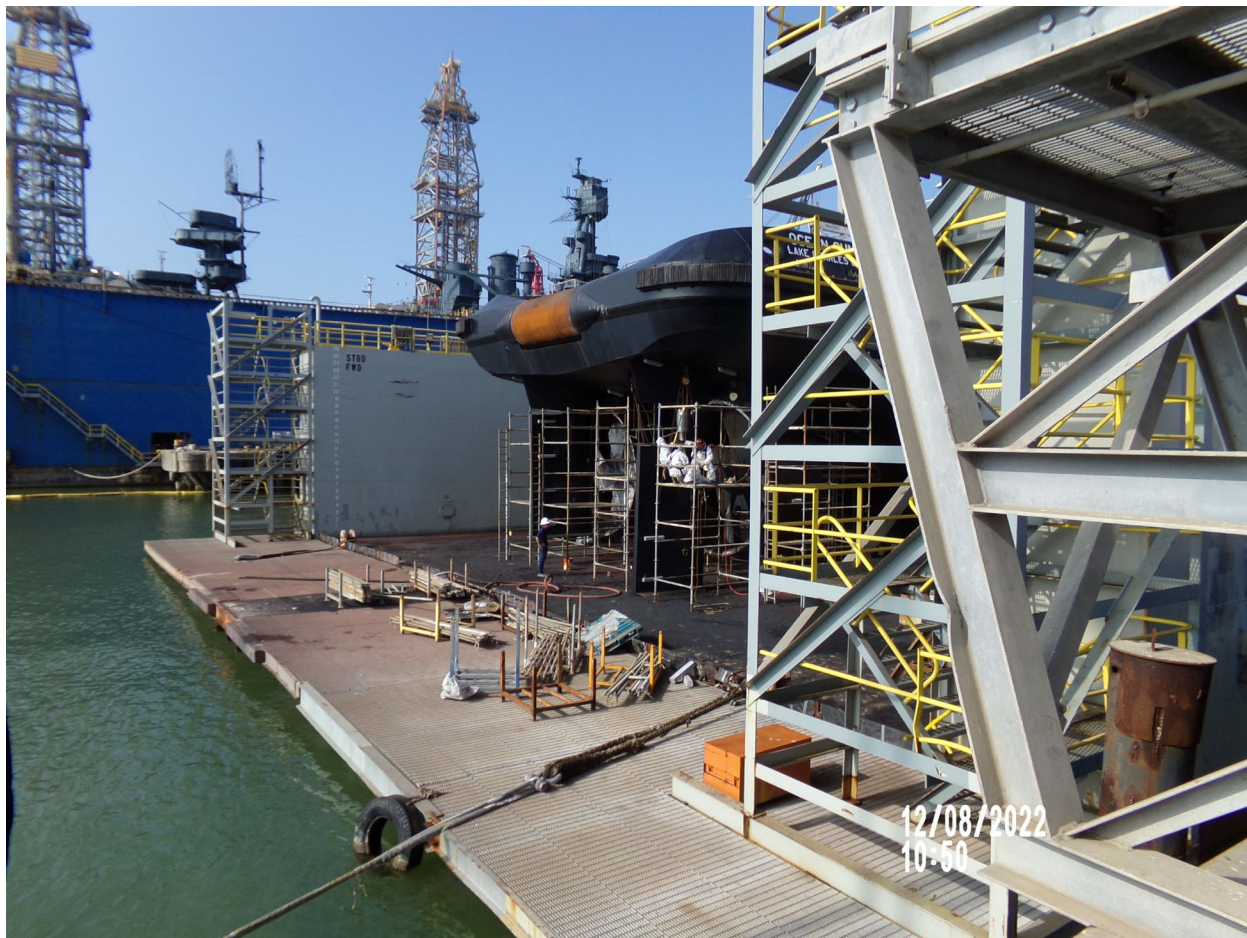
Photo No. 8

| Description:<br>View of maintenance and repair operations on Pier D drydock. Looking west. | | |

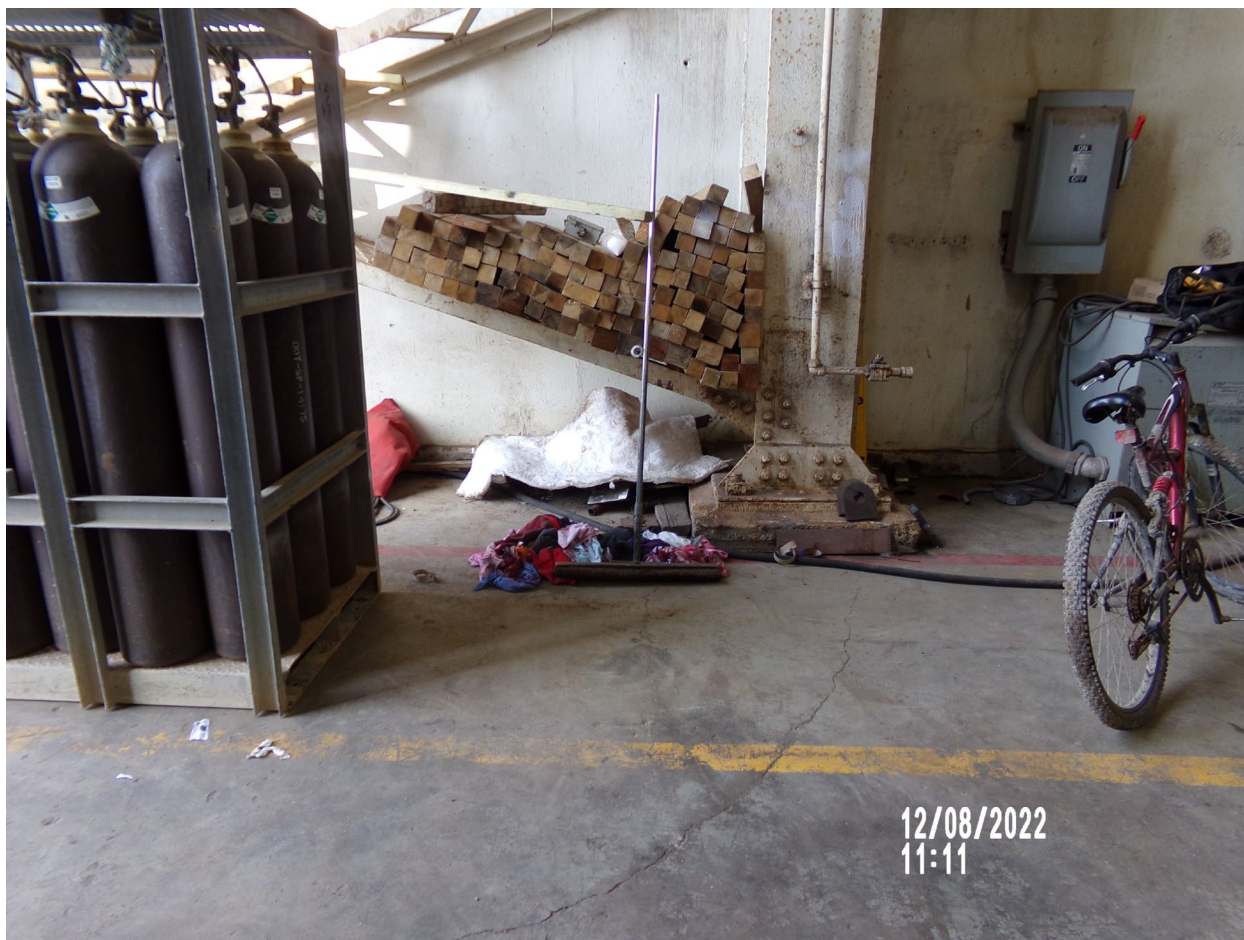
Photo No. 9

At approximately 1105 hrs., we entered the High Bay Building area on the far eastern side of the Gulf Copper facility. Ship tanks are assembled here, and at the time of the inspection, there were several in-process tank constructions taking place. We observed used rags lying on the floor of the building (Appendix 1, Photo 9). We also observed workers penetrate testing with a compound called "SpotCheck" (Appendix 1, Photo 10). I noted a couple of instances where workers wiped the tank surface with a blue rag. We were told by Mr. Haughton, who asked the workers onsite, that the material on the blue rag is not a solvent.

| Description:<br>Used rags in the High Bay Building. Rags are used to clean ship tank components during assembly. | | |

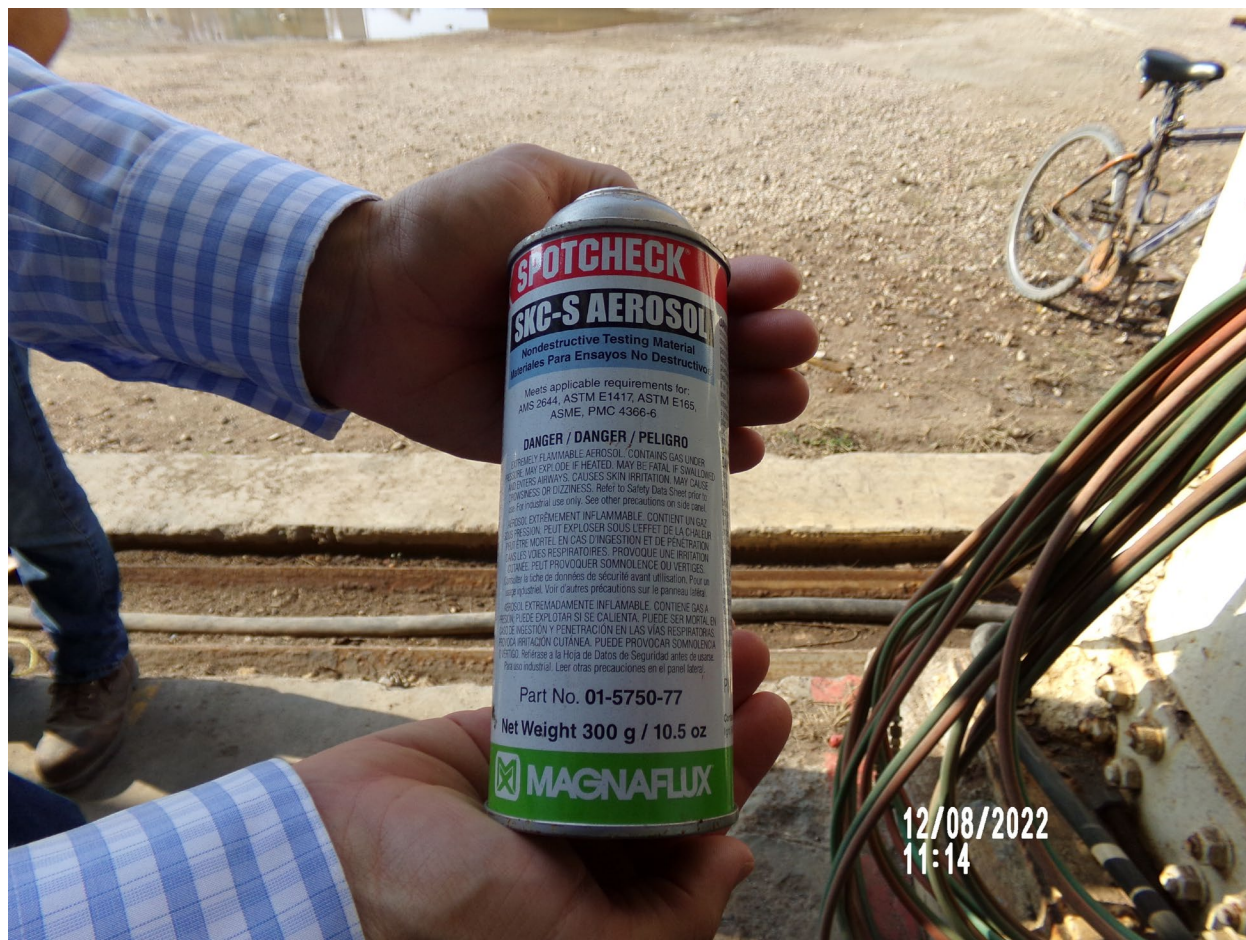
Photo No. 10

| Description:<br>Aerosol used by facility to identify and isolate cracks or seam issues during tank assembly. | | |

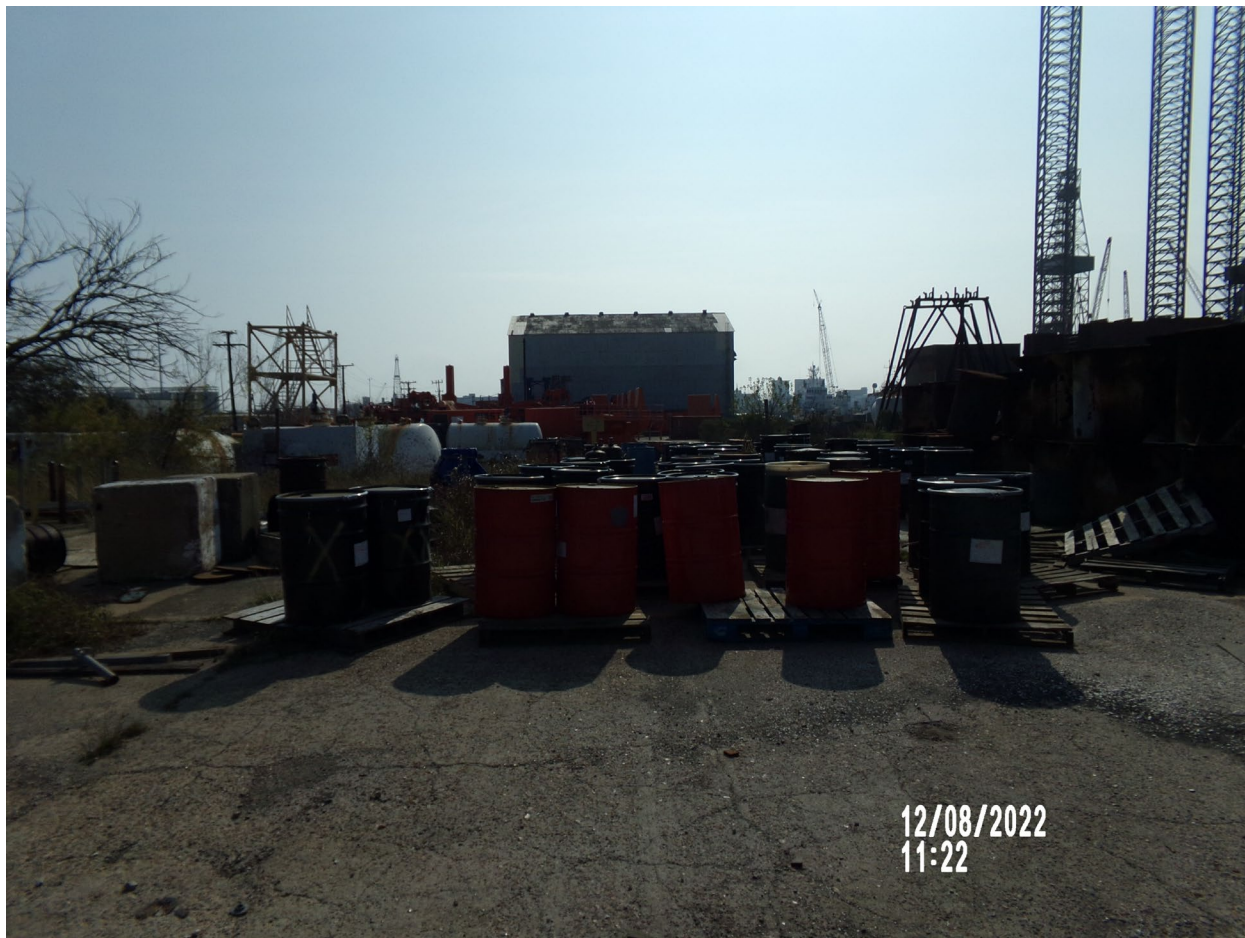
Photo No. 11

The inspection team observed the waste storage area at approximately 1120 hrs. Mr. Haughton told us that waste pickup is approximately every 1-2 months, but could be longer as needed, as is allowed for VSQGs. Mr. Haughton explained that upon receiving a drum request, the foreman fills out a receipt ticket in the tool room, near the docks, and paints a number identifier on the drum that correlates with a logbook. In total, there were 62 drums, including four plastic drums, one 33-gallon drum, and three cylinders (Appendix 1, Photo 11).

- Sixty-two containers were observed in the waste storage area. This amount may be in excess of the 1,000 kg allowed for a VSQG to accumulate without meeting additional regulations (40 CFR 262.14(a)(4)).
- The waste storage area as observed was lacking in adequate and organized aisle spacing, containers were observed open, unsecured, undated, and/or unlabeled as to their contents, and there were multiple drums in poor condition (e.g., bulging drums, heavily corroded).
- Potential for inadequate waste determination of waste stored in the waste storage area based on lack of knowledge of material in the area and lack of labels on containers (40 CFR 262.11).
- Waste characterization of used coal slag in the blasting area.
- Gulf Copper is actively receiving solid waste and possibly hazardous waste from ships and storing those containers in the waste storage area.

| Description:<br>View of waste storage area, looking south from the scaffold yard. | | |

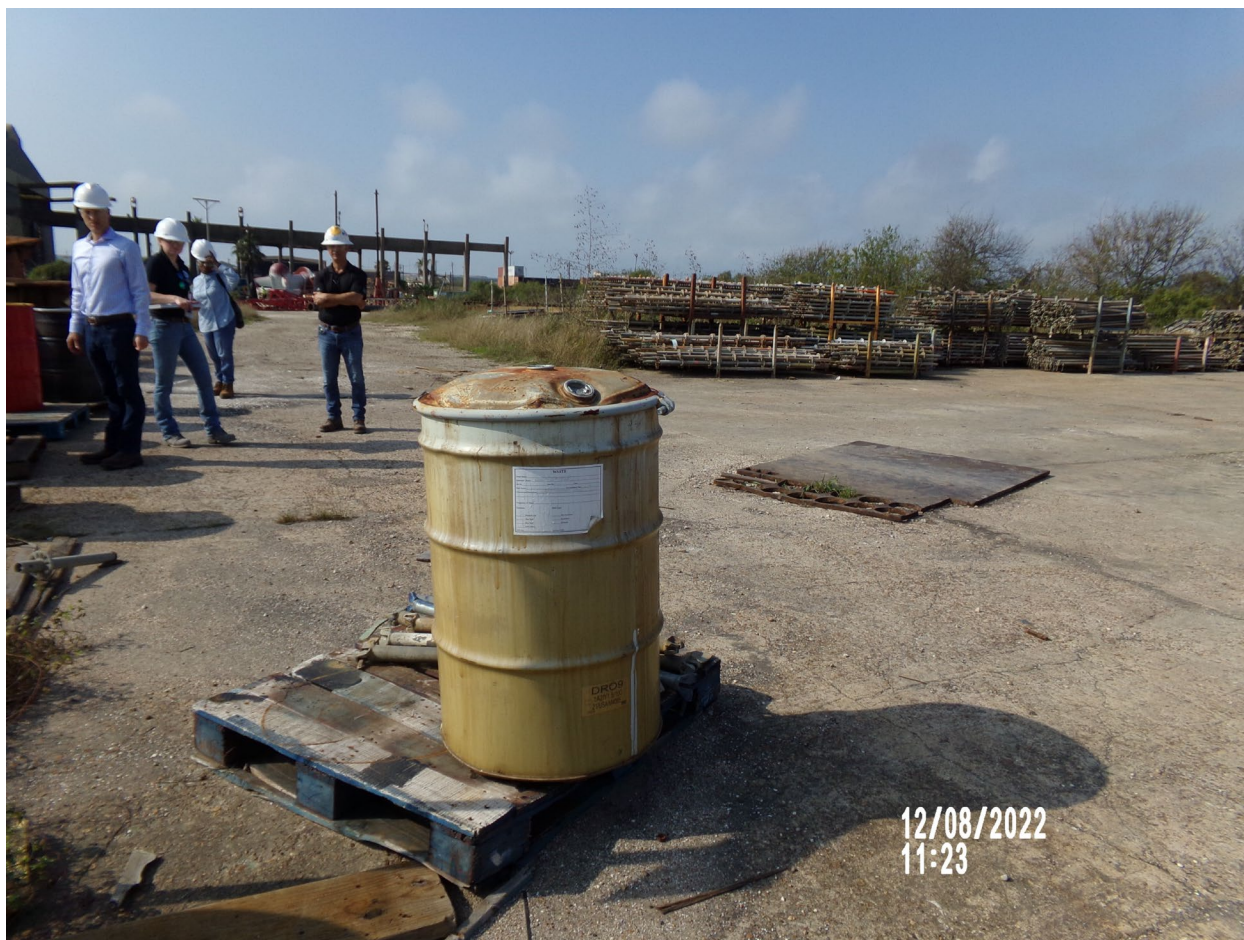
Photo No. 12

While in the waste storage area, we observed multiple instances of unlabeled and/or unsecured drums and/or containers in poor condition. This included two bulging drums: one undated yellow drum labeled as paint waste and one unlabeled black drum (Appendix 1, Photos 12, 15, & 16). Mr. Haughton said these drums were from a vessel and would be repackaged. We observed a corroded drum covered with a blue tarp tied around the drum to cover the top of the un-lidded drum (Appendix 1, Photo 20). Corroded fire extinguishers were next to it. We observed a heavily corroded drum containing what was labeled as "oily debris" (Appendix 1, Photo 18). We also saw an unlabeled plastic blue drum with three black gas cylinders around it (Appendix 1, Photo 19). Mr. Haughton said the cylinders had been placed there by the environmental team. For those containers with labels, the contents were identified as paint waste, oily waste, or food waste.

| Description:<br>Photo of bulging yellow drum near the waste storage area. Waste label denotes contents as "Paint Waste." | | |

- In the waste storage area, we noticed multiple instances of waste stored in drums in poor condition (e.g., bulging drums, heavily corroded).

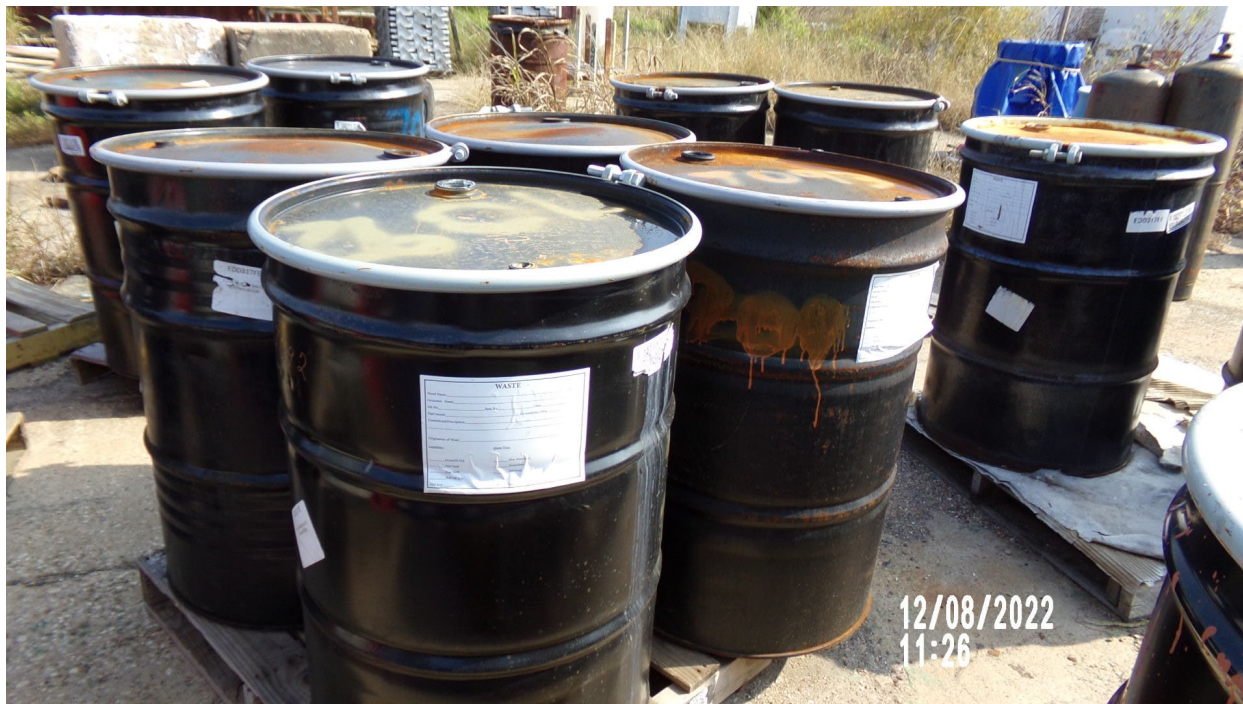
Photo No. 13

| Description:<br>View of black metal drums in the waste storage area with contents awaiting disposal.<br>Unsecured drum with blue tarp lid in the background. | | |

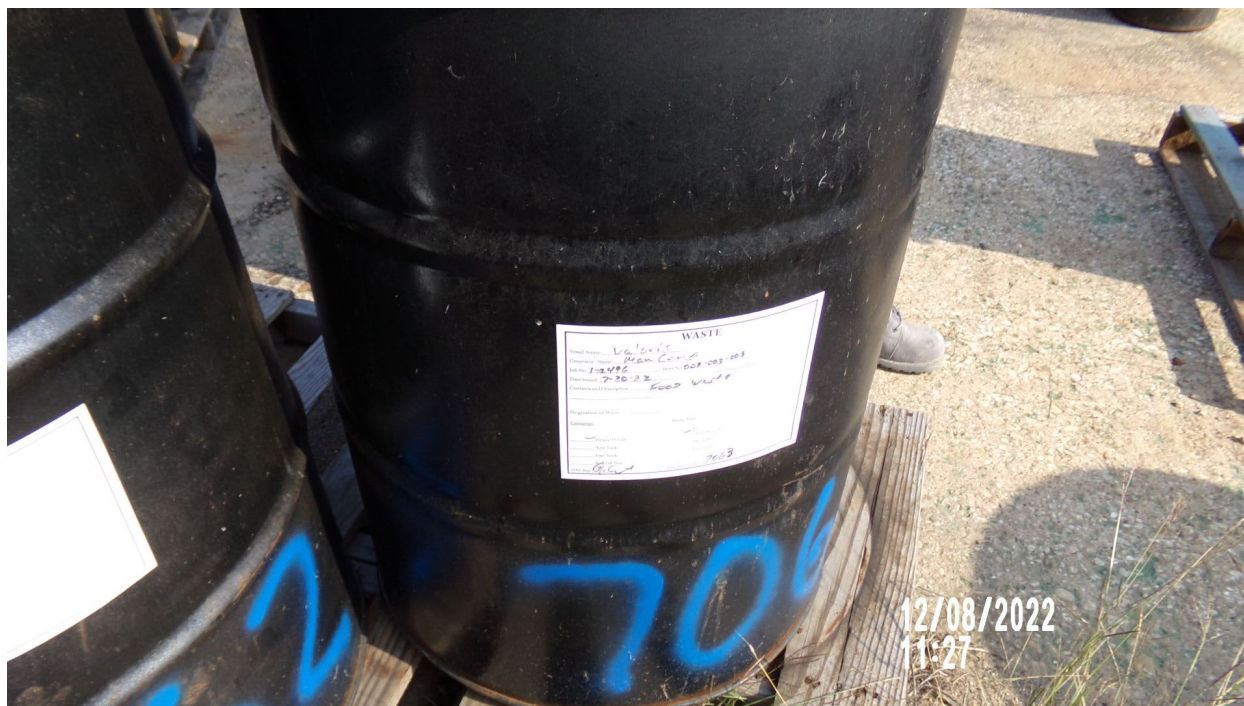
Photo No. 14

| Description:<br>Close-up of a drum labeled "Food Waste" from the waste storage area. | | |

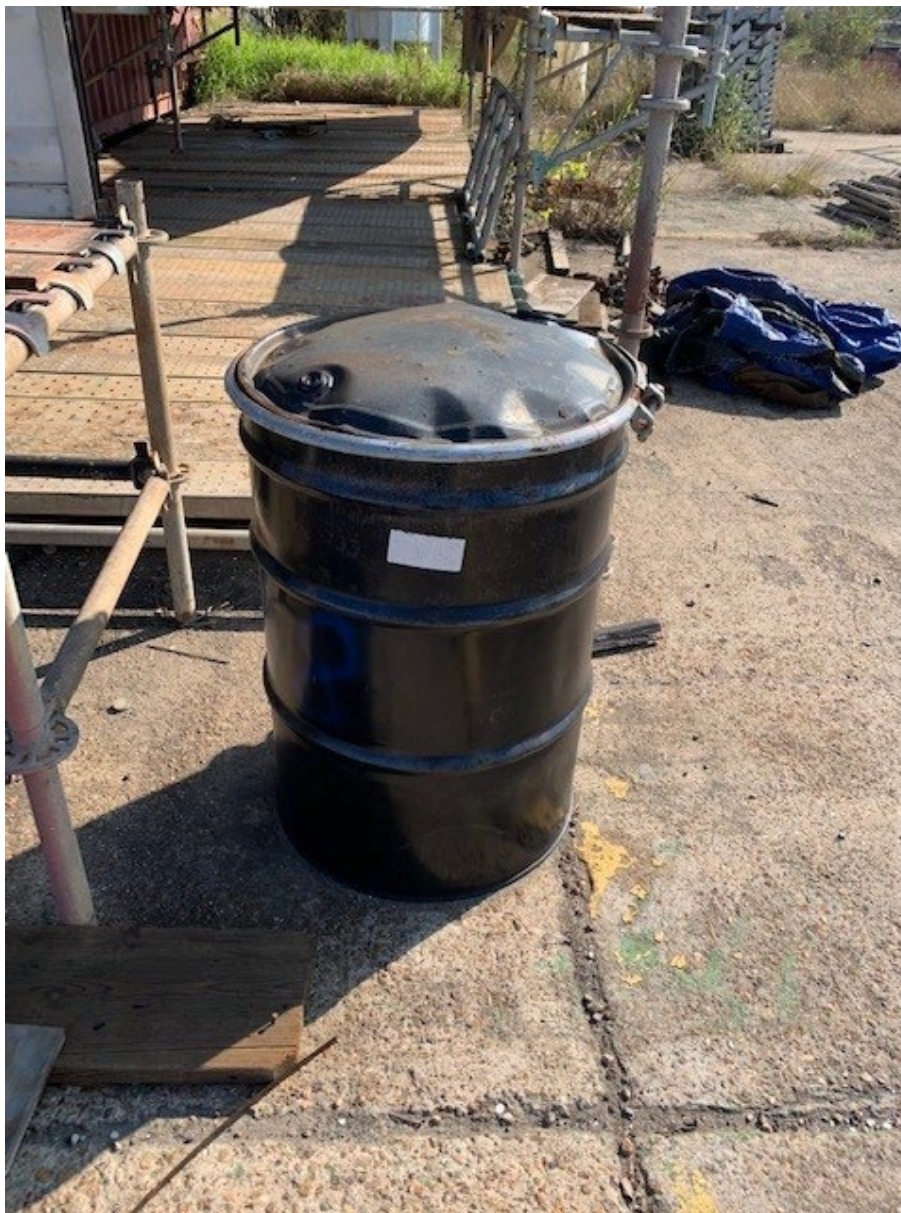
Photo No. 15

| Description:<br>Bulging black drum near waste storage area. Drum has no legible label describing its contents. | | |

- We saw unlabeled drums in the Waste Storage Area, including a black drum in poor condition by the shipping container and a white pony drum near the tarped scaffold in the middle of the gravel area that appeared to be leaking a fluid and leaving a solid residue. There were also multiple containers in the main storage area that had no waste labels on them.

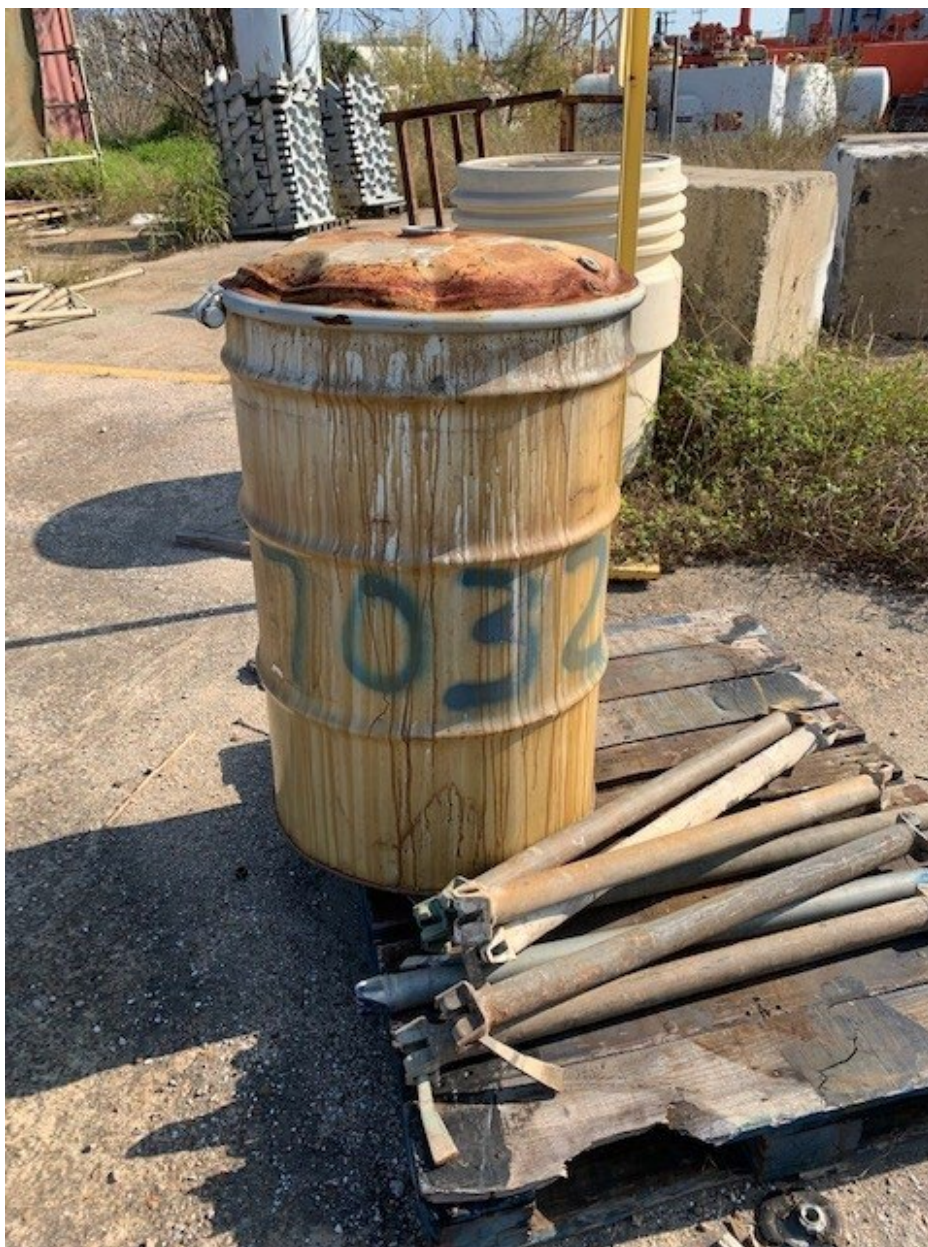
Photo No. 16

| Description:<br>Another view of the bulging yellow drum labeled as "Paint Waste." | | |

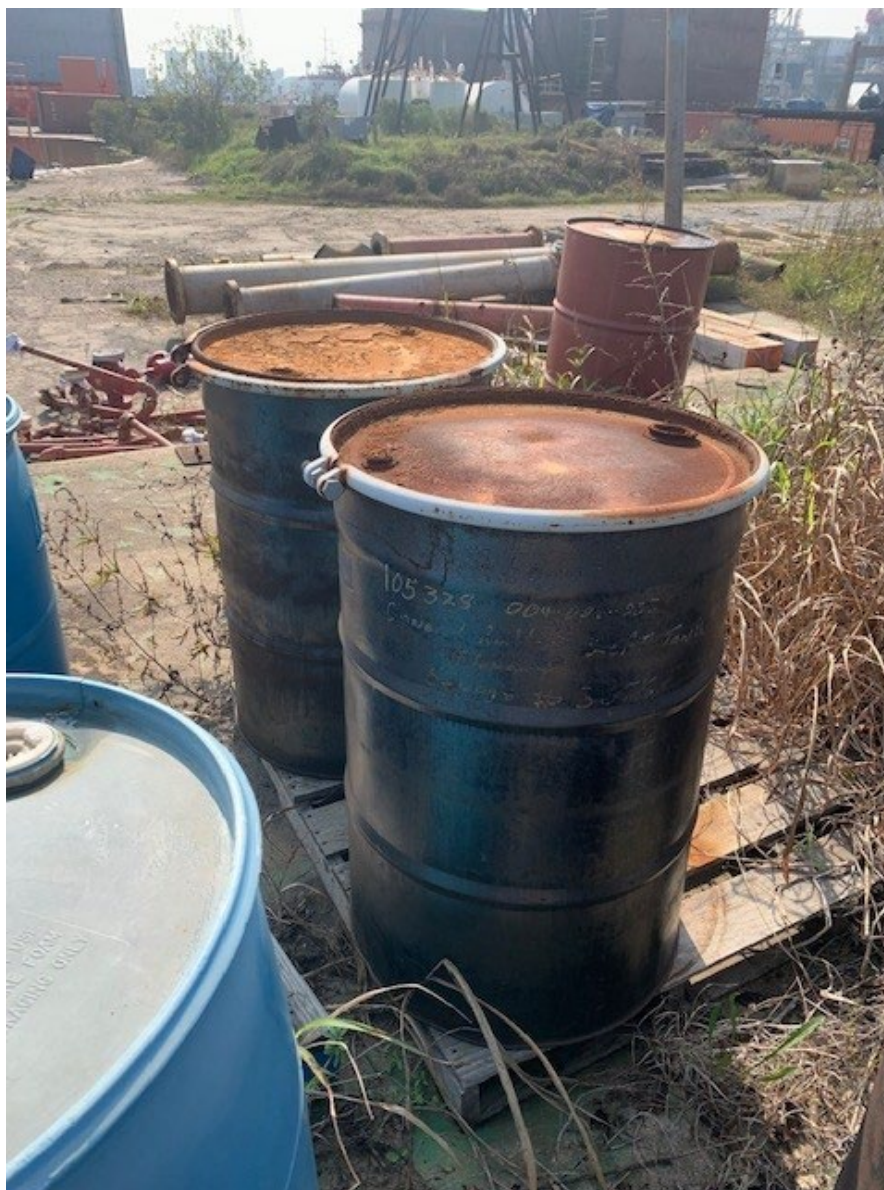
Photo No. 17

| <b>Description:</b><br>Two black drums with corroded lids. Drum in the back is closed, but unsecured. | | |

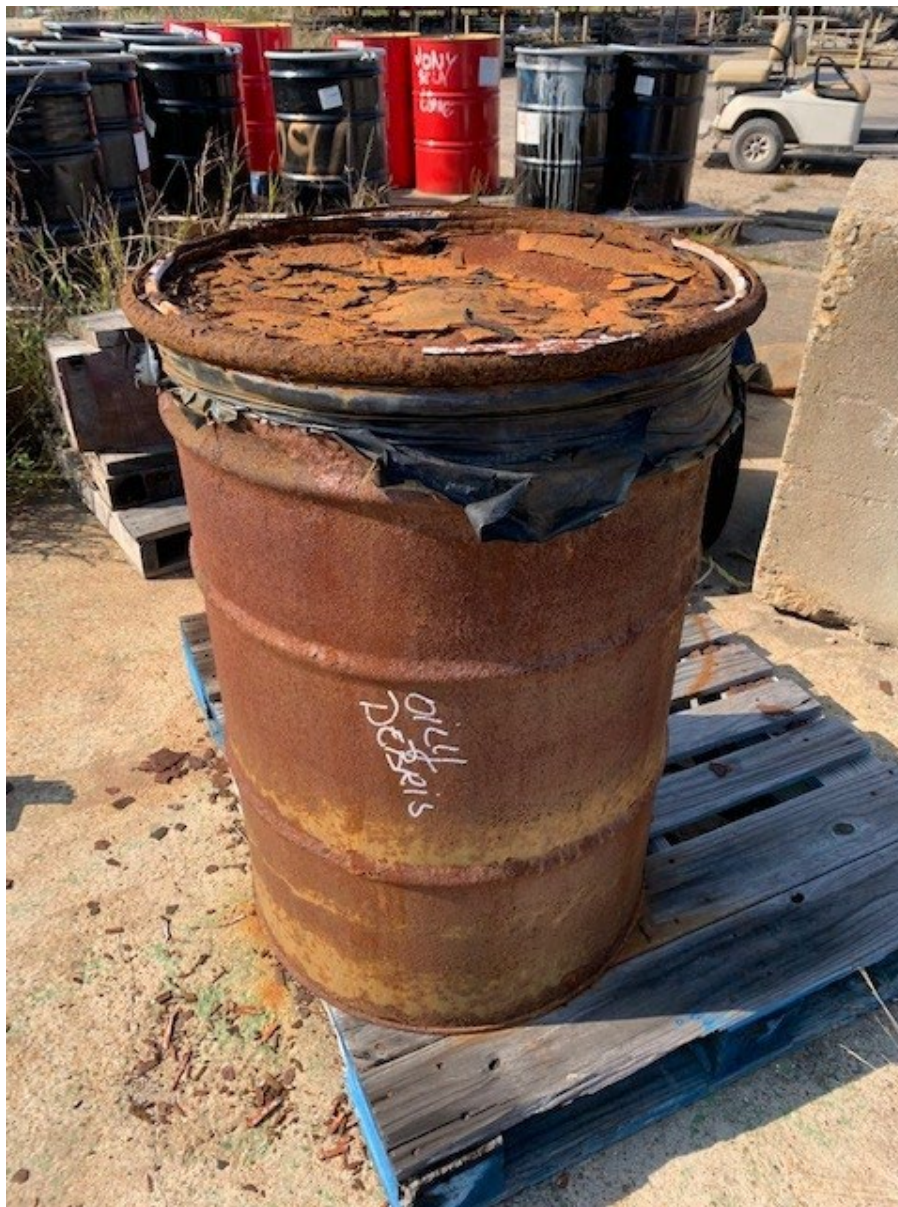
Photo No. 18

| Description:<br>Heavily corroded drum marked as "Oily Debris." | | |

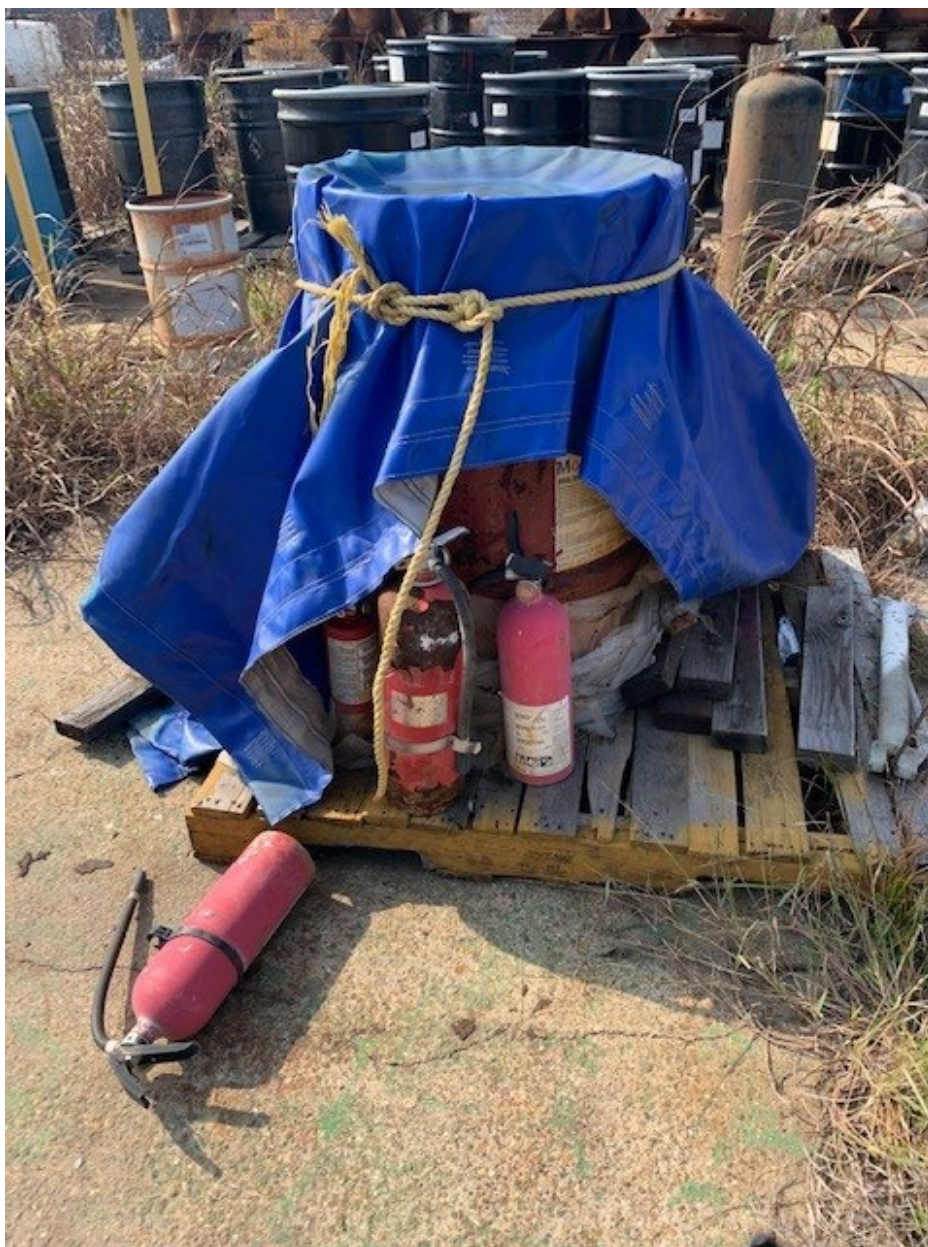
Photo No. 20

| Description:<br>Corroded metal drum covered with a blue tarp, tightened around the drum by rope. Corroded fire extinguishers next to the drum. | | |

- We saw multiple open, unlabeled containers housing unknown wastes. One container, the pony drum near the tarped scaffold in the scaffold area, appeared to be leaking. A drum in the main waste storage area was covered by a tarp and tied loosely with rope, but it did not have an attached drum lid beneath the tarp.
