**NPDES Stormwater Inspection
Industrial Facility**

R&F ASPHALT UNLIMITED, INC.
P.O. Box 801028, Ponce, Puerto Rico 00780
Telephone Numbers: (787) 848-1210 / (787) 848-1212

ASPHALT CEMENT MANUFACTURING FACILITY
PR-14 Road, Km. 9.6, Coto Laurel Ward
Ponce, Puerto Rico 00780
Coordinates: 18.050906° N; 66.543734° W
Telephone Number: (787) 376-3923

Inspection Date: February 25, 2025

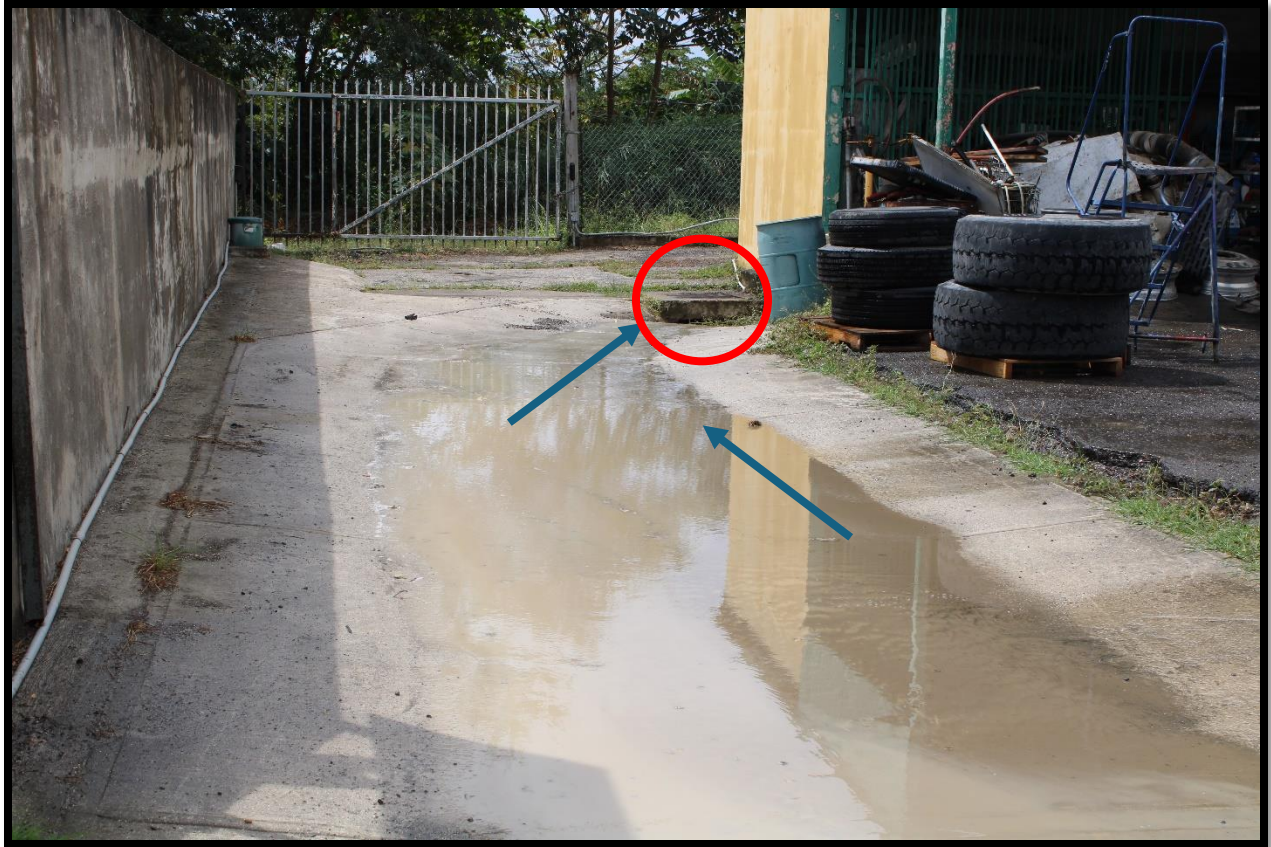
- b. The EPA inspector observed that storm sewer drain inlets lacked protection measures. Refer to Pictures 1 through 5, 11, 15 and 16 in Attachment 1 for pictures of the inlets lacking protection measures.

Picture 1 shows concrete swale that conveys stormwater runoff into the storm sewer drain inlet located near the mechanical shop. This drainage system collects stormwater runoff flowing from the asphalt cement processing plant. The inlet (depicted by the red circle) can be seen in the background. No inlet protection was observed. The blue arrows depict the flow path of the stormwater runoff.

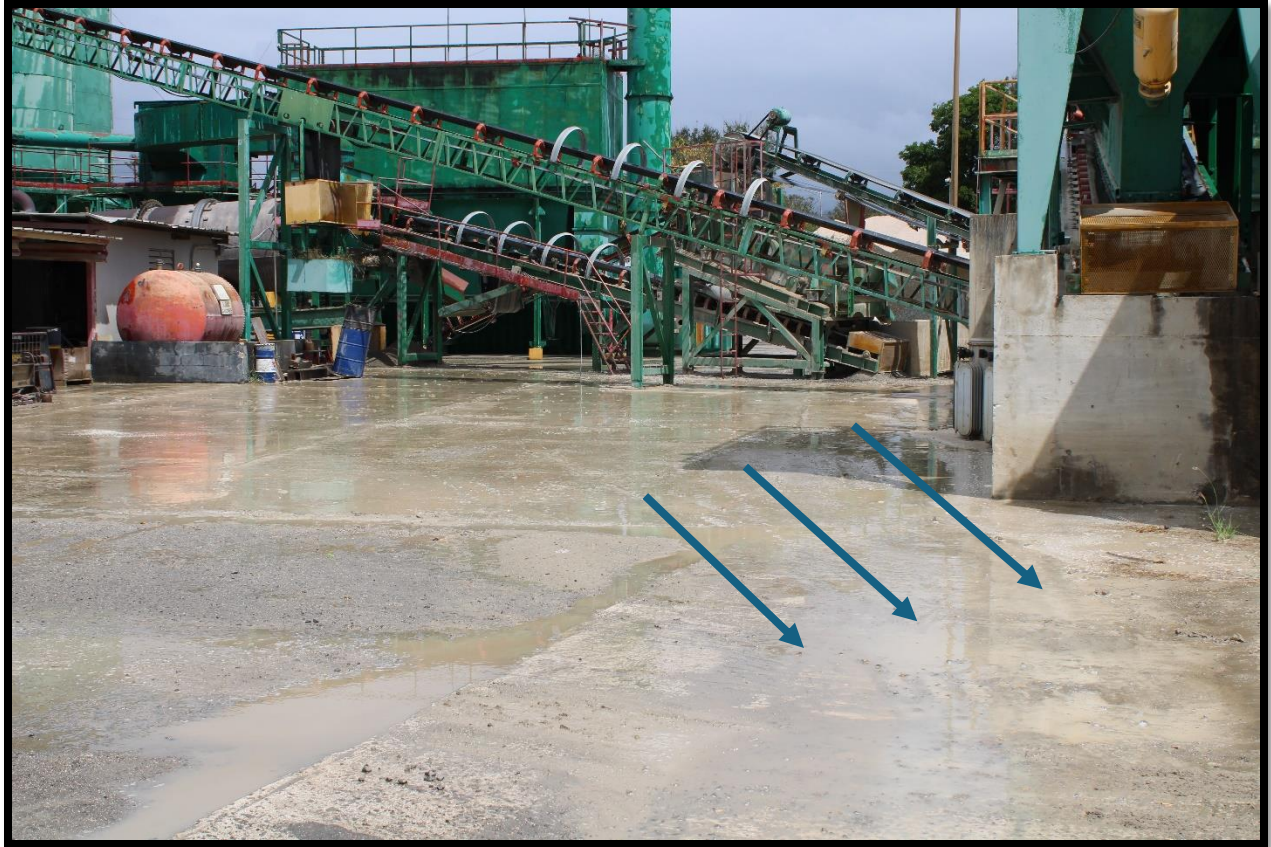
Picture 2 shows the asphalt cement processing plant and stormwater runoff flowing towards the storm sewer drain inlet shown in the previous picture. The blue arrows depict the flow path of stormwater runoff.

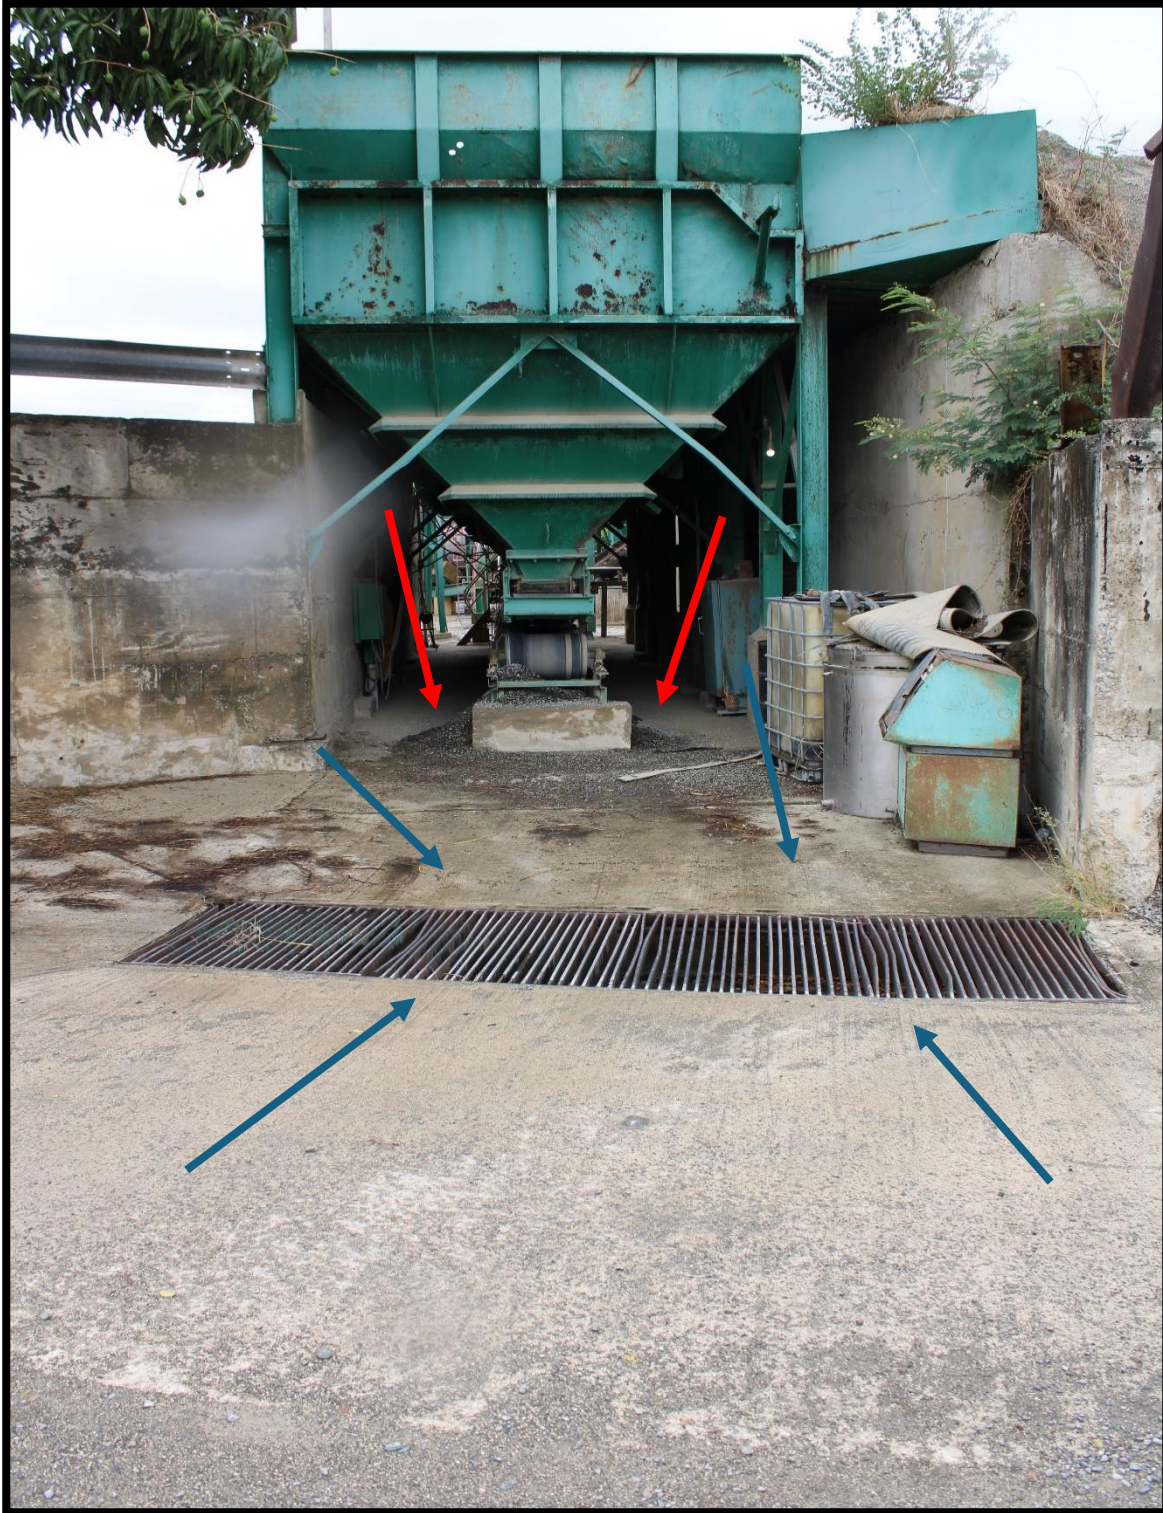
Picture 3 shows the aggregate bin feed system and a drainage grate. A tote for water storage is also visible in the picture. The holding tank was empty at the time. Unused equipment parts can also be seen. The blue arrow depicts the flow path of storm water. No inlet protection measure was observed for the storm sewer drain inlet. Also, the picture shows an aggregate spill from the bin loading machine (indicated by the red arrows).

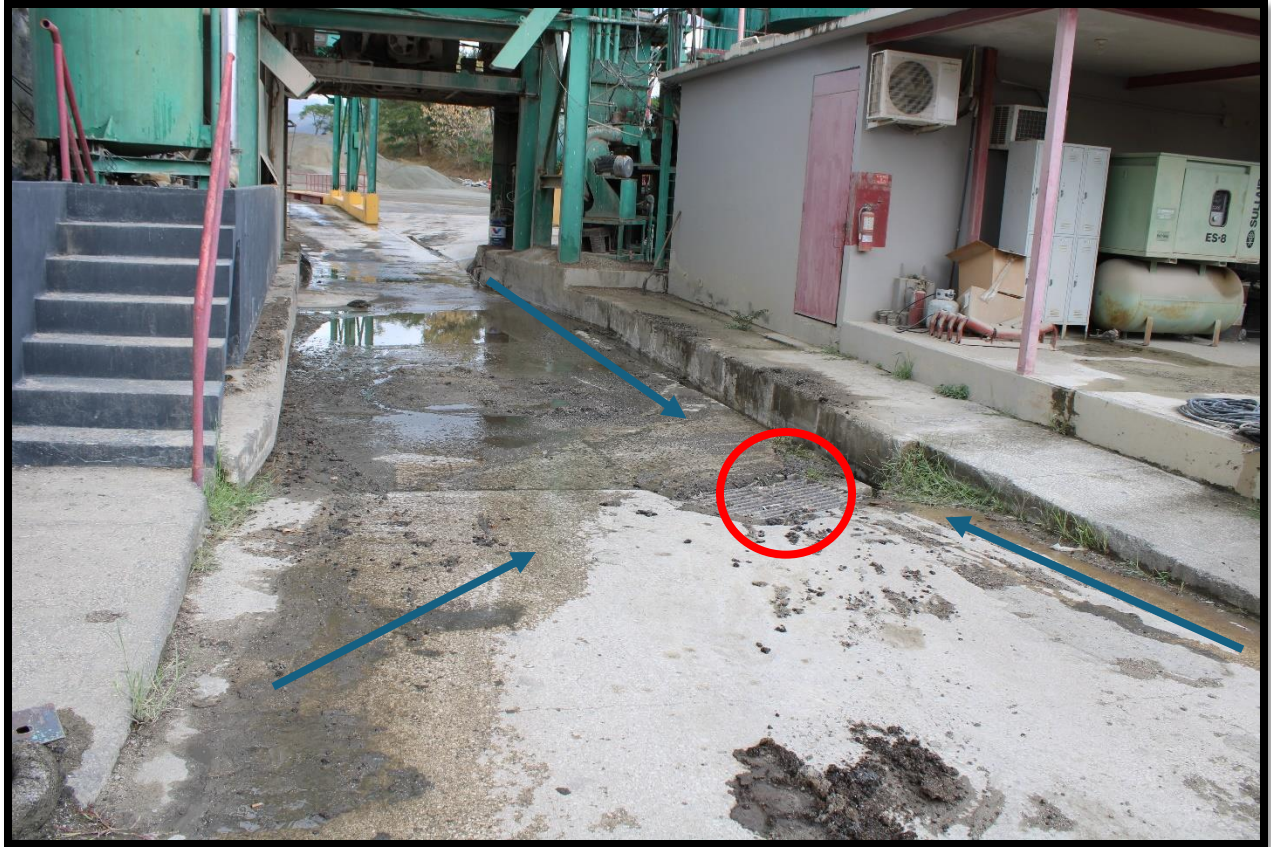
Picture 4 shows a storm sewer drain inlet (depicted by the red circle) located in the asphalt cement processing plant area. The inlet did not have inlet protection measure. A significant amount of sediment is visible around the inlet and in the stormwater runoff path. The blue arrows depict the flow path of stormwater runoff.

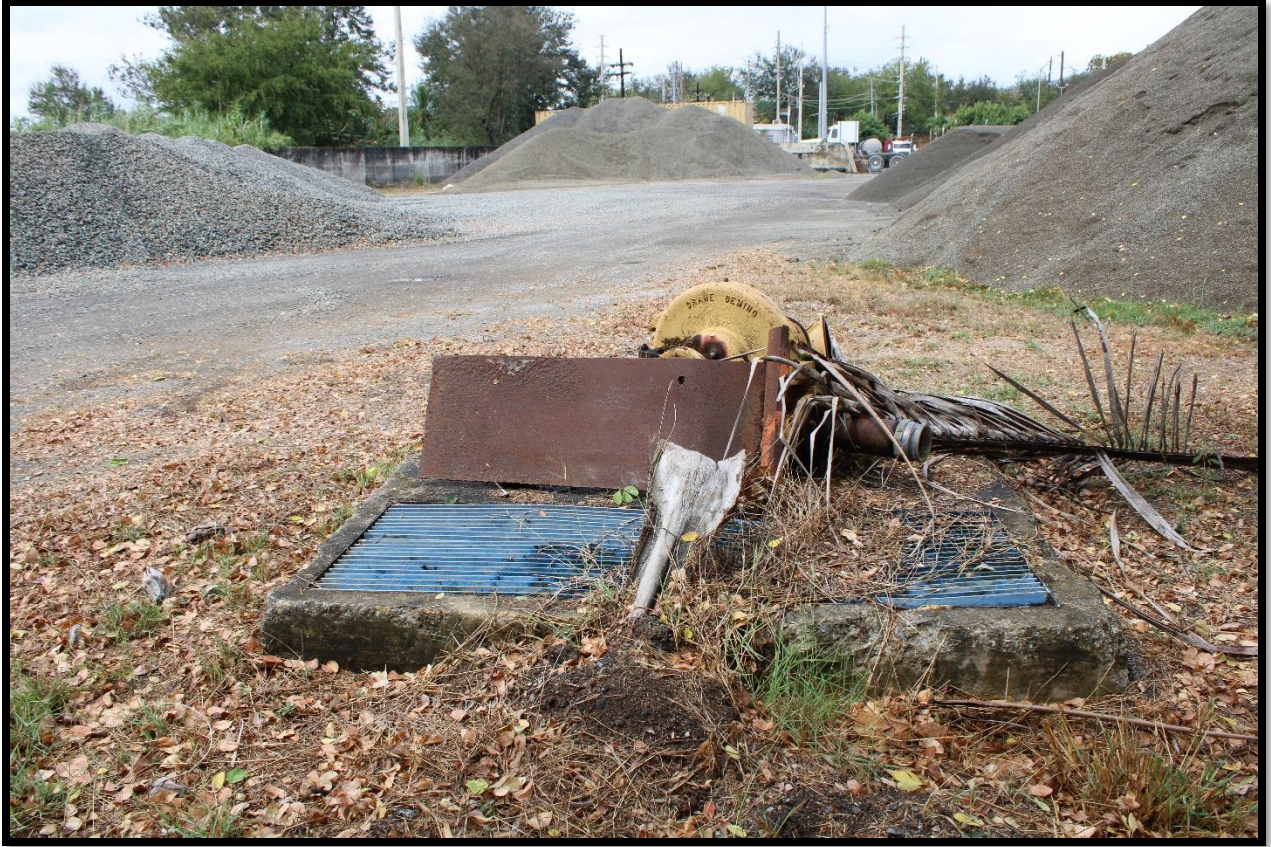
Picture 5 shows two storm sewer drain inlets next to each other without inlet protection measure and accumulated trash in the top of one of the inlet grates.

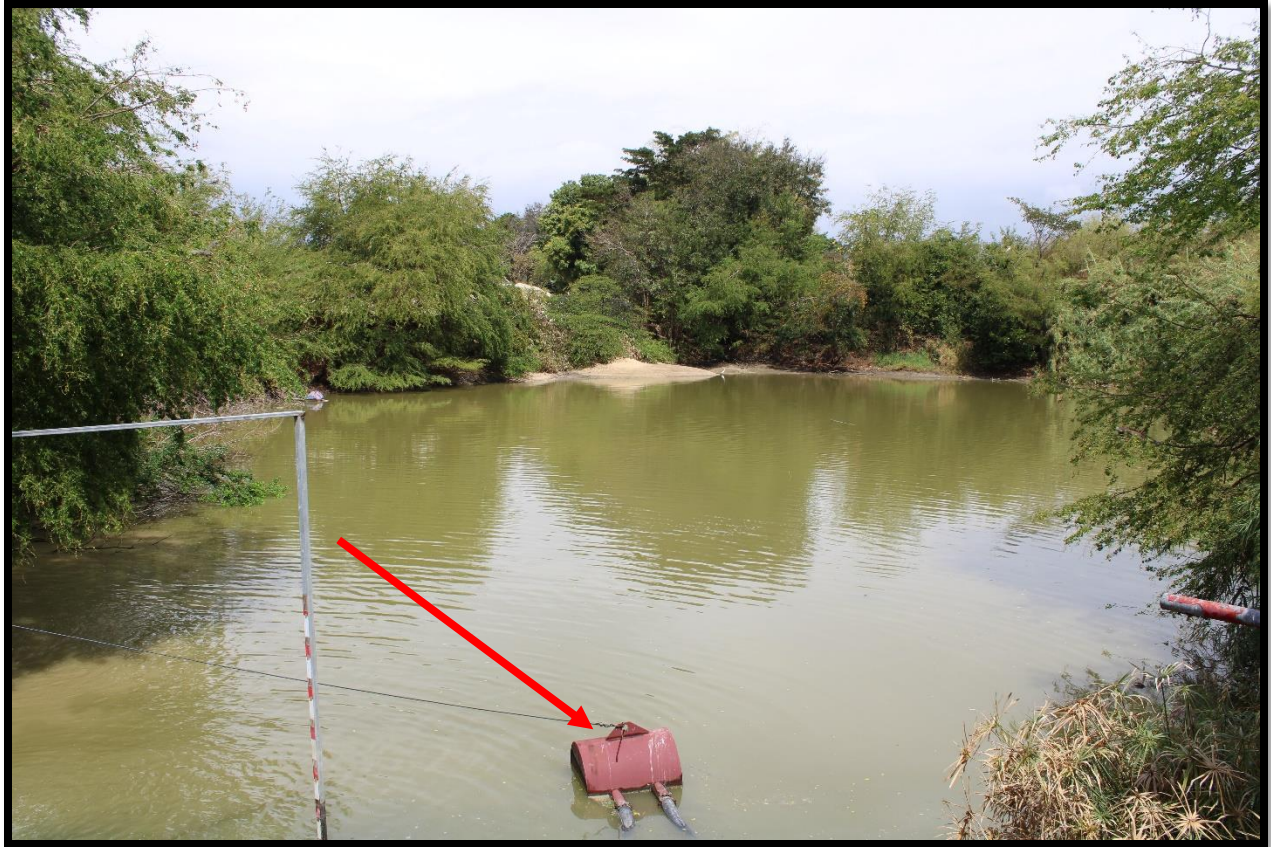
Picture 6 shows the detention pond. The picture also shows a floating device where two pipes are connected (indicated by the red arrow). There is a pump at the Inabón River that when turn-on, conveys river water into the detention pond. This system is no longer in use.

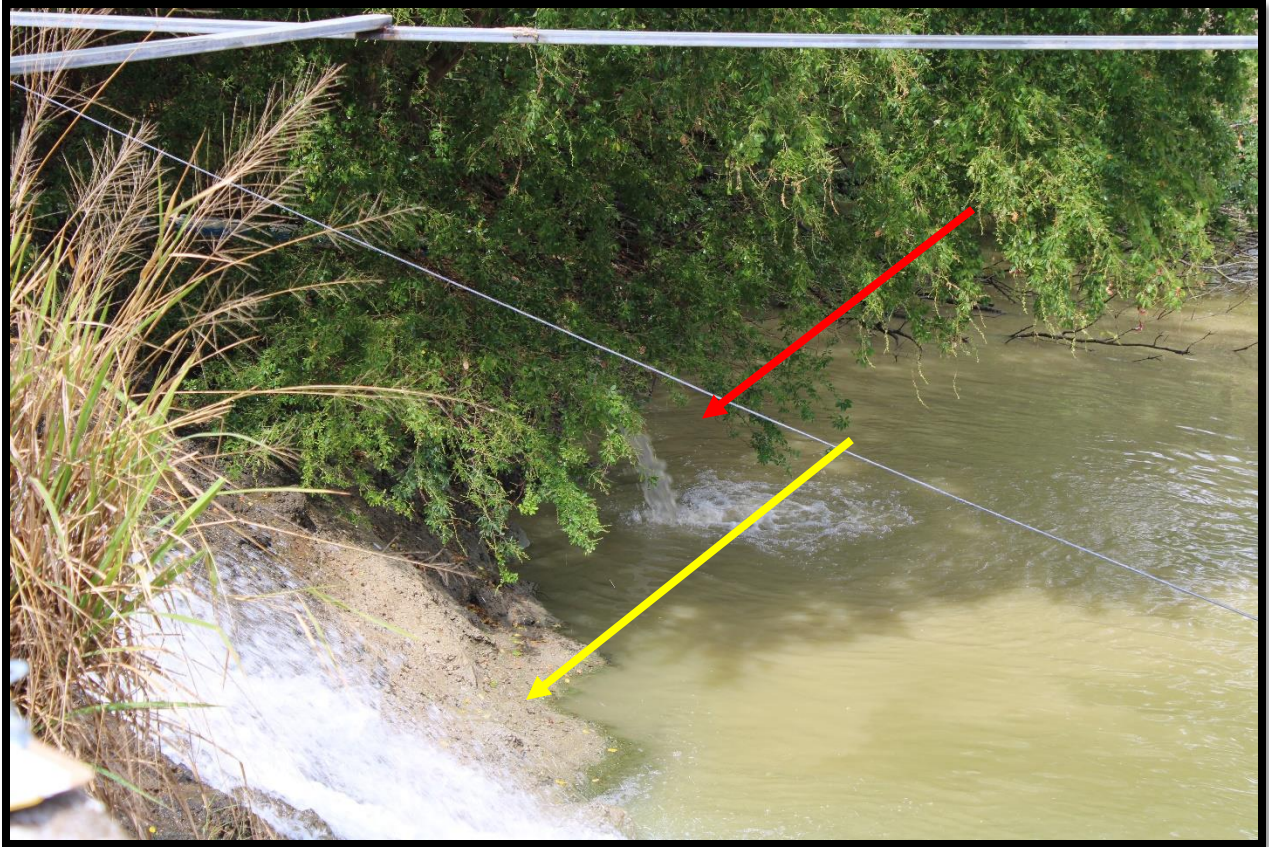
Picture 7 shows stormwater being discharged into the detention pond (indicated by the red arrow). The picture also shows water from the Inabón River being discharged into the pond (indicated by the yellow arrow).

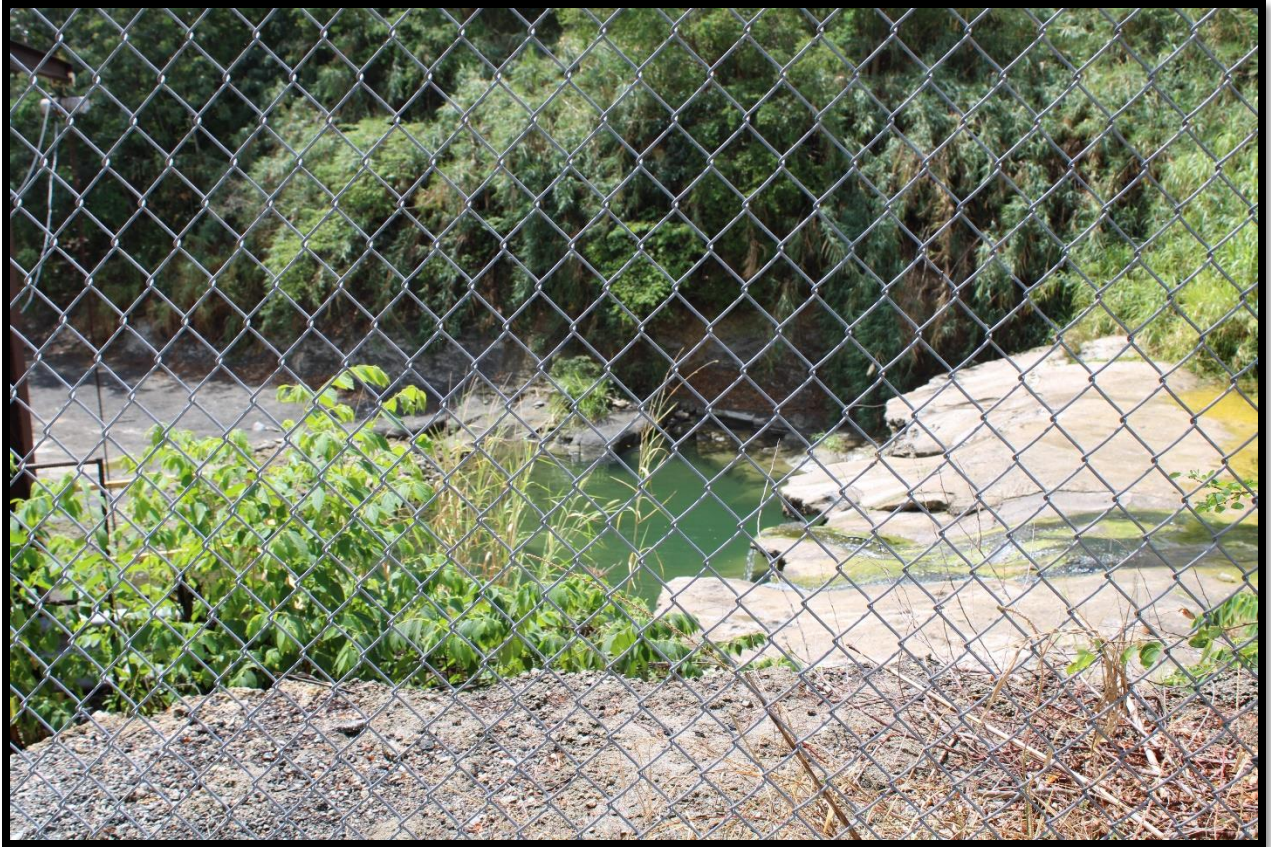
- c. Within the Facility's action area, a body of water, the Inabón River was observed. Refer to Picture 8 in Attachment 1 for a picture of the Inabón River.

Picture 8 shows a segment of the Inabón River near the Site.

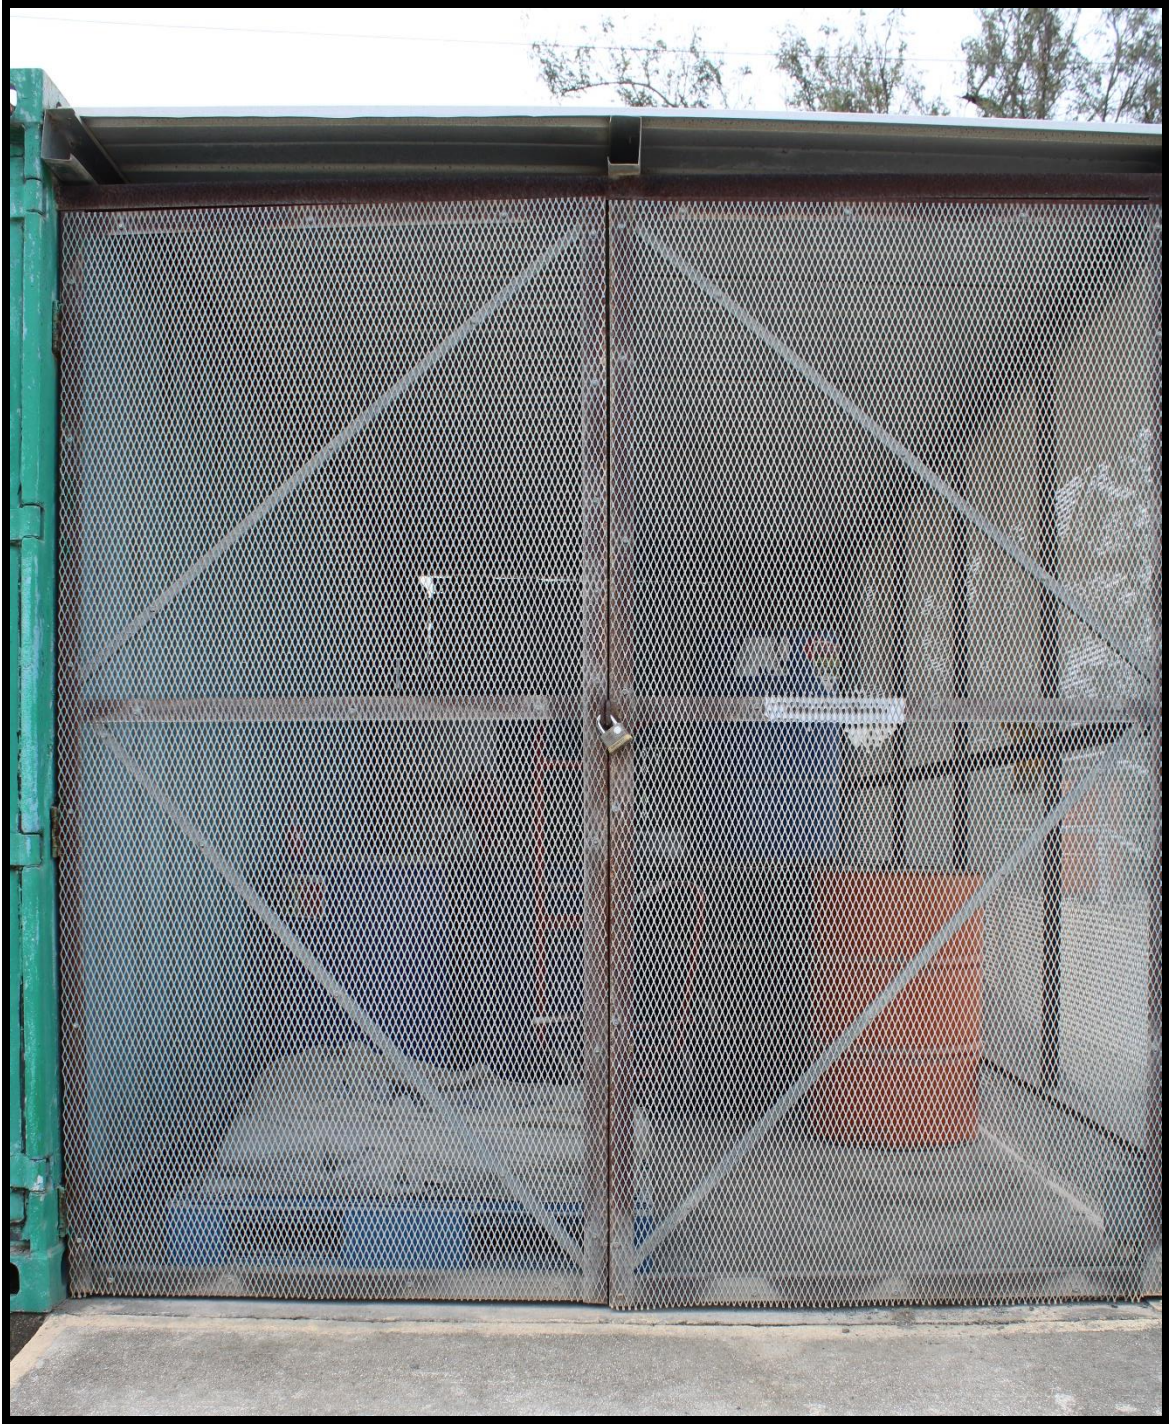
- d. Raw materials for asphalt cement manufacturing were observed stored in a covered and locked shed. However, even though the shed was raised from the ground, it lacked secondary containment structure. Refer to Picture 9 of Attachment 1.

Picture 9 shows raw materials for asphalt production being stored in a covered and locked shed but lacking secondary spill containment structure.

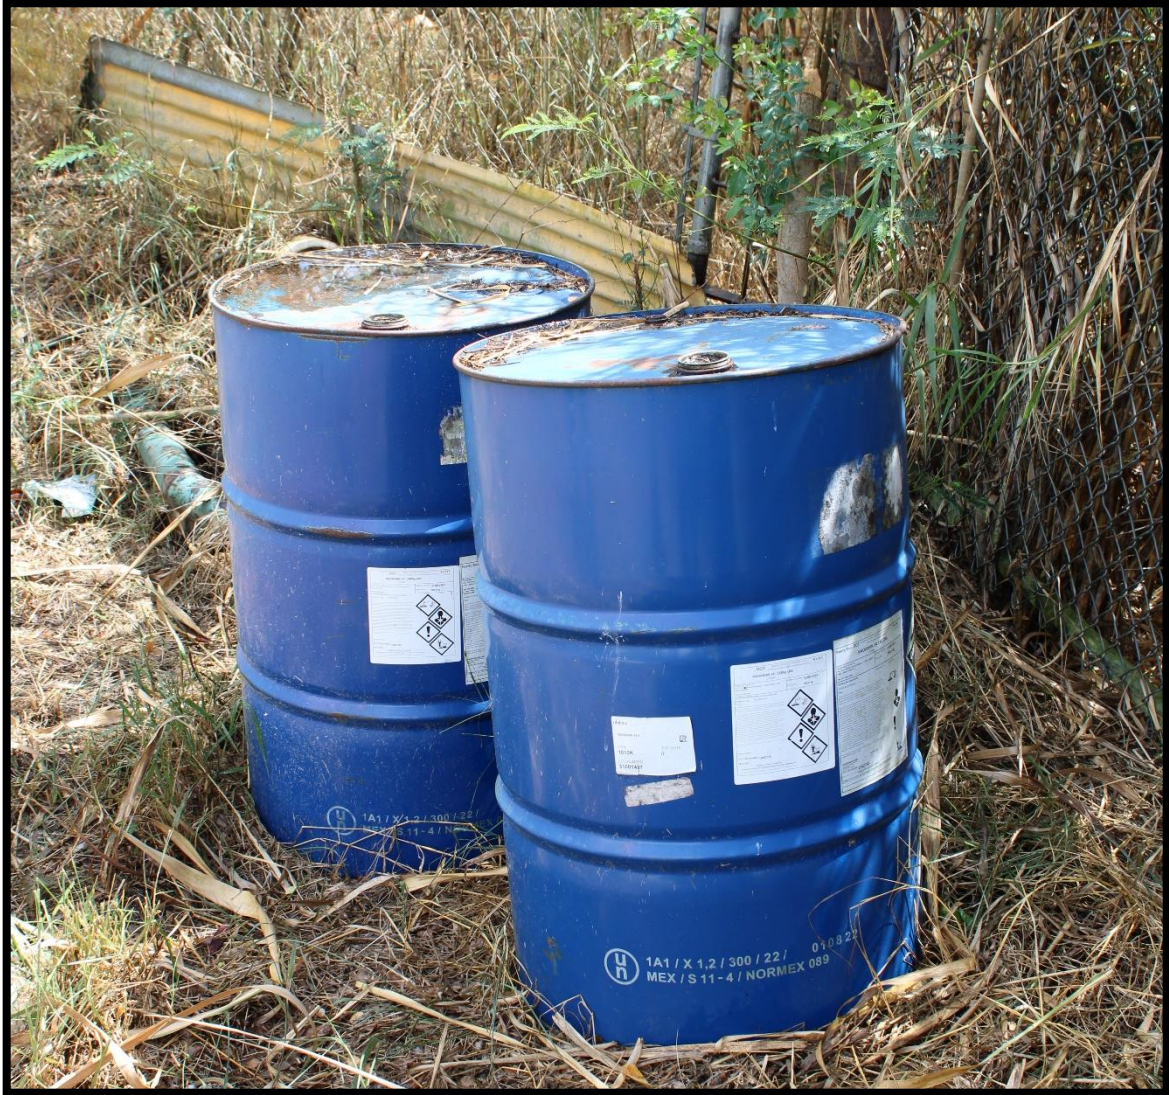
- e. Drums were scattered throughout the Facility without proper secondary containment. Refer to Picture 10 in Attachment 1.
- f. Spill response materials were located at a neighboring facility owned by R&F. However, spill containment devices were not readily available near potential spill areas.

Picture 10 shows two 55-gallon metal drums exposed to rain and lacking secondary spill containment.

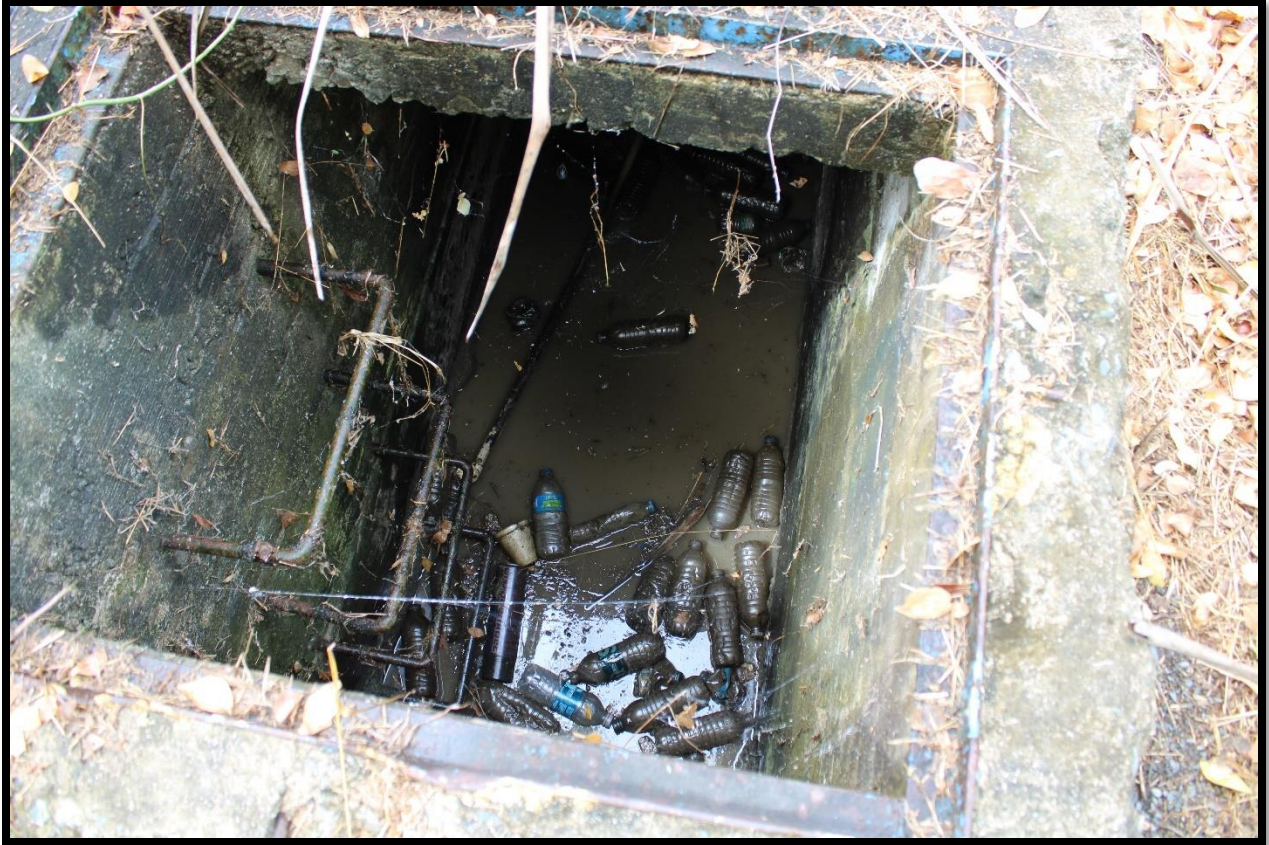
- g. Trash was observed scattered throughout the Site. A buildup of plastic bottles was found inside a storm sewer drain located in the aggregate storage area. Refer to Picture 11 in Attachment 1.

Picture 11 shows a buildup of plastic bottles found inside a storm drain inlet located in the aggregate storage area. The accumulated water is turbid and had a light brown color. The inlet lacked protection.

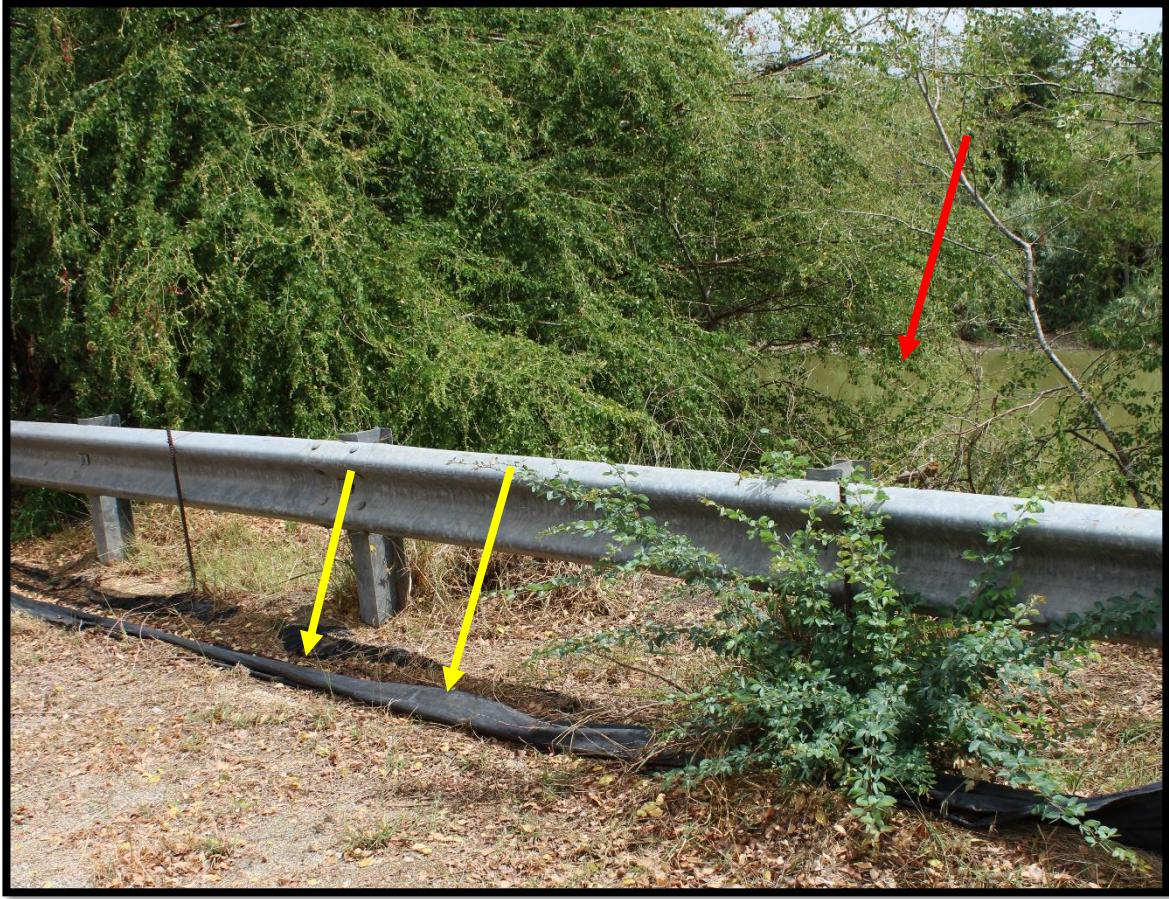
- i. No erosion control measures were observed in place at the Site. The only sediment control measure seen was a damaged silt fence. Refer to Picture 12 in Attachment 1.

Picture 12 shows a collapsed silt fence (indicated by the yellow arrow). The detention pond can be seen in the background (indicated by the red arrow)

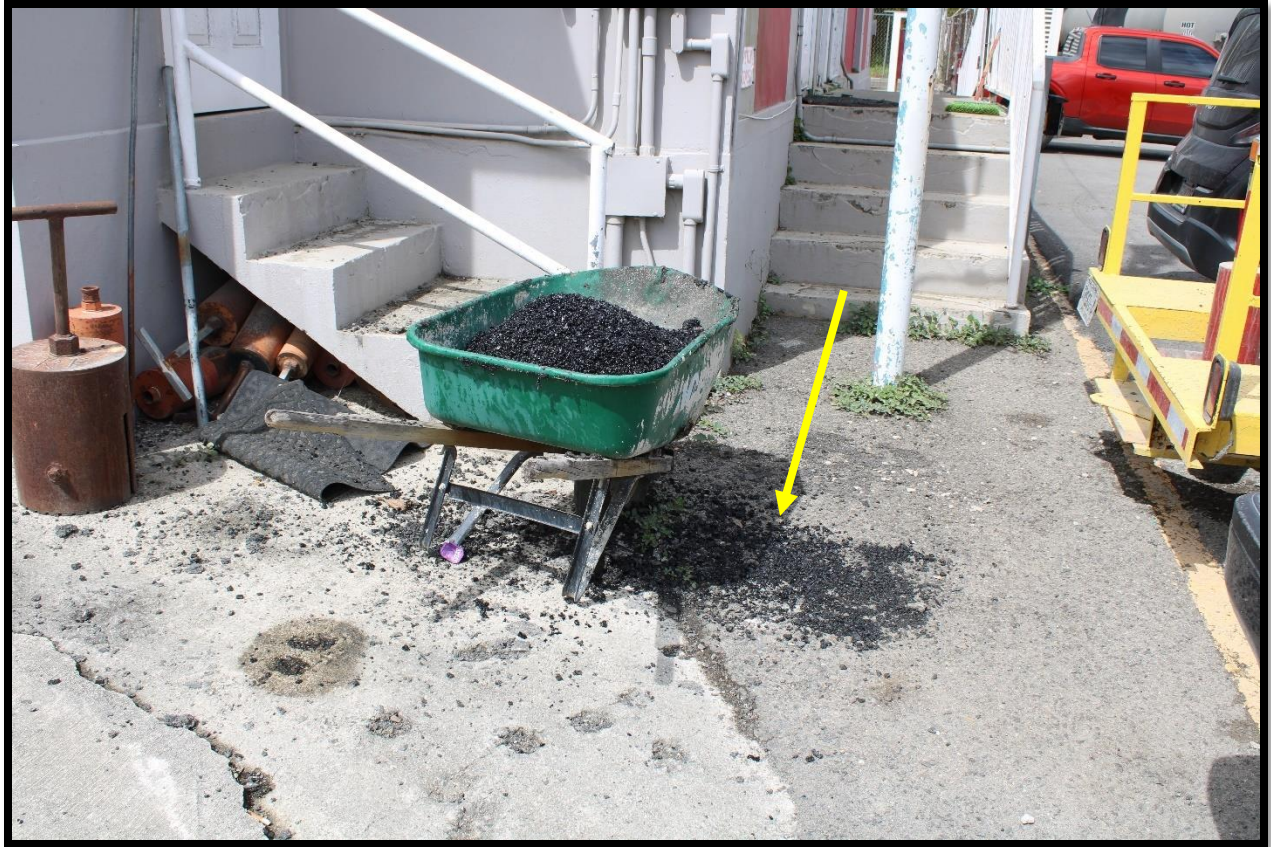
- j. An asphalt spill was observed at the Facility. The spill occurred while a Facility personnel was filling a wheelbarrow with asphalt, causing asphalt to spill onto the ground. This practice took place in front of the laboratory offices, and spill containment structures were in place. No organized housekeeping measures were evident in these areas. However, after the concern was raised, the Facility personnel were observed cleaning the spill. Refer to Picture 5 of Attachment 1.

Picture 13 shows an asphalt concrete spill (yellow arrow). No organized housekeeping measures were evident in these areas.

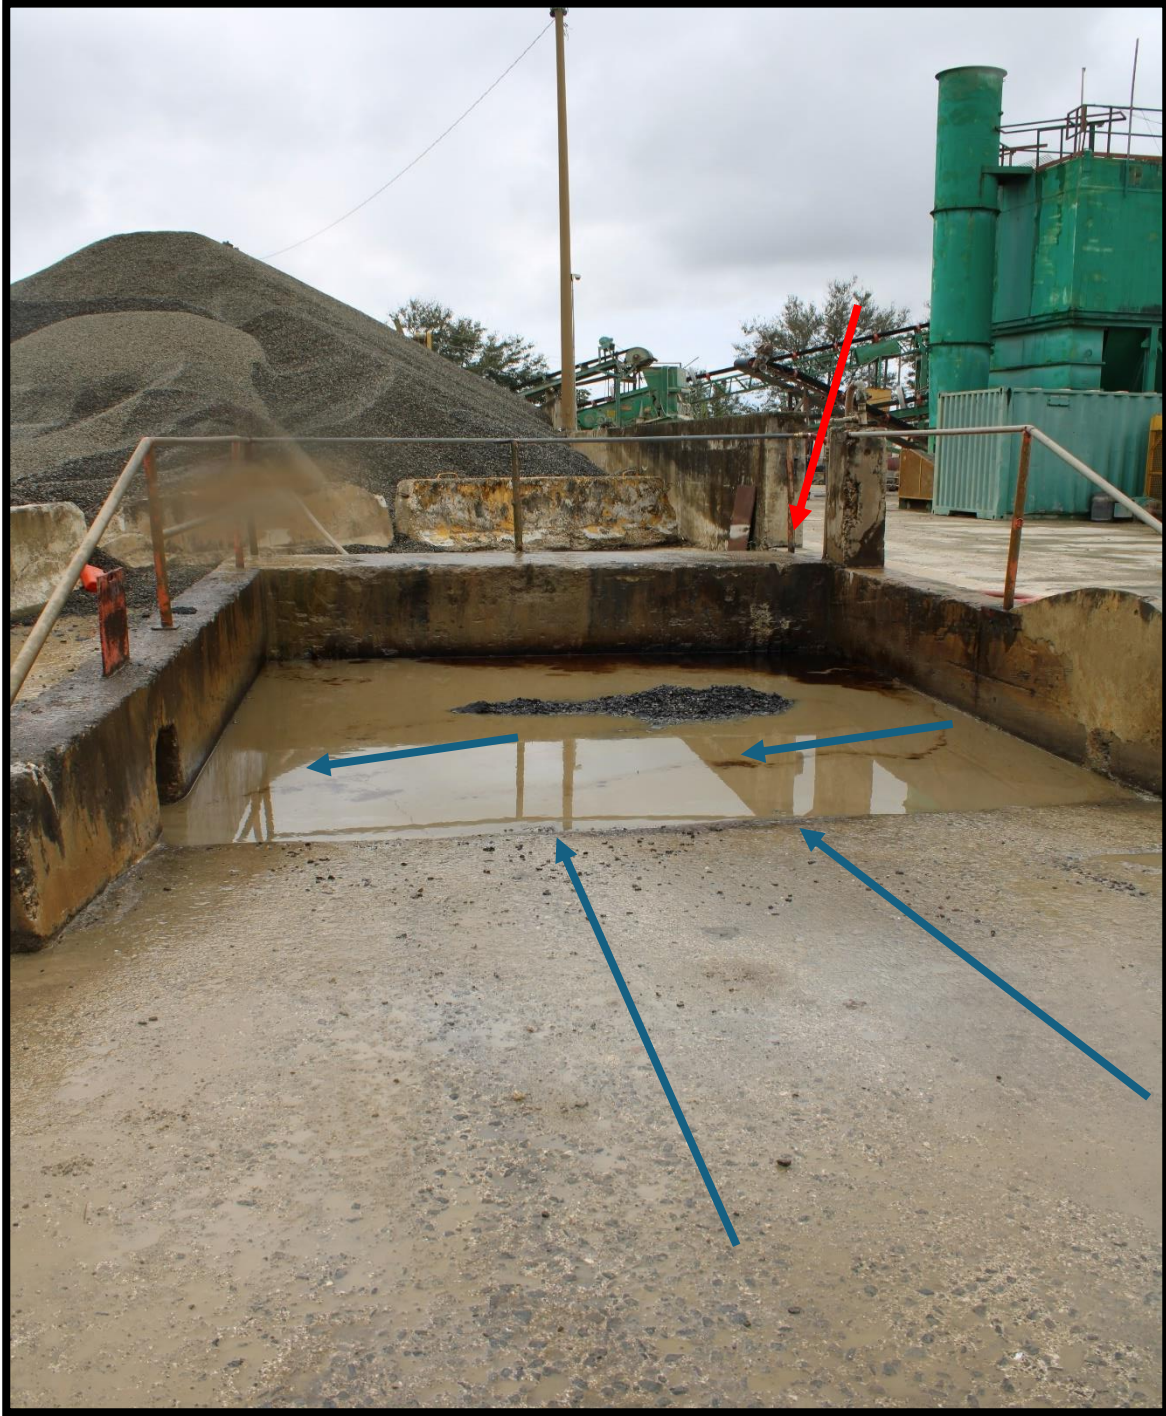
- k. An oil spill was observed entering a stormwater catch basin in the vehicle washing area. Upon notification by the EPA inspector, facility staff implemented corrective measures, utilizing spill containment and cleanup devices to remove the remaining oil. Refer to Pictures 14 through 16 for pictures of the oil spill and implemented corrective measures.

Picture 14 shows an oil spill (indicated by the red arrow) that reached the vehicle washing area. The water in the washing area had oil and was observed flowing into a concrete drainage. The blue arrows indicate the flow path of stormwater runoff into the washing area. Also, they show the flow path into the concrete drainage.

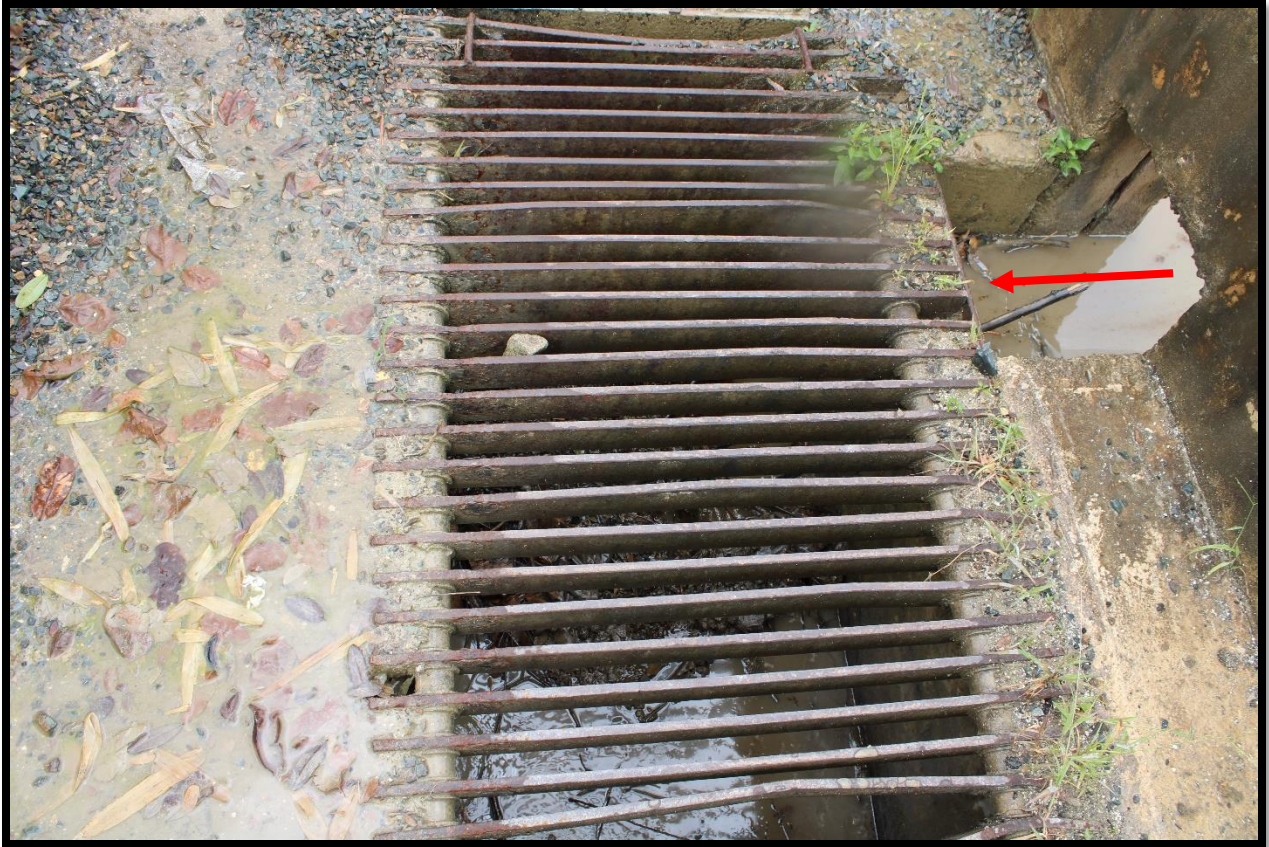
- No signs marking stormwater outfalls were observed at the Facility.
- No NPDES permit sign was posted at the facility entrance.
- Stormwater containing oil spill was observed flowing into a storm sewer drain inlet located near the vehicle washing area.

Picture 16 shows the storm sewer drain inlet located in the vehicle washing area. The inlet lacked a protection measure. Also, water containing oil was observed flowing the washing area into the inlet (indicated by the red arrow).
