## Region 6 - Enforcement & Compliance Assurance Division

### INSPECTION REPORT

| Company Name: | <b>Citation Oil and Gas Corporation</b> | |
| Facility Name: | <b>Bayou Unit</b> | |

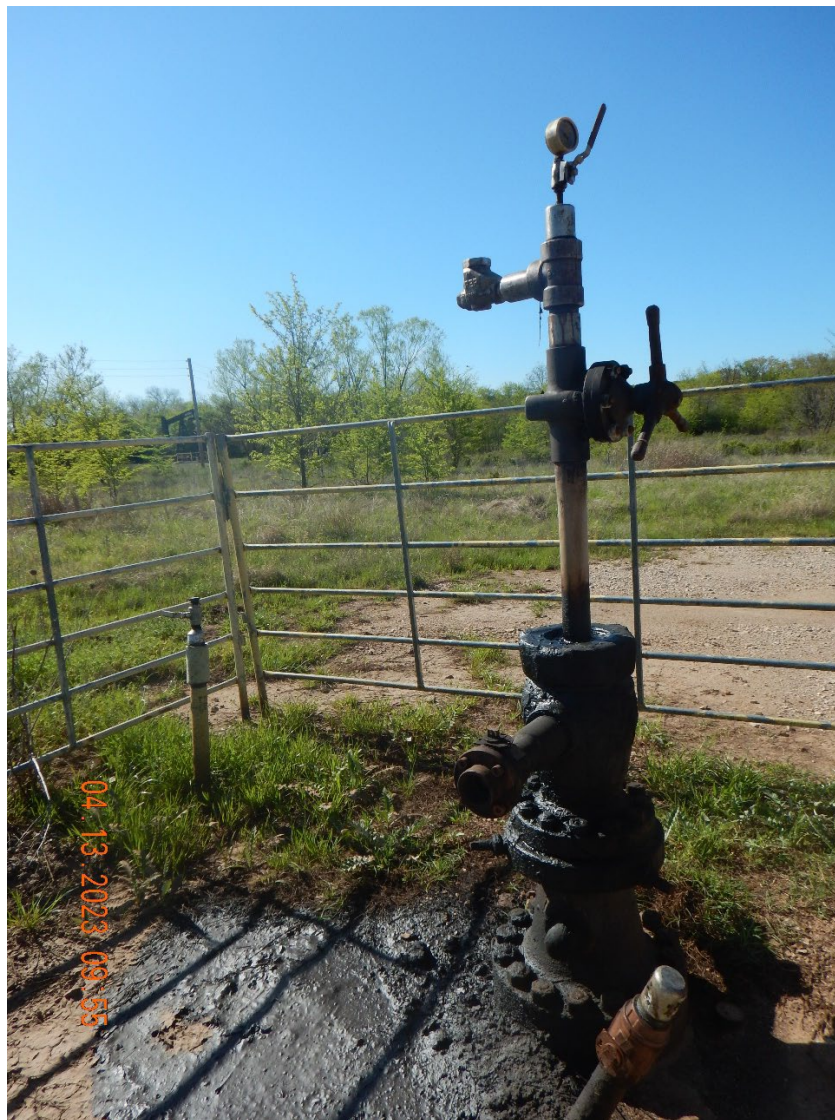
**Description:** This was the injection well Bayou Unit #58 at the time of the inspection. According to OCC representatives on site, the top perforations of this well were around 2,000 feet. At the time of the inspection this well was temporarily abandoned or a TA injection well. I observed oil staining on and around the well indicating a lack of best management practices at the well.

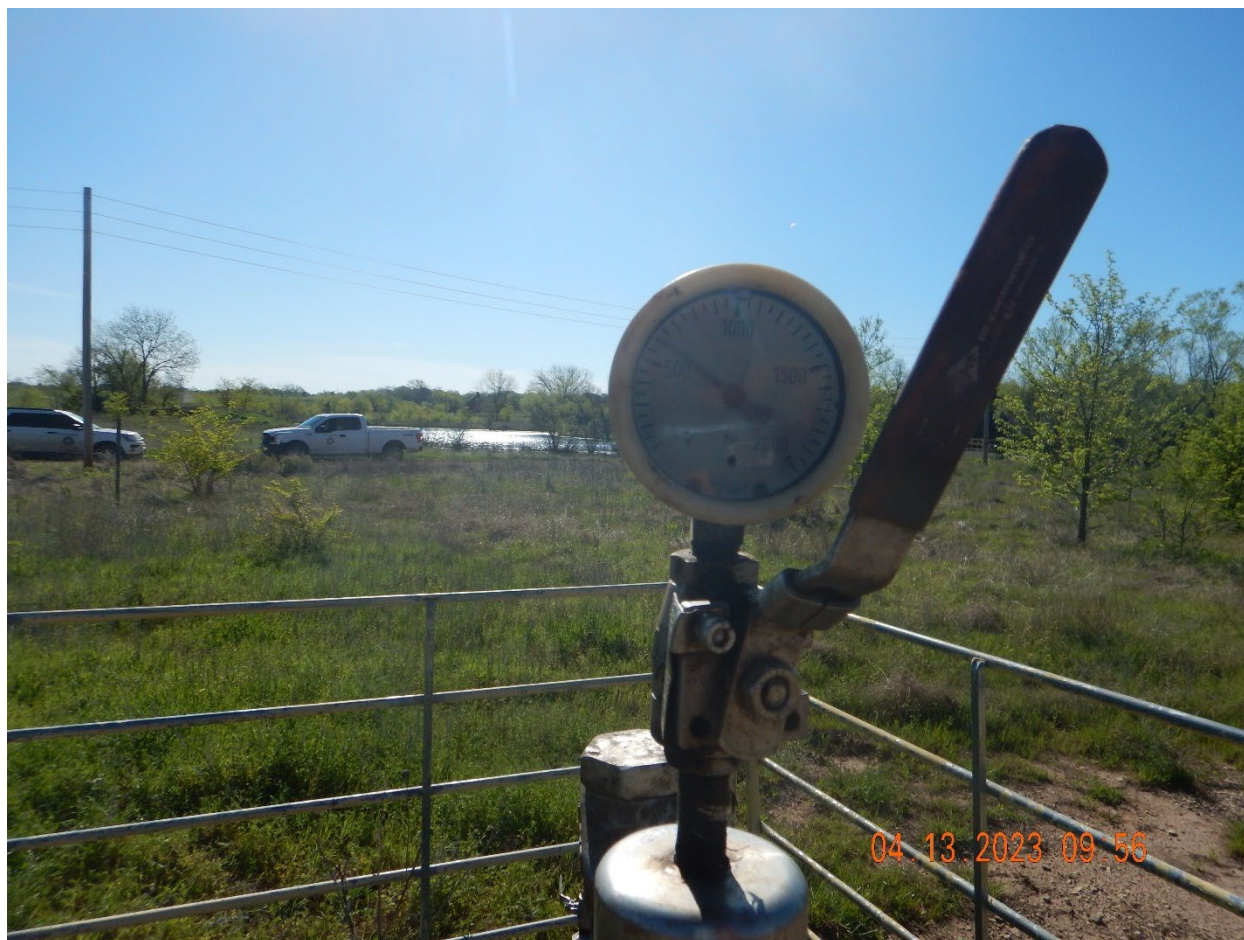
**Description:** This was the injection well Bayou Unit #58 at the time of the inspection. At the time of the inspection this well was temporarily abandoned or a TA well. I observed the tubing pressure gauge (company gauge), which showed approximately 610 psig, shown in this photo.

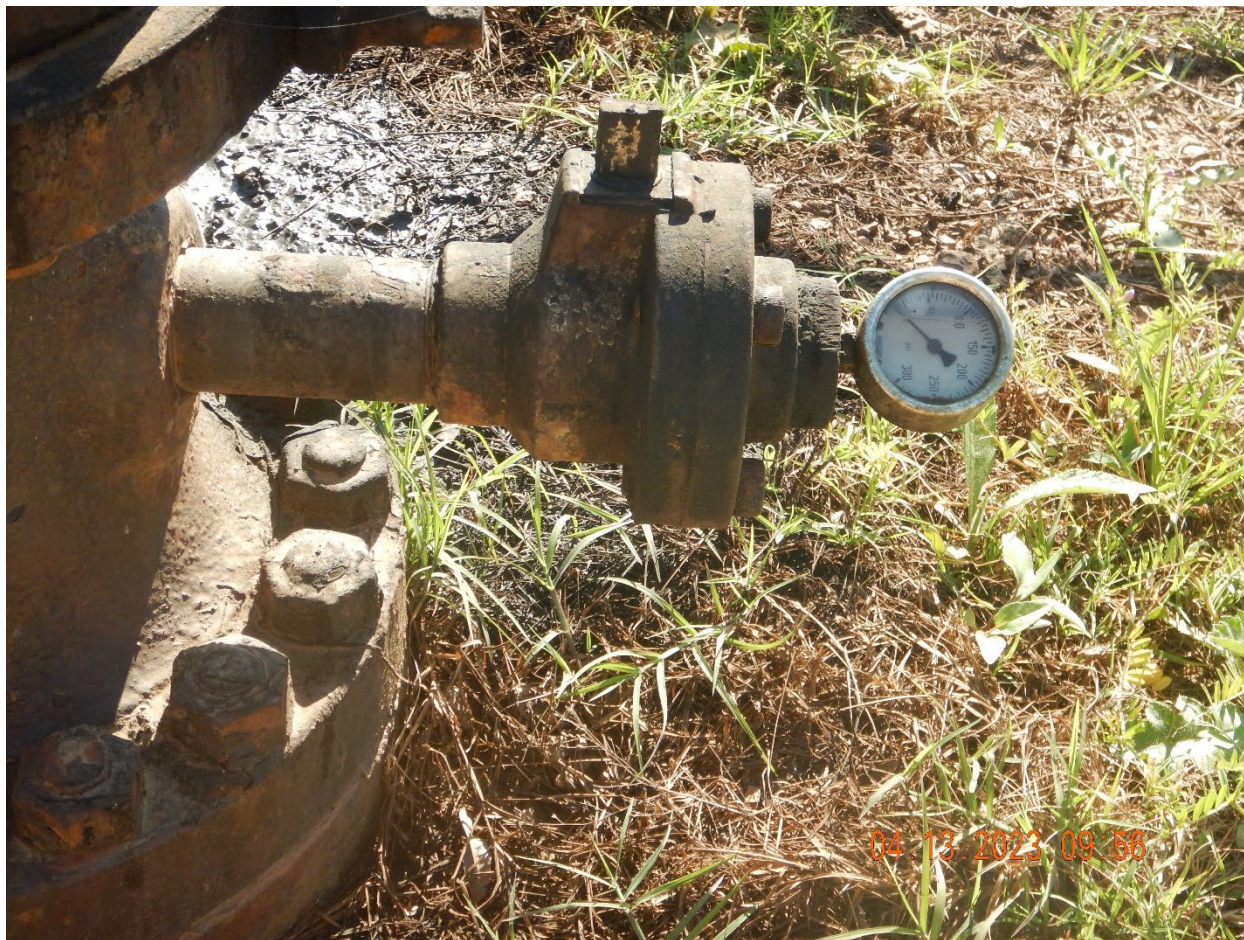
**Description:** This was the injection well Bayou Unit #58 at the time of the inspection. At the time of the inspection this well was temporarily abandoned or a TA well. I observed the casing pressure gauge (company gauge), shown in this photo.

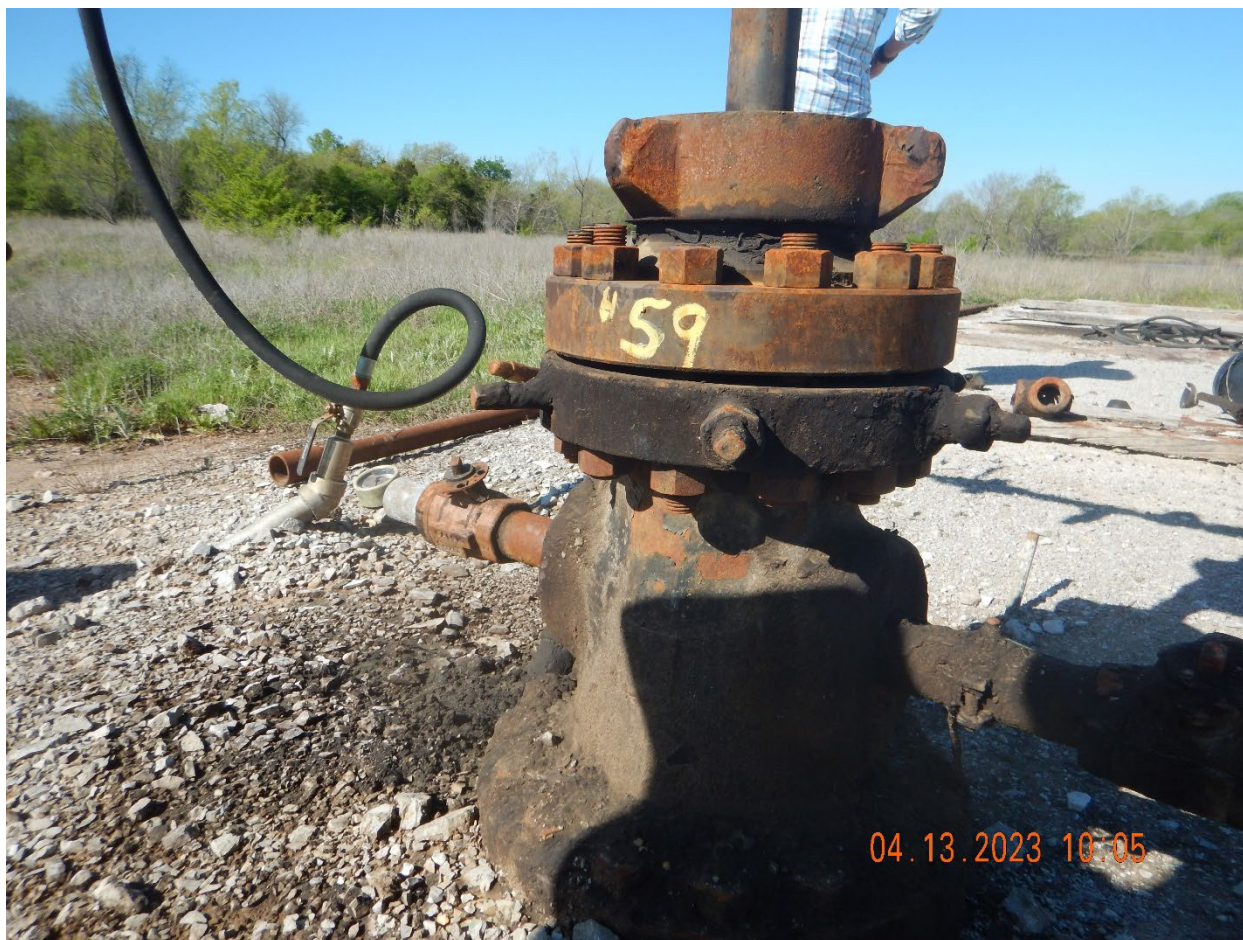
**Description:** This was the injection well Bayou Unit #59 at the time of the inspection. the time of the inspection this well was considered an active injection well and was hooked up for injection activities. Some oil staining was present around this well during the inspection.

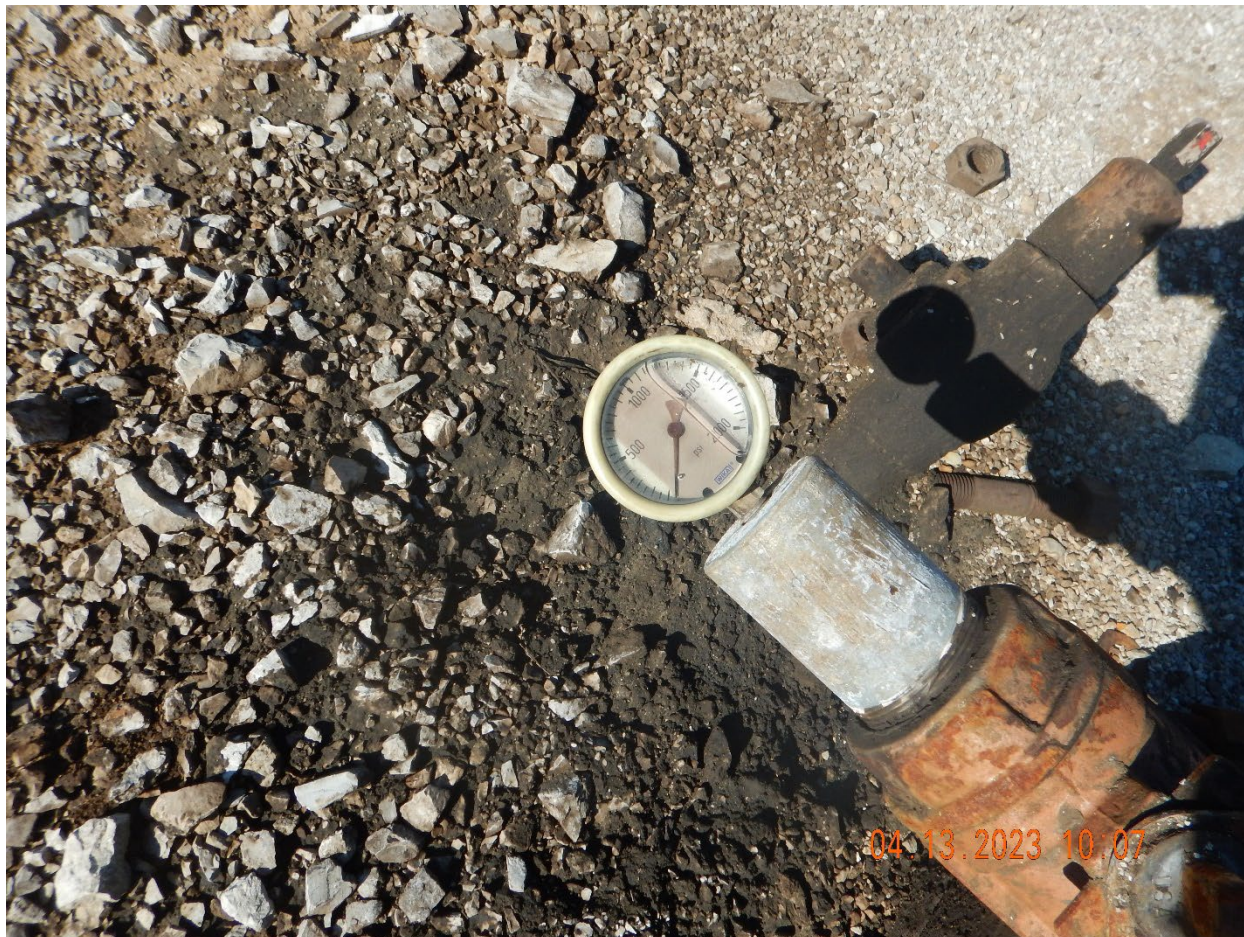
**Description:** This was the injection well Bayou Unit #59 at the time of the inspection. the time of the inspection this well was considered an active injection well and was hooked up for injection activities. Some oil staining was present around this well during the inspection. I observed the casing pressure gauge (company gauge), shown in this photo.

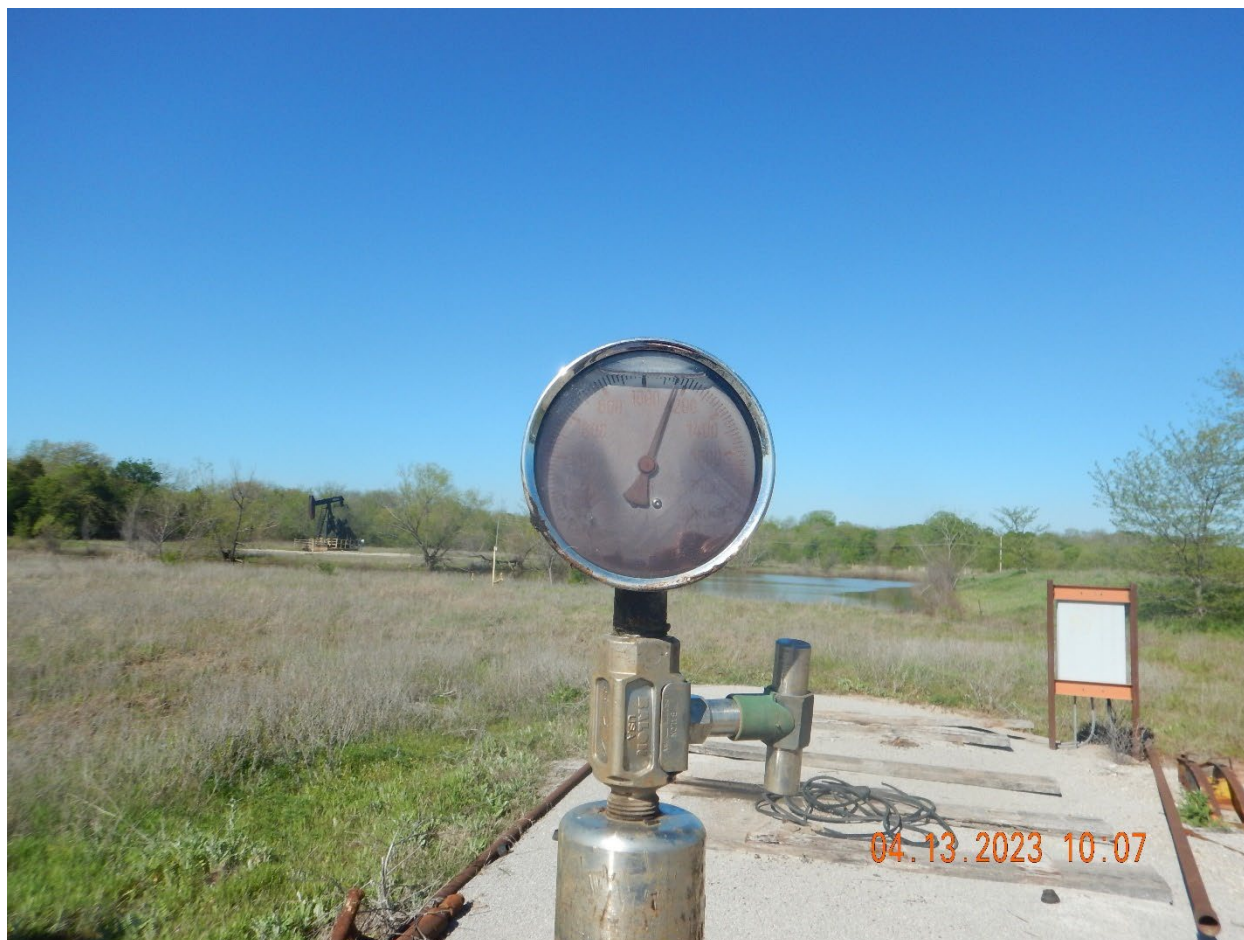
**Description:** This was the injection well Bayou Unit #59 at the time of the inspection. the time of the inspection this well was considered an active injection well and was hooked up for injection activities. Some oil staining was present around this well during the inspection. I observed the tubing pressure gauge (company gauge), which showed approximately 1150 psig, shown in this photo.

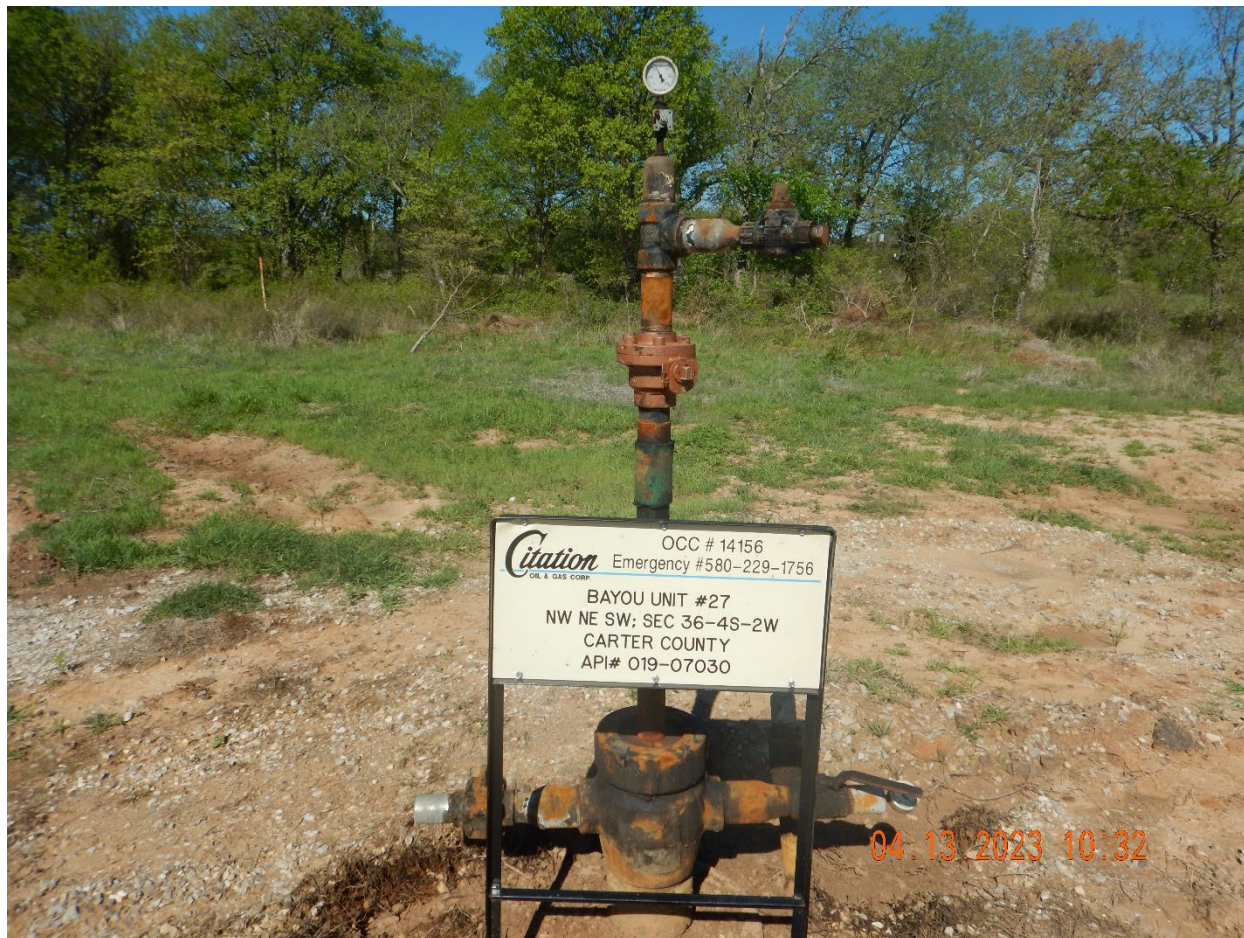
**Description:** This was the injection well Bayou Unit #27 at the time of the inspection. At the time of the inspection this well was temporarily abandoned or a TA injection well. I observed some oil staining on and around the well indicating a lack of best management practices at the well.

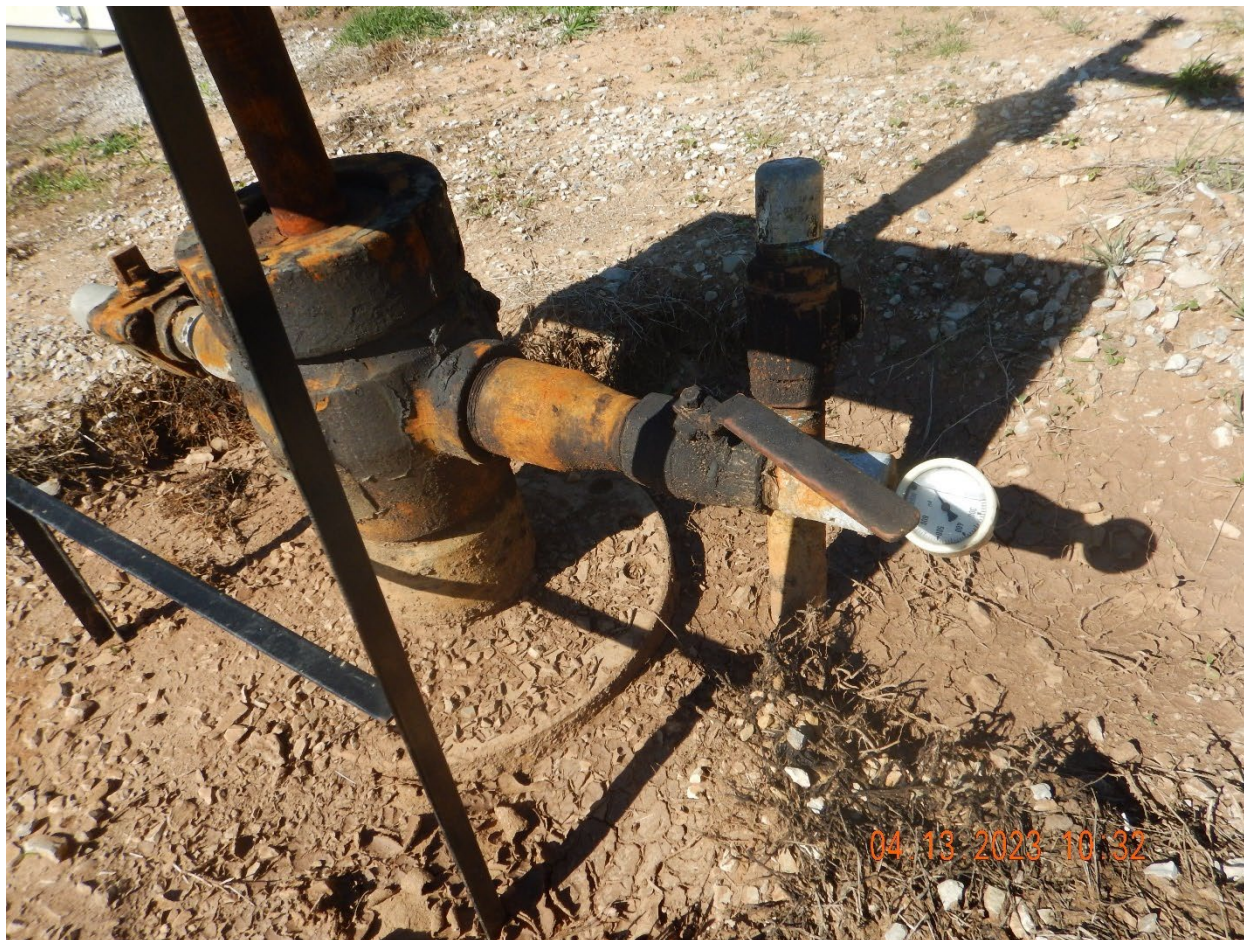
**Description:** This was the injection well Bayou Unit #27 at the time of the inspection. At the time of the inspection this well was temporarily abandoned or a TA injection well. I observed some oil staining on and around the well indicating a lack of best management practices at the well. This photo shows the annulus gauge (company) at the time of the inspection.

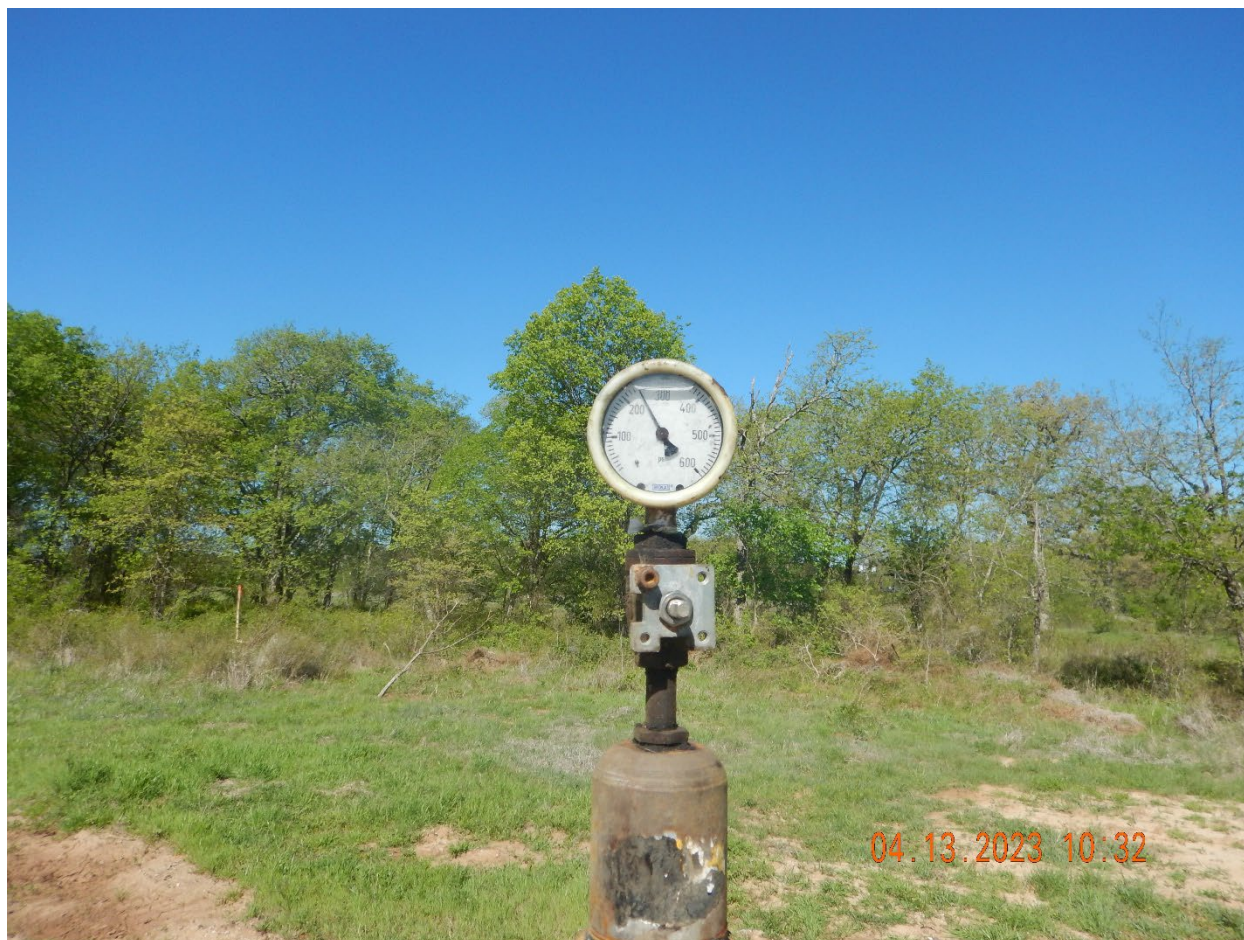
**Description:** This was the injection well Bayou Unit #27 at the time of the inspection. At the time of the inspection this well was temporarily abandoned or a TA injection well. I observed some oil staining on and around the well indicating a lack of best management practices at the well. This photo shows the tubing gauge (company) at the time of the inspection, which shows approximately 240 psig.

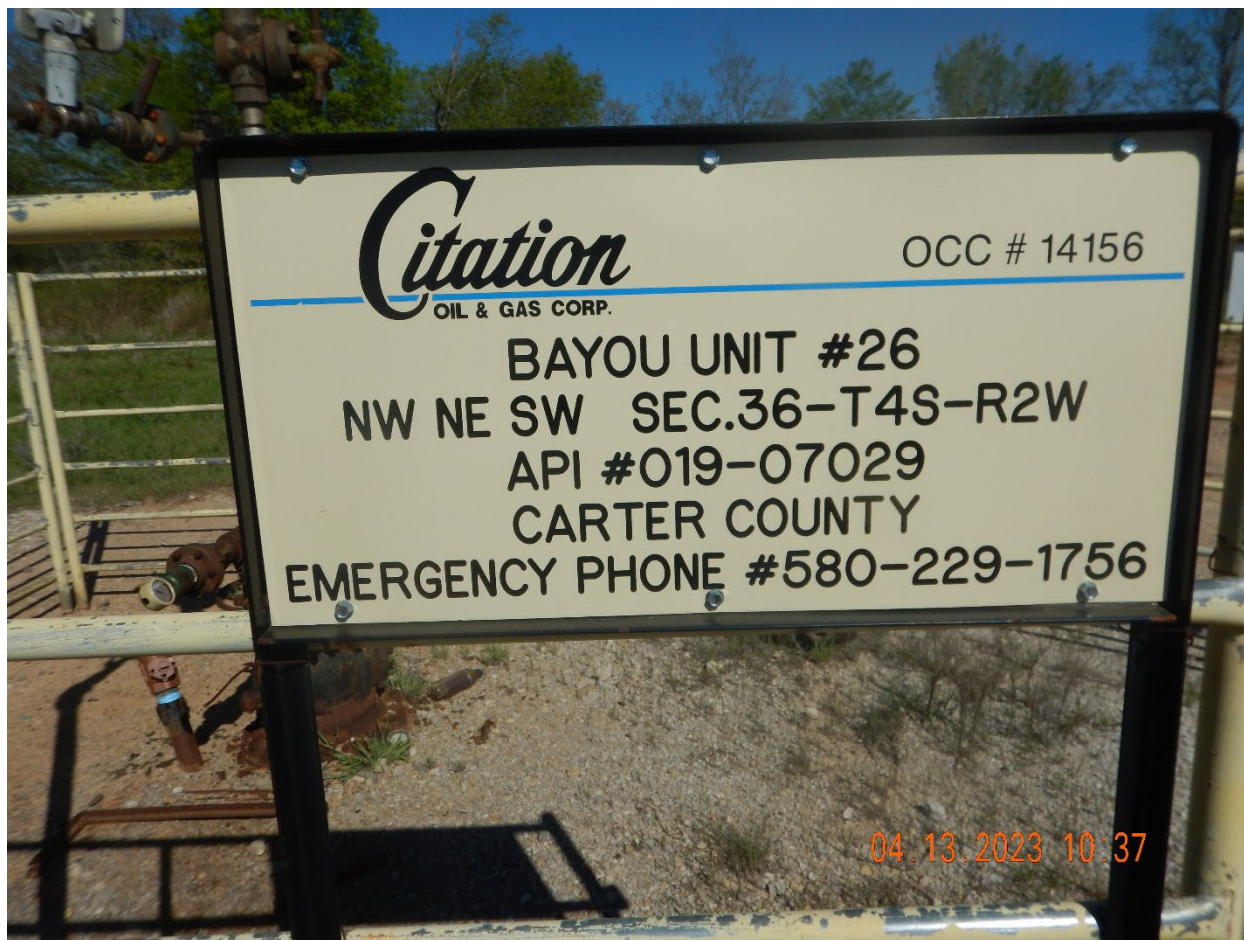
**Description:** This was the injection well Bayou Unit #26 at the time of the inspection. This well is near well #27, seen in Photo Nos. 13-15. This photo shows the hooked up injection well during the inspection with some oil staining around the well. The tubing had a gauge (company) on this well, but this photo doesn't clearly show the gauge reading at the time of the inspection.

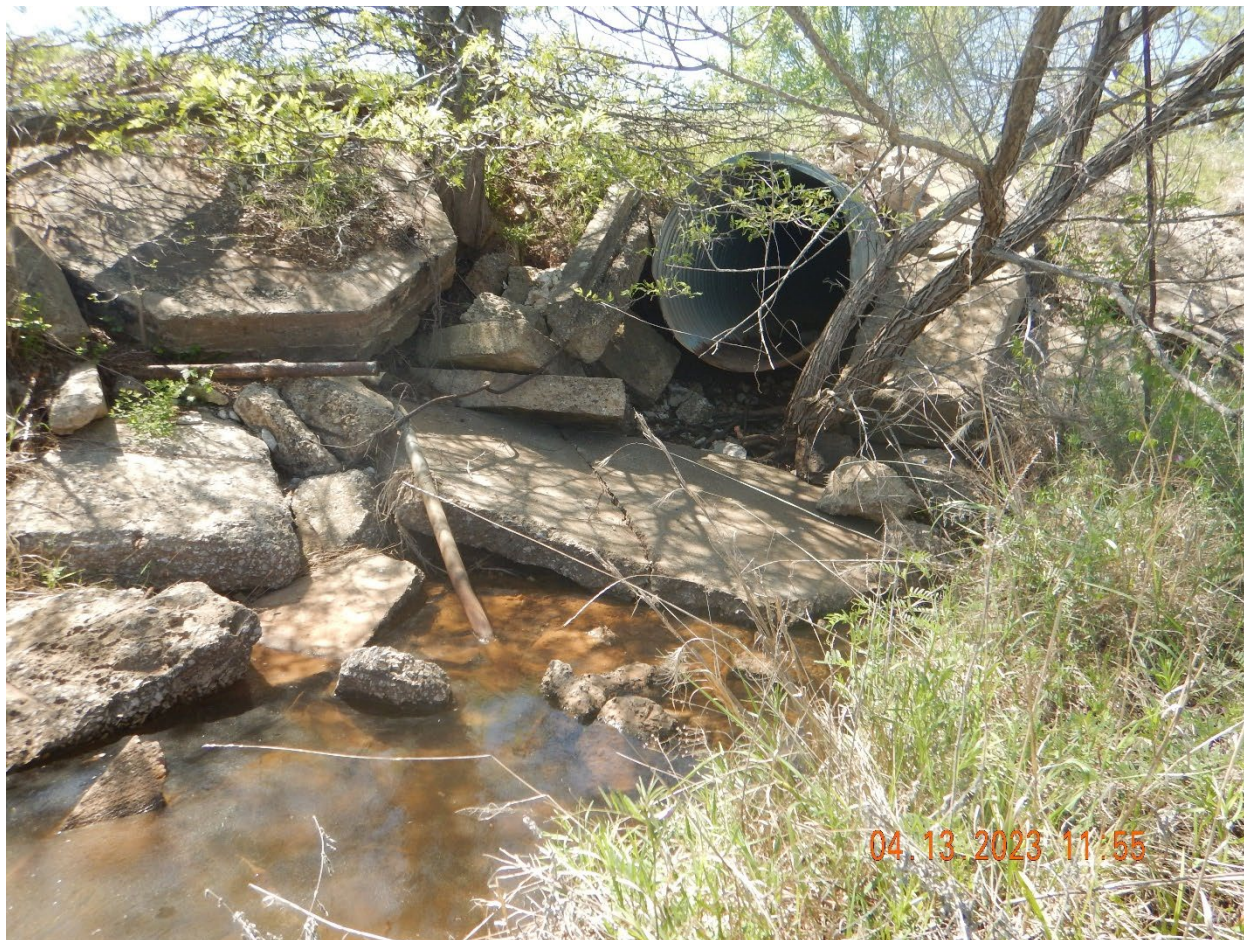
**Description:** This photo shows the location near the road culvert in the tributary of Walnut Creek, approximately 170 feet downstream from the pond during the inspection (*north of the pond*). This location of the tributary shows bed features, flow conditions during the inspection, and road infrastructure to support tributary flow conditions over time with a culvert. This photo shows an upstream view of the tributary from the road culvert location.

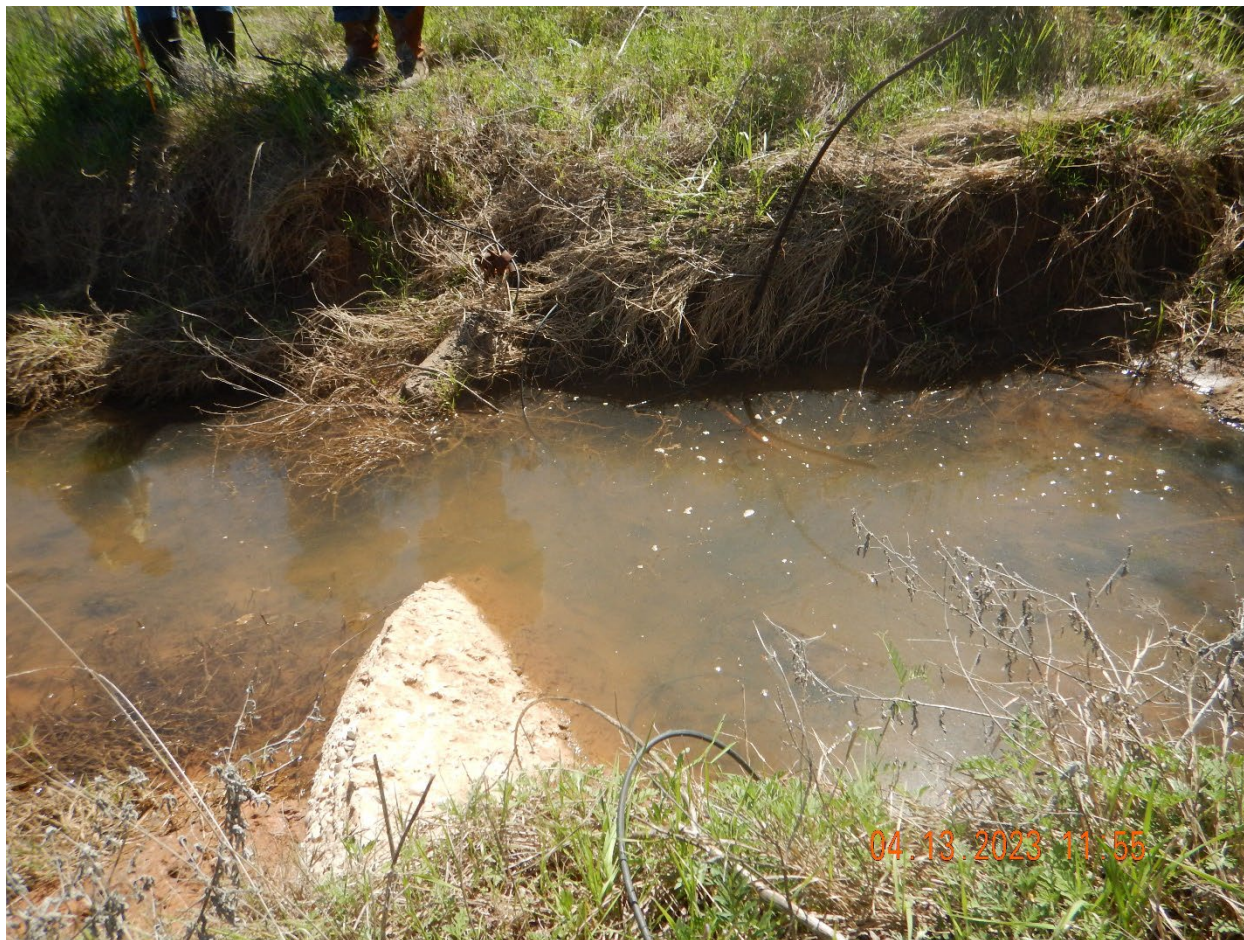
**Description:** This photo shows the location near the road culvert in the tributary of Walnut Creek, approximately 170 feet downstream from the pond during the inspection (*north of the pond*), and the same location as Photo No. 26. This location of the tributary shows bed features (rocks), bank features, and flow conditions during the inspection.

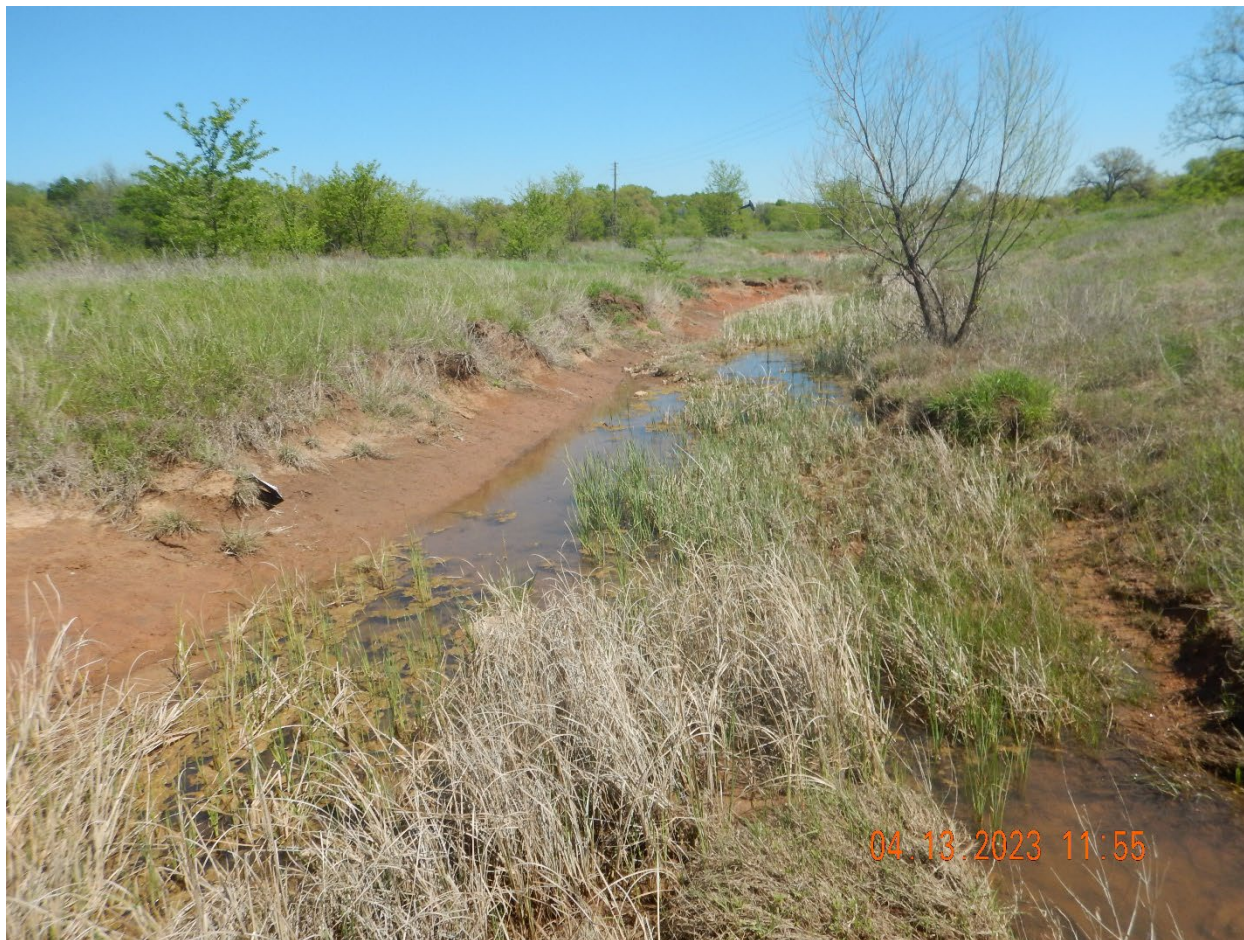
**Description:** This photo shows the location near the road culvert in the tributary of Walnut Creek, approximately 170 feet downstream from the pond during the inspection (*north of the pond*), and the same location as Photo No. 26. This location of the tributary shows bed features (rocks), bank features, and flow conditions during the inspection. This photo shows a downstream view of the tributary from the road culvert location. Some algae growth and riparian vegetation was observed in this part of the tributary as well.

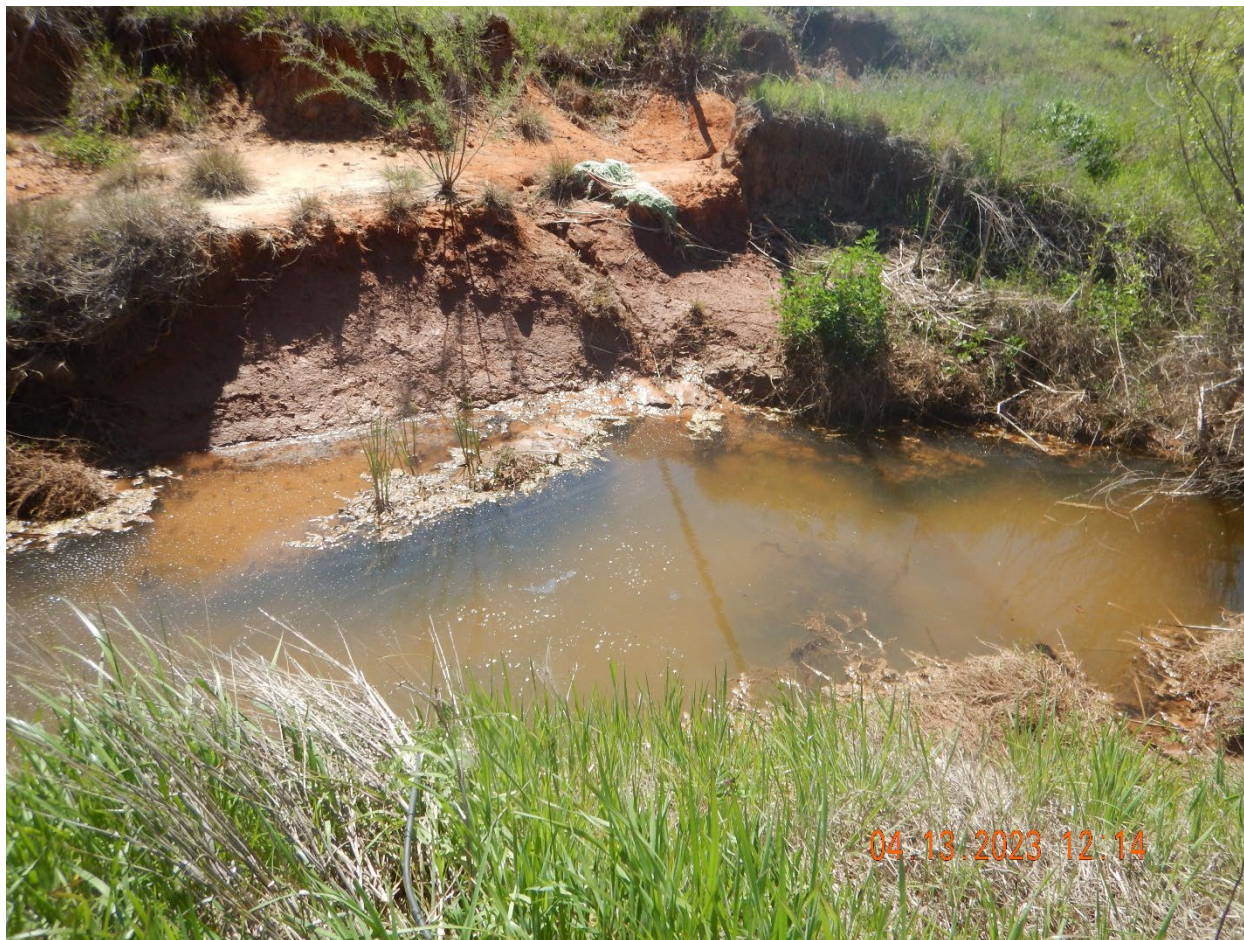
**Description:** This photo showed the tributary during the inspection approximately 600 feet downstream from the pond seen in Photo No. 22 of this Appendix. Bed, bank, and some aquatic life was observed at this location, including 5 small perch. The tributary had a pooled-up area of fluids at this location.

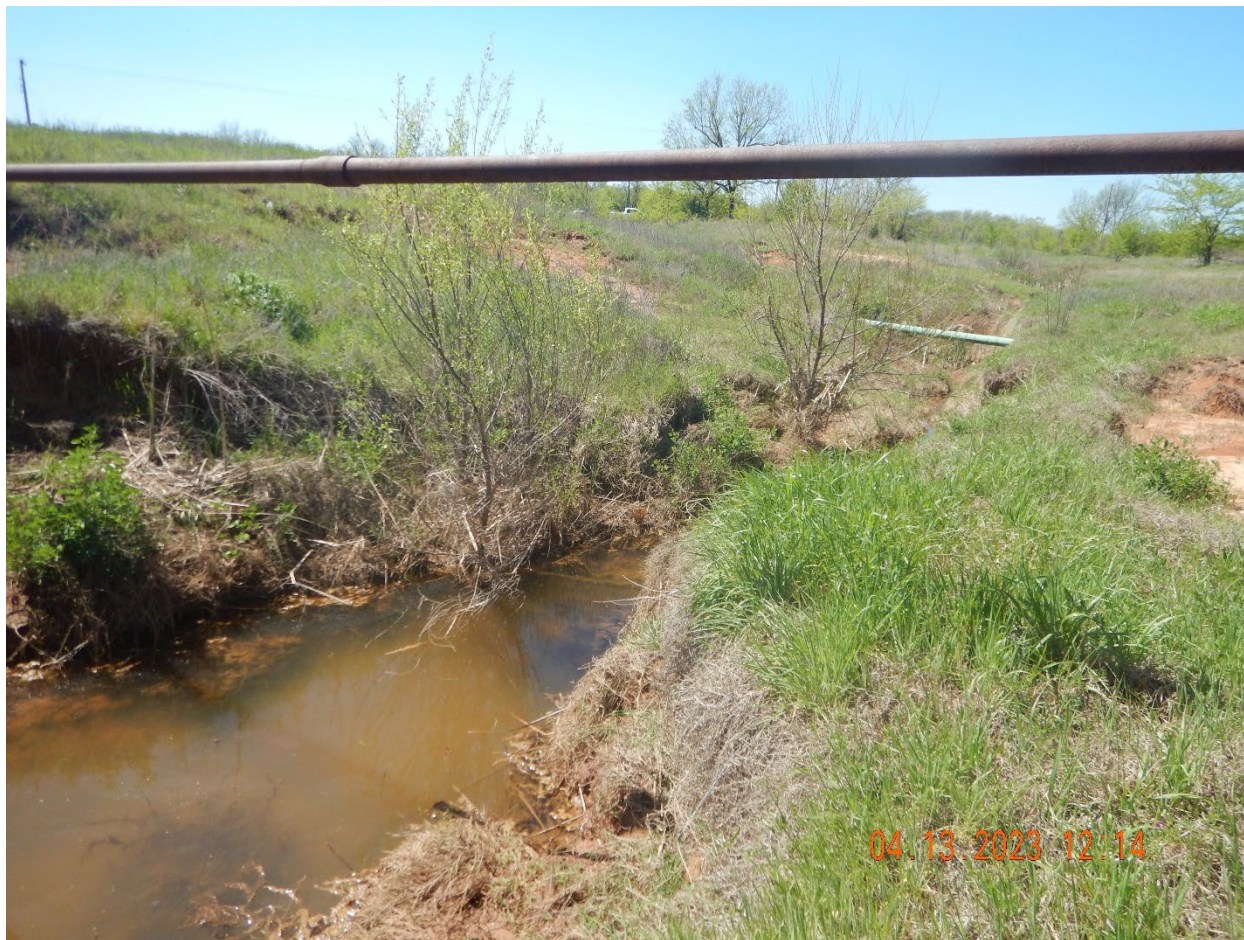
**Description:** This photo showed the tributary during the inspection approximately 600 feet downstream from the pond seen in Photo No. 22 of this Appendix. Bed, bank, and some aquatic life was observed at this location, including 5 small perch. The tributary had a pooled-up area of fluids at this location. This was the upstream view of the tributary at this location.

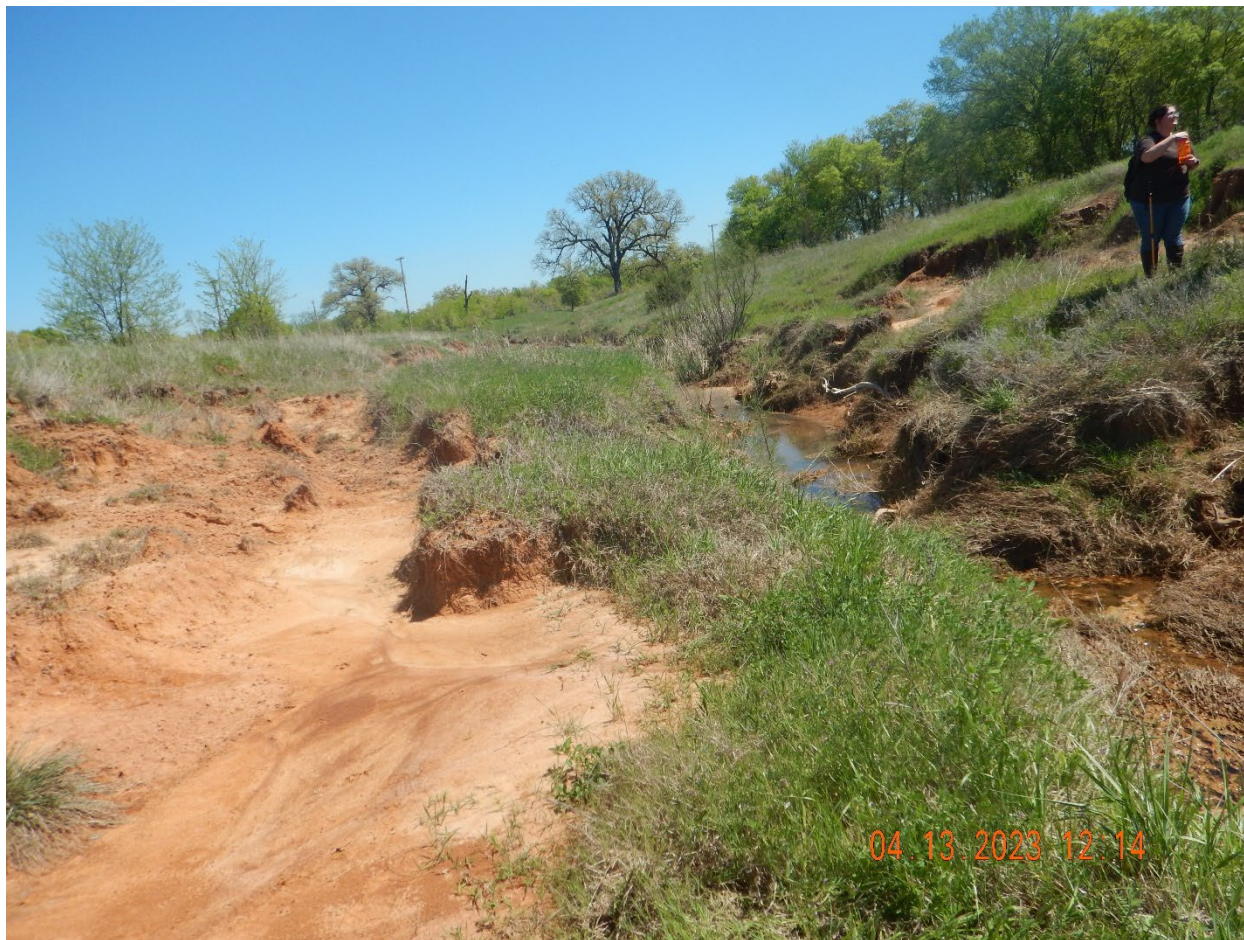
**Description:** This photo showed the tributary during the inspection approximately 600 feet downstream from the pond seen in Photo No. 22 of this Appendix. Bed, bank, and some aquatic life was observed at this location, including 5 small perch. The tributary had a pooled-up area of fluids at this location. This was the downstream view of the tributary at this location.

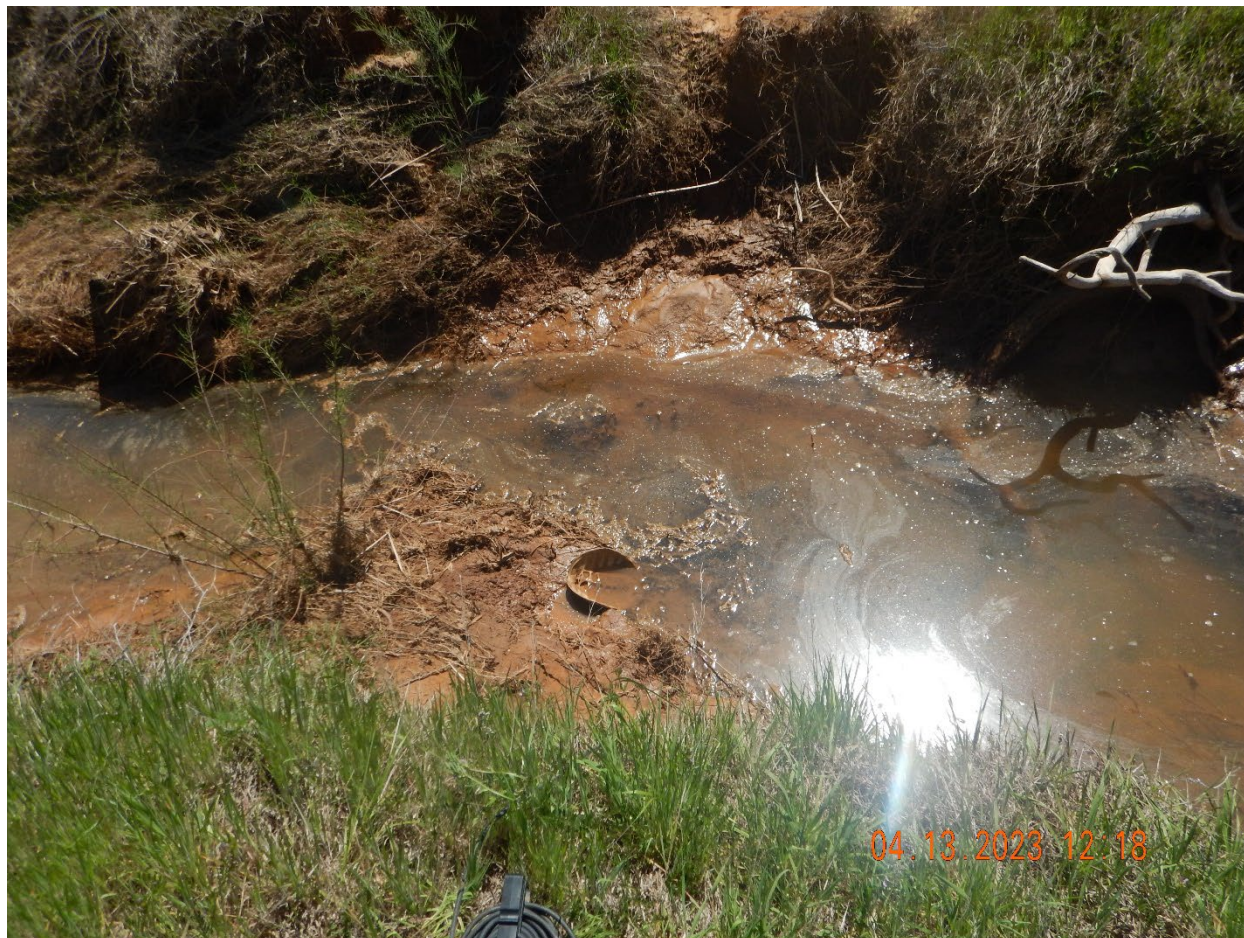
**Description:** This photo showed the tributary during the inspection approximately 620 feet downstream from the pond seen in Photo No. 22 of this Appendix. I observed what appeared to be seepage into the tributary at this location. Additionally, an aquatic or biological type of sheen was observed on the water at this location. I also observed a large turtle shell at this location indicating presence of aquatic life. I observed approximately 20 minnows as well in this part of the tributary.

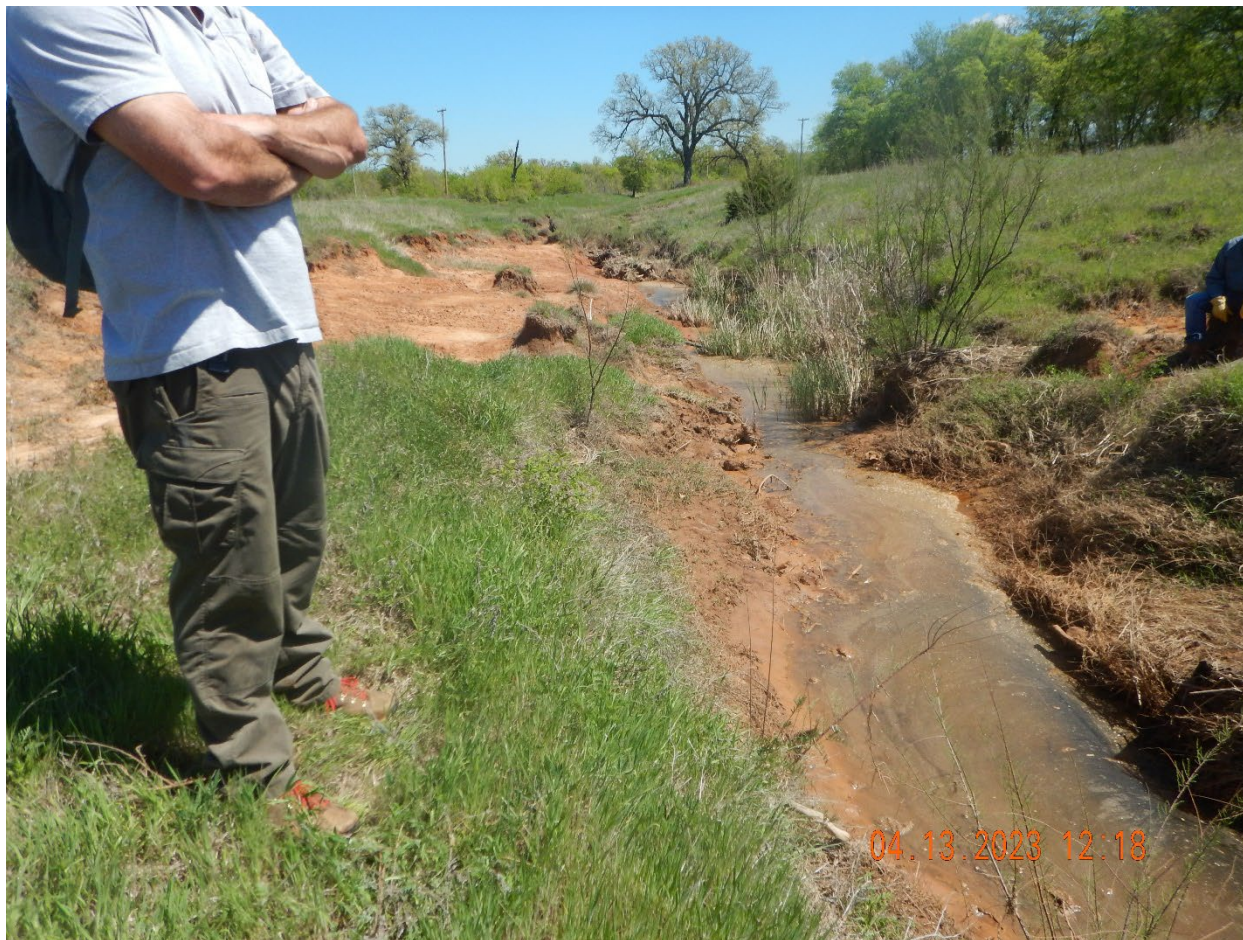
**Description:** This photo showed the tributary during the inspection approximately 620 feet downstream from the pond seen in Photo No. 22 of this Appendix. I observed bed and bank indicators at this part of the tributary.
