## Region 6 - Enforcement & Compliance Assurance Division

### INSPECTION REPORT

| Company Name: | <b>Citation Oil and Gas Corporation</b> | |
| Facility Name: | <b>Bayou Unit</b> | |

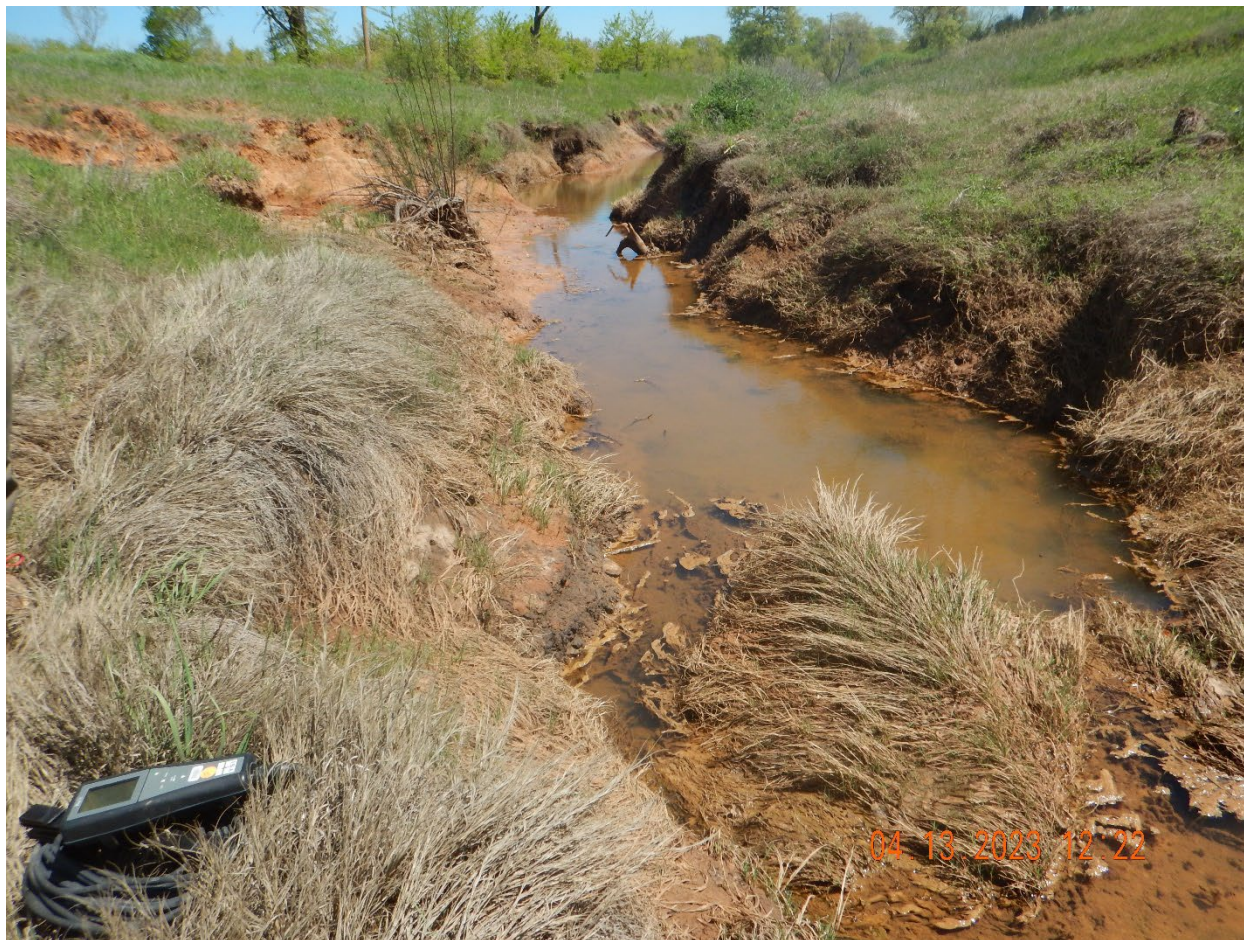
**Description:** This photo showed the tributary location during the inspection approximately 870 feet downstream from the pond seen in Photo No. 22 of this Appendix. I observed stream characteristics of bed and bank at this location in the tributary. I also observed some discolored algal growth and debris in the stream. There was some slight black discoloration along the banks of the tributary during the inspection, which can also be seen Photo No. 41 of this Appendix.

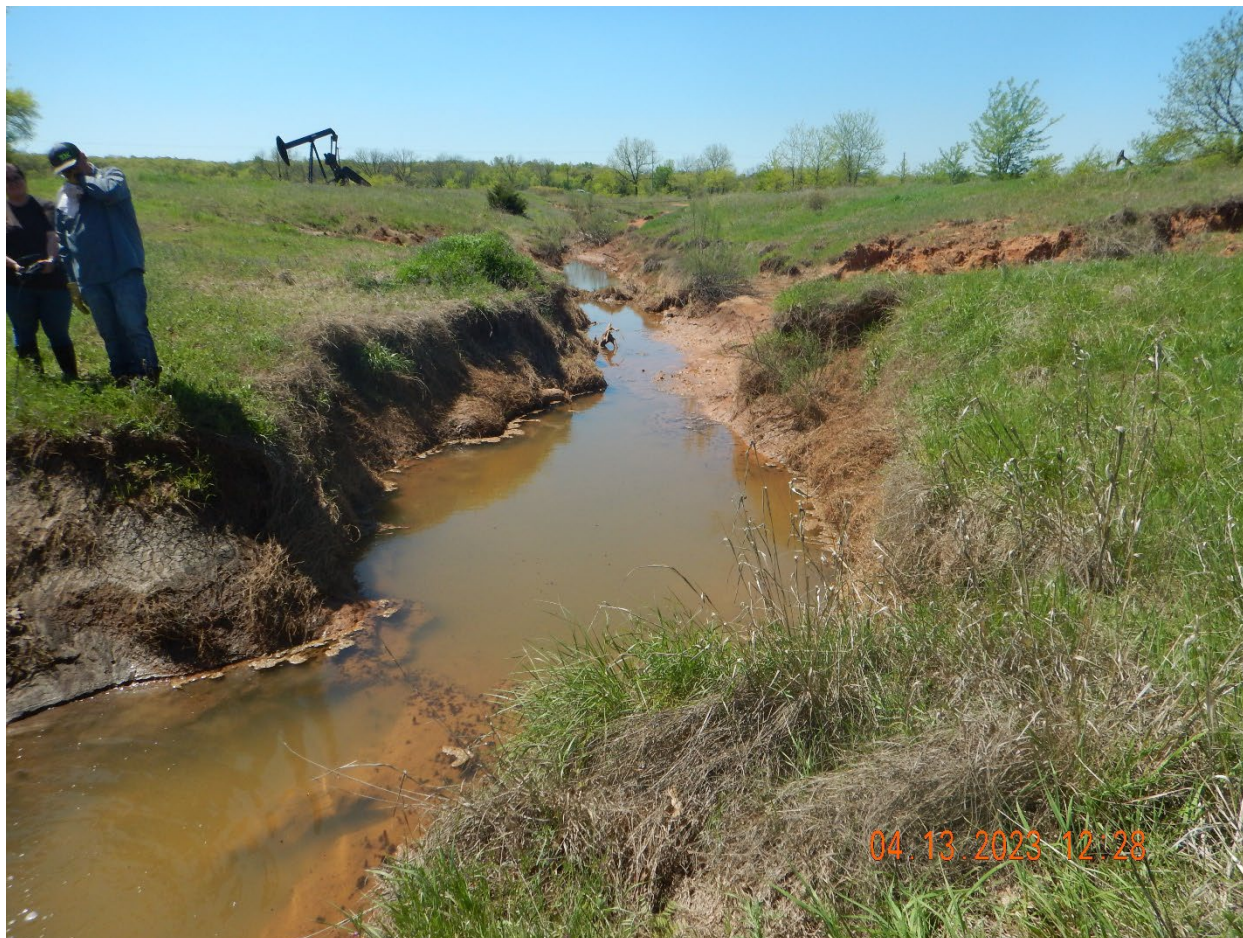
**Description:** This photo showed the tributary location during the inspection approximately 1000 feet downstream from the pond seen in Photo No. 22 of this Appendix. There was some slight black discoloration observed along the banks of the tributary during the inspection, seen towards the bottom left of this photo.
