United States Environmental Protection Agency  
Region 4

## Water Compliance Inspection Report

| Name and Location of Facility Inspected (For industrial users discharging to POTW, also include POTW name and NPDES permit number)<br>Savanna Street WWTP (Sanitary Sewer System)<br>3810 Interstate 55 South and Savanna Street<br>Jackson, Mississippi | Entry Date/Time<br>3/9/2023 8:40 AM<br>Exit Date/Time<br>3/9/2023 3:40 PM | Permit Effective Date<br>7/18/2017<br>Permit Expiration Date<br>6/30/2022 |

### Section D: Summary of Findings / Comments

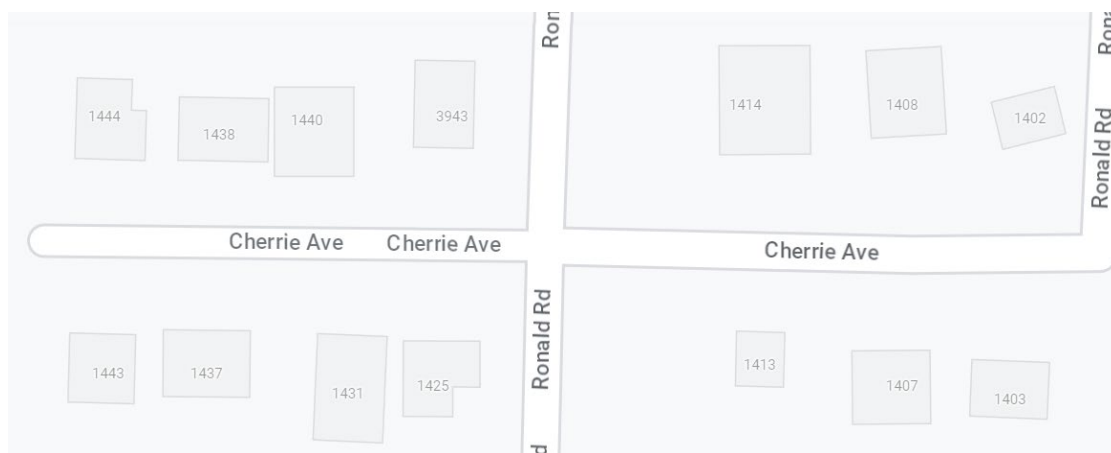
Figure 1. Cherrie Avenue.

1. Cherrie Avenue. Refer to Figure 1 and Photos 1. Inspectors observed sewage debris in the storm water ditch in front of 1444 Cherrie Avenue. The inspector also observed what appeared to be a weep hole (circled in red on Photo 1) that could be a sewage path from the residents lateral at the sewer main. The Inspector also discussed sewage issues with four other residents, not the complainant, that resides on Cherrie Avenue, west of Ronald Road. Each resident described sewage backing up into their homes frequently. Several residents stated that they have had plumbers verify that there are no blockages in their laterals.

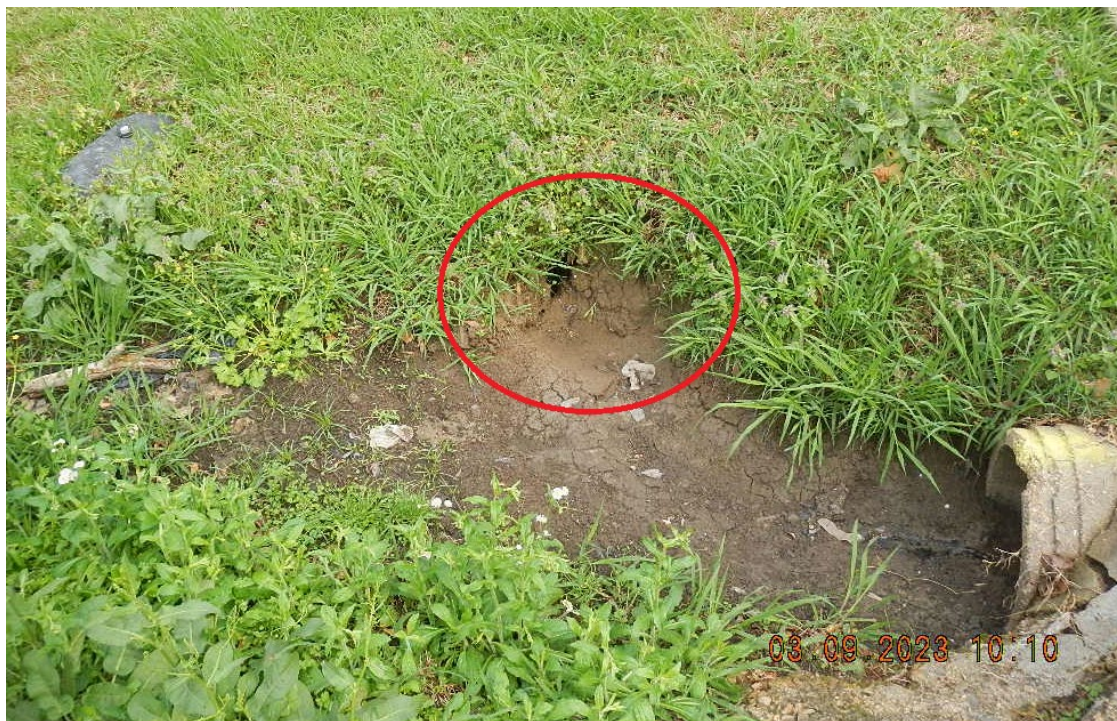
Photo 1. Sewage debris and sewer sludge was observed at the storm water ditch in front of 1444 Cherrie Avenue. Circled in red appears to be a weep hole where sewage is being released into the ditch.

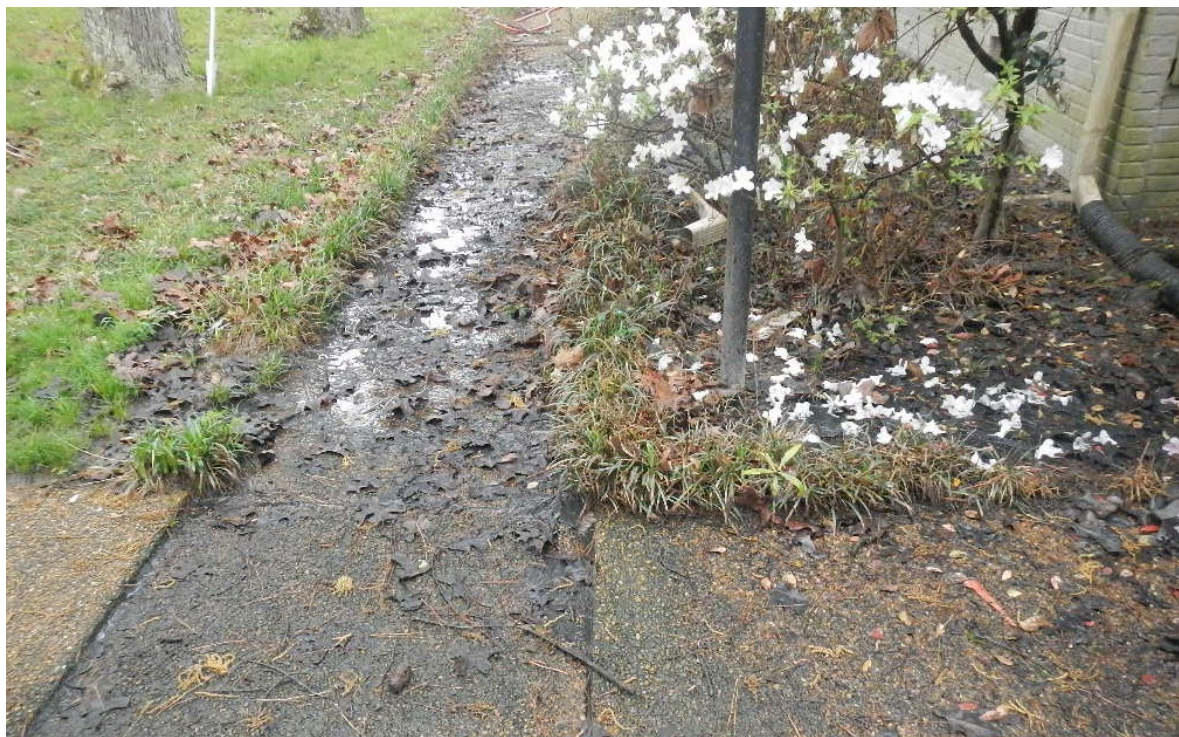
2. 3955 Eastline Drive. Raw sewage and a buildup of sewage sludge was observed in and around the front side of the resident's home, on the walkway, (Photos 2 and 3), and in the storage area for childrens toys (bikes, etc..). A sewage path was also observed traveling across the resident's driveway and into the house next to the driveway on Robert Drive, (Photo 4). Discussions with the resident indicates that they have called plumbers to the residence more than once and have verified that the issue is in the sewer main. Of note, there is too much volume of sewage sludge and sewage runoff on the ground to suggest that it would have originated from the resident's home.

Photo 2. Raw sewage standing in the front walkway.

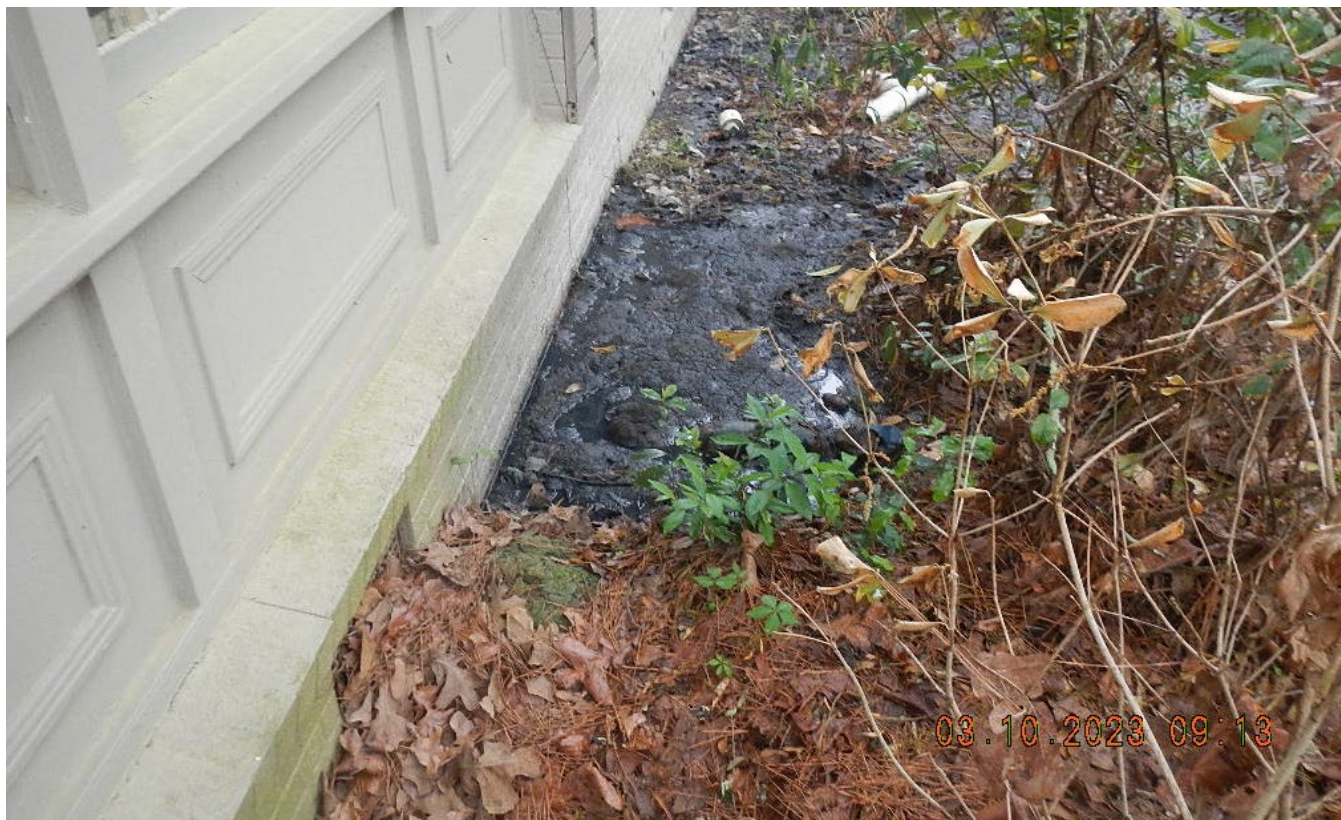
Photo 3. Raw sewage next to the house. The resident had to remove the lateral cap to prevent sewage from entering the house. It's unclear why a portion of the sewage lateral is removed but could be a result of washout from high sewage volume and pressure at the house being discharged from the sewer main.

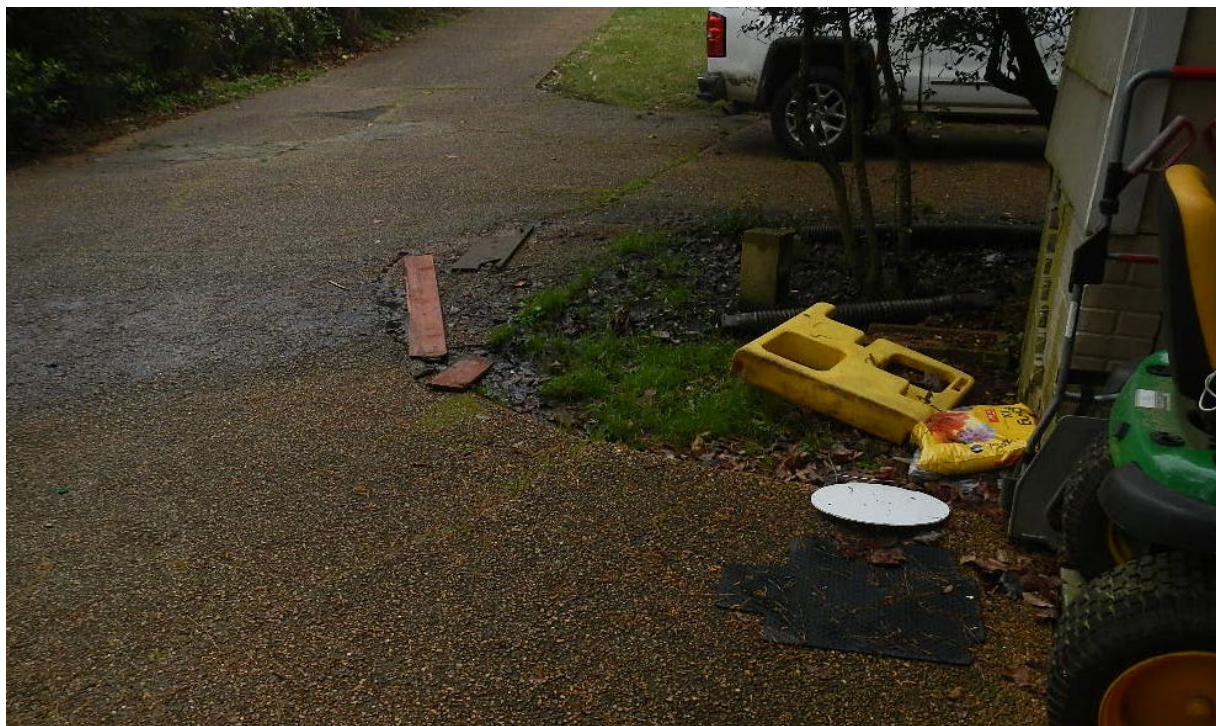
Photo 4. Sewage running across the driveway and into the yard of another resident.

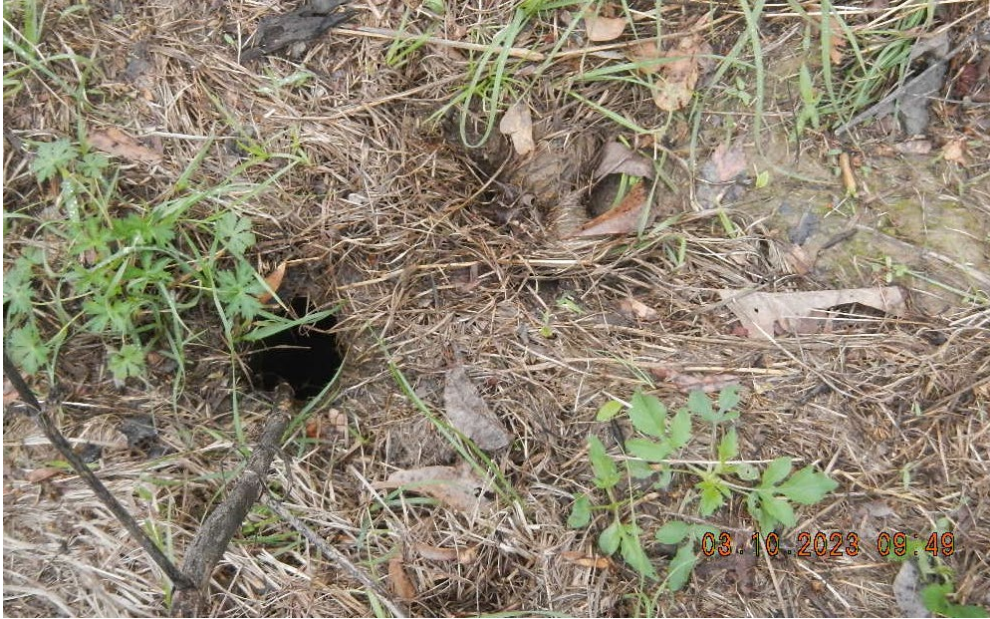
3. McCluer Road. A sink hole located at 1303 McCluer Road was observed next to a sanitary sewer manhole, (Photo 6). The Inspector also notes several weep holes on the opposite side of the sink hole on McCluer Road that smelled of sewage, indicating that sewage may be seeping from the sewer main under, or alongside the road, (Photo 7).

Photo 7: Weep holes smelling of sewage noted on the opposite side of the road where the sink hole was located at 1303 McCluer Road.

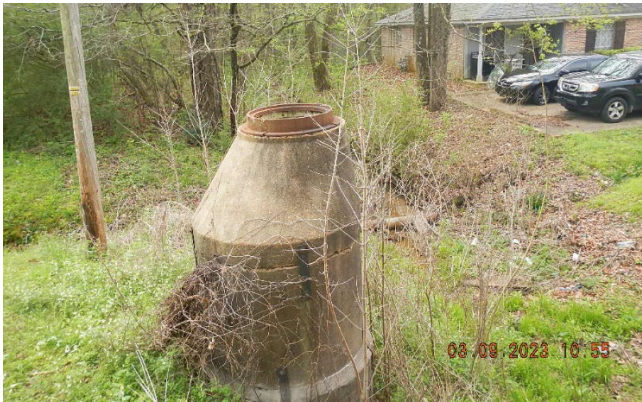
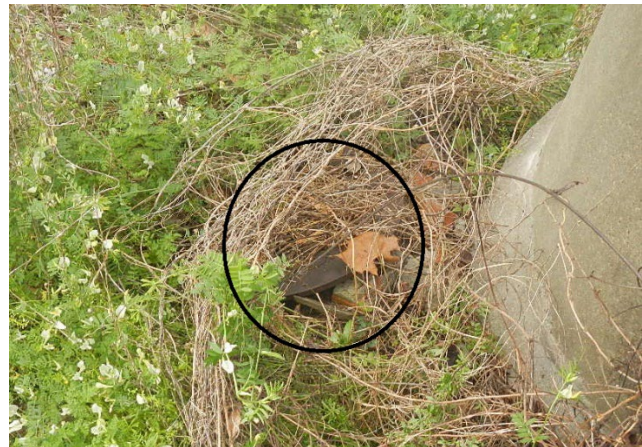
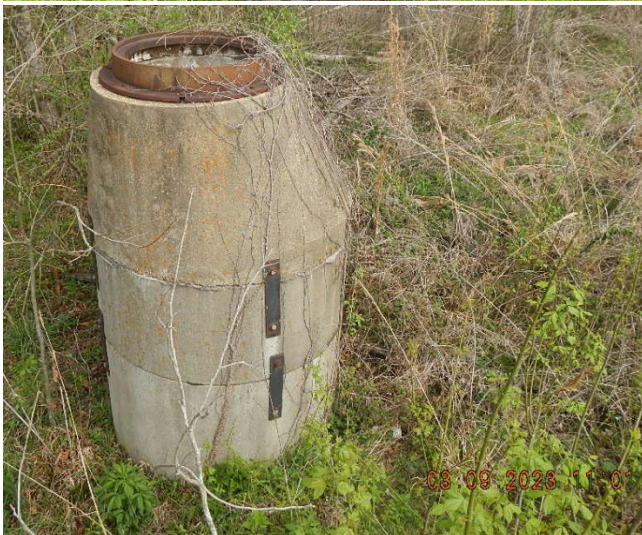
Further east on McCluer Road, the inspector observed two manholes at, or near 193 McCluer Road that were missing the manhole covers, (Photos 8 and 10). The manhole at 193 McCluer Road had its manhole cover laying next to the base of the manhole, (Photo 9). Excessive wet weather inflow can, if enough volume is present at a given time, blow the manhole lid from the top of the manhole.

Photos 8 through 10: Missing manhole covers from two manholes at or near 193 McCluer Road. The black circle indicates where the Inspector observed the missing manhole cover on one of the manholes.
