**Region 6 - Enforcement & Compliance Assurance Division**  
**INSPECTION REPORT**

| Inspection Date(s): | 07/10/2024 | |
| Regulatory Program(s) | NPDES | |
| Facility Name: | <b>Cutter Treatment Plant Lateral (CTPL)</b> | |

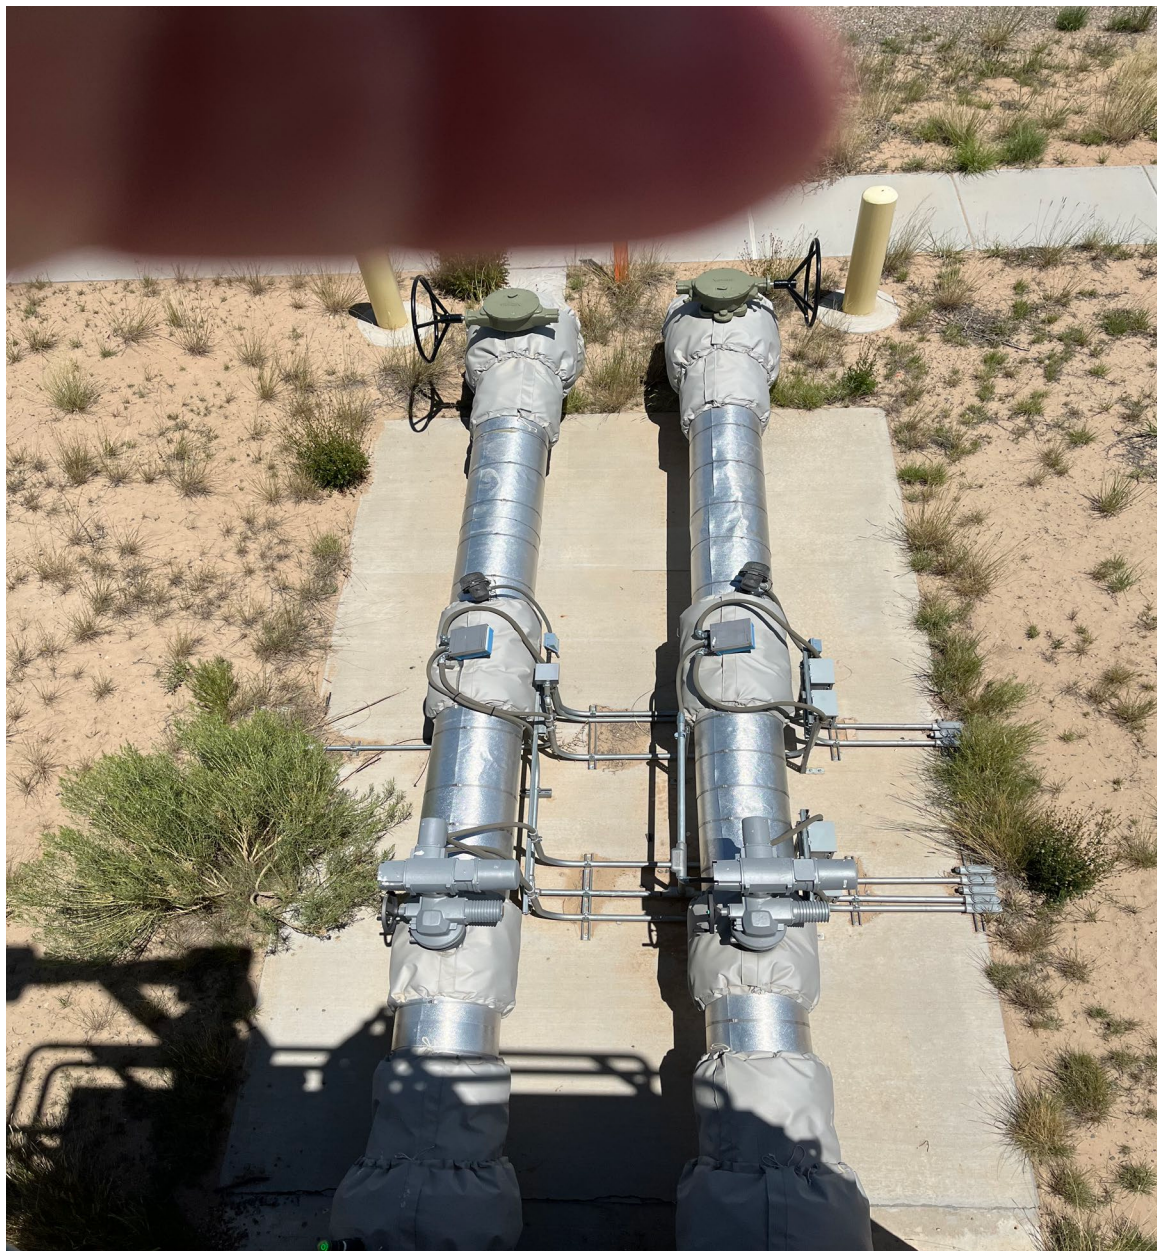
Photo No. 2

View of the raw water influent lines delivered from Pumping Plant #2 prior to the Rapid Mix process. (IMG\_0013) (July 10, 2024: 1:51 PM) Photographed by D. Esparza

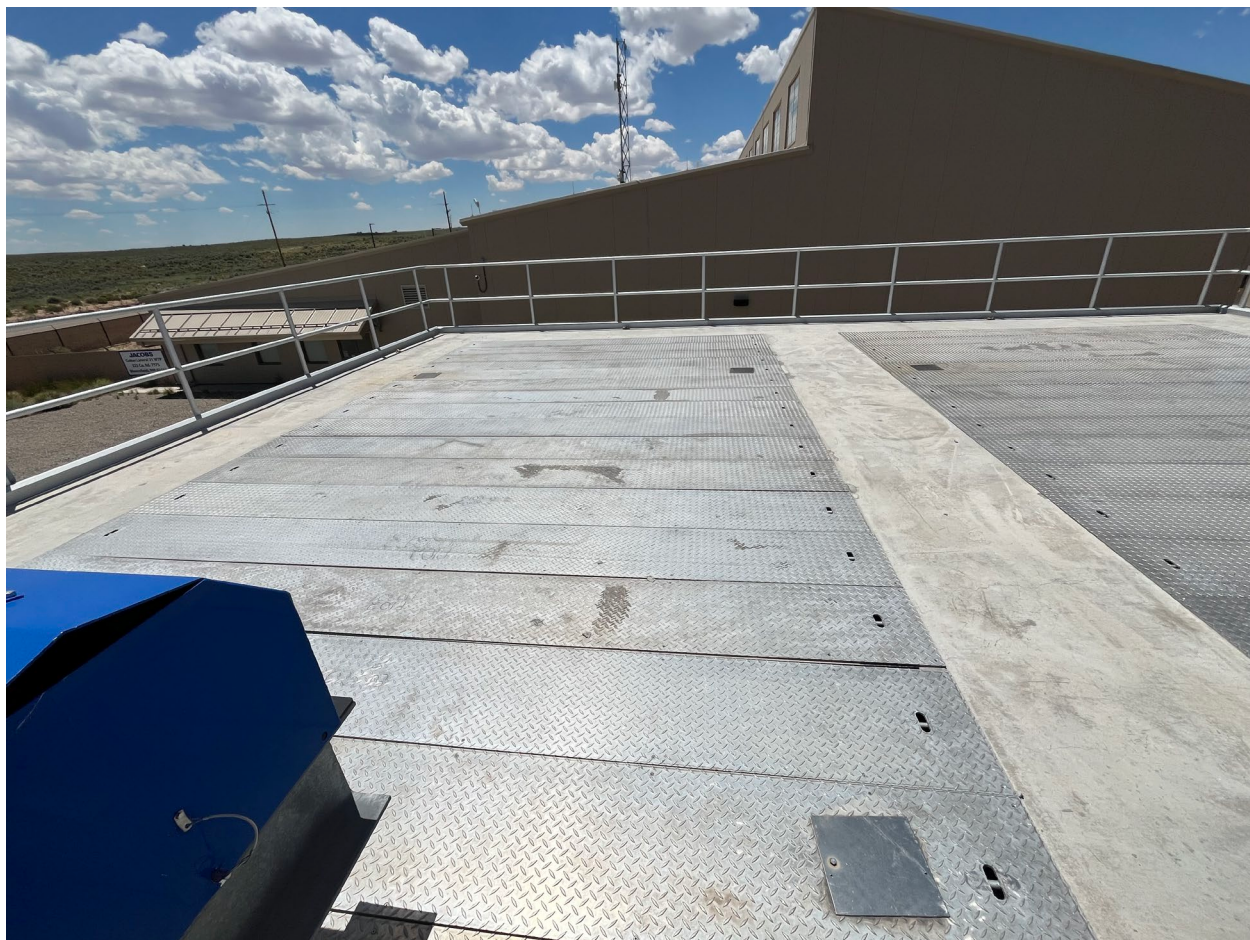
Photo No. 3

View looking approximately Southwest of the Flocculation/Sedimentation basin after the addition of the polymer. (IMG\_0018) (July 10, 2024: 1:55 PM) Photographed by D. Esparza

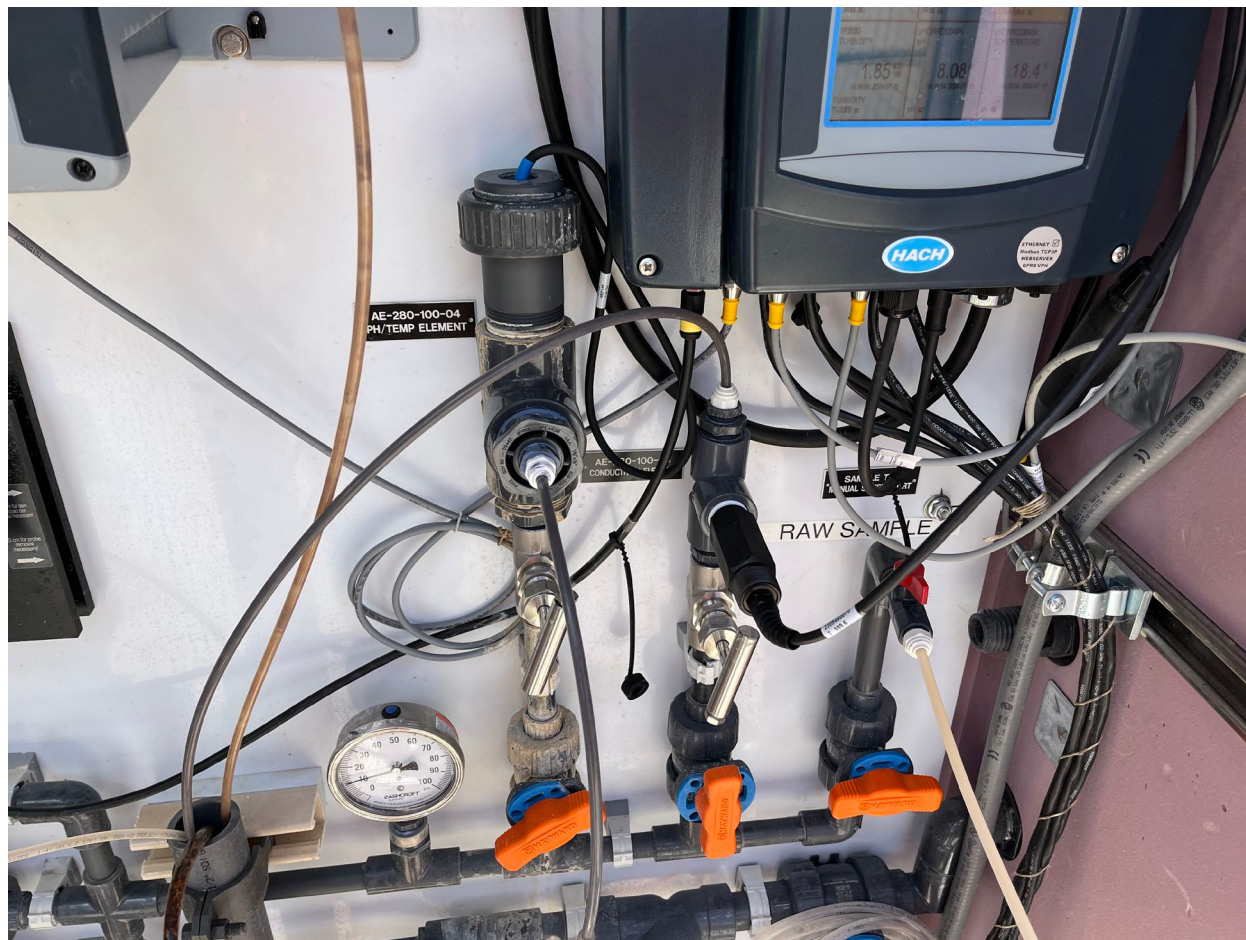
Photo No. 4

View of some of the process sampling equipment. (IMG\_0018) (July 10, 2024: 2:01 PM) Photographed by D. Esparza

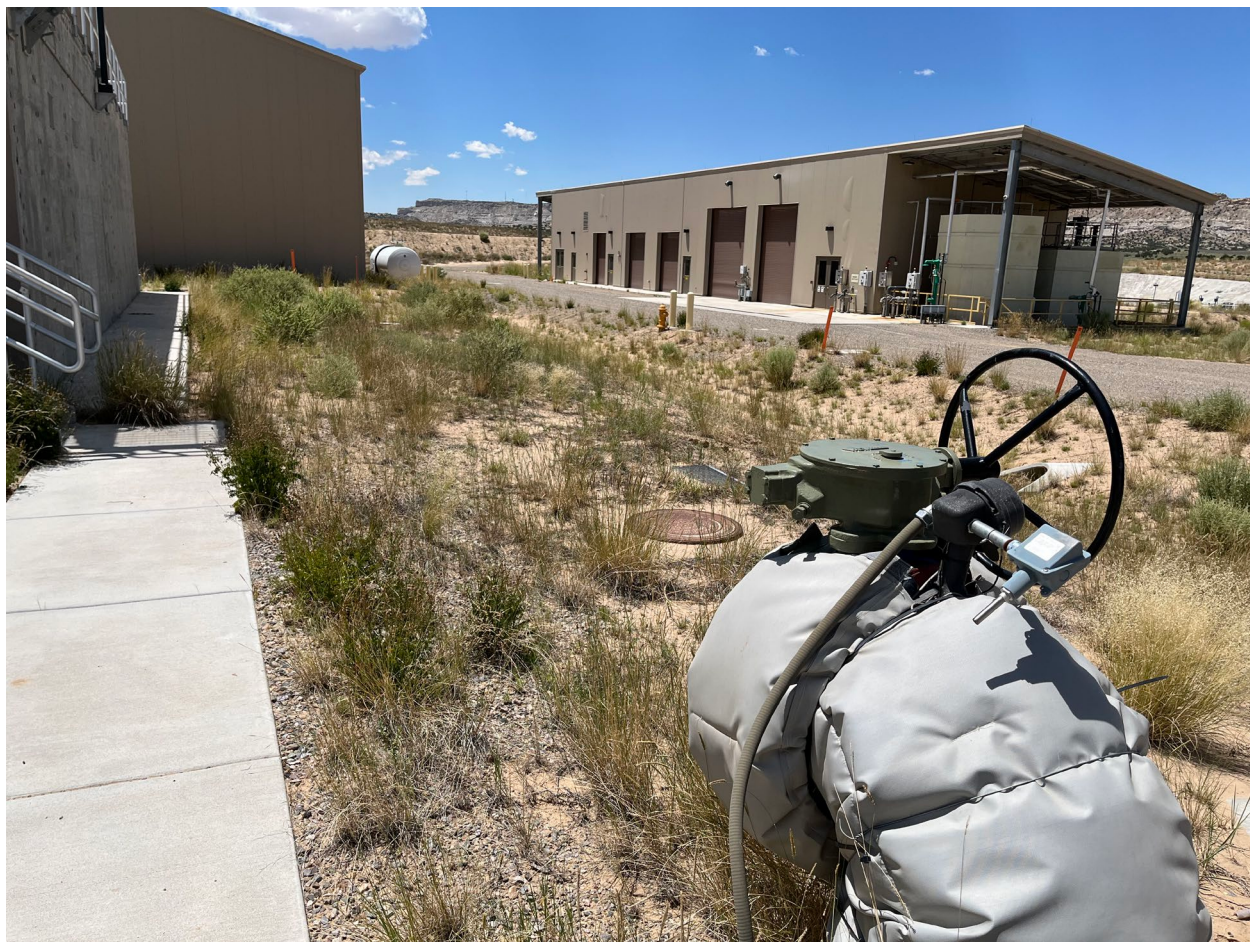
Photo No. 5

View of the location for future expansion adjacent to the existing flocculation/sedimentation basins. Looking approximately West. (IMG\_0023) (July 10, 2024: 2:04 PM) Photographed by D. Esparza

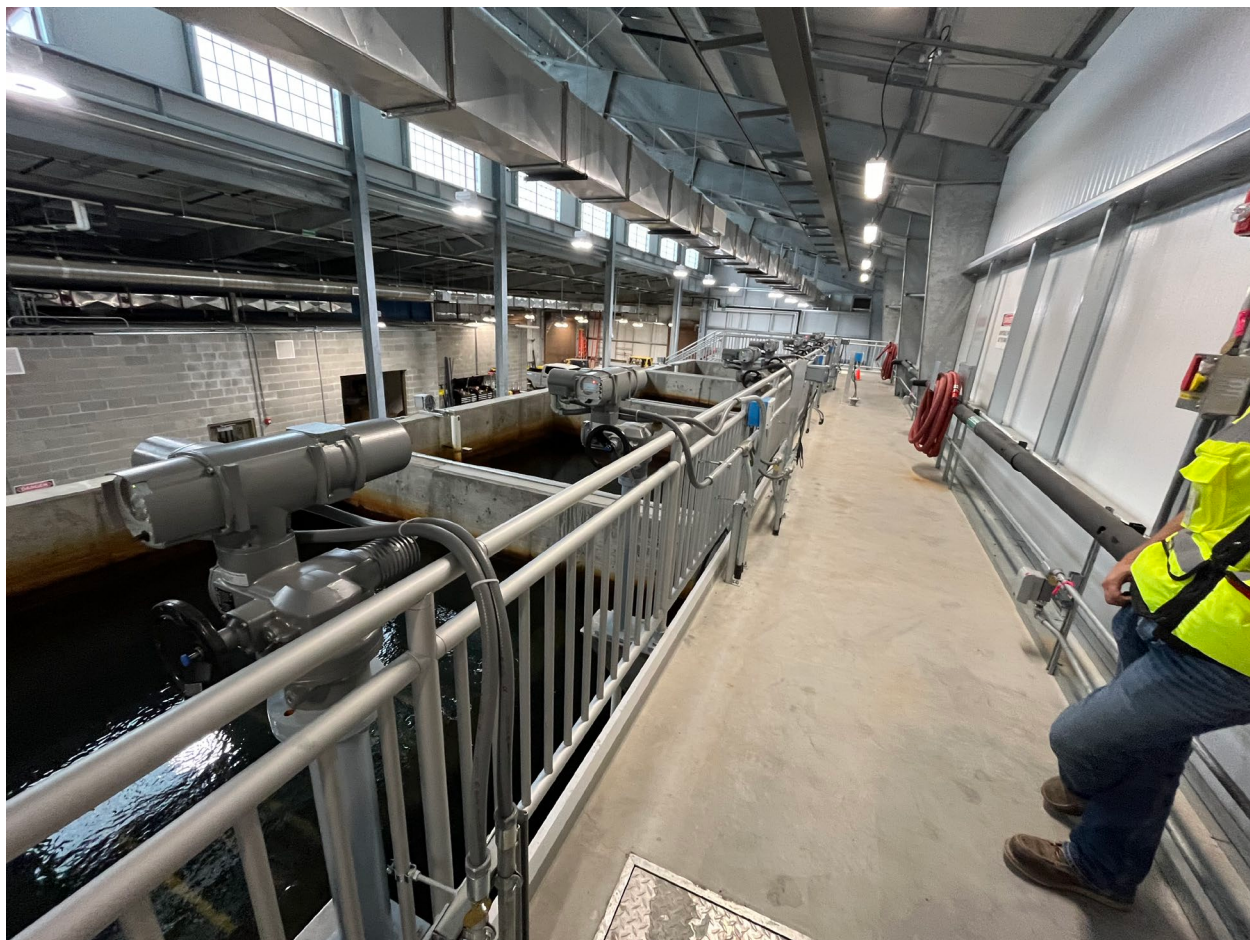
Photo No. 6

View of the filtration basin inside the CTPL facility. (IMG\_0029) (July 10, 2024: 2:09 PM) Photographed by D. Esparza

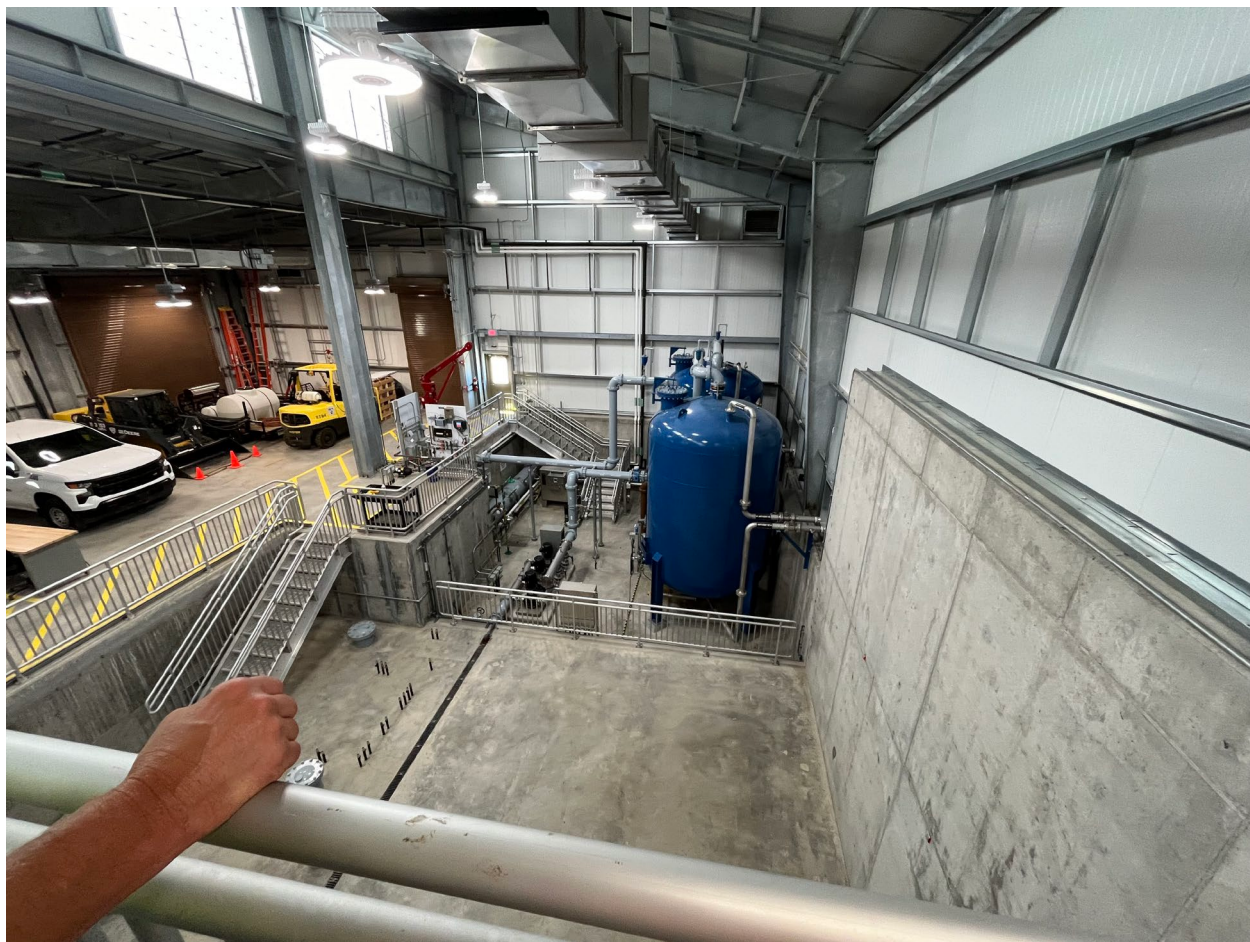
Photo No. 7

View of the granular activated carbon (GAC) filter system inside the CTPL facility. (IMG\_0030) (July 10, 2024: 2:12 PM) Photographed by D. Esparza

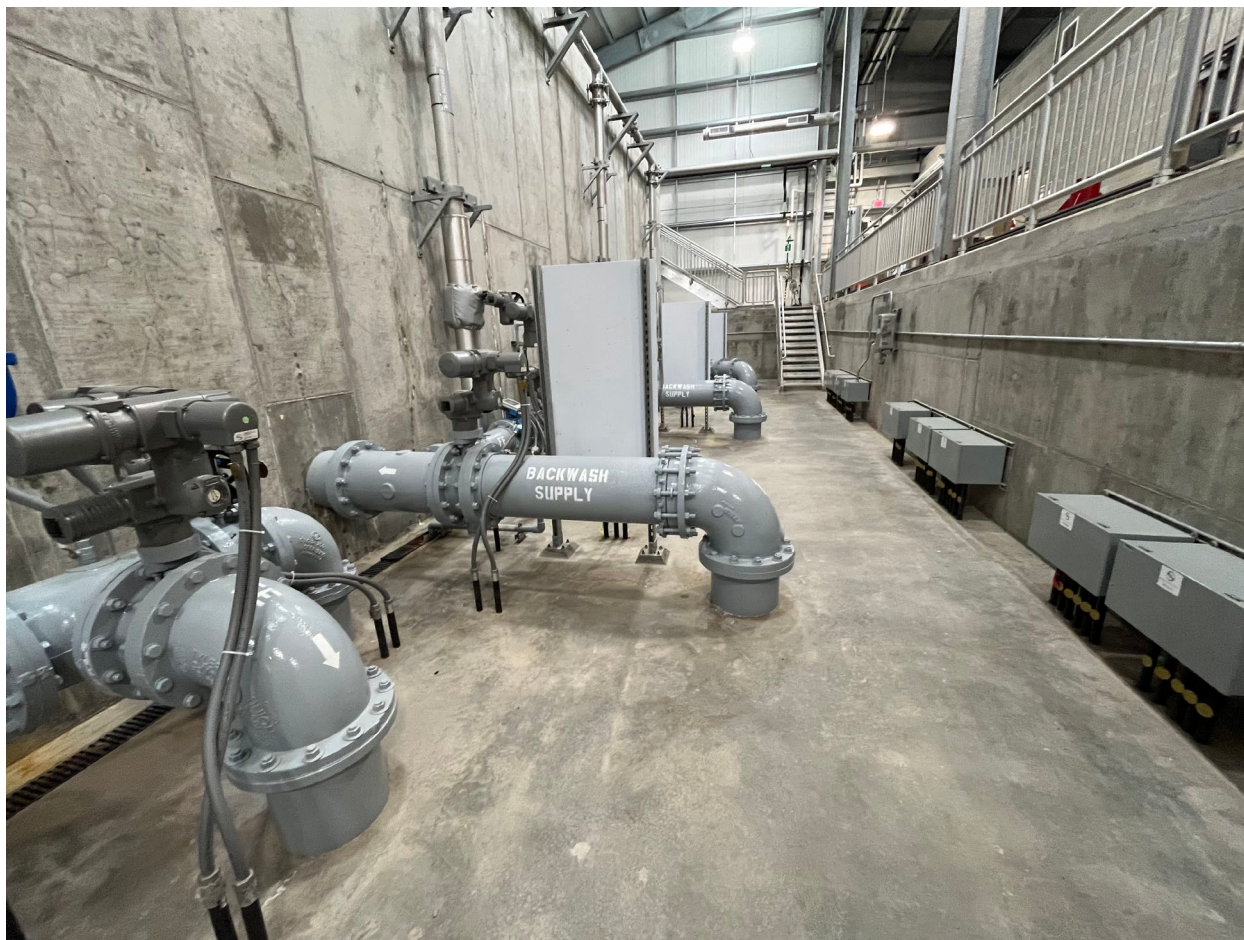
Photo No. 8

View of a portion of the process piping located inside the CTPL facility. (IMG\_0031) (July 10, 2024: 2:17 PM) Photographed by D. Esparza

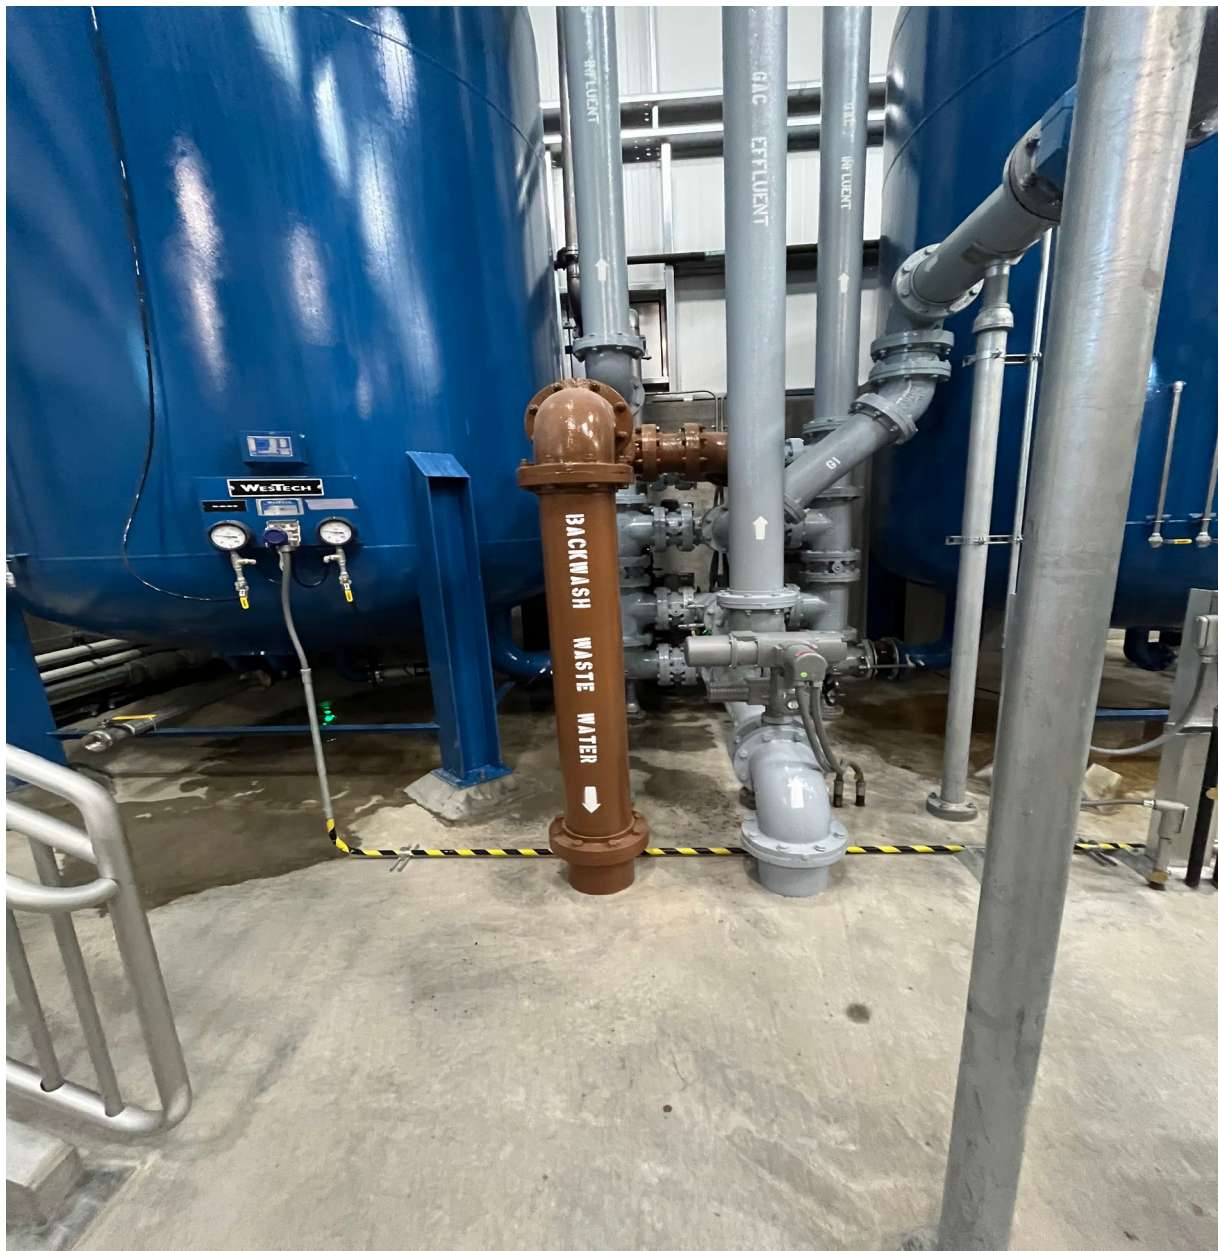
Photo No. 9

View of the backwash waste piping from the GAC tanks. (IMG\_0036) (July 10, 2024: 2:25 PM)

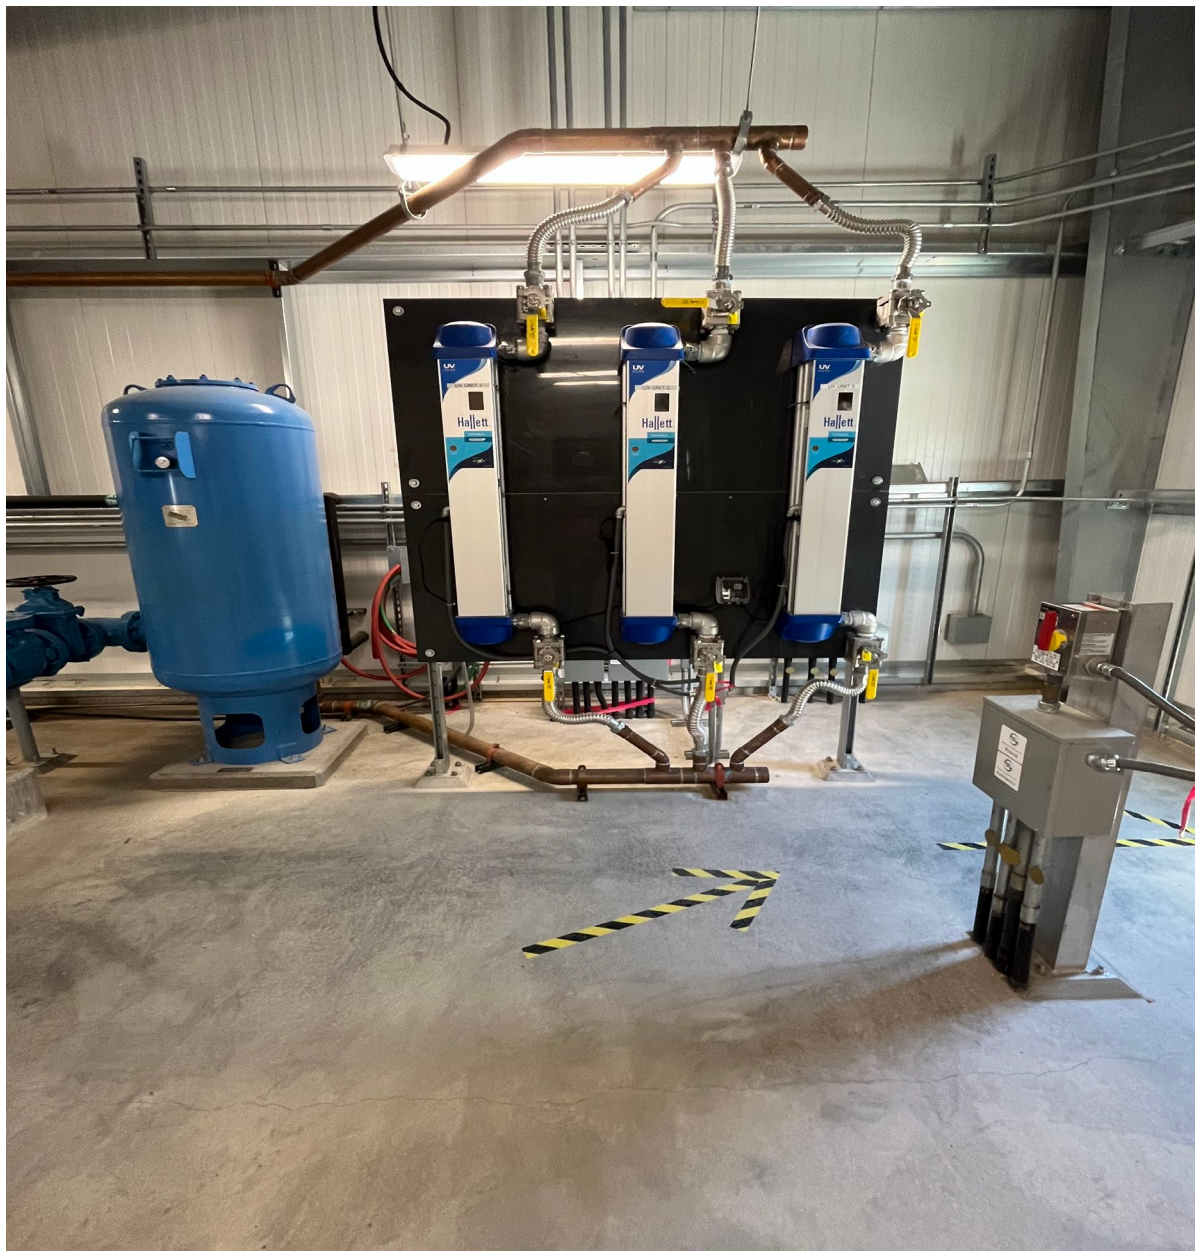
Photo No. 10

View of the Hallet ultraviolet (UV) disinfection system. (IMG\_0039) (July 10, 2024: 2:30 PM)  
Photographed by D. Esparza

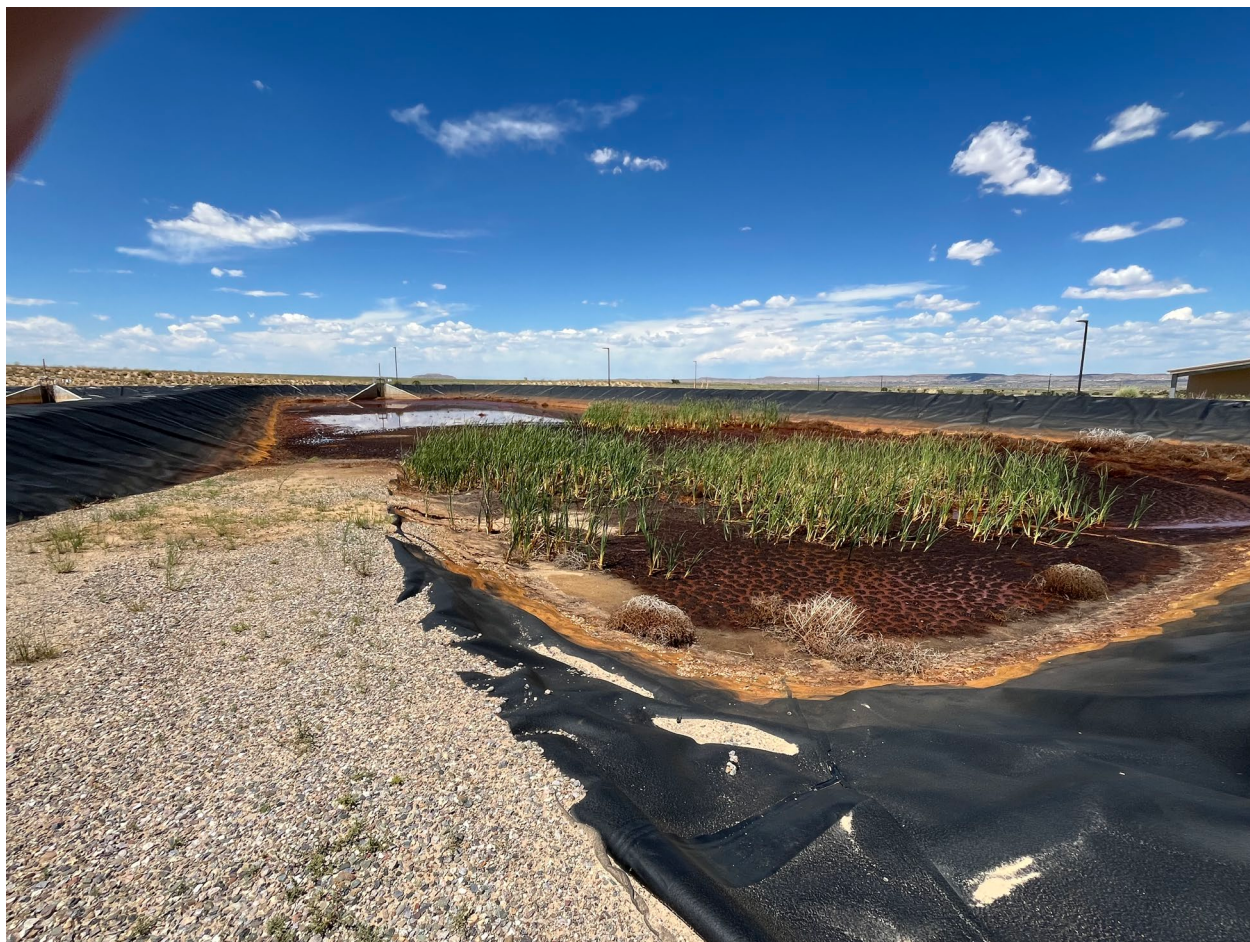
Photo No. 11

View of the solids drying beds. Note: The dried sludge material is transported and disposed at a landfill.  
(IMG\_0046) (July 10, 2024: 2:40 PM) Photographed by D. Esparza

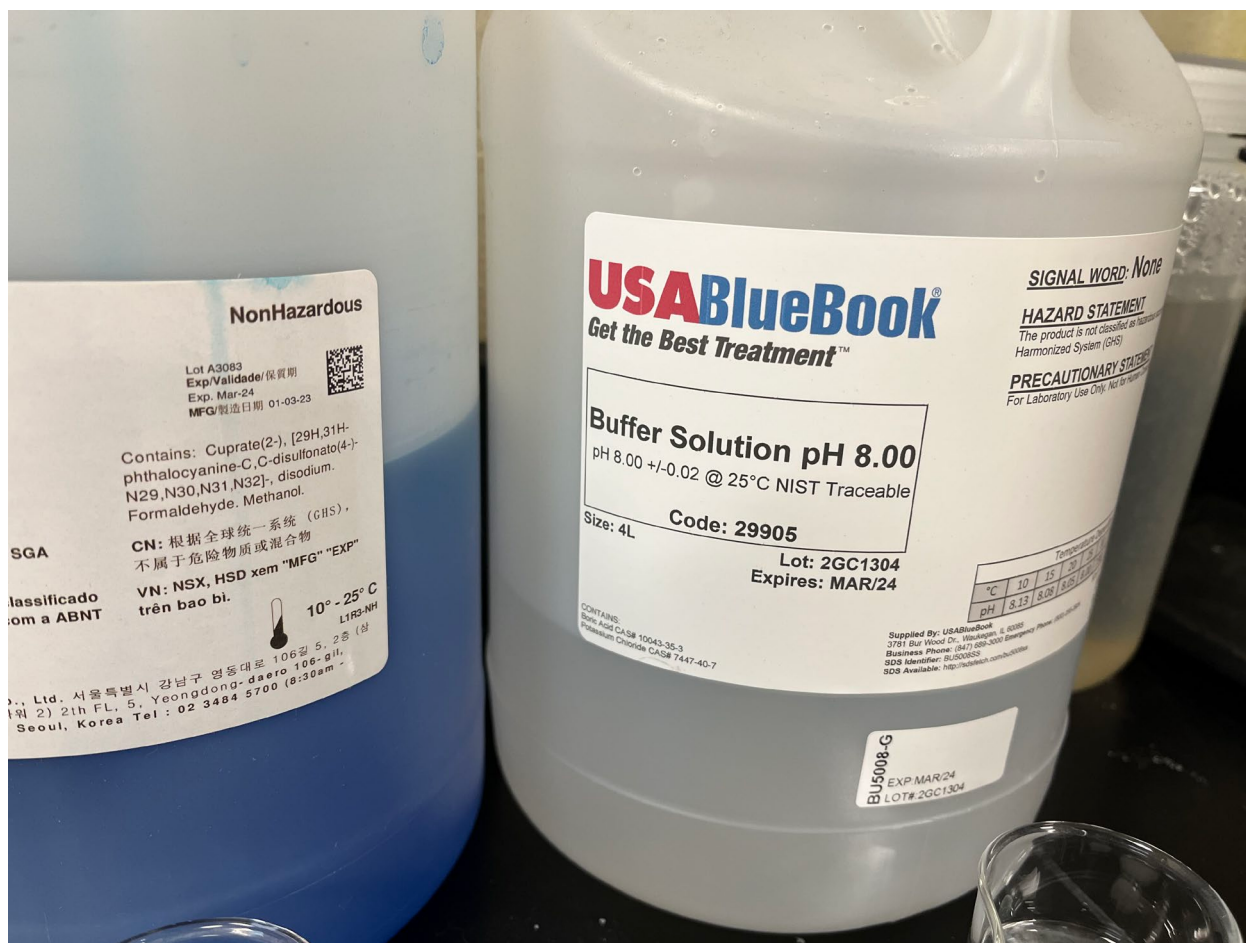
Photo No. 12

1. The on-site laboratory analytical analysis consists of alkalinity and pH. All additional samples are forwarded to Hall Laboratory (Eurofins). Note: the pH-8 and pH-10 were both expired (March 2024). Additionally, a review of the “bench sheet data” appears to indicate the recorded pH values (June 24, 2024) are outside the permitted ranges of 6.43 to 7.21 (S.U.) for the previous NPDES permit (expired in 2023), but within the ranges 6.6 to 9.0 (S.U) in the new permit (issued in January 2024) in some analysis. Note: the recorded values for the sedimentation basins effluent #1 and #2, and the flocculation/sedimentation basins (top) #1 and #2 are outside the ranges for either the old or new NPDES permit.

View of the pH10 and pH8 buffer solutions. Note: Both had expired in March 2024. (IMG\_0007) (July 10, 2024: 1:30 PM) Photographed by D. Esparza

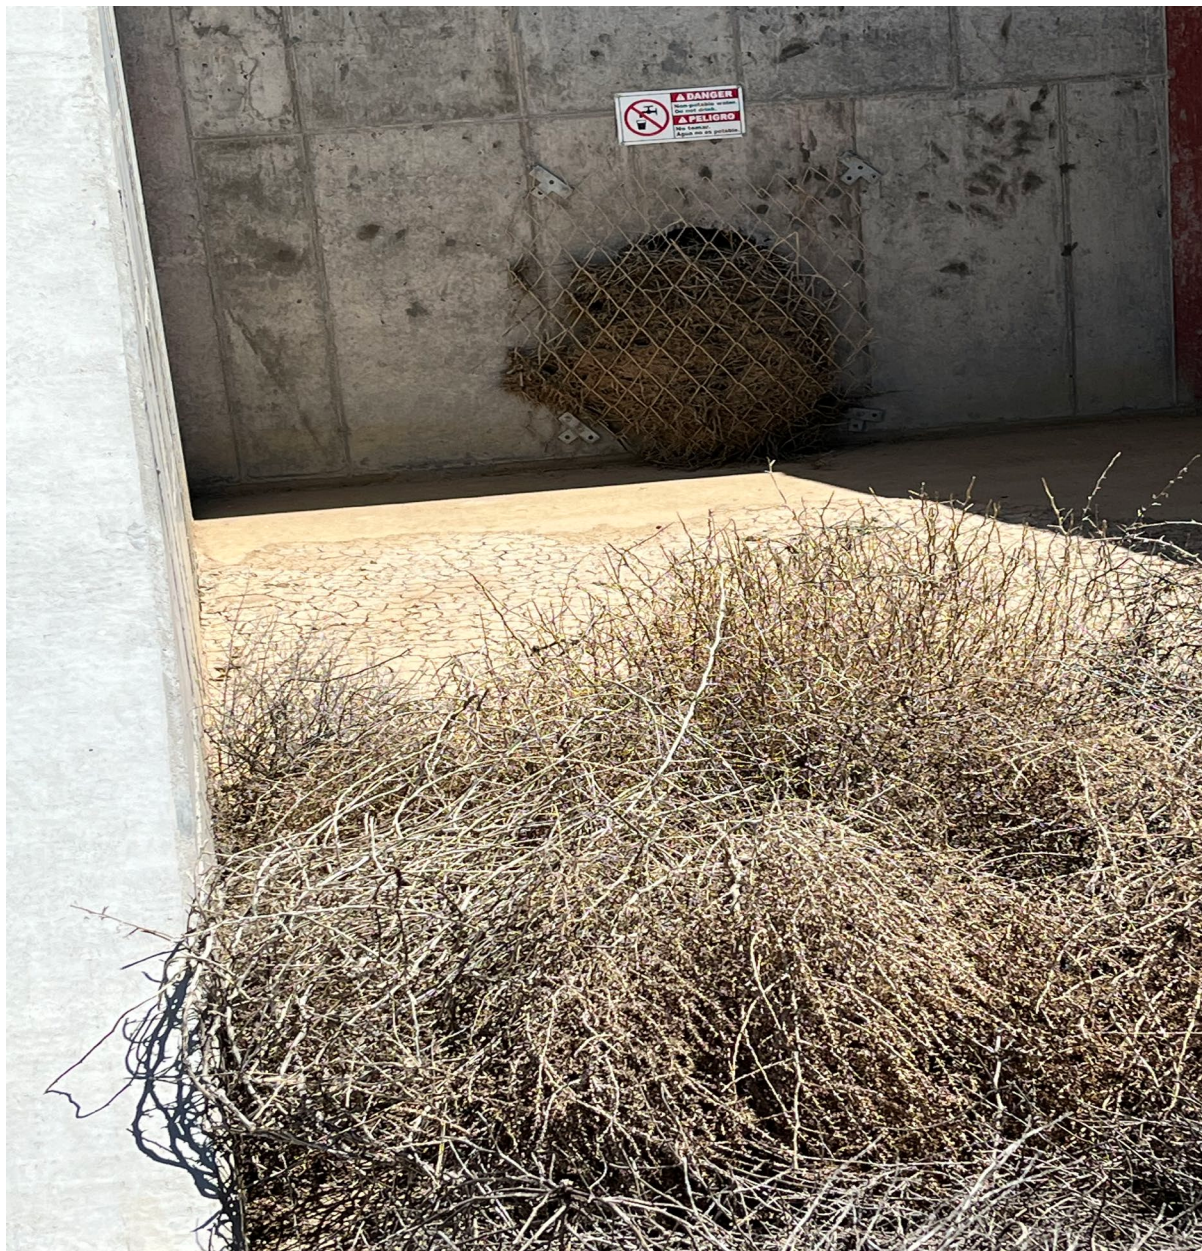
Photo No. 13

View of the CTPL discharge conduit. Note: It was recommended the vagrant debris be removed.  
(IMG\_0056) (July 10, 2024: 2:57 PM) Photographed by D. Esparza
