**Region 6 - Enforcement & Compliance Assurance Division**  
**INSPECTION REPORT**

| Inspection Date(s): | 12/11/2024 | |
| Company Name: | <b>Merit Energy Company, LLC</b> | |
| Facility Name: | <b>Denman 2-13, Denman 3-13, and Denman-Wright Humphries 1-13 Tank Battery</b> | |

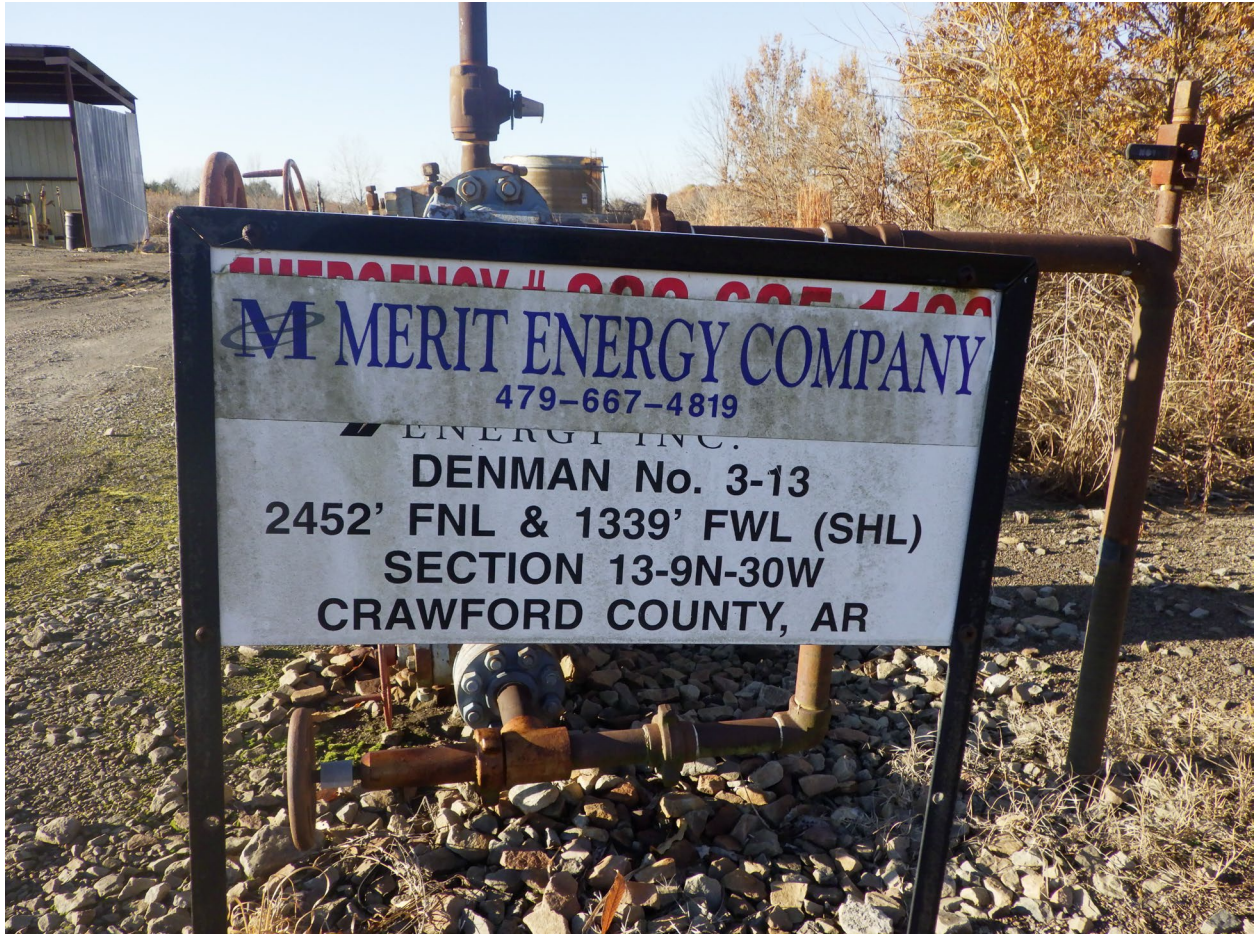
Photo No. 1

**Description:** Looking N, this photo shows the first of three signs at the facility.

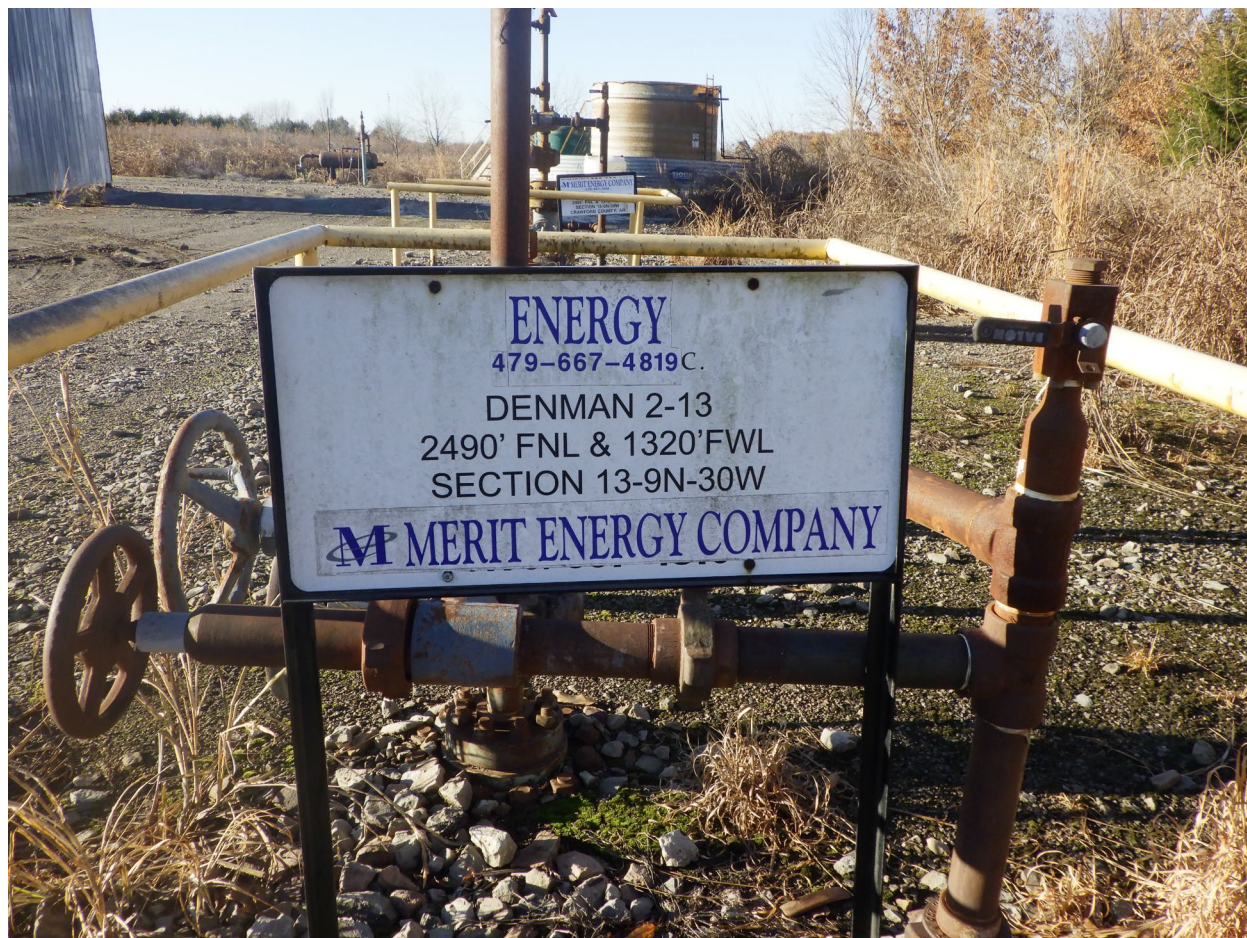
Photo No. 2

**Description:** Looking N, this photo shows the second of three signs at the facility.

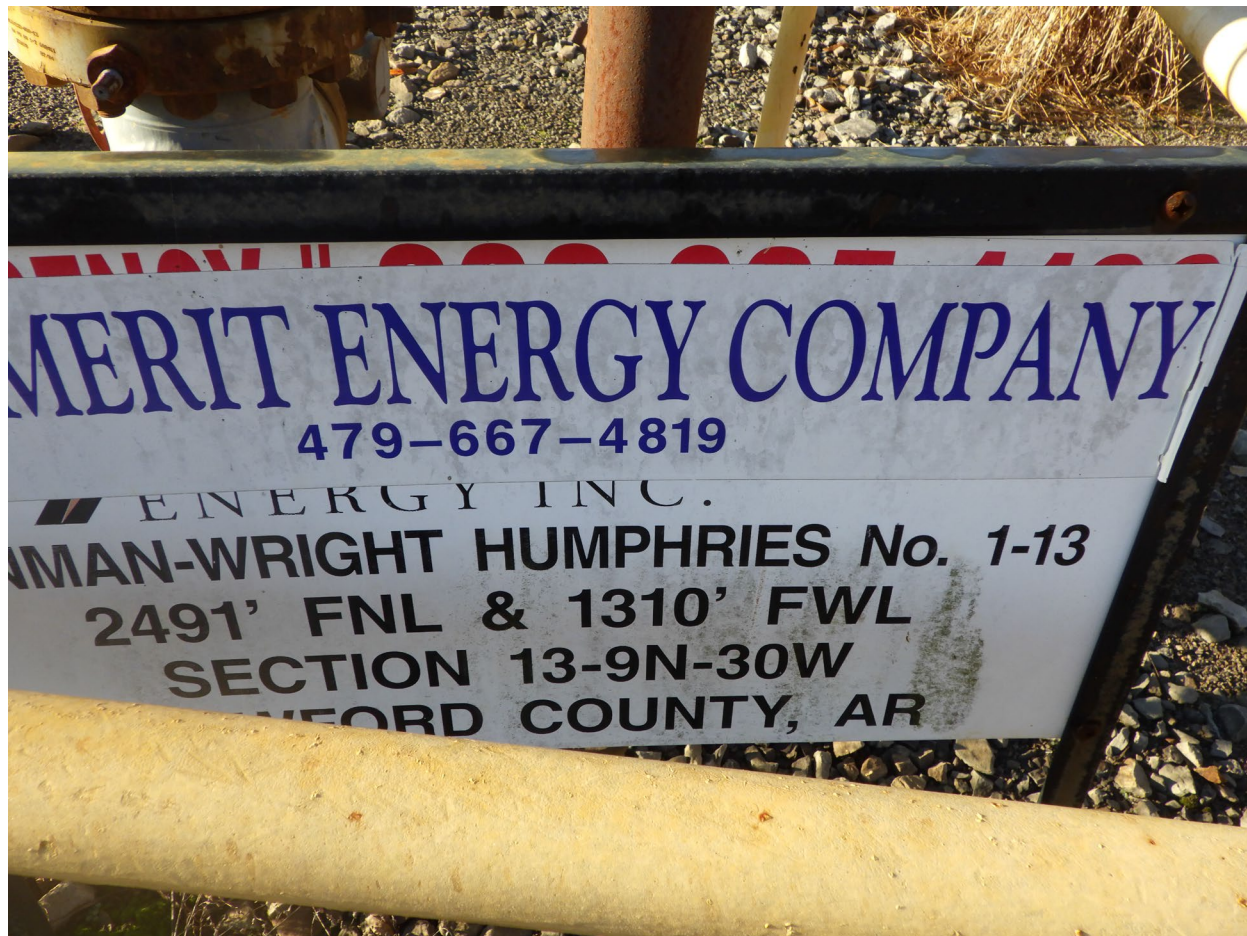
Photo No. 3

**Description:** Looking NNE, this photo shows the third of three signs at the facility.

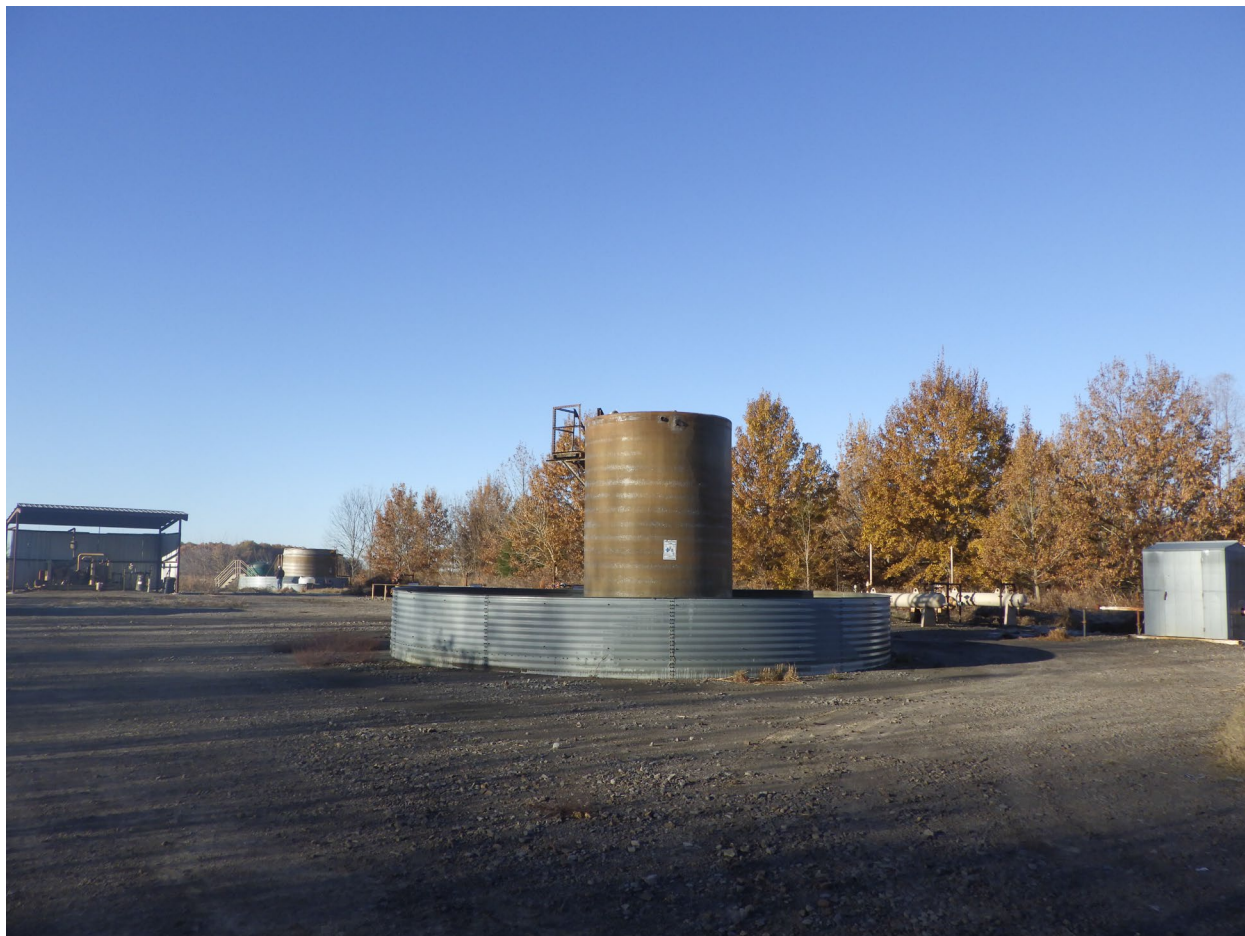
Photo No. 4

**Description:** Looking SSW, this photo shows an overview of the facility.

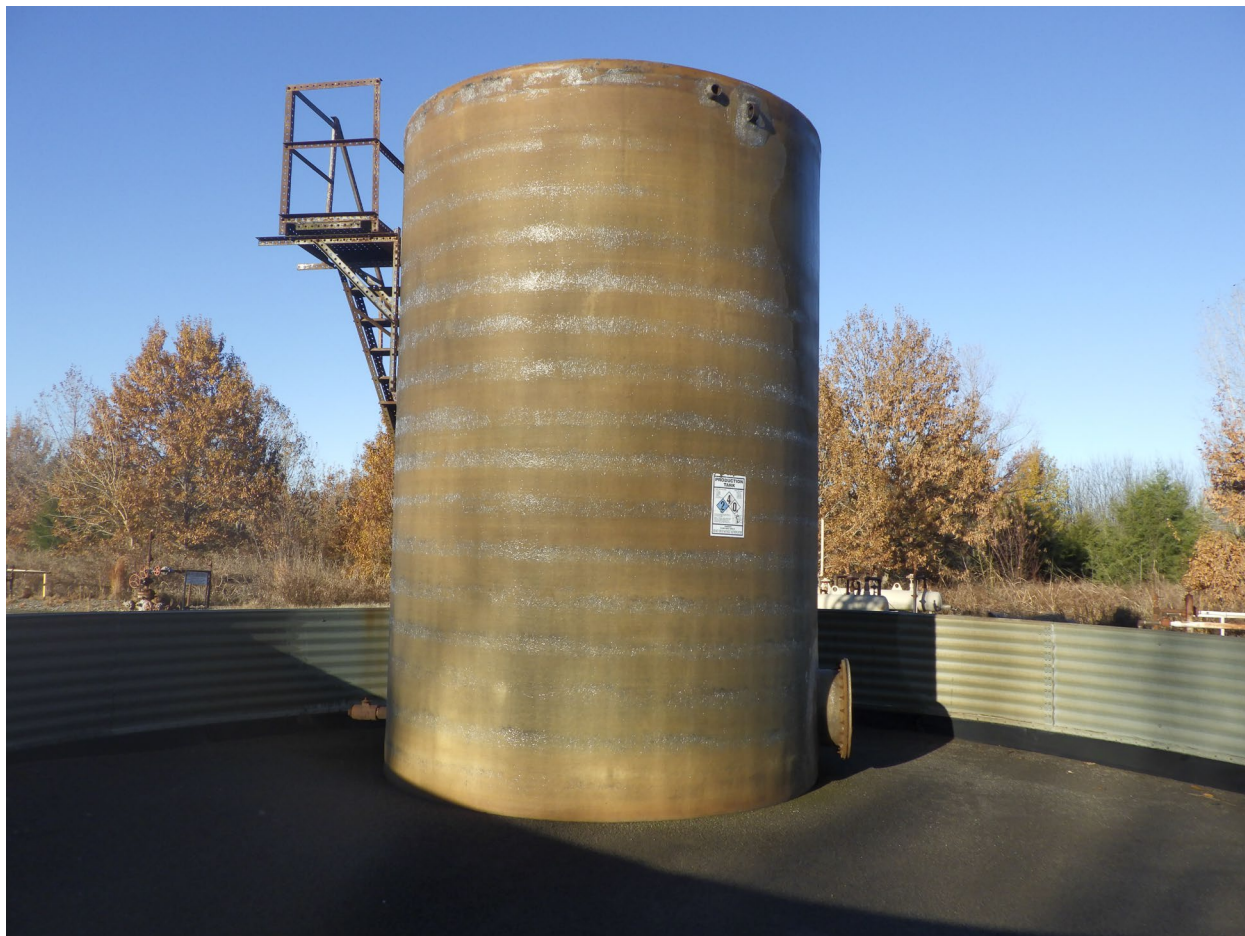
Photo No. 5

I observed one large fiberglass storage tank within secondary containment, see Photo No. 5.

**Description:** Looking NW, this photo shows a large fiberglass storage tank for produced water inside secondary containment.

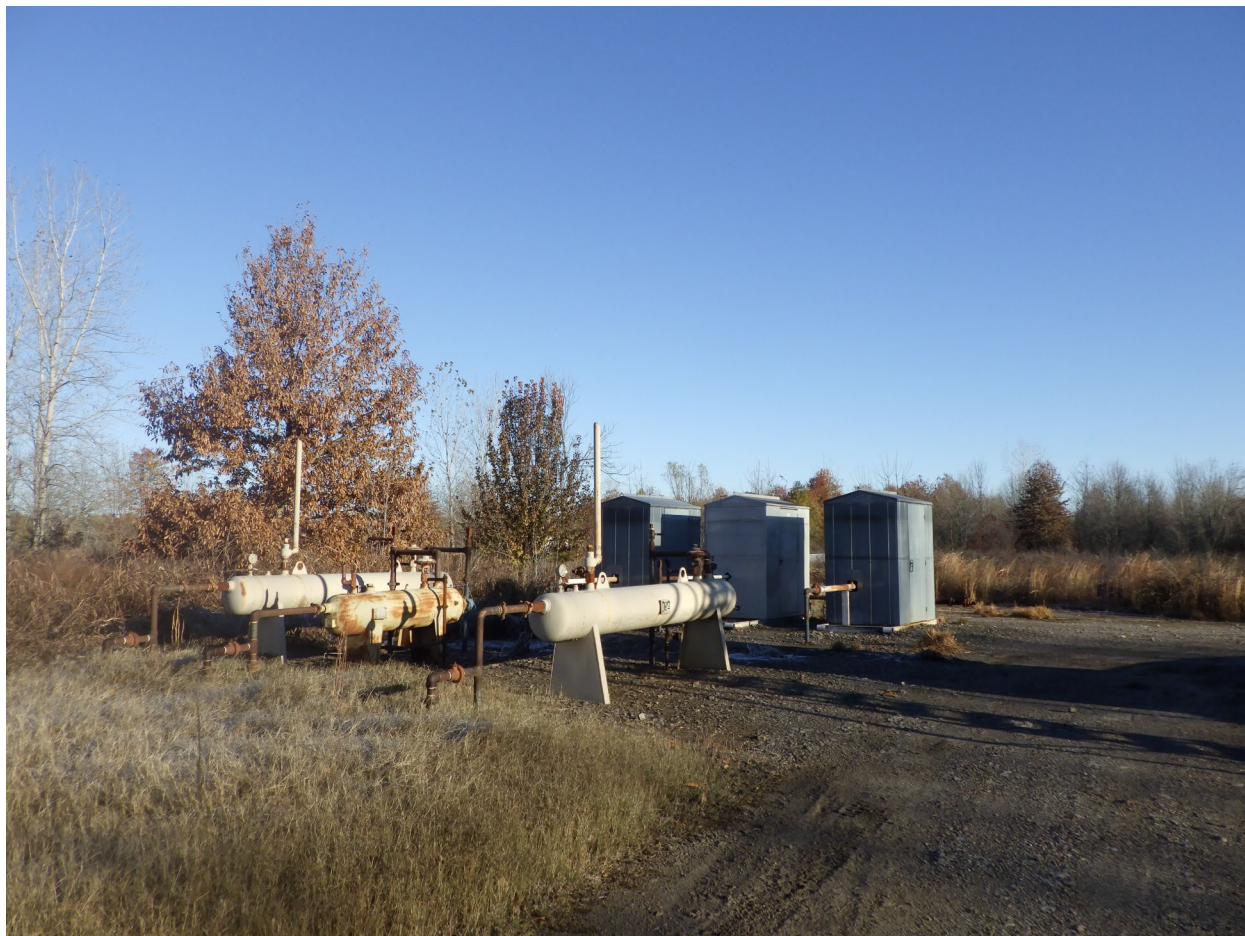
Photo No. 6

**Description:** Looking NE, this photo shows three of four 2-phase separators located at the facility.

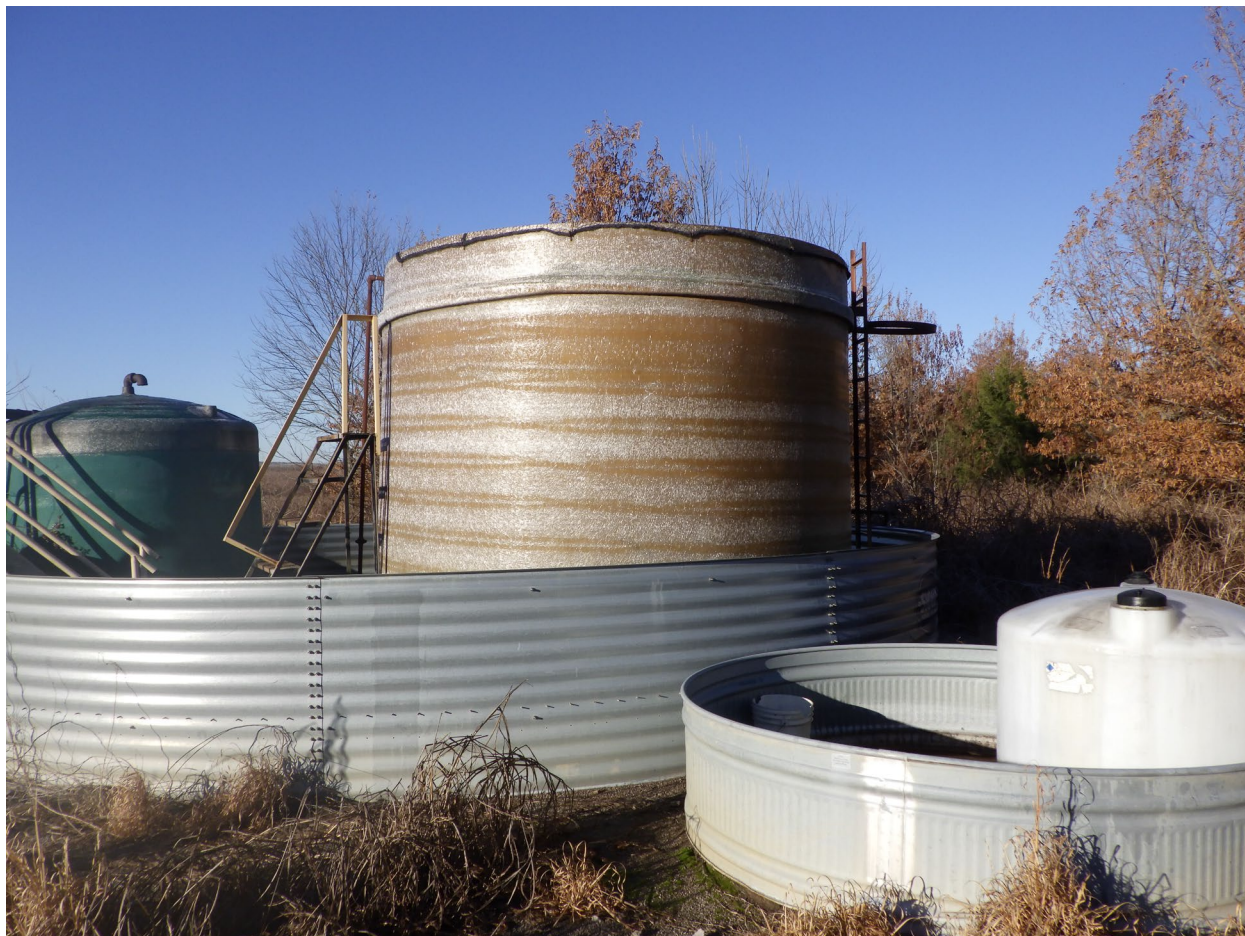
Photo No. 7

I observed three more storage tanks for produced water and additives, see Photo No. 7.

**Description:** Looking W, this photo shows two additional secondary containment structures with three storage tanks.

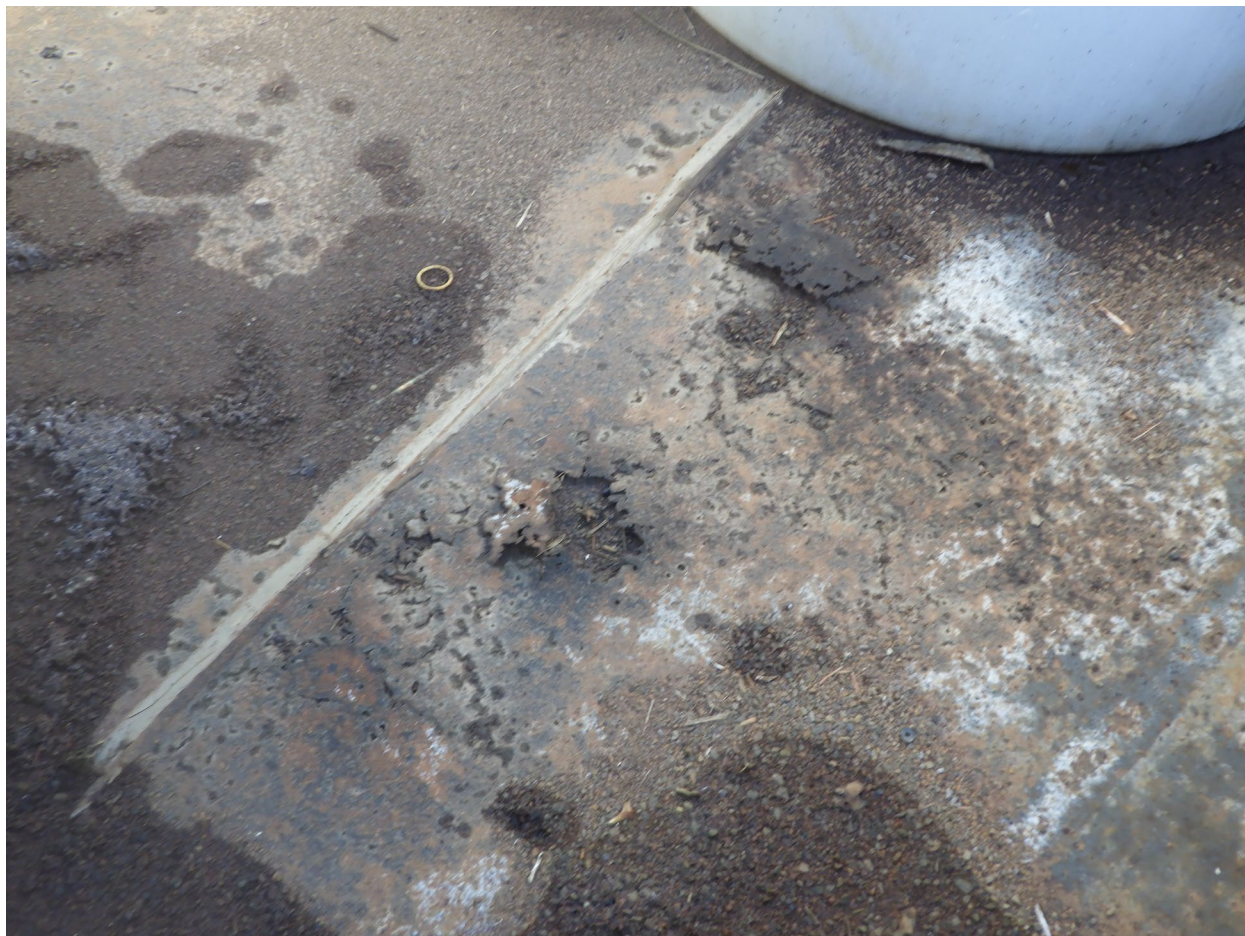
I observed holes in the secondary containment structure and holes/tears in the liner for secondary containment for the tanks referenced above, see Photo No. 8 and No. 9.

- Holes in secondary containment structures and holes/tears in the synthetic liner for secondary containment.

**Description:** Looking NNE, this photo shows holes in the smaller secondary containment structure from Photo No. 7.

Inspector will conduct follow-up phone calls and emails with the company representative(s) over the coming weeks and months to ensure areas of concern are properly addressed.

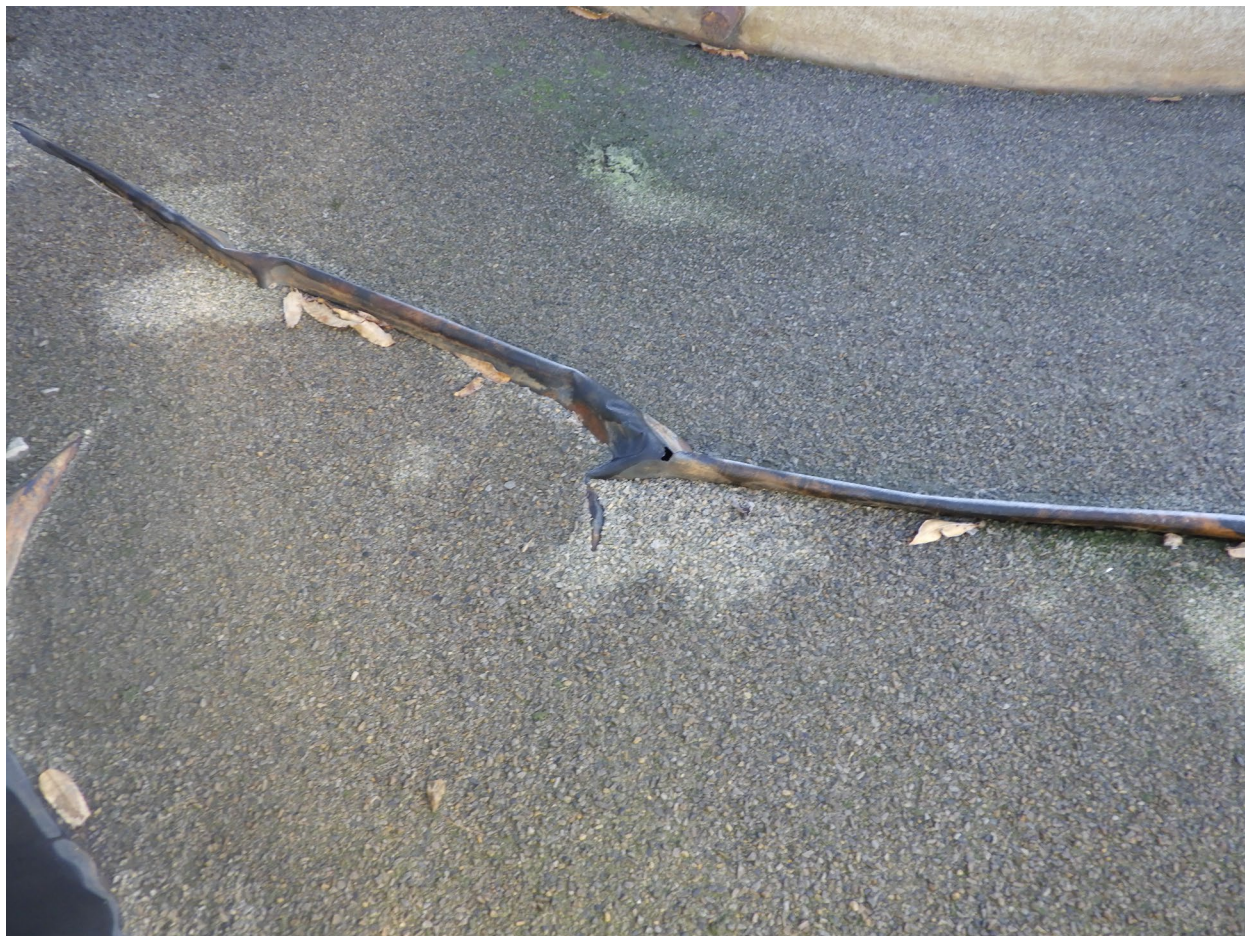
Photo No. 9

**Description:** Looking ENE, this photo shows a hole in the synthetic liner for the larger secondary containment structure from Photo No. 7.

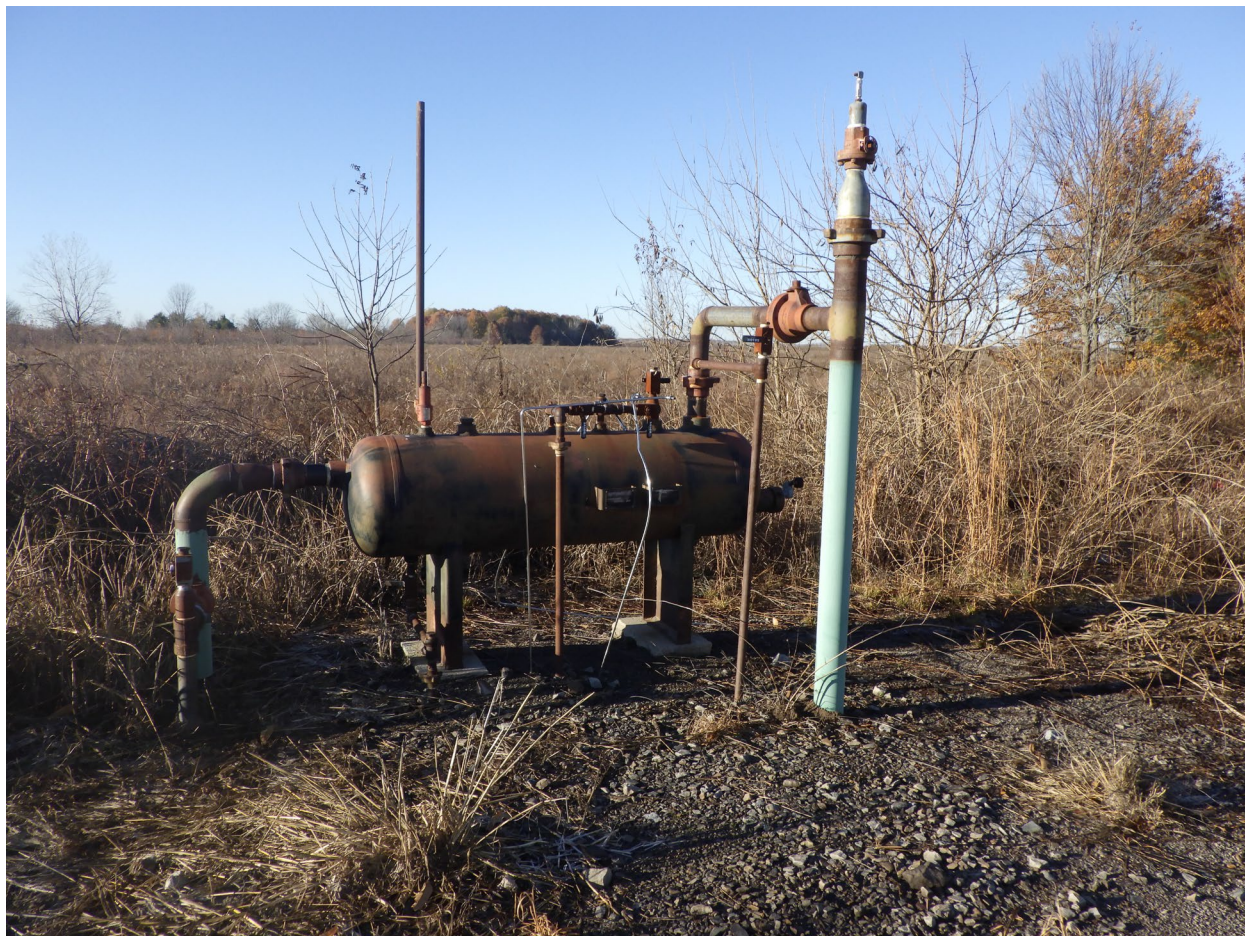
Photo No. 10

**Description:** Looking SSW, this photo shows the fourth of the four 2-phase separators located at the facility.

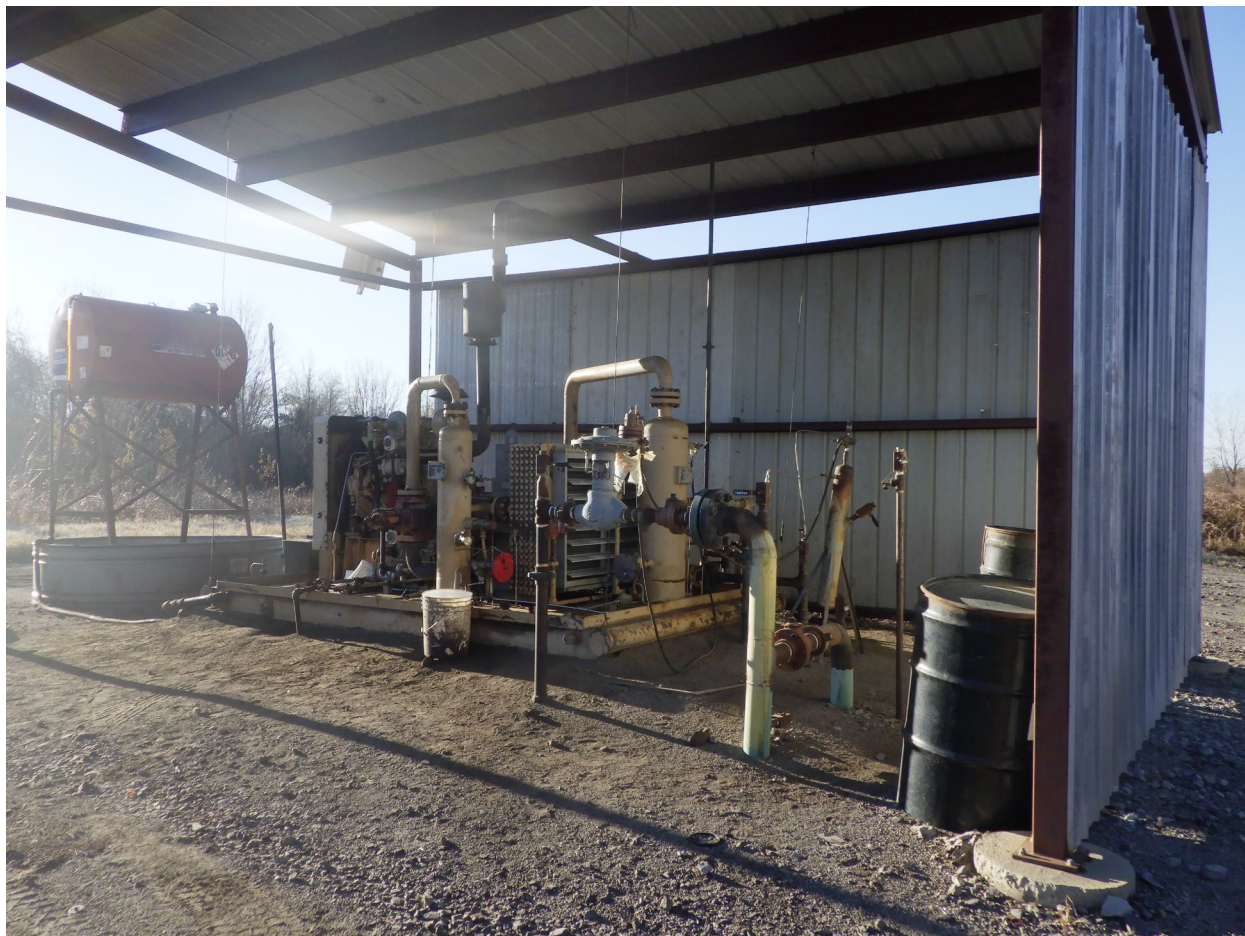
Photo No. 11

I observed the compressor onsite, see Photo No. 11.

**Description:** Looking SSE, this photo shows the compressor located at the facility.
