## Region 6 - Enforcement & Compliance Assurance Division

### INSPECTION REPORT

| Company Name: | <b>Calgary Energy, LLC</b> | |
| Facility Name: | <b>Tidal Osage</b> | |

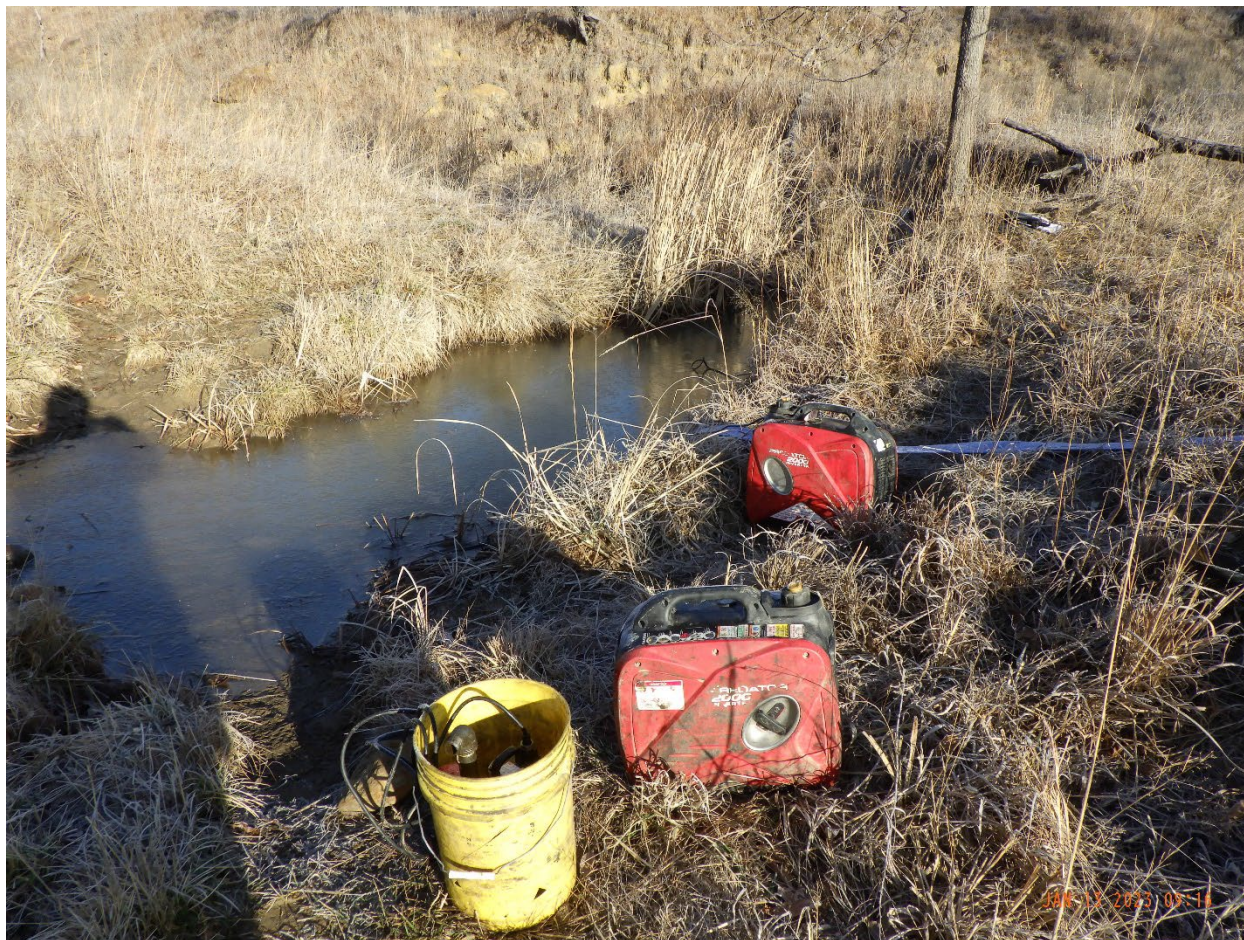
Photo No. 1

I observed portable generators and a submersible pump along the main channel of the impacted tributary, see Appendix 1 (photo log) photo No. 1 (GPS 36.538443, -96.415749). At the same location I observed and elevated TDS field reading of 91,953 mg/L (photo No. 2), this was the highest concentration observed during the inspection.

**Description:** This was a photo of portable generators and an electric submersible pump which had been used to remove contaminated waters from the impacted tributary of Little Hominy Creek.

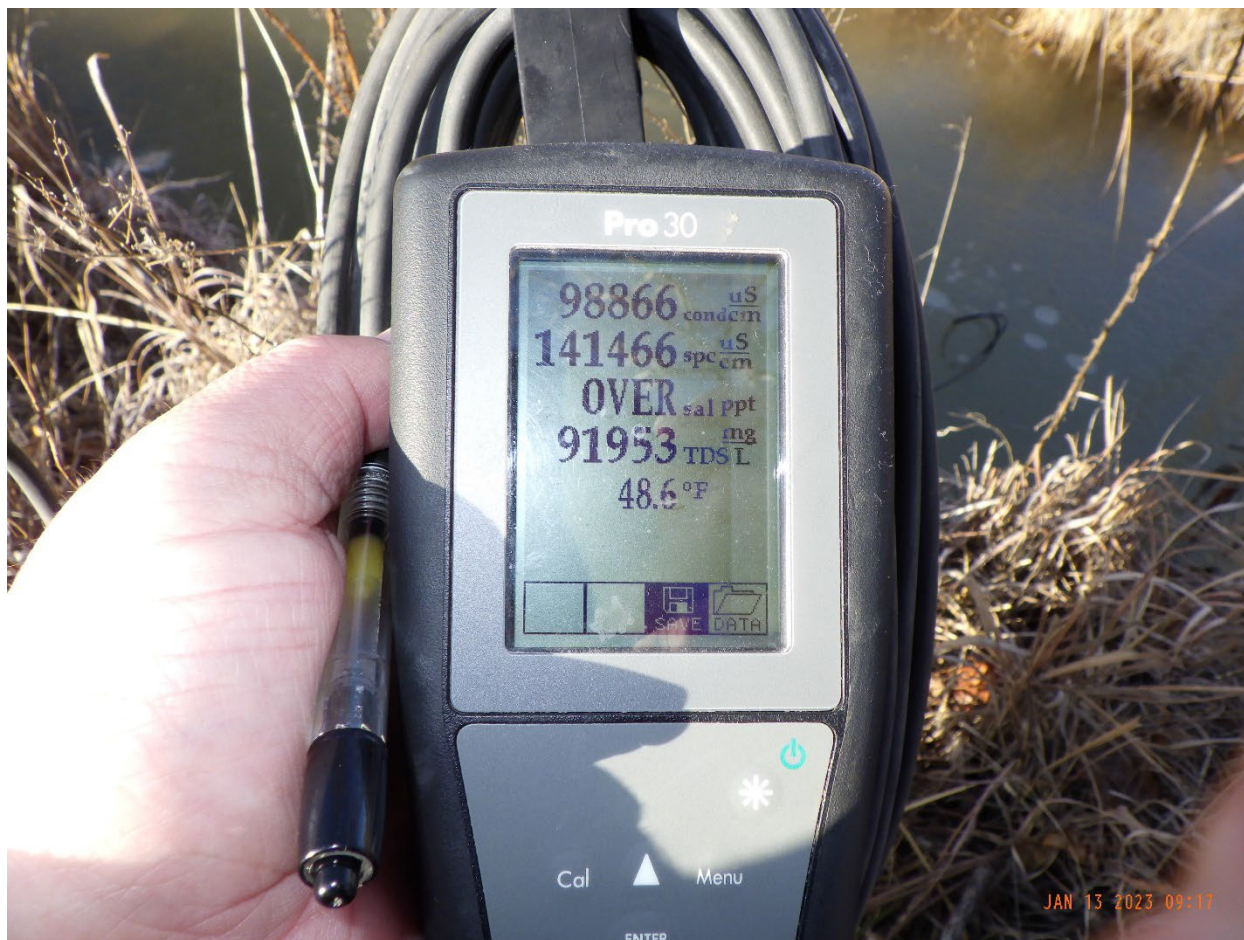
Photo No. 2

**Description:** This was an elevated TDS field reading of 91,953 mg/L taken at the same location as photo No. 1.

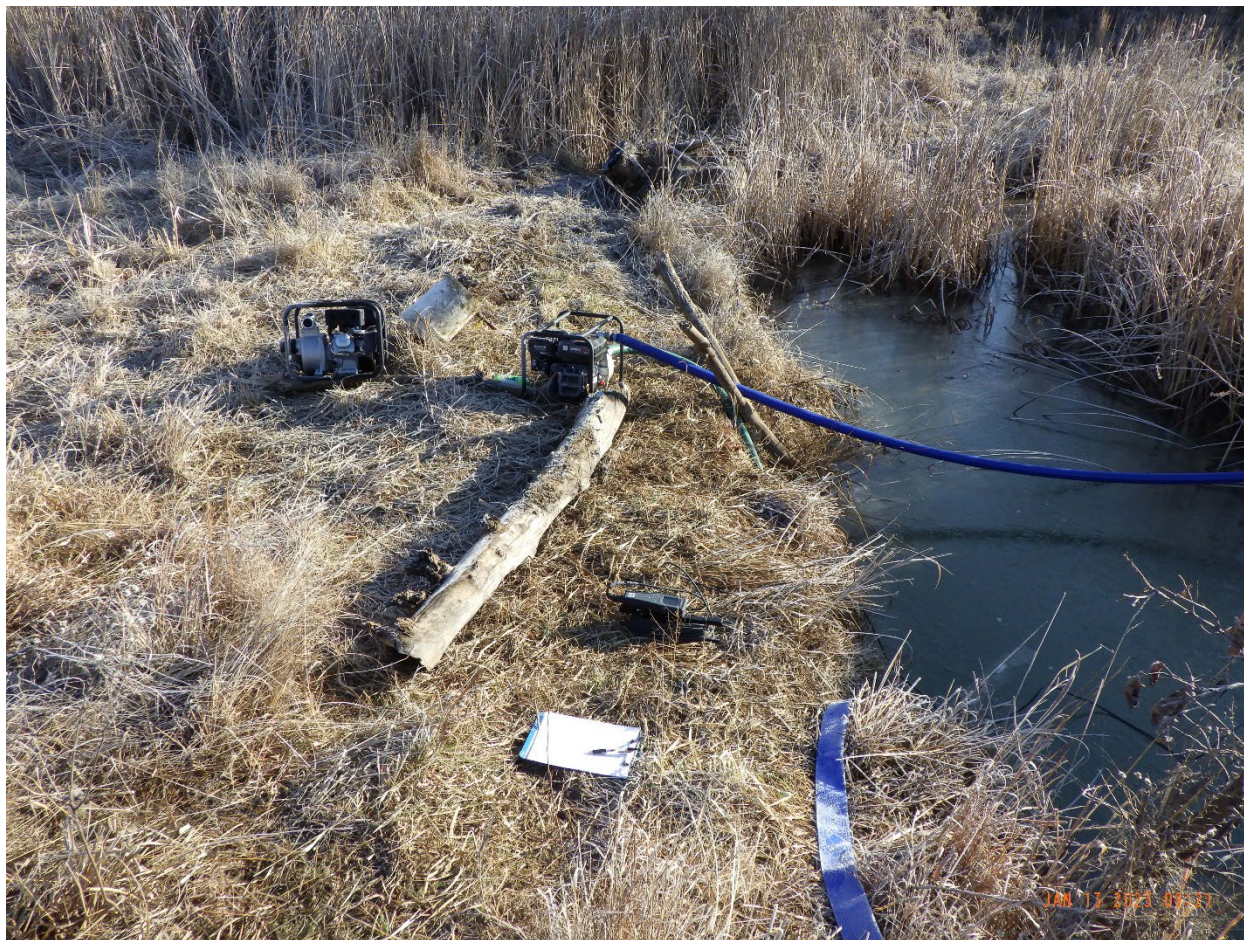
Photo No. 3

I observed 2 portable trash/transfer pumps which had been used to removed impacted waters from the tributary. See photo No. 3 (GPS 36.538154, -96.415099). At the same location, I observed and elevated TDS field reading of 58,256 mg/L, see photo No. 4.

**Description:** This was a photo of two trash/transfer pumps which had been used to remove contaminated waters from the impacted tributary.

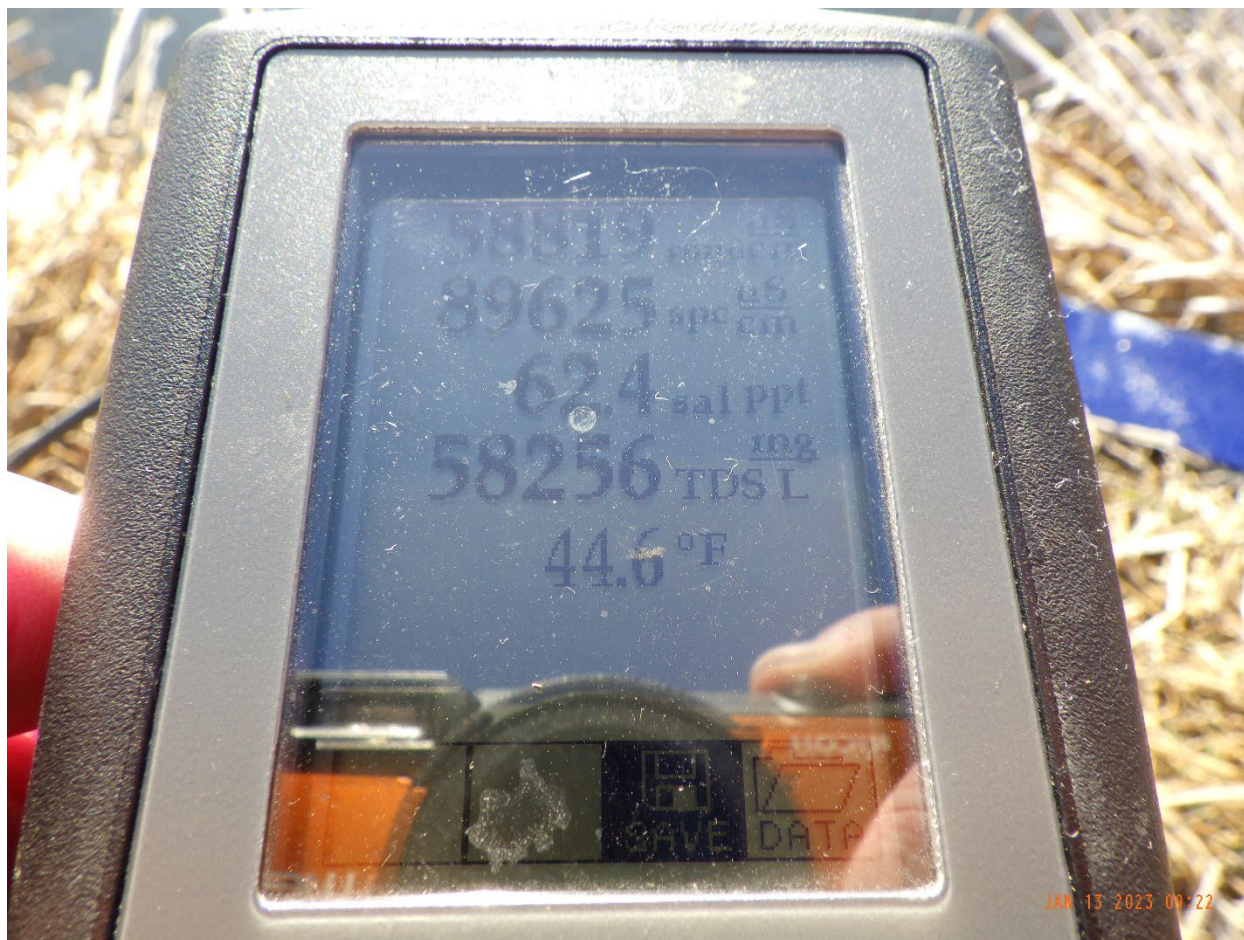
Photo No. 4

**Description:** This was an elevated TDS field reading of 58,256 mg/L taken at the same location as photo No. 3.

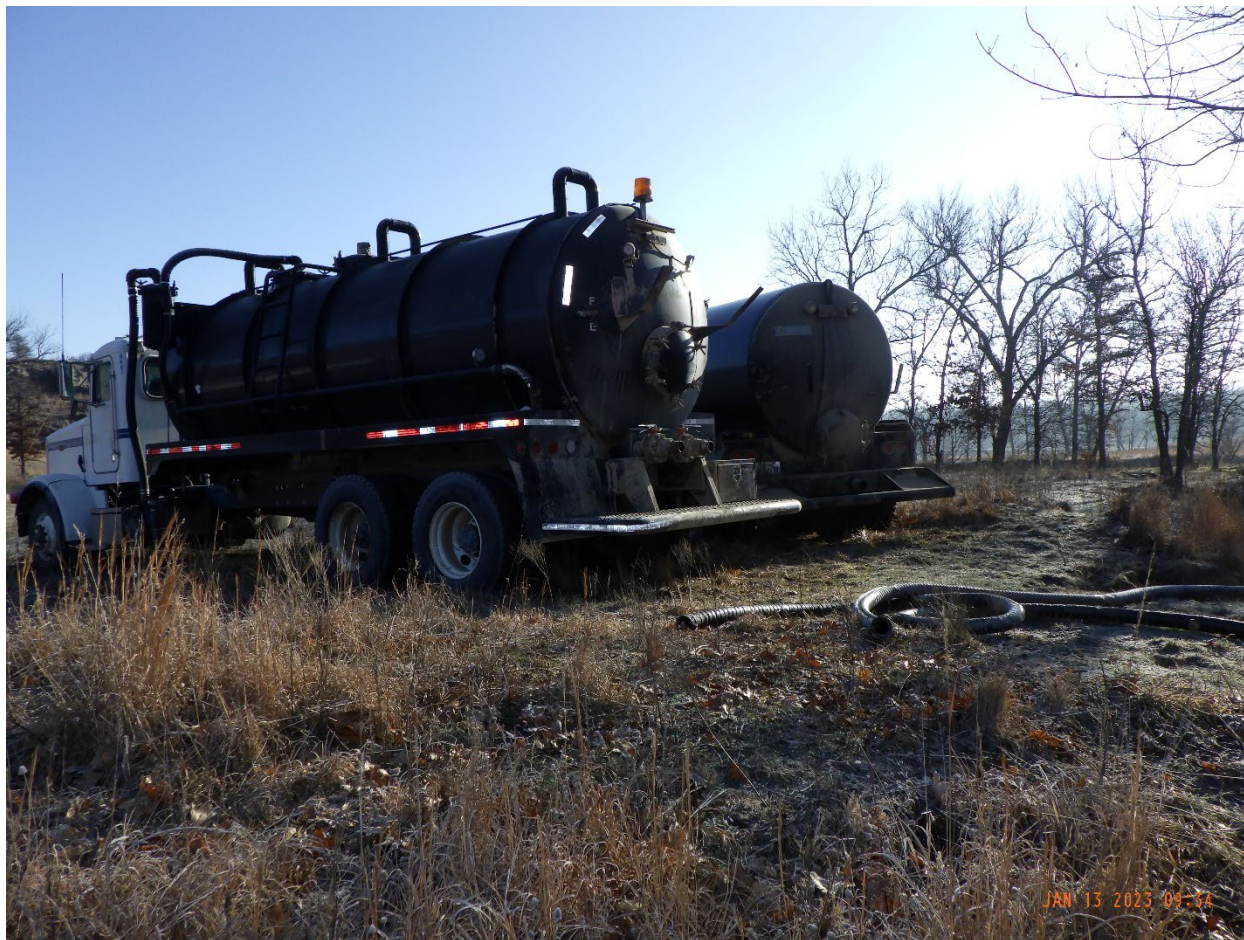
Photo No. 5

I observed 2 bobtail vacuum trucks which were being used to removed impacted waters from the tributary, see photo No. 5.

**Description:** This was a photo of two bobtail vacuum trucks which were being used as part of the cleanup operations.

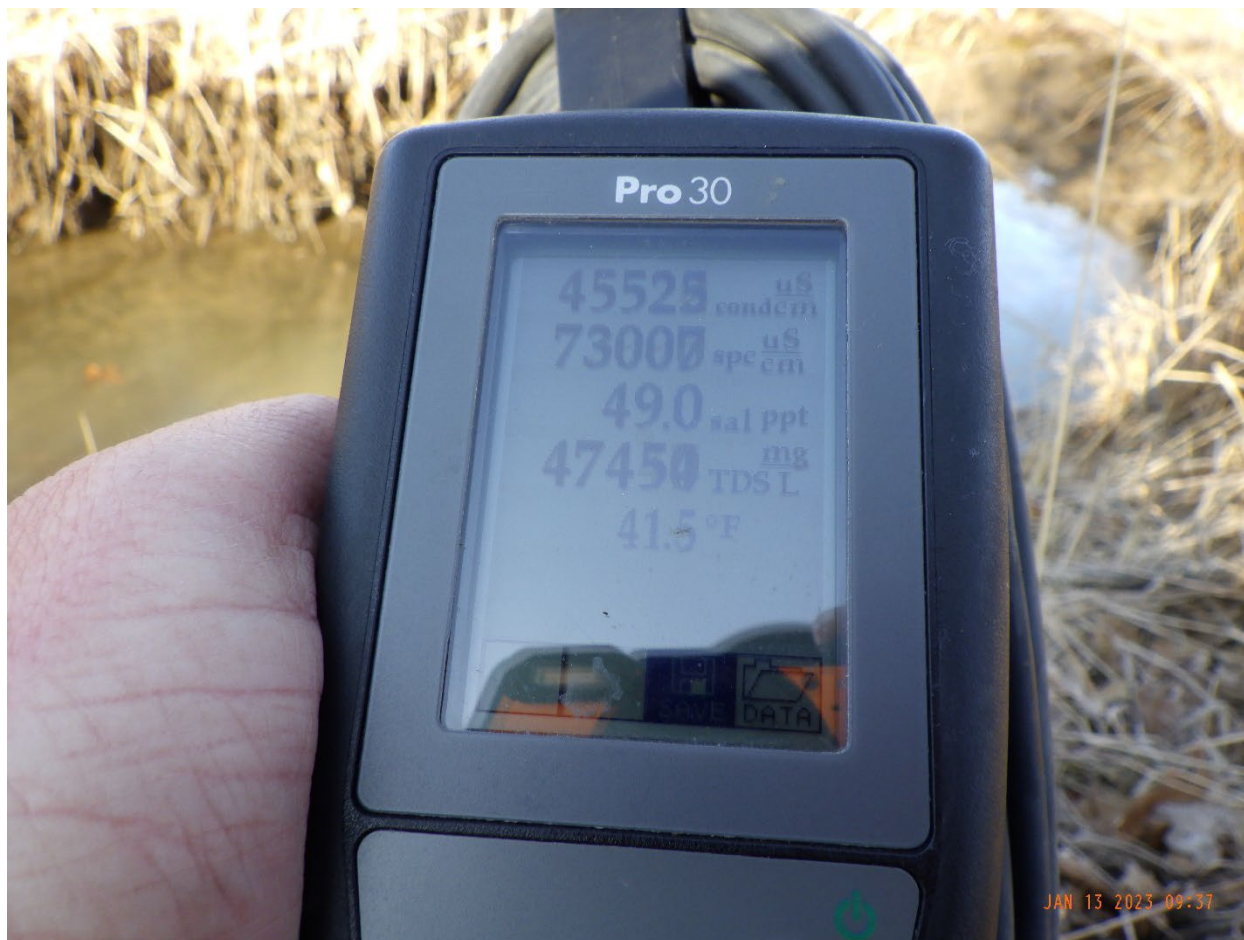
Photo No. 6

I observed an elevated TDS field reading of 47,450 mg/L (GPS 36.537482, -96.414324) along the impacted tributary. See photo No. 6.

**Description:** This was an elevated TDS field reading of 47,450 mg/L taken in the main channel of the impacted tributary.

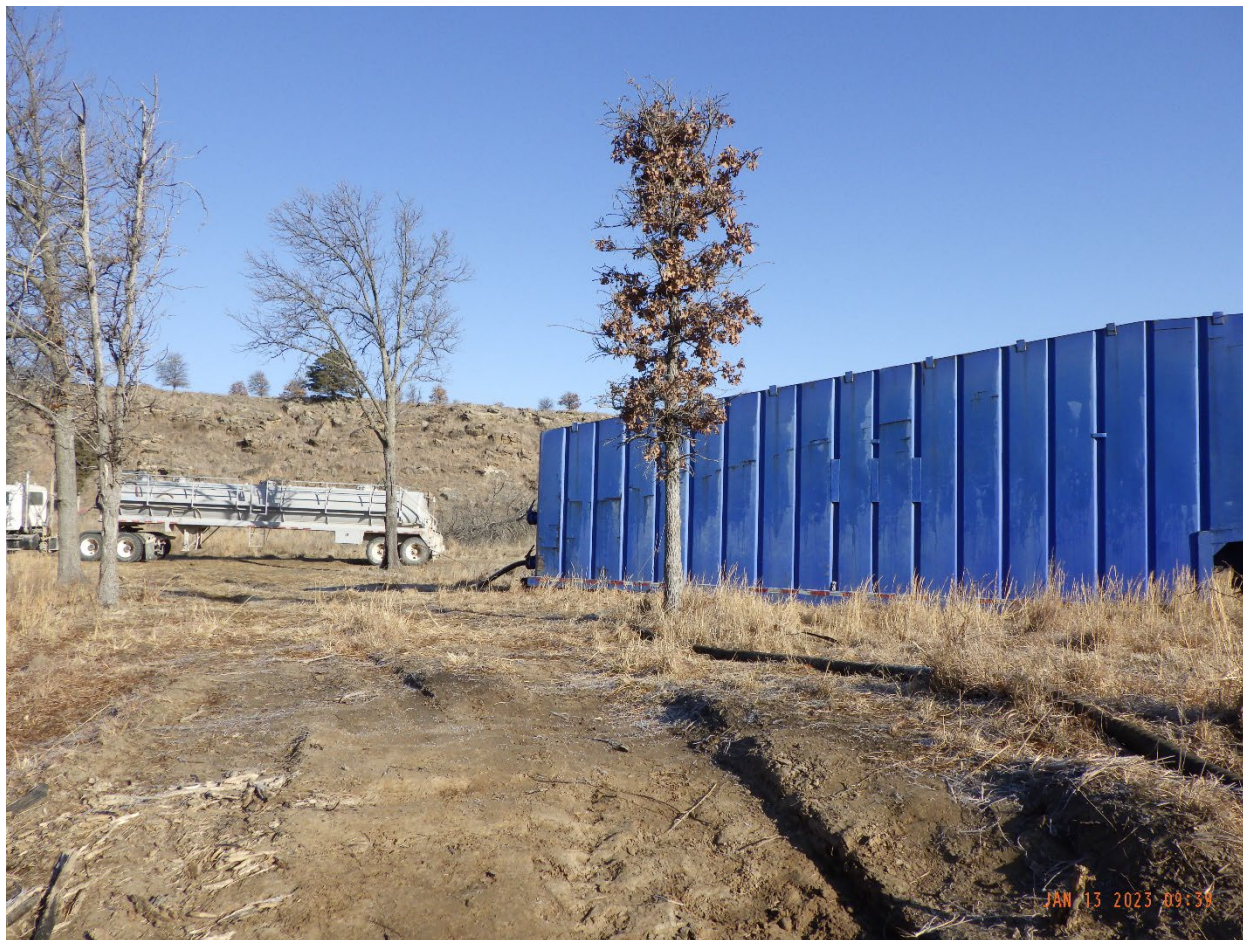
Photo No. 7

I observed a transport truck and frac tank which were being used as part of the clean-up operation, the frac tank was located at the same location as the temporary containment dam. At the same location (GPS 36.537204, -96.413103), I observed an elevated TDS field reading of 11,562 mg/L.

**Description:** This was a transport and frac tank which were both used during cleanup operations.

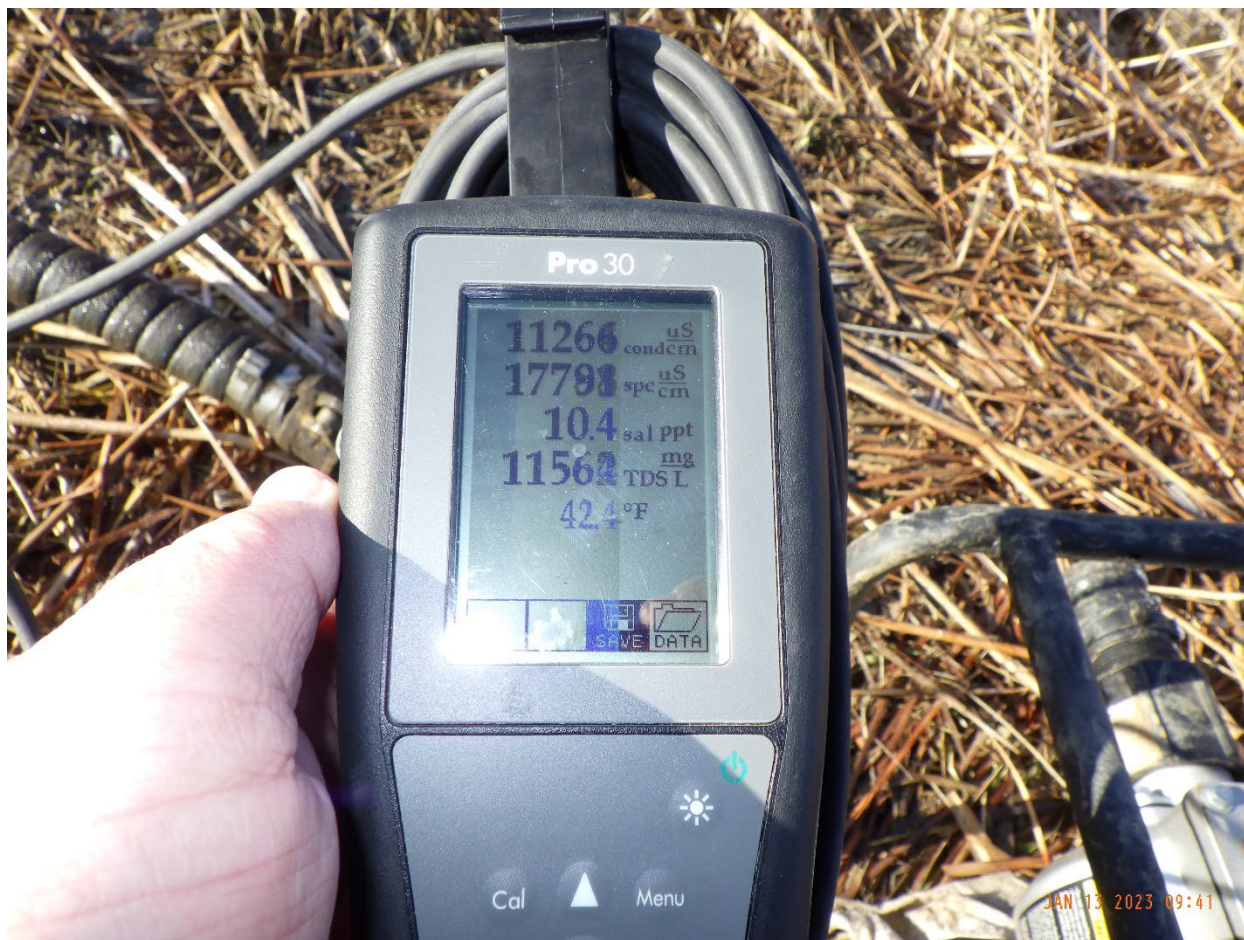
Photo No. 8

**Description:** This was a TDS field reading of 11,562 mg/L taken at the lowermost temporary containment dam. This reading represents an improvement over the initial spill inspection observations.

During the closing conference with Duane Easley, representing Calgary Energy, LLC, I noted my primary areas of concern. Calgary Energy, LLC should continue removing elevated TDS waters from the impacted tributary. The flowpath from the release point to the point of entry should be cleaned. Cleanup activities should continue until background TDS readings are observed along the impacted tributary.
