**Region 10 Enforcement and Compliance Assurance Division**  
**1200 6th Avenue**  
**Seattle, WA 98101**  
**INSPECTION REPORT**

| <b>Regulatory Program:</b> | CWA NPDES/Construction Stormwater | |
| <b>Site Name:</b> | Falcon Crest Subdivision | |

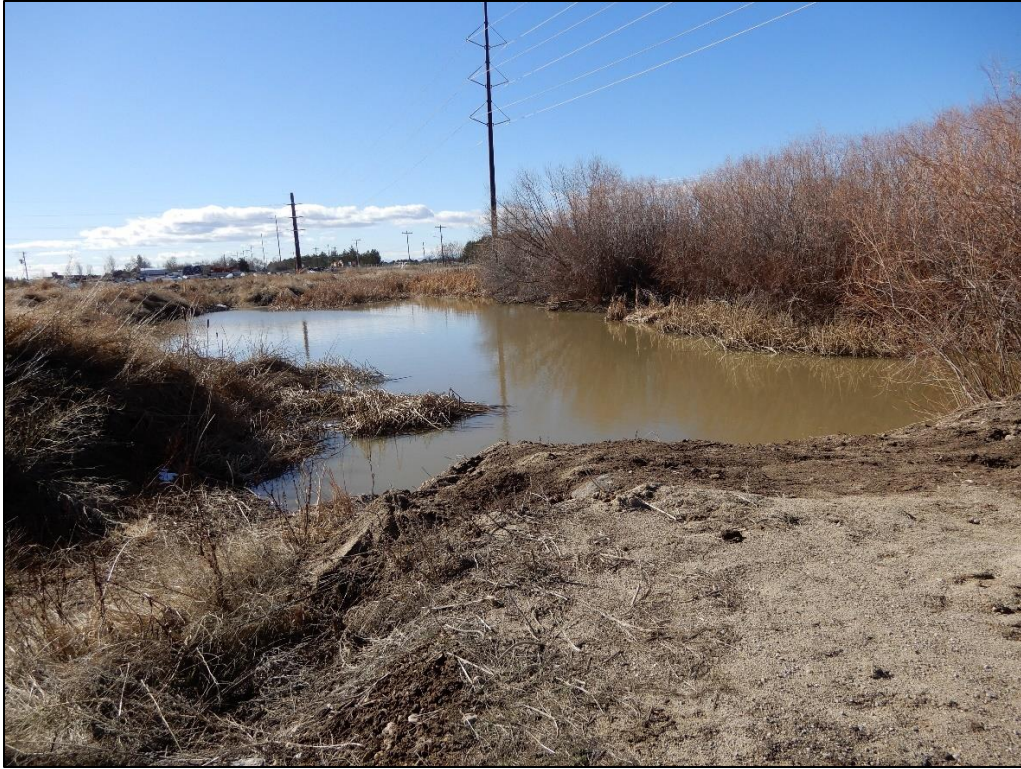
We then observed the wet pond located on the southwestern perimeter of the Site. The wet pond collects runoff from the western portion of the Site (refer to Attachment A, Photograph 1).

**Photograph 1.** View, facing southwest, of the wet pond on the southwestern perimeter of the Site.

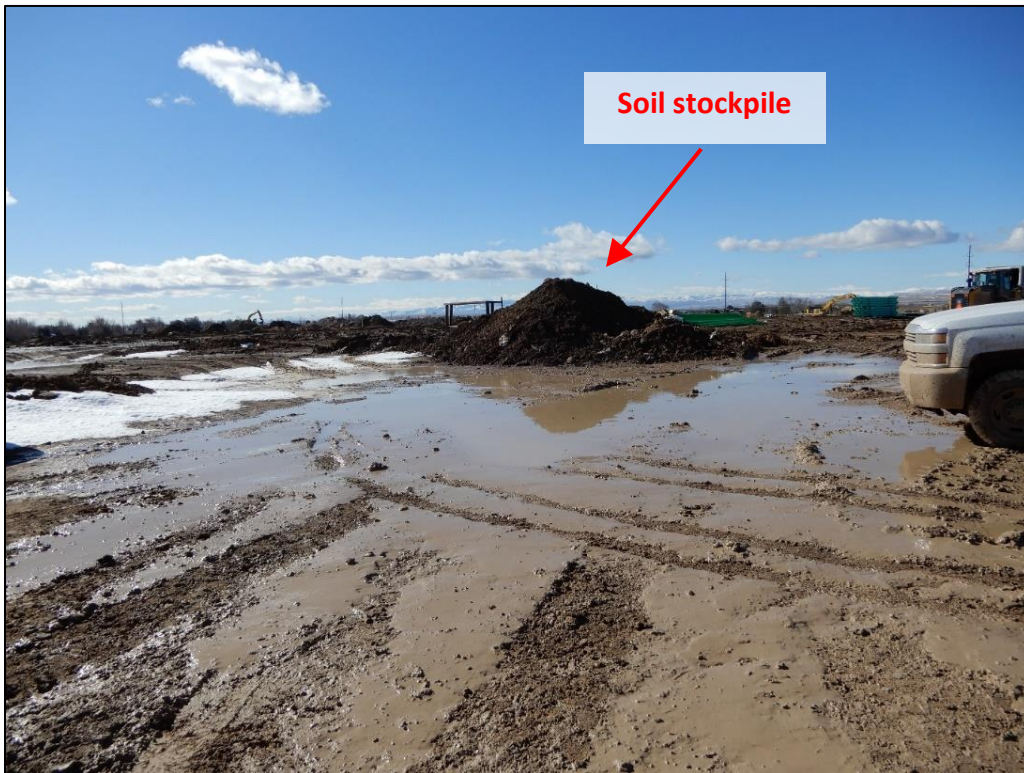
We observed that the SWPPP map presented onsite did not identify a soil stockpile located at the center of the Site in Phase 1. The SWPPP map designated a stockpile area, however, the stockpile was not located in that area (refer to Attachment A, Photograph 2, and Attachment B, Exhibit 2).

We observed one unstabilized soil stockpile at the center of the Site in Phase 1. Downgradient of the stockpile, we observed a vegetated buffer along the Site's western perimeter; however, no other source control BMPs had been implemented for the stockpile (refer to Attachment A, Photographs 2 and 3).

**Photograph 2.** View, facing south, of an unstabilized stockpile of soil located at the center of the Site.

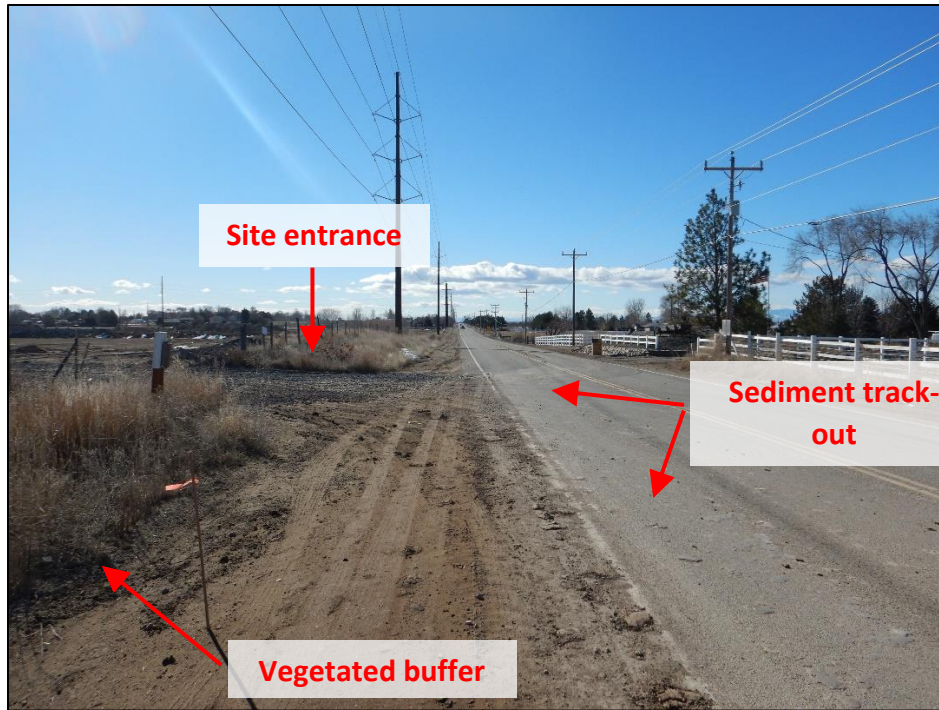
Additionally, we observed a perimeter control of a vegetated buffer along the western perimeter of the Site that was not labeled on the SWPPP map as required by part 7.2.4.i of the Permit (refer to Attachment A, Photograph 3).

We observed sediment track-out onto South Cloverdale Road from the unstabilized construction entrance along the western perimeter of the Site in Phase 1 (refer to Attachment A, Photograph 3). The construction vehicle track-out controls appeared to be inadequate at removing sediment from vehicles prior to vehicle exit.

**Photograph 3.** View, facing south, of sediment track out onto South Cloverdale Road from the Site entrance located at the west-central perimeter of the Site. Note the vegetated buffer.

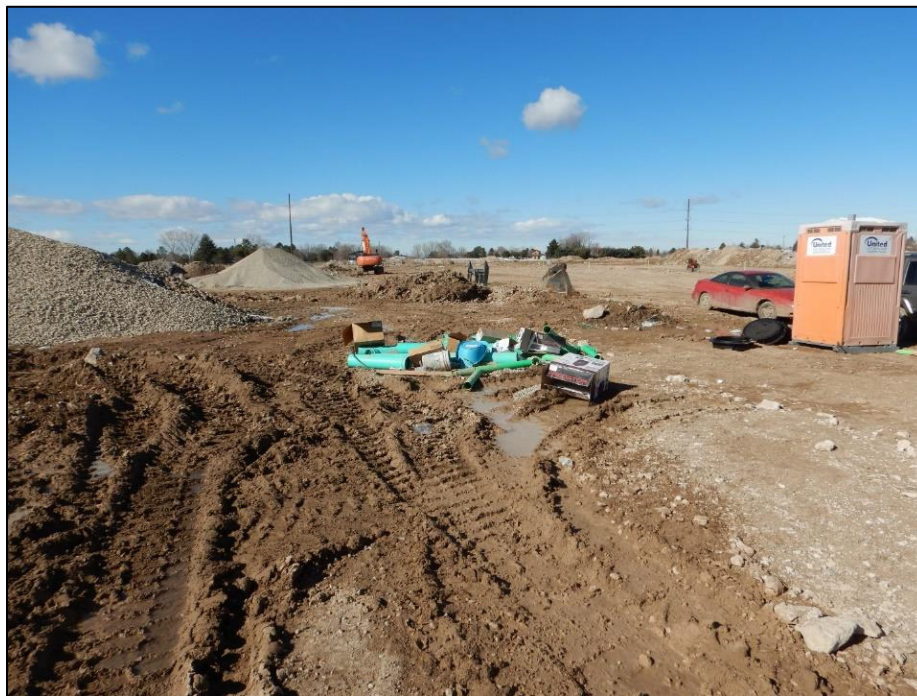
We observed a pile of uncontained construction waste and debris on the ground at the center of the Site in Phase 1 (refer to Attachment A, Photograph 4).

**Photograph 4.** View, facing south, of a pile of uncontained construction waste located at the center of the Site.

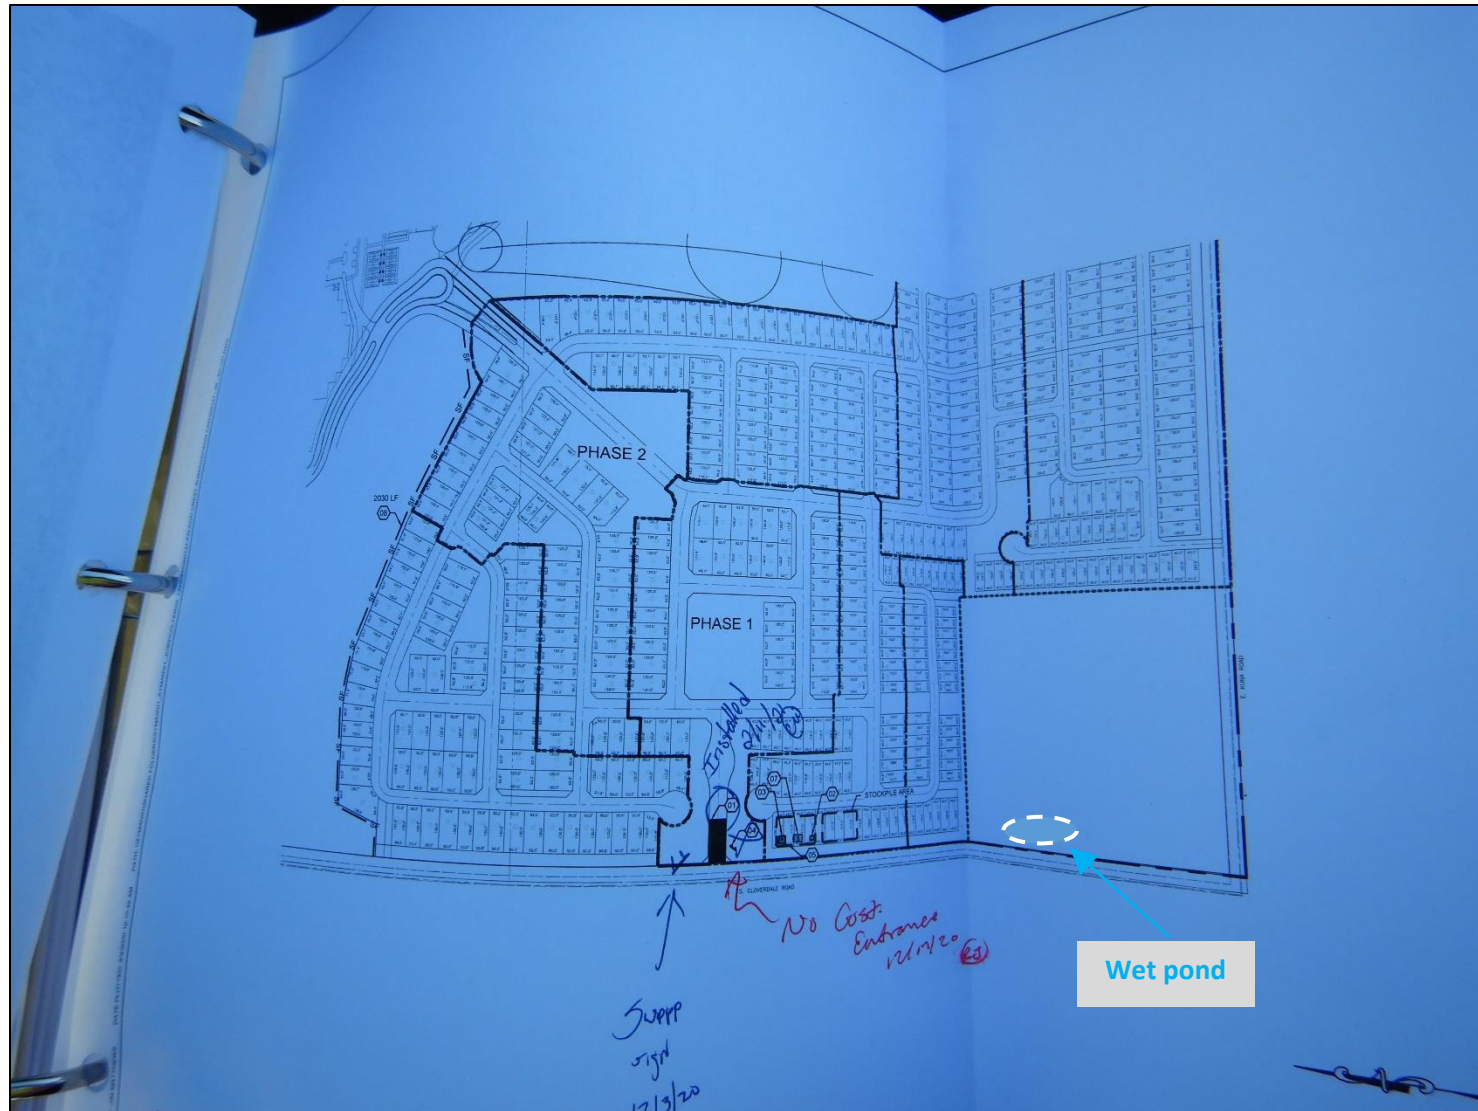
We also observed that the SWPPP map did not contain drainage patterns of stormwater and authorized non-stormwater before and after major grading activities as required by part 7.2.4.f of the Permit.

**Exhibit 2.** Image of the Site map provided on Site of the Falcon Crest Subdivision. It was noted the Site map does not include all the locations where stockpiles, drainage patterns, or perimeter controls were located. Note the wet pond.
