**SUBJECT:** CLEAN AIR ACT INSPECTION REPORT  
Waste Connections – Front Range Landfill, Erie, CO

**Facility Name:** Front Range Landfill

**Date of Inspection:** October 18, 2023

**Purpose of Inspection:** To determine Clean Air Act (CAA) compliance and perform a comparative Surface Emissions Monitoring (SEM) survey

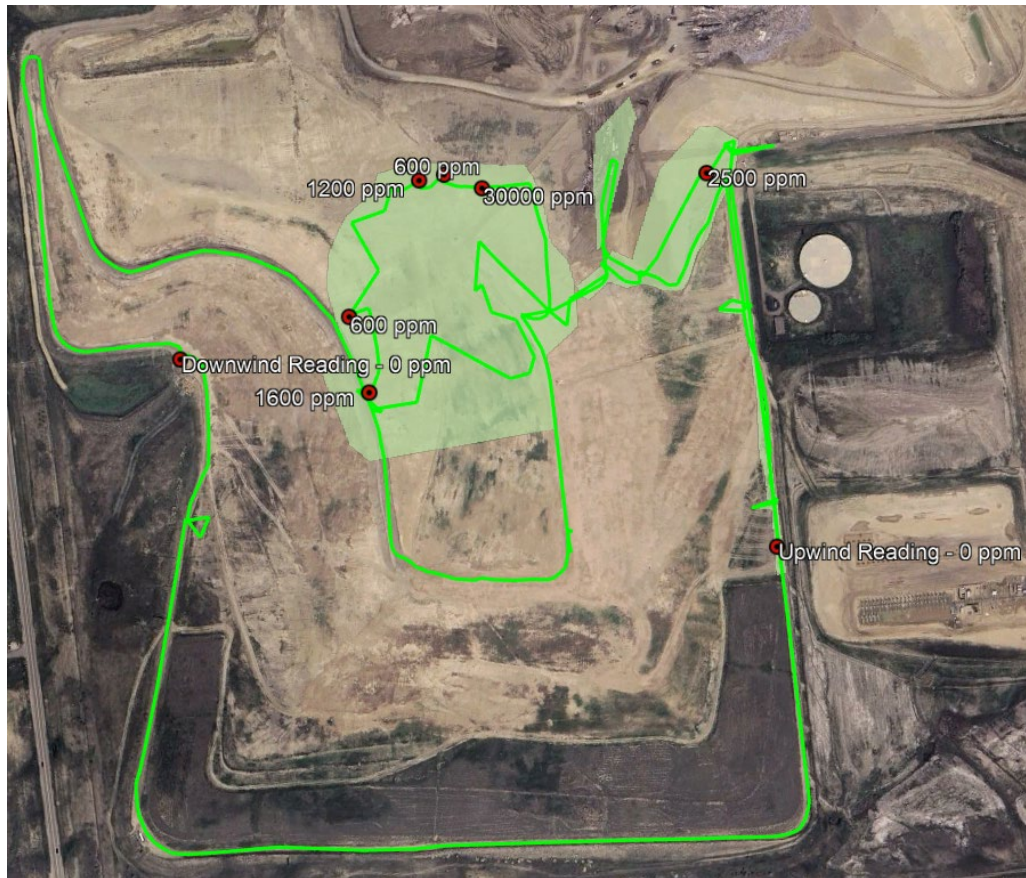
SEM hit locations plotted over satellite imagery from September 4, 2023 as depicted on Google Earth. Approximate monitoring path and monitored areas included (green line and green highlight), derived from GPS data.

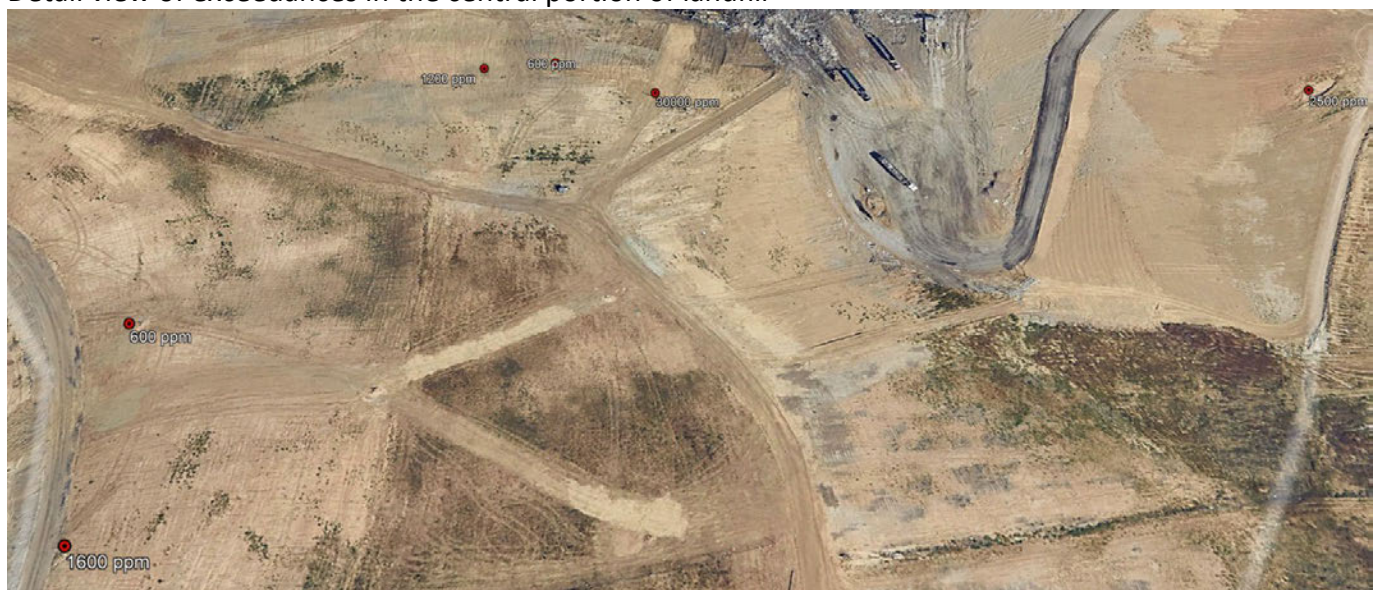
Detail view of exceedances in the central portion of landfill

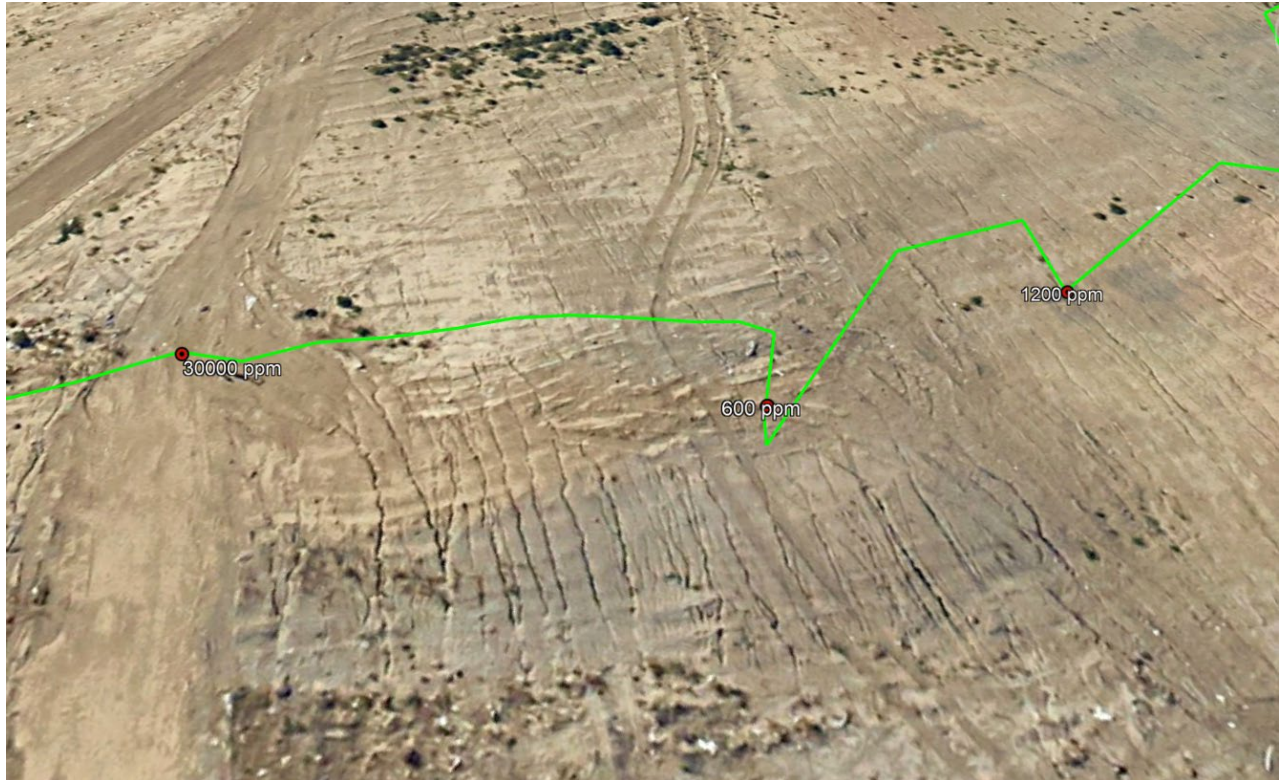
On the landfill slope where exceedances #3 - #5 were recorded, EPA observed a large continuous area with little to no vegetation and some erosion rills. These conditions were also noted near exceedances #6 and #7. Aside from these locations, the landfill cover was generally in good condition, with minimal erosion and well-established vegetation.

Google Earth satellite imagery from September 4, 2023, demonstrating extensive erosion rills and sparse vegetation on the central slope of the landfill near exceedances #3 – #5

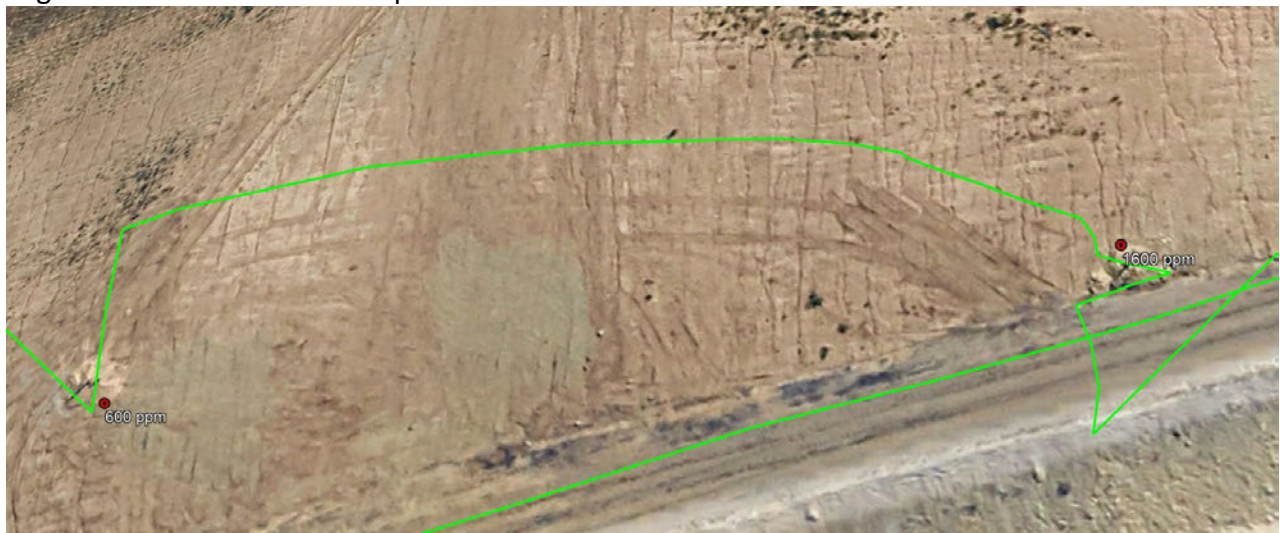
Google Earth satellite imagery from September 4, 2023, demonstrating erosion rills and sparse vegetation on the western slope of the landfill near exceedances #6 and #7.
