**Region 6 - Enforcement & Compliance Assurance Division**  
**INSPECTION REPORT**

| Inspection Date(s): | 1/25/2024 | |
| Company Name: | <b>CapturePoint, LLC</b> | |
| Facility Name: | <b>North Burbank Unit (NBU) 24 Battery</b> | |

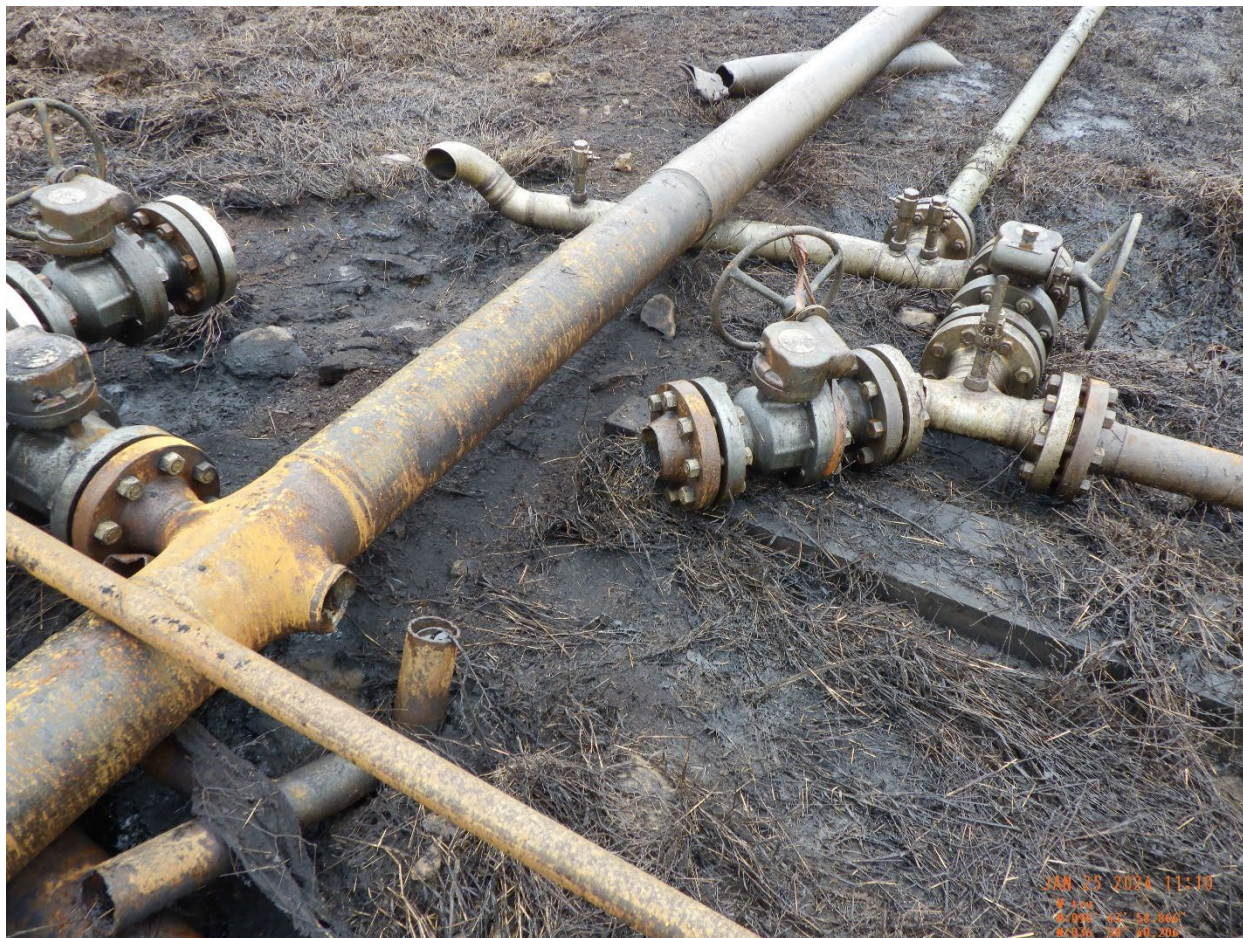
Photo No. 1

I observed the release point of the spill (36.844502, -96.733018). Oil and produced water-stained soil and vegetation were observed in the area immediately surrounding the release point. The ruptured steel flowlines were present and not yet repaired at the time of the inspection. The damaged flowlines were isolated and taken out of service at the time of the inspection. See photo No. 1, Appendix 1 (photo log). For additional GPS location information and photo metadata, see the attached photo log.

**Description:** This was the release point. Extreme freezing temperatures, below zero, caused the injection lines to freeze and rupture.

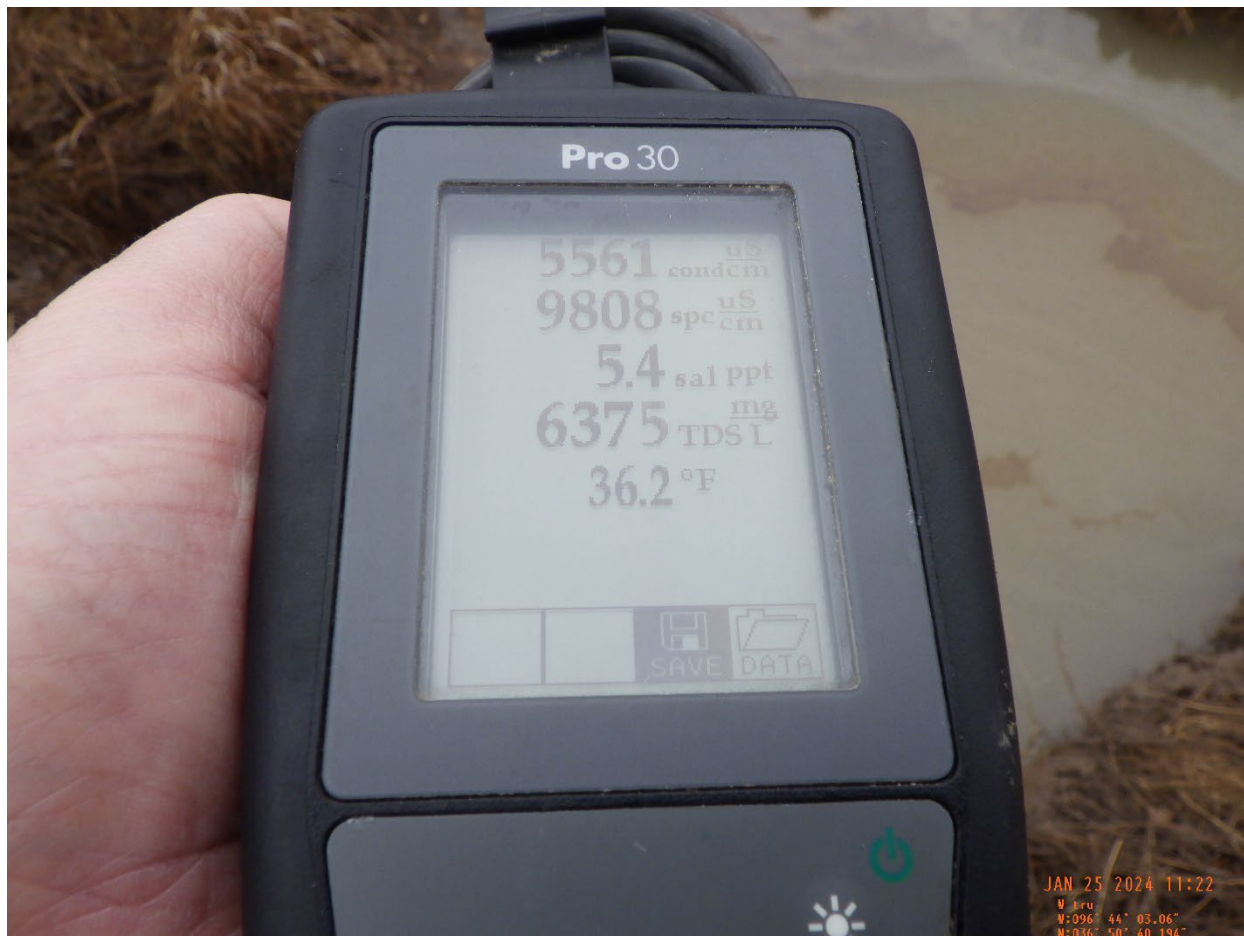
Photo No. 2

I observed the point of entry (POE) (36.844452, -96.734203) into an unnamed tributary of Haines Creek approximately 300 feet west from the release point. At this same location I observed an elevated total dissolved solids (TDS) field reading of 6375 mg/L. This reading was the highest observed throughout the inspection. I also observed crude oil floating on the water in the main channel of the impacted tributary. See photos No. 2 and 3 in the photo log.

**Description:** This was an elevated total dissolved solids (TDS) field reading of 6375 mg/L taken at the point of entry (POE) into the impacted unnamed tributary.

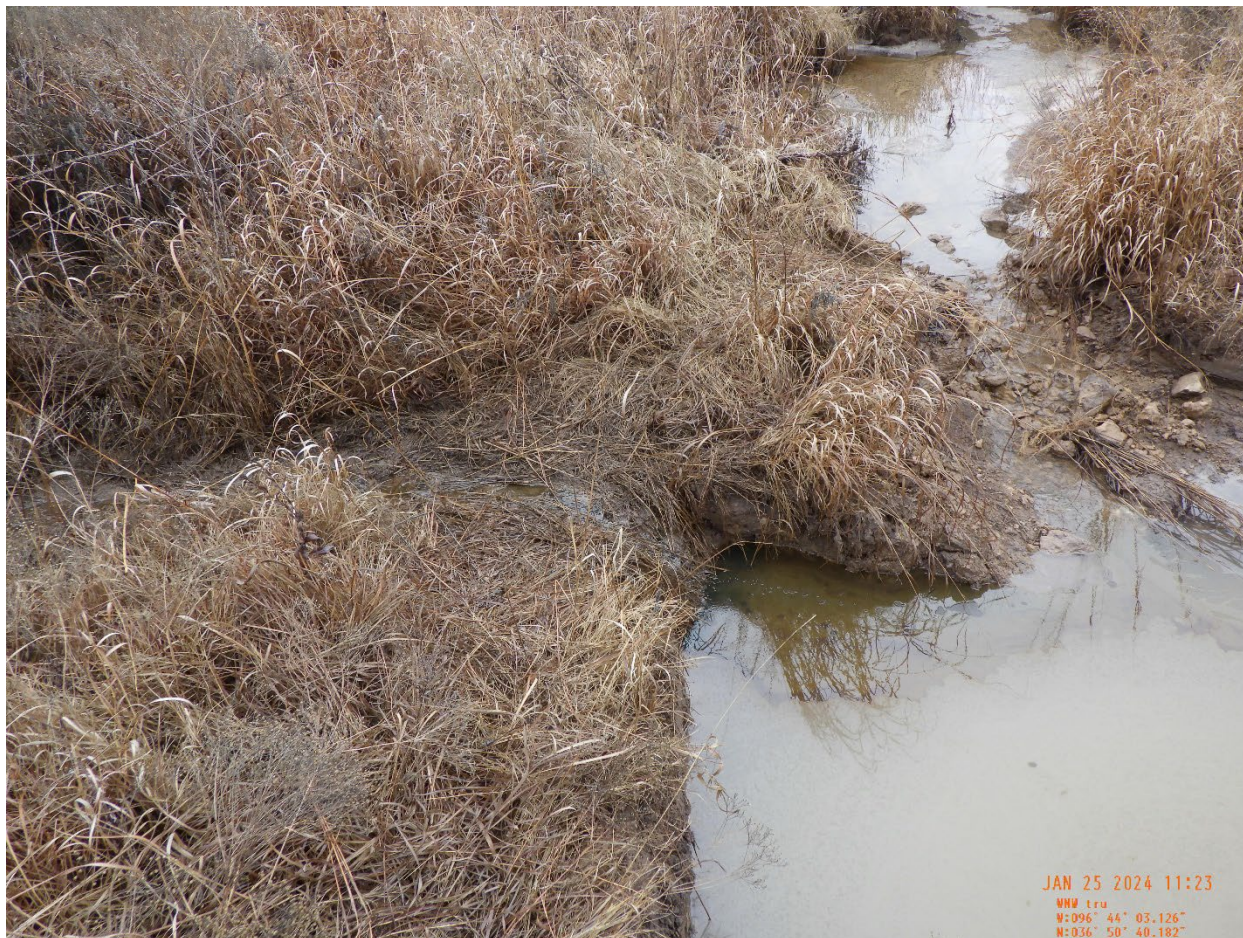
Photo No. 3

**Description:** This was the POE into the unnamed tributary. This is the same location where the TDS field reading from photo No. 2 was observed.

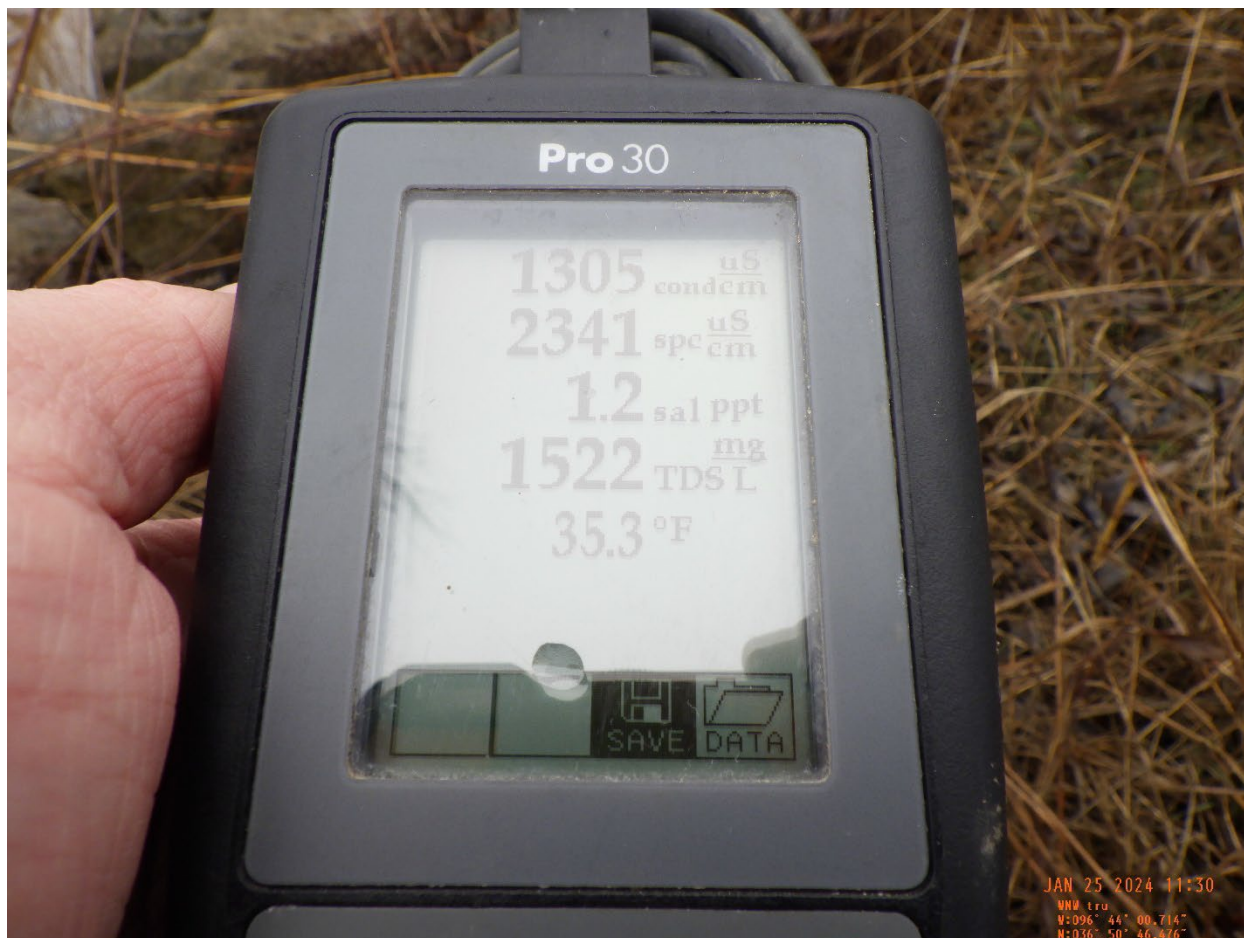
Photo No. 4

Continuing downstream, I observed a TDS field reading of 1522 mg/L immediately upstream from a temporary containment dam which had been created by the operator to prevent further downstream migration of elevated TDS waters. See photos No. 4 and 5.

**Description:** This was an elevated TDS field reading of 1522 mg/L taken downstream from the POE, on the upstream side of a temporary containment dam.

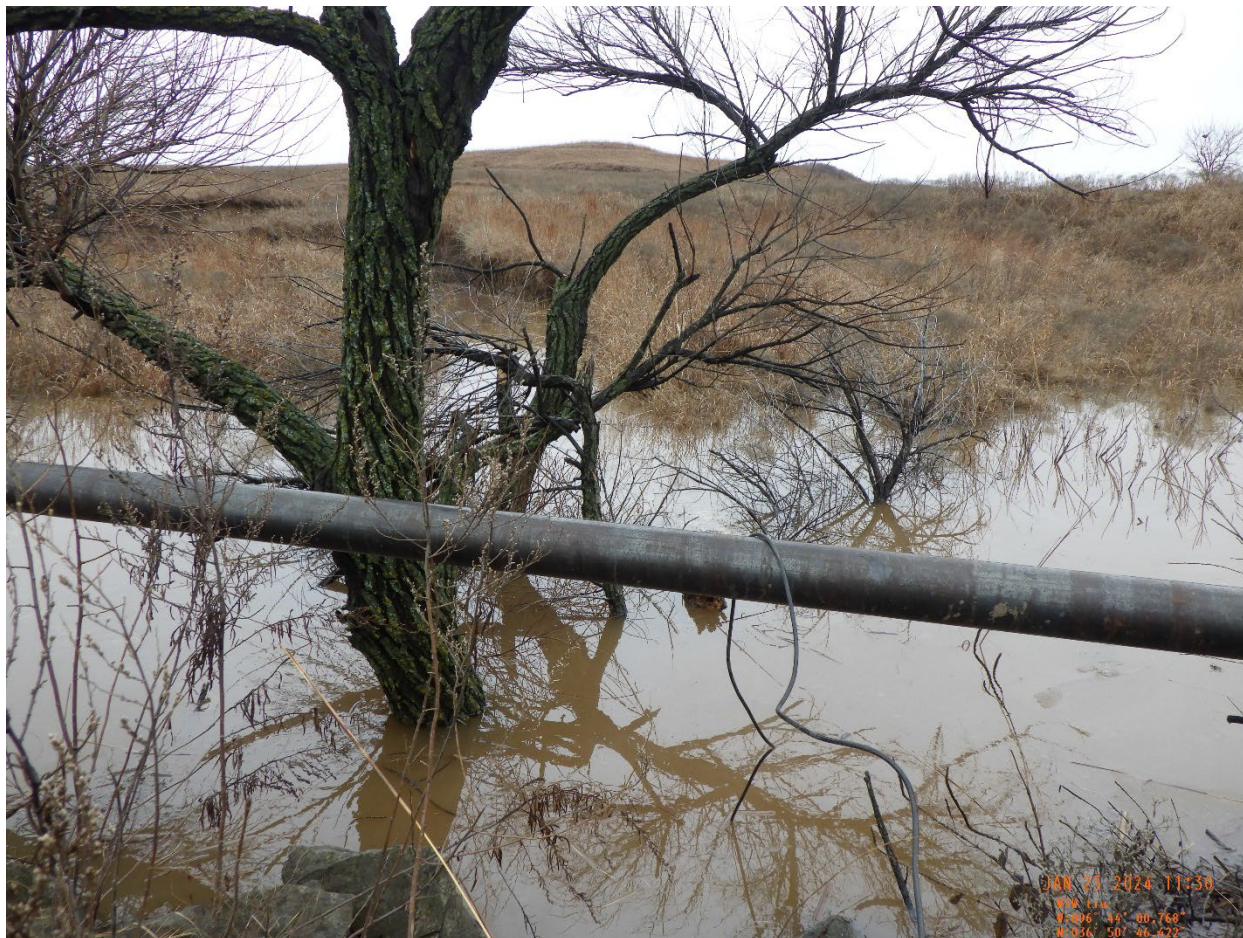
Photo No. 5

**Description:** This was the pool of water where the TDS field reading from photo. No 4 was observed.

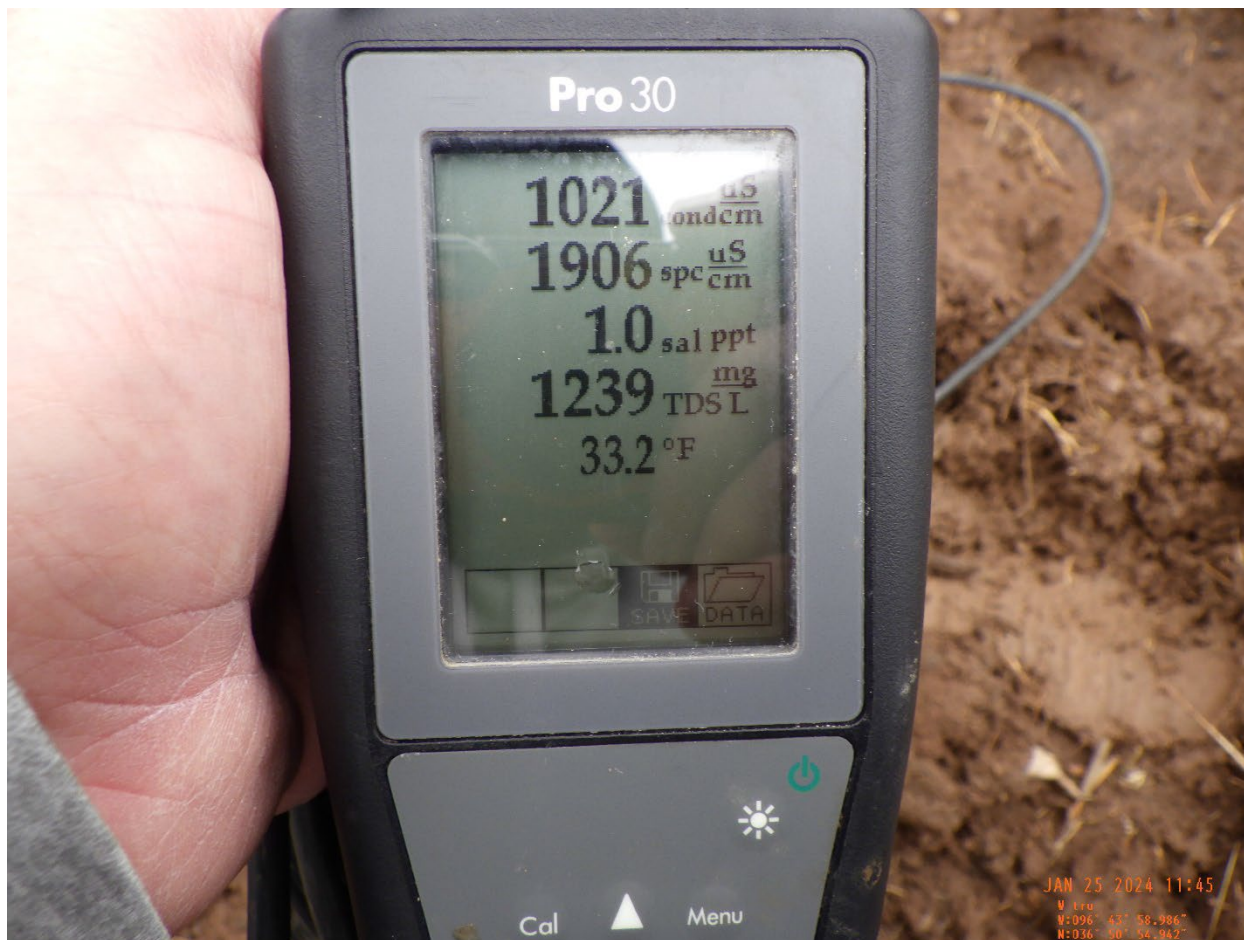
Photo No. 6

I observed the confluence of the impacted unnamed tributary with another unnamed tributary of Haines Creek. At this same location I observed an elevated TDS field reading of 1239 mg/L in the main channel of the impacted tributary, see photo No. 6. I also documented the bed and bank features of the

**Description:** This was an elevated TDS field reading of 1239 mg/L observed where the impacted unnamed tributary entered another unnamed tributary. This point was upstream from where the combined unnamed tributaries flowed into Haines Creek.

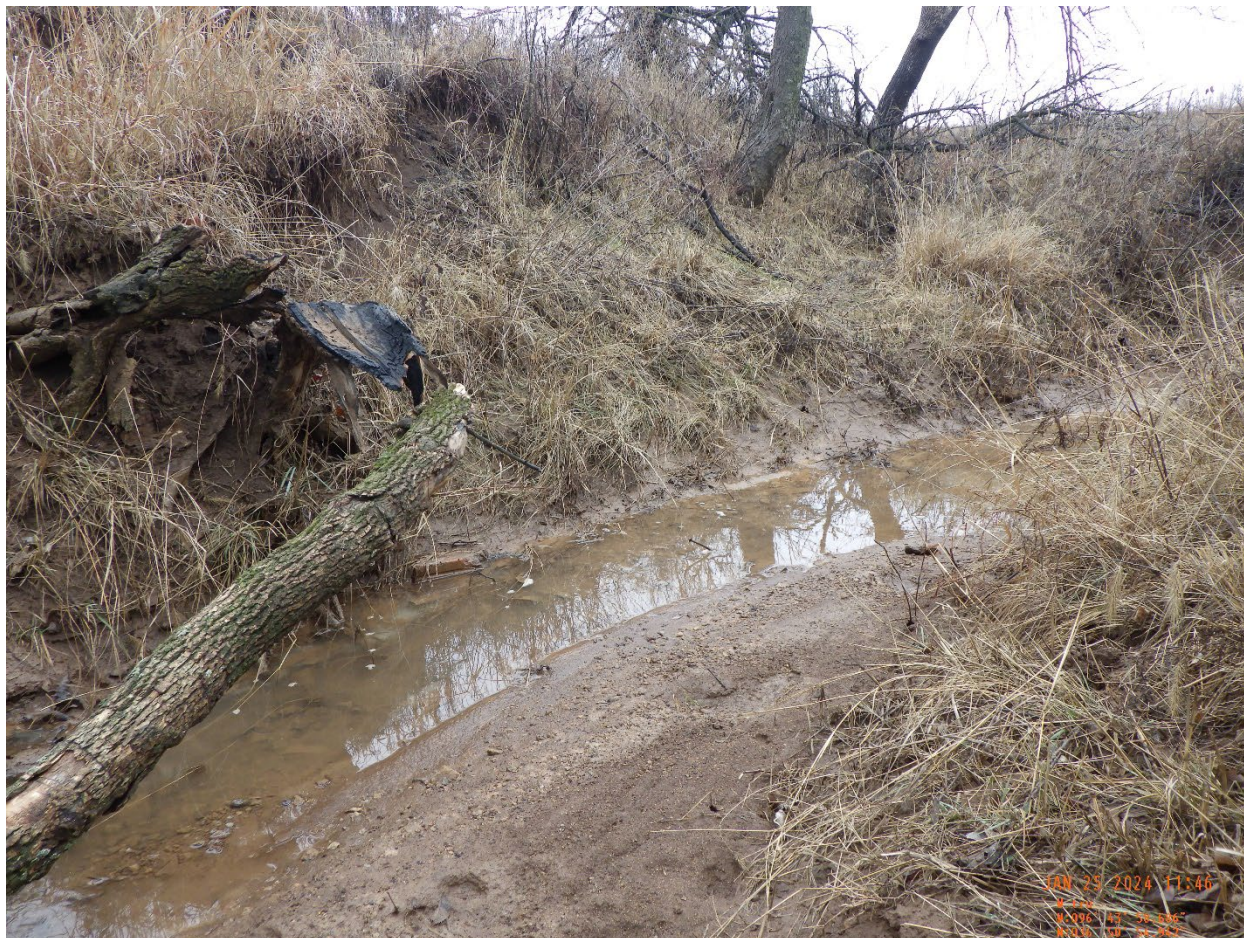
Photo No. 7

impacted tributary which can be seen in photo No. 7. At this same location, immediately downstream from the confluence of the two unnamed tributaries, I observed a TDS field reading of 379.8 mg/L. At this point, the combined tributaries had increased the in-stream flow and dilution was impacting the ability to observe elevated TDS spill impacts.

**Description:** This was a photo taken along the impacted tributary showing the bed and bank features of the tributary immediately upstream of its confluence with another unnamed tributary. This was the same location where the TDS field reading from photo No. 6 was observed.

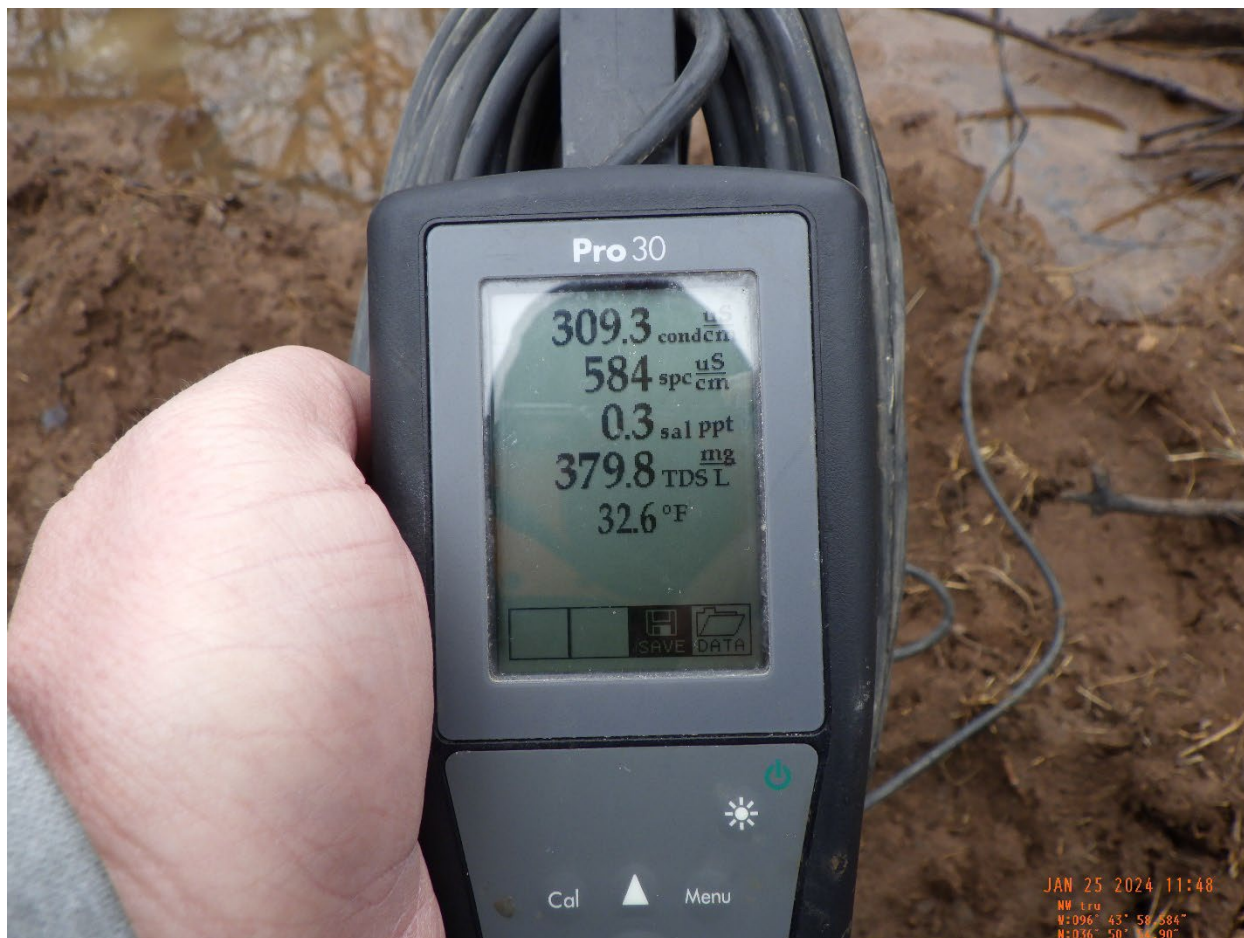
Photo No. 8

**Description:** This was a TDS field reading of 379.8 mg/L taken downstream from the confluence of the two unnamed tributaries. In-stream flow substantially increased downstream from the confluence of the two unnamed tributaries and TDS levels no longer showed significant impact.

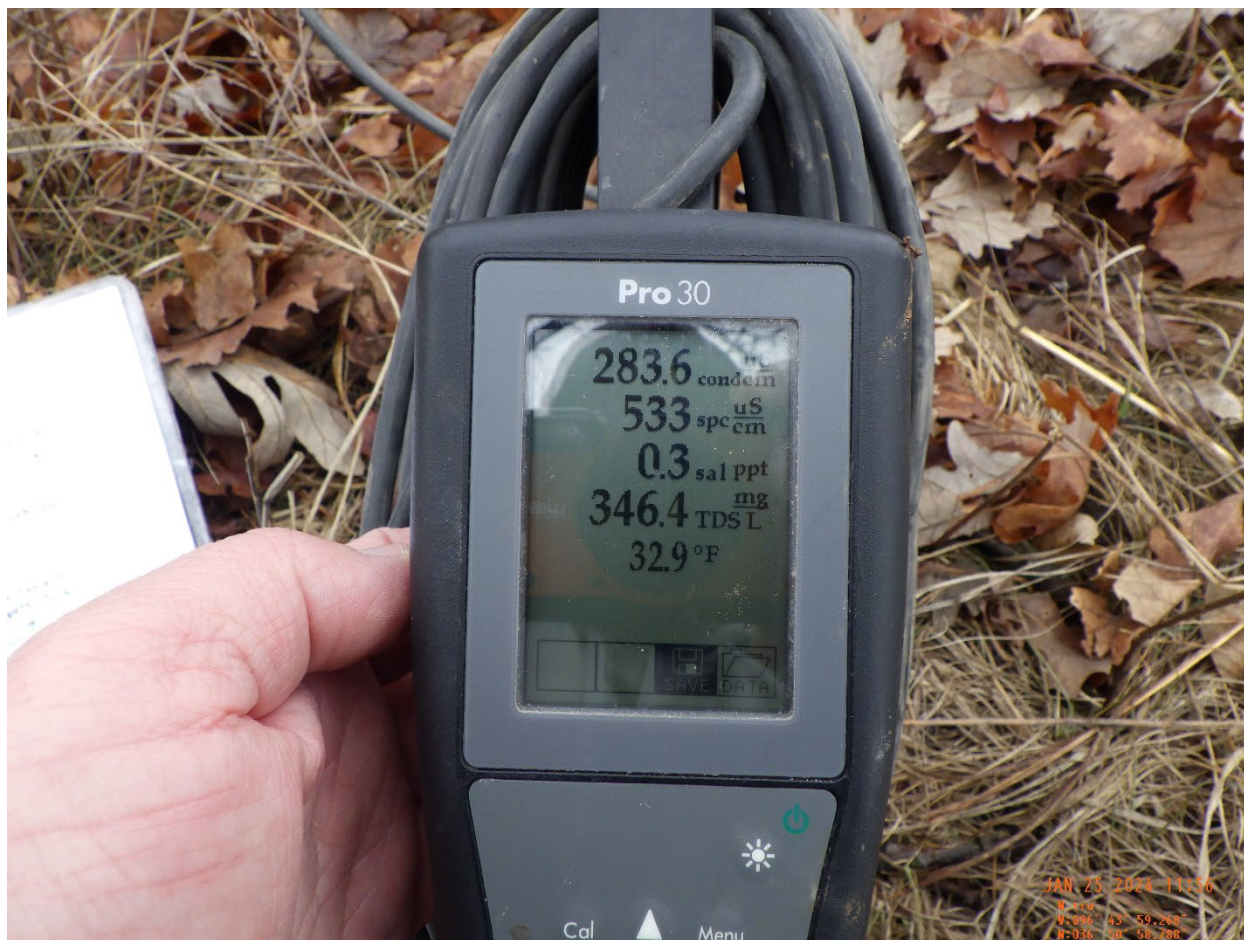
Photo No. 9

At Haines Creek, I observed identical TDS field readings of 346.4 mg/L on the upstream and downstream sides of where the impacted tributary entered the main channel of Haines Creek. The upstream TDS field reading of 346.4 mg/L taken in the main channel of Haines Creek should be used to help establish background TDS levels in the area.

**Description:** This was a TDS field reading of 346.4 mg/L observed in the main channel of Haines Creek. The TDS level observed was the same upstream and downstream in the main channel of Haines Creek at the point where the unnamed tributary entered Haines Creek.
