**CLEAN WATER ACT COMPLIANCE EVALUATION INSPECTION REPORT  
U.S. ENVIRONMENTAL PROTECTION AGENCY  
REGION 5**

**Facility:** City of White Hall Sewage Treatment Plant (STP)  
901 NE 200 Avenue  
White Hall, Illinois 62092

**Date of Inspection:** November 28, 2023

**White Hall STP**  
**Photo Log**  
**EPA Inspection November 28, 2023**  
**All photos taken by Ray Cullen, Environmental Engineer, EPA**

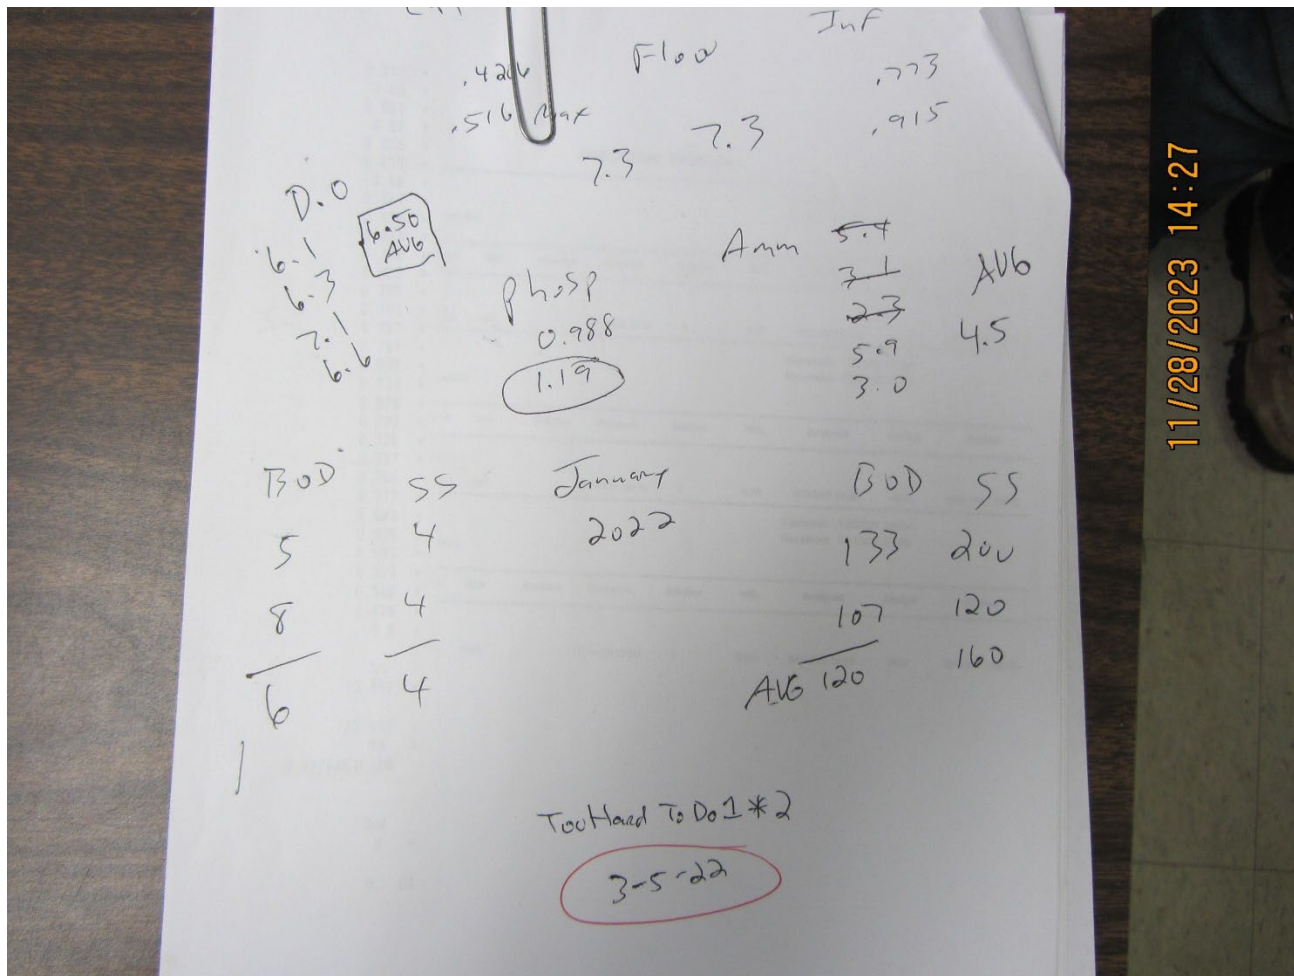
The City keeps the chain of custody forms and the monitoring records in an office on-site. The chain of custodies, which Pace emails to Mr. McCarthy, appeared to be complete and properly filled in. However, the monitoring records Mr. McCarthy showed me did not include who did the sampling and analyses, the date and time that the samples were collected and analyzed, or other required information (Photo 1). The records just showed what are assumed to be the

10. The monitoring records lack all required data, including the name of the person(s) doing the sampling and the analyses and the date/time the samples were collected and the date/time analyzed.

1: IMG\_0399  
 Description: Monitoring record for January 2022  
 Location: Office building  
 Camera Direction: N/A  
 Date/Time: 11/28/23, 2:27 p.m.

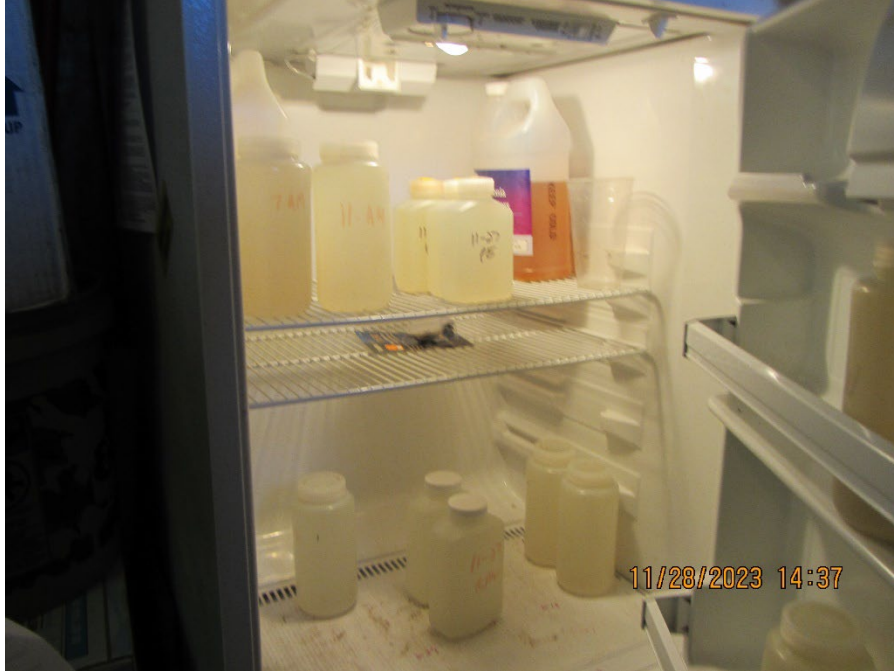
2: IMG\_0400

Description: Fridge with wastewater samples

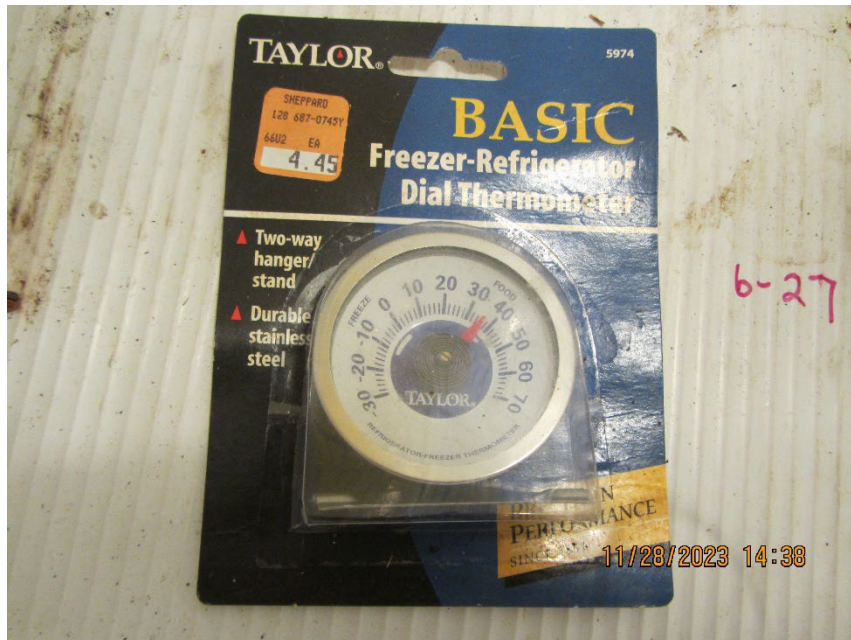
3: IMG\_0401

Description: Thermometer displaying 36°F (2.2°C) temperature inside fridge shown in Photo 2

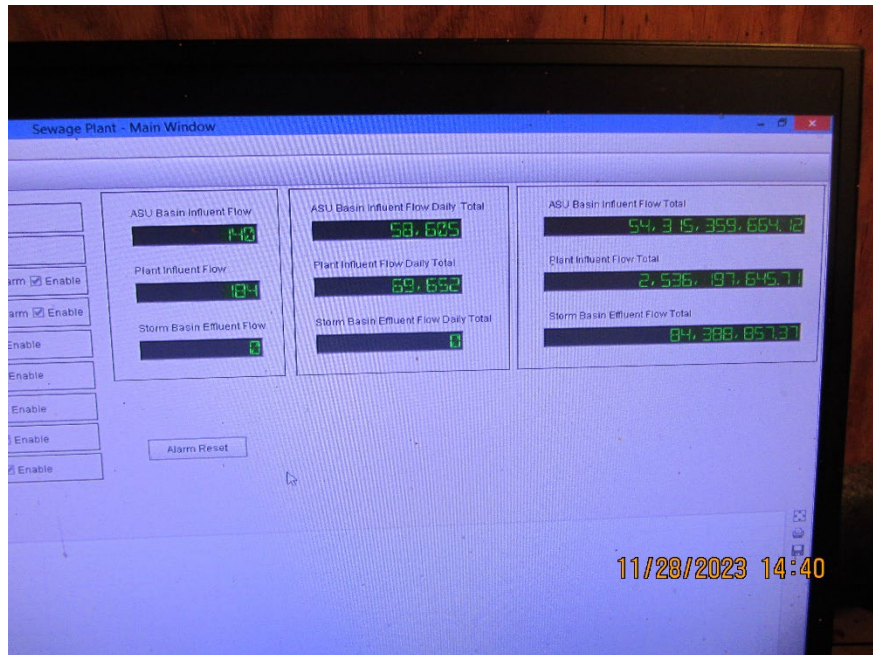
4: IMG\_0402

Description: Monitor showing ASU influent, STP influent, and storm basin effluent flowrates

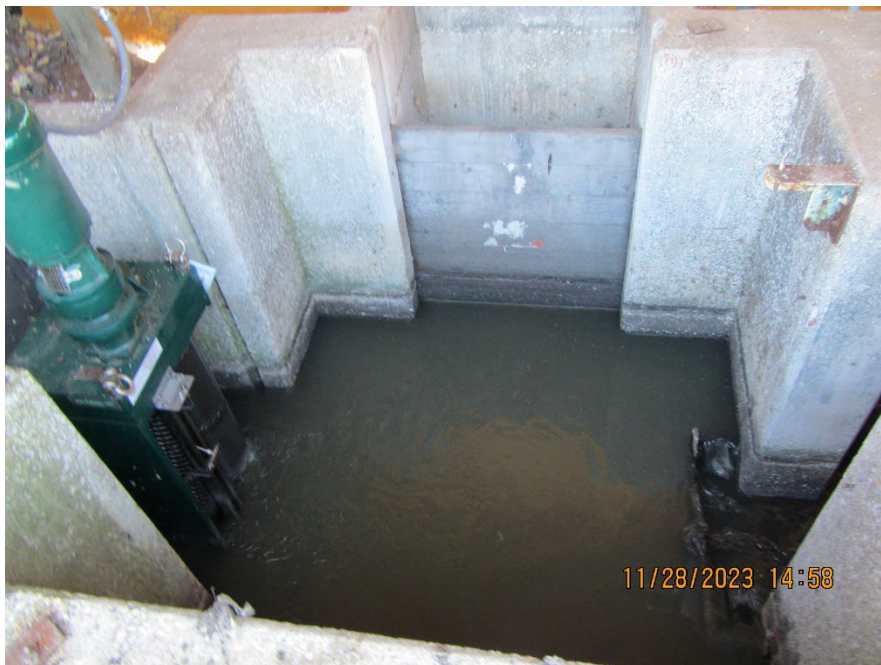
5: IMG\_0403

We toured the facility starting a little before 3 p.m. at the influent sampling location, where we saw the newly-installed grinder (Photo 5) and influent flow sensor and weir (Photo 6). We then saw the primary clarifier located immediately south of the influent well (Photos 7 and 8). The surface water in the clarifier was frothy and full of scum, and the weirs were extremely dirty and coated with grime. We did not see a skimmer in operation. On the southwest side of the clarifier is a well where the sludge pump usually sits (Photo 9). At the time of the inspection, the pump had been removed for the past 3 weeks, during which time sludge could not be wasted. When the pump is in operation, the City wastes daily or weekly depending on the sludge coming in.

Description: Influent sampling location with grinder on the left

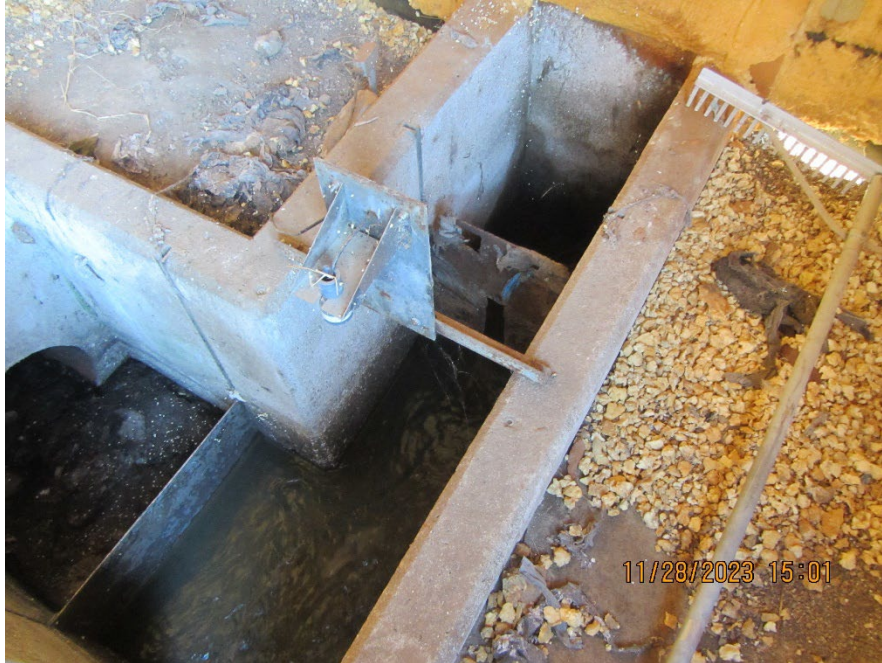
6: IMG\_0404

Description: Ultrasonic influent flow sensor and weir

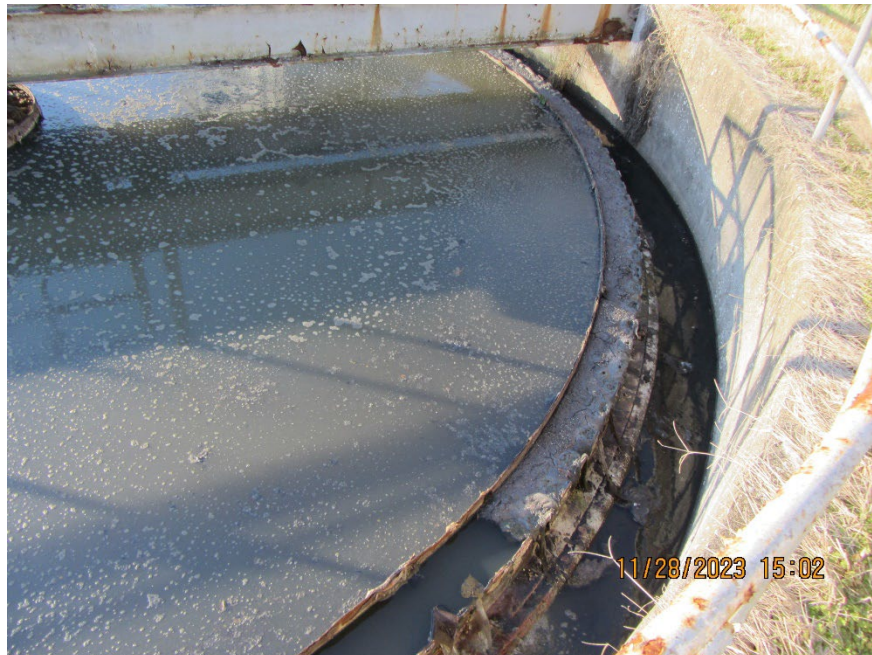
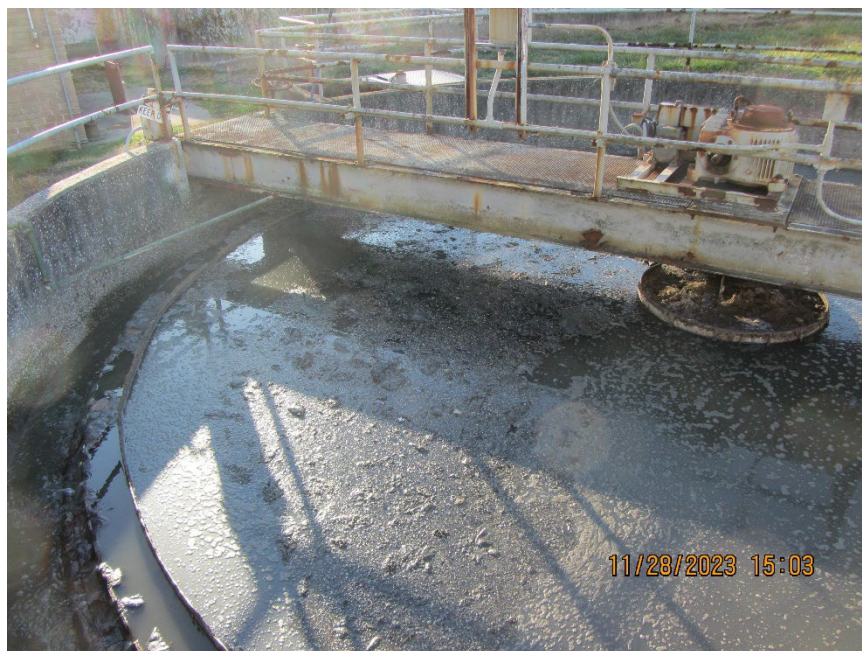
3. The primary clarifier was full of scum, its weirs were coated with grime, and it did not have a skimmer to remove floating solids.
4. The receiving water around Outfall 001 appeared to contain sludge and other solids or pollutants from the STP.

Description: Primary clarifier

Description: Primary clarifier  
 Location: South of influent well  
 Camera Direction: West  
 Date/Time: 11/28/23, 3:03 p.m.

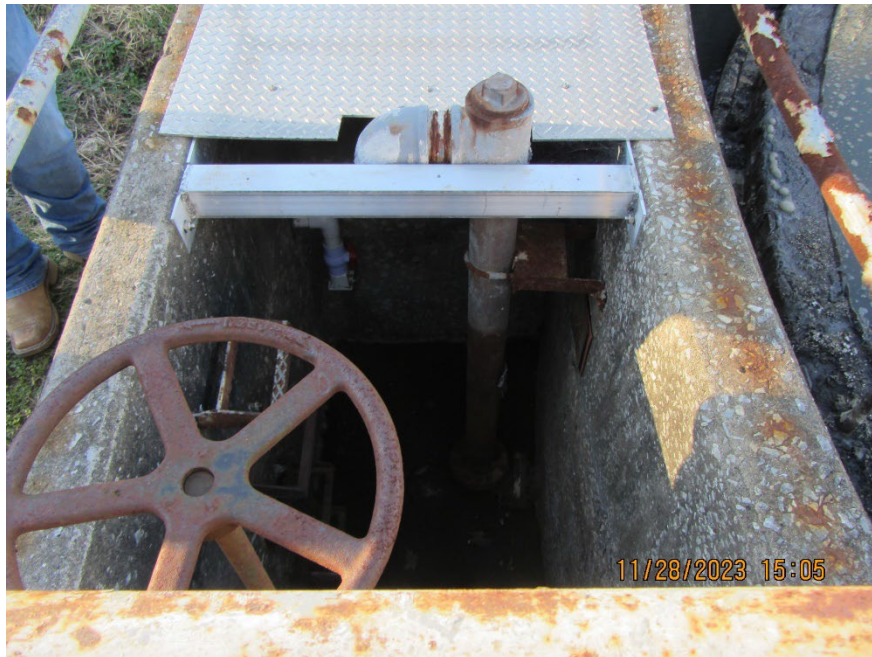
Description: Location where primary sludge pump usually is, currently removed  
 Location: Southwest side of primary clarifier  
 Camera Direction: Northwest  
 Date/Time: 11/28/23, 3:05 p.m.

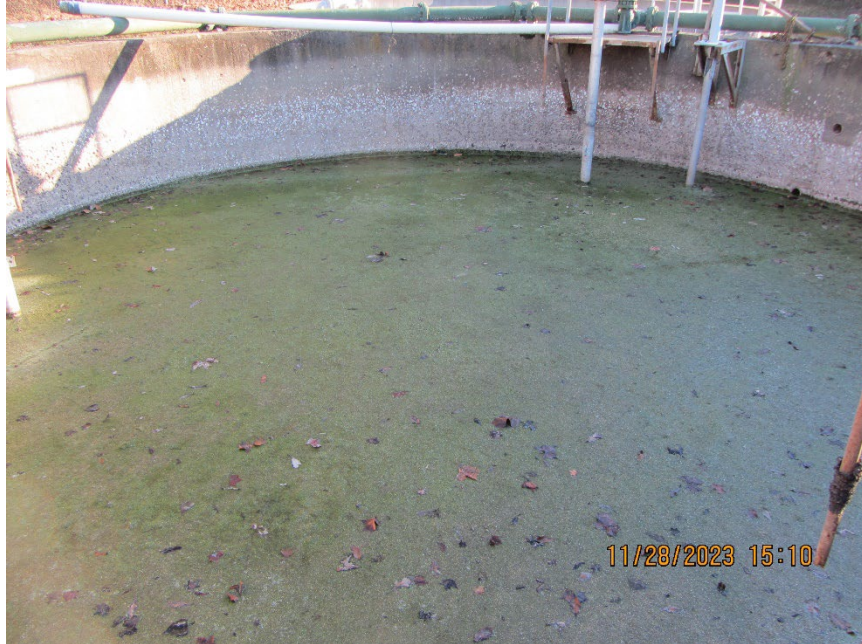
10: IMG\_0408

We then walked to the digesters, starting with the north one, which Mr. McCarthy believed to be 16 feet deep (Photo 10). The level in this tank can only drop three to four feet when decanting. There are holes in the sides of the tank that the City previously used for decanting but are now plugged and unusable. Then, the water level in the south digester, which was also believed to be 16 feet deep, appeared abnormally low due to a broken valve that would cause the water to leak back into the wet well when it reaches a certain height (Photo 11). We saw a strong flow of wastewater from the primary clarifier wet well to the ASU (Photo 12).

Description: North digester

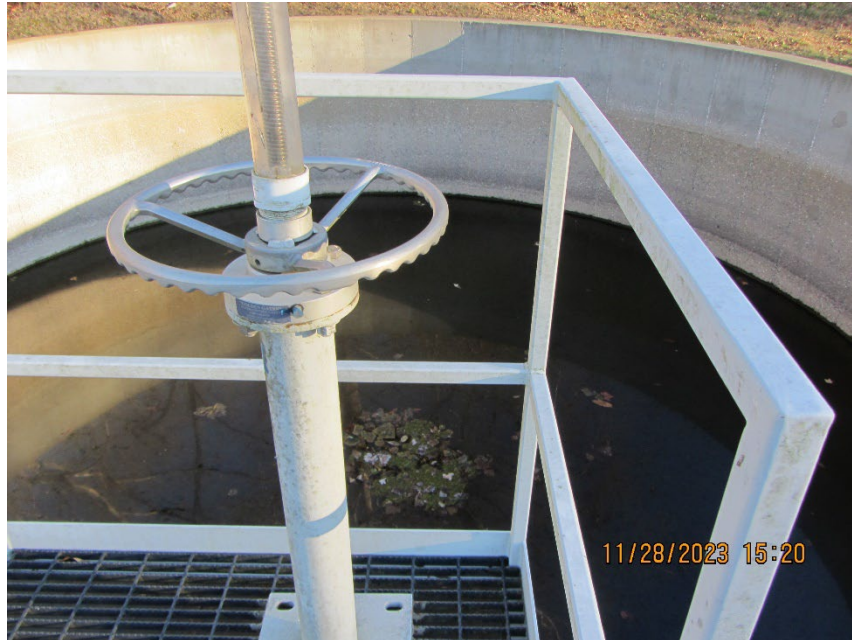
11: IMG\_0409

Description: South digester

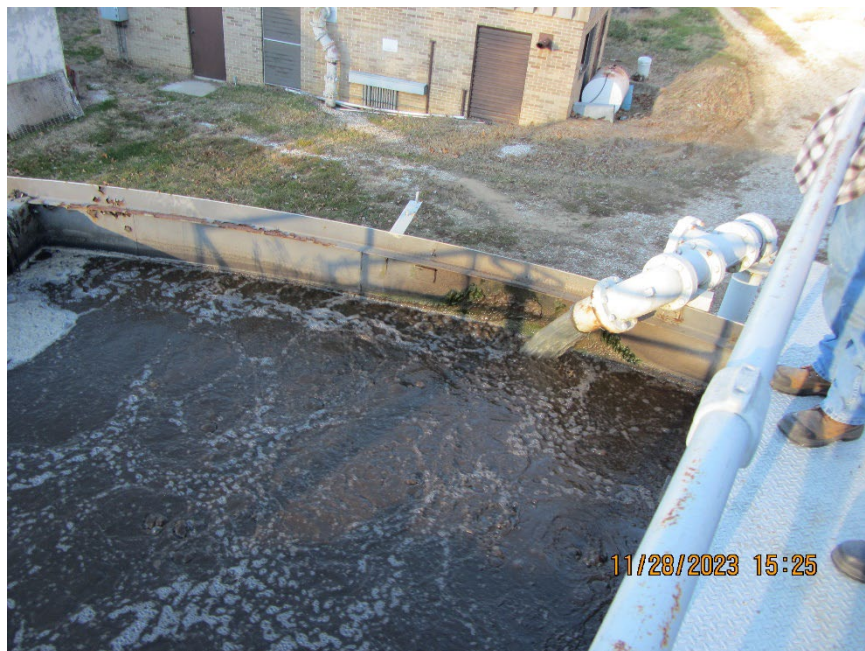
12: IMG\_0410

Description: Pipe with flow from the primary clarifier wet well into the ASU

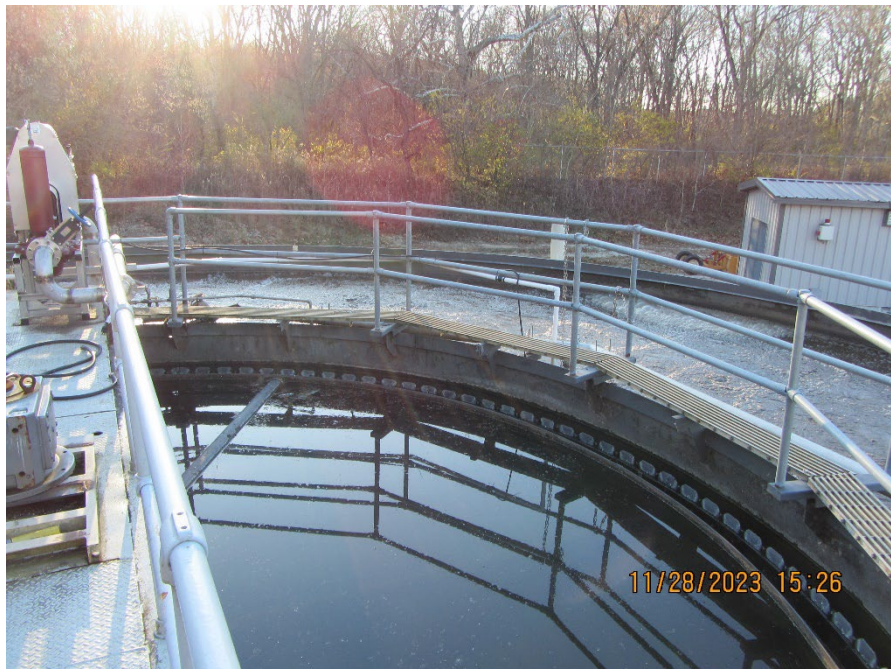
13: IMG\_0411

Description: Secondary clarifier in foreground, reactivation basin in background

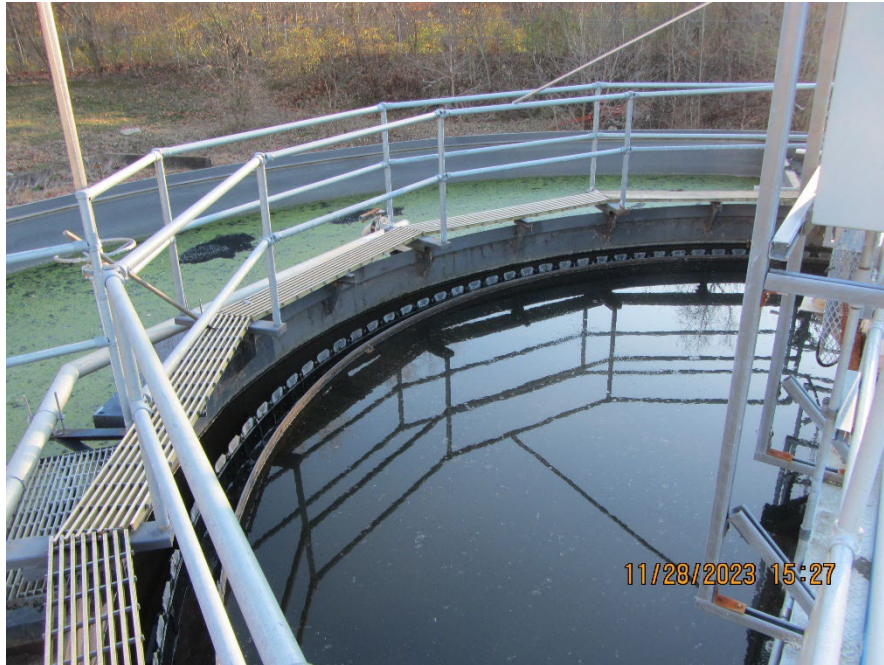
14: IMG\_0412

Description: Secondary clarifier in foreground, digester in background

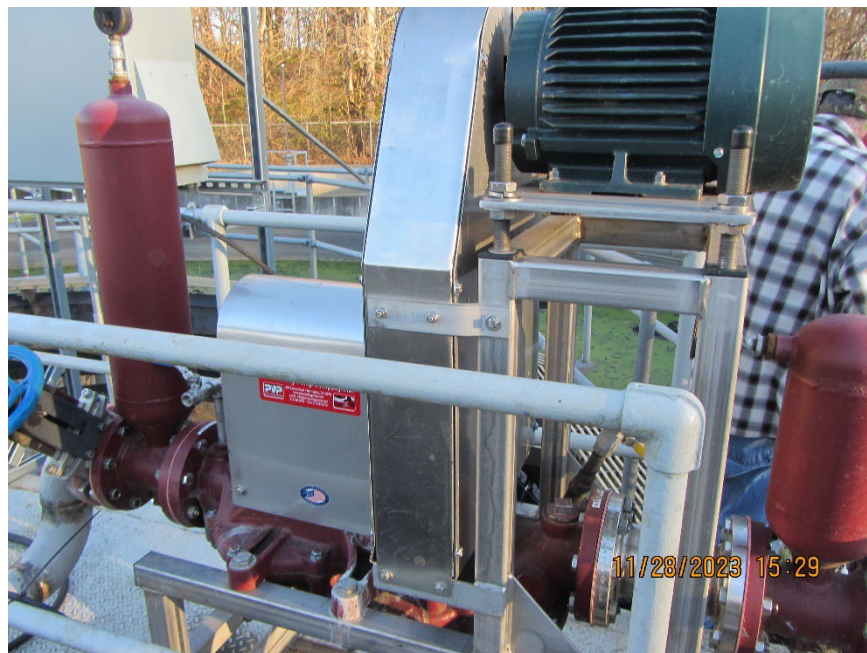
15: IMG\_0413

Also in the ASU, we saw the secondary clarifier and reaeration basin (Photos 13, 14, and 17), along with the return sludge pump (Photo 15). The effluent flow from this pump to the reaeration basin was very low. As explained above, the operators believe this is due to debris at the bottom of the clarifier plugging the pump (Photo 16).

Description: Return sludge pump

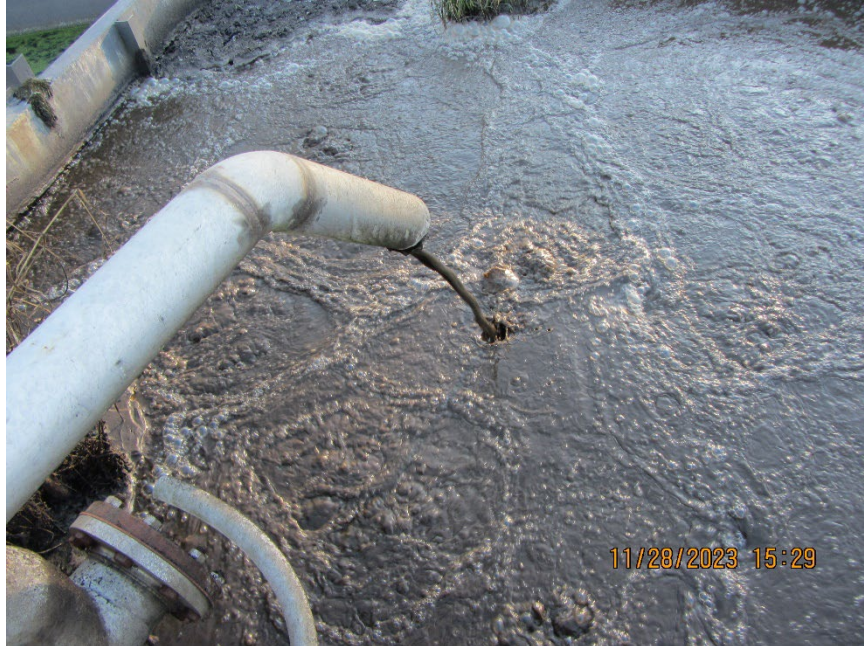
16: IMG\_0414

Description: Effluent from the return sludge pump to the reaeration basin

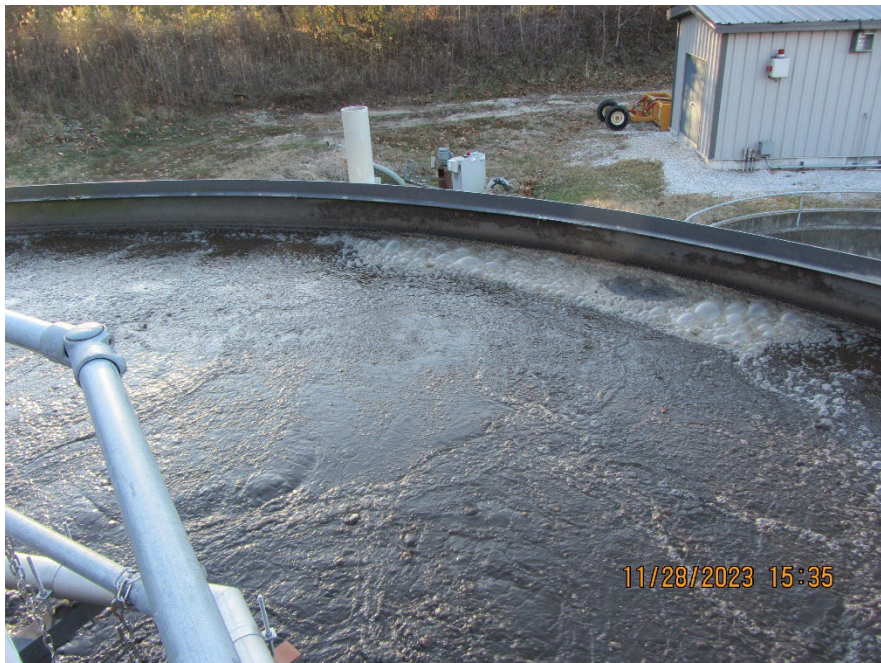
17: IMG\_0415

Description: Reaeration basin

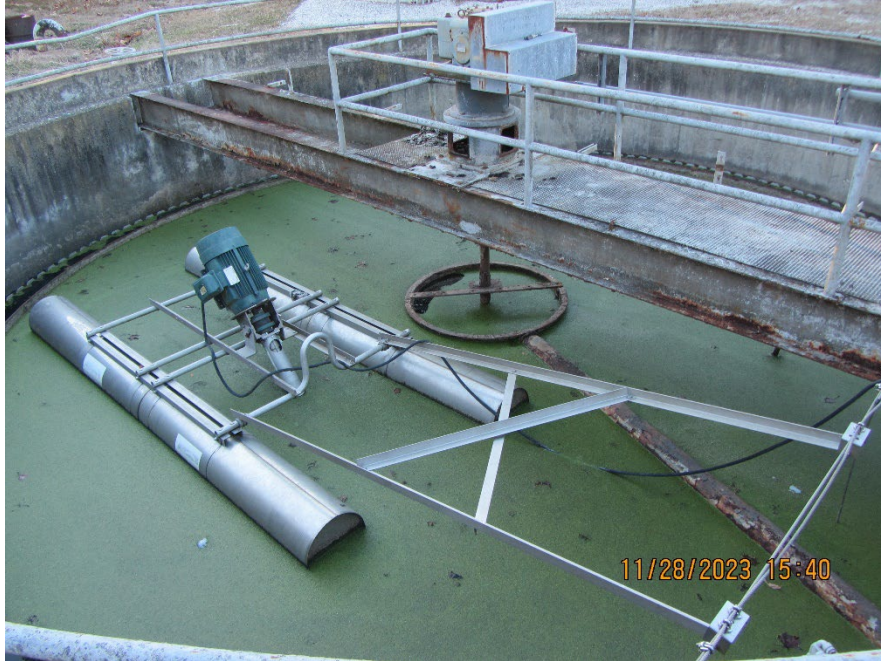
Next, we saw the final clarifier (Photos 18), and the location at the clarifier where the operators conduct effluent sampling (Photo 19), along with the DO meter (Photo 22). The water in the final clarifier was covered with a green material. We then walked to Outfall 001 at Seminary Creek, where the receiving water at the effluent pipe appeared to contain sludge and other solids from the STP (Photo 20). There is another pipe to the south of the Outfall 001 effluent pipe that the City installed after the 2015 flood, but it never hooked it up to a pump that would have removed stormwater from the site. There is a building on-site that has pumps in case of a major storm event. A pipe located to the north of the effluent pipe was used during the 1970s but is now defunct. North of this pipe is Outfall 002 (Photo 21), which is for excess flow from the stormwater tank on-site (Photo 23). Mr. McCarthy thinks this tank, which appeared to be at or very near capacity during the inspection, will soon start discharging through Outfall 002. The water in the tank, which we were told is mostly stormwater, appeared to contain algae or other substances.

5. The water in the final clarifier was covered with a green material.
6. The stormwater tank, which appeared to contain algae or other substances is nearly full. If it were to discharge (through Outfall 002) it may exceed the  $\text{BOD}_5$  and TSS limits in the Permit.

18: IMG\_0416  
 Description: Final clarifier  
 Location: Northwest of ASU  
 Camera Direction: Wes  
 Date/Time: 11/28/23, 3:40 p.m.

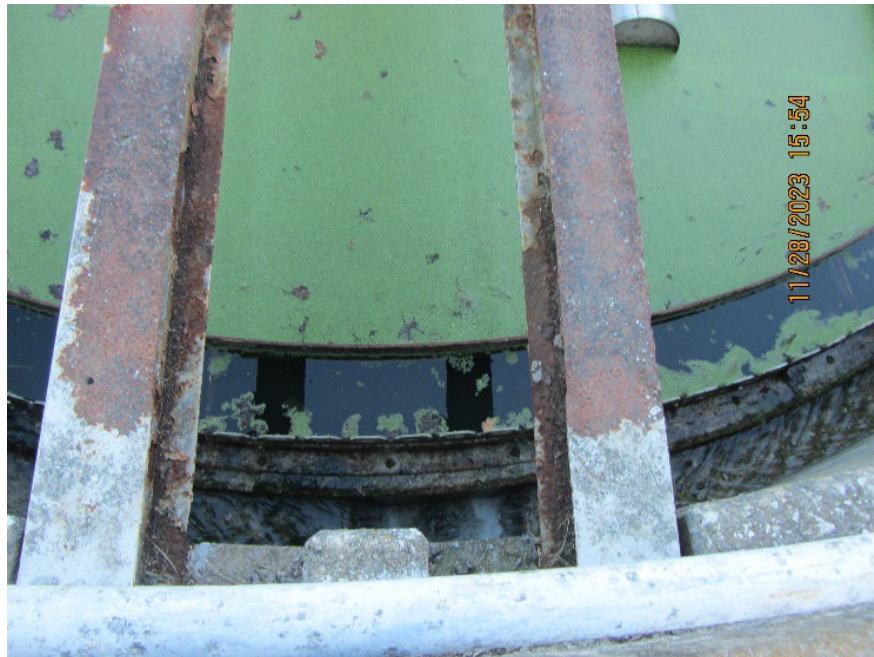
19: IMG\_0417  
 Description: Effluent sampling location  
 Location: Final clarifier  
 Camera Direction: Northeast  
 Date/Time: 11/28/23, 3:54 p.m.

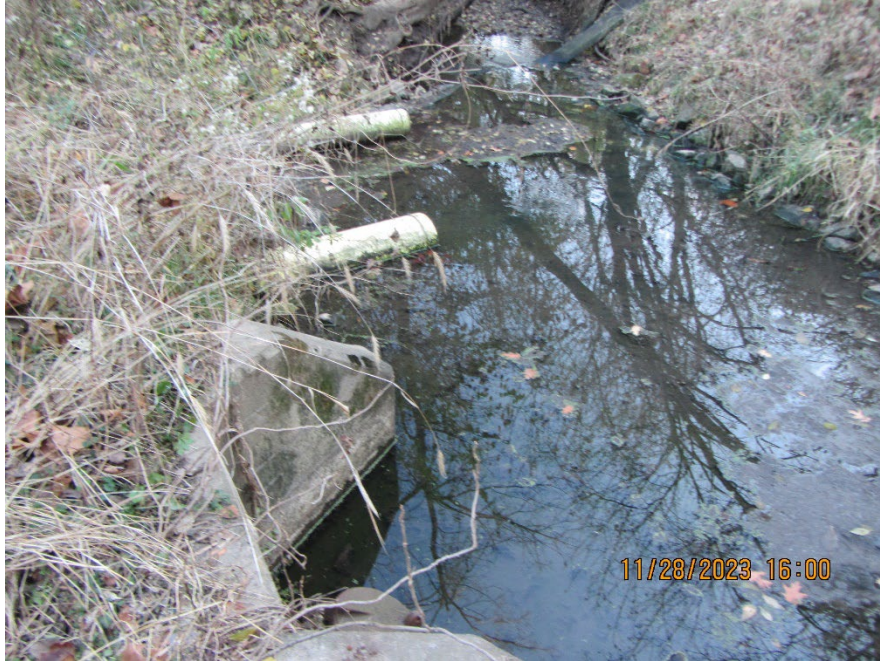
20: IMG\_0418

Description: Outfall 001 (middle pipe)

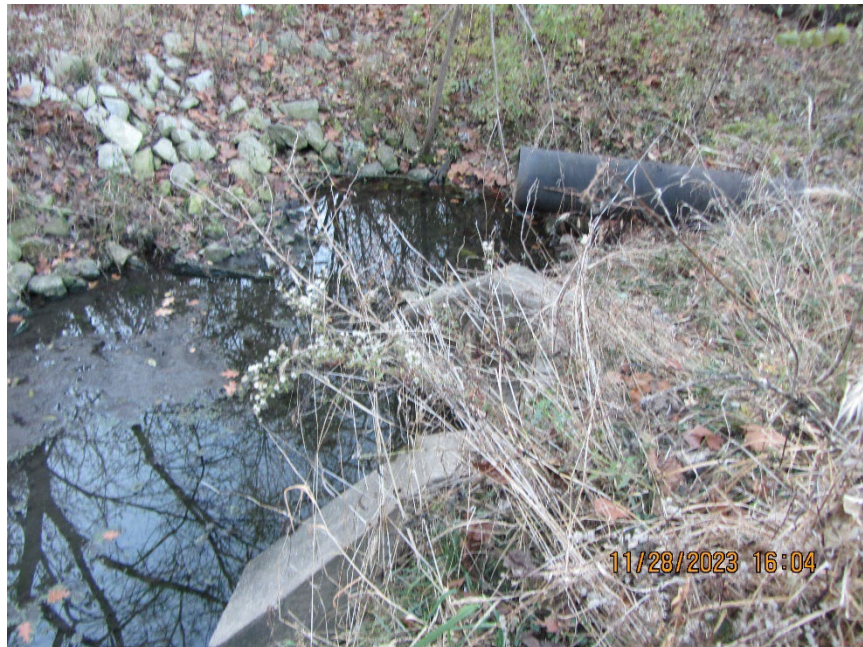
21: IMG\_0419

Description: Outfall 002

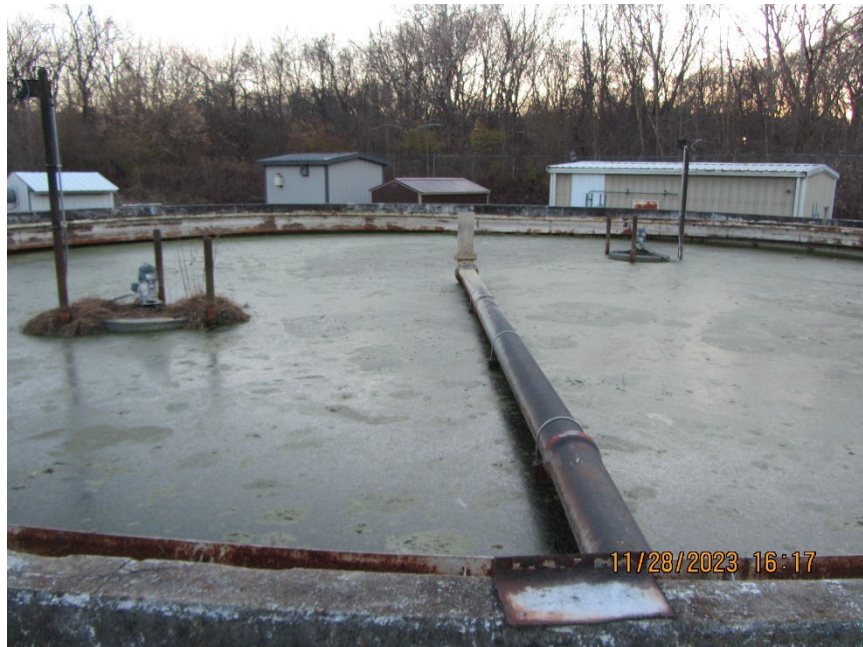
23: IMG\_0421

Description: Stormwater tank
