**U.S. Environmental Protection Agency  
Region 5**

**Purpose:** Clean Water Act National Pollutant Discharge Elimination System Compliance Evaluation Inspection

**Facility:** Cleveland-Cliffs Inc. – Empire Mine  
County Road PEE  
Ishpeming, Michigan 49849

**Inspection Date:** September 13 - 15, 2022

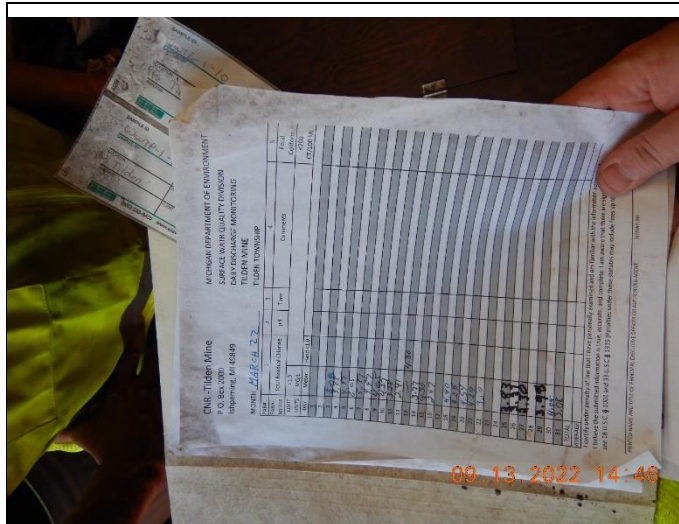
1: DSCN0960.JPG

Description: Residual chlorine bench sheet from the sewage treatment system at Tilden.

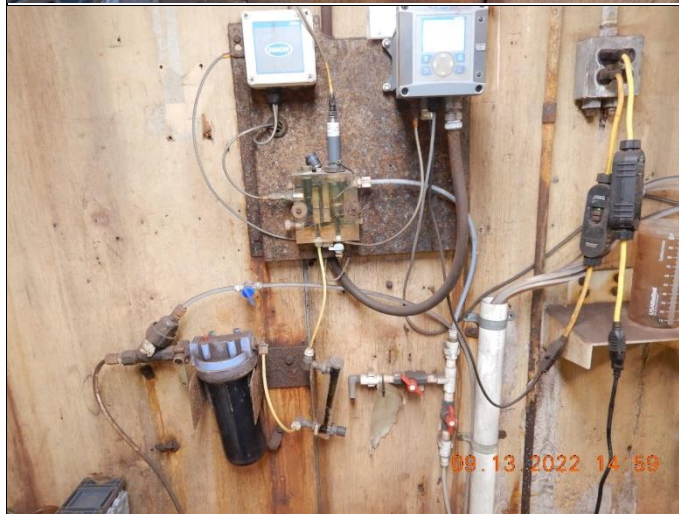
3: DSCN0962.JPG

Description: Continuous chlorine analyzer at the Tilden sewage treatment system. The chlorine probe was labeled for free chlorine analysis.

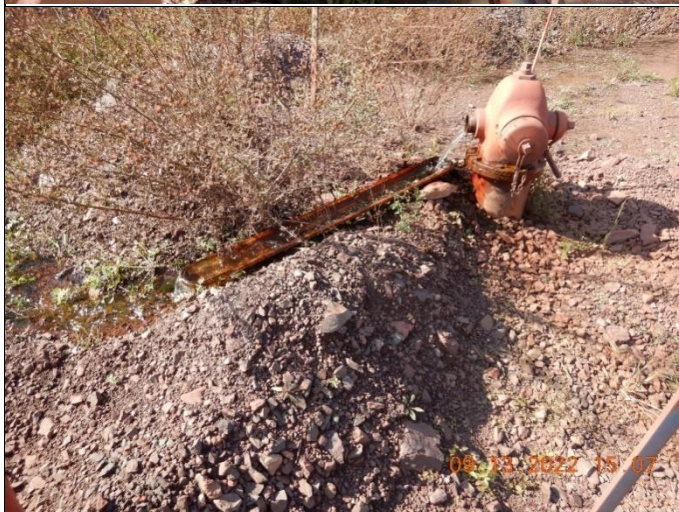
6: DSCN0965.JPG

Description: Flowing hydrant near the  
Tilden Mine sewage treatment facility.

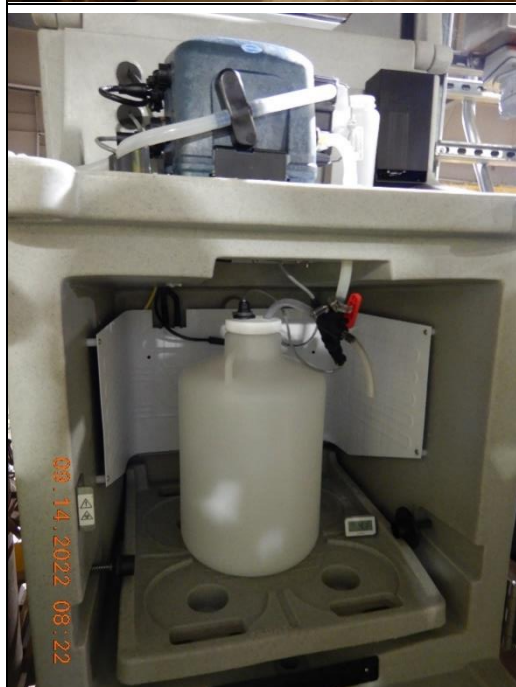
8: DSCN0967.JPG

Description: Automatic sampler at the treatment facility for the Tilden tailings basin discharge point 002B. Samples for TSS, TDS and Iron are collected in this composite bottle.

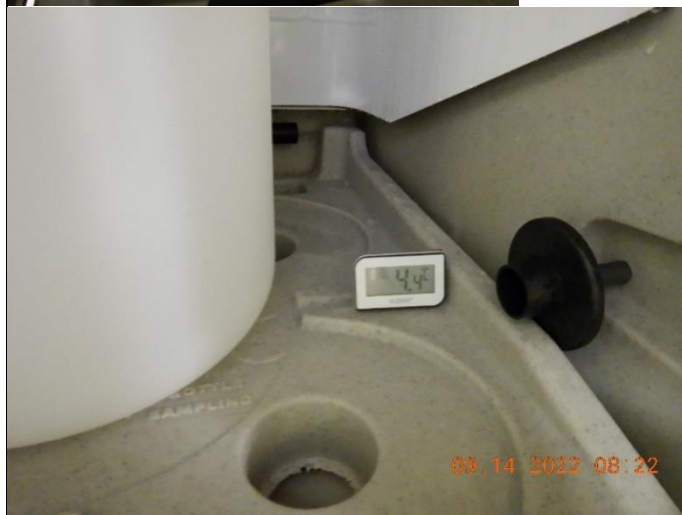
9: DSCN0968.JPG

Description: Non-NIST traceable thermometer at the location shown in photo 8.

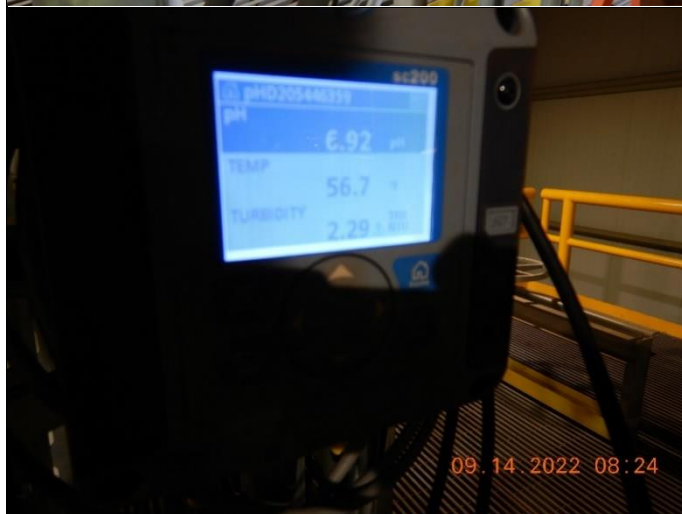
11: DSCN0970.JPG

Location: Tilden and Empire Mine  
 Photographer: Jonathan Moody  
 Date/Time: 9/14/2022 8:24 AM  
 Description: pH, temperature and turbidity measurements on train #2 at the treatment facility for the Tilden tailings basin discharge. Per Michael Korvela, these continuous measurements are for operational purposes only. At the time of the inspection, the turbidity measurement had an active alarm.

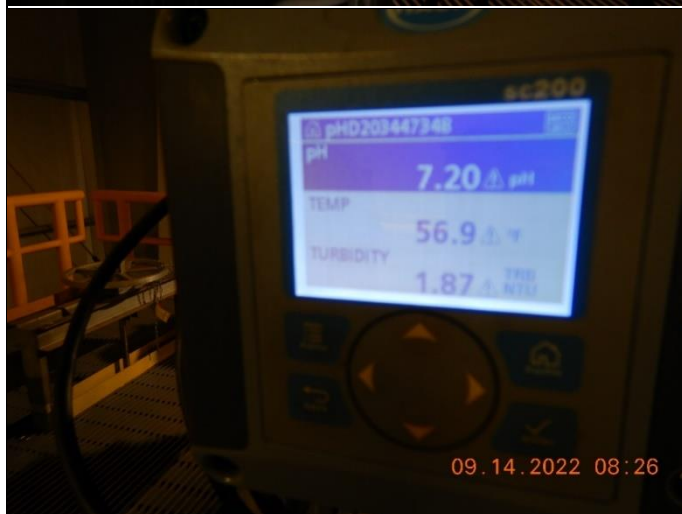
12: DSCN0971.JPG

Location: Tilden and Empire Mine  
 Photographer: Jonathan Moody  
 Date/Time: 9/14/2022 8:26 AM  
 Description: pH, Temperature and Turbidity measurements on train #1 at the treatment facility for the Tilden tailings basin discharge. Per Michael Korvela, these continuous measurements are for operational purposes only. At the time of the inspection, pH, temperature, and turbidity all had active alarms.

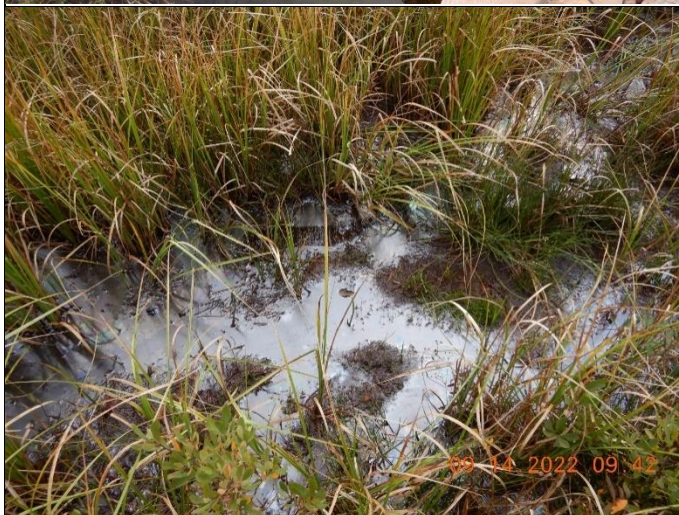
19: DSCN0983.JPG

Description: Location of possible daylighted seep at the east side of the tailings basin. The water had an iridescent sheen.

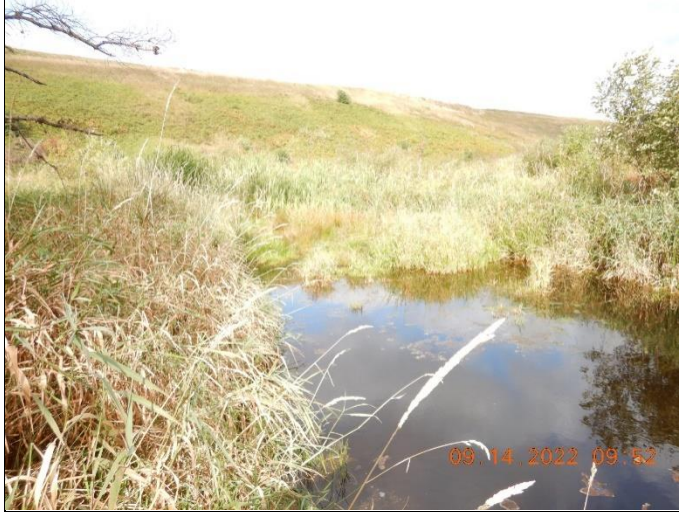
23: DSCN0987.JPG

Description: Location of possible daylighted seep at the east side of the tailings basin. The water had an iridescent sheen. Camera is looking upstream at the outslope of the tailings basin.

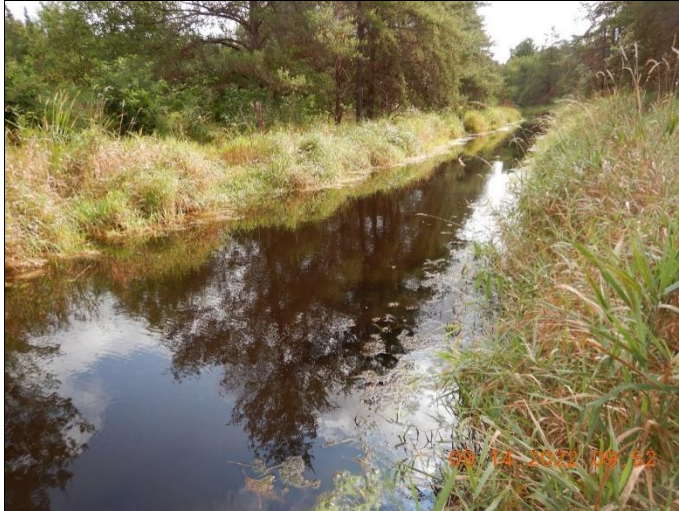
24: DSCN0988.JPG

Description: Location of possible daylighted seep at the east side of the tailings basin. Camera is facing downstream. Location of monitoring point 04. Camera is facing downstream.

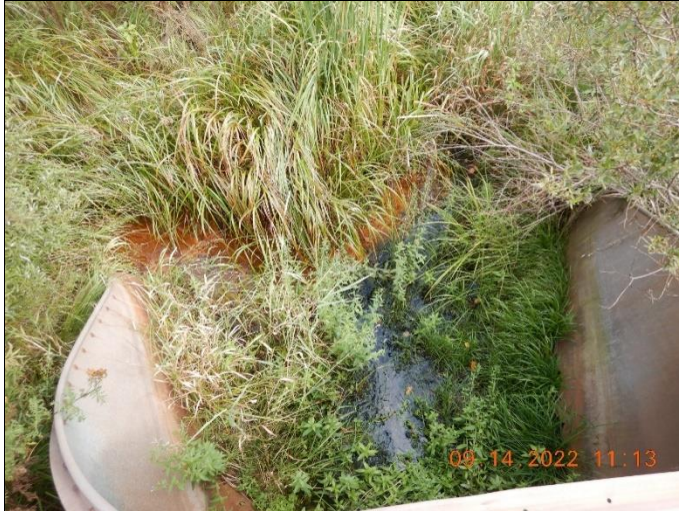
29: DSCN0993.JPG

- USEPA observed and conducted field monitoring of flowing water originating near Hoover Pond impoundment of process water. Water flowing from inside culvert connected to impoundment was originating from an unspecified source. Northeast of the culvert is a possible daylighted seep and EPA field monitoring at this location showed a conductivity of greater than 900  $\mu\text{S}/\text{cm}$  , which is above the background values. The waterway, culvert, and possible daylight seep are depicted in photos 29 through 32.

| Monitoring Point | Description | Photo Number | Date Time | Temperature (°C) | pH (SU) | Specific Conductivity (µS/cm) | DO Concentration (mg/L) |
|---|---|---|---|---|---|---|---|
| 06 | At Culvert leading away from Hoover Pond. Location of emergency Tilden 001. | 29 | 9/14/2022<br>12:17 | 9.91 | 7.43 | 928.98 | 5.04 |

Location: Tilden and Empire Mine  
 Photographer: Jonathan Moody  
 Date/Time: 9/14/2022 11:13 AM  
 Description: Downstream of Hoover Pond at the downstream end of a culvert leading away from Hoover Pond. This is the historic E003 discharge which is no longer an active outfall. At the time of the inspection there was water flowing through the culvert and joining with another surface conveyance of red discolored water. Monitoring point 06.

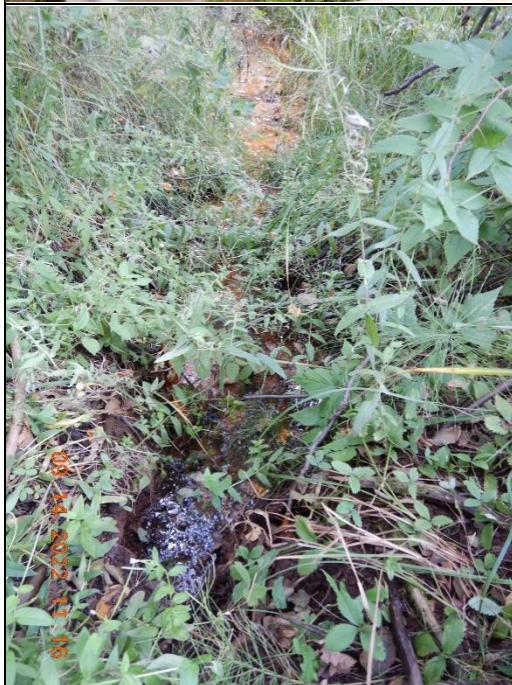
30: DSCN0994.JPG

Location: Tilden and Empire Mine  
 Photographer: Jonathan Moody  
 Date/Time: 9/14/2022 11:16 AM  
 Description: Northeast of the location of the downstream end of the culvert shown in photo 29. Possible location of a daylighted seep. At the time of the inspection the water shown in this photo was flowing and had a red/orange discoloration.

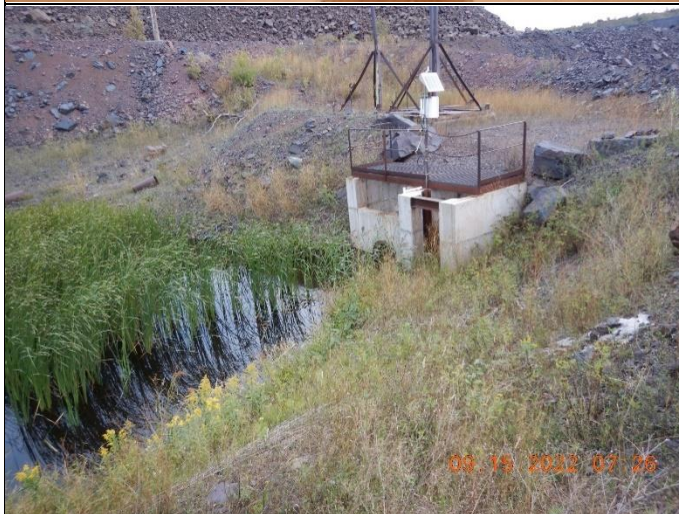
37: DSCN1001.JPG

Location: Tilden and Empire Mine  
 Photographer: Jonathan Moody  
 Date/Time: 9/15/2022 7:26 AM  
 Description: Historic Empire outfall 003.  
 At the time of the inspection, water flowing from this location was

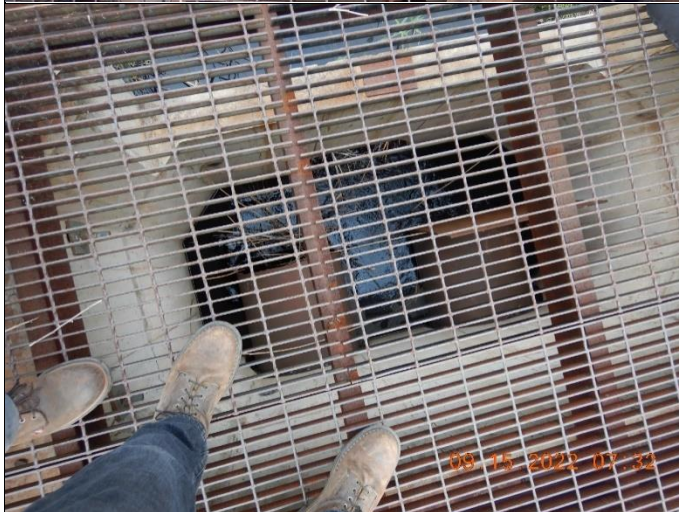
Location: Tilden and Empire Mine  
 Photographer: Jonathan Moody  
 Date/Time: 9/15/2022 7:31 AM  
 Description: Staff gage at the historic Empire Outfall 003. Facility representatives said they no longer use this staff gage. Location of monitoring point 09.

| Monitoring Point | Description | Photo Number | Date Time | Temperature (°C) | pH (SU) | Specific Conductivity (µS/cm) | DO Concentration (mg/L) |
|---|---|---|---|---|---|---|---|
| 09 | Historic Empire Outfall 003 | 39 | 9/15/2022<br>8:32 | 17.60 | 7.24 | 200.13 | 7.13 |

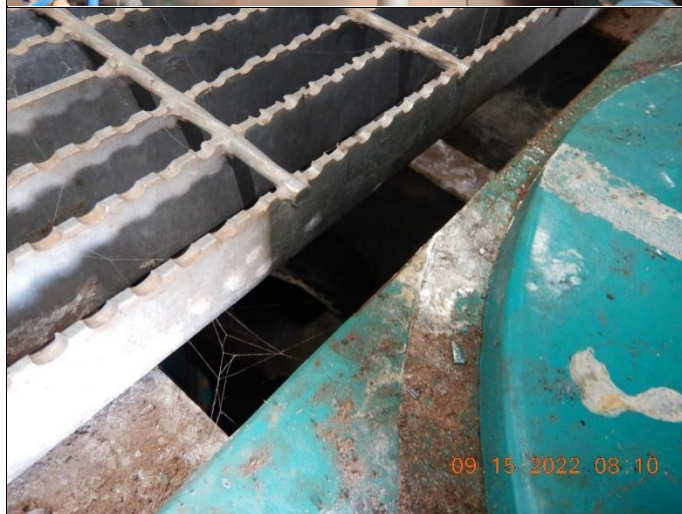
49: DSCN1013.JPG

Description: An overflow weir could be seen under the grating in the pump house for location CC-95. The water level in the wet well for this pump station was below the overflow weir elevation. If the water level in the wet well exceeds the weir it will discharge out the structure shown in photo 45.
