**NPDES Compliance Evaluation Inspection
Industrial Facility**

CAROLINA MUNICIPAL SOLID WASTE LANDFILL
PR-874 Road, Hoyo Mula Ward, Carolina Puerto Rico, 00986
Coordinates: 18.32406° N; 65.10312° W (Decimal)

NPDES ID: PRR053155

Inspection Date: July 16, 2024

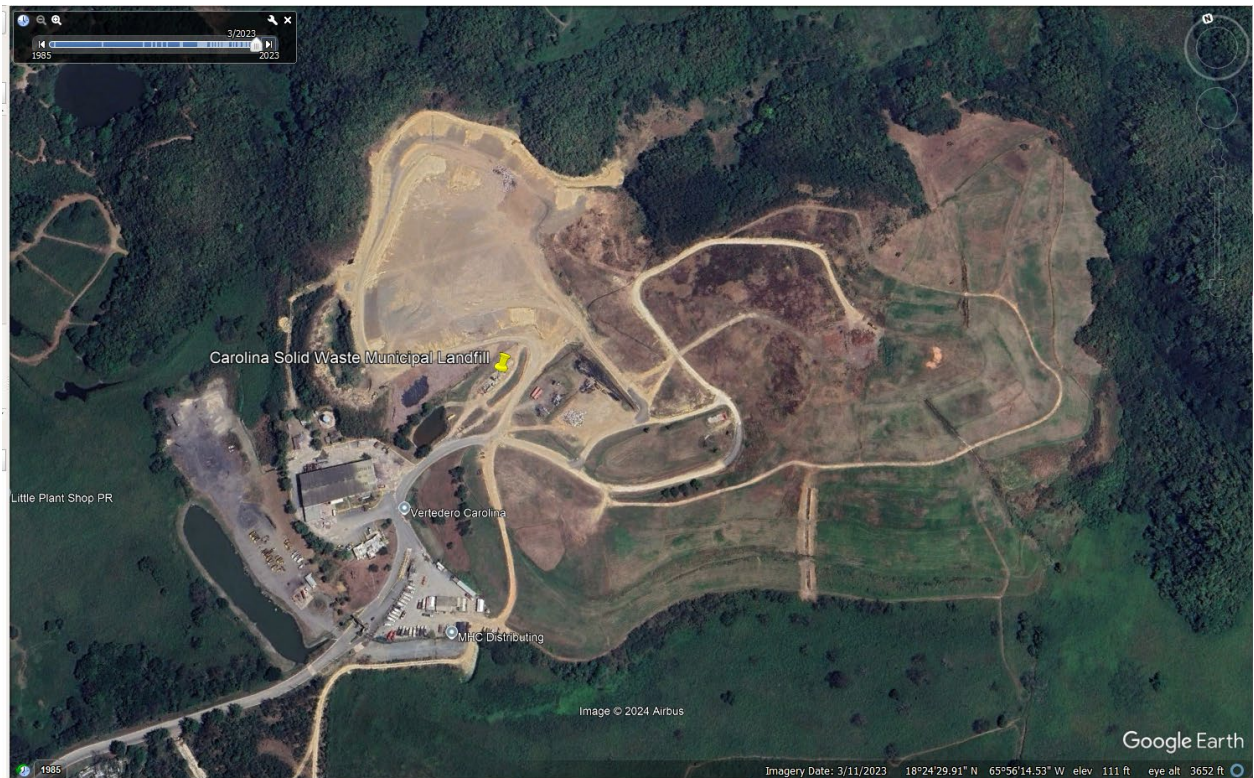
Image 1²

The Landfill is located at PR-874 Road, Hoyo Mula Ward, Carolina Puerto Rico (the “Site”). The Site is comprised of a parcel of land and is situated on approximately 148 acres. The areas surrounding the Site are mostly agricultural lands. **Image 1** (below) depicts an aerial imagery of the Site and its surroundings.

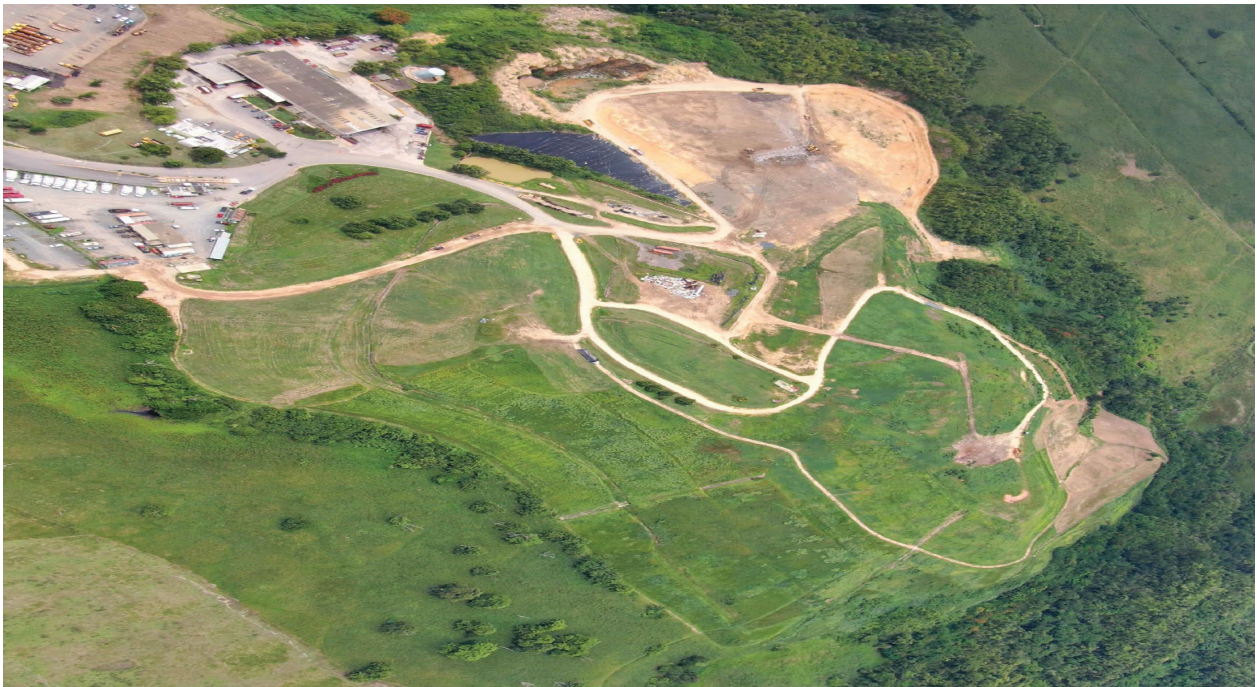
Image 2³

Once these solid wastes (except the recyclable materials, which are processed in the Recycling Plant), are received at the active cell, they are compacted and covered with soil material. This procedure is performed at the end of each operation day or in frequent intervals, as needed, according to the requirements of the Resource Conservation and Recovery Act (RCRA), Subtitle D, Part 258 from the US Environmental Protection Agency. The action area for Landfill's stormwater discharges extends downstream from outfalls towards different flowlines. **Image 2** (below) depicts an aerial photograph of the Landfill.

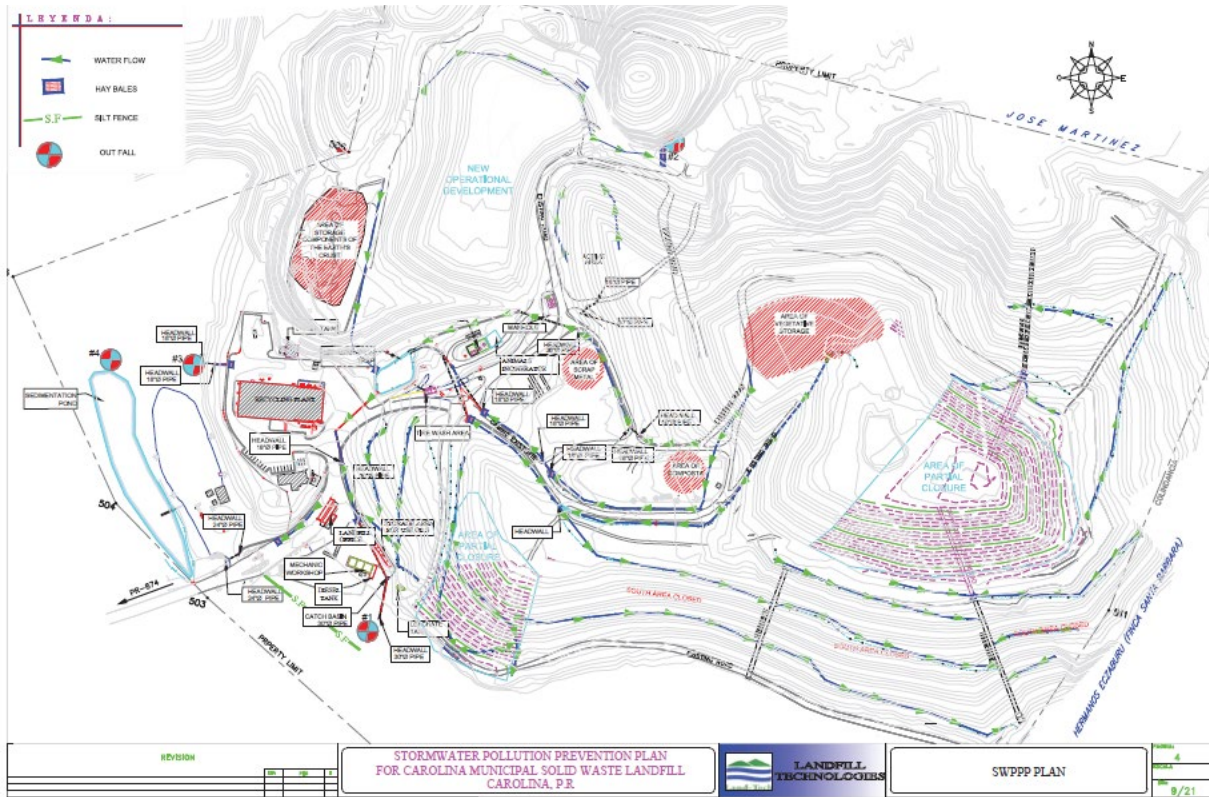
Figure 1 (next page) depicts a Site Map found in the Stormwater Pollution Prevention Plan (“SWPPP”) developed for Site, including the stormwater sampling points.

- a tributary flowline of the Caño Martín Peña and the River. Refer to Pictures 9-12, 15, in Attachment 1.
- d. Four discharge points at the Site, as described in Part 4 (*Description of the Stormwater Collection, Conveyance and Discharge System*) of this Inspection Report. Inspector López was informed that Outfall 002 will be relocated to an area opposite of the actual location. Refer to Picture 23 and Figure 1, above.

- j. Established vegetative cover at the closed cells on the south and southeast slopes of the Landfill. Refer to Figure 1 above.
 - k. A leachate seepage stain located at the north bottom slope face of the Landfill. No leachate flows reaching the stormwater drainage ditch were observed. Refer to Picture 19 in Attachment 1.

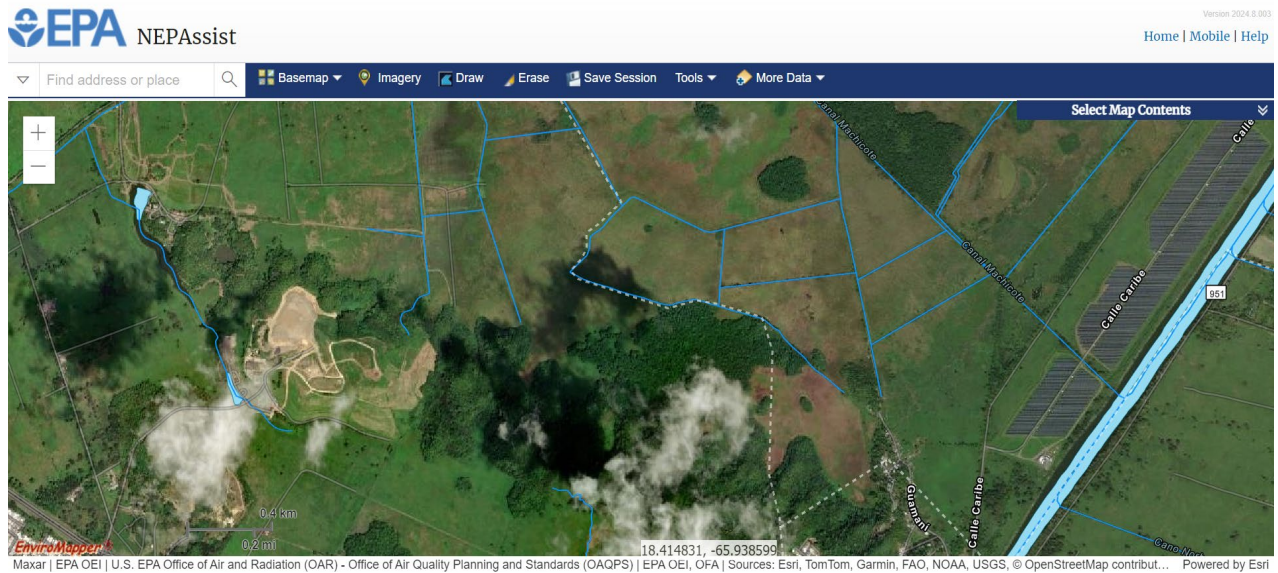
Image 2⁴

The Caño Martín Pena and the River are classified as SD waters in the Puerto Rico Water Quality Standards Regulation (“PRWQSR”) promulgated by the Puerto Rico Department of Natural and Environmental Resources (“DNER”) on November 23, 2022. **Image 2** (next page) depicts the hydrographic area surrounding the Site, including Rio Grande de Loiza.
