**Region 6 - Enforcement & Compliance Assurance Division**  
**INSPECTION REPORT**

| Inspection Date(s): | 04/11/2024 | |
| Company Name: | Plott Acres | |
| Identification/Permit Number: | TX1520062 | |

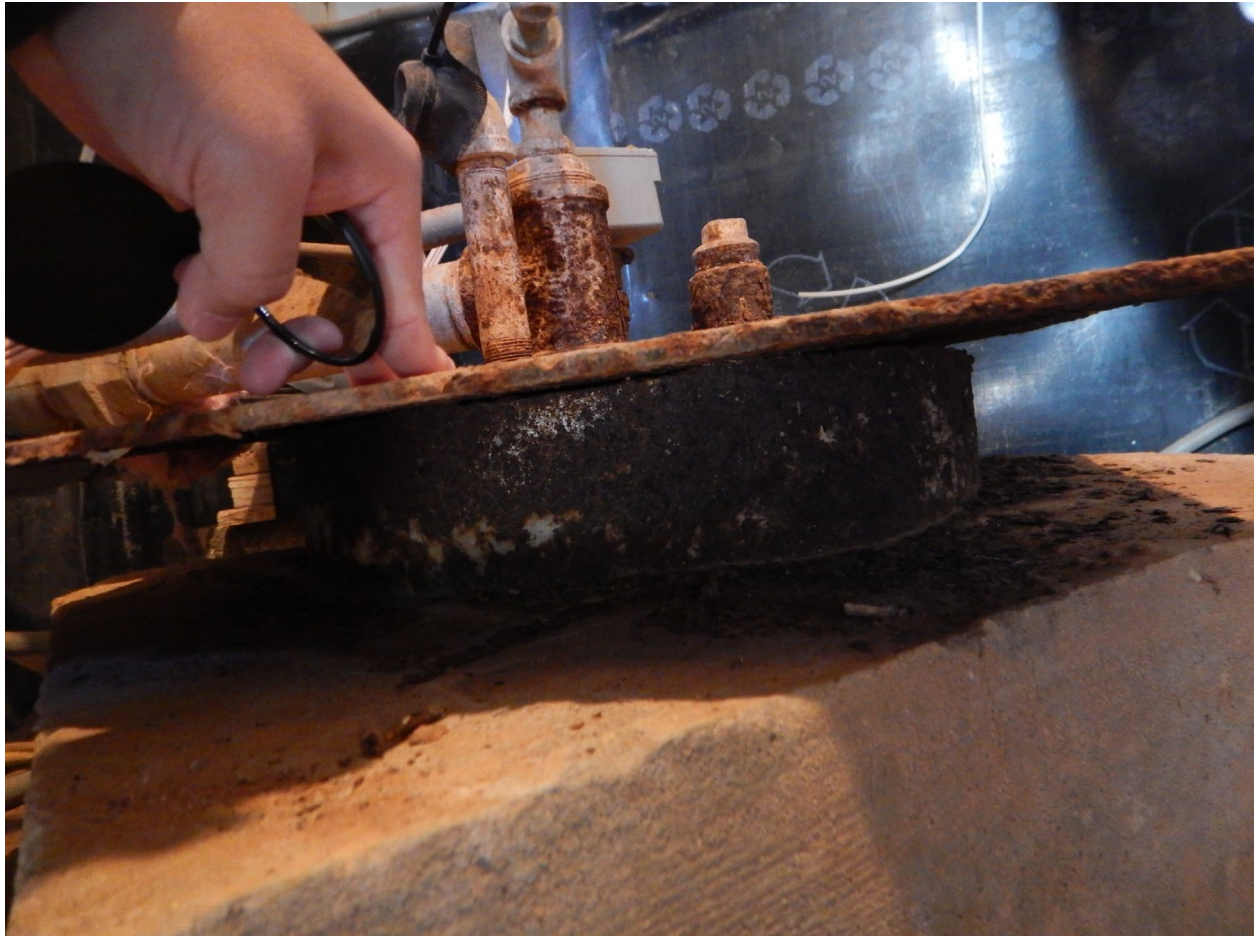
Photo No. 1

- The well didn't appear to have a sanitary seal under the well cover (Appendix 1, Photo 1; AOC 1).
- The mixing barrel for sodium-hypochlorite was missing a label (Appendix 1, Photo 2; AOC 2).

Description: The seal status of Well #2 inside of the wellhouse.

1. Well #2 lacked a sanitary seal. We recommend properly sealing the well.
2. The mixing barrel for sodium-hypochlorite was missing a label. We recommend replacing the missing label.
3. The sodium-hypochlorite mixing barrel had an opening on top of the container, which could serve as a path for contamination or accelerated degradation of the solution. We recommend properly sealing the barrel.
4. The insulated cover of the pipe located outside of the wellhouse was not properly secured. We recommend properly securing the cover.
5. The drain valve of hydro-pneumatic tank (Well #2) did not have a backflow prevention device.

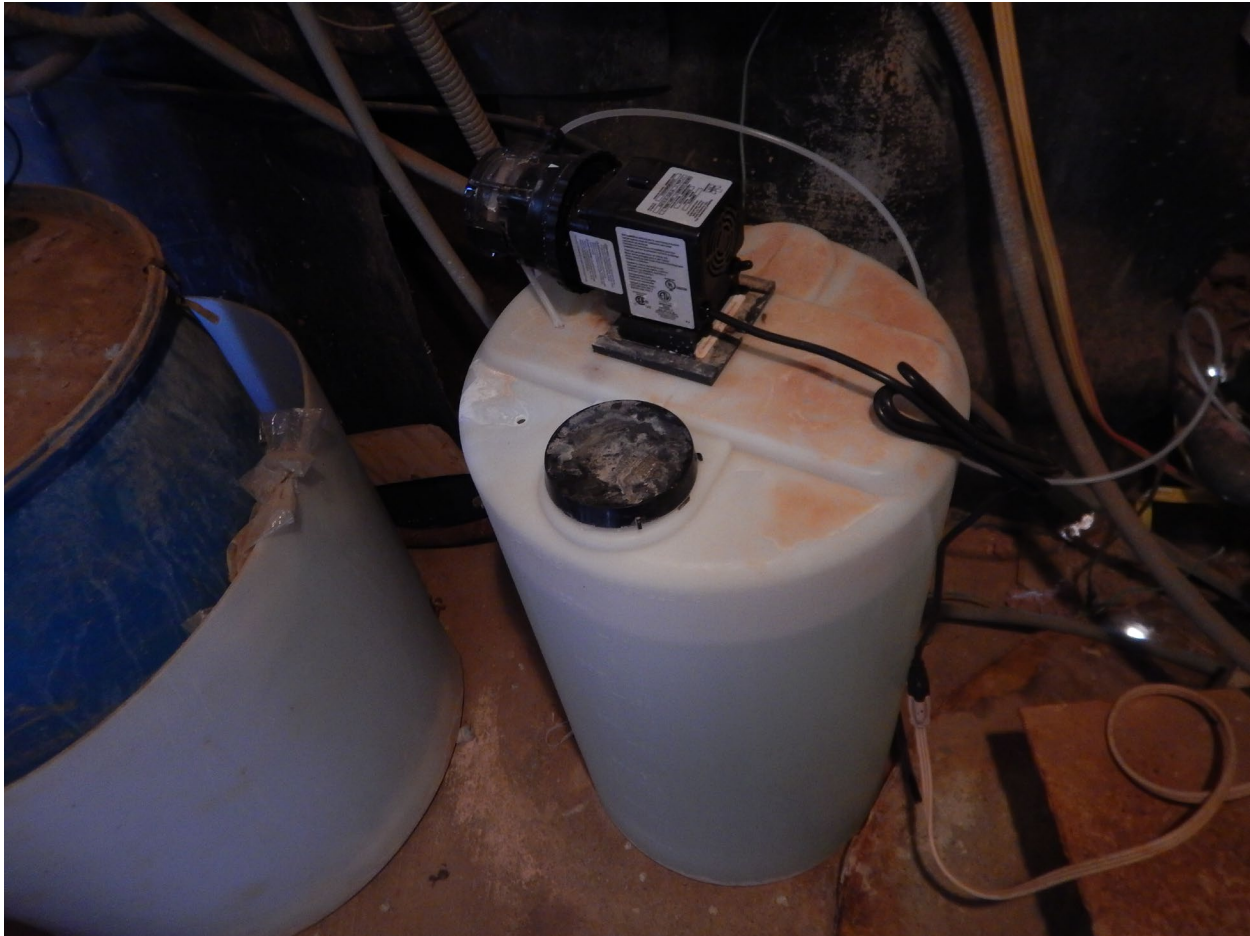
Photo No. 2

- The sodium-hypochlorite mixing barrel had an opening on top of the container, which could serve as a path for contamination or accelerated degradation of the solution (Appendix 1, Photo 2; AOC 3).

Description: Opening in the top of the mixing barrel for Sodium hypochlorite (Well #2).

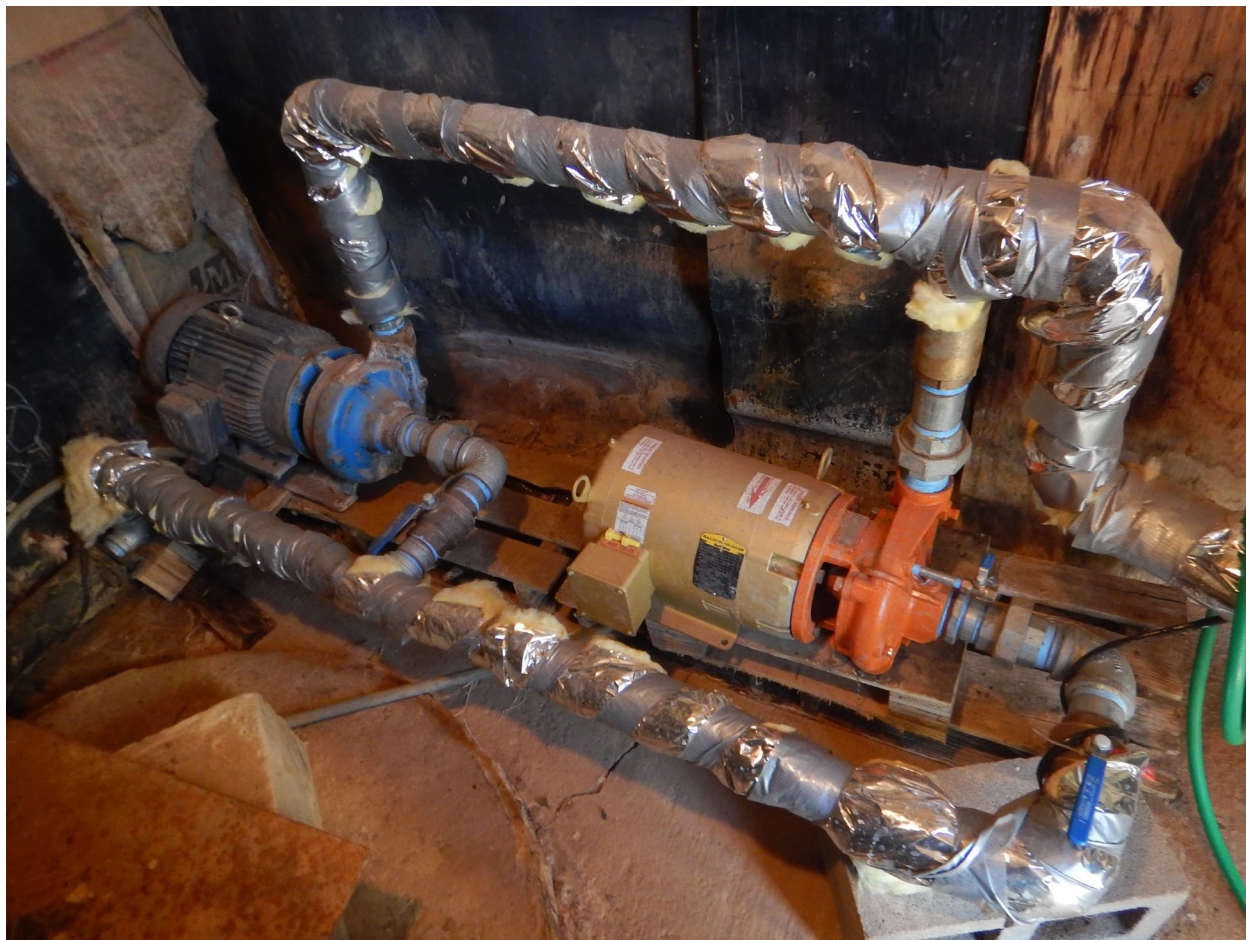
Photo No. 3

- The two service pumps were observed to be in good condition. The pipes were covered with the insulation materials at the time of inspection (Appendix 1, Photo 3).

Description: Two service pumps in good condition (Well #2).

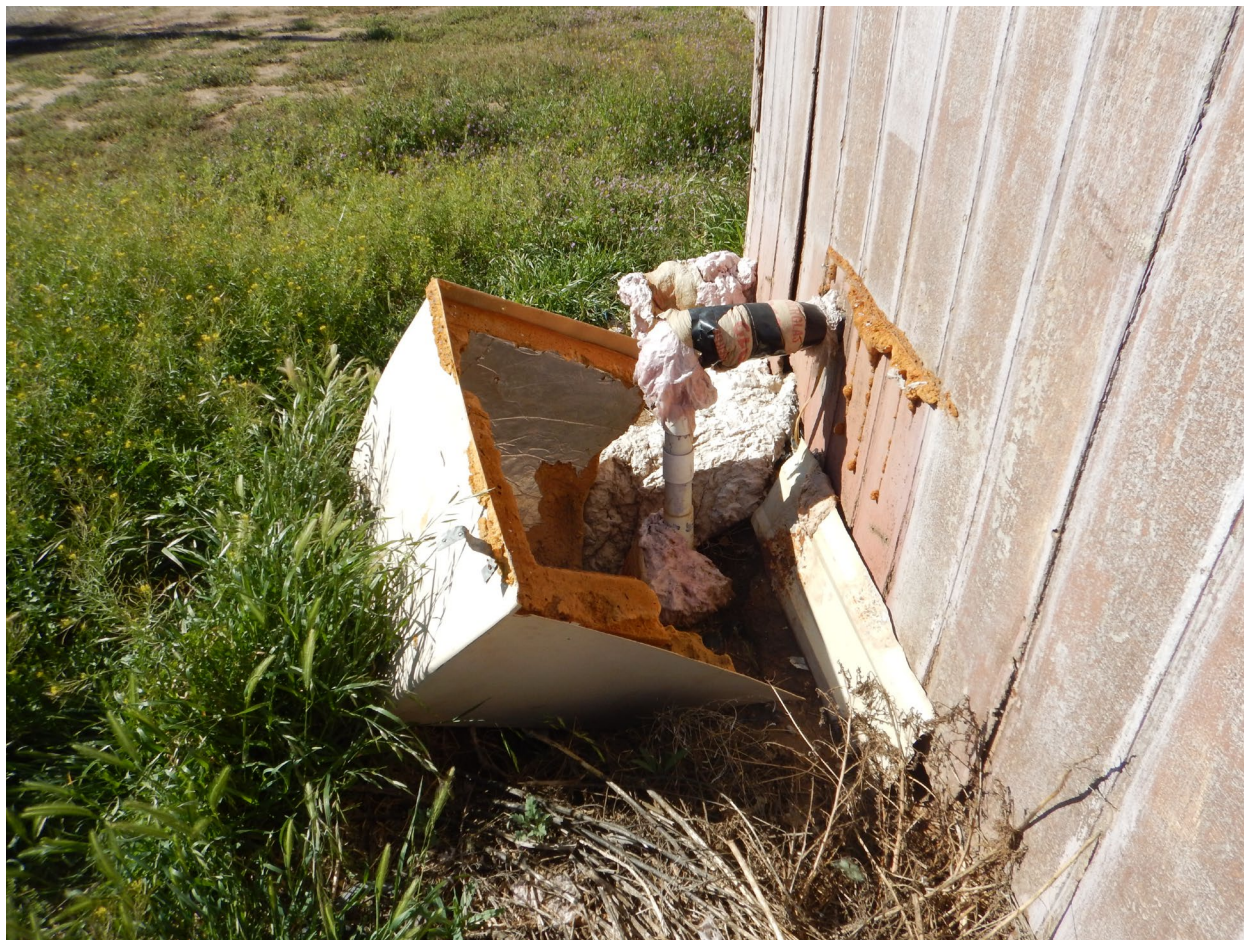
Photo No. 4

- The insulated cover of the pipe located outside of the wellhouse was not properly secured (Appendix 1, Photo 4; AOC 4).

Description: The detached box shape structure covering the pipe located outside of the wellhouse (Well #2)

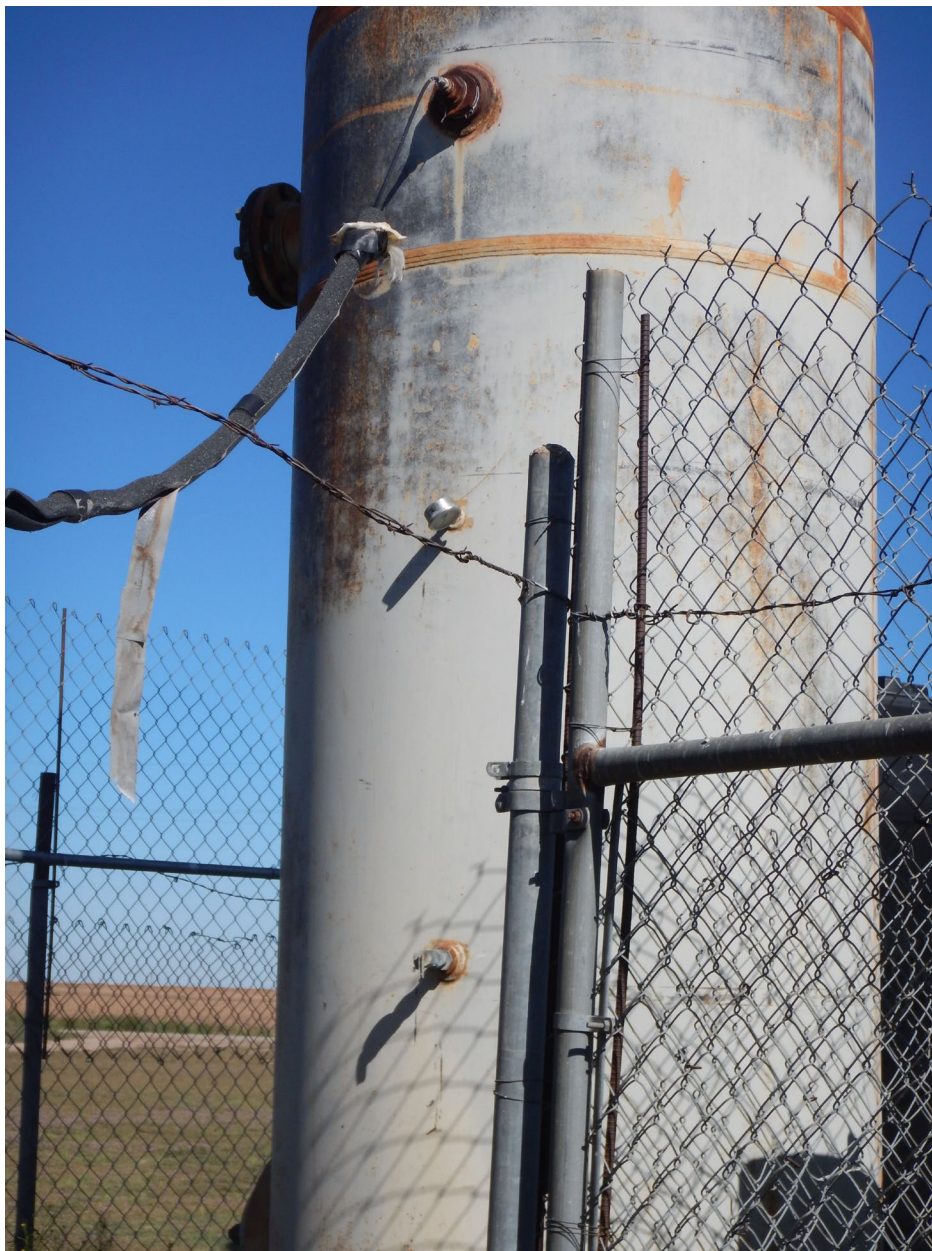
Photo No. 5

Description: Hydروpneumatic tank equipped with a pressure relief valve and a pressure gauge located in a secured fence (Well #2).

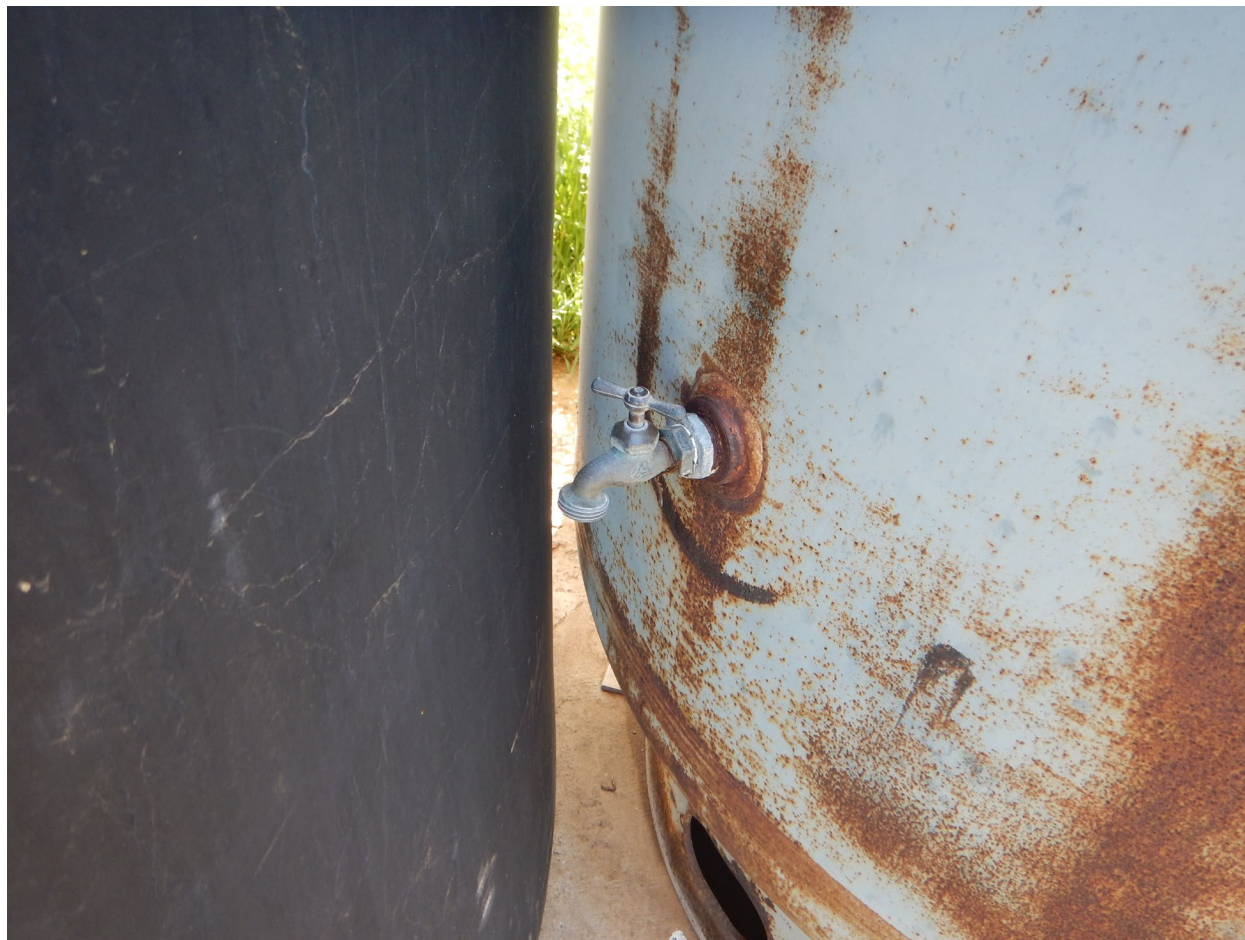
Photo No. 6

- The capacity of the tank is 0.001 MG, and the tank is equipped with a drain valve, a pressure relief valve, and a pressure gauge (Appendix 1, Photo 5 and 6).
- We observed that the drain valve of the tank lacked a backflow prevention device (Appendix, Photo 6; AOC 5).
- We observed that a damaged plastic storage tank located near the hydro-pneumatic tank was disconnected from the system and not in use (Appendix 1, Photo 7; AOC 6).

Description: The drain valve of the hydropneumatic tank in Well #2.

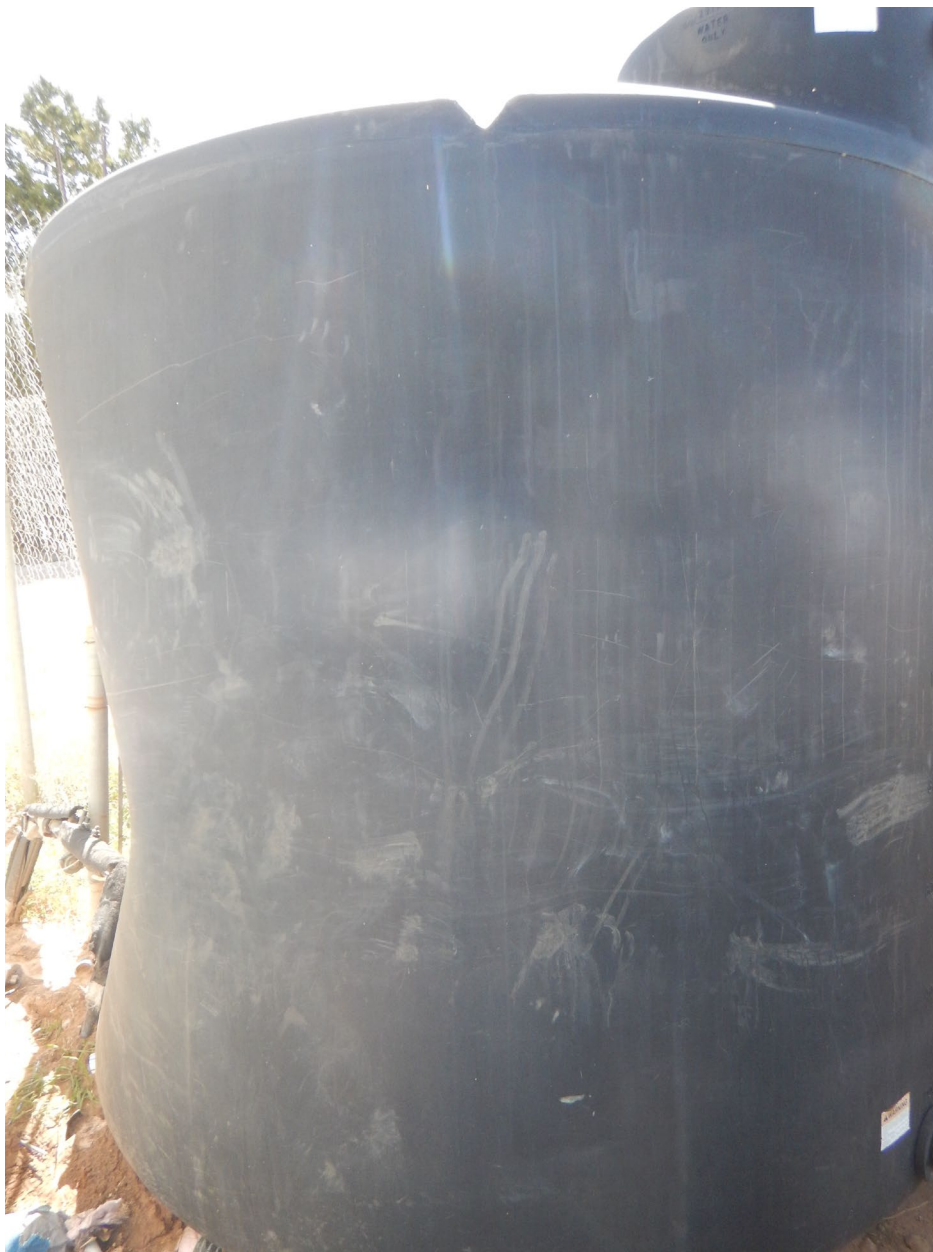
Photo No. 7

Description: The unutilized plastic storage tank near the hydropneumatic tank (Well #2).

6. A damaged plastic storage tank was not in use and placed near the hydro-pneumatic tank. We recommend disposing of the tank.
7. The AFRS was disconnected from the system but still contained ACH and was stored near the ground storage tank. We recommend properly disposing of the AFRS if the system does not intend to rehabilitate it for future use.
8. The mixing barrel for arsenic and fluoride removal was not in use and placed near wellhouse (Well #2). We recommend disposing of the mixing barrel.
9. We observed a leak coming from a pipe downstream of the standing hydro-pneumatic tank for Well #1. The leak was repaired by April 19, 2024 (Appendix 2)
10. According to Texas DWW, the public water system has exceeded Fluoride MCL since 2021.

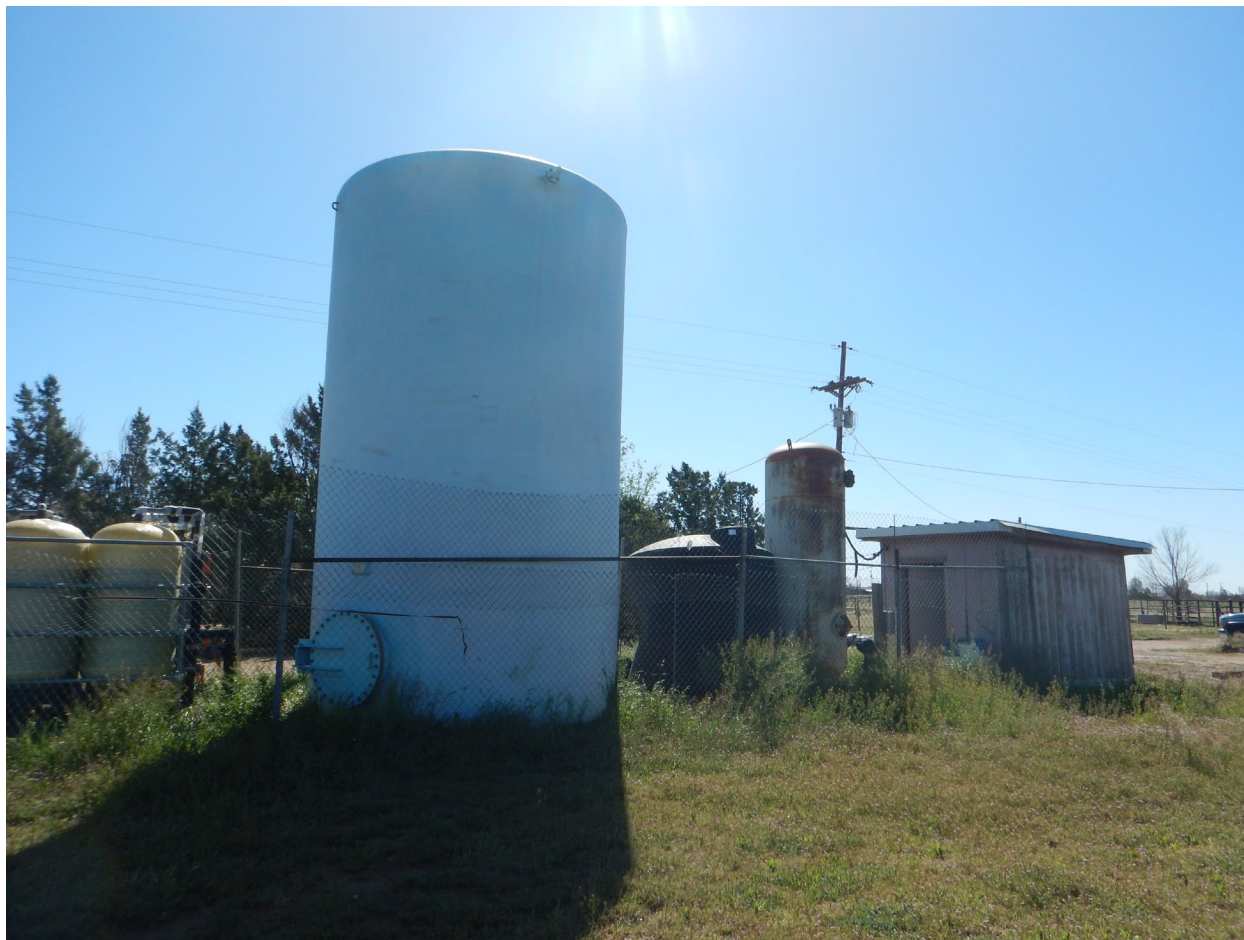
Photo No. 8

- According to the Operator's manual for this facility, the well is controlled by the float switch in the ground storage tank. Depending on the water level in the tank, the well is automatically operated to transfer water to the ground storage tank.
- The storage tank was built in 1992, and the capacity and empty weight are 0.017 MG and 3000 lbs. The ground storage tank appeared to be in good condition (Appendix 1, Photo 8).

Description: Ground storage tank in good condition (Well #2).

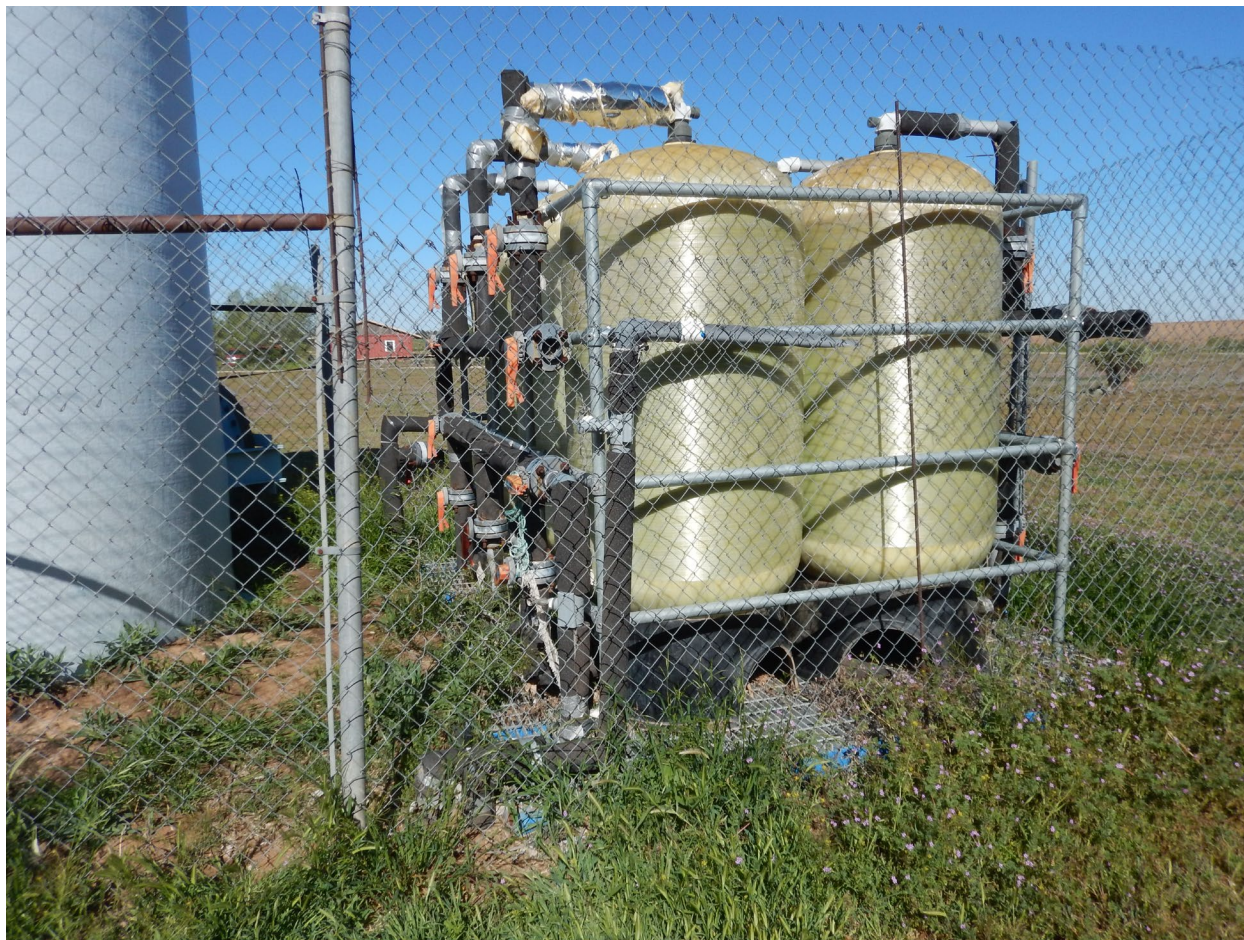
Photo No. 9

Description: Unutilized arsenic and fluoride removal system in a secured fence (Well #2).

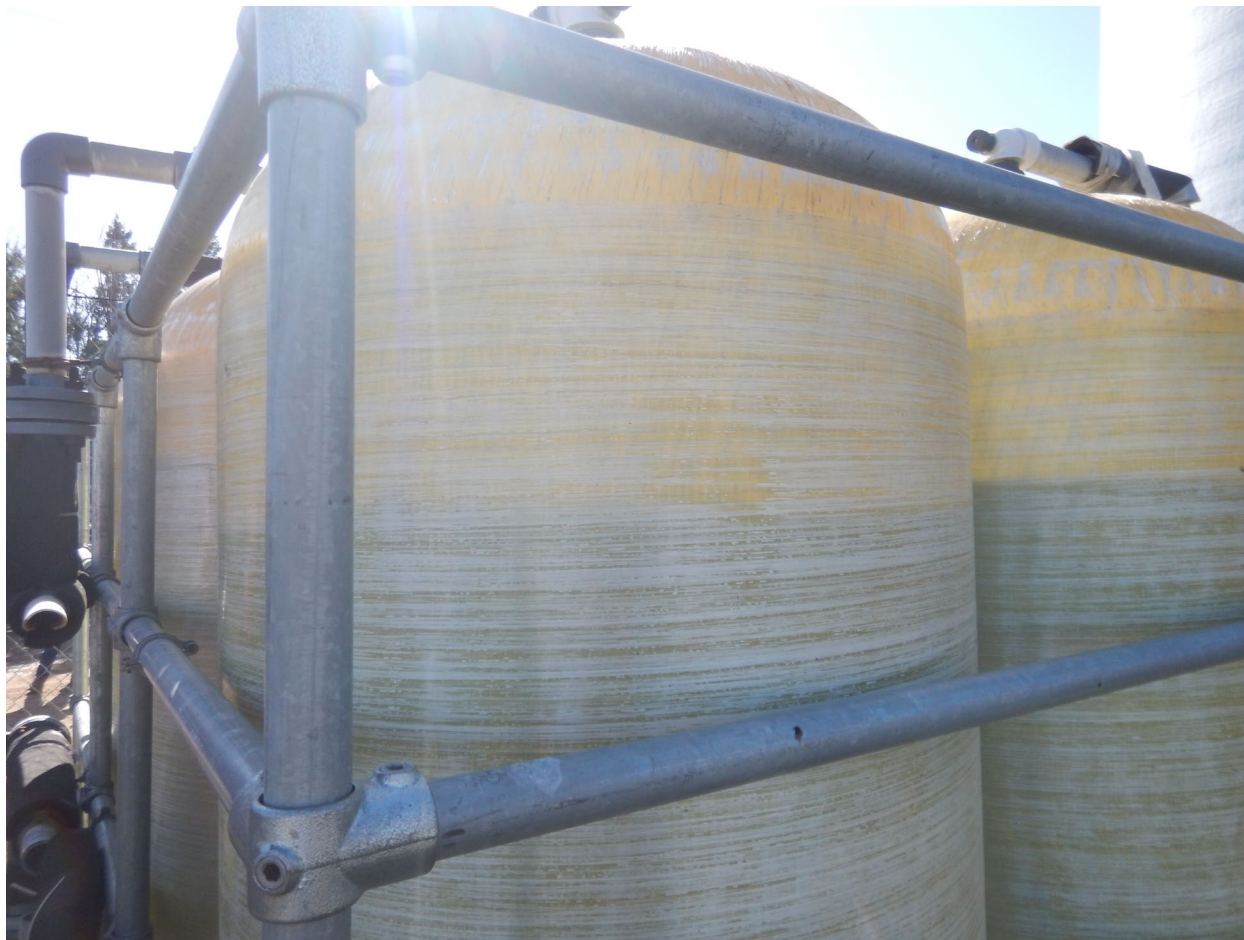
Photo No. 10

- We were informed that the AFRS had been disconnected and not in use (Appendix 1, Photo 9).
- The AFRS contained Aluminum Chloro-hydrate (ACH) and was being stored near the ground storage tank (Appendix 1, Photo 10; AOC 7).
- The mixing barrel for the AFRS was not in use and was placed near the wellhouse (Well #2) (Appendix 1, Photo 11; AOC 8).

Description: ACH stored in the unutilized arsenic and flouride removal system (Well #2).

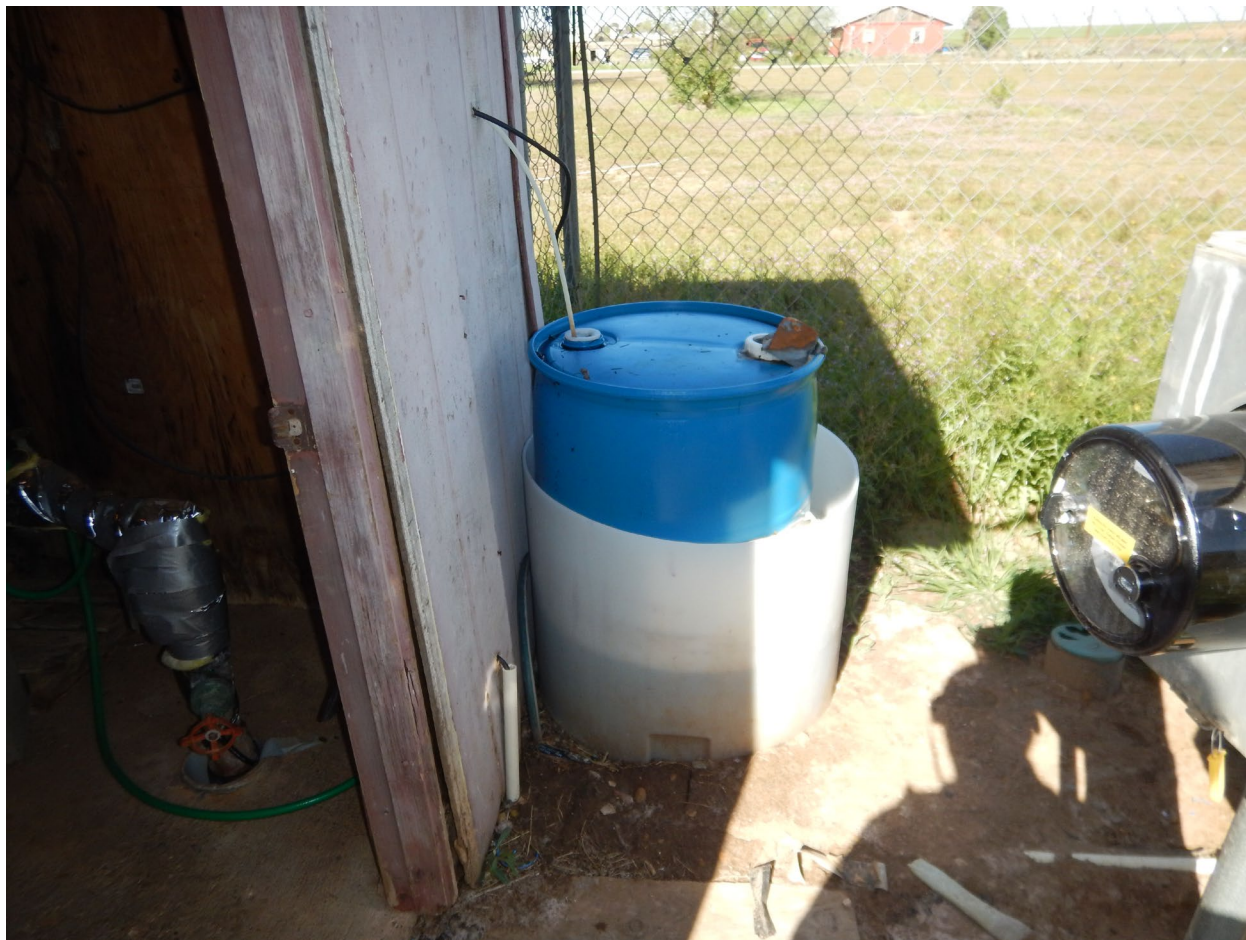
Photo No. 11

Description: Unutilized mixing barrel for arsenic and flouride removal near the wellhouse (Well #2).

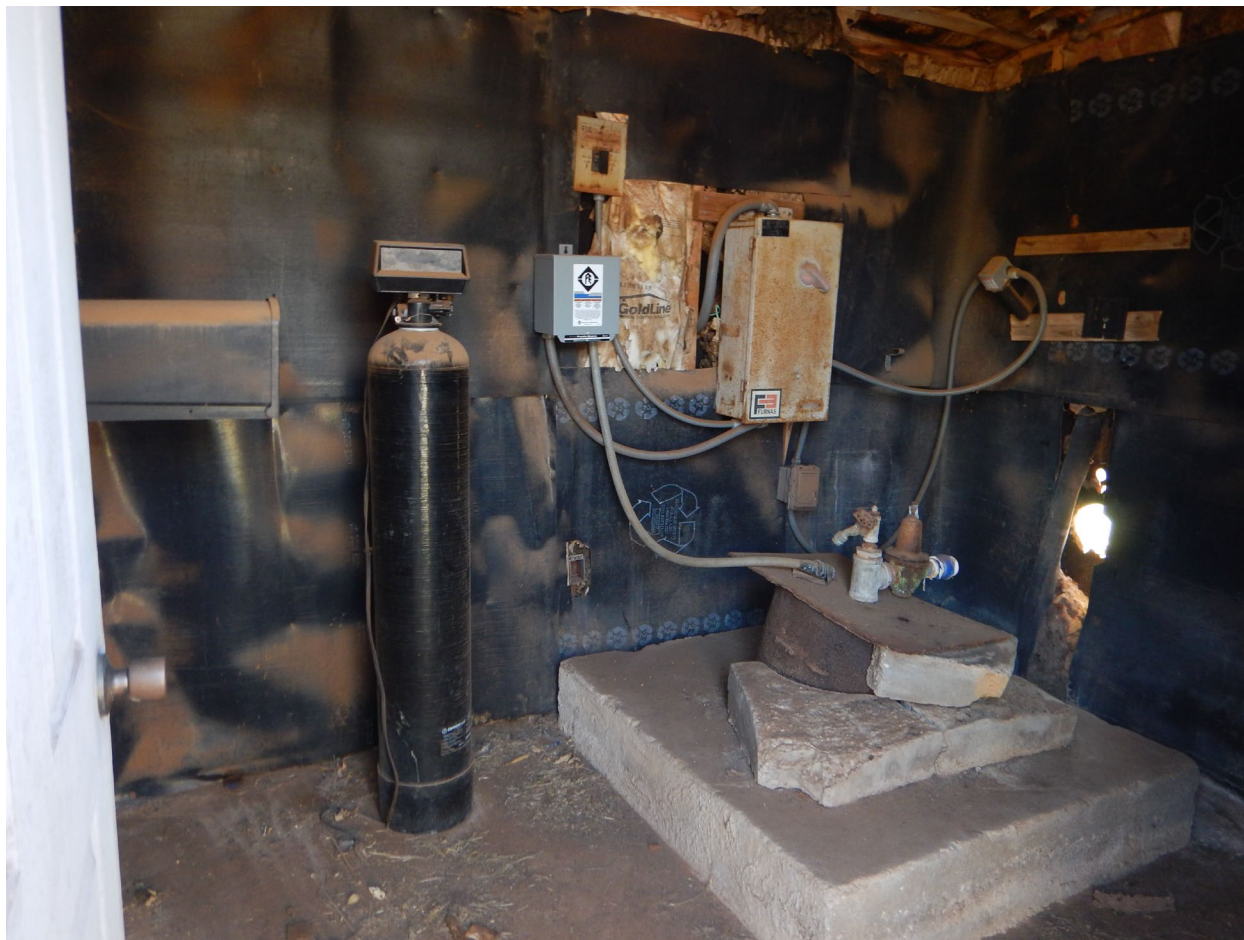
Photo No. 12

- We observed that Well #1 was completely disconnected from the two hydro-pneumatic tanks and not operated (Appendix 1, Photo 12).
- No chemical feed system for disinfection was equipped with Well #1 (Appendix 1, Photo 12).
- The two hydro-pneumatic tanks for Well #1 were observed to be not in use at the time of inspection. They were air-gapped from Well #1, but still connected to the distribution system (Appendix 1, Photo 13).
- We observed a leak coming from a pipe downstream of the standing hydro-pneumatic tank for Well #1 (Appendix 1, Photo 14; AOC 9). We notified Mr. Smith of the leak, and he placed a work order to the operating company, Patterson Water Supply, which handles all maintenance and repairs for the system. The leak was repaired and photos documenting the repair were provided to EPA by Mr. Smith on April 19, 2024 (Appendix 2).

Description: The interior of the wellhouse for the inactive Well #1. No chemical feed system for disinfection.

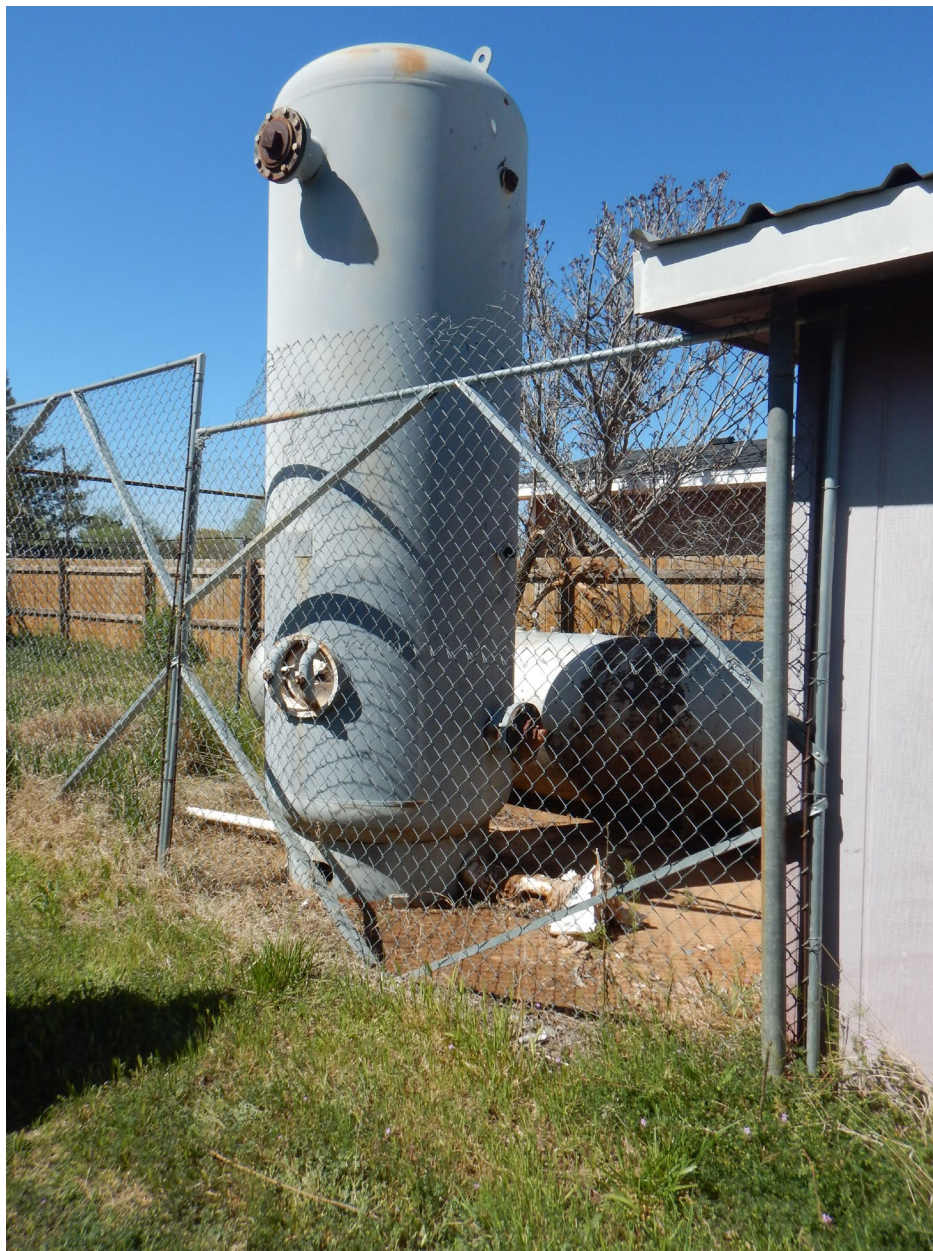
Photo No. 13

Description: Two disconnected hydro-pneumatic tanks from Well #1.

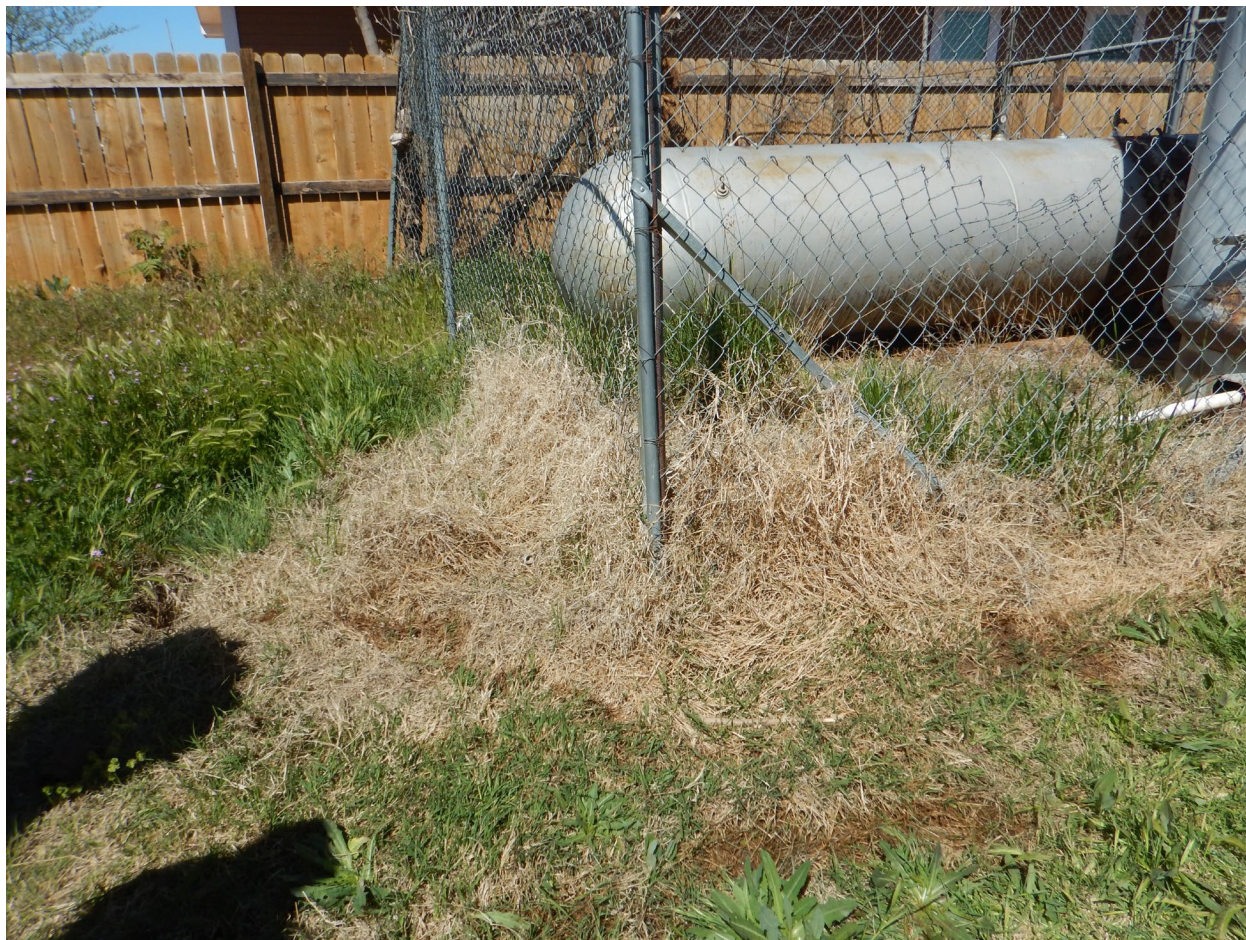
Photo No. 14

Description: Leaking issue from a pipe near the standing hydropneumatic tank (Well #1).

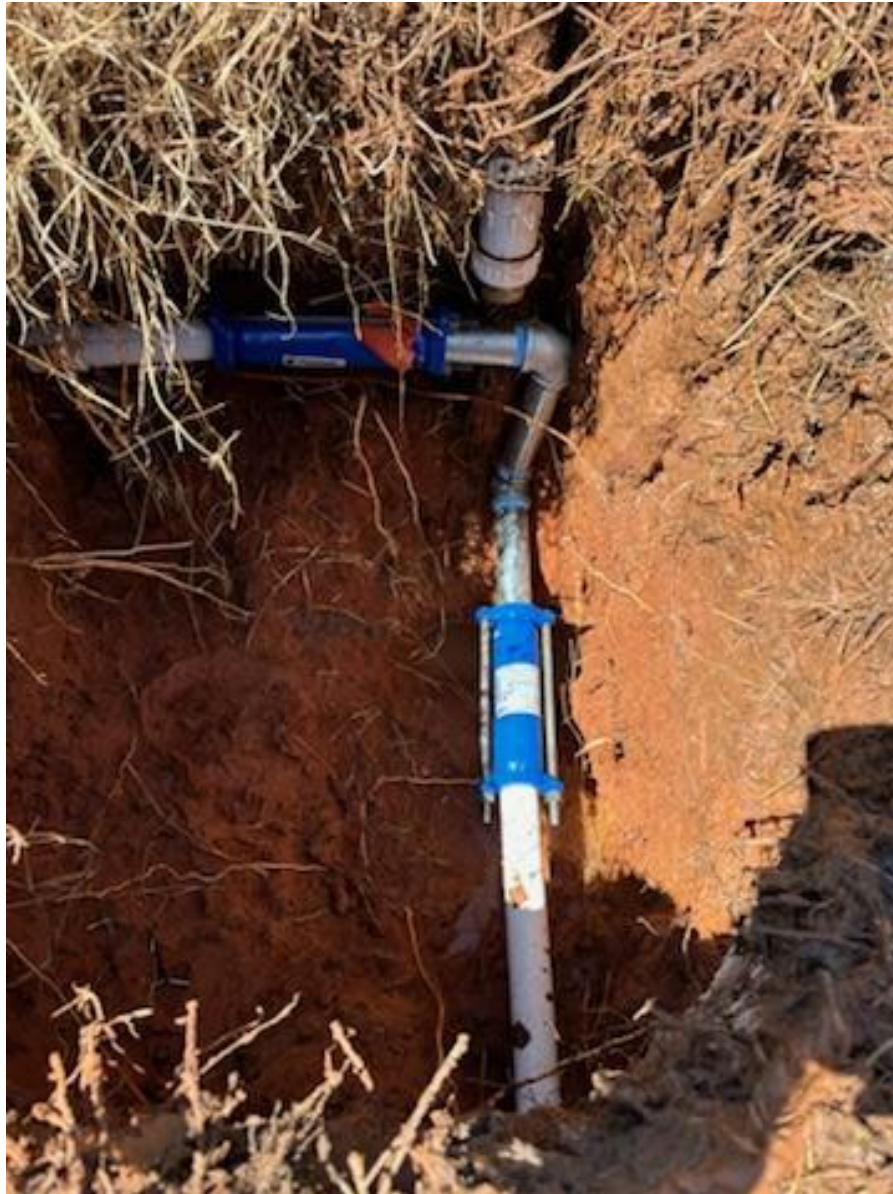
Photo No. 2

Description: The completion of the work for leaking issue (Well #1).

The following information was received by EPA on April 19, 2024, after exiting the Facility on April 11, 2024: The photo of the repaired leaked pipe at Plott Acres was provided by Mr. Smith (Appendix 2, Photo 2).
