## ATTACHMENT C: Photograph Log

### Cypress Pit

Bama Concrete Products Company, Inc.  
dba Davis Sand and Gravel

Cypress, Alabama  
April 26-27, 2023

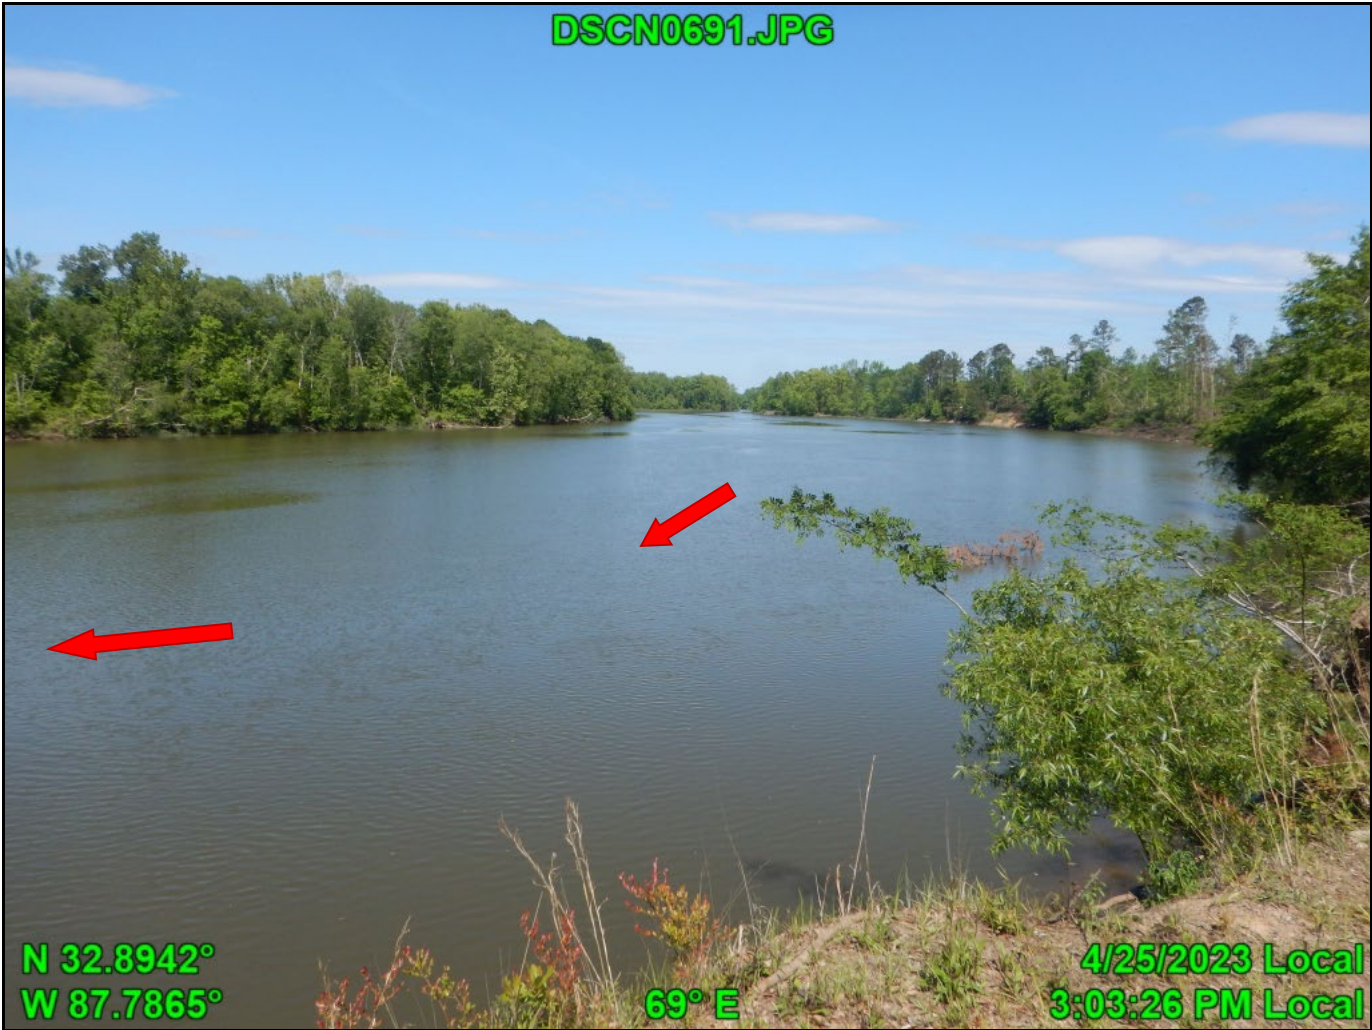
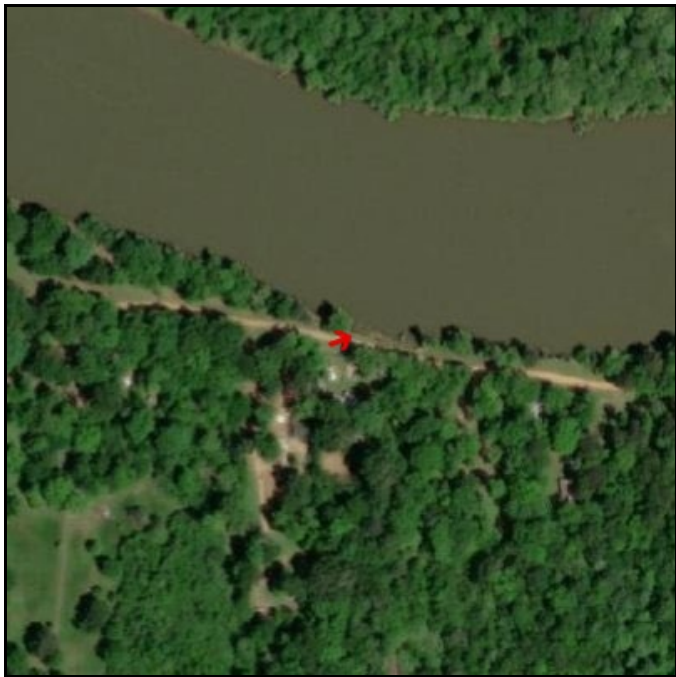
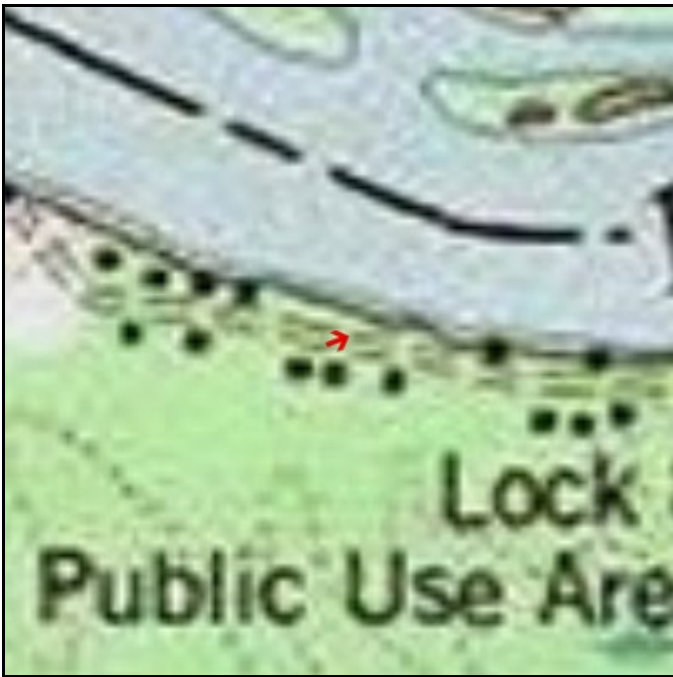
| Title | Photo 1 |

| Description | Striking northeast, east. Black Warrior River, looking upstream toward the site. Red arrows in top photo indicates direction of flow. |

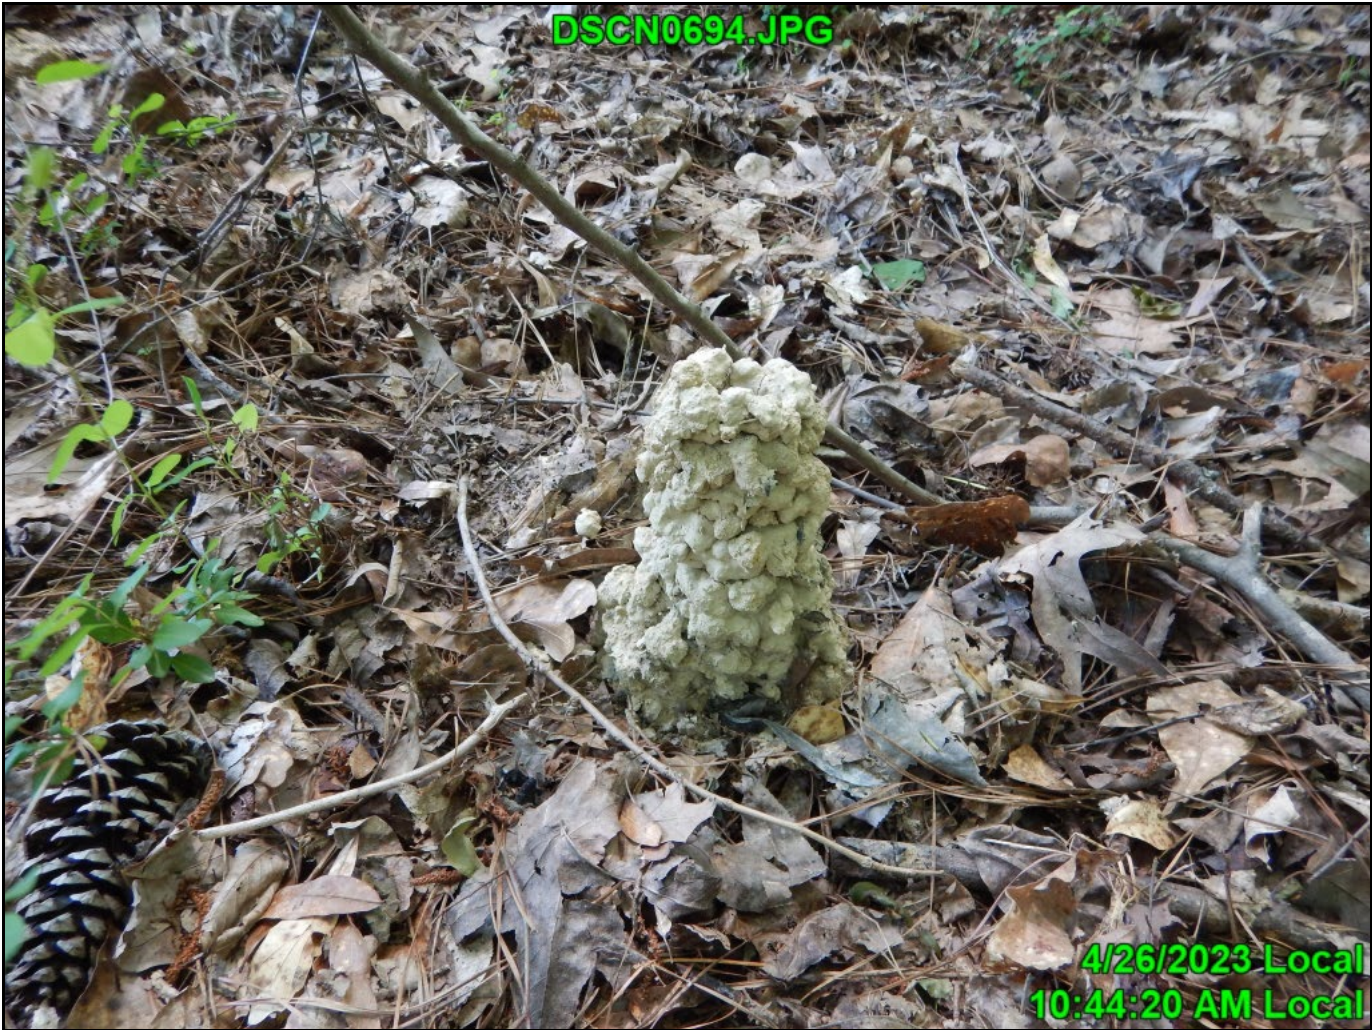
| Title | Photo 4* |

| Description | Crawfish burrow in vicinity of reference area, which is displayed in Photos 5 and 6. |

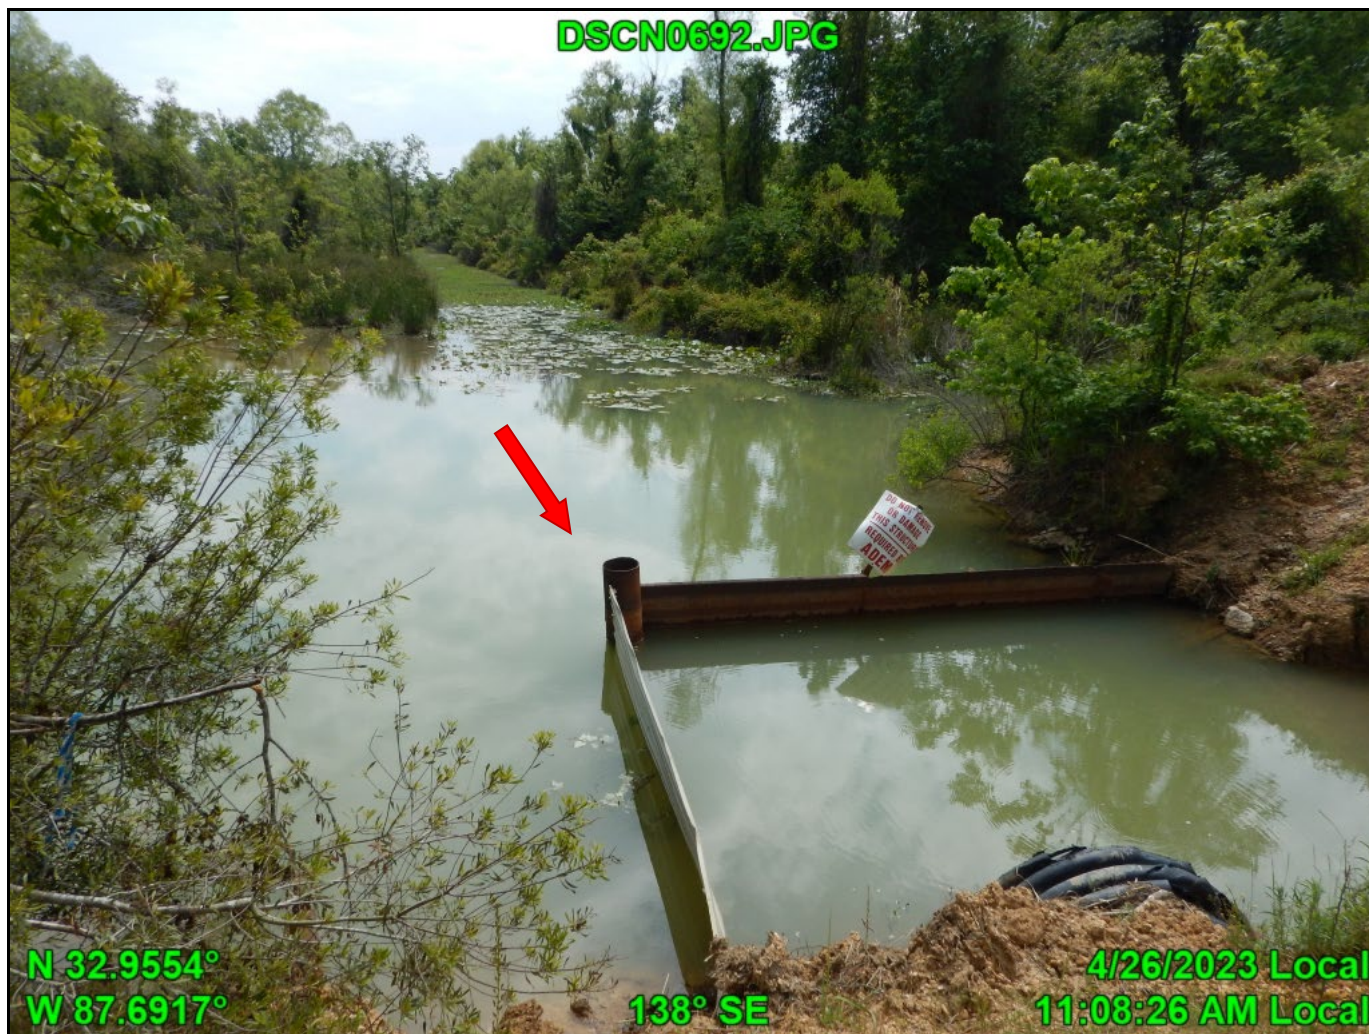
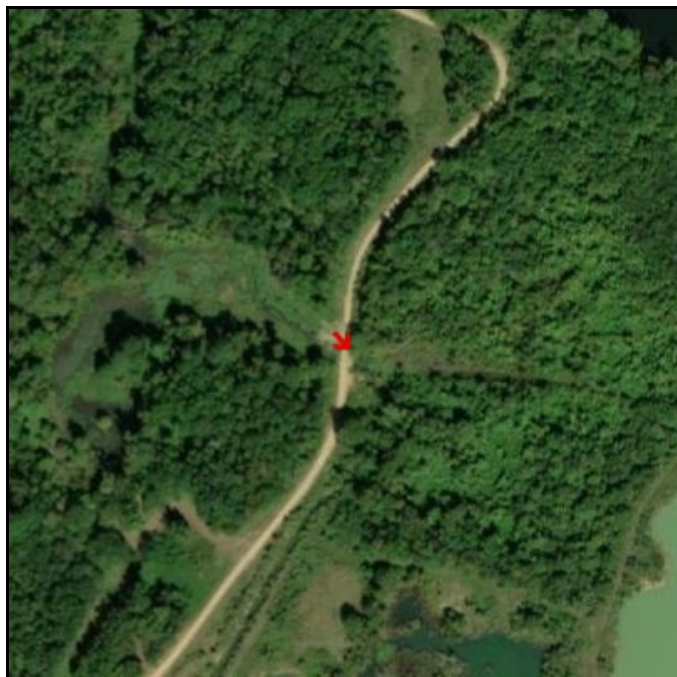
| Title | Photo 2 |

| Description | Striking southeast; upstream. Outfall per the NPDES permit. Skimmer in the bottom righthand corner of image. Red arrow in top photo indicates direction of flow. |

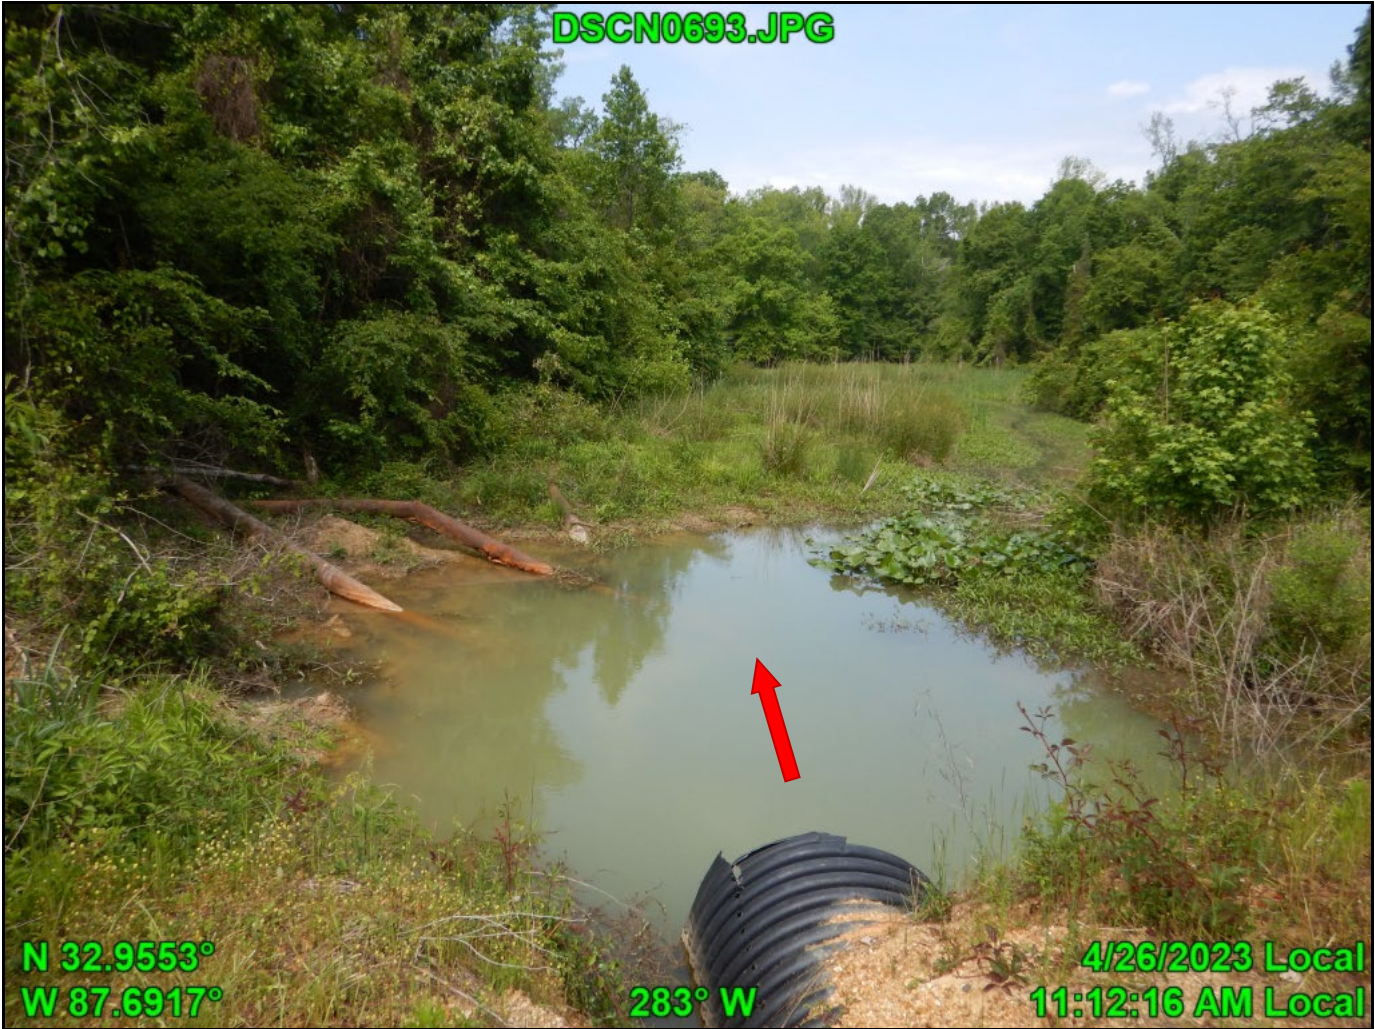
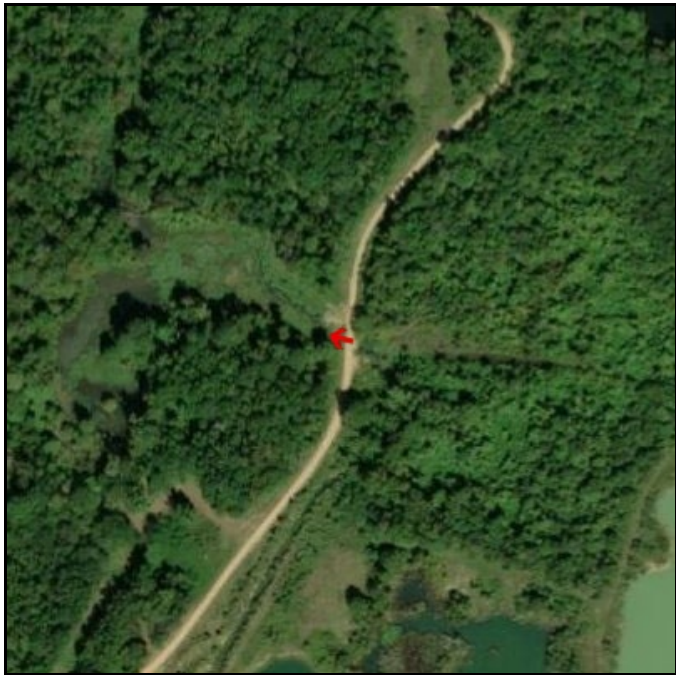
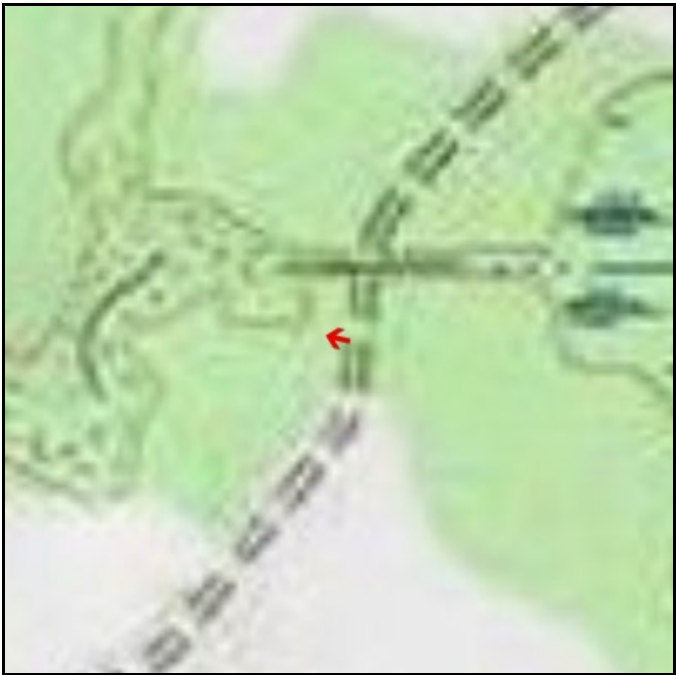
| Title | Photo 3 |

| Description | Striking west, northwest; downstream. NPDES outfall. Red arrow in top photo indicates direction of flow. |

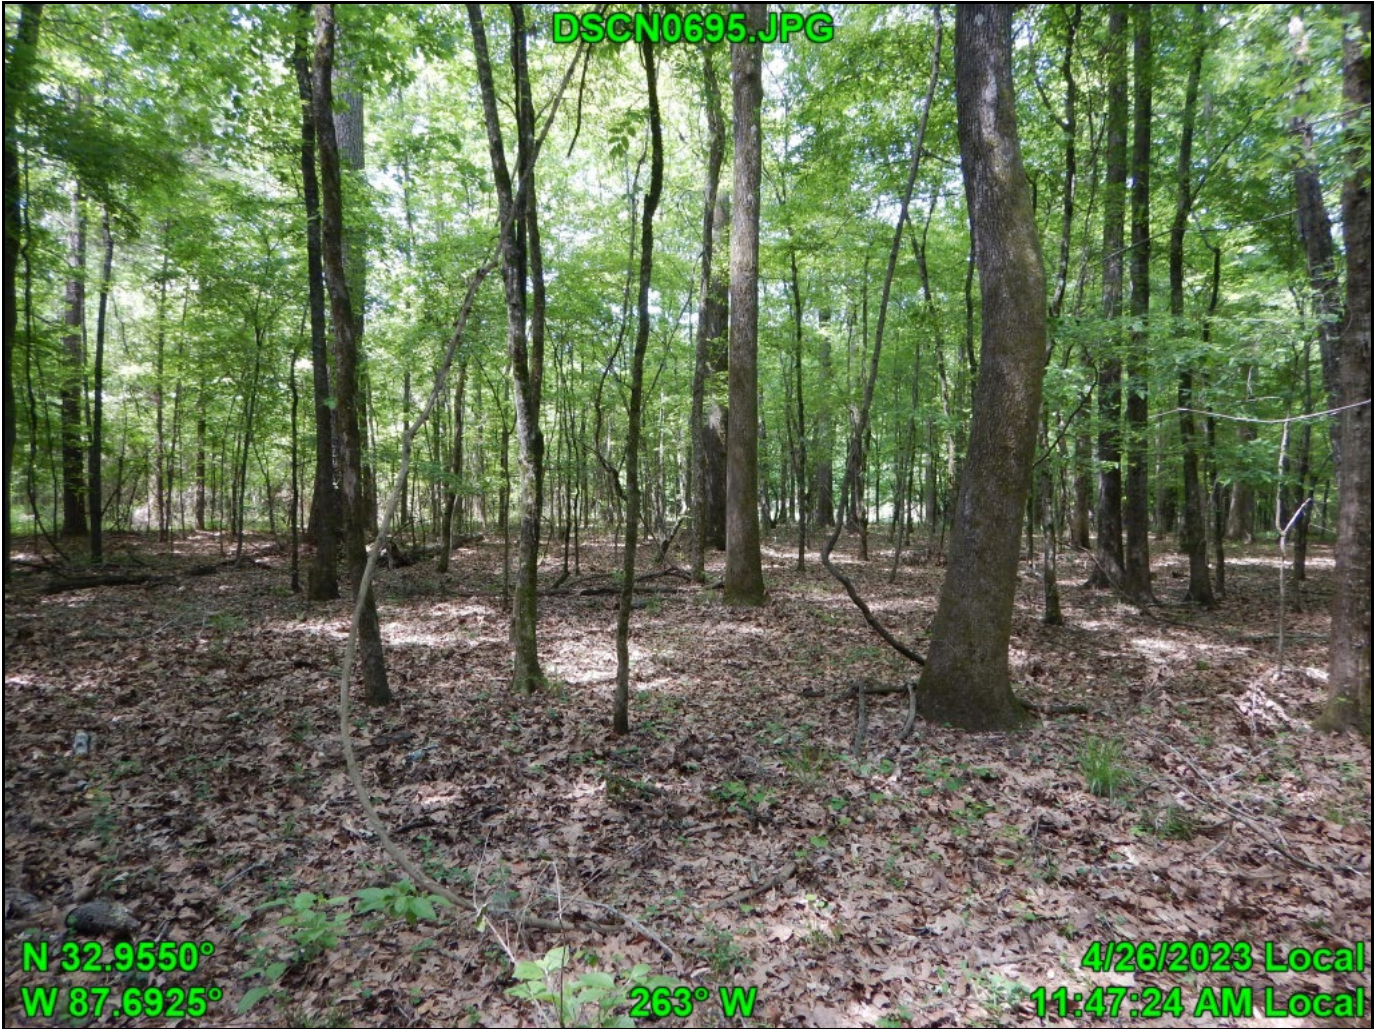
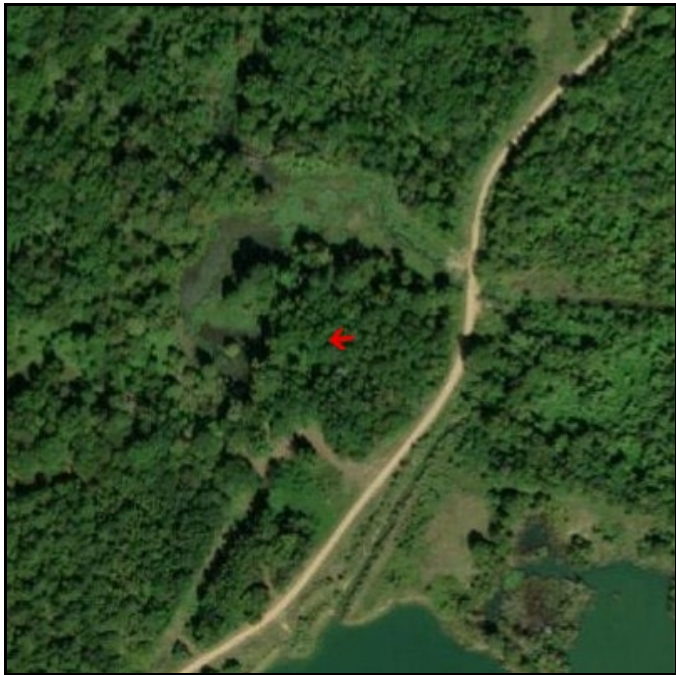
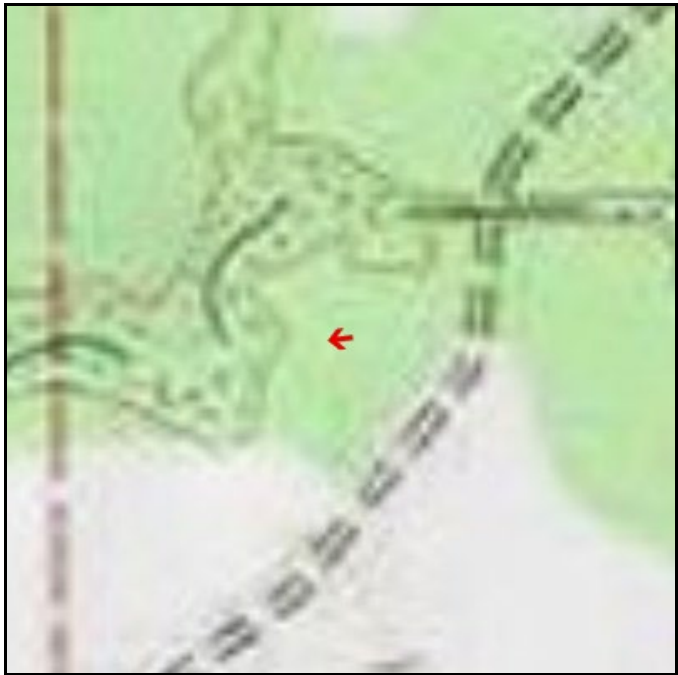
| Title | Photo 5 |

| Description | Striking west, over approximate location of data point S1. |

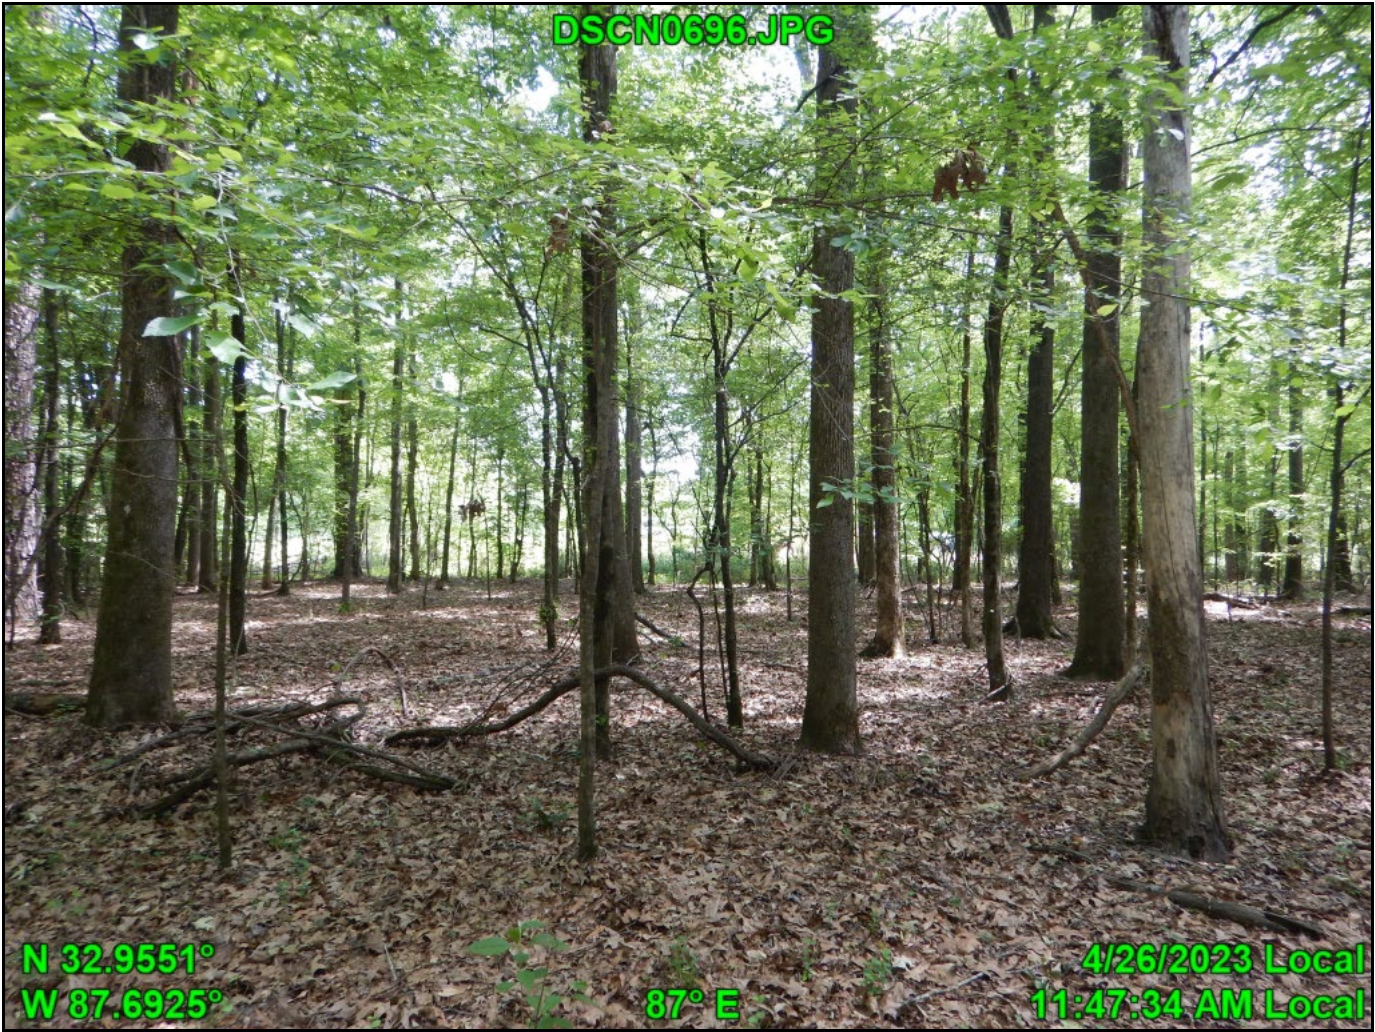
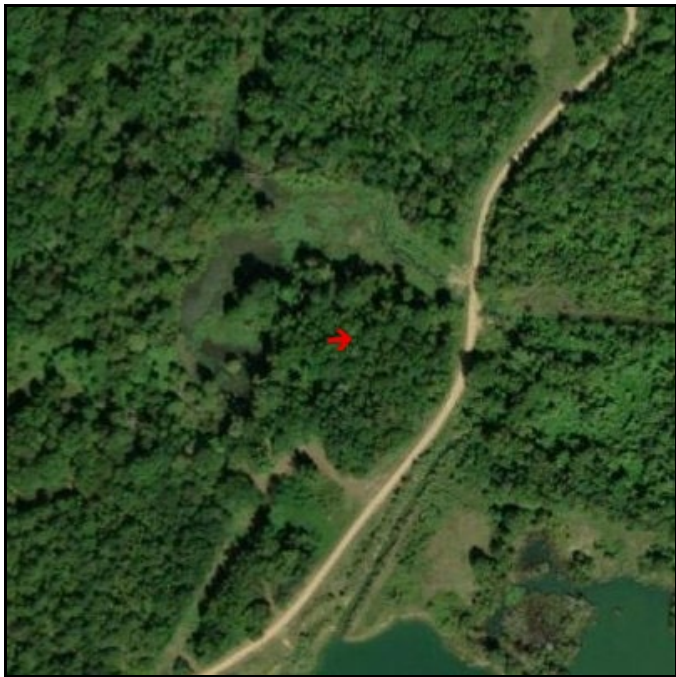
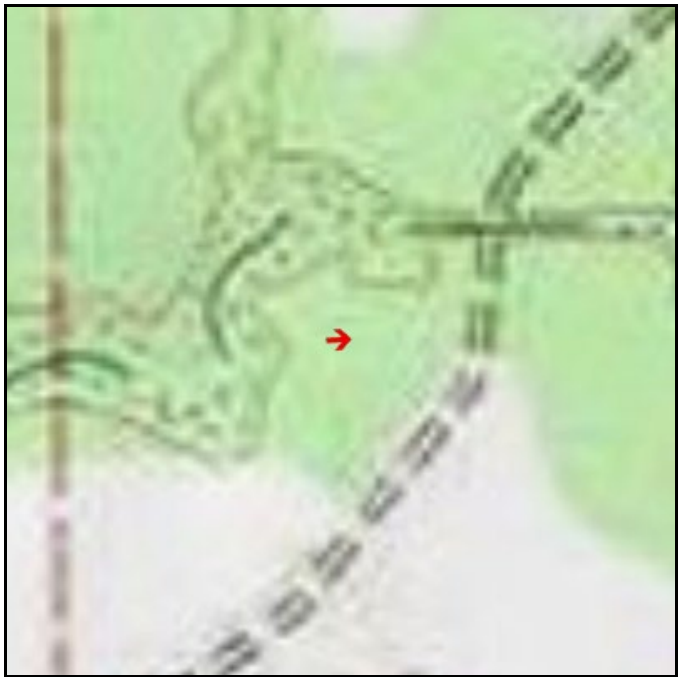
| Title | Photo 6 |

| Description | Striking east, over approximate location of data point S1. |

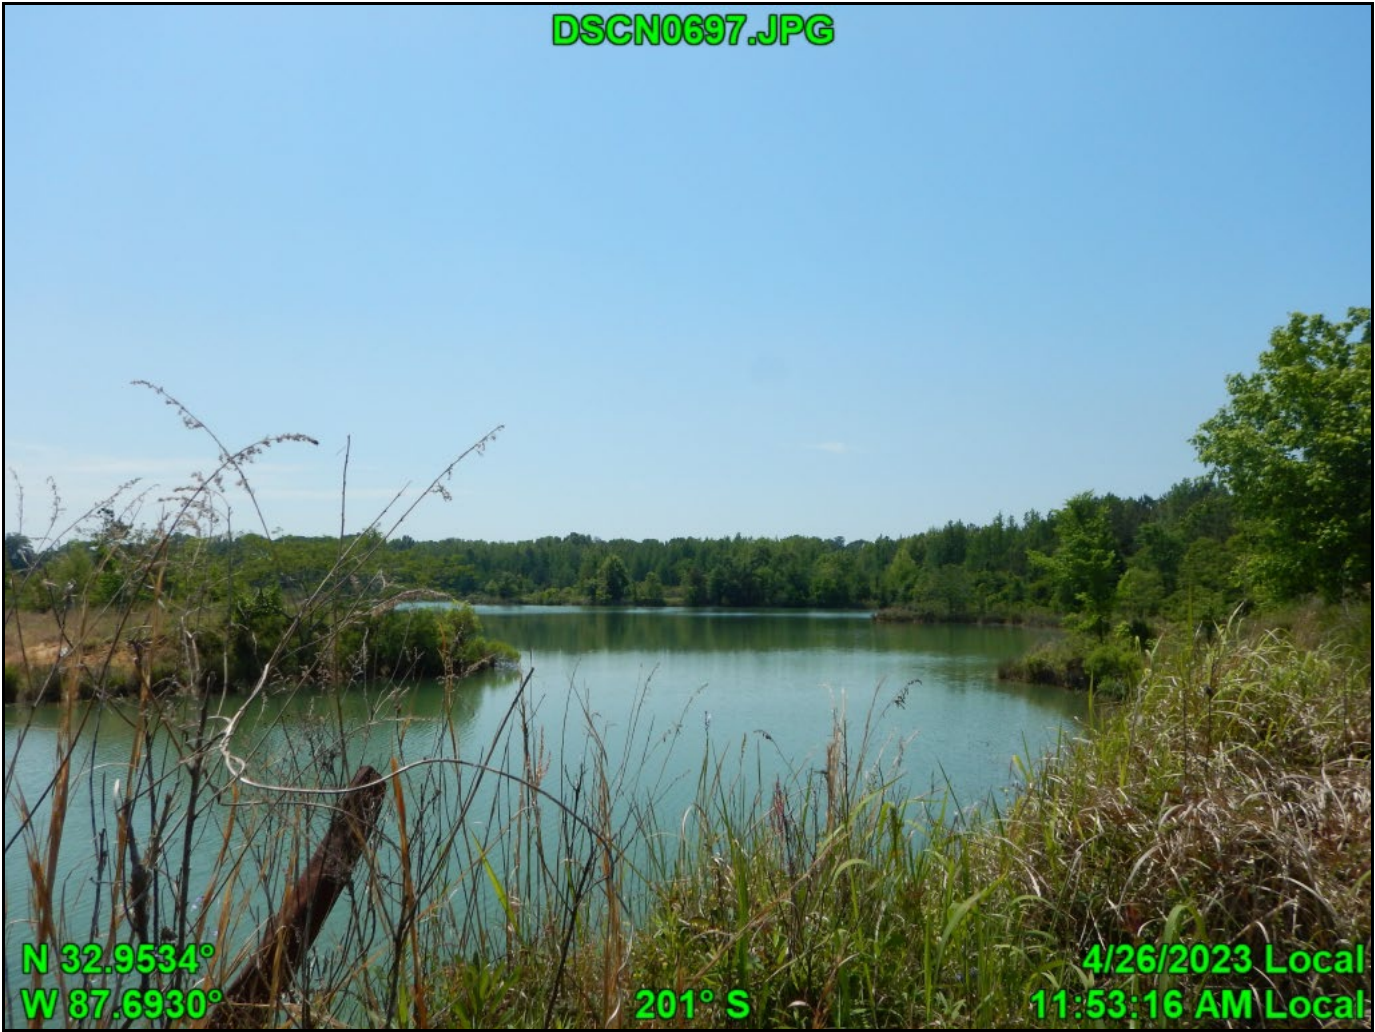
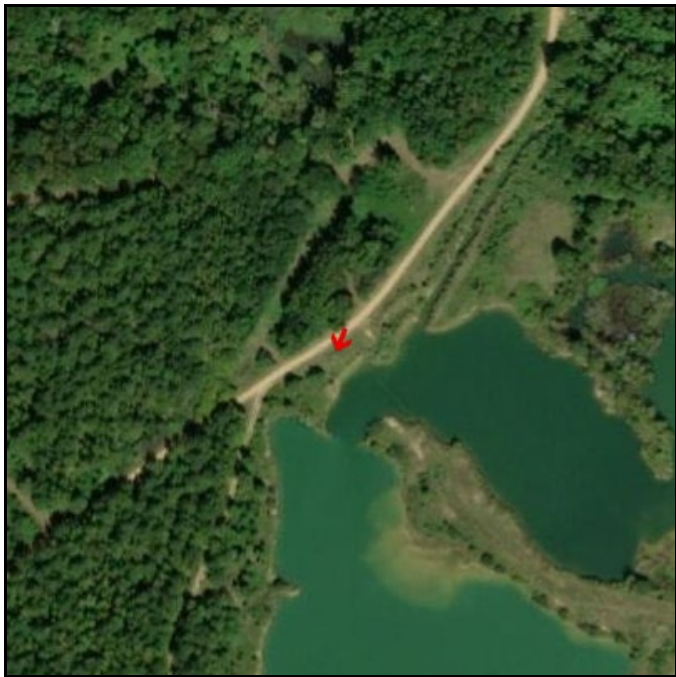
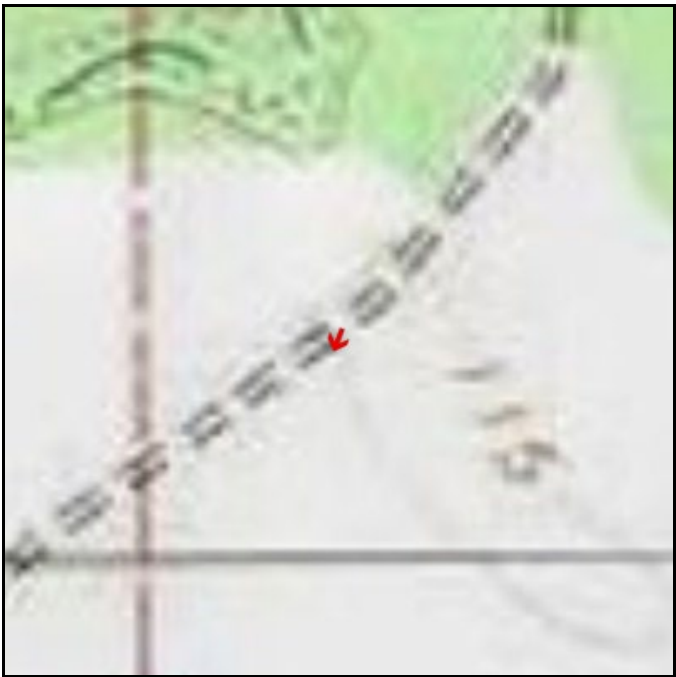
| Title | Photo 7 |

| Description | Striking south, southwest. View of pond, “Pond 3” (per NPDES permit) that feeds outfall. |

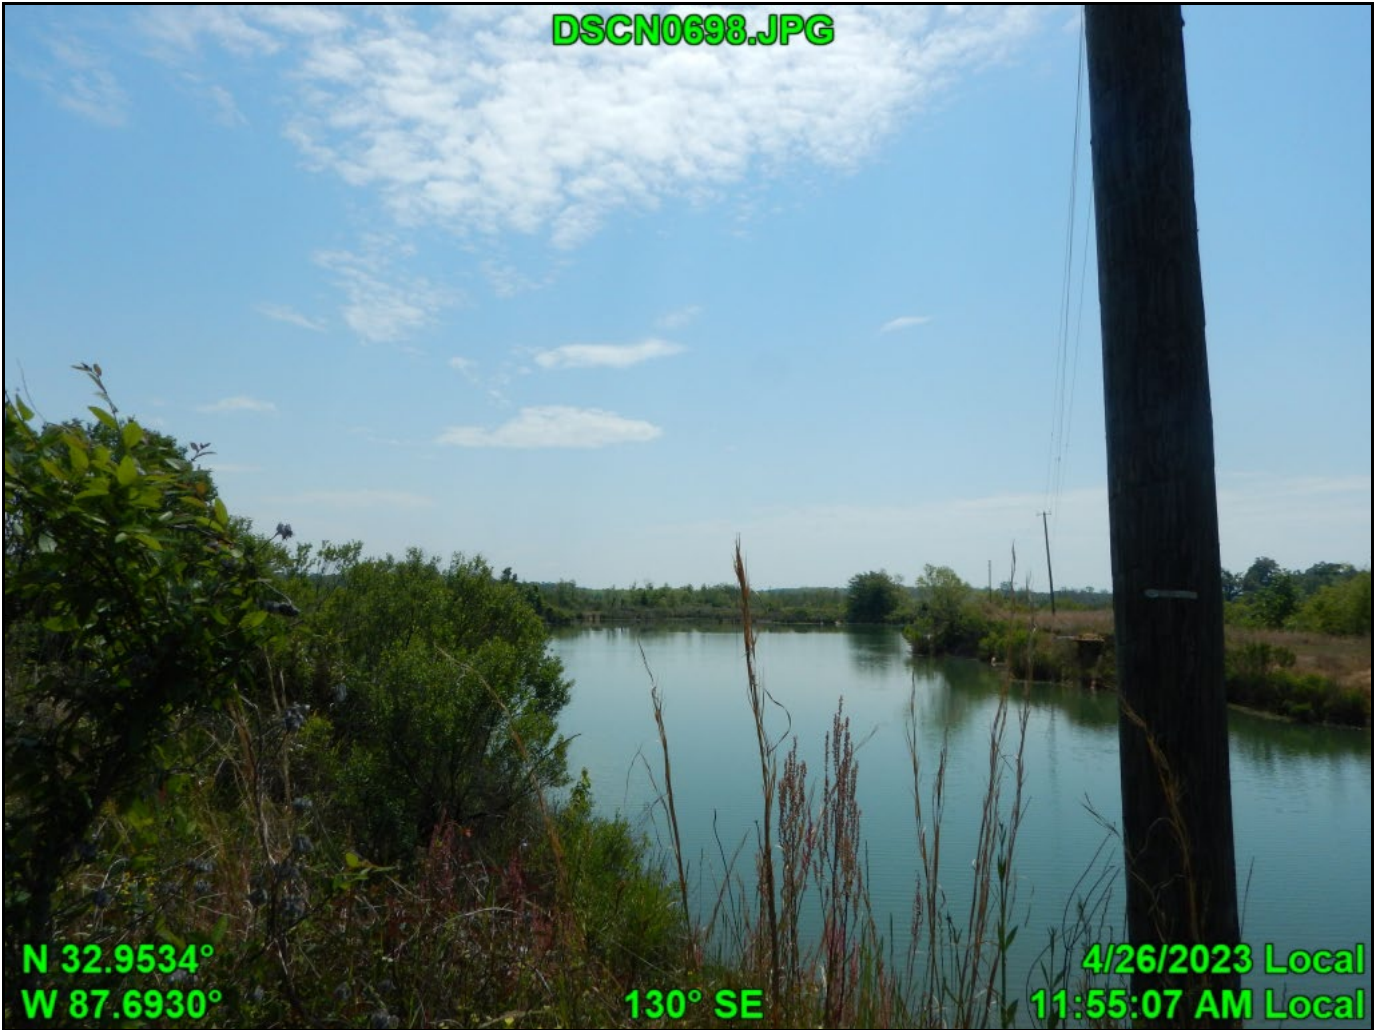
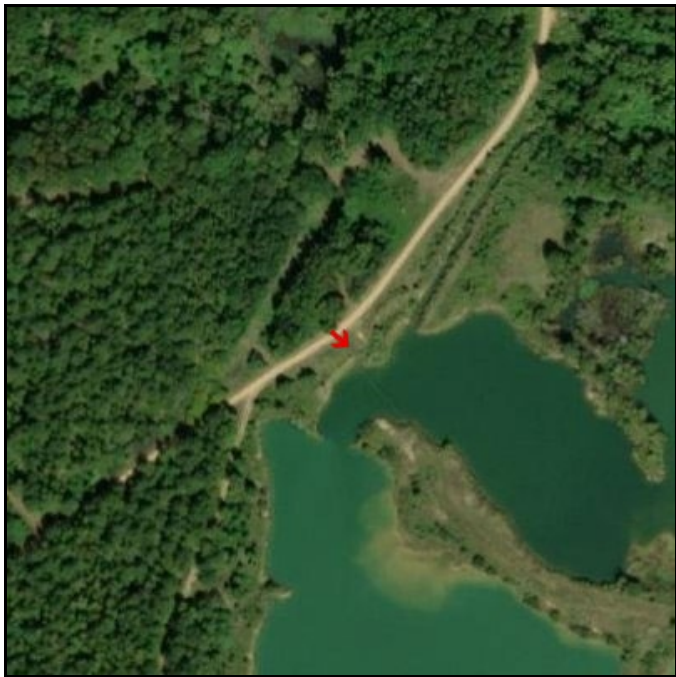
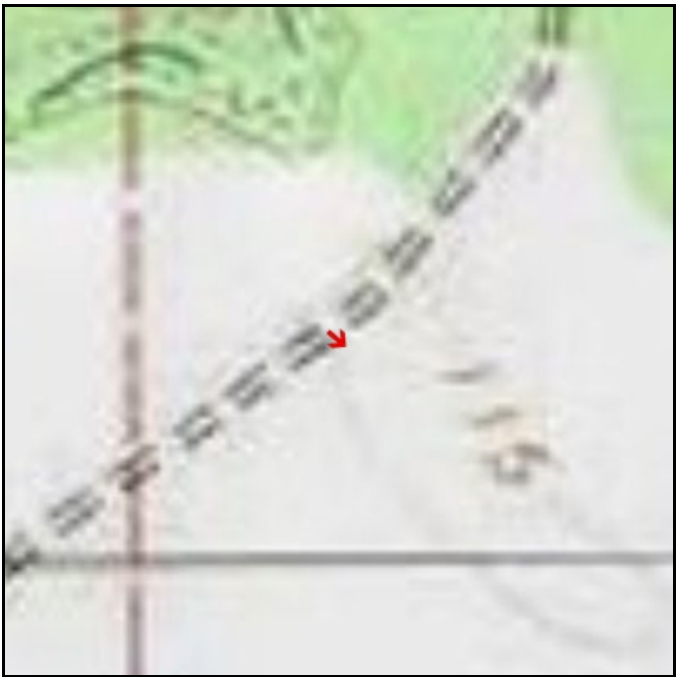
| Title | Photo 8 |

| Description | Striking southeast. Pond 3, pointing in a direction closer to the outfall. |

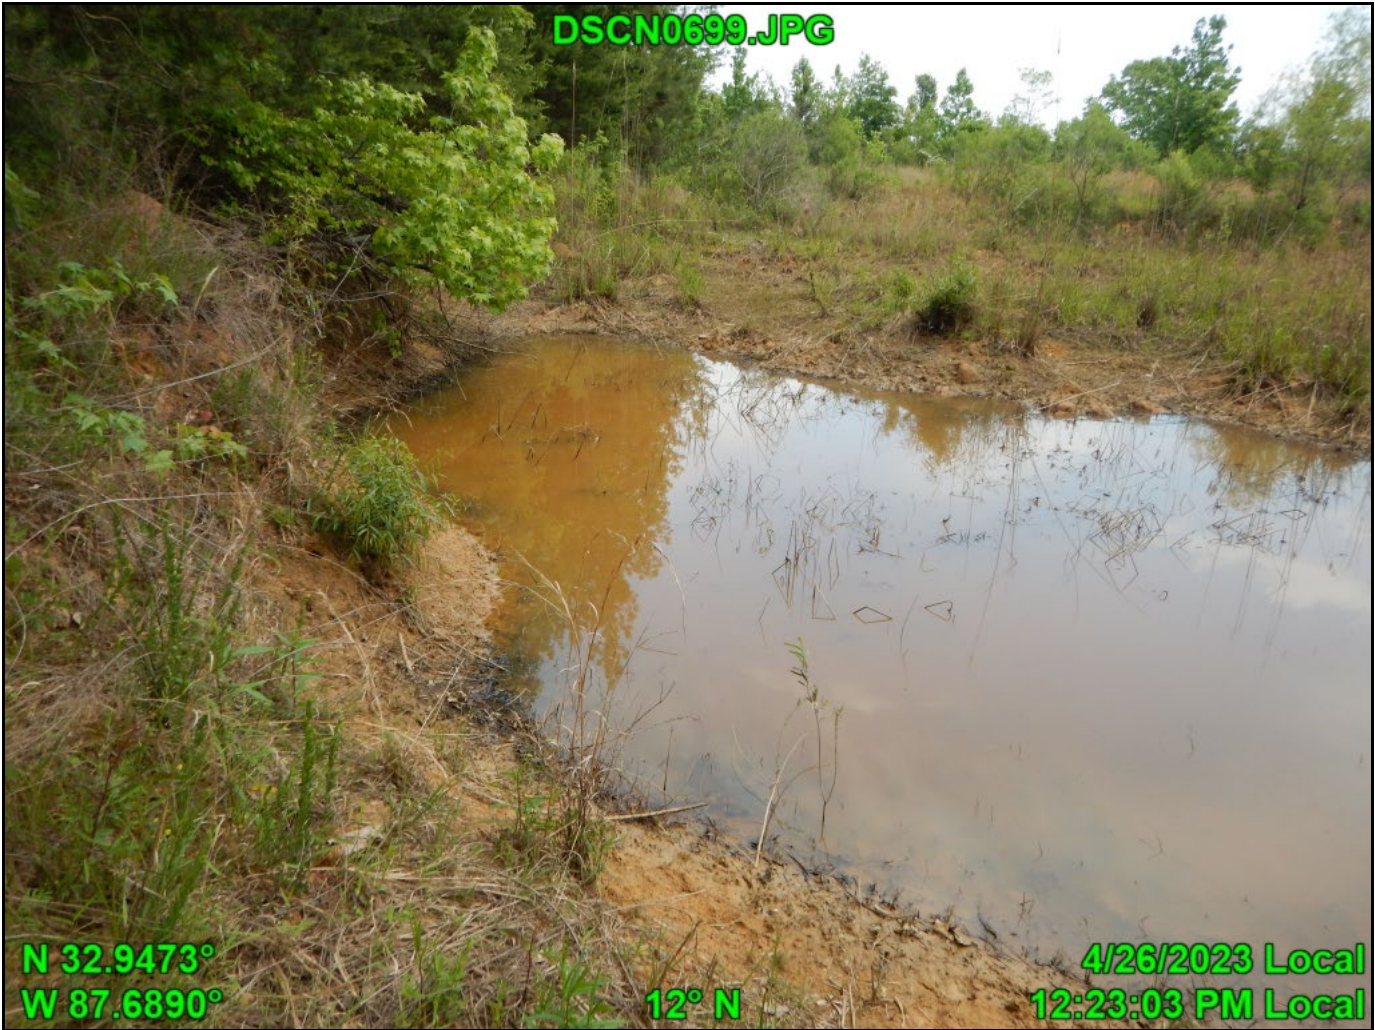
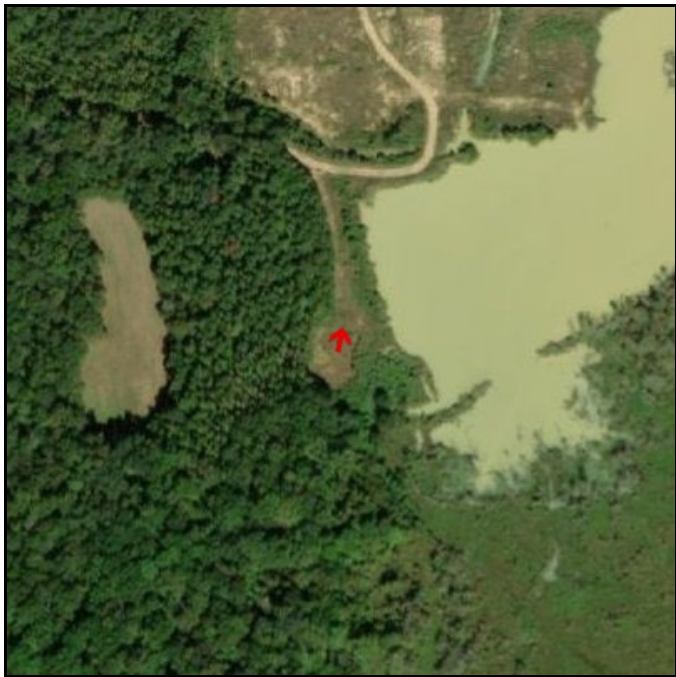
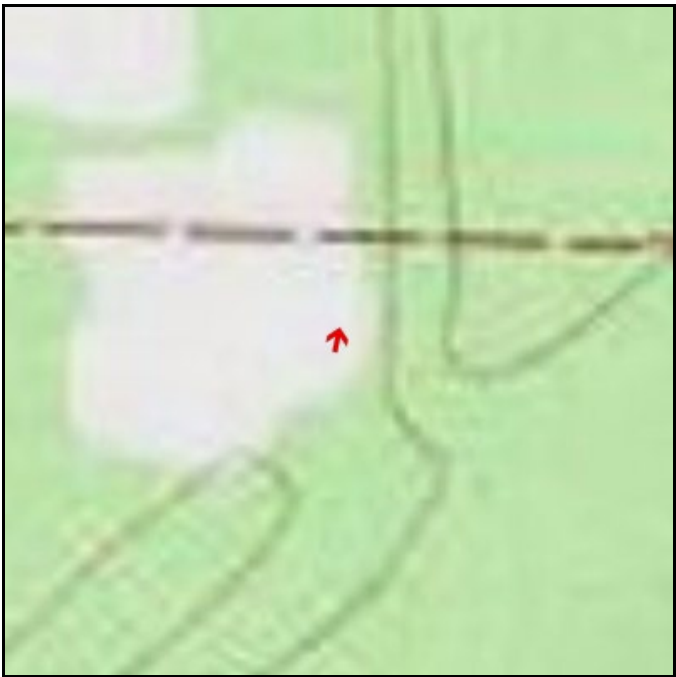
| Title | Photo 9 |

| Description | Striking north. Historical exploration/extraction area pertaining to a local methane concern, periodically fed by Pond 4. |

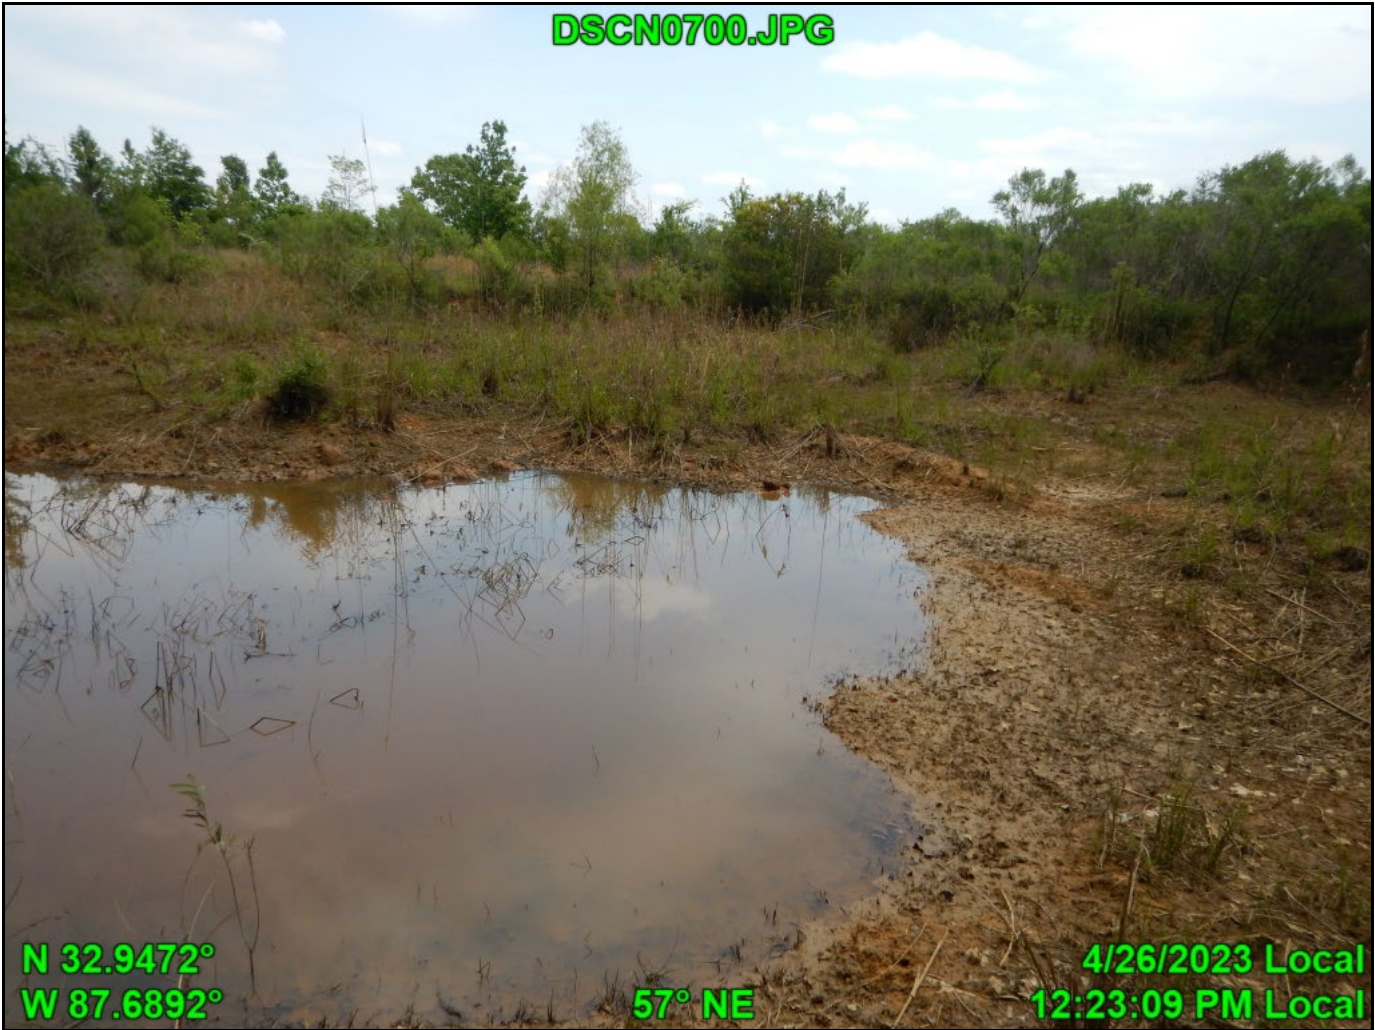
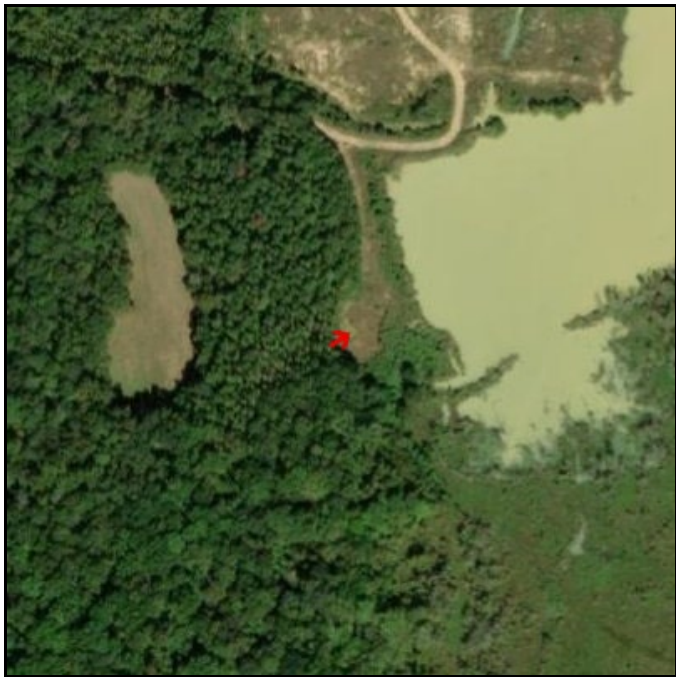
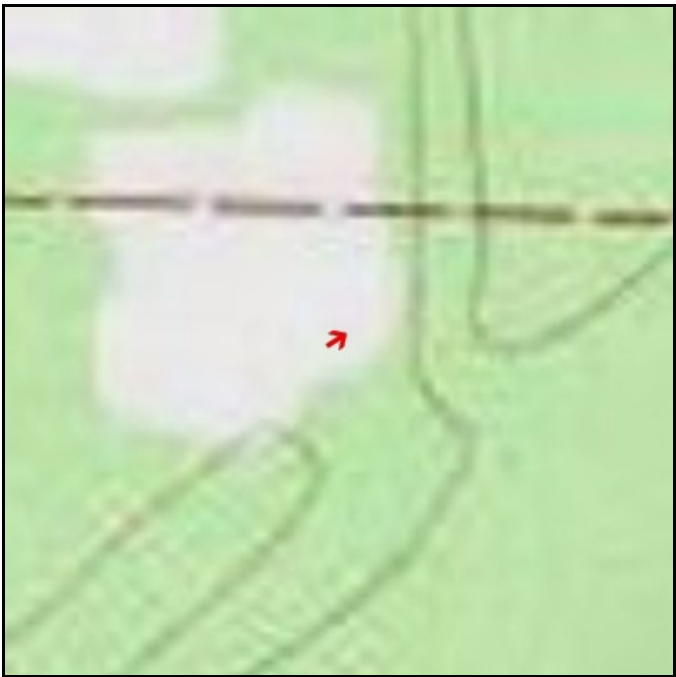
| Title | Photo 10 |

| Description | Striking northeast. Methane exploration/extraction area, looking in direction of Pond 4. |
