## ATTACHMENT C: Photograph Log

### Cypress Pit

Bama Concrete Products Company, Inc.  
dba Davis Sand and Gravel

Cypress, Alabama  
April 26-27, 2023

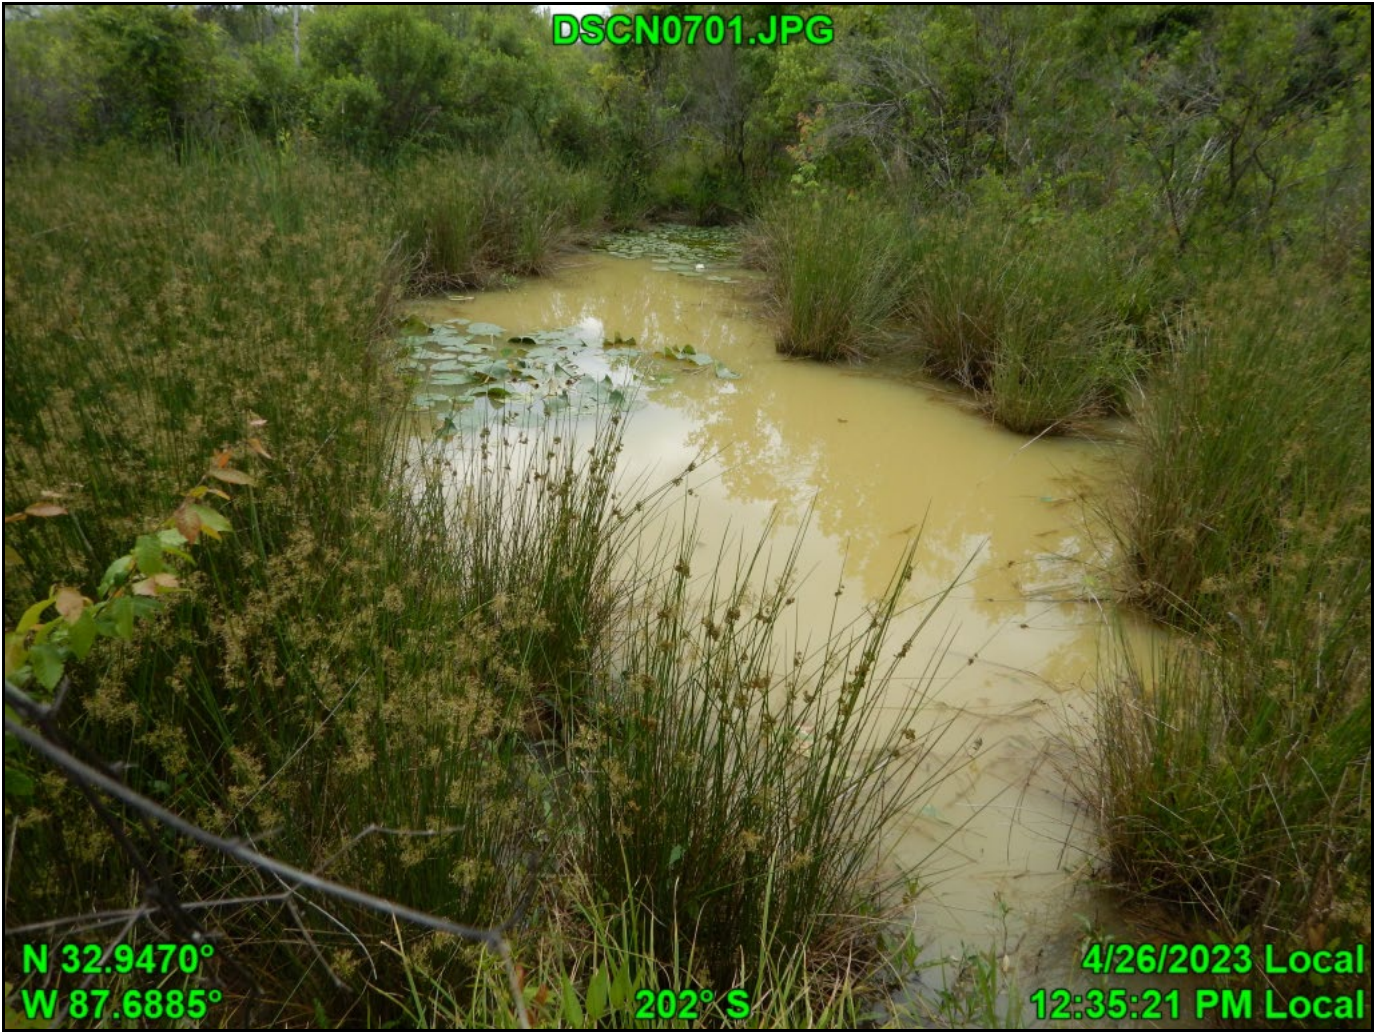
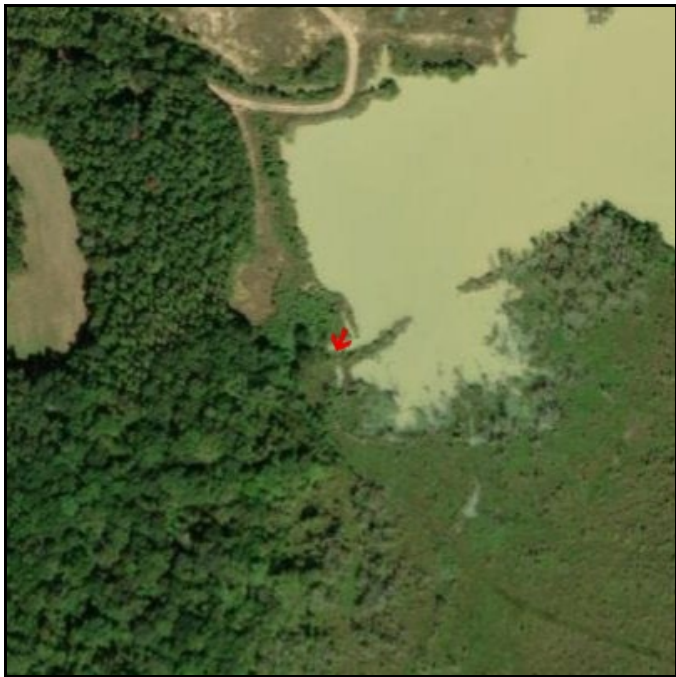
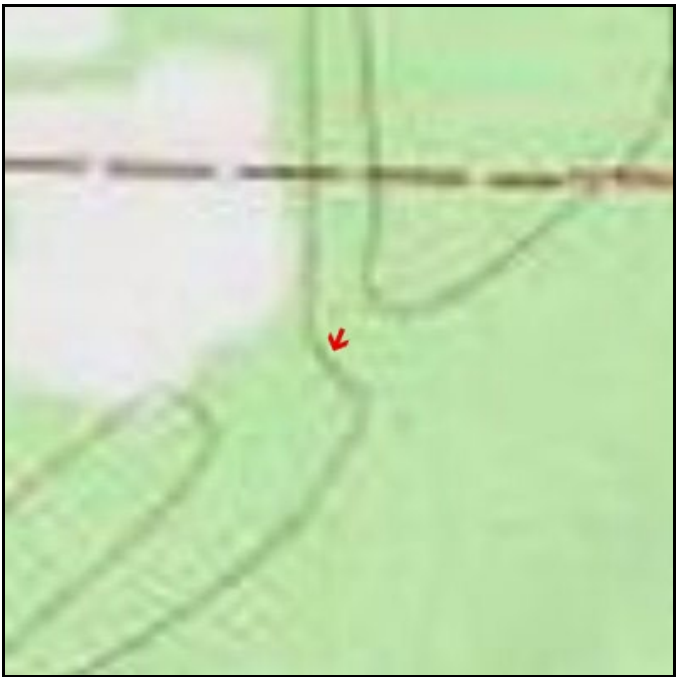
| Title | Photo 11 |

| Description | Striking south, southwest. Obligate wetland vegetation growing in cove area potentially created by a berm breach. |

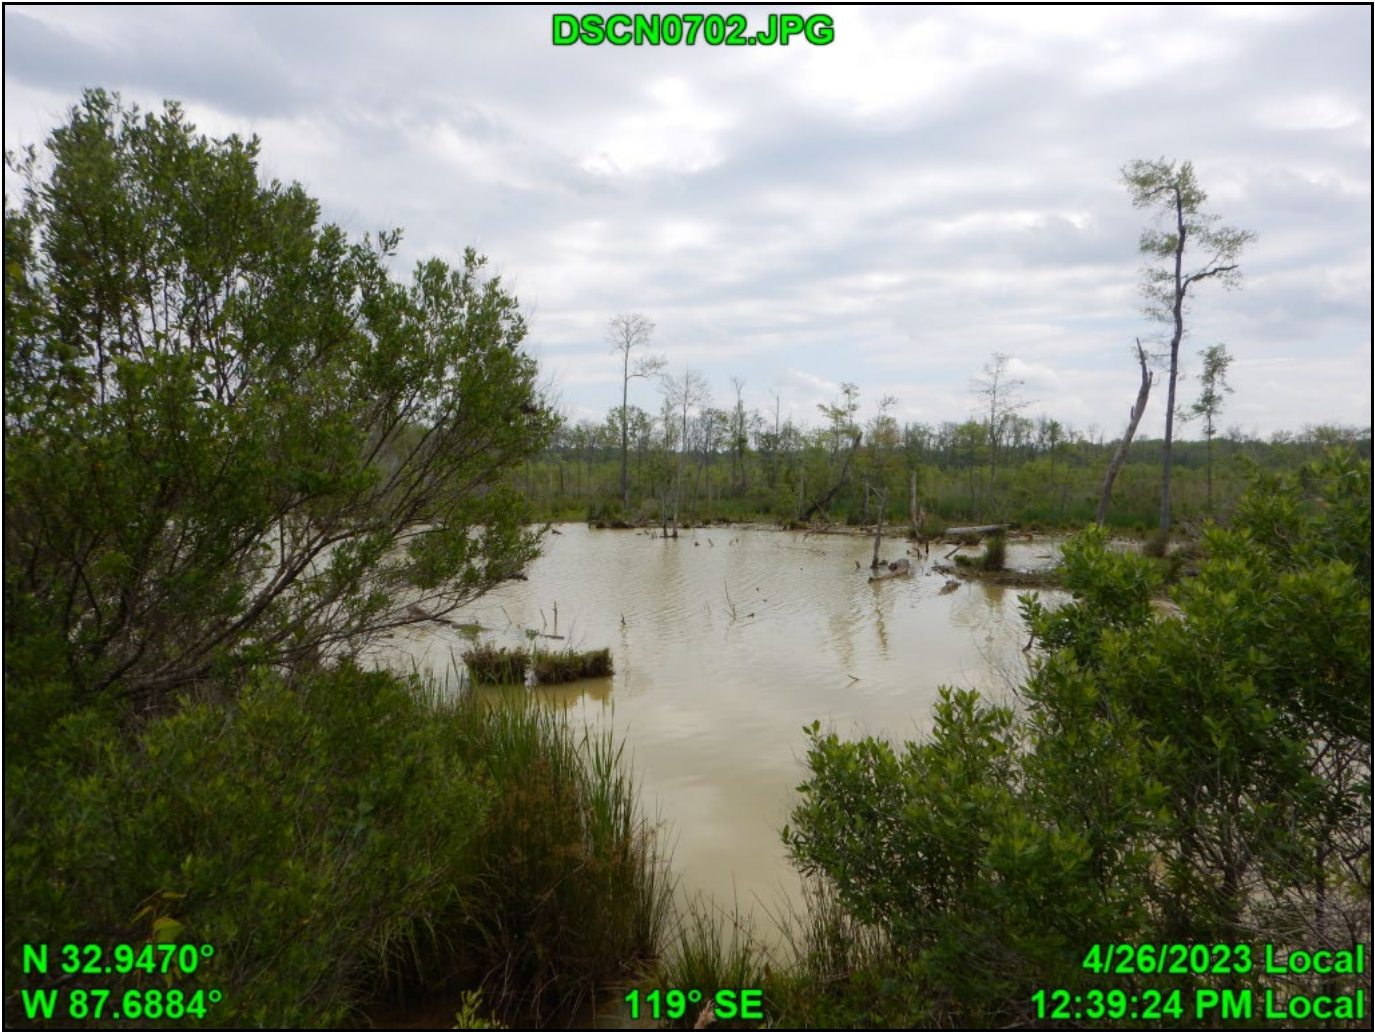
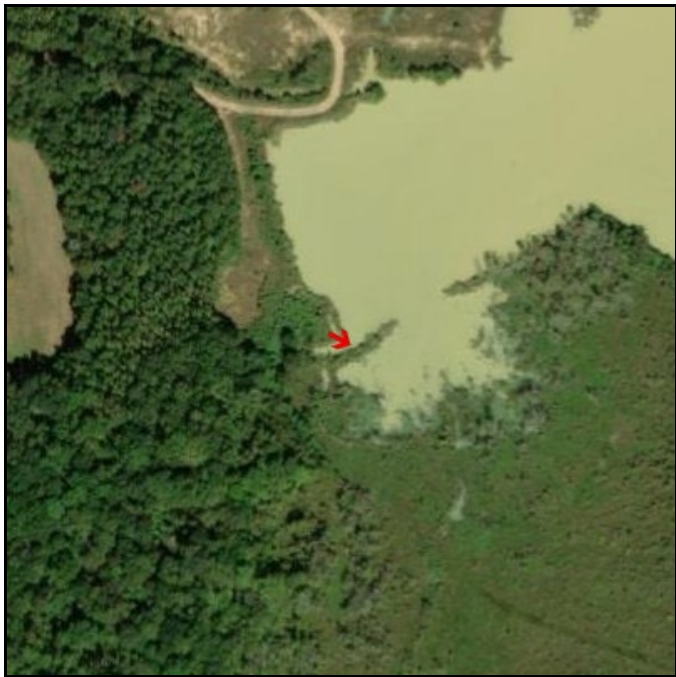
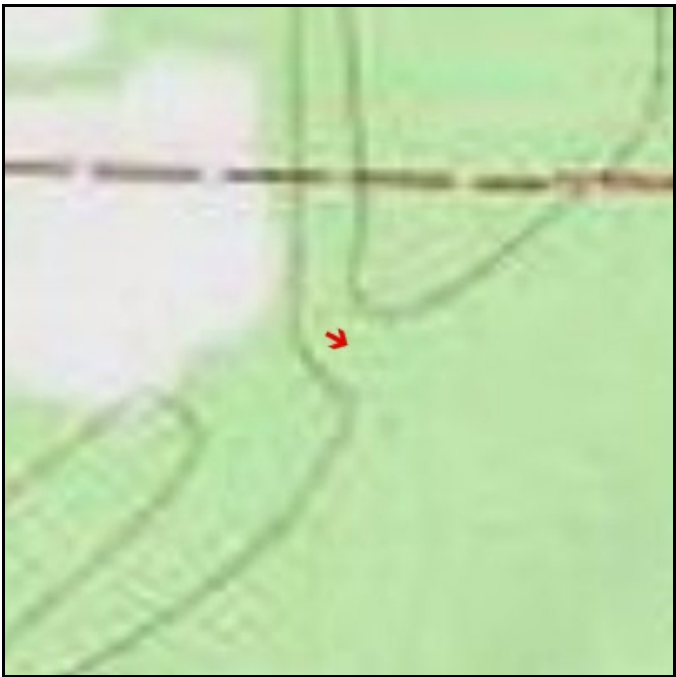
| Title | Photo 12 |

| Description | Striking east, southeast. Taken from the breached berm, looking toward a wetland system beyond the permitted limits of settling Pond 4. |

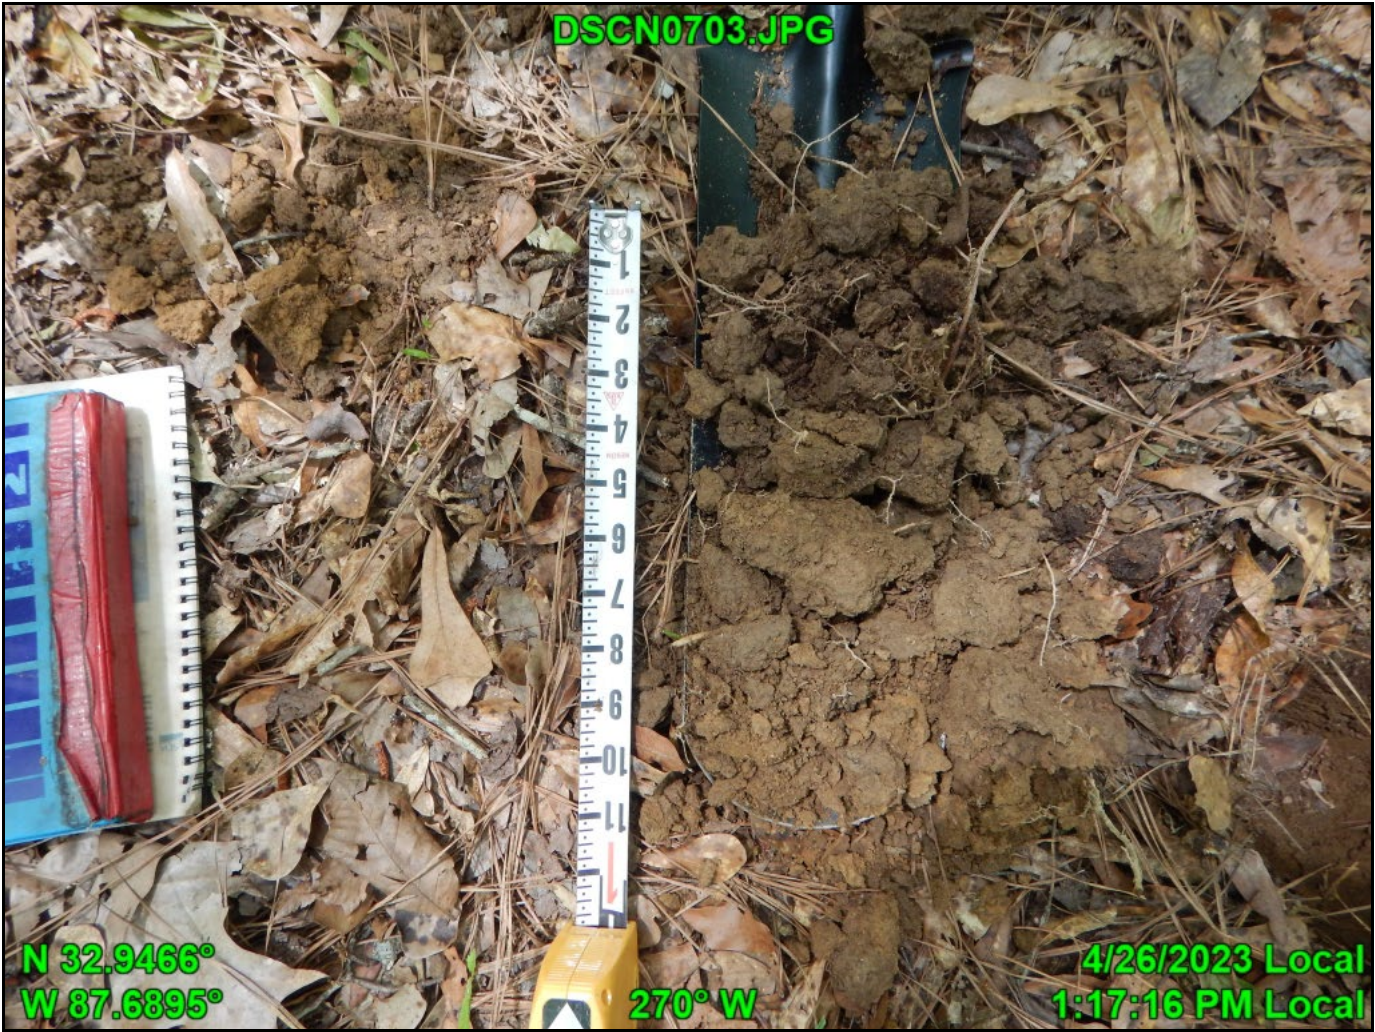
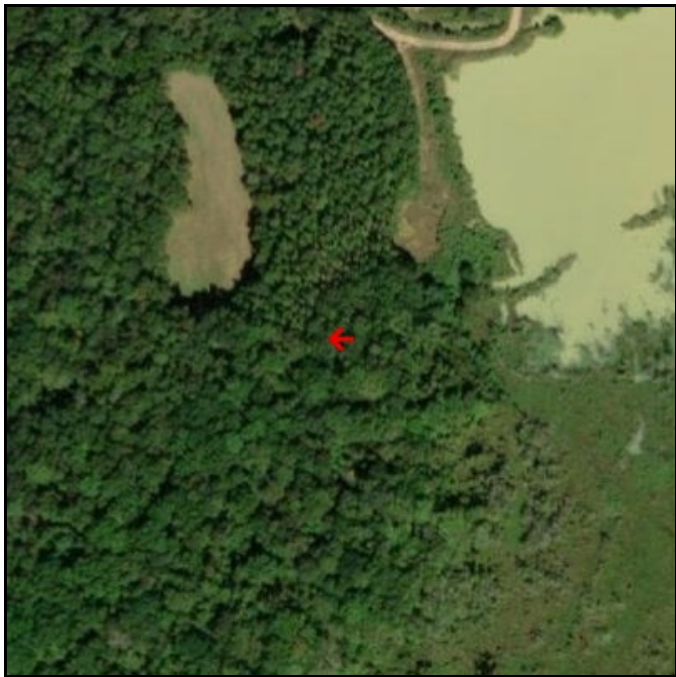
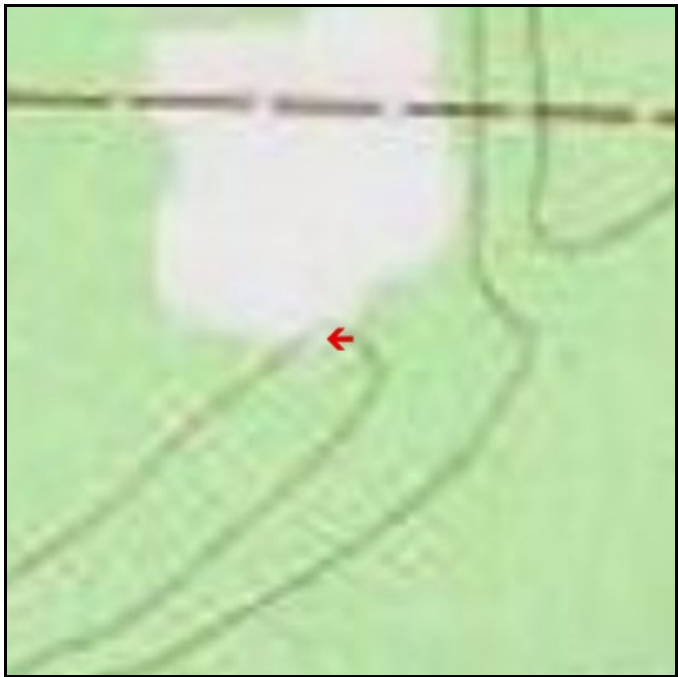
| Title | Photo 13 |

| Description | Soil profile, data point S2. |

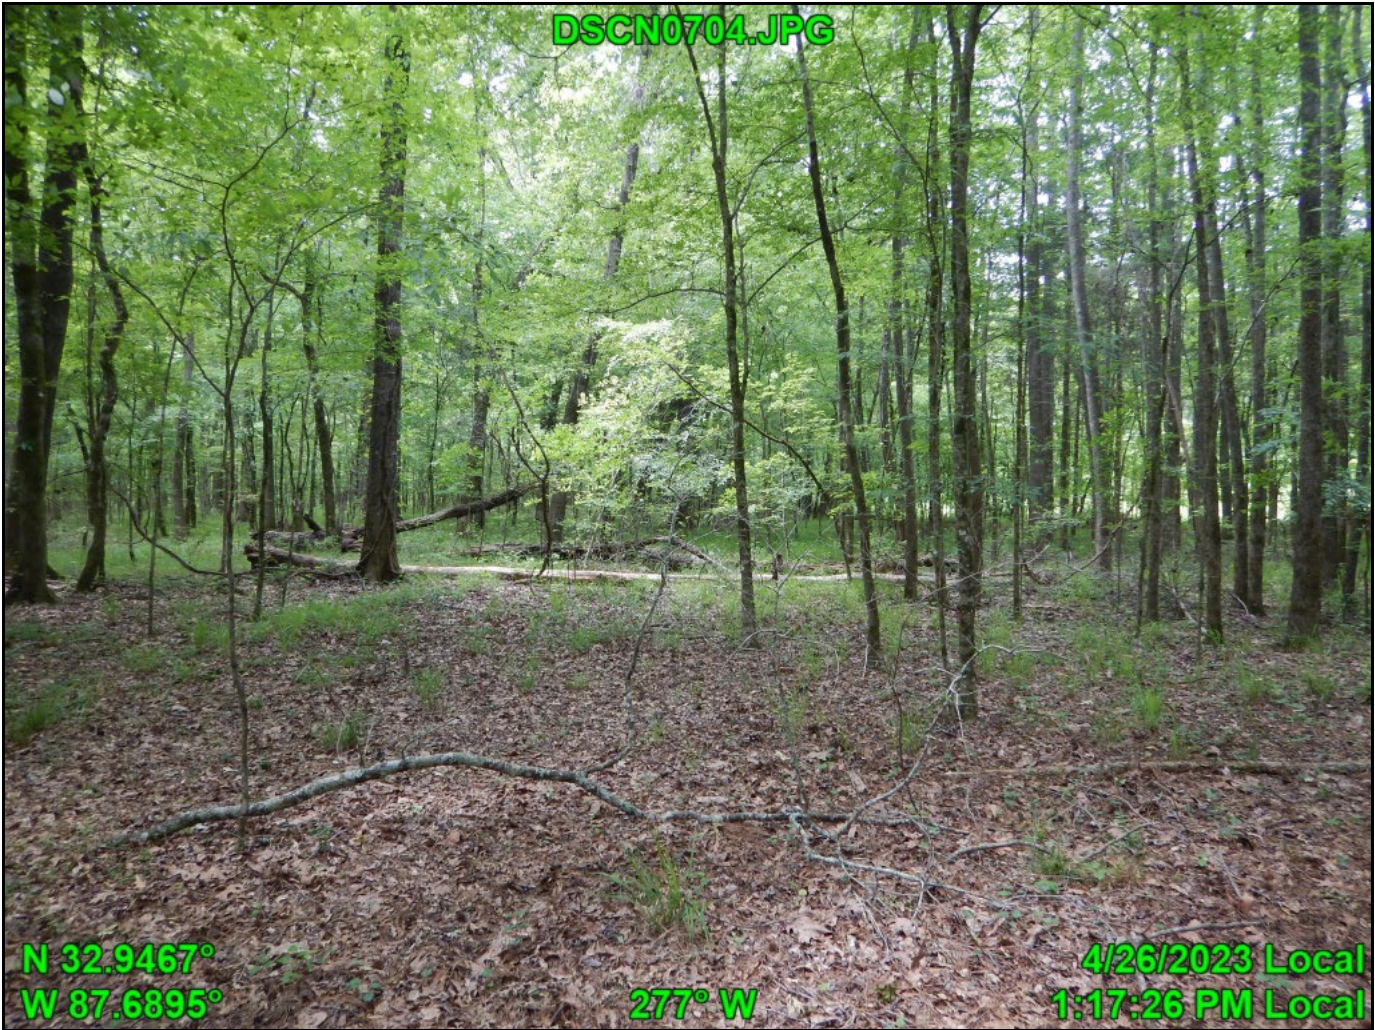
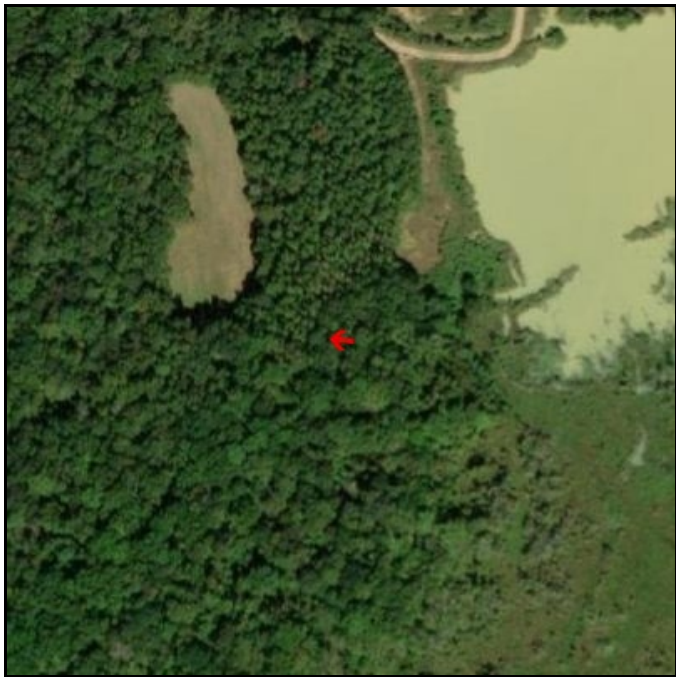
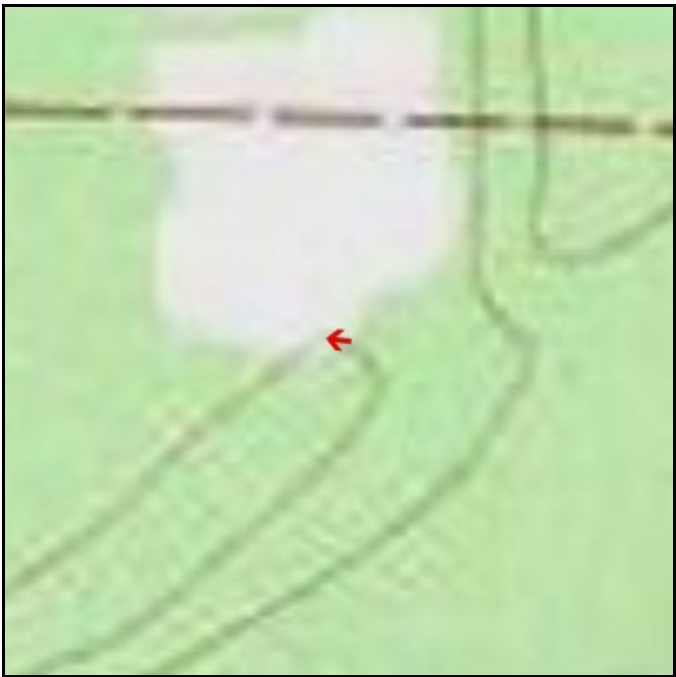
| Title | Photo 14 |

| Description | Striking west, over data point S2. |

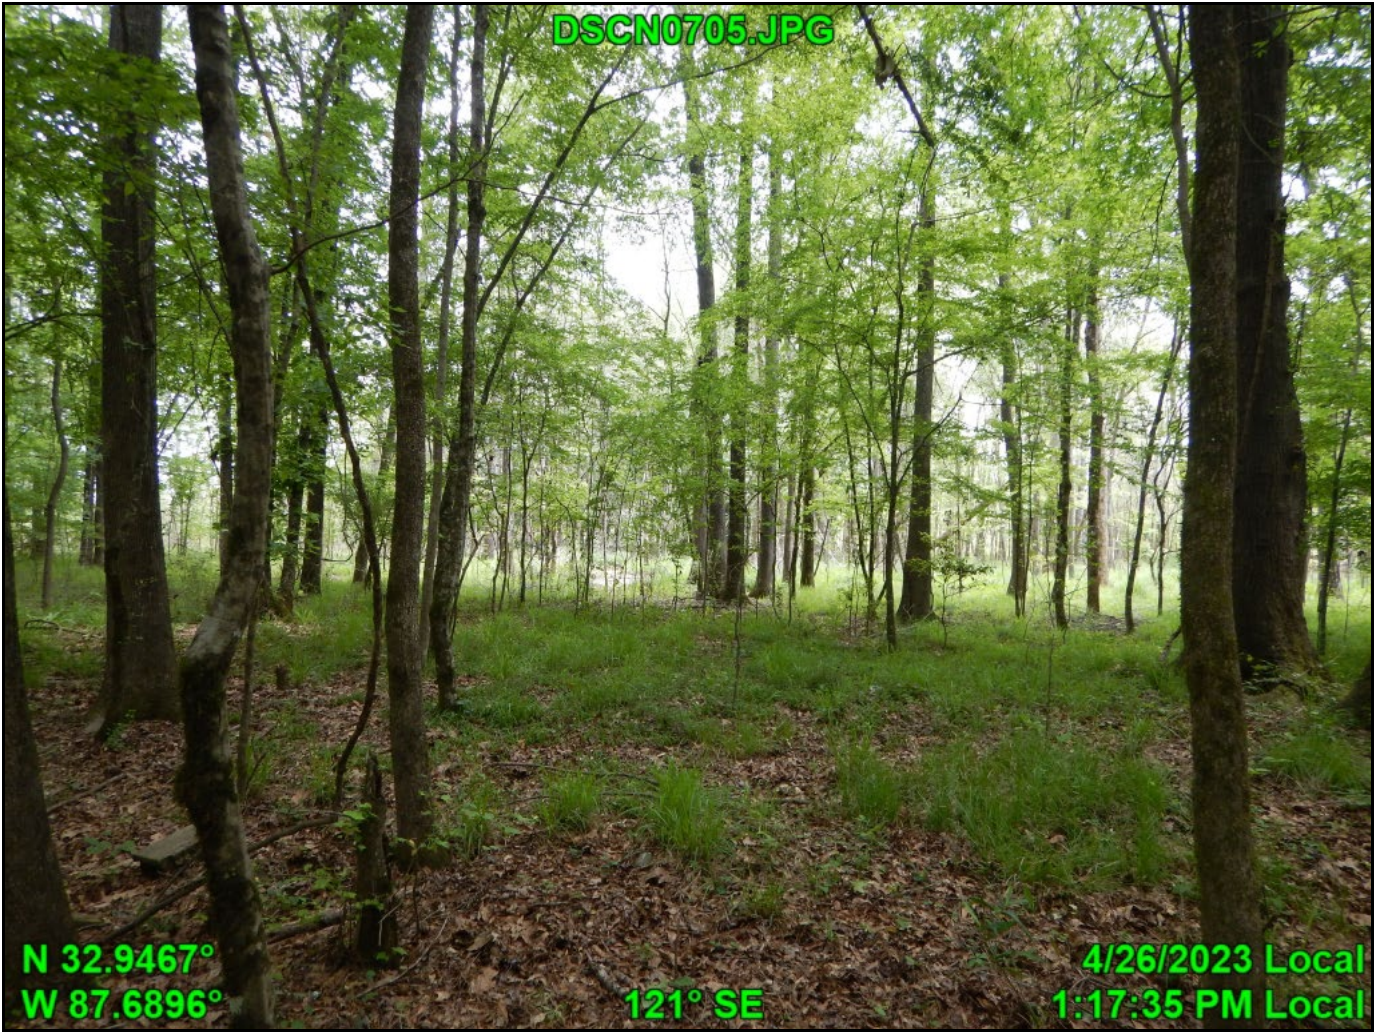
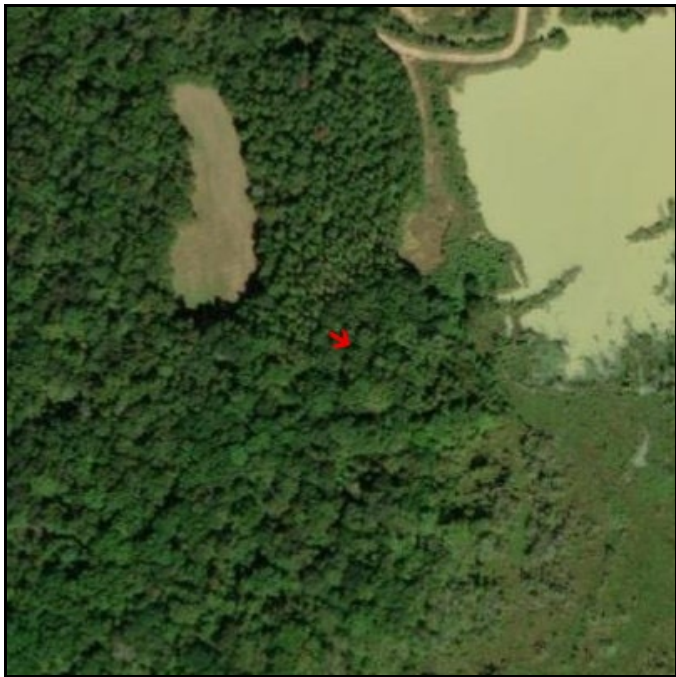
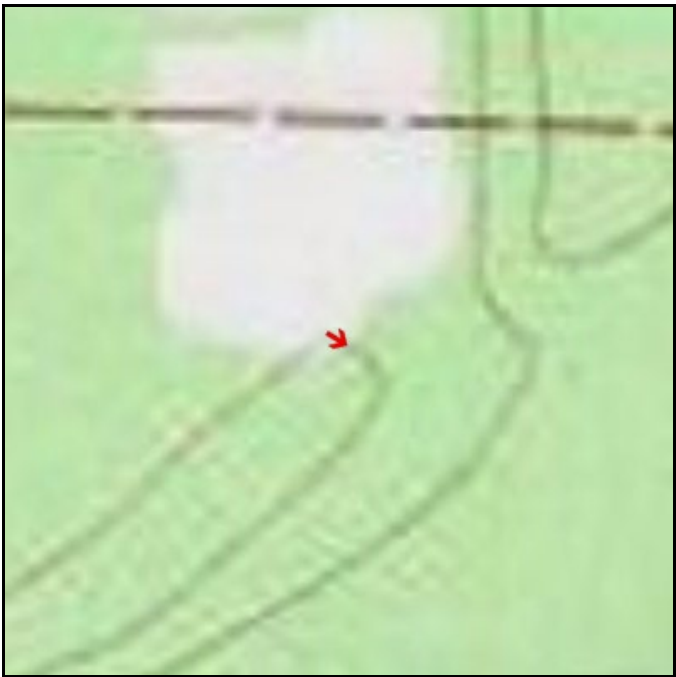
| Title | Photo 15 |

| Description | Striking east, southeast, over data point S2. |

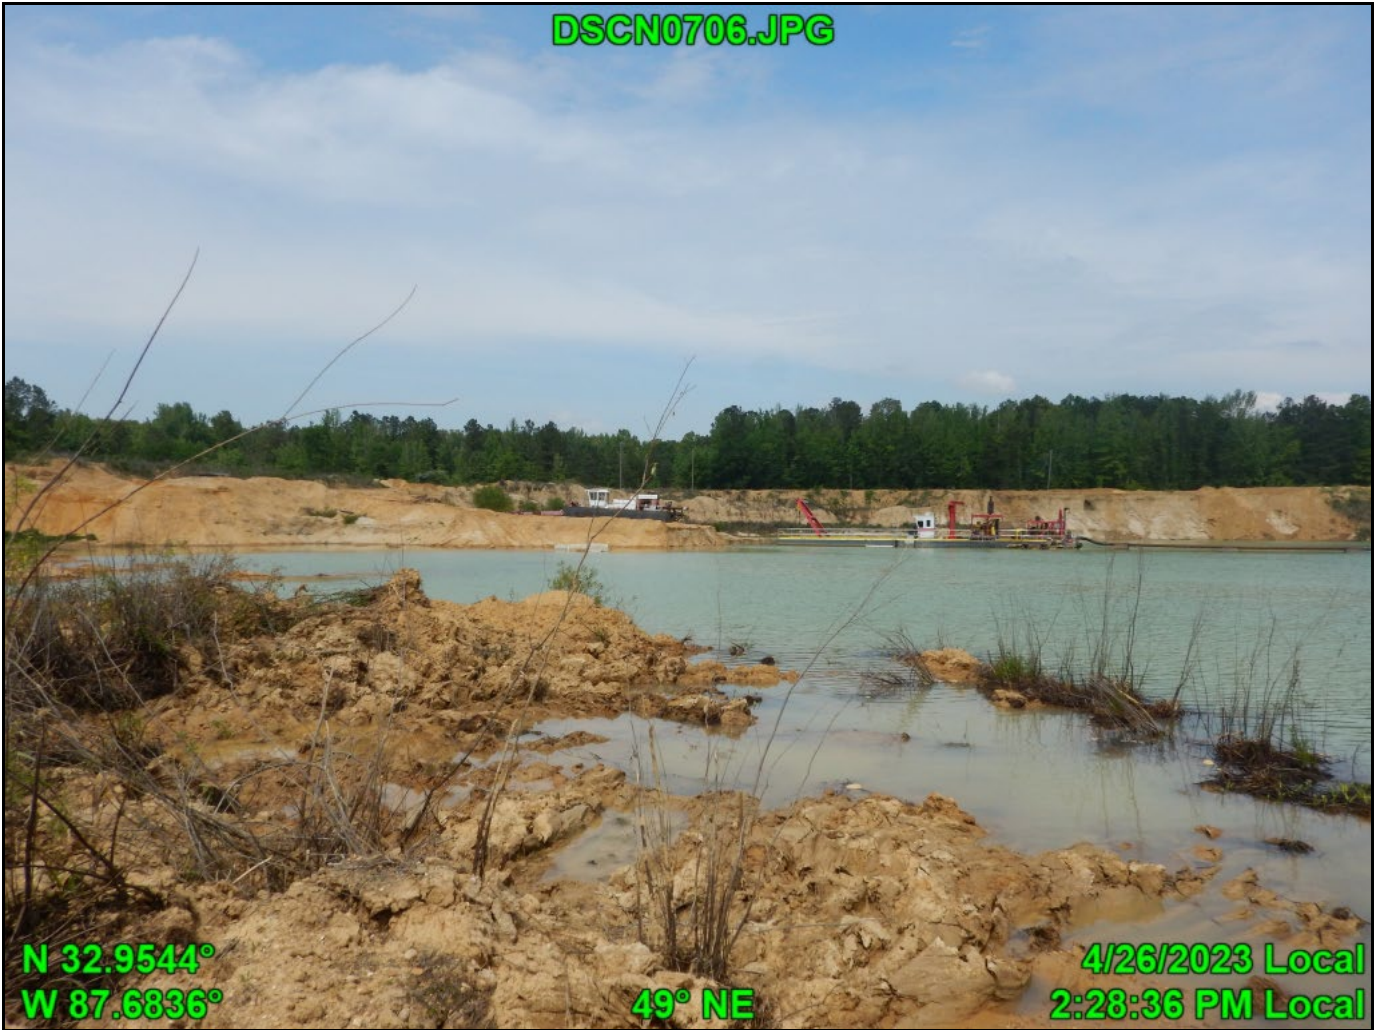
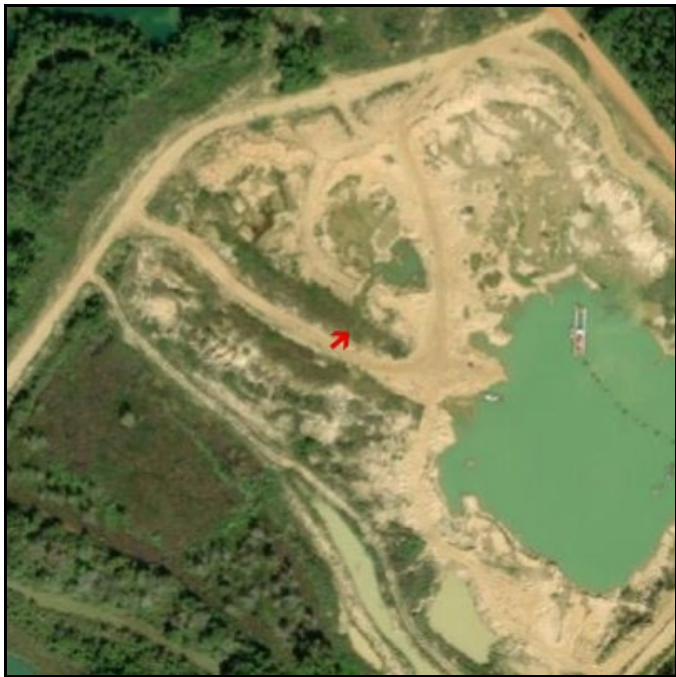
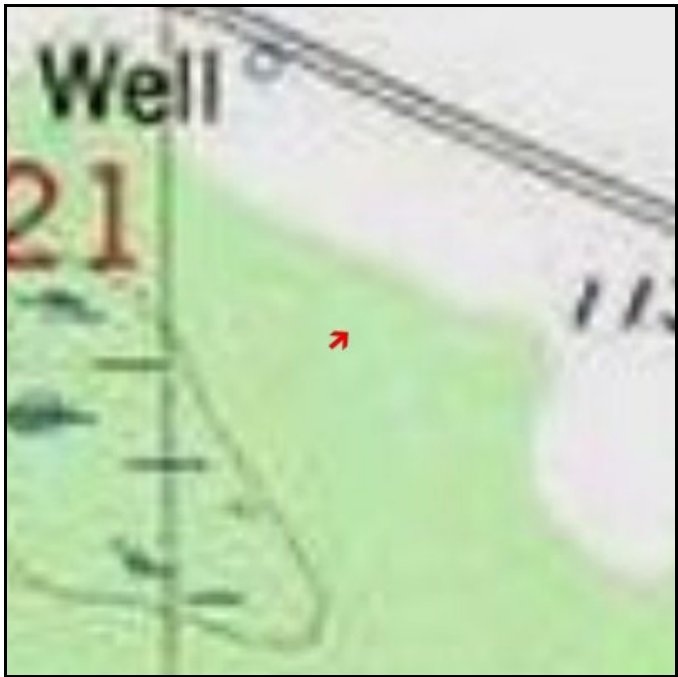
| Title | Photo 16 |

| Description | Striking northeast. Facility's new dredge. Material dredging actively taking place in cell directly south of Cutoff Road. |

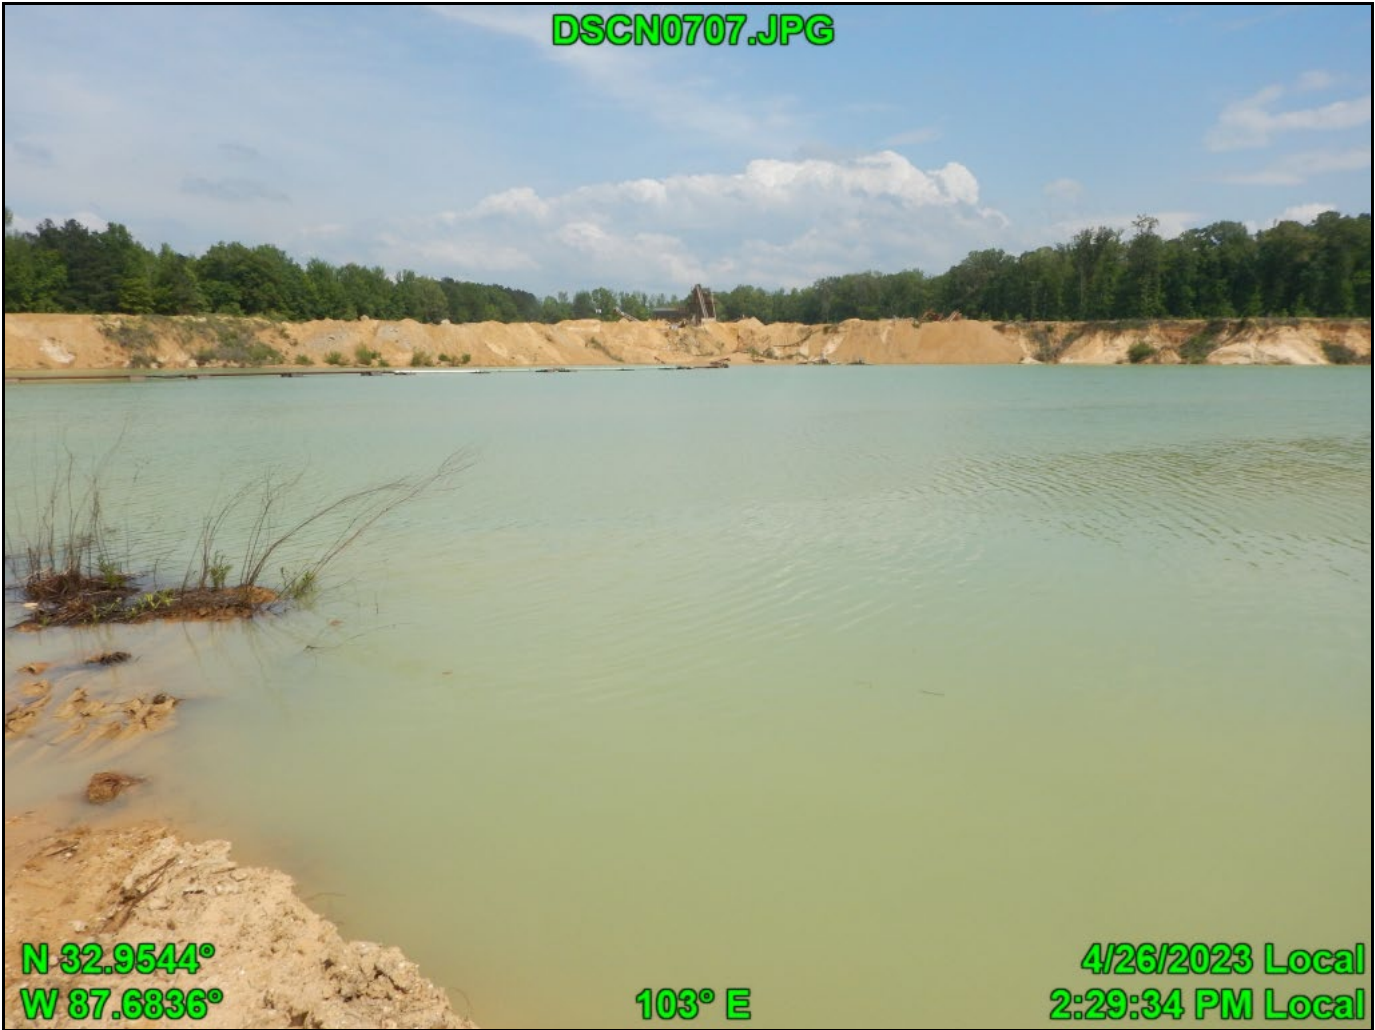
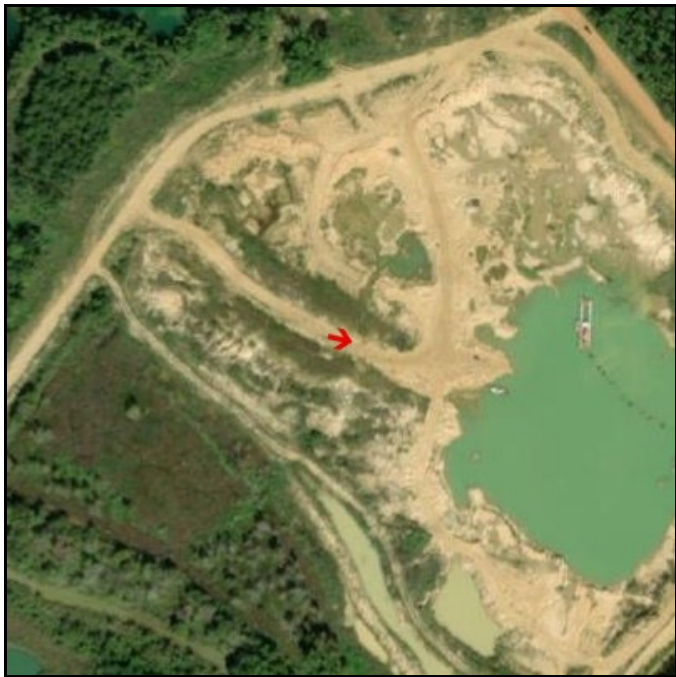
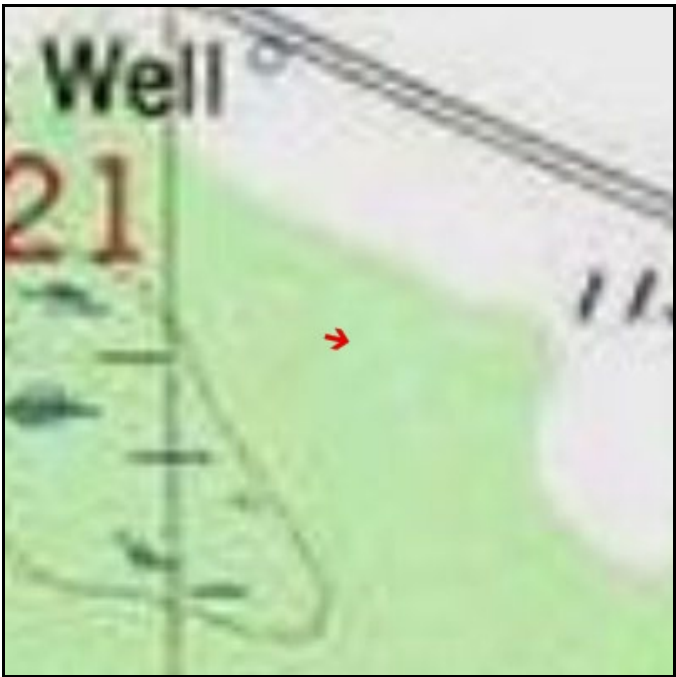
| Title | Photo 17 |

| Description | Striking east. Broad view of active dredging location, material sorter in the background. |

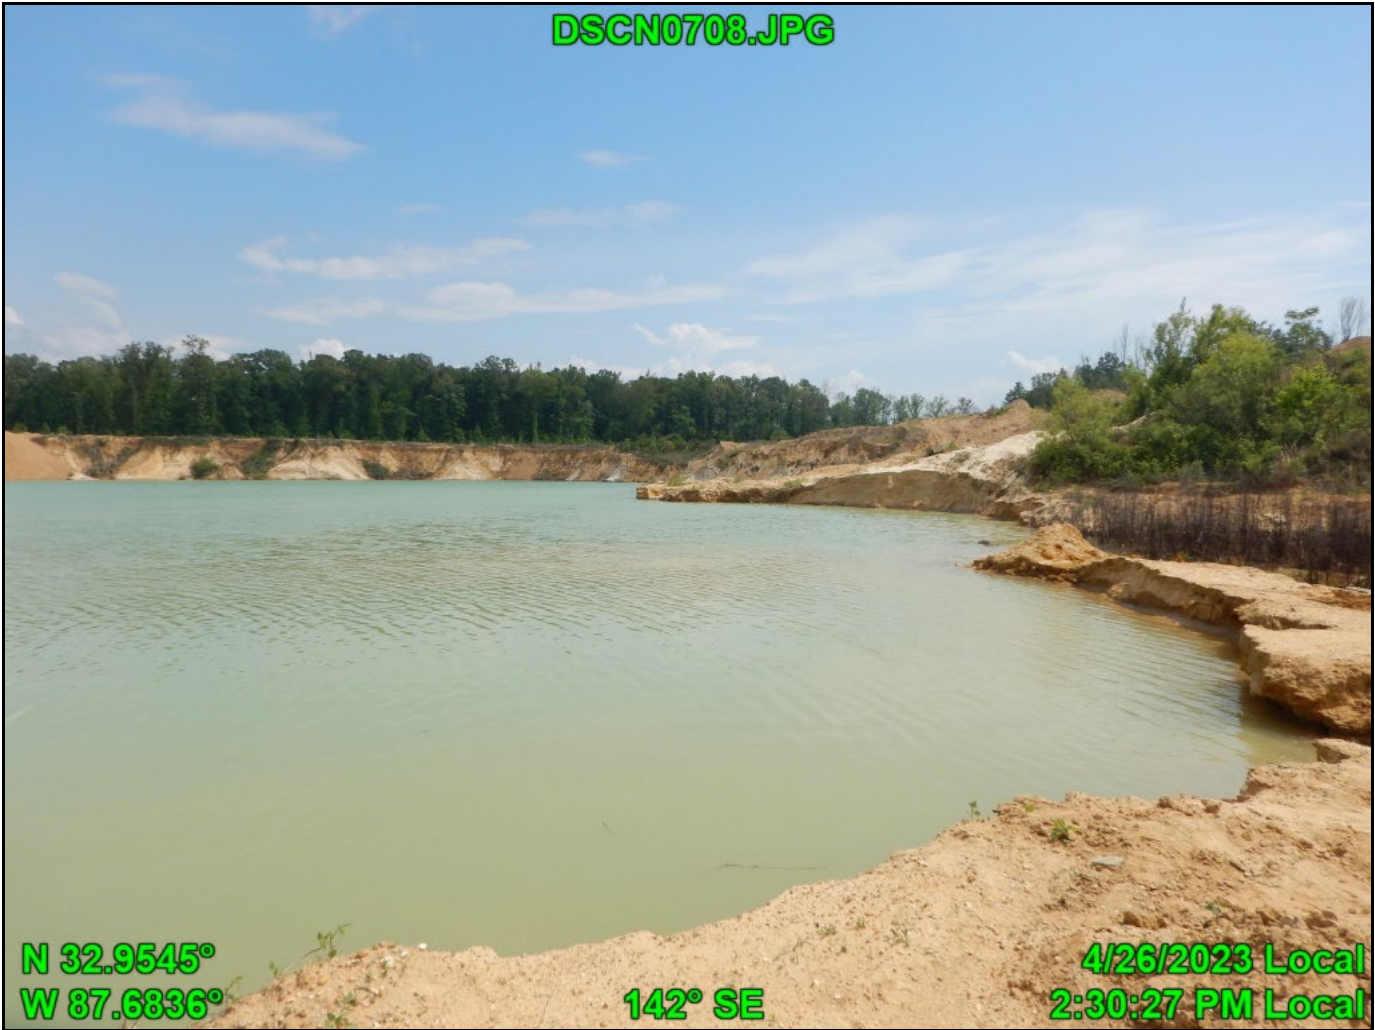
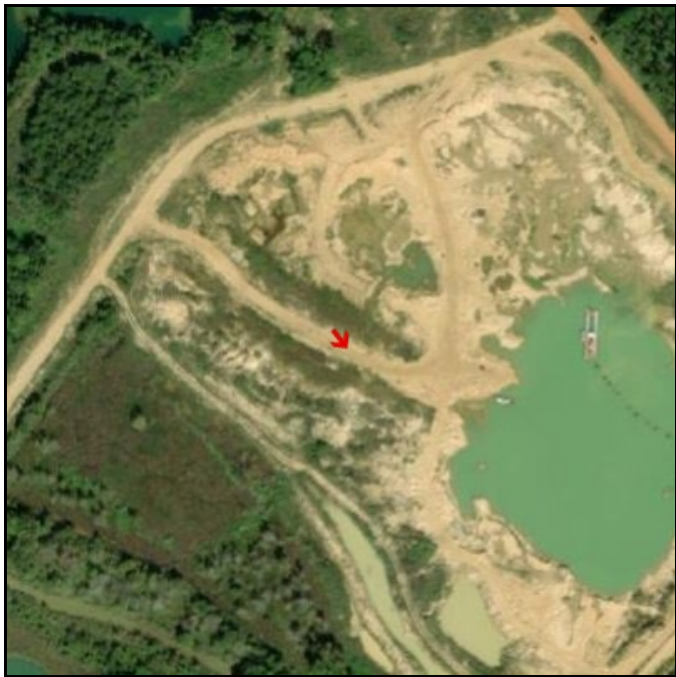
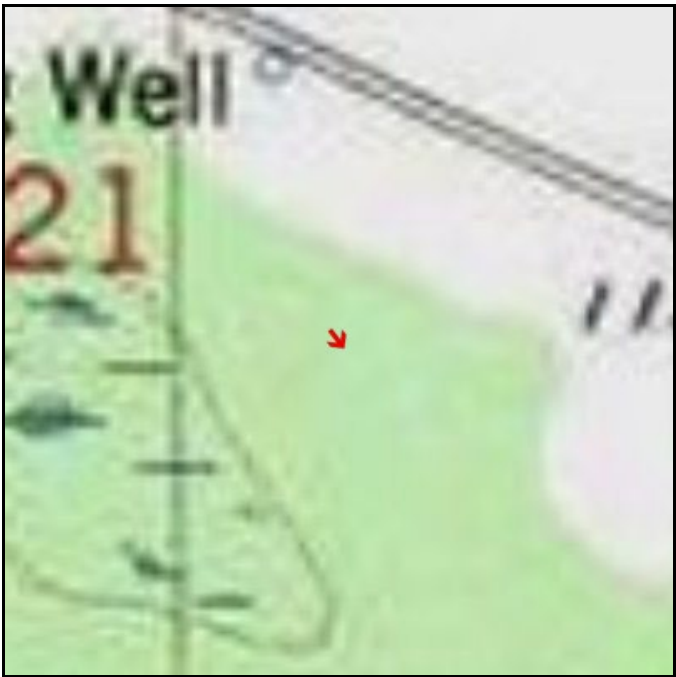
| Title | Photo 18 |

| Description | Striking southeast. Continuation of active dredging location. |

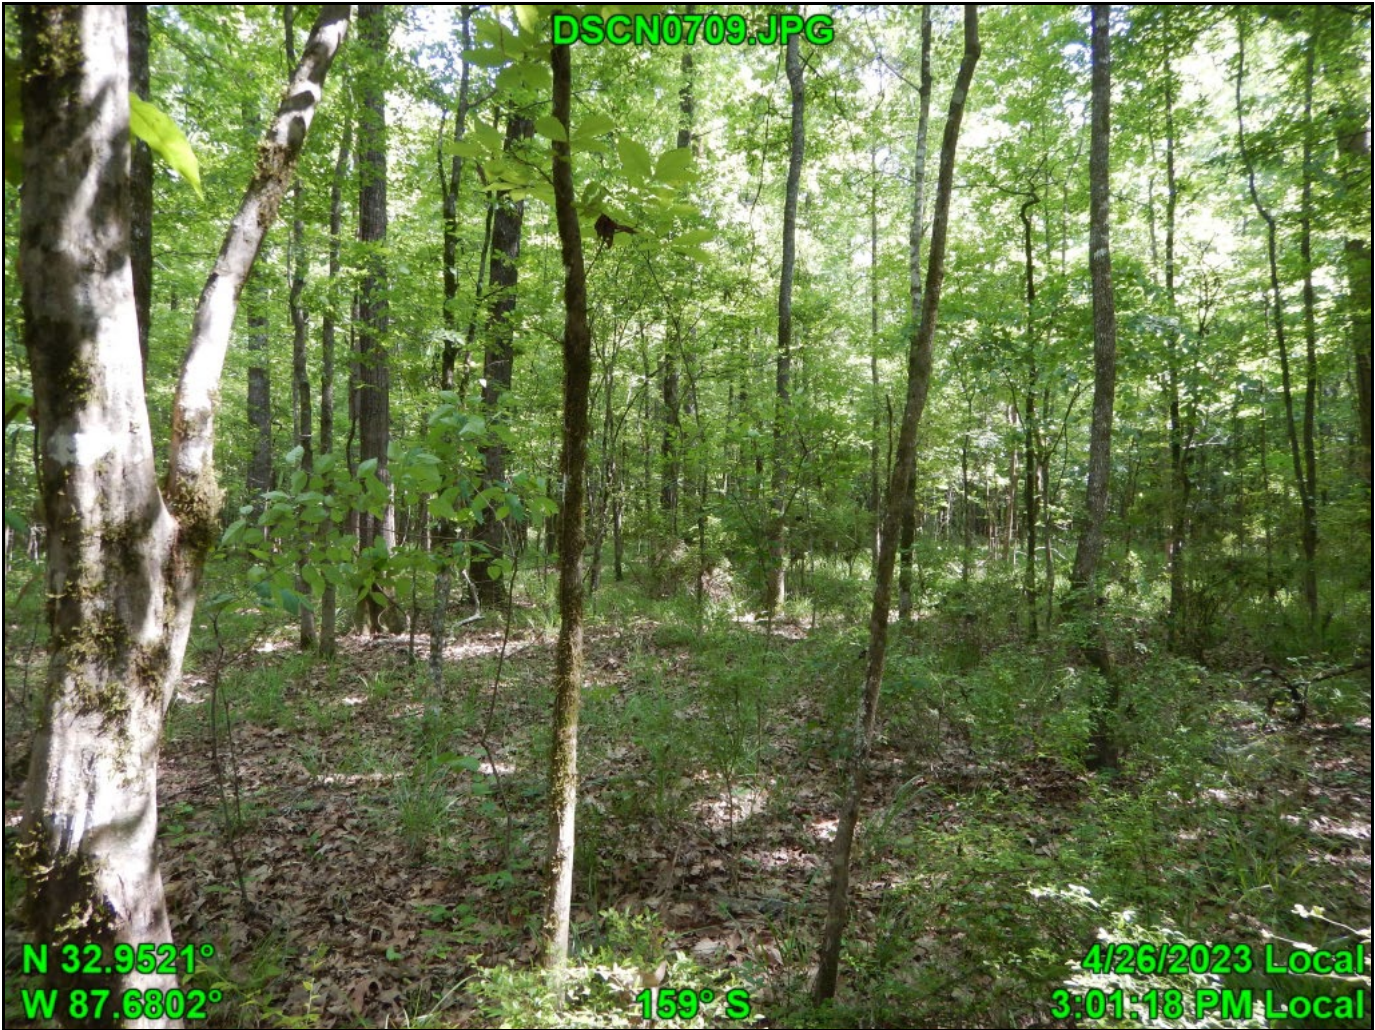
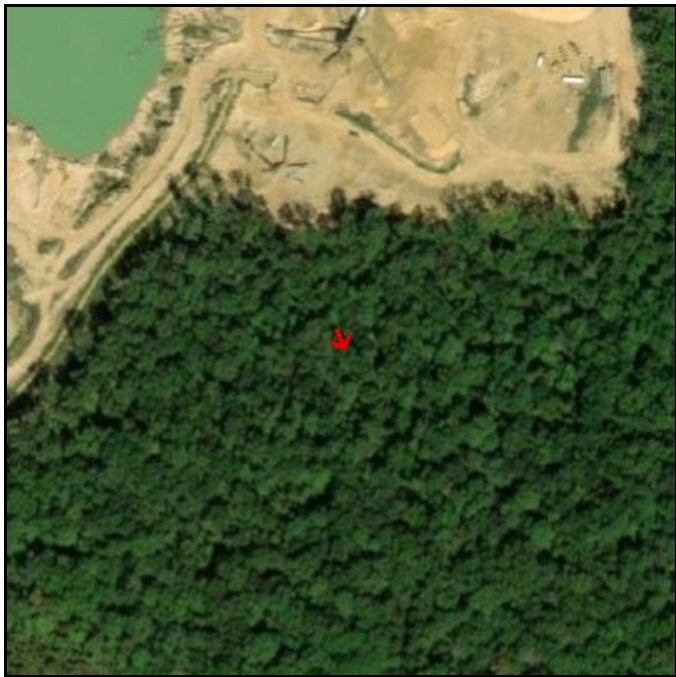
| Title | Photo 19 |

| Description | Striking south, southeast, over data point S3. |

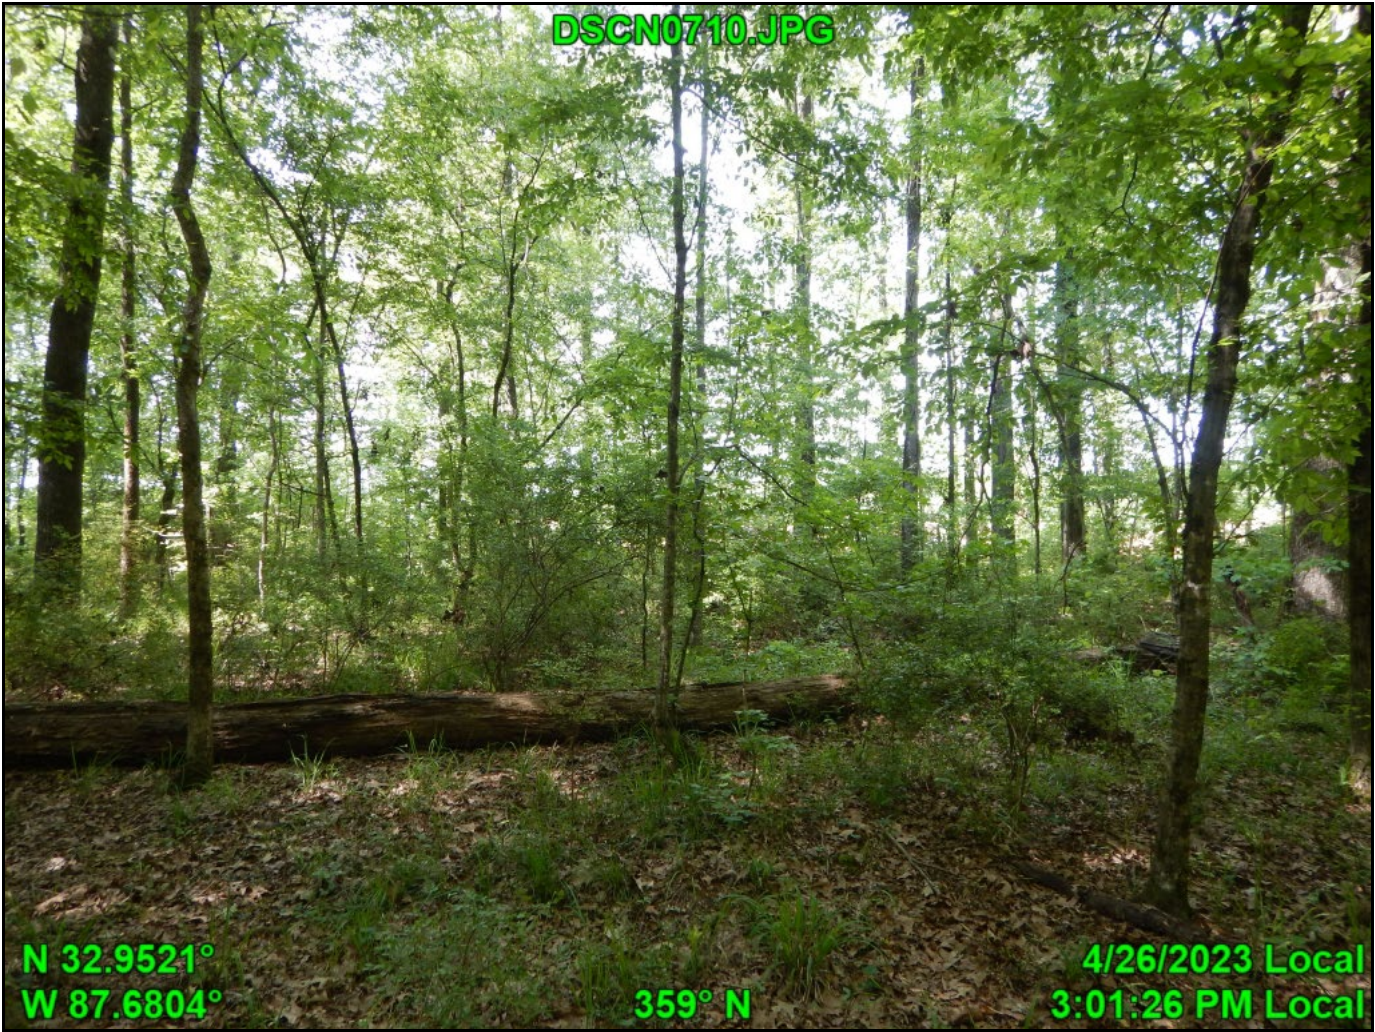
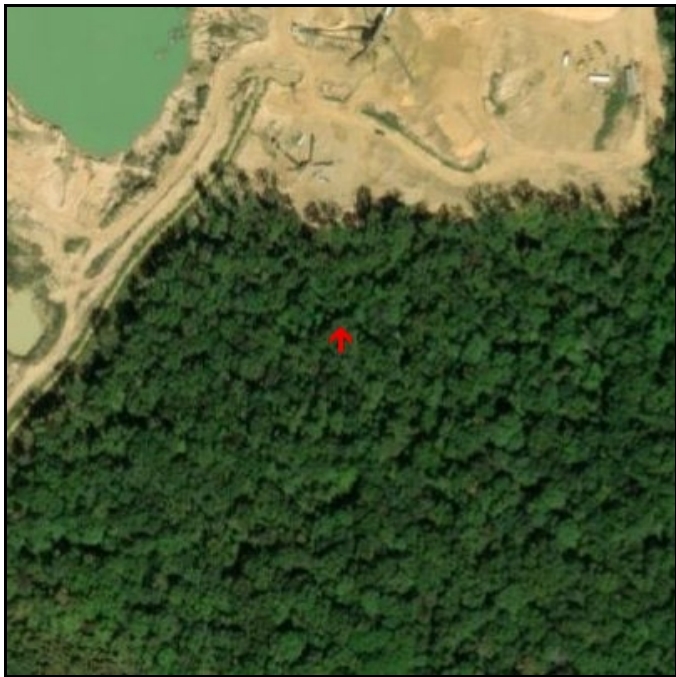
| Title | Photo 20 |

| Description | Striking north, over data point S3. |
