## ATTACHMENT C: Photograph Log

### Cypress Pit

Bama Concrete Products Company, Inc.  
dba Davis Sand and Gravel

Cypress, Alabama  
April 26-27, 2023

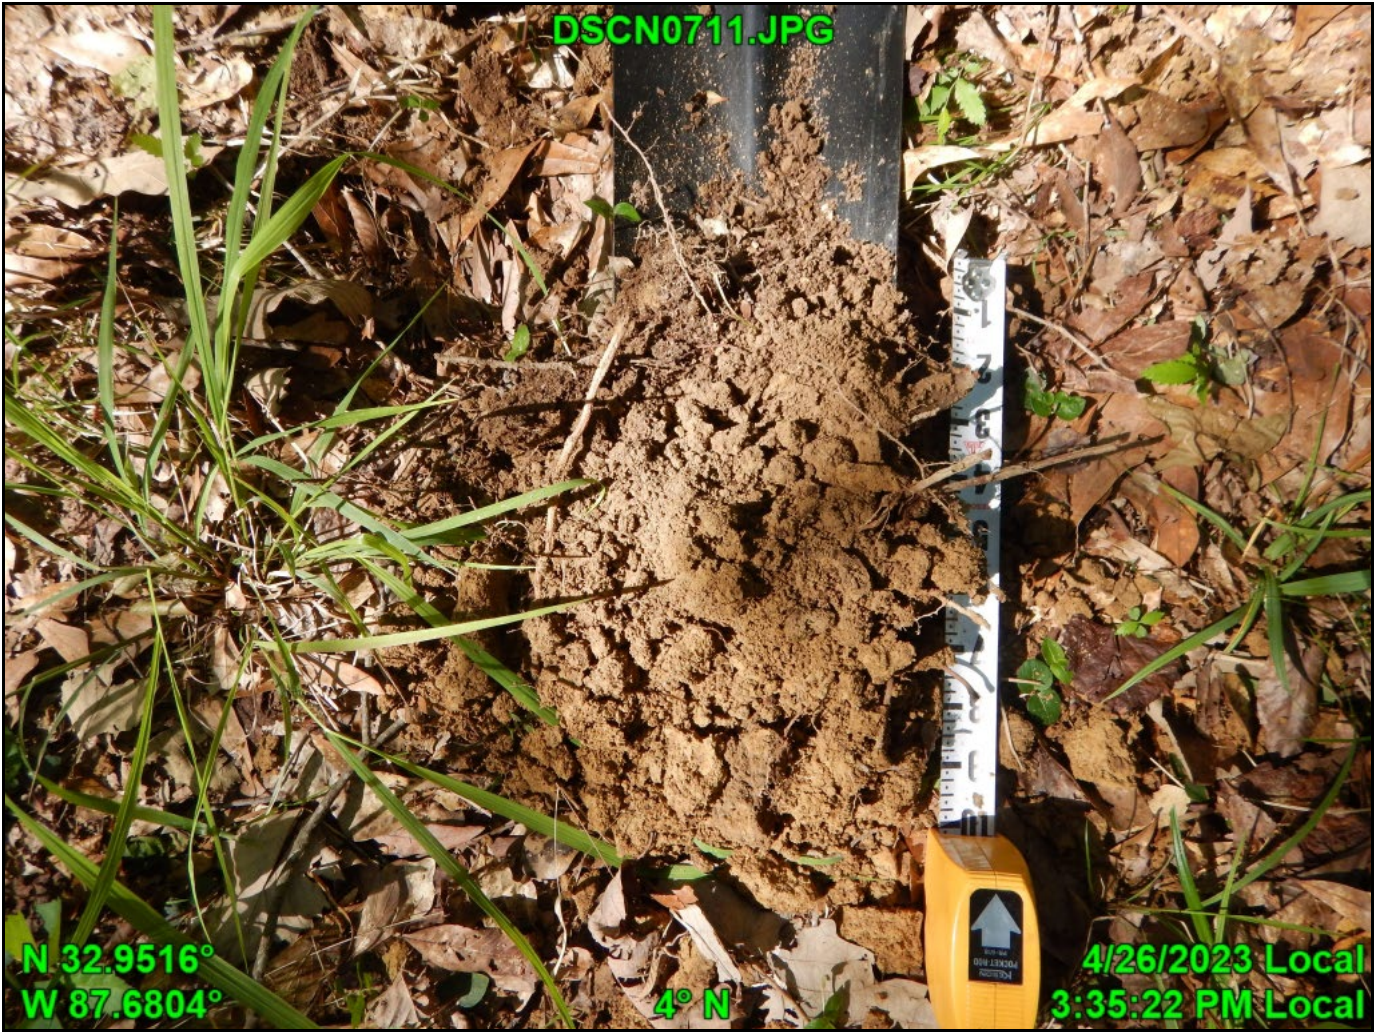
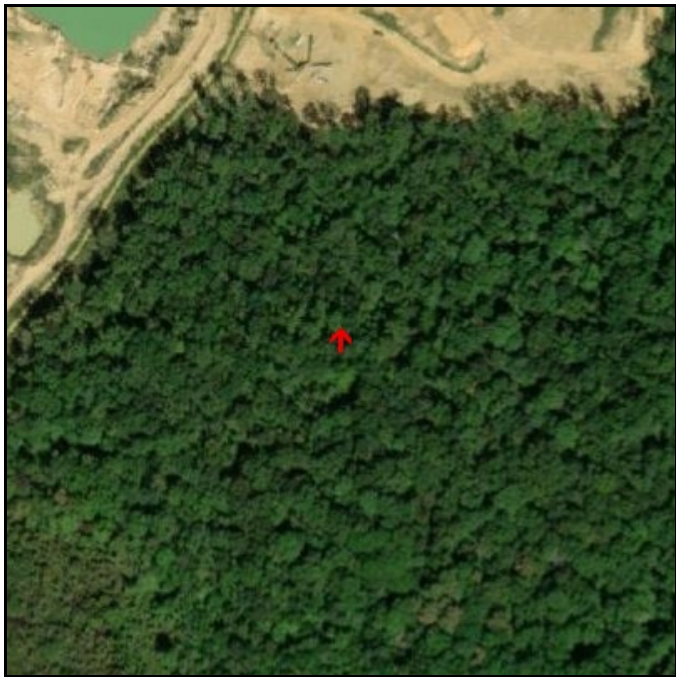
| Title | Photo 21 |

| Description | Soil profile, data point S4. |

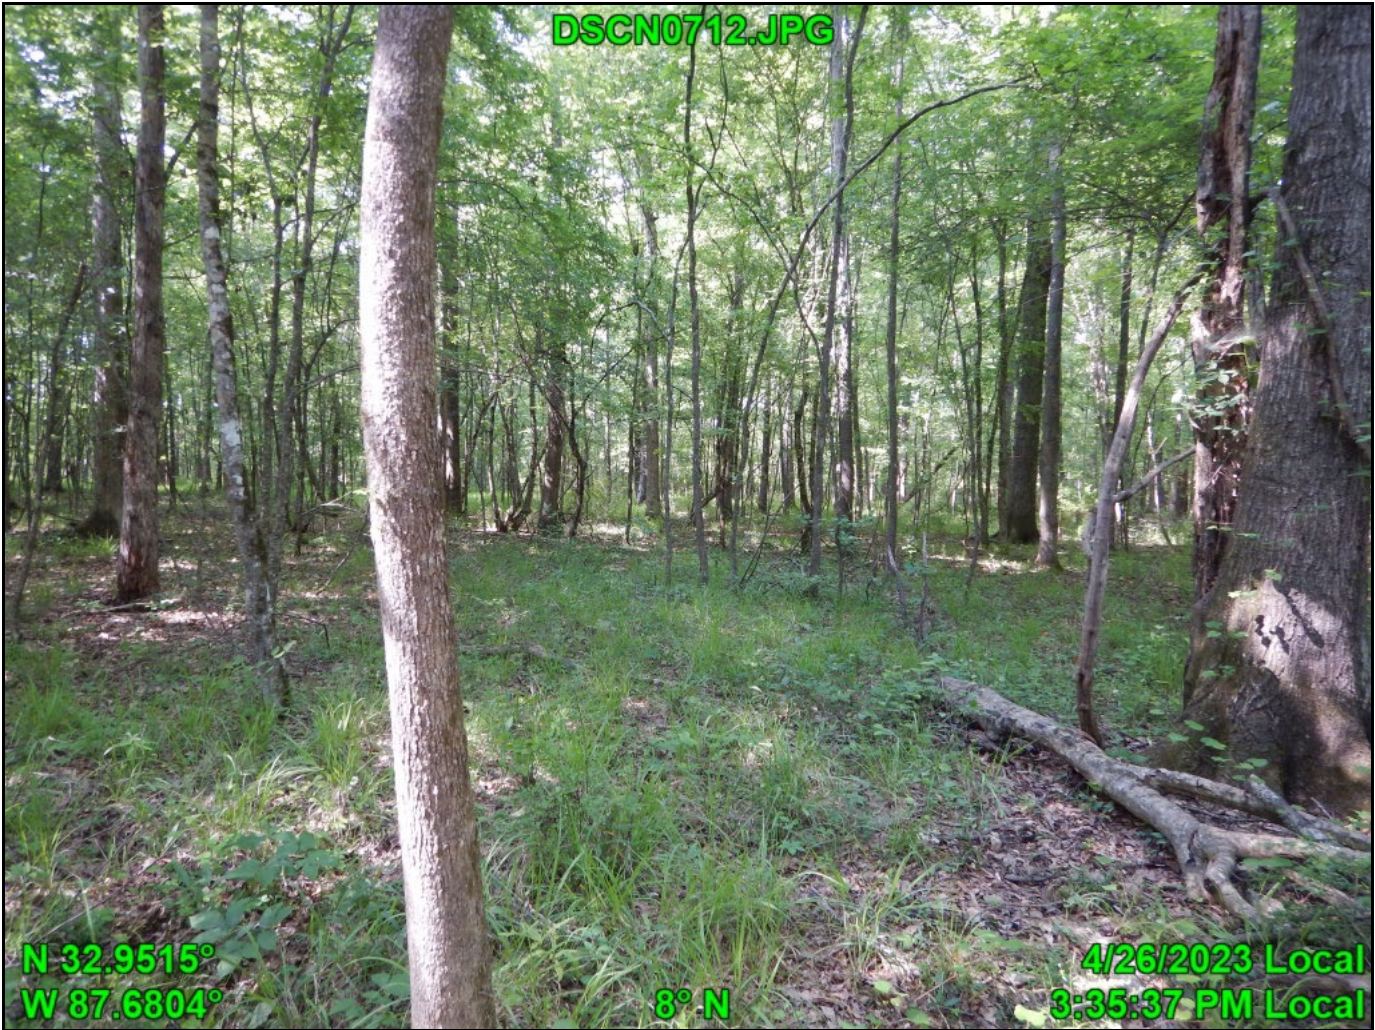
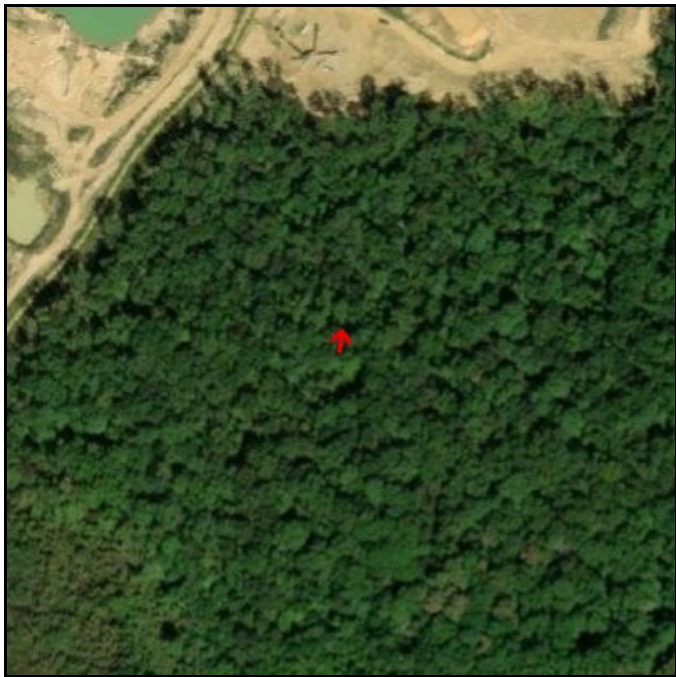
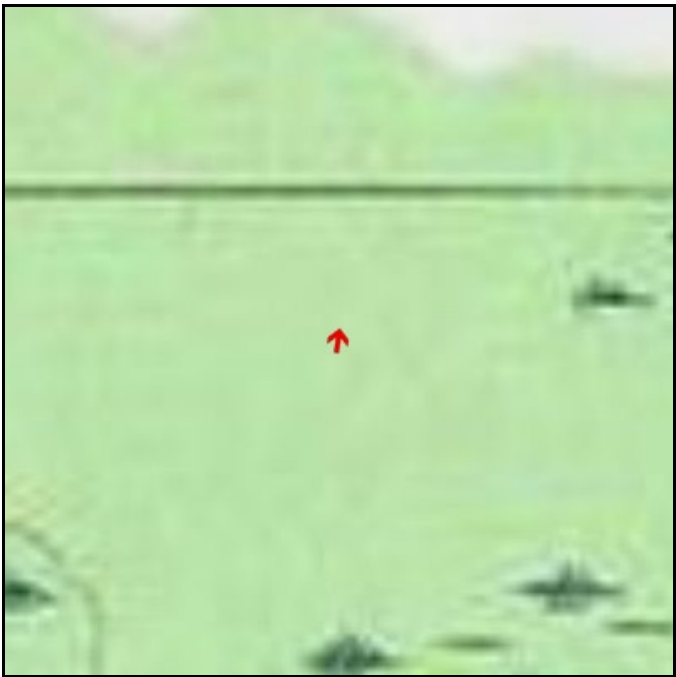
| Title | Photo 22 |

| Description | Striking north, over data point S4. |

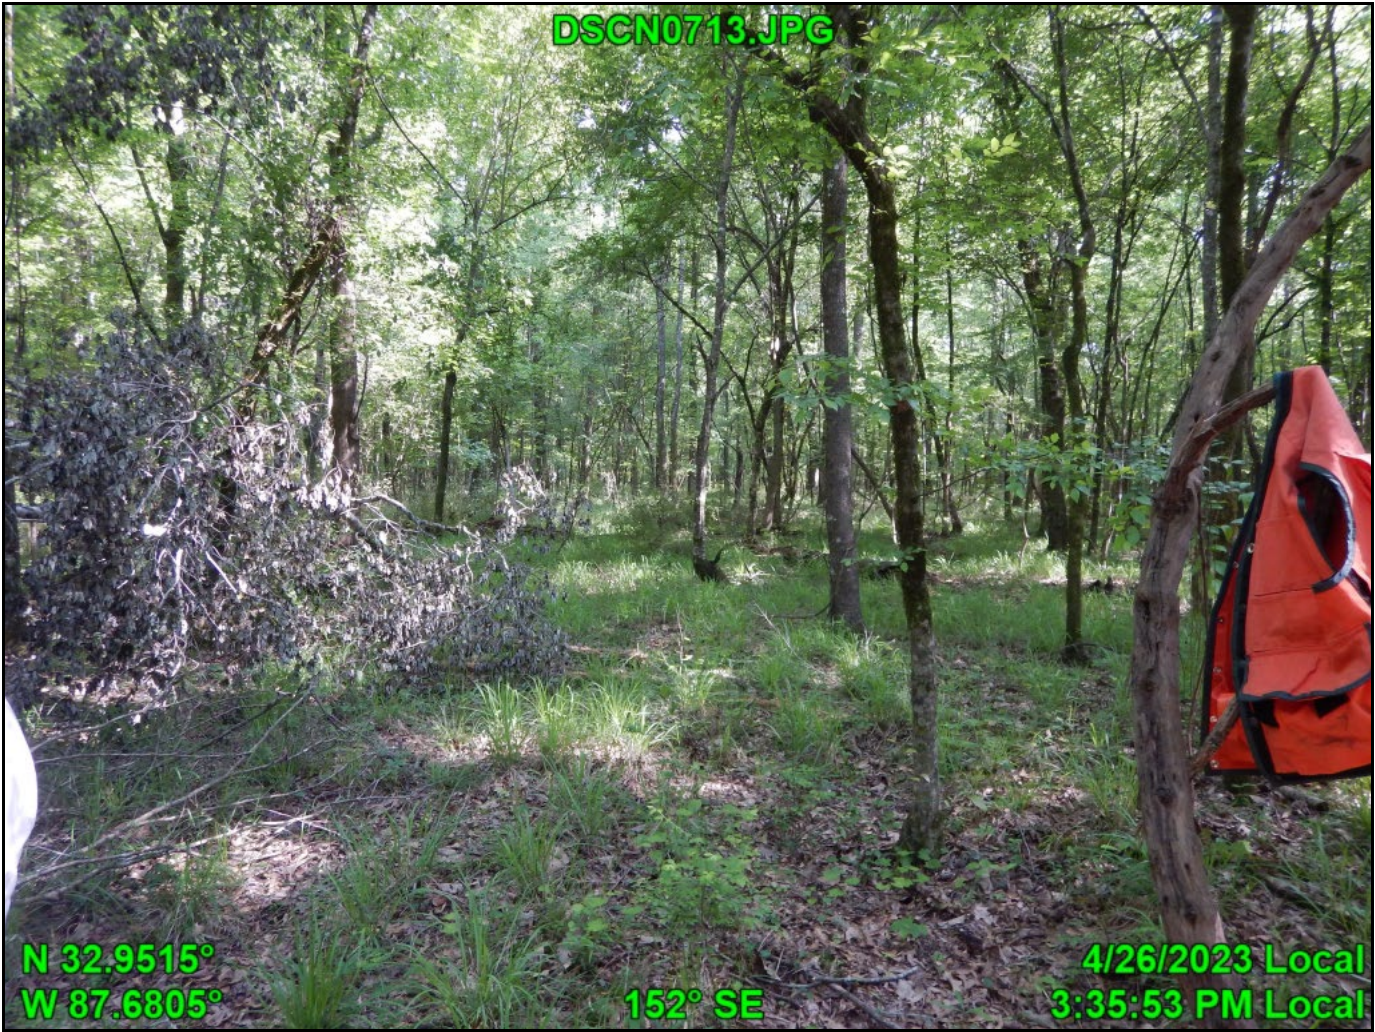
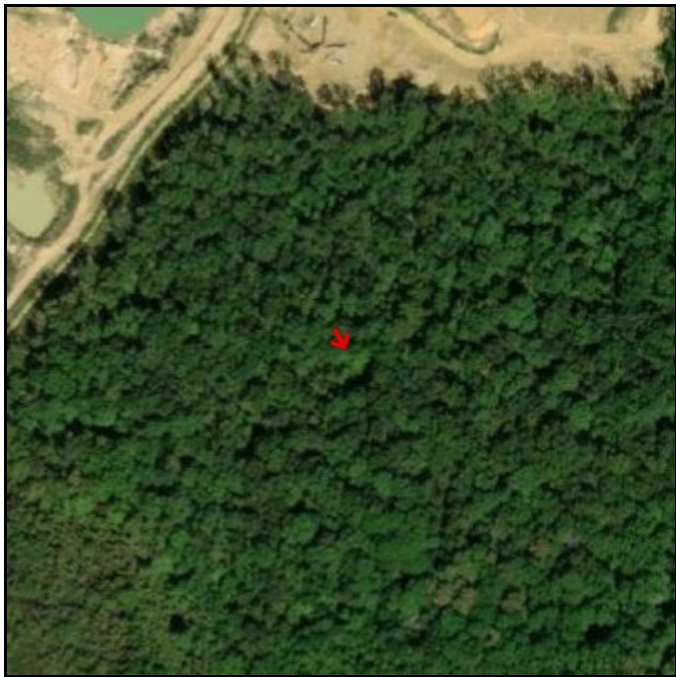
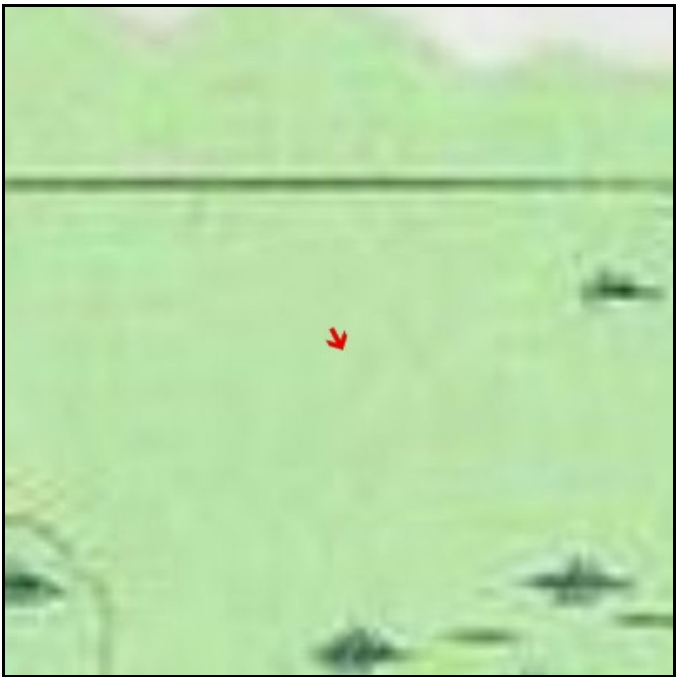
| Title | Photo 23 |

| Description | Striking southeast, over data point S4. |

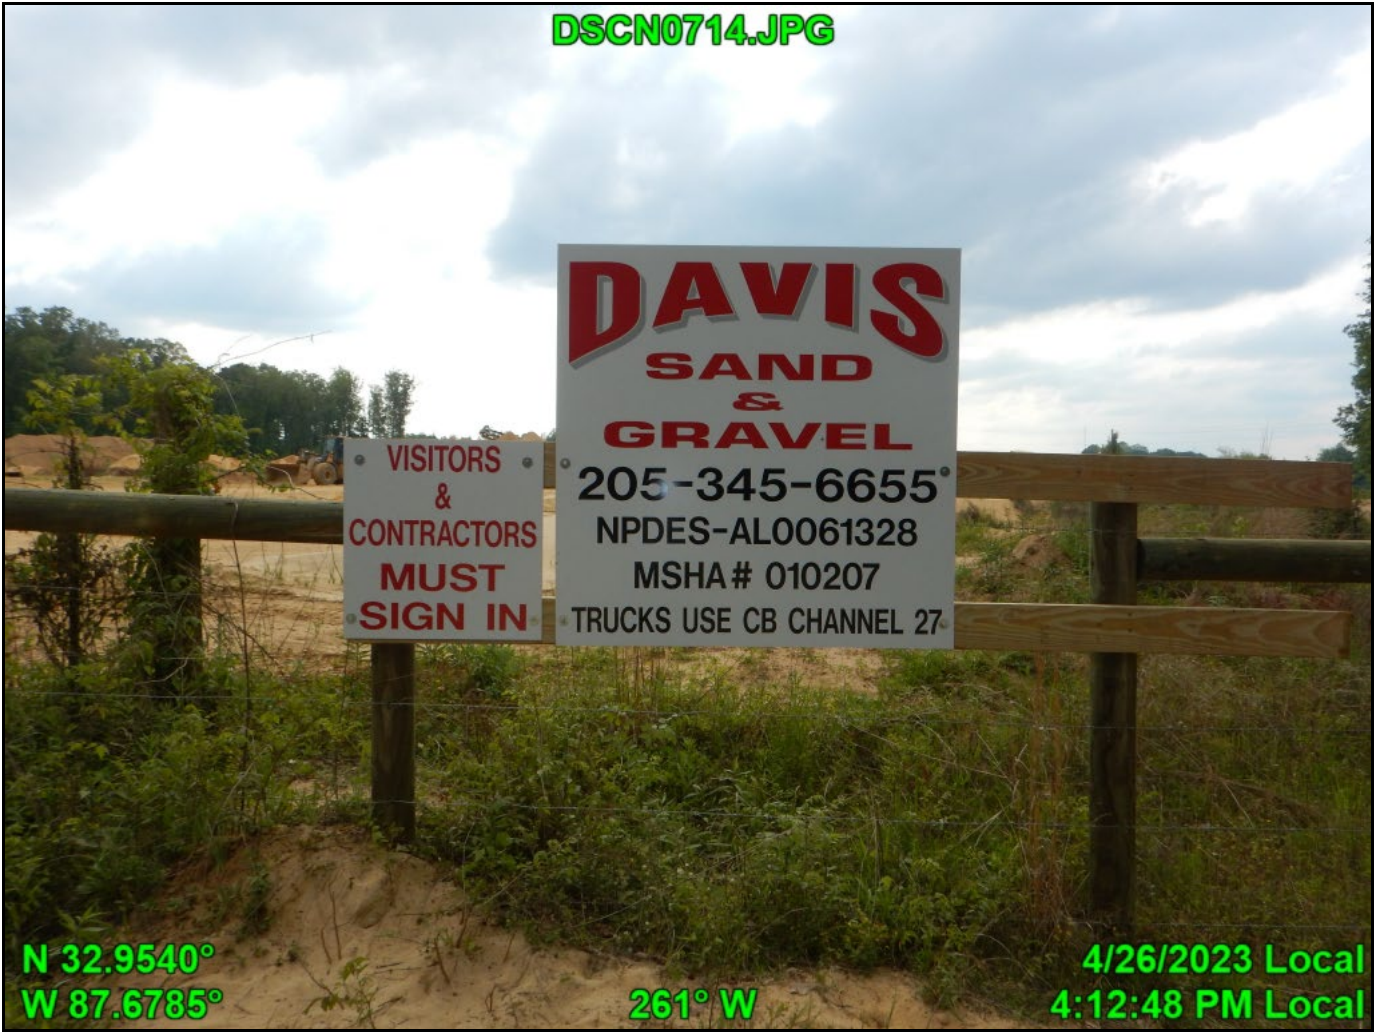
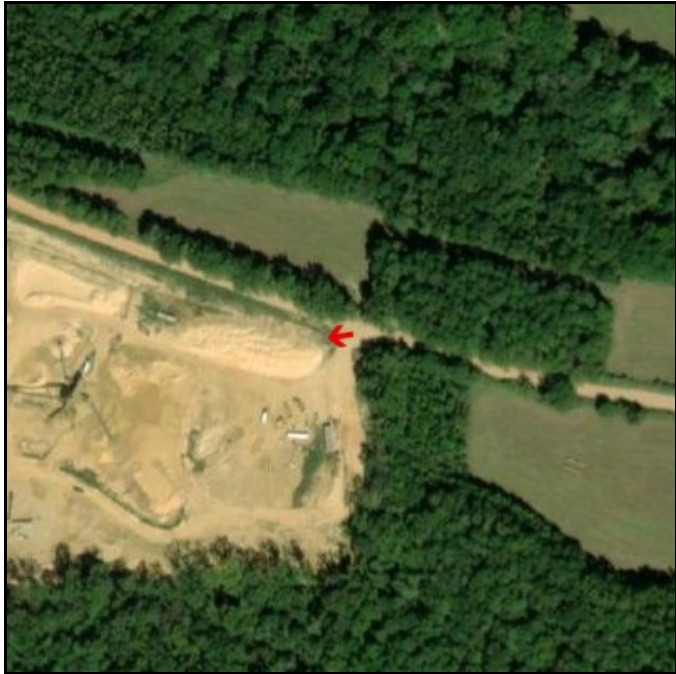
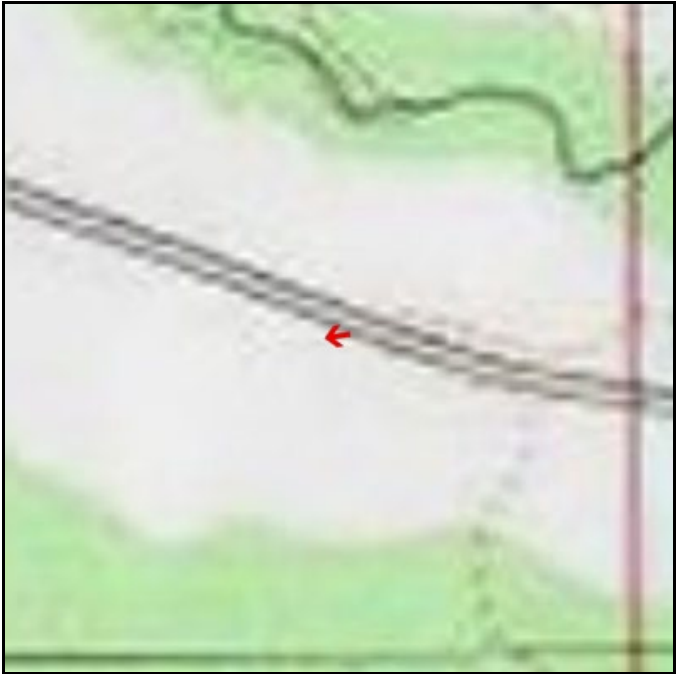
| Title | Photo 24 |

| Description | Signage at the facility's entrance. Note NPDES permit information. |
