## CAA112(r) INSPECTION REPORT

| <b>Name:</b> Heartland Coop - Henderson | |
| <b>Address:</b> 301 South East Street<br>Henderson, IA 51541 | <b>Date of Inspection:</b> September 28, 2022 |

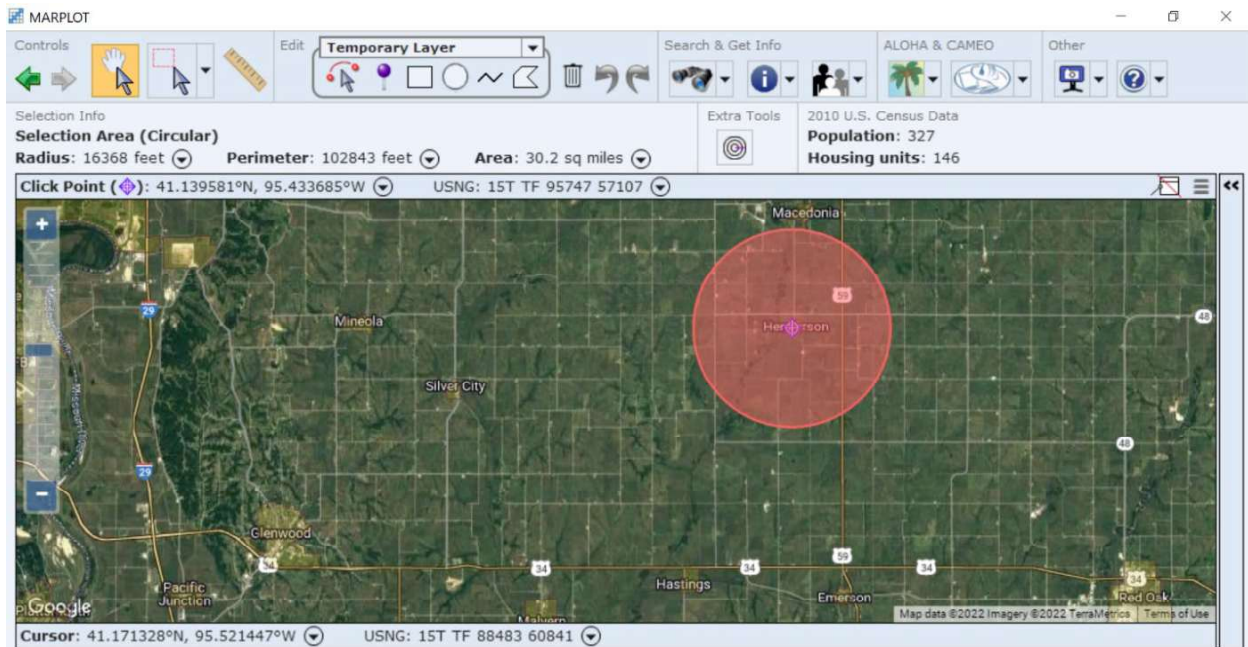
Worst Case:

The change in volume (to include only the largest vessel instead of the volume of both bulk tanks), decreased the distance to endpoint from 4.4 miles to 3.1 miles which also reduced the affected population for the worst- case scenario from 791 to 327 individuals.

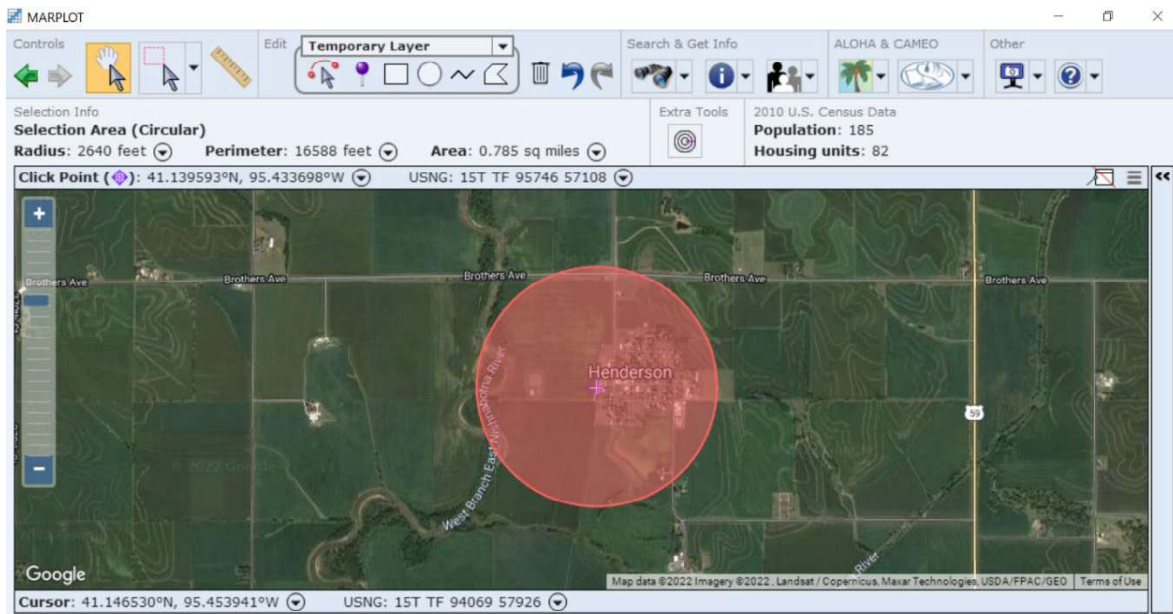
Alternate Release:

Using the existing scenario described in the Hazard assessment of a 1” transfer hose rupture releasing 4,520 pounds over 2 minutes and urban terrain, I came up with a DTE of 0.5 miles resulting in an affected population of 185 individuals as opposed to 95.
