Subject: March 28, 2024, EPA Inspection at Autumn Drive, Middleborough, MA

**Subj:** Inspection Report  
Clean Water Act - National Pollutant Discharge Elimination System  
("NPDES")  
Autumn Drive

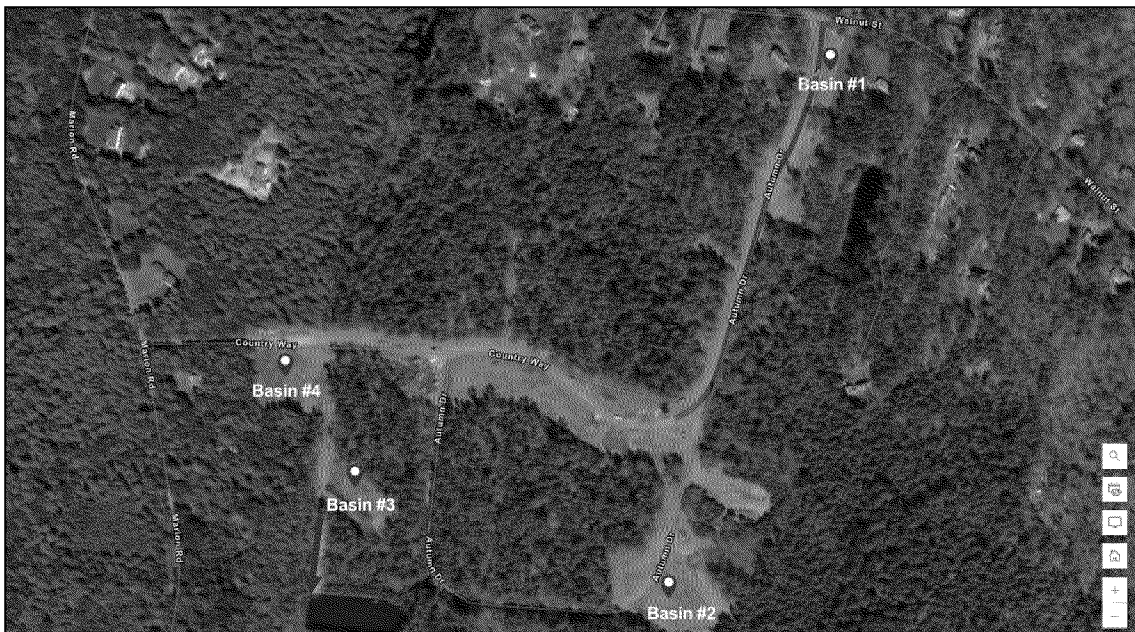
- a. During the inspection, EPA representatives observed a turbid discharge leaving the site from the third of four on-site basins (map below) without adequate stormwater controls. The discharge appeared to be draining towards nearby cranberry bogs to the south. Part 2 of the 2022 CGP authorizes stormwater discharges provided that appropriate stormwater controls are designed, installed, and maintained.

*Site map: During inspection, EPA observed a stormwater discharge from Basin 3 traveling south along the indicated path toward nearby cranberry bogs.*

- b. Please provide photographic evidence and a description of actions taken documenting the erosion control methods implemented to mitigate this turbid discharge in compliance with Part 2 of the 2022 CGP.
