**Region 6 - Enforcement & Compliance Assurance Division**  
**INSPECTION REPORT**

| Inspection Date(s): | 09/18/ 2025 | |
| Company Name: | Pueblo of Tesuque | |
| Facility Name: | <b>Tesuque Casino</b> | |

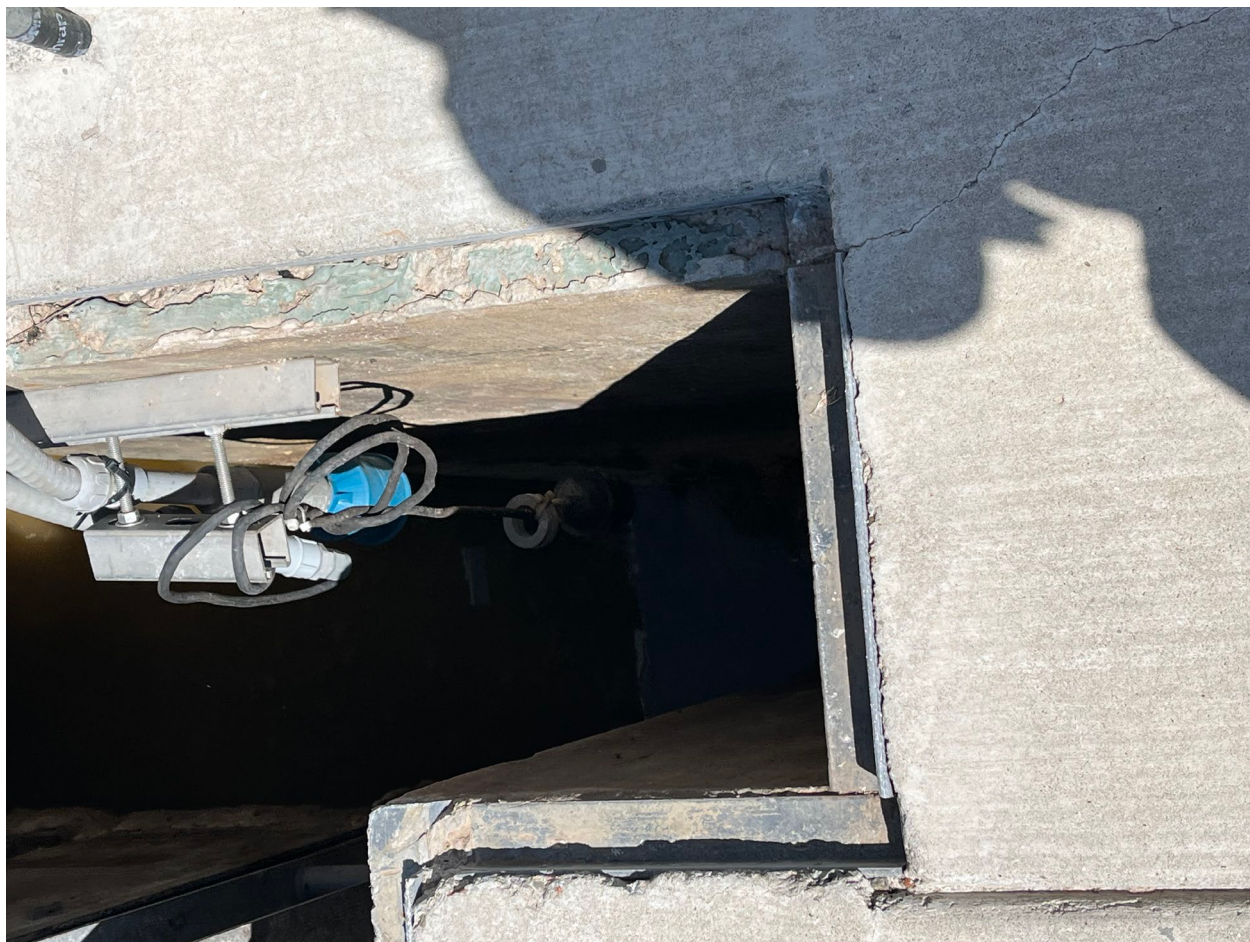
Photo No. 1

View inside the onsite lift station after the hatchway had been opened. (IMG\_0371) Photographed by D. Esparza. 09/18/2025 (1:23 PM)

- Installation of a locking device on the lift station hatchway cover and safety gate into the lift station beneath the cover.

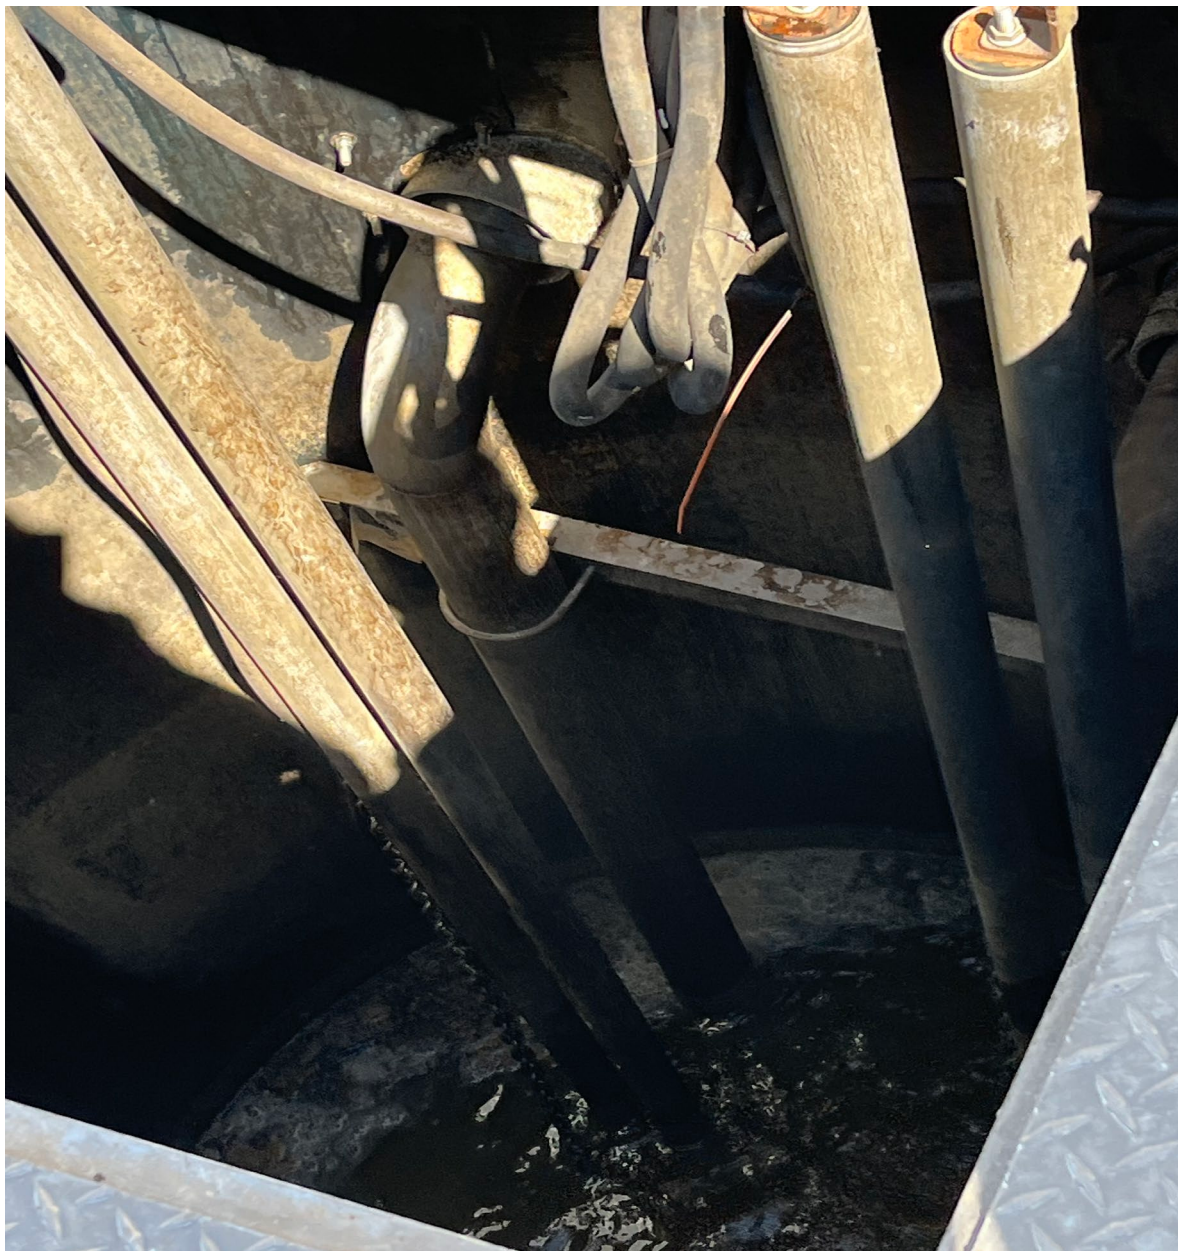
Photo No. 2

View inside the onsite lift station (LS). Note: it was stated that LS is approximately 14-feet deep. (IMG\_0372) Photographed by D. Esparza. 09/18/2025 (1:25 PM)
