Region 2 Enforcement & Compliance Assurance Division
Air Compliance Branch
CAA Inspection Report

Inspection Date: 7/24/2024
Facility Name: 49 Gingerbread Castle Rd
Facility Address: 49 Gingerbread Castle Rd, Hamburg NJ
ICIS-Air ID #: 3601694258
EPA Lead Inspector: Christopher Collins, Collins.Christopher.W@epa.gov
EPA Asst. Inspector: Victor Tu, tu.victor@epa.gov
Facility Contact: Joseph Park, Owner, joseph@selininy.com
State Inspector(s): James Harris, NJDOL, james.harris@dol.nj.gov
State Inspector(s): Ray Djurin, NJDOL, radovan.djurin@dol.nj.gov
State Inspector(s): Frank Cuomo, NJDOL, frank.cuomo@dol.nj.gov
State Inspector(s): Jim Vermeychuk, NJDOH, james.vermeychuk@doh.nj.gov

40 CFR Part 61 Subpart M – Asbestos NESHAPs

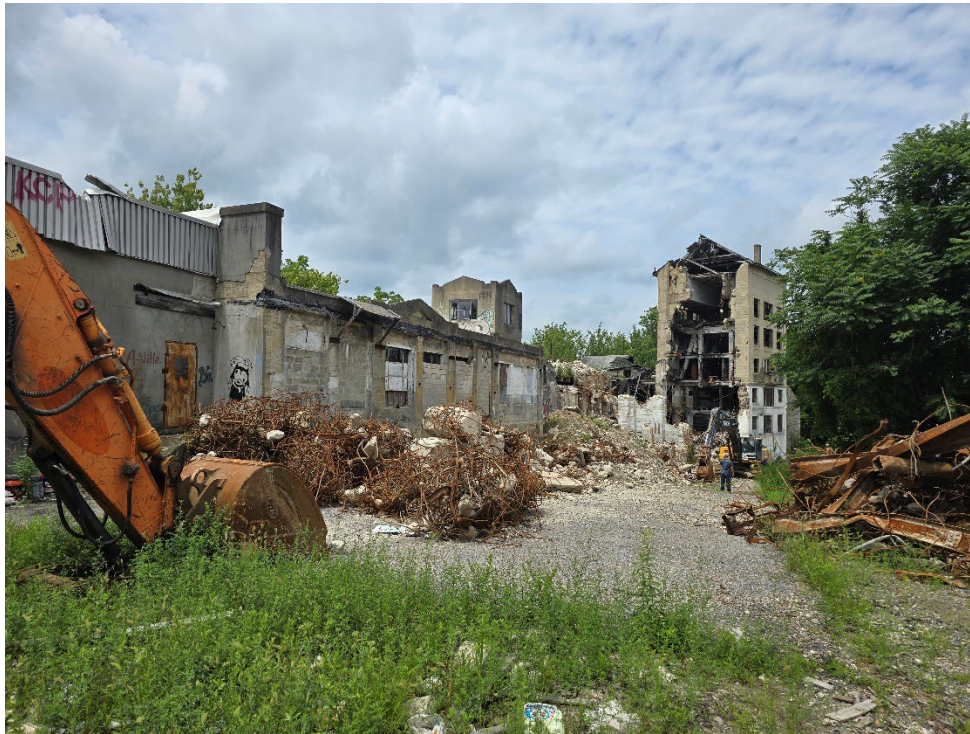
Figure 2: Demolition Site. Note the removed wall on the 7-story structure, and the concrete and metal debris.

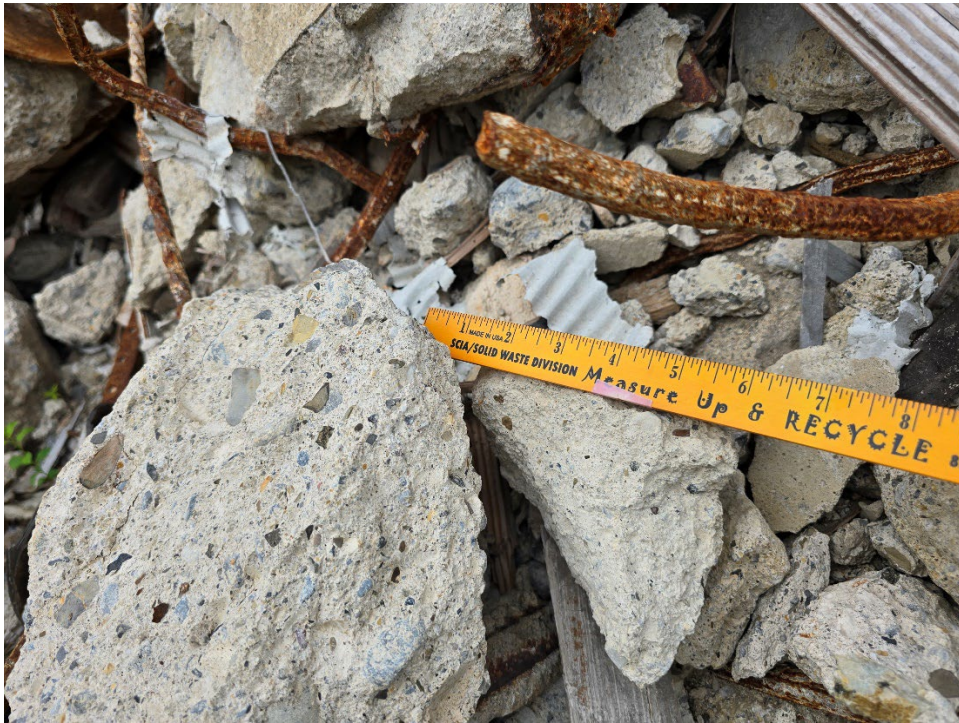
Frank Marino and Ray Djurin identified several materials that had been previously tested positive for asbestos during a prior DOL inspection (Figures 3-6):

Figure 3: Corrugated insulation.

The inspection team noted there was no signage on the gates, and no visible wetting of materials. They explained to the Owner that all materials need to be kept wet and documented with a logbook and photos demonstrating wetting. They also explained that signage should be present on the gates warning of asbestos, and that all waste is considered asbestos-contaminated. The inspection team further explained that all waste generated is considered asbestos containing waste material.

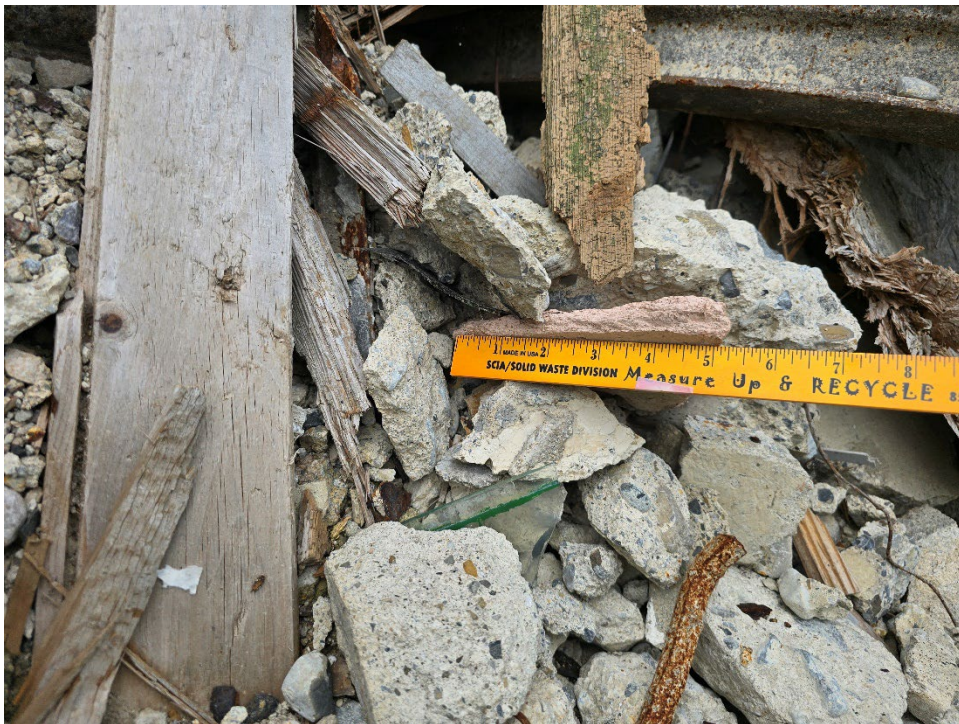
Figure 4: Pink Cementous Material

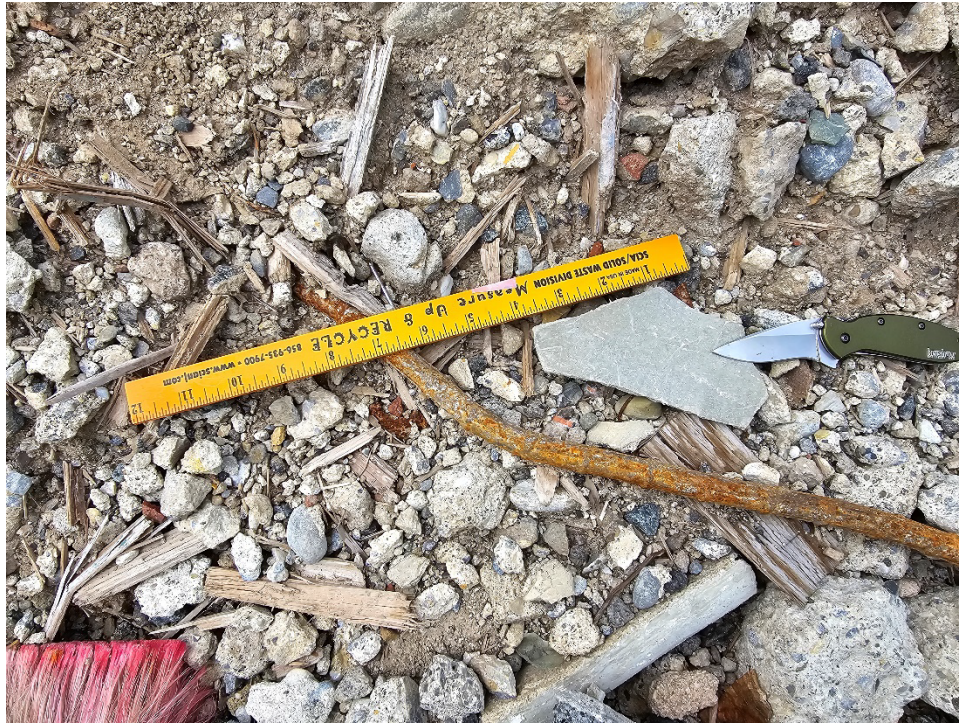
Figure 5: Transite material.

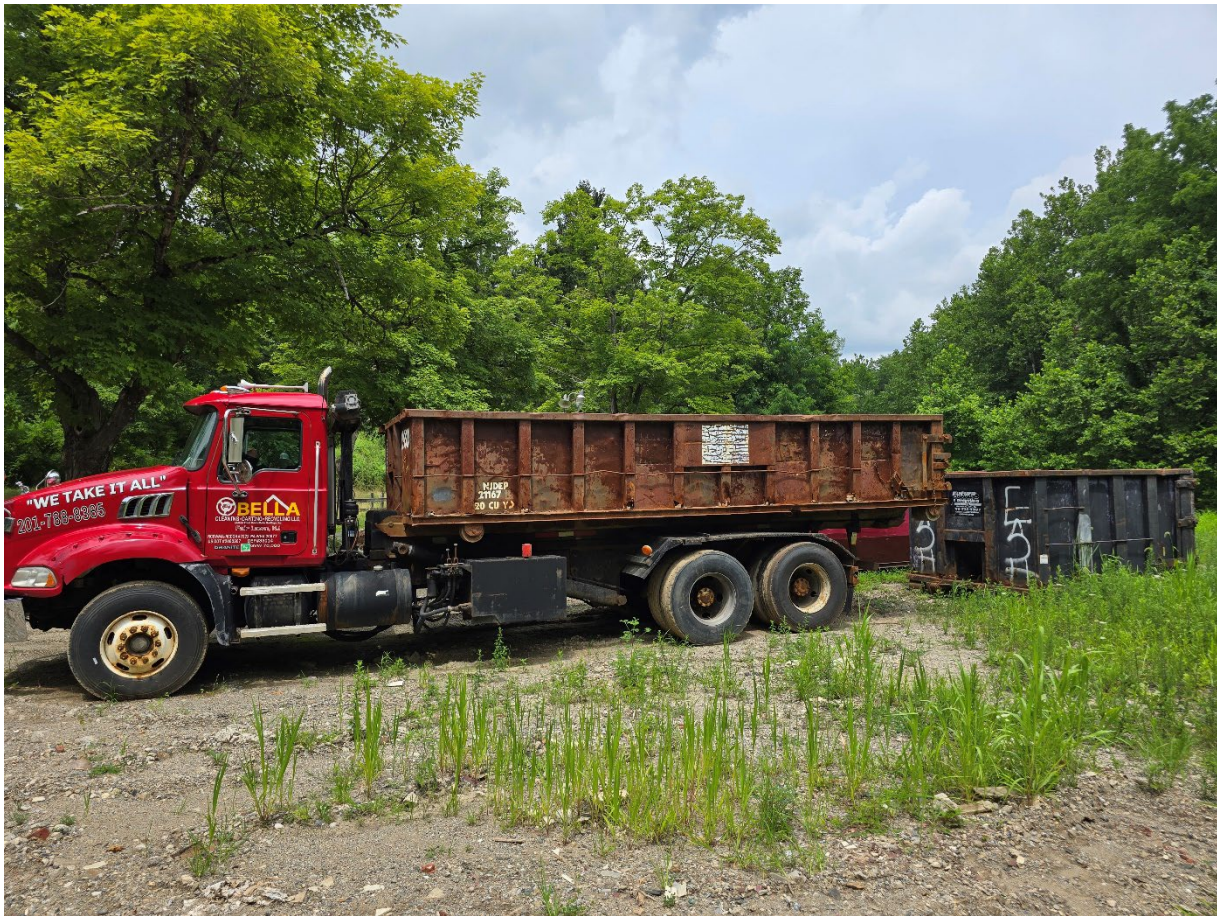
The tour continued to the debris field across the street, owned by Winners Property LLC (30 Gingerbread Castle Rd), an entity owned by the Owner's family. At this site, inspectors found Bella vehicles, containers with waste, and demolition waste laying on the ground and seemingly buried in the ground (see figure 7, 8 and 9).

Figure 7: Bella Truck with 20 cubic ft container.

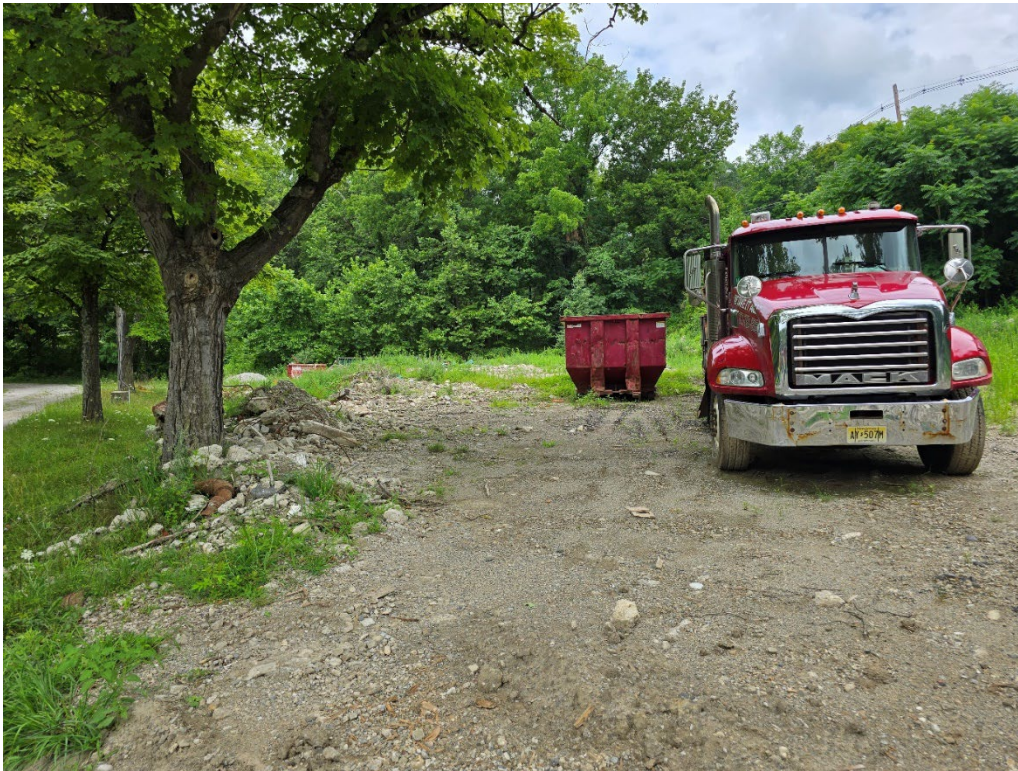
Figure 9: Bella Truck and debris, alternate angle. The red container was filled with metal at the time of inspection.

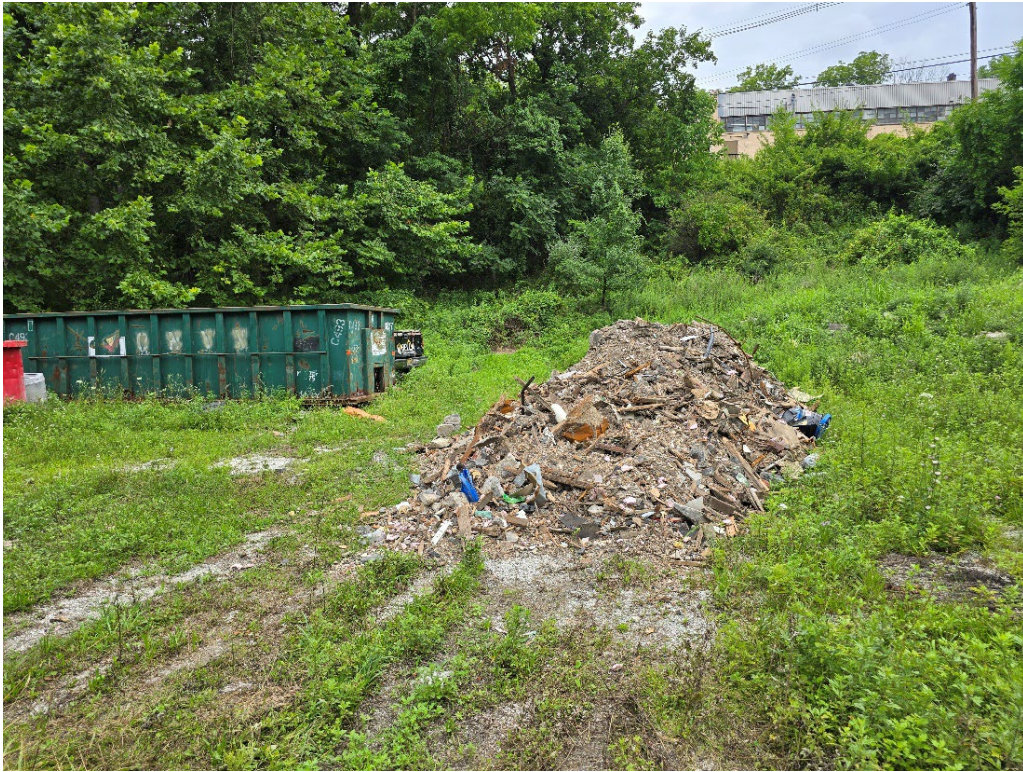
Numerous mounds of debris, what appears to be C&D debris, was observed on the site (Figure 10, 11 and 12). The Owner stated he does not believe that these debris pile are from the demolition project and had not seen this waste prior to the inspection. He also stated that he has only authorized Bellas to dump debris from this demolition project and nothing else.

Figure 10: Pile of waste which included non-construction waste.

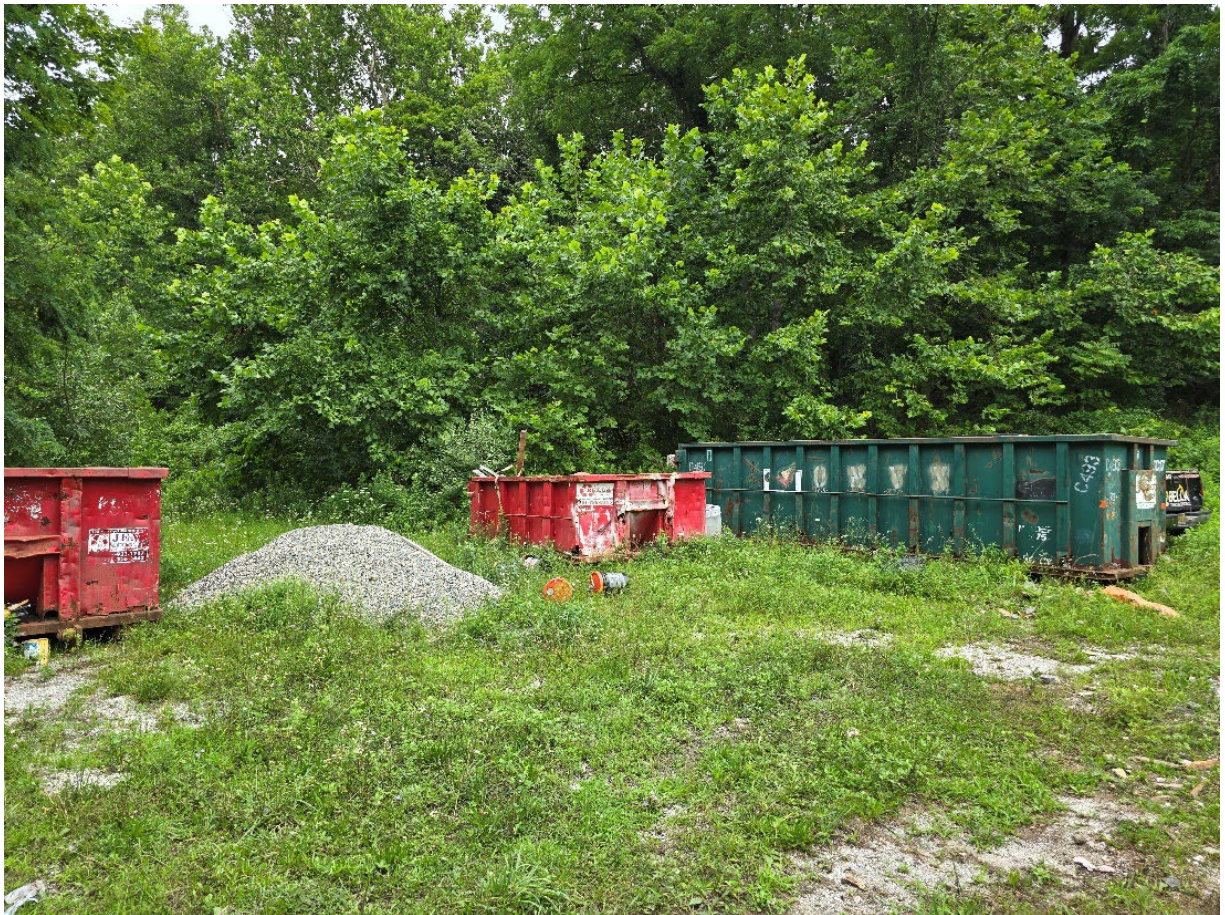
Figure 11: Pile of waste material and "Bella" labeled containers.

Possible black tar was observed in the debris.

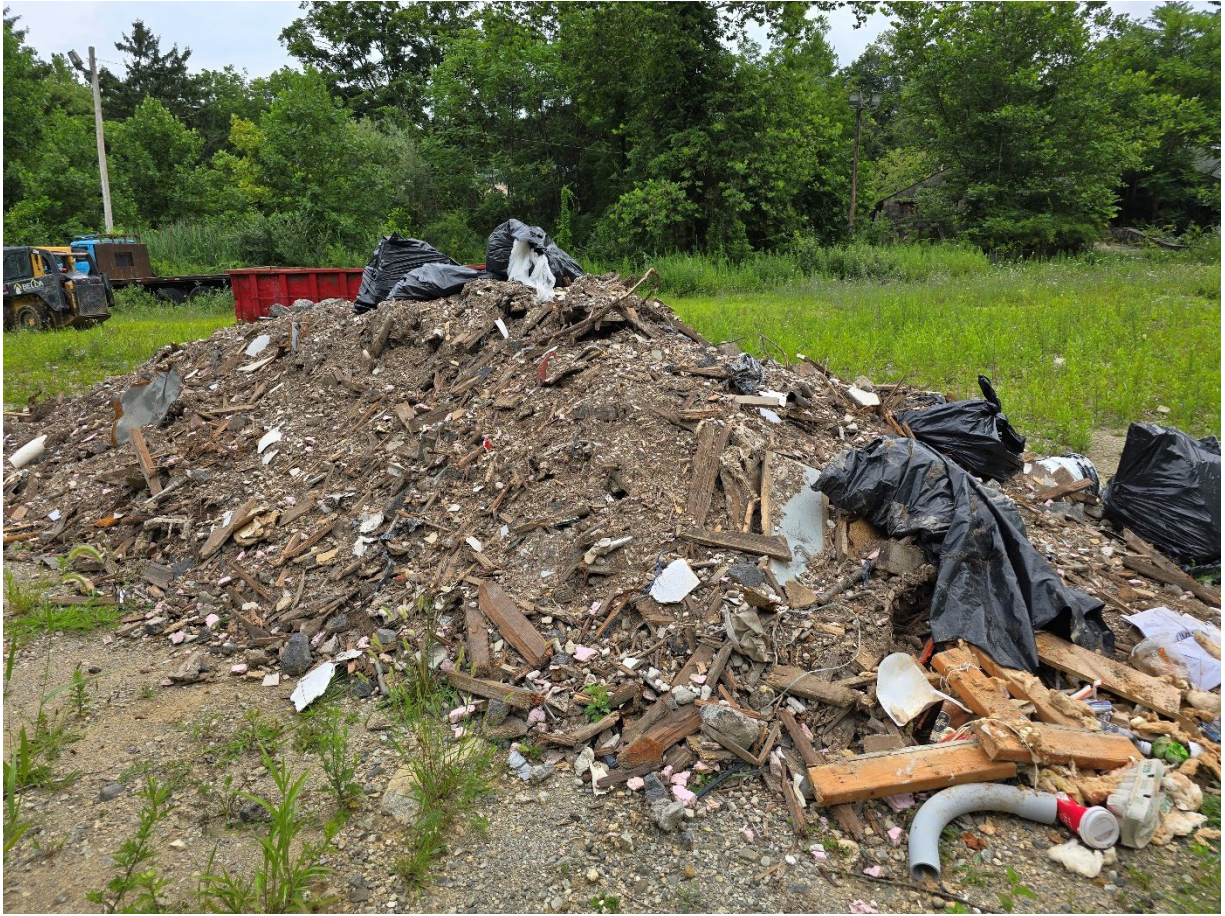
A second pile of debris was found further into the property, which appeared to contain non-construction waste (Figure 12). The Owner stated he had not seen this waste prior to the inspection and was unaware of its presence.

Figure 12: Pile of debris with non-construction waste.

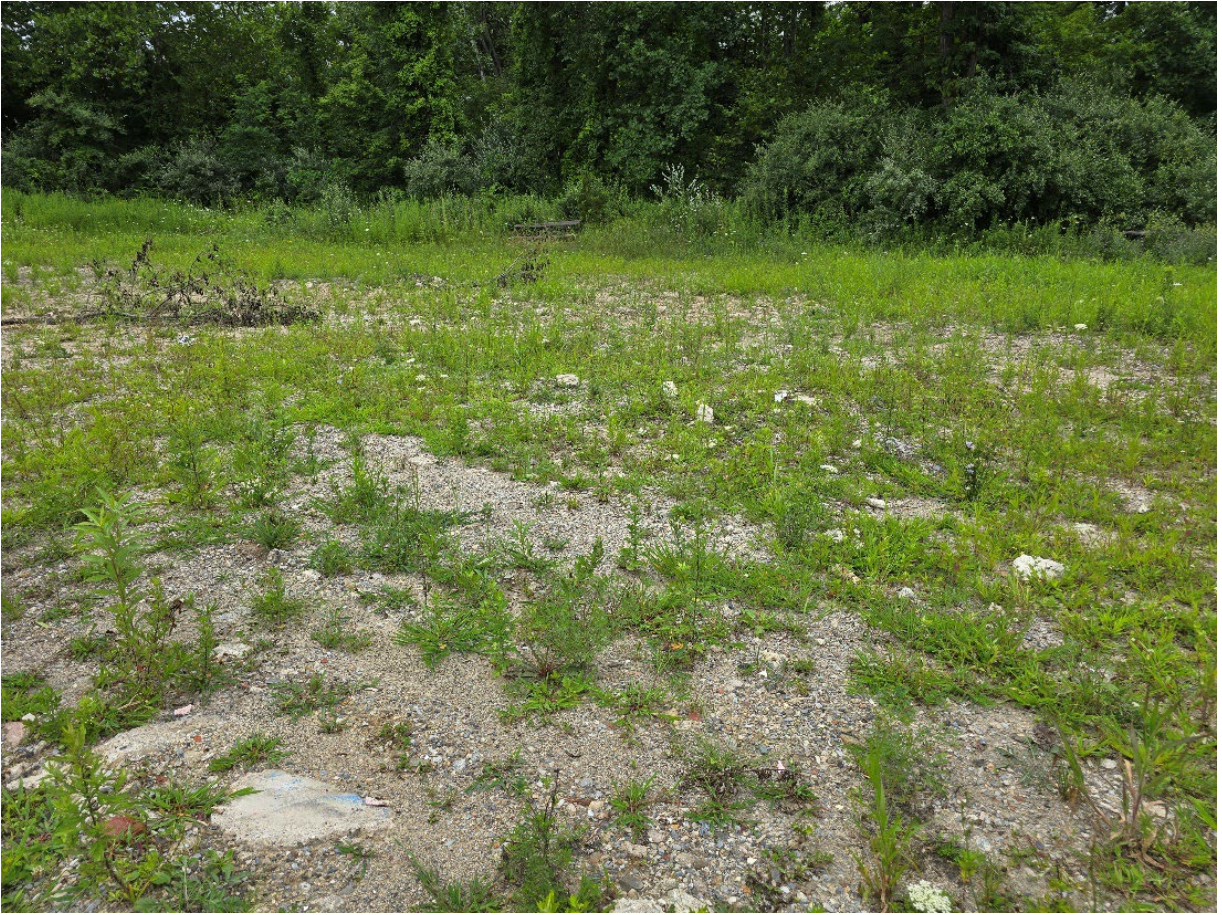
The owner stated that the construction debris was originally placed in this area (see figure 13) of the property, until he instructed Bella to move the waste to where it is currently.

Figure 13: Site where construction debris was originally placed, before being moved to final site. Remanent of the demolition debris was still present on the ground.

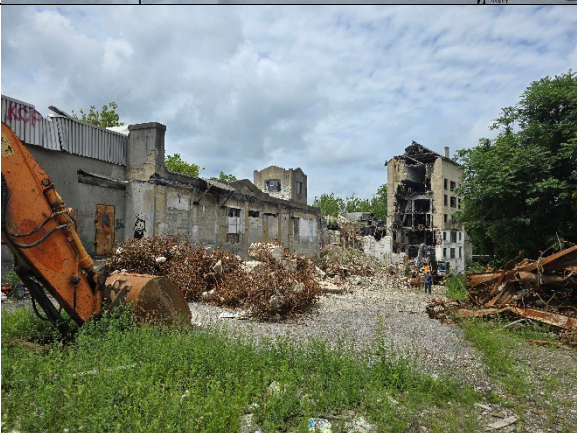
<p>20240724_124048.jpg</p>	<p>Asbestos transite material, Identified as ACM during prior DOL inspection</p>

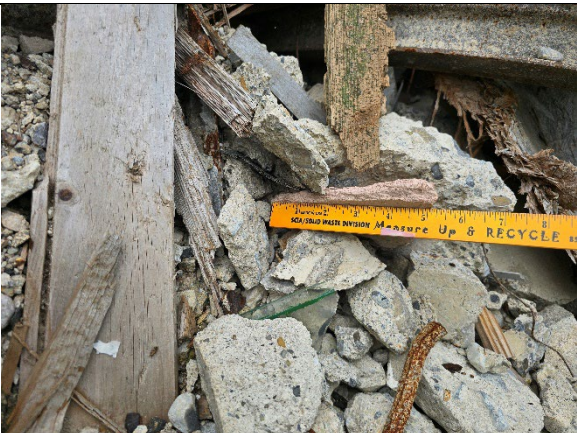
<p>20240724_124203.jpg</p>	<p>Asbestos corrugated paper material, Identified as ACM during prior DOL inspection</p>
