INSPECTION REPORT

| Type of Inspection | Industrial Stormwater Inspection (ISI) | |
| Permittee Name | Kinder Morgan | |
| Facility or Site Name | Limestone Storage Area, Bottom Ash Storage Area, South Salt Domes, Main Terminal, Cargill Salt Pad | |

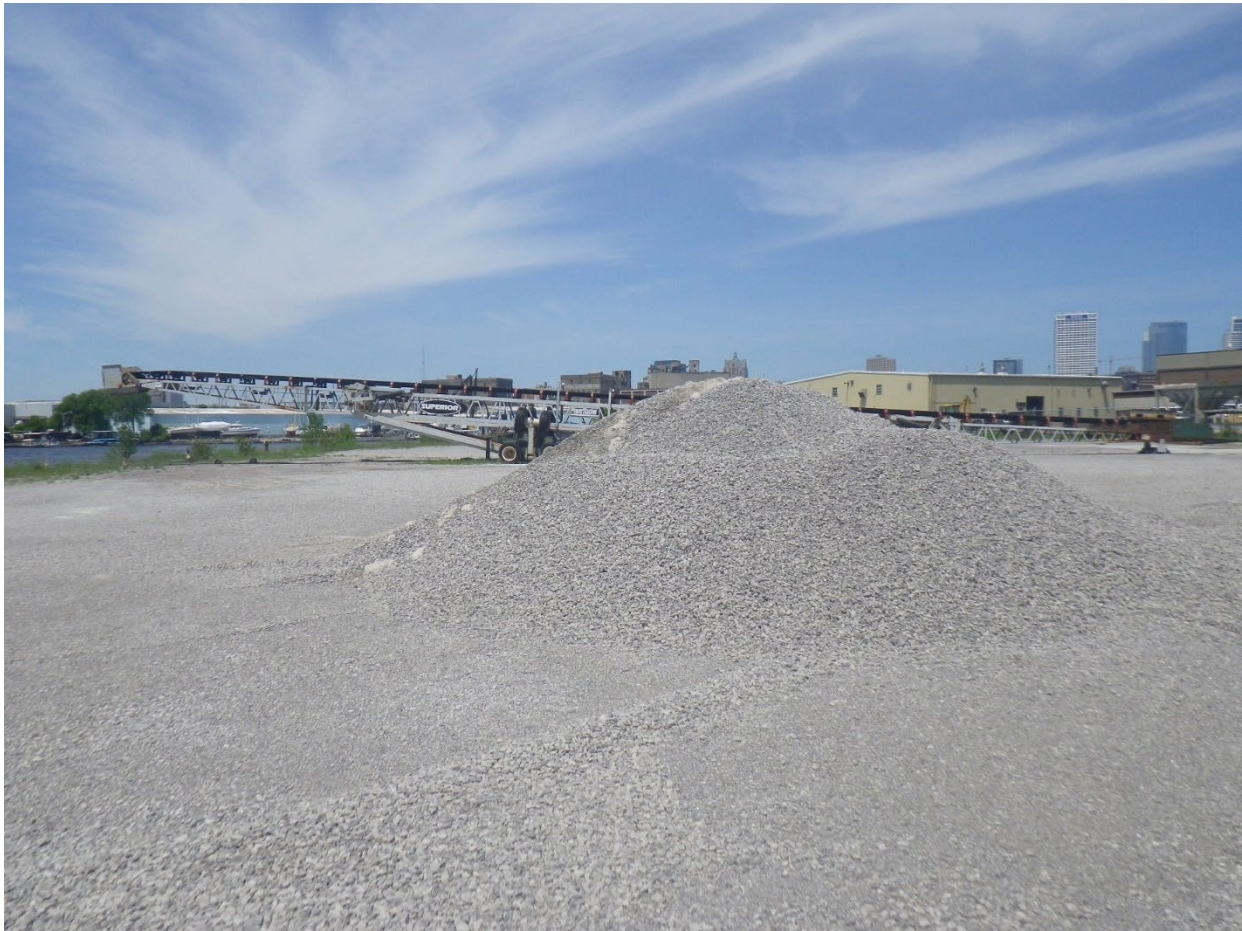
EPA observed the pebble limestone pile and conveyor where it is loaded onto ships. EPA observed the limestone piled up to the edge of the Kinnickinnic River under the conveyor.

| Photograph 1. Small pile of limestone and conveyor at parcel 8. | | | IMGP0001.JPG |

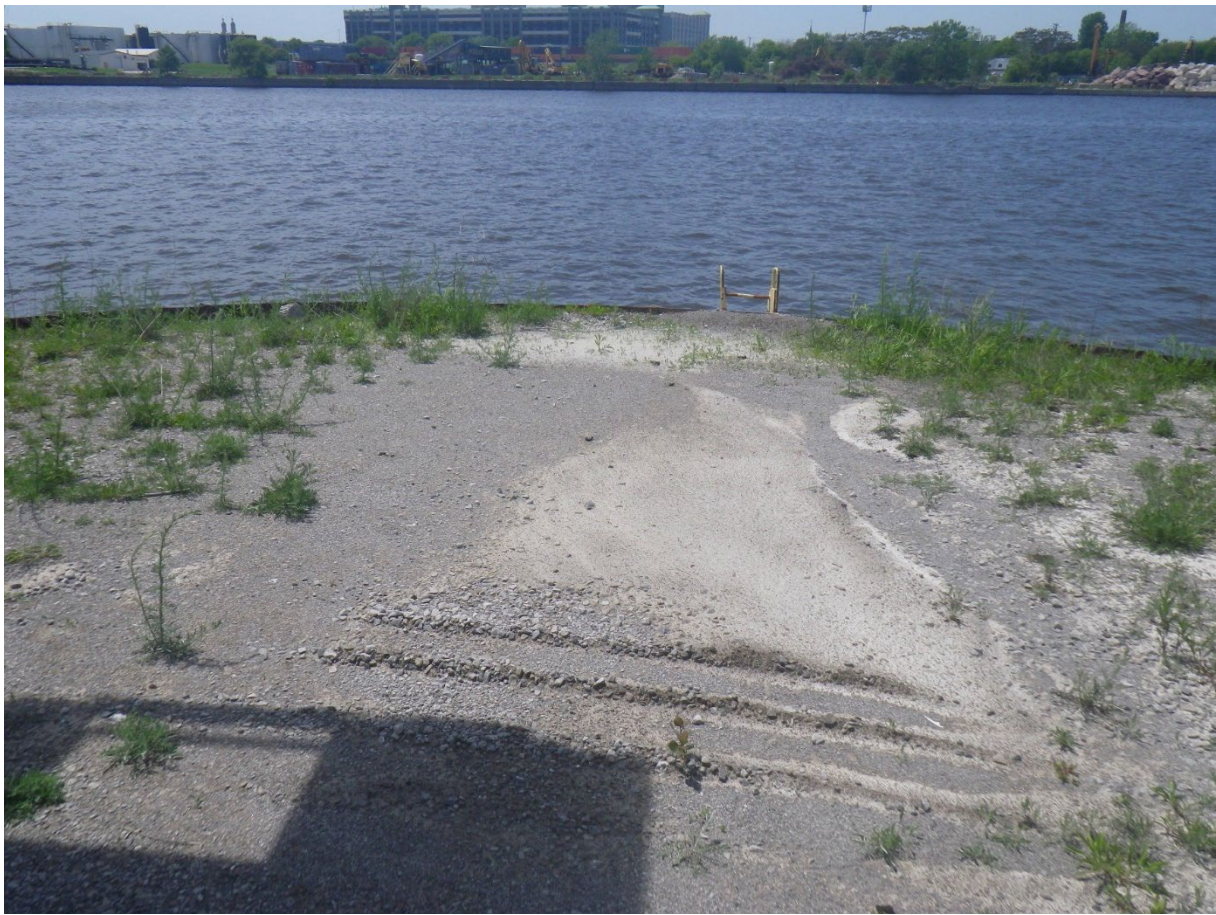
| Photograph 2. Limestone material at edge of parcel 8 under the conveyor. The material is piled up to the top edge of the pilings along the Kinnickinnic river. | | | IMGP0002.JPG |

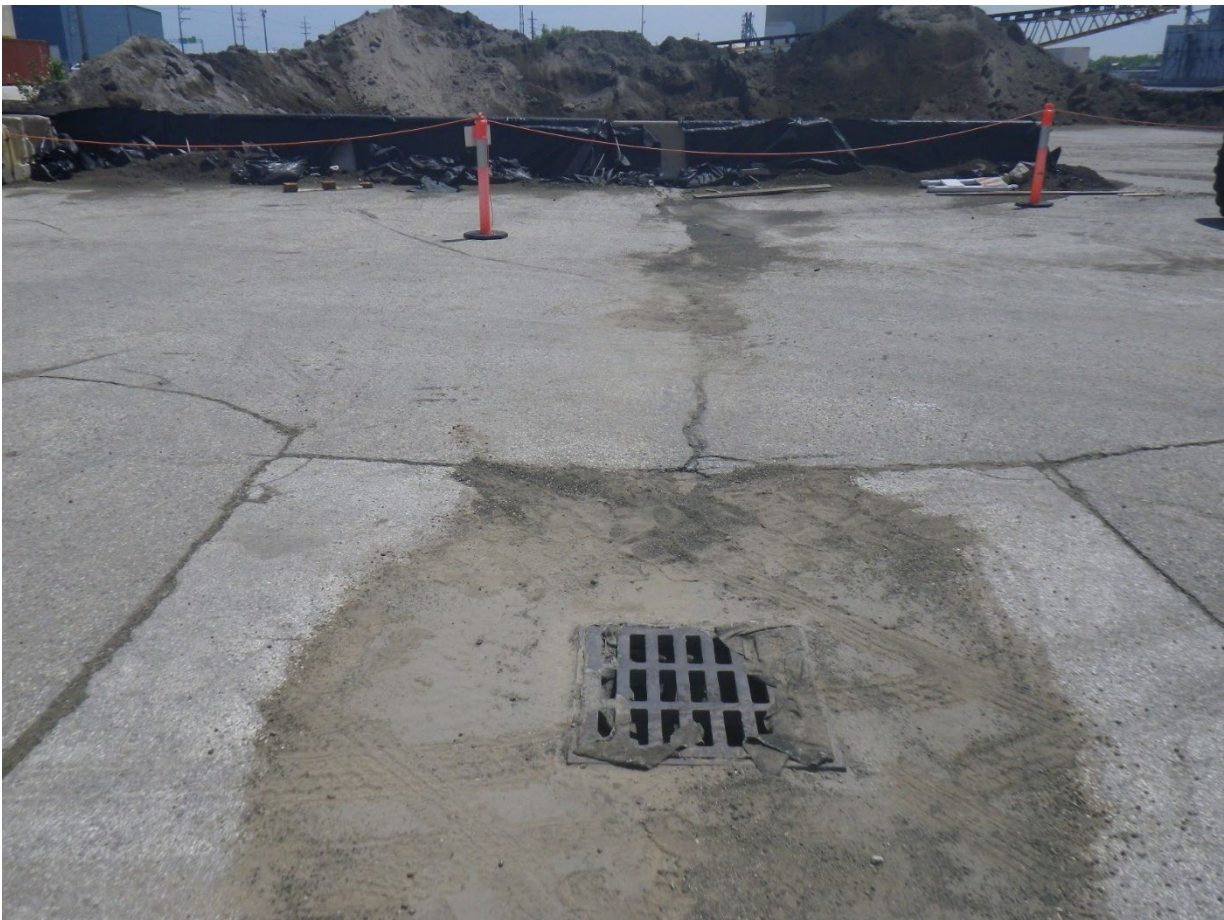
| Area just north of the bottom ash pad. The inlet has a cloth filter and sediment has accumulated around the inlet. | | | IMGP0003.JPG |

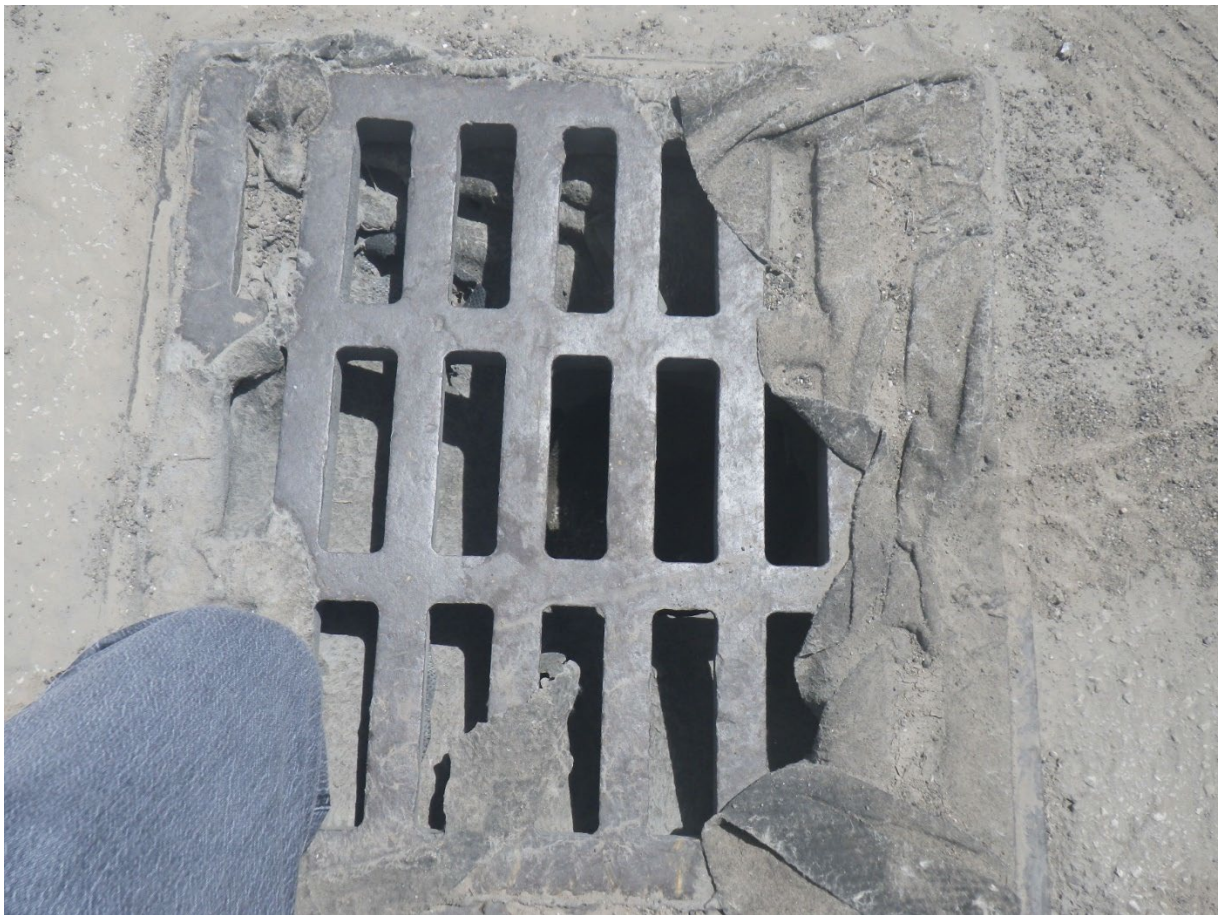
| Photograph 4. Area just north of the bottom ash pad. The inlet has a cloth filter and sediment has accumulated around the inlet. This is also shown in photograph 3. | | | IMGP0004.JPG |

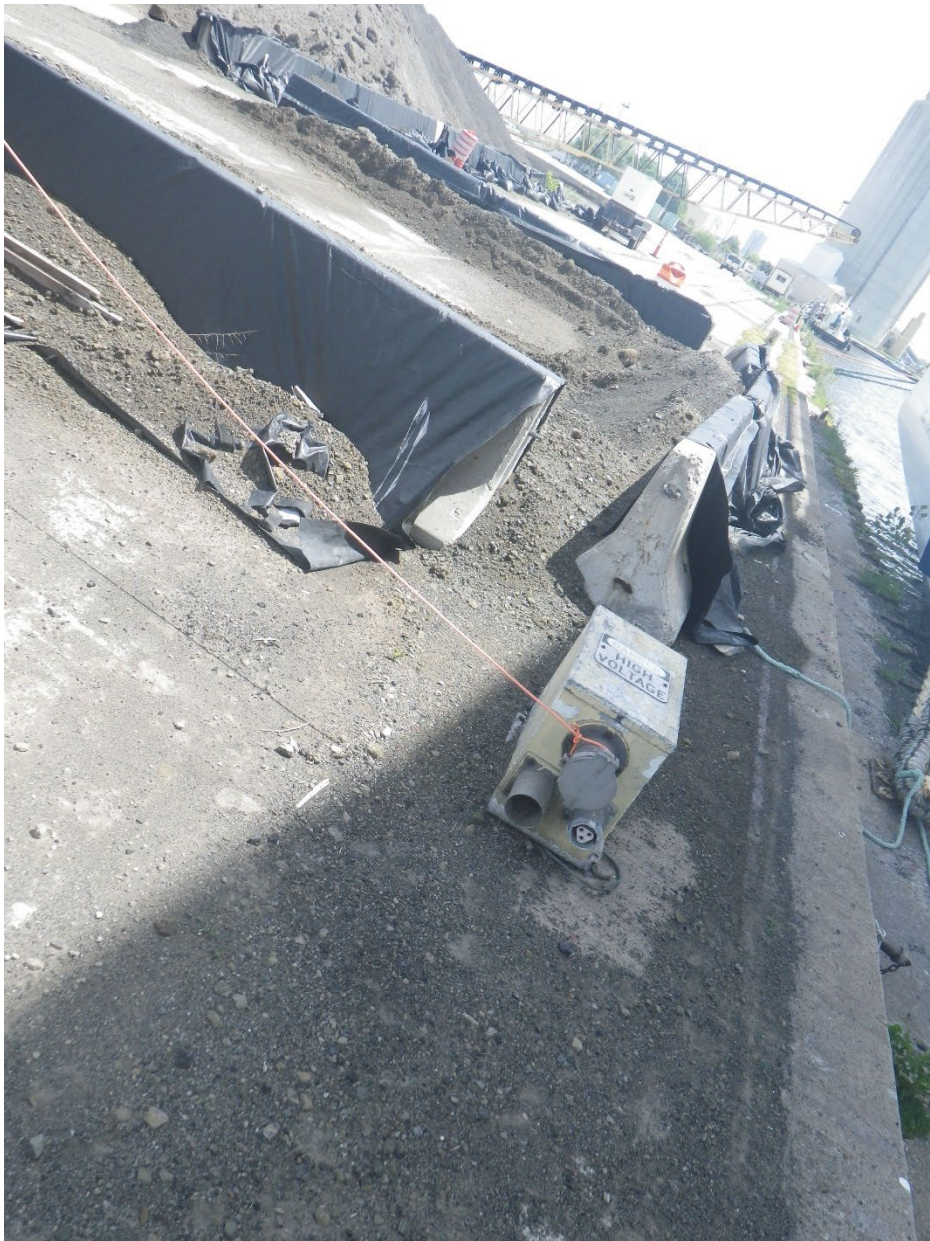
EPA observed Bottom Ash stored in this area along the river. EPA observed that the concrete jersey barriers were not containing the ash, and ash was outside of the barriers nearby the Kinnickinnic River. EPA observed that the inlet protection, by the orange cone, was not completely covering the inlet, and the piles of ash were uncovered/exposed. EPA observed ash mixed into the storm water that was ponded and appeared to have drained to the inlet, by the orange cone, that leads to the Kinnickinnic River, according to the stormwater pollution prevention plan (SWPPP).

| Photo 5. Bottom ash stored next to Kinnickinnic River. Ash is not contained within the barriers and is located on the edge of the river. | | | IMGP0005.JPG |

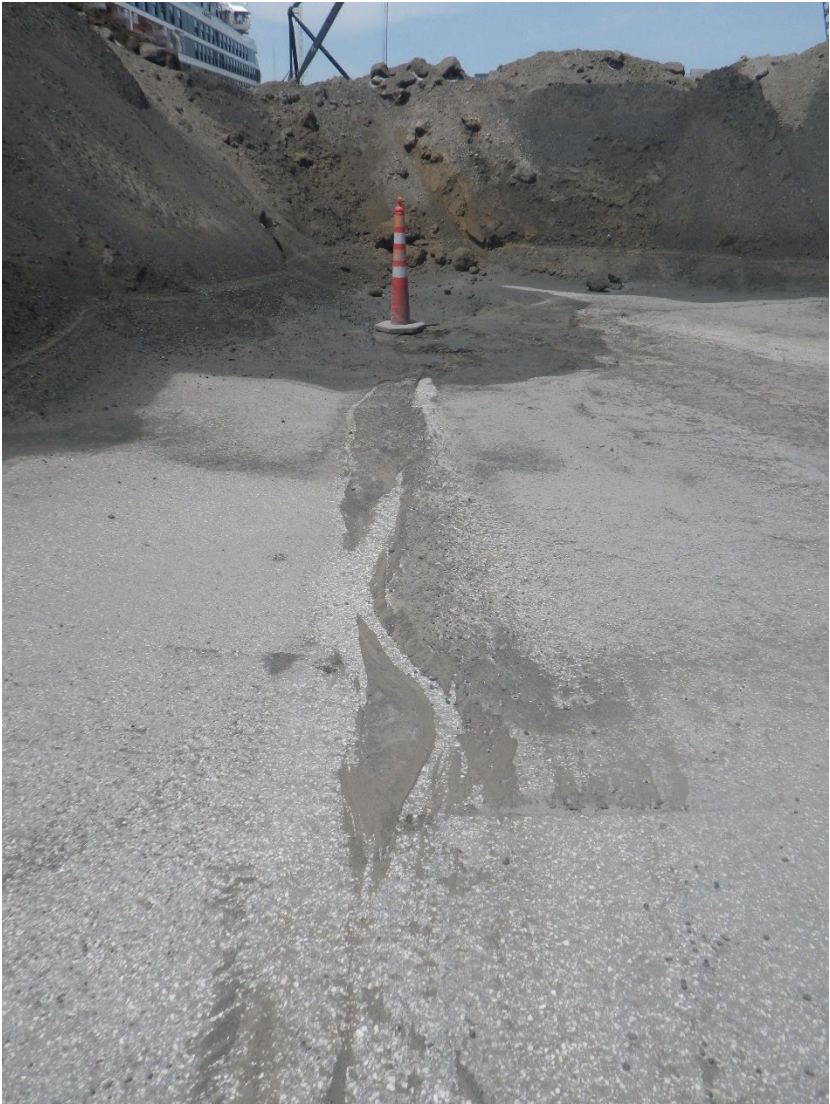
| Photograph 6. Bottom Ash pile along the river. The orange cone sits on top of a catch basin. It appears that rain water ponds in the area as can be seen by the water marks on the ash piles. The piles are uncovered. | | | IMGP0006.JPG |

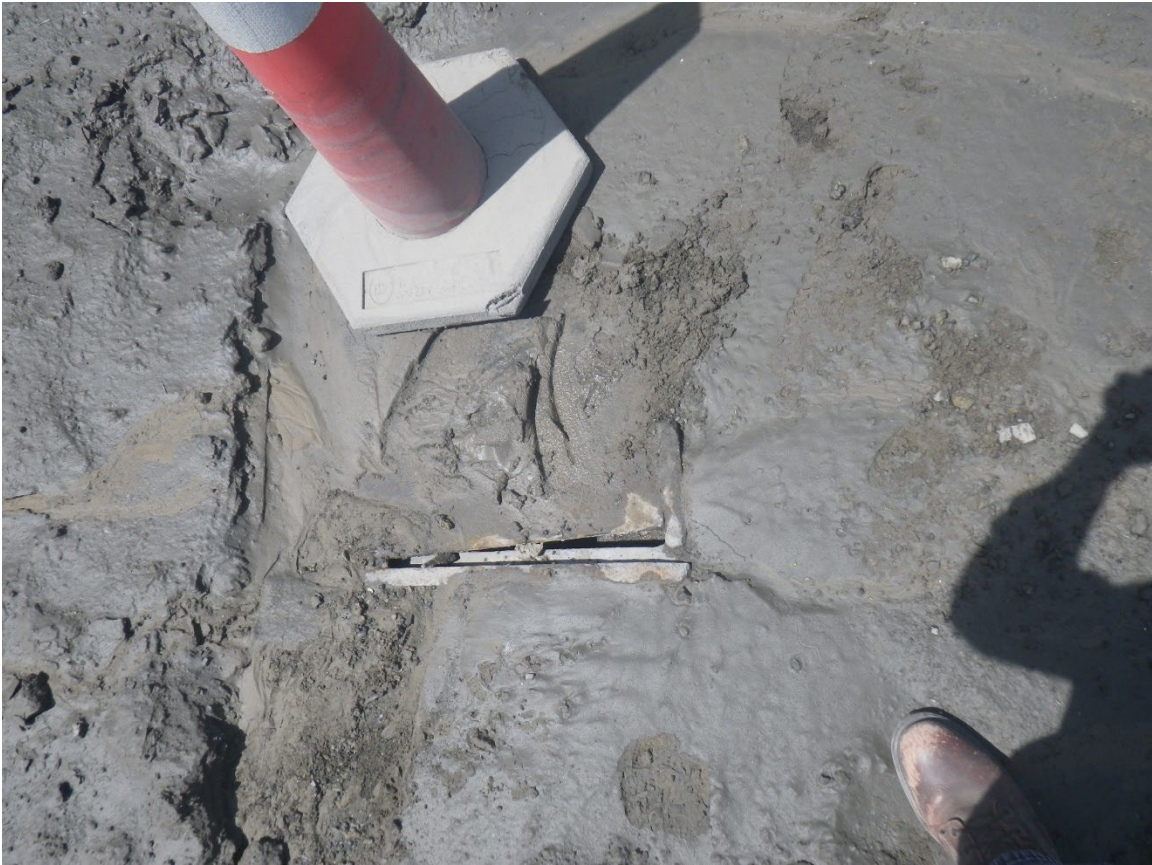
| Photograph 7. Close up of orange cone shown in photograph 6 and area surrounding it. The catch basin inlet can be seen below the orange cone. Filter fabric does not completely cover the inlet. | | | IMGP0007.JPG |

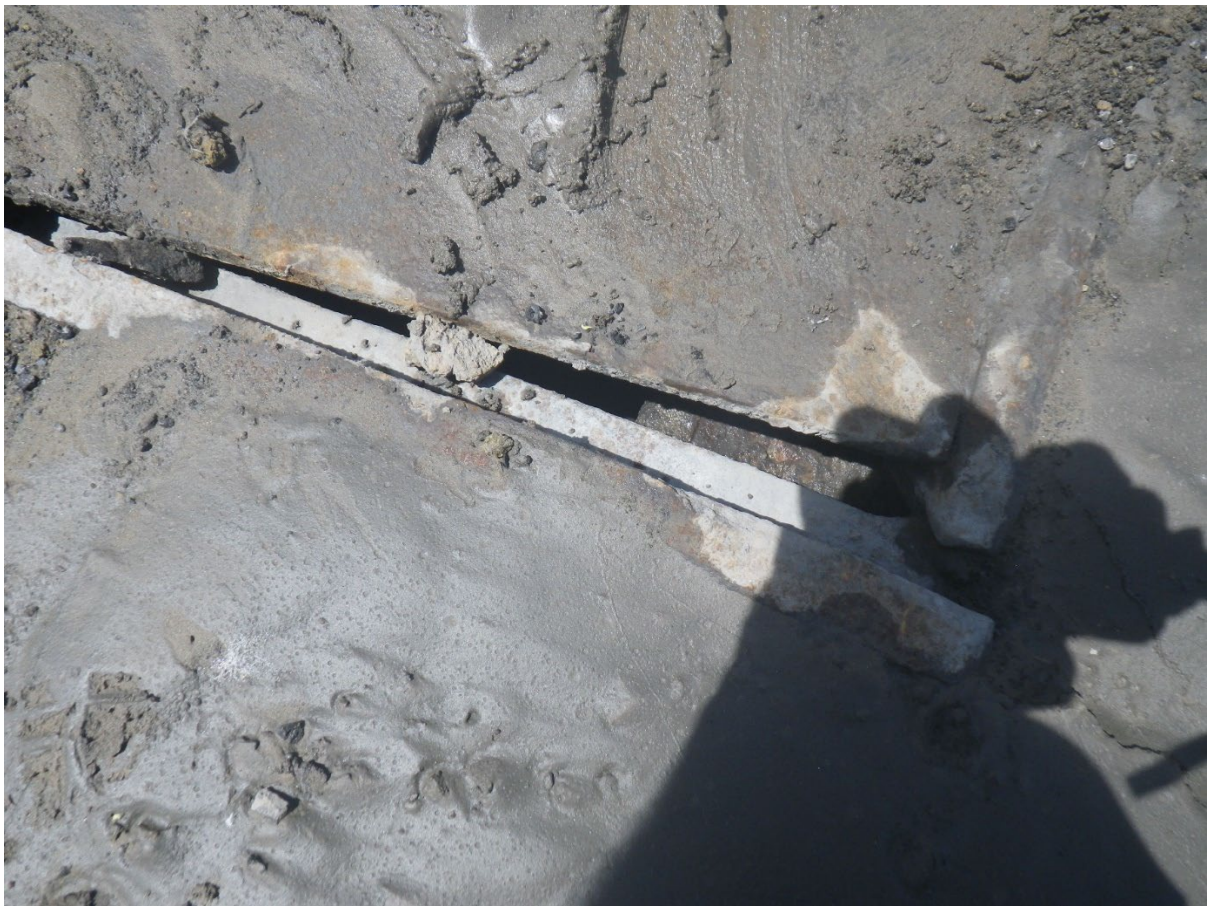
| Photograph 8. Close up of catch basin inlet shown in photograph 7 and area surrounding it. Filter fabric does not completely cover the inlet. | | | IMGP0008.JPG |

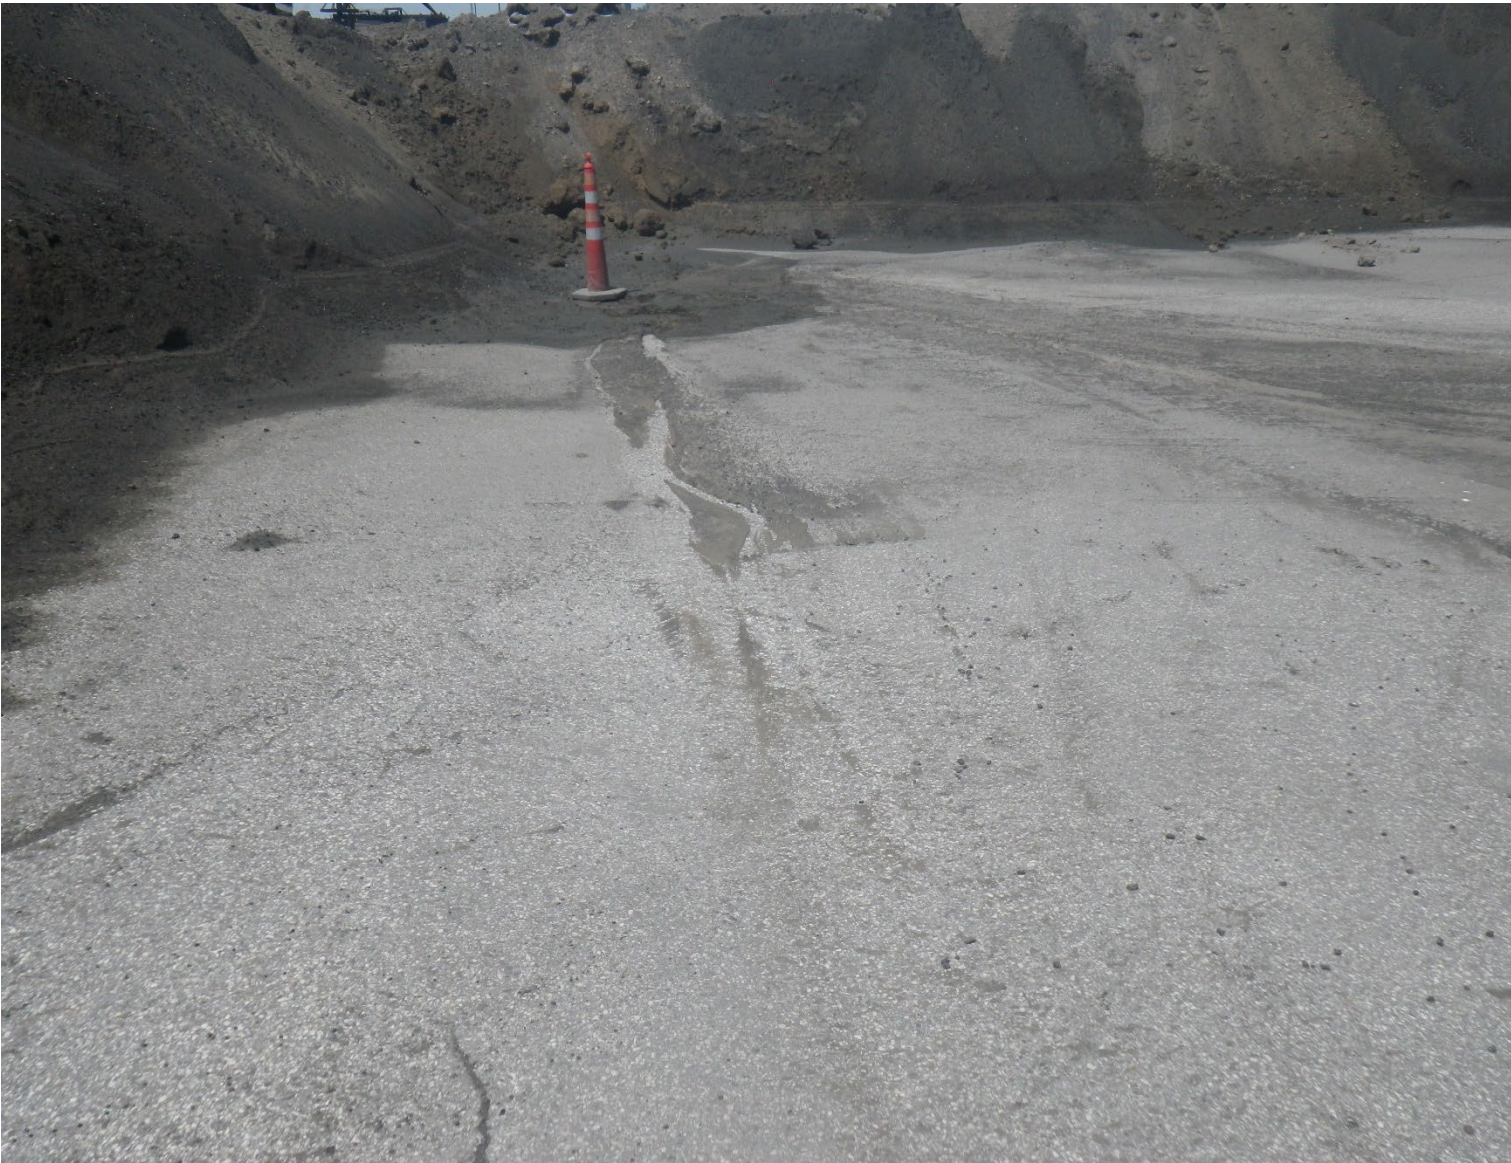
| Photograph 9. Bottom Ash pile along the river. The orange cone sits on top of a catch basin. It appears that rain water ponds in the area as can be seen by the water marks on the ash piles. This area is also shown in photographs 6-8. | | | IMGP009.JPG |

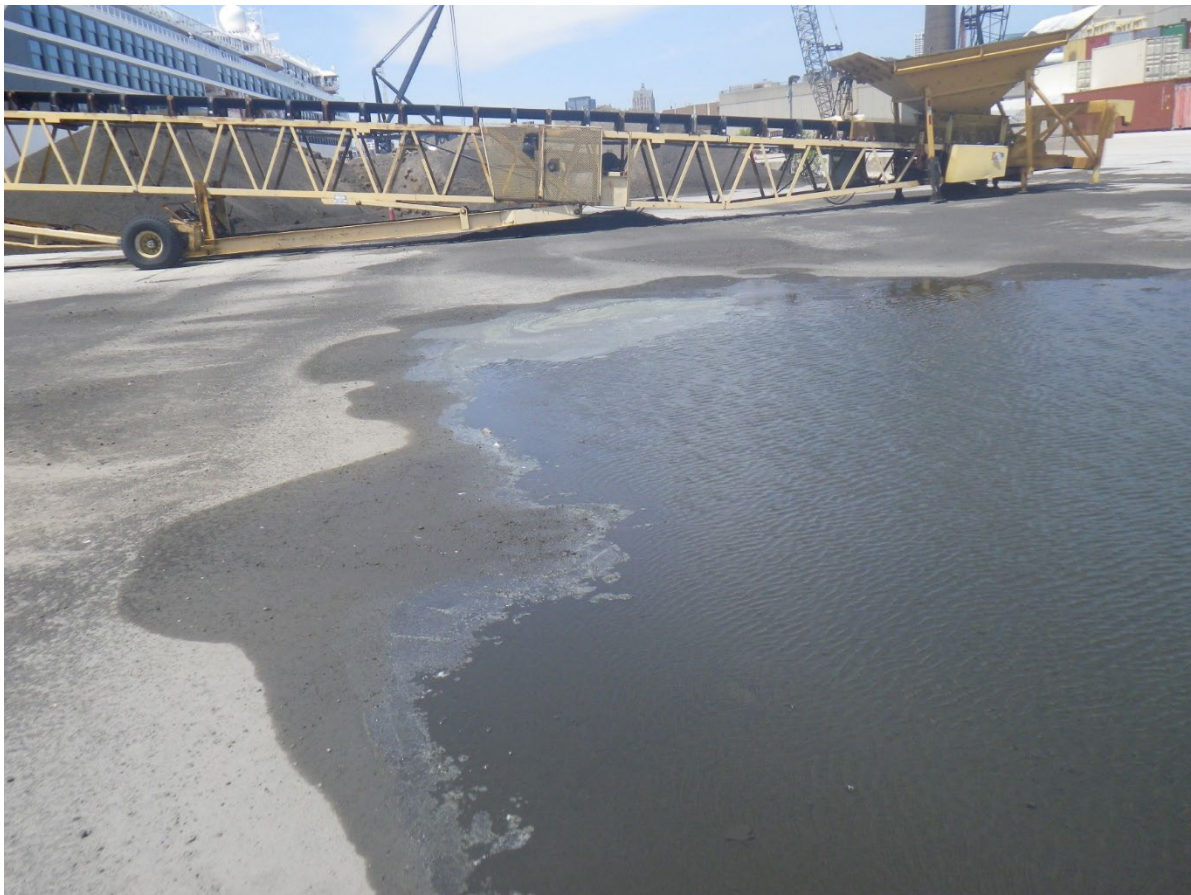
| Photograph 10. Area showing pooled storm water with ash piles shown at top of photograph. These same ash piles are shown in photographs 6 and 9. It appears that water has flowed from the pooled water to the location of the orange cone in the past. | | | IMG0010.JPG |

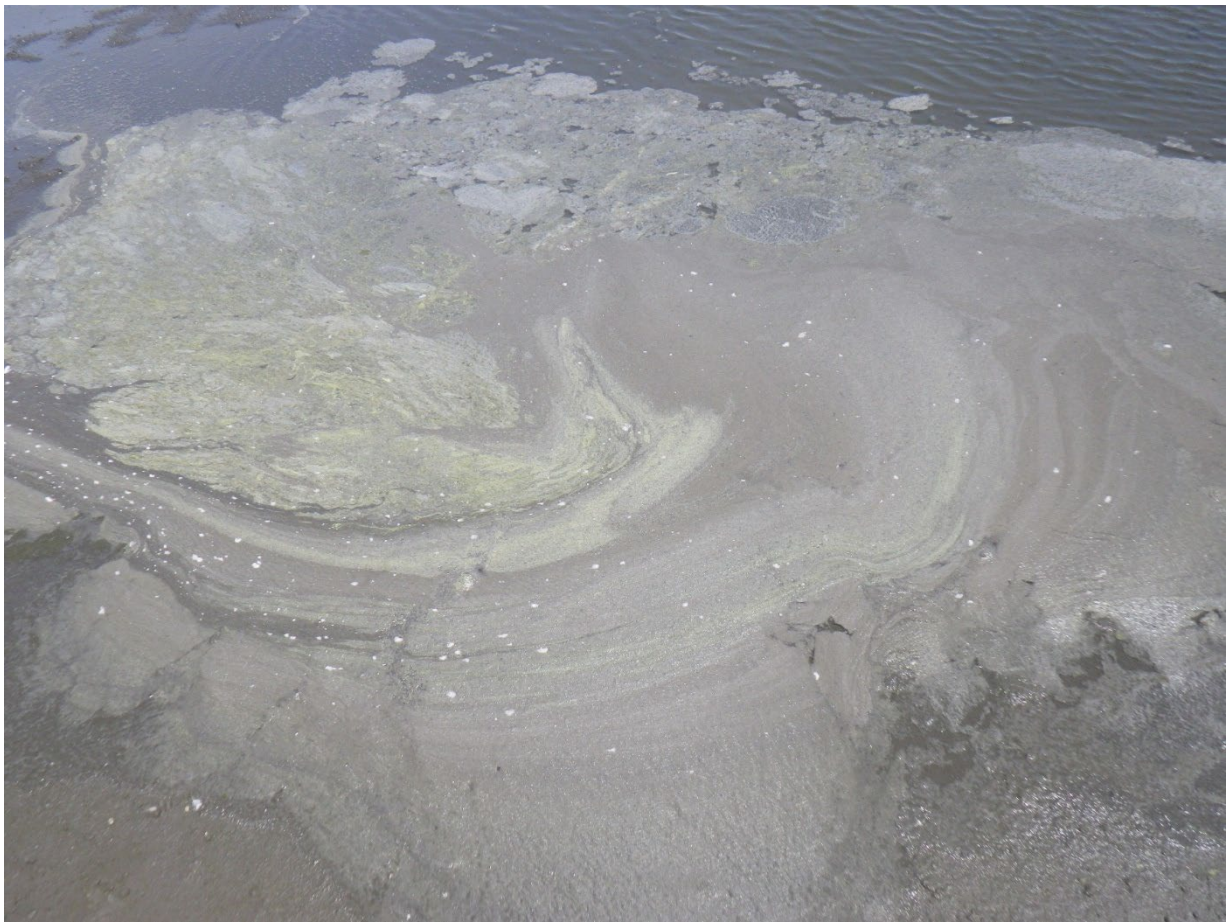
| Photograph 11. Close up of ponded water in photo 10 in ash storage area. | | | IMGP0011.JPG |

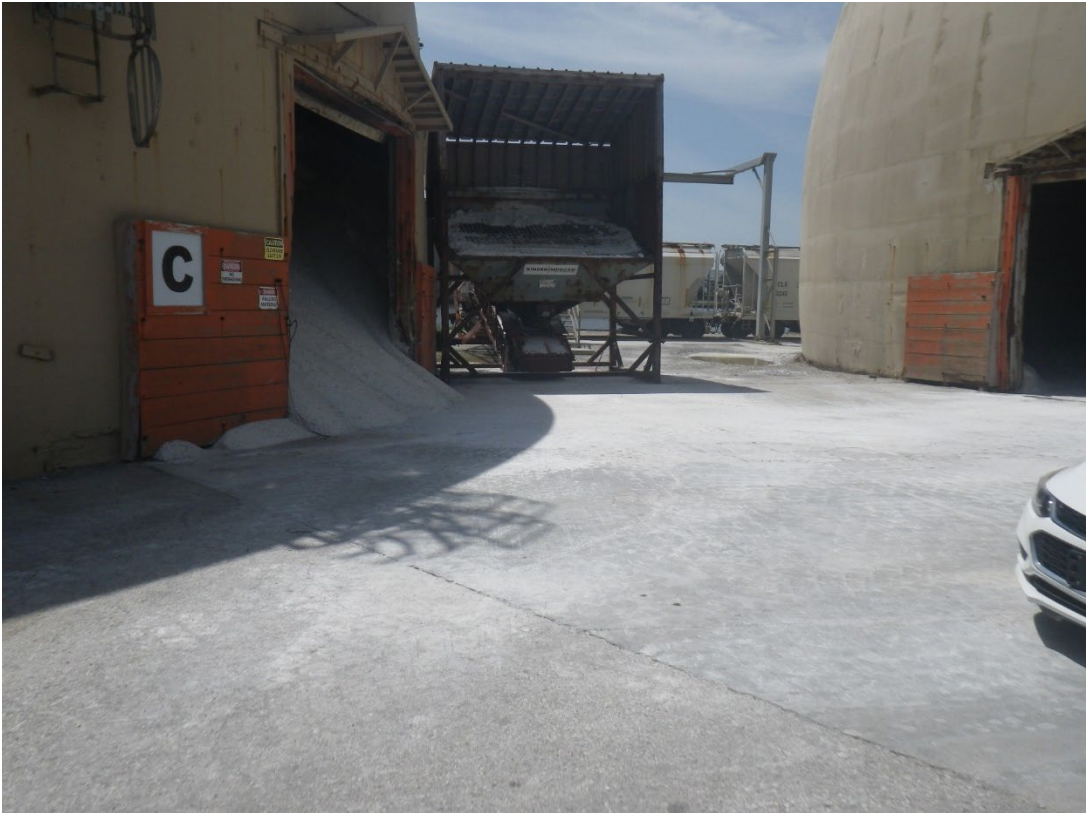
EPA observed two salt domes in this area. EPA observed that some of the salt had spilled outside of the salt dome. EPA observed salt-stained ground, up to the edge of the site, and the Kinnickinnic River.

| Photograph 12. Salt on the ground between the salt domes and salt stored outside of the dome at the entrance to the dome. | | | IMGP0012.JPG |

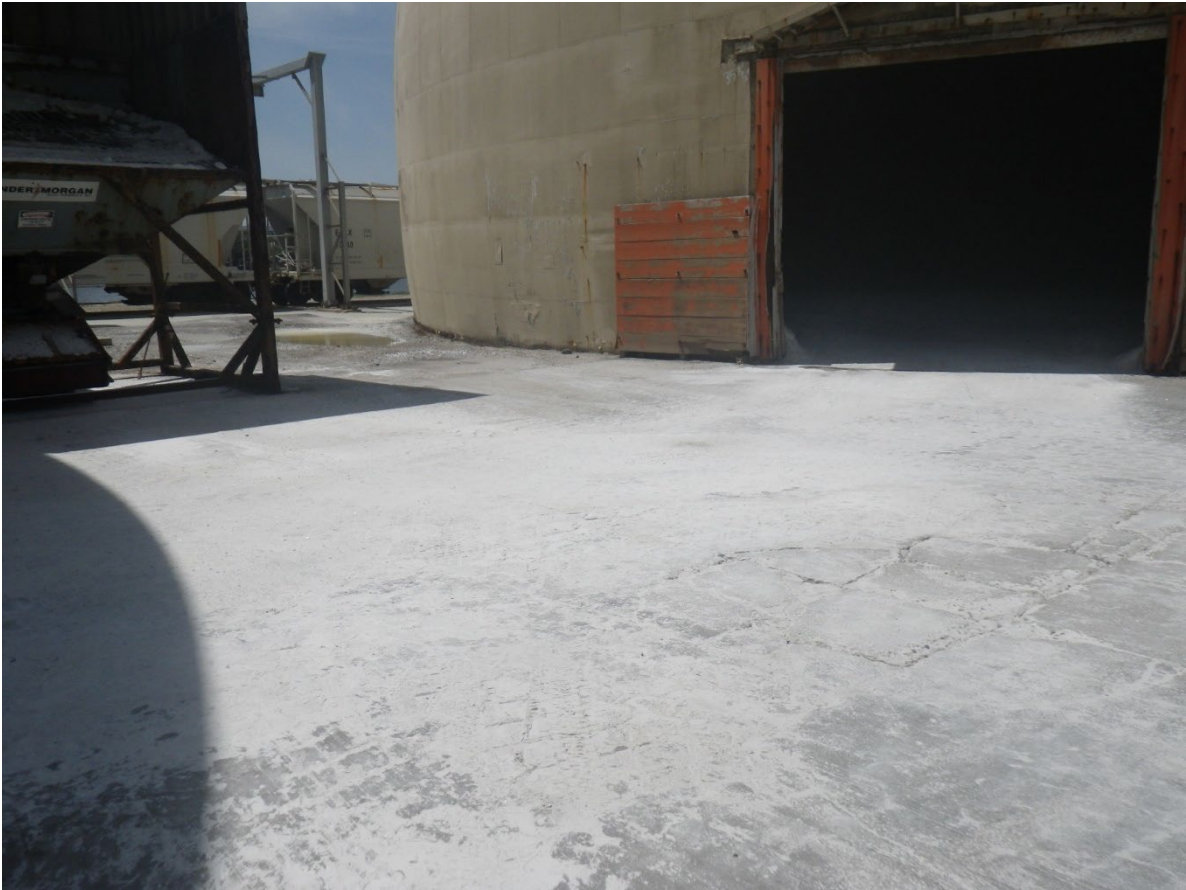
| Photograph 13. Salt on the ground between the salt domes. This area is also shown in photograph 12. | | | IMGP0013.JPG |

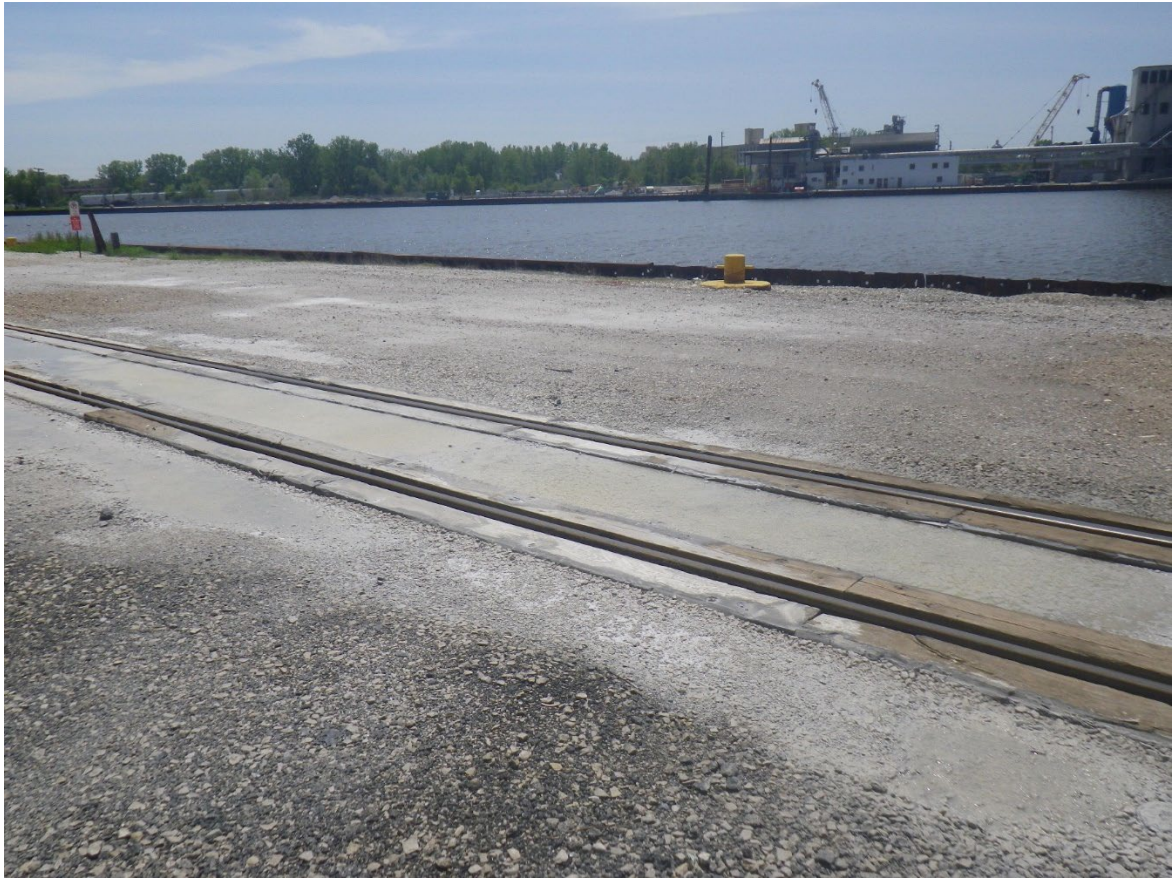
| Photograph 14. Area west of the salt domes by the Kinnickinnic River. The grayish coloring on the pavement/ground appears to be salt. Holes were observed in the sheet pilings along the edge of the river. | | | IMGP0014.JPG |

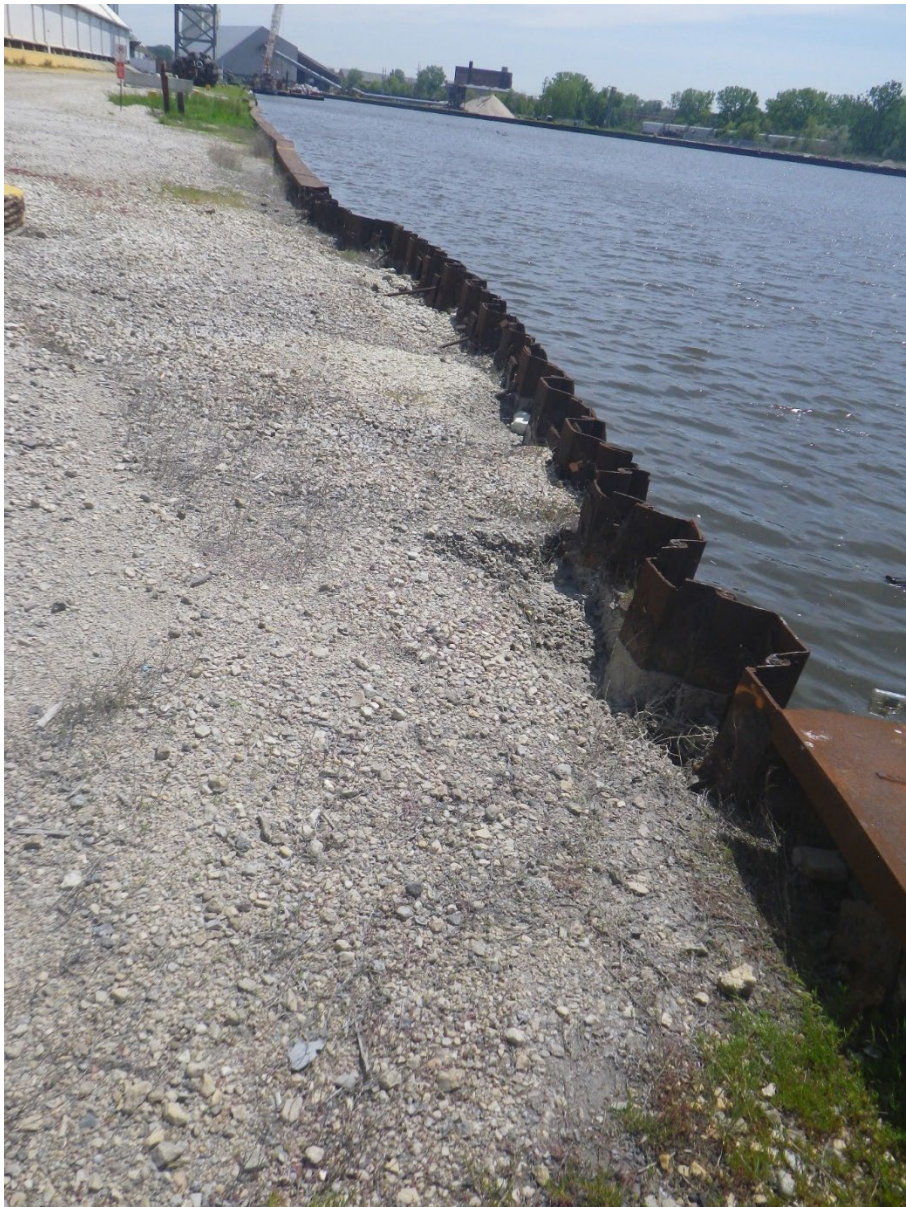
| Photograph 15. Area along the Kinnickinnick River show in photograph 14. The metal sheet pilings appear corroded and have holes in them. | | | IMGP0015.JPG |

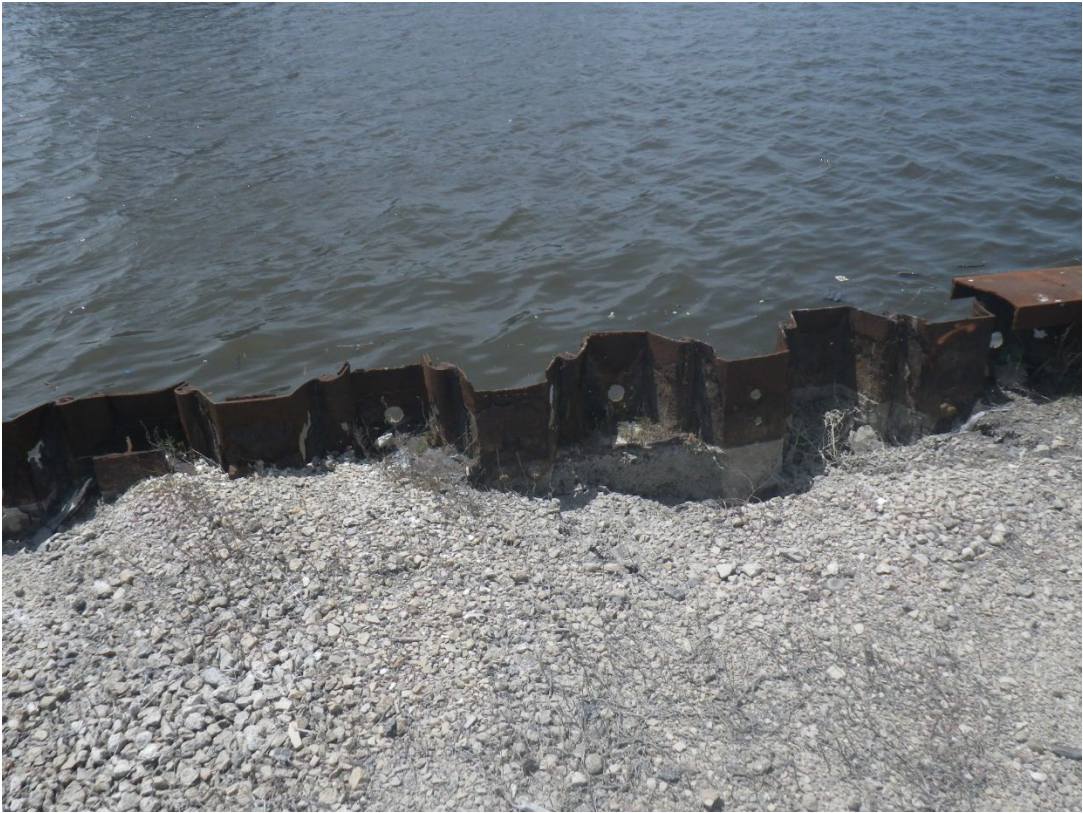
| Photograph 16. View of sheet pilings shown in photograph 15 showing the holes and corrosion. | | | IMGP0016.JPG |

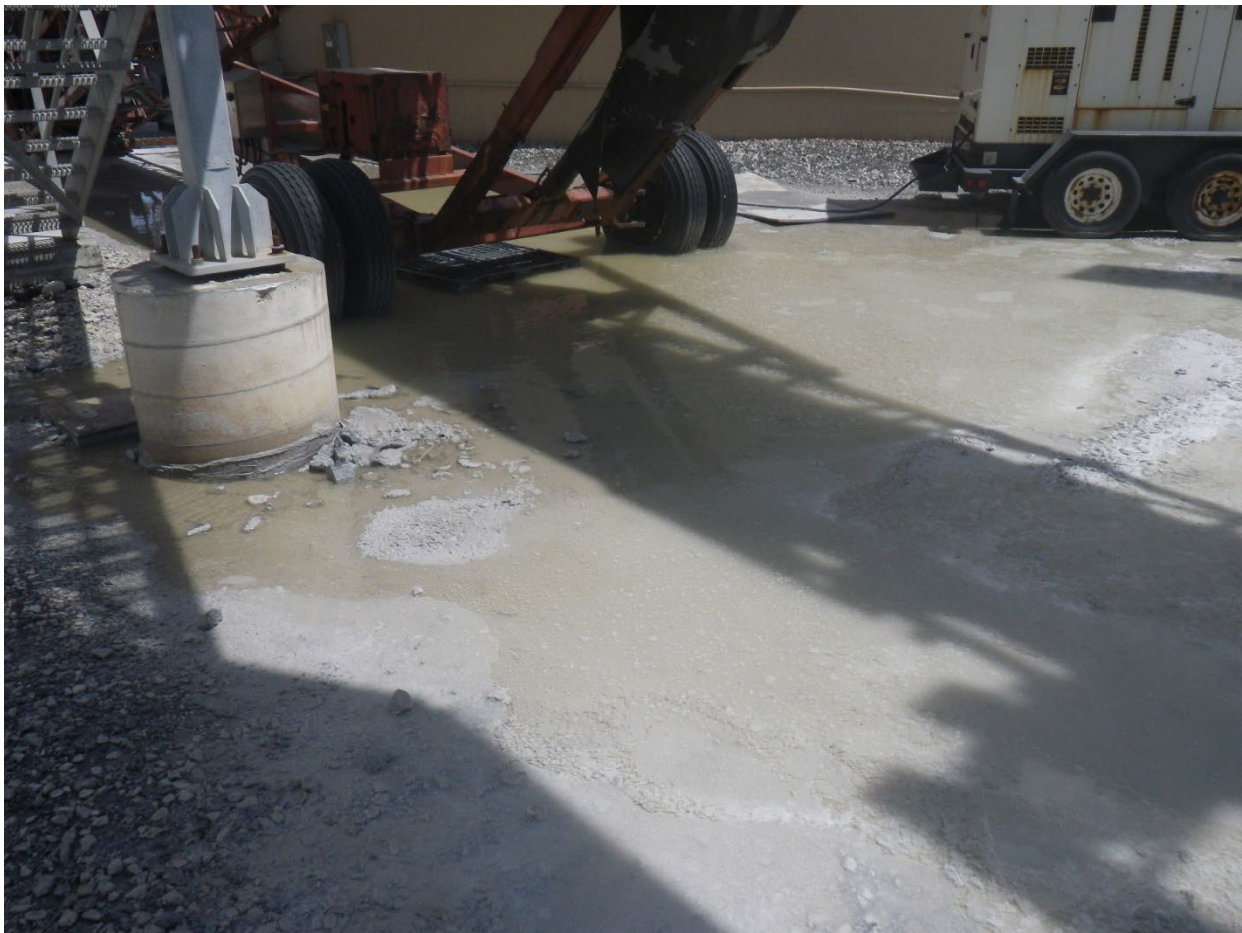
| Photograph 17. Closeup of area adjacent to salt domes showing ponded salt water | | | IMGP0017.JPG |

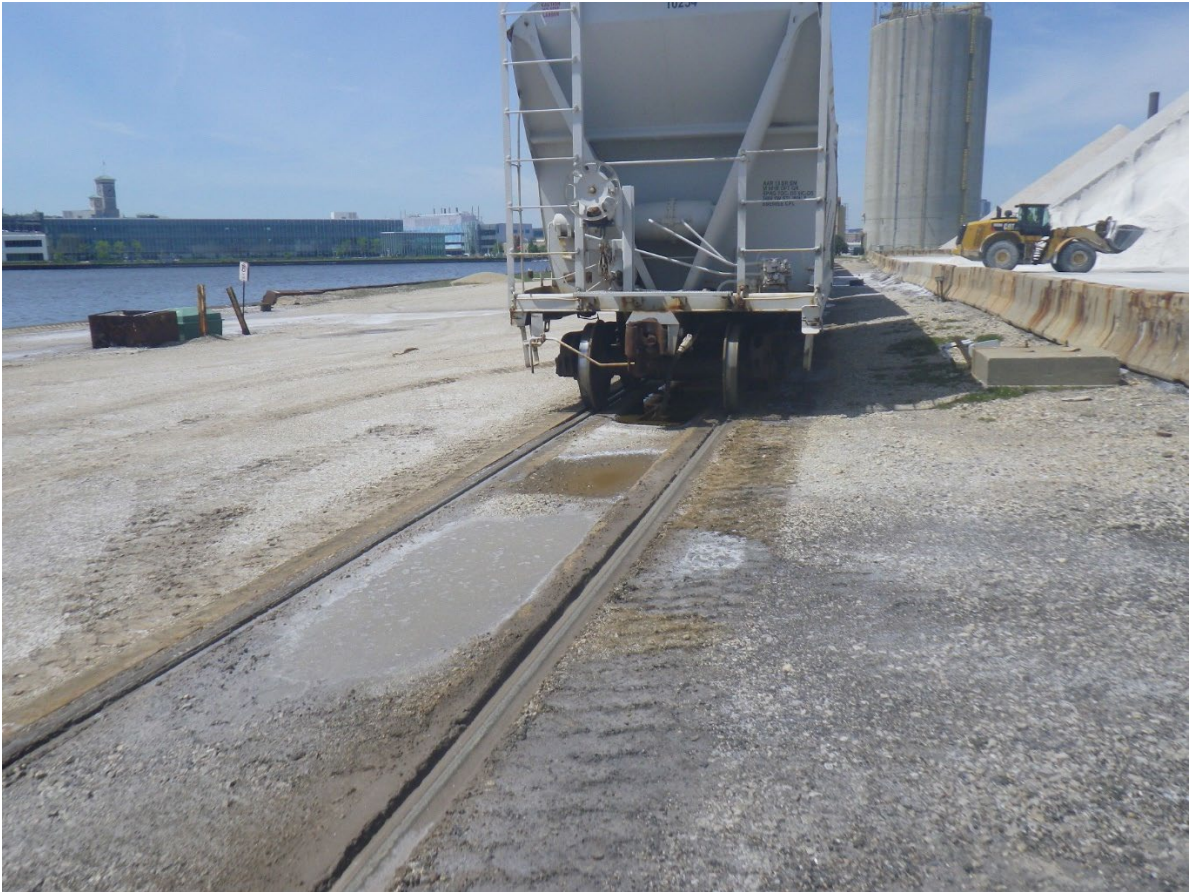
EPA observed salt staining on the ground leading to the Kinnickinnic River.

| Photo 18. Shows a salt pile on the right side of the photograph and grayish white salt staining on the ground on the left side of the photograph leading to the river. | | | IMGP0018.JPG |

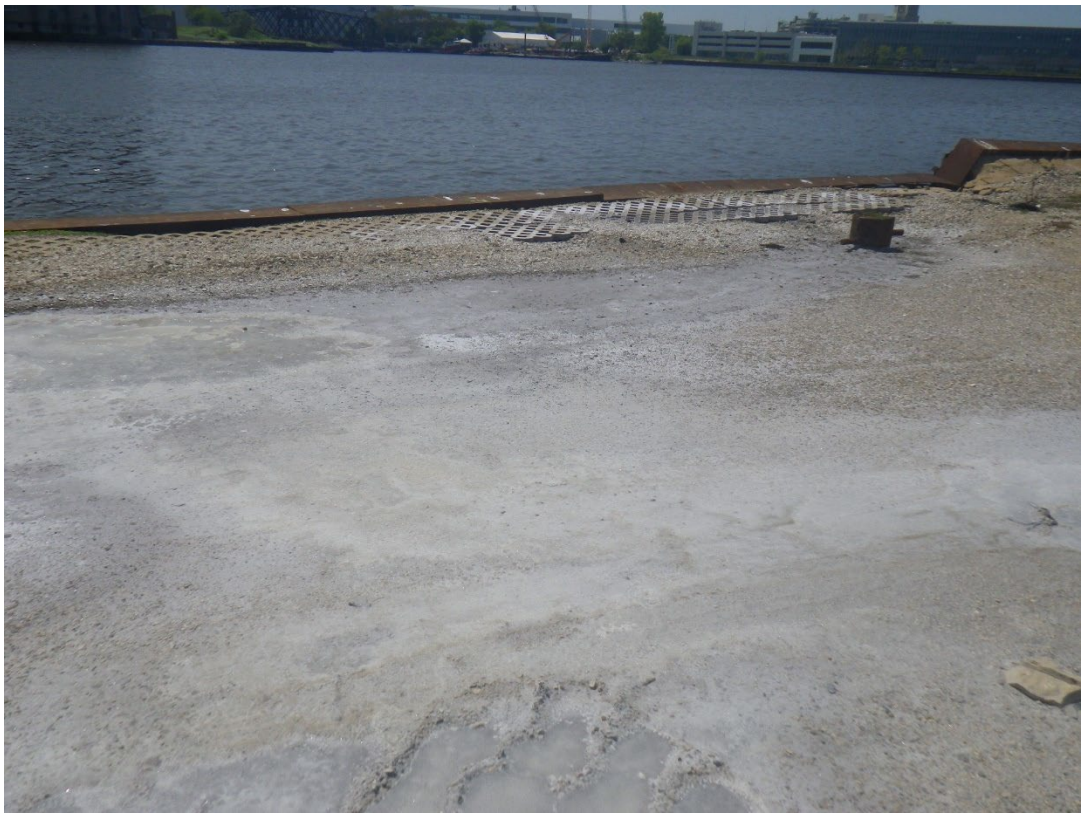
| Photo 19. Close up of salt staining in photograph 18 leading towards the river. | | | IMGP0019.JPG |

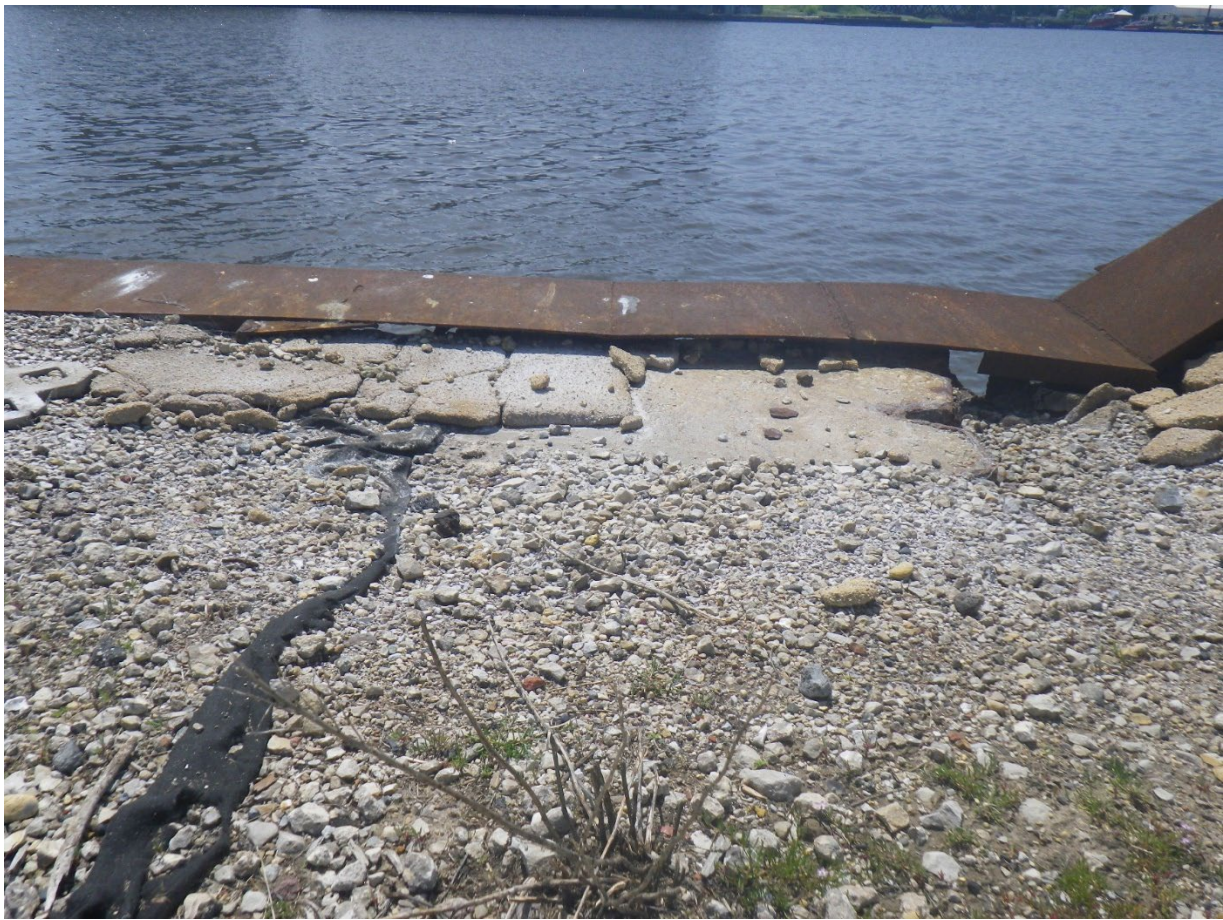
| Photograph 20. Closeup of the wall along the Kinnickinnic River showing erosion and holes in the wall leading to the river. This area is shown in photograph 19. | | | IMGP0020.JPG |
