INSPECTION REPORT

| Type of Inspection | Industrial Stormwater Inspection (ISI) | |
| Permittee Name | Kinder Morgan | |
| Facility or Site Name | Limestone Storage Area, Bottom Ash Storage Area, South Salt Domes, Main Terminal, Cargill Salt Pad | |

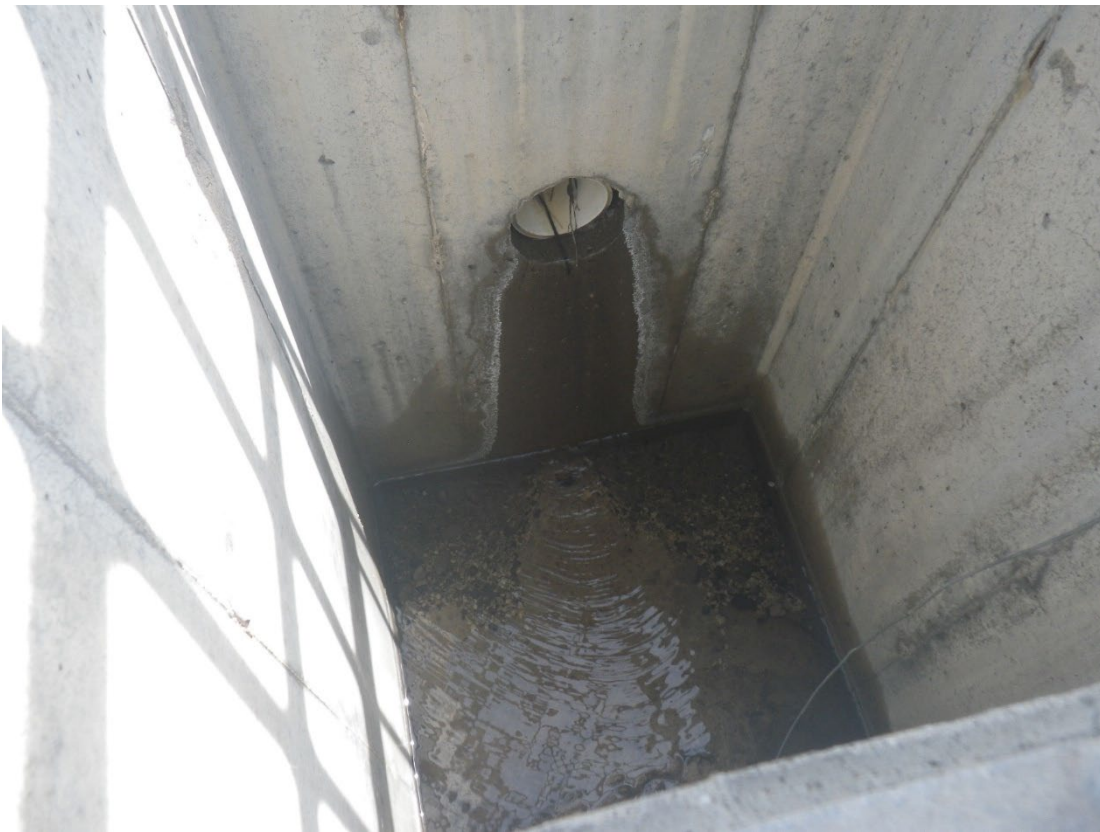
| Photograph 21. Showing a structure with water flowing into it from a ditch on the east side of the salt pile located on parcel 17. The SWPPP indicates that this leads to the combined sewer. | | | IMG0021.JPG |

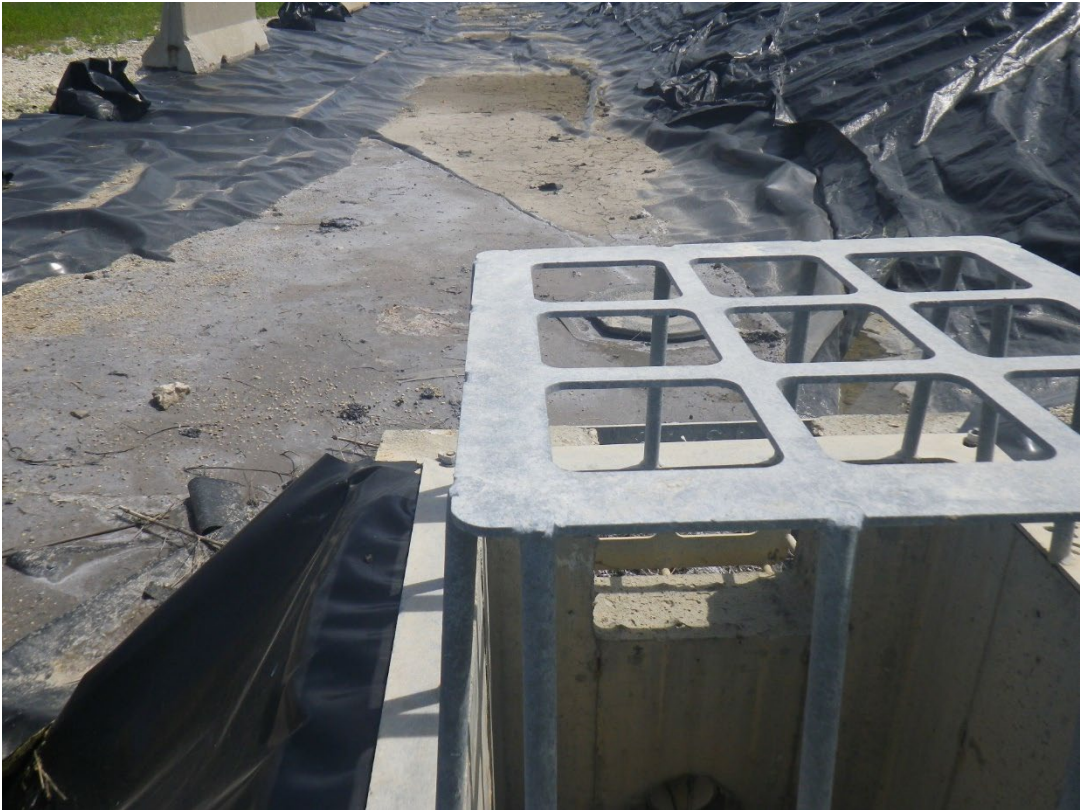
| Photograph 22. View of top of structure shown in photograph 21 and ditch on east side of salt pile. | | | IMGP0022.JPG |

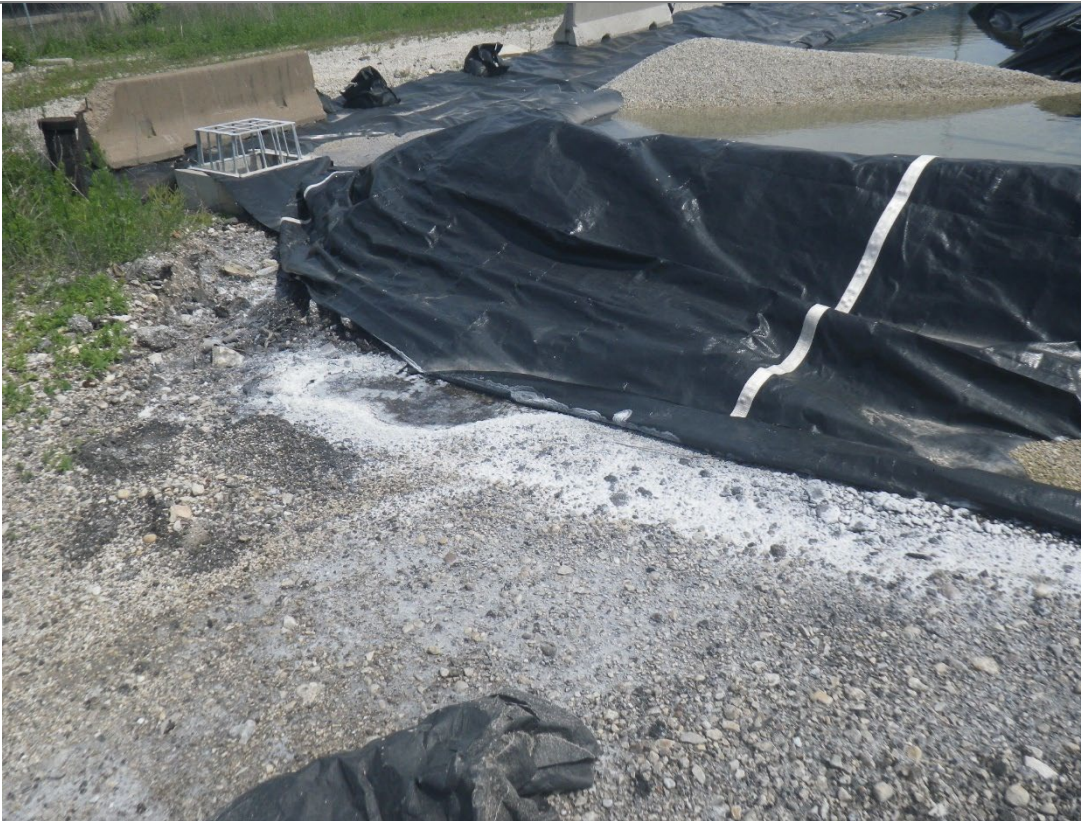
| Photograph 23. View of concrete structure shown in photograph 22 and 21. Salt staining can be seen on the ground in the center of the photograph | | | IMG0023.JPG |

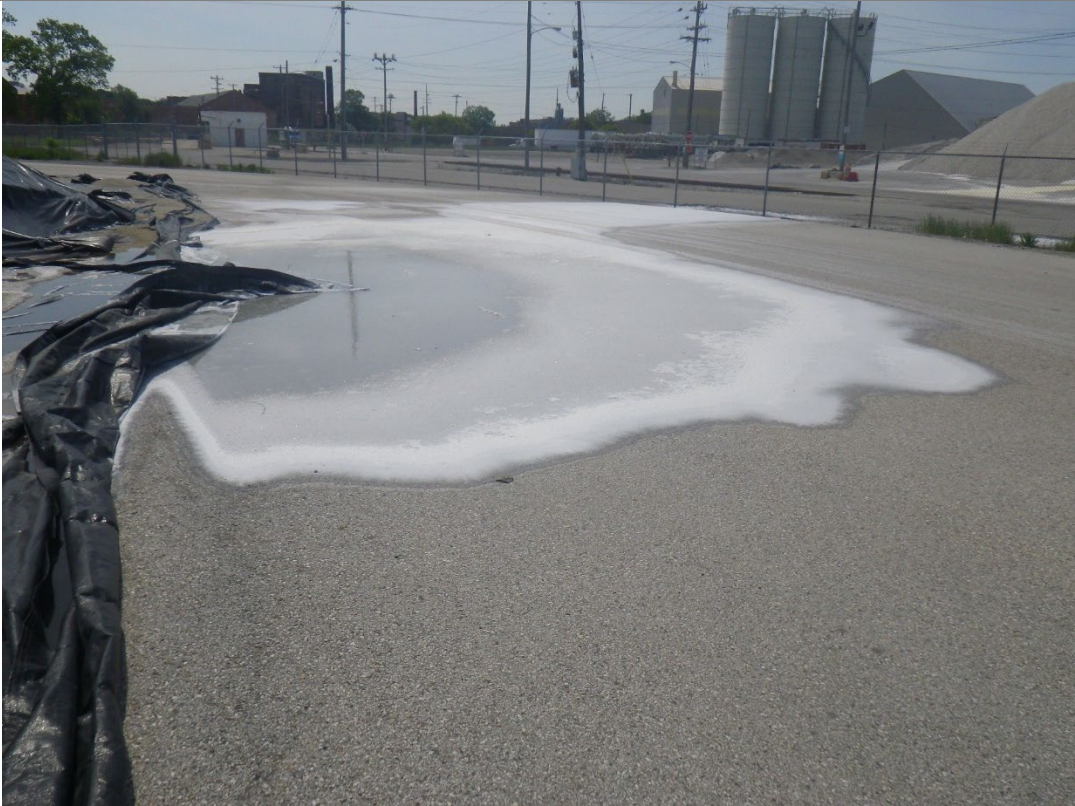
| Photograph 24. Salt water can be seen ponded on the north side of the salt pile with staining leading out towards the gate and onto the roadway. | | | IMG0024.JPG |

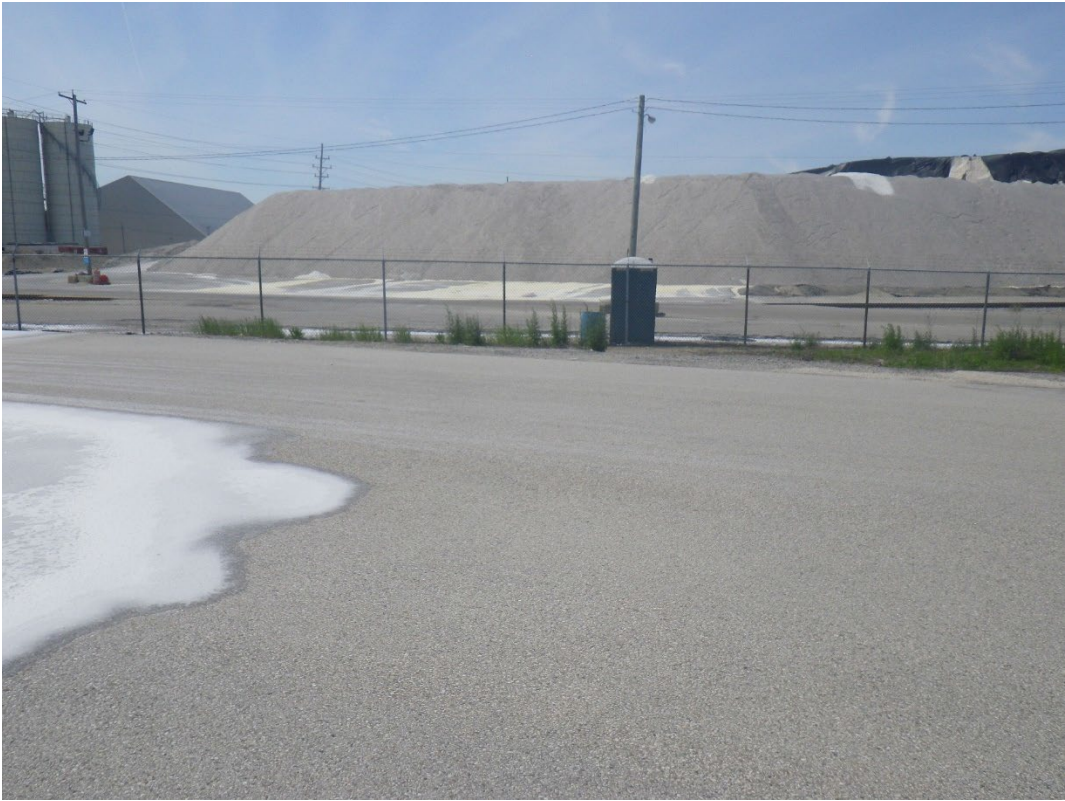
| Photograph 25. Salt water can be seen ponded on the north side of the salt pile with staining leading out towards the gate. This area is also shown in photograph 24. | | | IMGP0025.JPG |

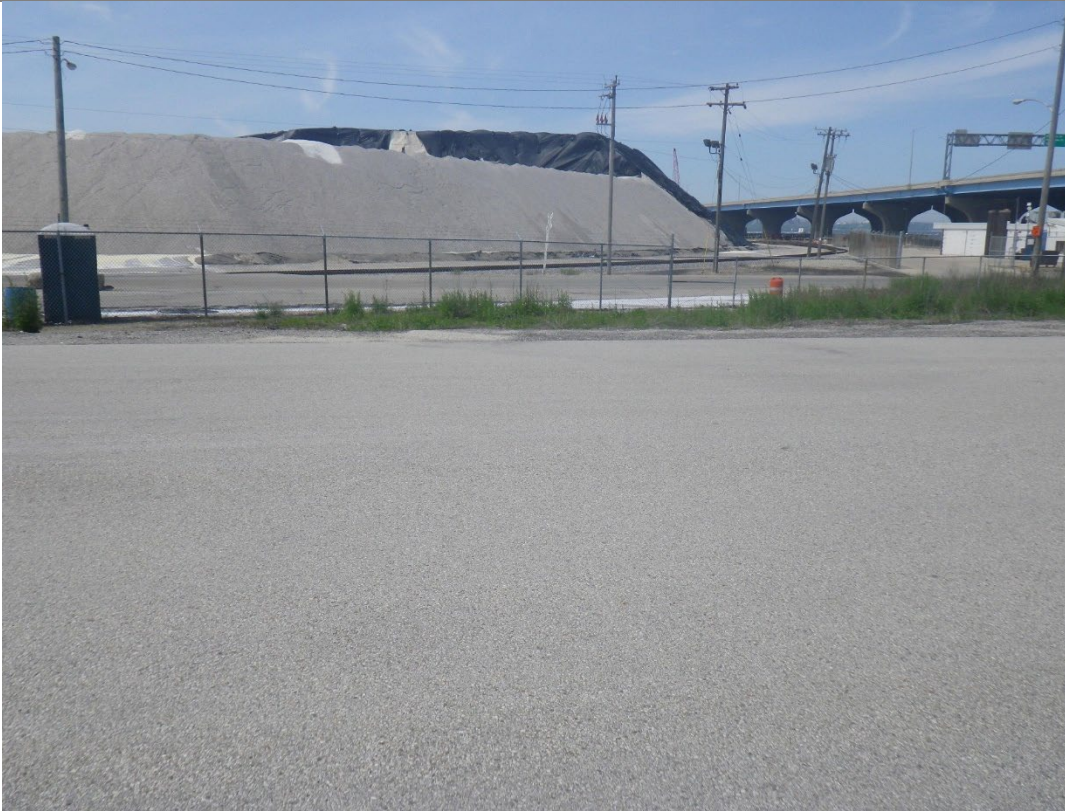
| Photograph 26. North side of the salt pile with staining shown in the gutter outside of the fenceline. Also see photograph 25. | | | IMGP0026.JPG |

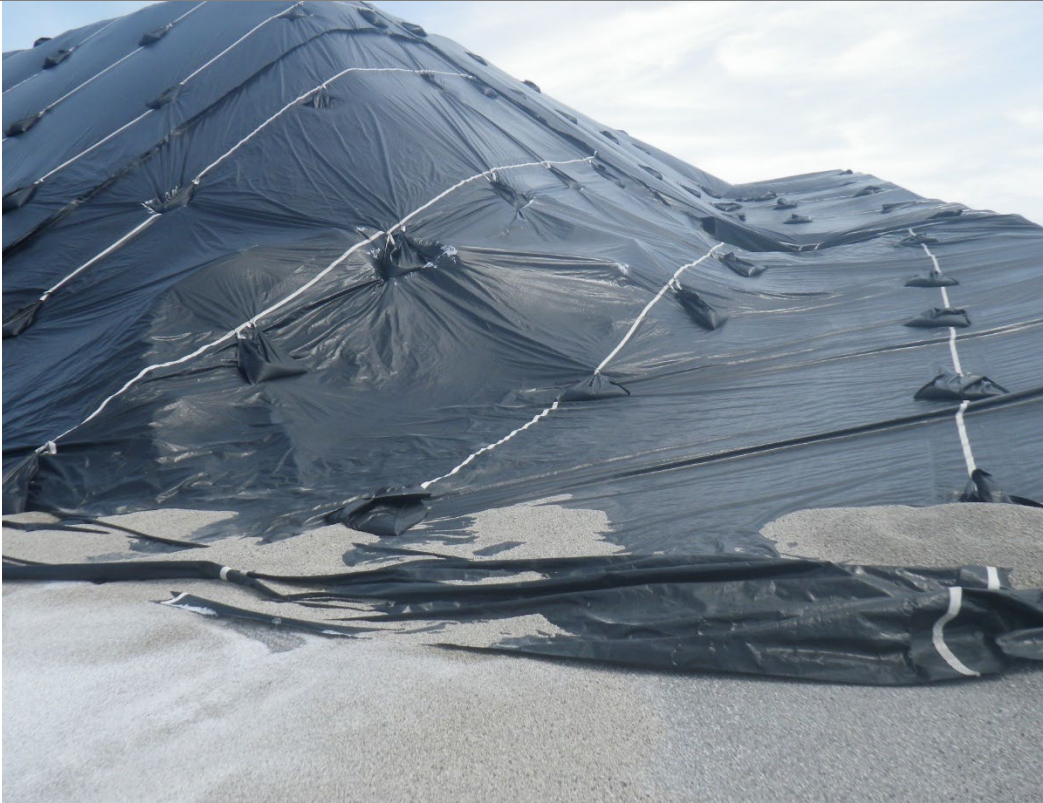
EPA observed a hole in the tarp covering the salt pile, and water appeared to have washed the salt off the pile, in the area below the hole, and it had stained the pavement and street nearby.

| Photograph 27. North side of salt pile showing area that has lost salt. The black plastic cover is also ripped open in the top right-hand side of the photograph. This appears to have allowed rainwater to go under the tarp and to wash salt off the pile and onto the pavement. | | | IMGP0027.JPG |

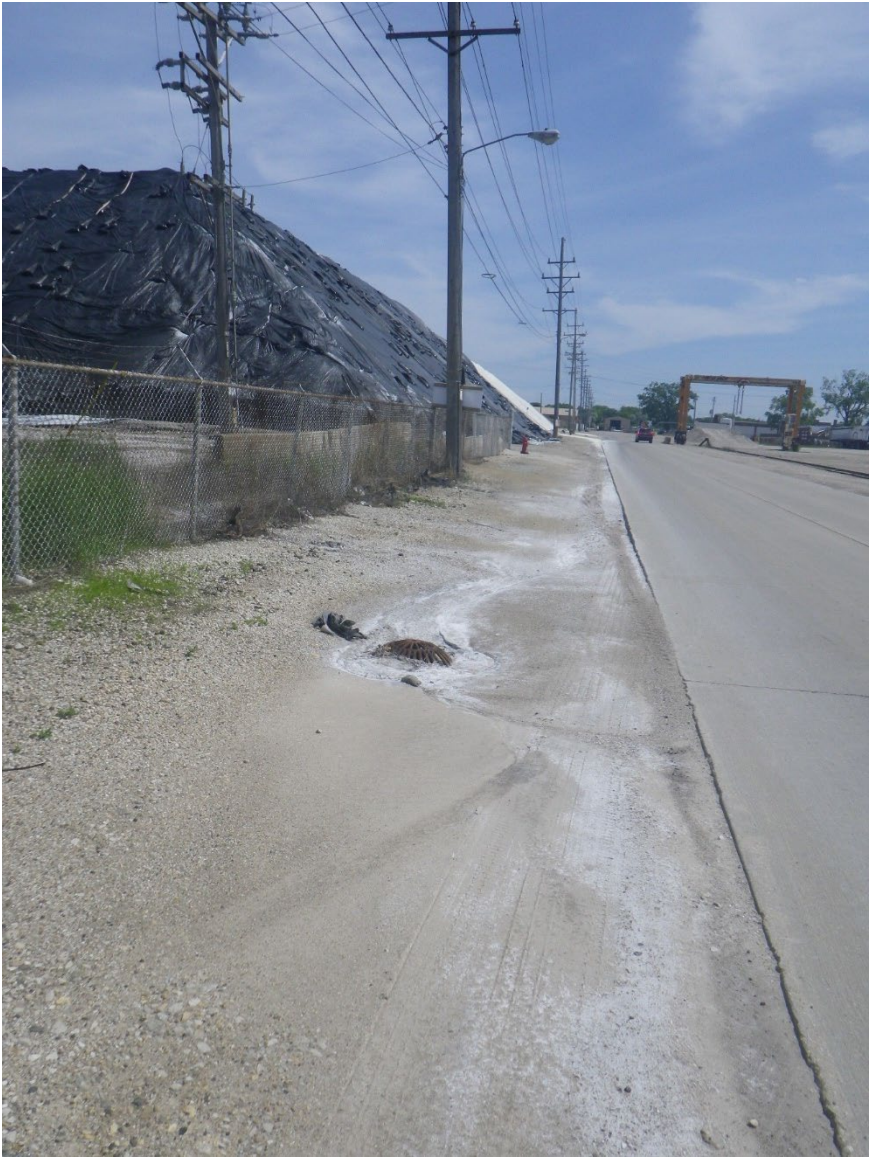
| Photograph 28. Photograph of storm drain inlet between parcel 9 and S. Harbor Drive showing a salt trail leading to the storm drain inlet. The salt pile in the top middle of the photograph is uncovered along parcel 5. | | | IMG0028.JPG |

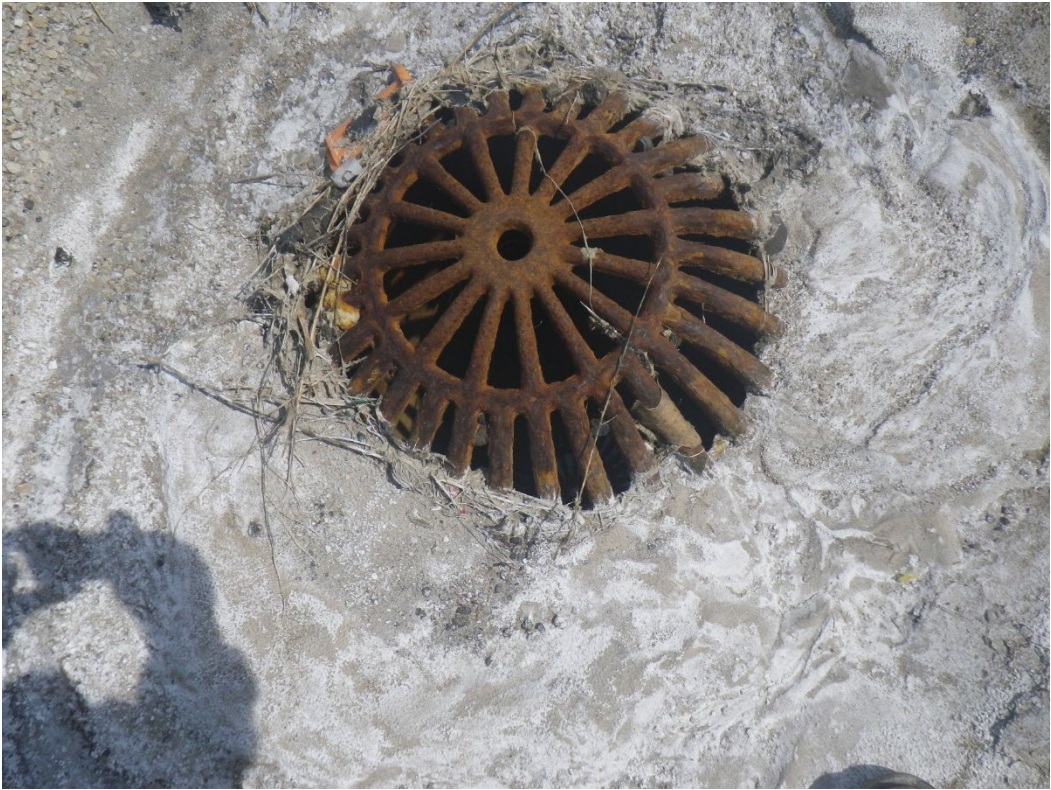
| Photograph 29. Close-up of the storm drain inlet shown in photograph 28 showing the salt staining around the inlet and the corrosion. | | | IMGP0029.JPG |

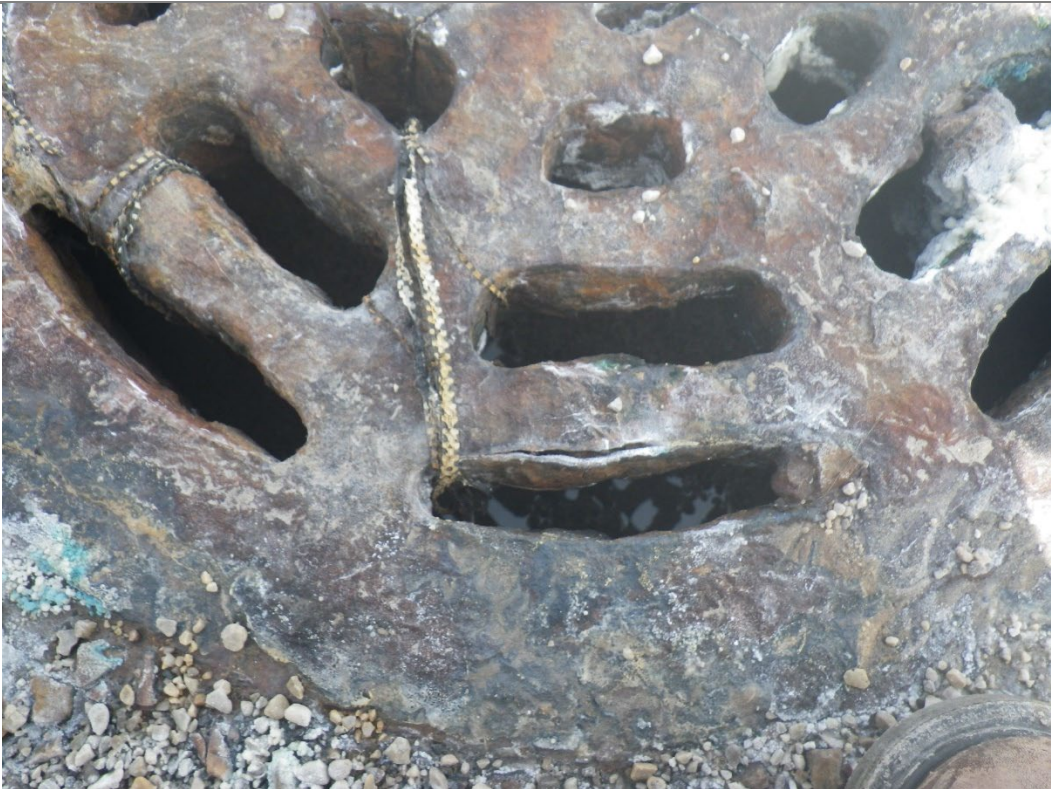
| Photograph 30. Storm drain inlet near the scale and just north of salt pile on parcel 1. This is also shown in photograph 31. | | | IMGP0030.JPG |

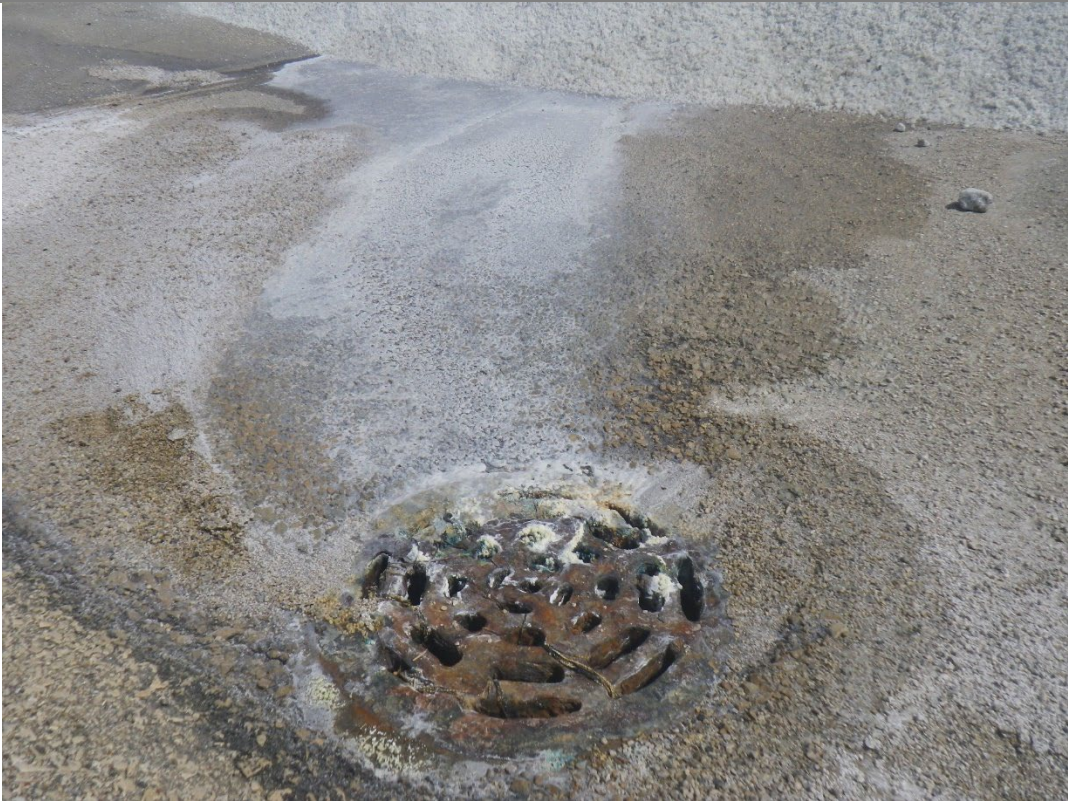
| Photograph 31. Storm drain inlet near scale just north of salt pile on parcel 3. The salt pile can been seen at the top of the photograph. Salt has stained the pavement and leads to the storm drain inlet. This is also shown in photograph 30. The SWPPP indicates that this drains to the combined sewer. | | | IMGP0031.JPG |

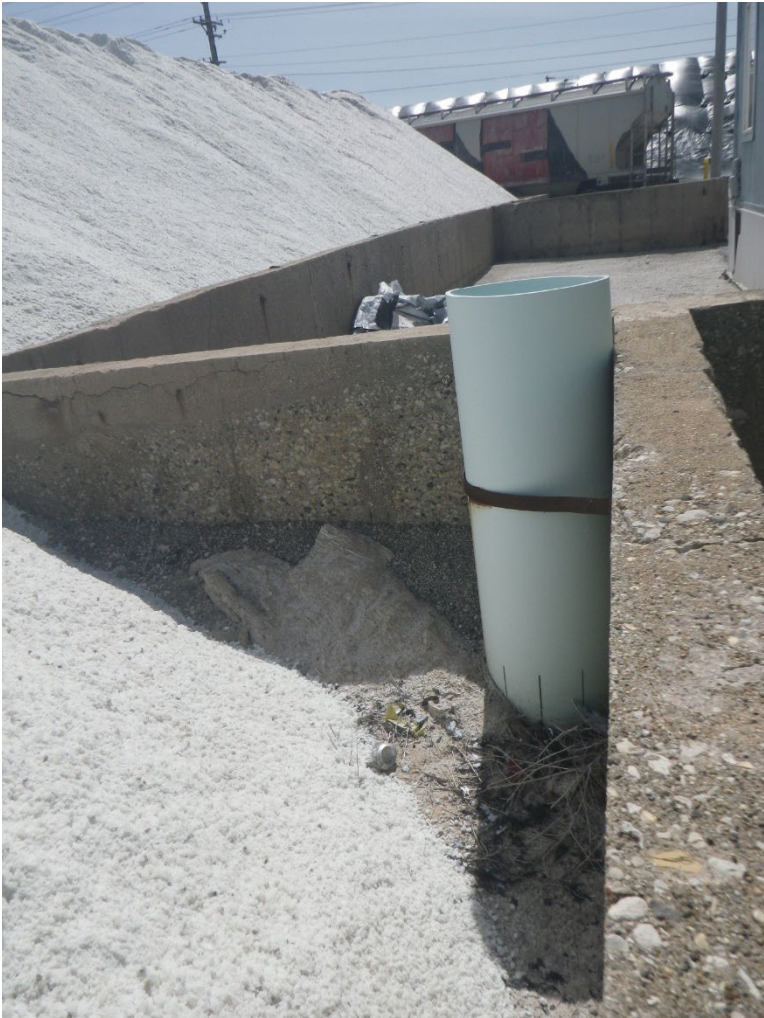
| The SWPPP did not identify the blueish green pipe, shown in photograph 32. Additionally, the SWPP did not identify where storm water enters this pipe and where it goes, i.e. storm or combined sewer. | | |

| Photograph 32. Riser pipe with slits at the bottom. The salt pile is uncovered next to the pipe. It is unknown where the pipe drains to. | | | IMGP0032.JPG |
