**SUBJECT:** CLEAN AIR ACT INSPECTION REPORT  
Waste Connections Seabreeze Environmental Landfill, Angleton, TX

**Facility Name:** Seabreeze Environmental Landfill

**Date of Inspection:** On Site Inspection: March 16, 2023  
Virtual Conference: April 21, 2023

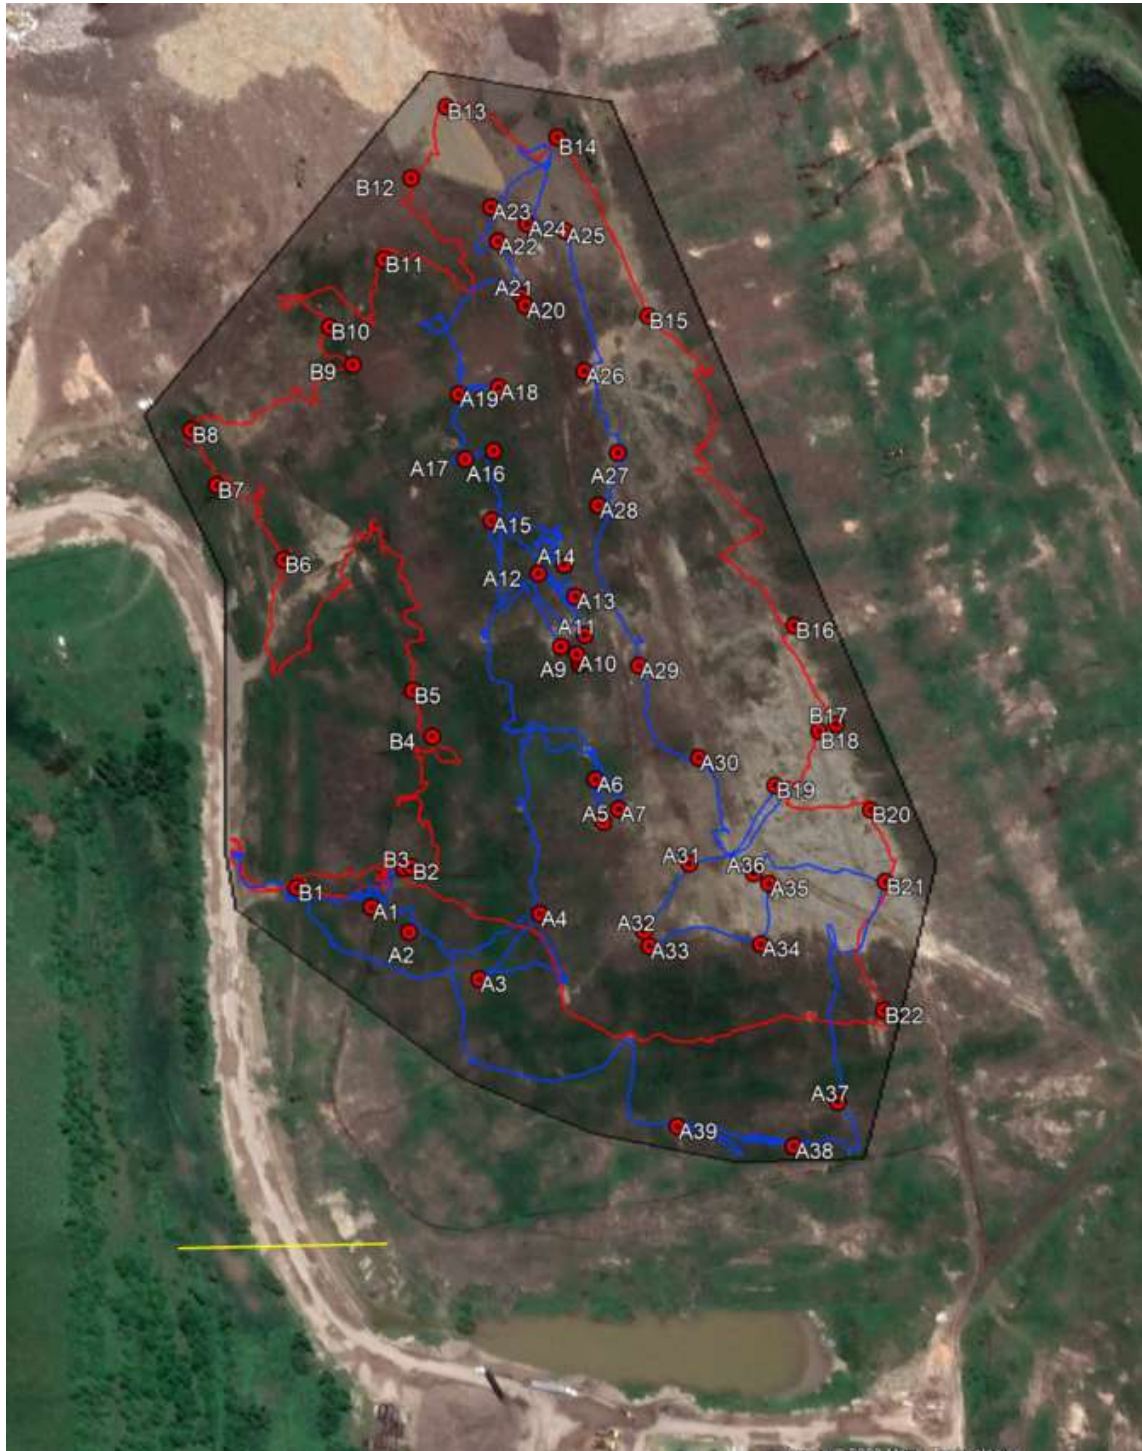
EPA inspectors identified 61 exceedances of the surface methane standard, all of which were confirmed by the SCS technicians. See Appendix B for location and description of measurements

and map of exceedances. Exceedances were primarily found at penetrations, in exposed waste, and in areas of erosion.

Zoom in on map of EPA survey paths and detected exceedances, paths colored for each survey team. Yellow line is 100m for scale.
